NACA RM E55L06

RESEARCH MEMORANDUM

EFFECTS OF A STRAIGHTENING OPERATION ON PERFORMANCE

OF INCONEL 550 BUCKETS

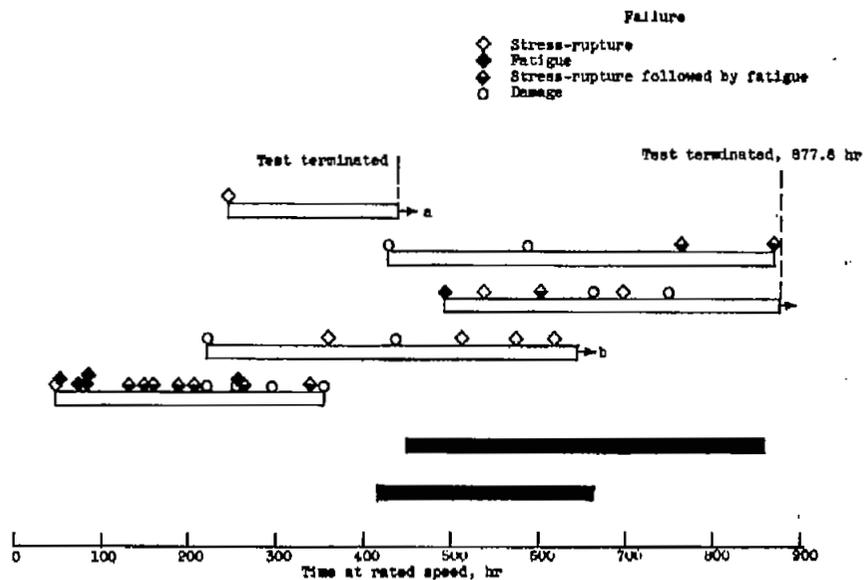
Figure 4. - Effect of straightening on bucket life of Inconel 550 in J33-9 engine at bucket temperature of 1500° F.

Engine life of the different groups of buckets is listed in table II and shown in figure 4. The straightened buckets (group 1), which were placed in the engine after 438 hours had been accumulated on the other groups of buckets, had a first failure after 248 hours. No other failure occurred in this group of buckets for the remainder of the investigation. The total accumulated time on these straightened buckets was 439 hours.

The buckets that were straightened and re-solution-treated prior to aging (group 2 buckets) had an excellent engine life. The first two failures of this group were damage-induced failures occurring at 428 and 586 hours. One unfailed bucket was removed from the engine at 618 hours to permit balancing of the turbine wheel. The first true failure occurred at 765 hours, and the other failure (last bucket of group 2) occurred at 872 hours at rated speed.

Only one failure occurred in the bucket group that was straightened after solution treatment (group 1). This failure occurred in 248 hours and possibly was the result of damage from the straightening operation. However, this life of 248 hours is somewhat better than the mean life of the S-816 buckets used as standards for comparison. All other buckets of group 1 had run for 439 hours when the engine test was discontinued. (It should be remembered that these buckets were inserted in the engine after the other groups of buckets had run 438 hours.)

The results also show that reproducibility of performance was obtained for the two groups of Inconel 550 (groups 3 and 4) which were common to both this investigation and the previous one (see fig. 4).

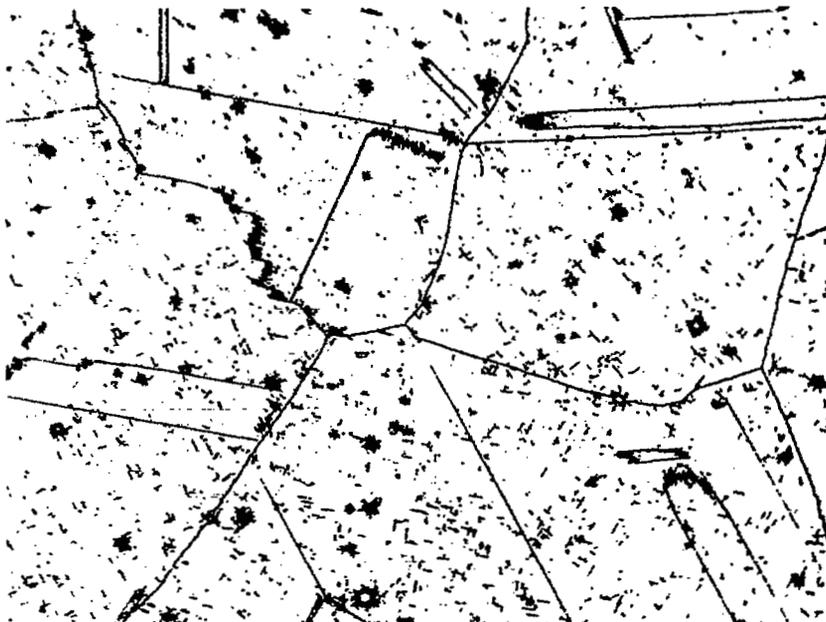
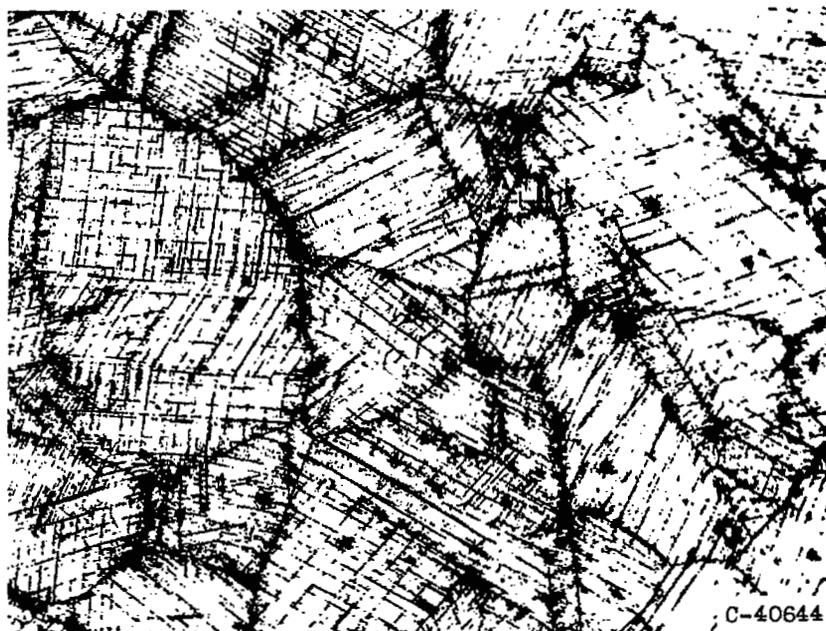
(a) Group 1 (straightened after solution treatment).

Microstructures representative of the different bucket groups, prior to operation in the engine, are shown in figure 6. The Inconel 550 buckets that were straightened (restruck) after solution treatment, prior to aging (group 1), show considerable evidence of working (fig. 6(a)). This is revealed by precipitation in slip lines and by Widmanstätten structures that formed during subsequent aging. Re-solution-treatment after the straightening operation has eliminated most of this evidence of cold work (fig. 6(b)); and the structure appears similar to that of groups 3 and 4, which have not been given the straightening treatment (figs. 6(c) and (d)).

In the present investigation, the stress-rupture life of straightened buckets (group 1), which contained Widmanstätten structure and slip-line precipitates, was approximately 1/4 of the stress-rupture life at 20,000 psi of the unstraightened buckets (group 3). The stress-rupture life of the straightened and flash-solution-treated buckets of group 2 (which was devoid of Widmanstätten structure and relatively free of slip-line precipitation) was equal to that of the group 3 buckets. These significant facts strongly indicate that a flash solution treatment after straightening would be desirable.

1. The straightening operation reduced the stress-rupture properties of the airfoil material and produced a microstructure containing fairly large quantities of Widmanstätten structures and slip-line precipitation.

Under certain conditions, as was the case of this investigation, it may be possible to compensate for damage to properties by a re-solution-treatment. It would seem advisable to avoid straightening wherever possible; however, when it cannot be avoided, careful consideration should be given to the possible detrimental effects.

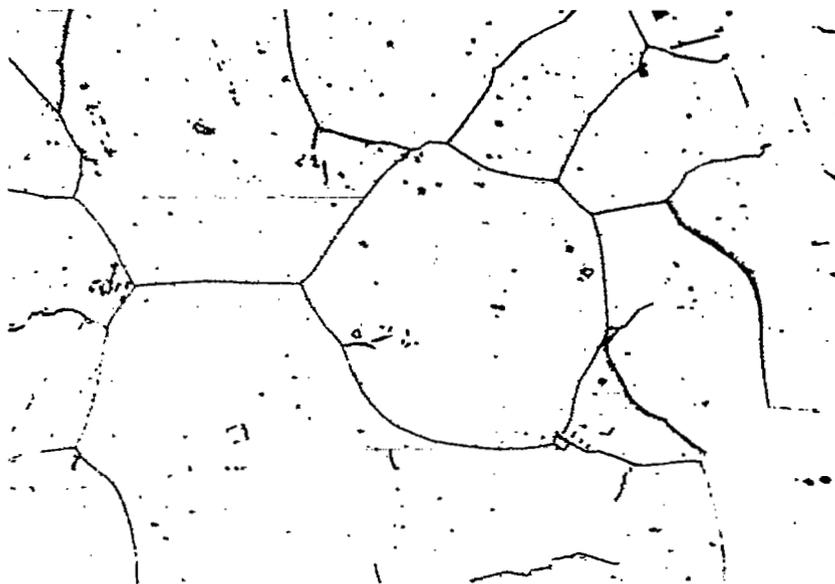
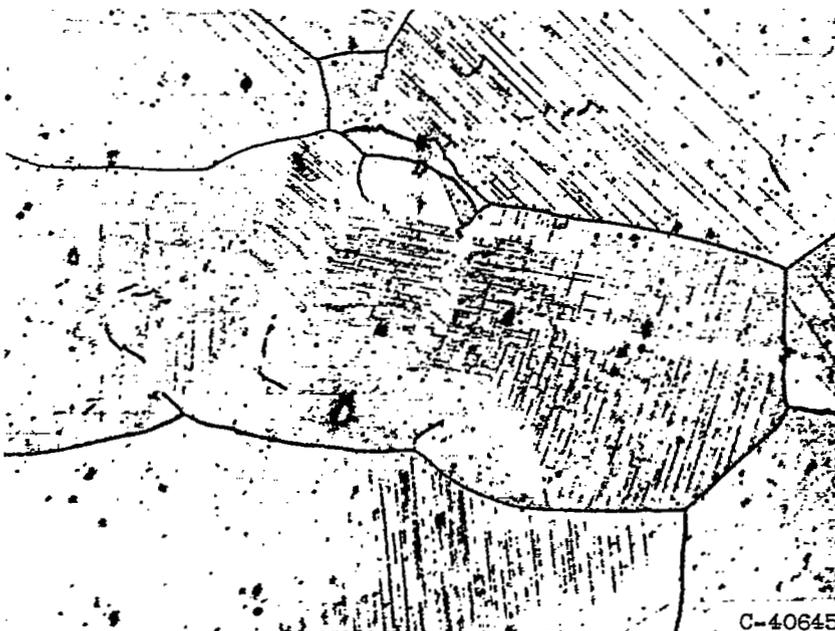
(b) Group 2 (straightened and flash-solution-treated).

It can be noted in figures 7, 6(a), and 6(b), respectively, that the interposed flash solution treatment affected both the stress-rupture life and the precipitation mechanisms of the restruck buckets. The effects of various precipitation phenomena on the physical properties of high-temperature alloys are not definitely known, but a past investigation (ref. 2) showed that the stress-rupture life of a cobalt-base alloy was structure-sensitive. It was found that a Widmanstätten structure was associated with low stress-rupture life and that salt-and-pepper precipitation (general precipitation) was beneficial.

2. A flash solution treatment after restriking recovered stress-rupture properties of the alloy and restored a more normal solution-treated microstructure. Buckets given this treatment ran as well as unstraightened buckets.

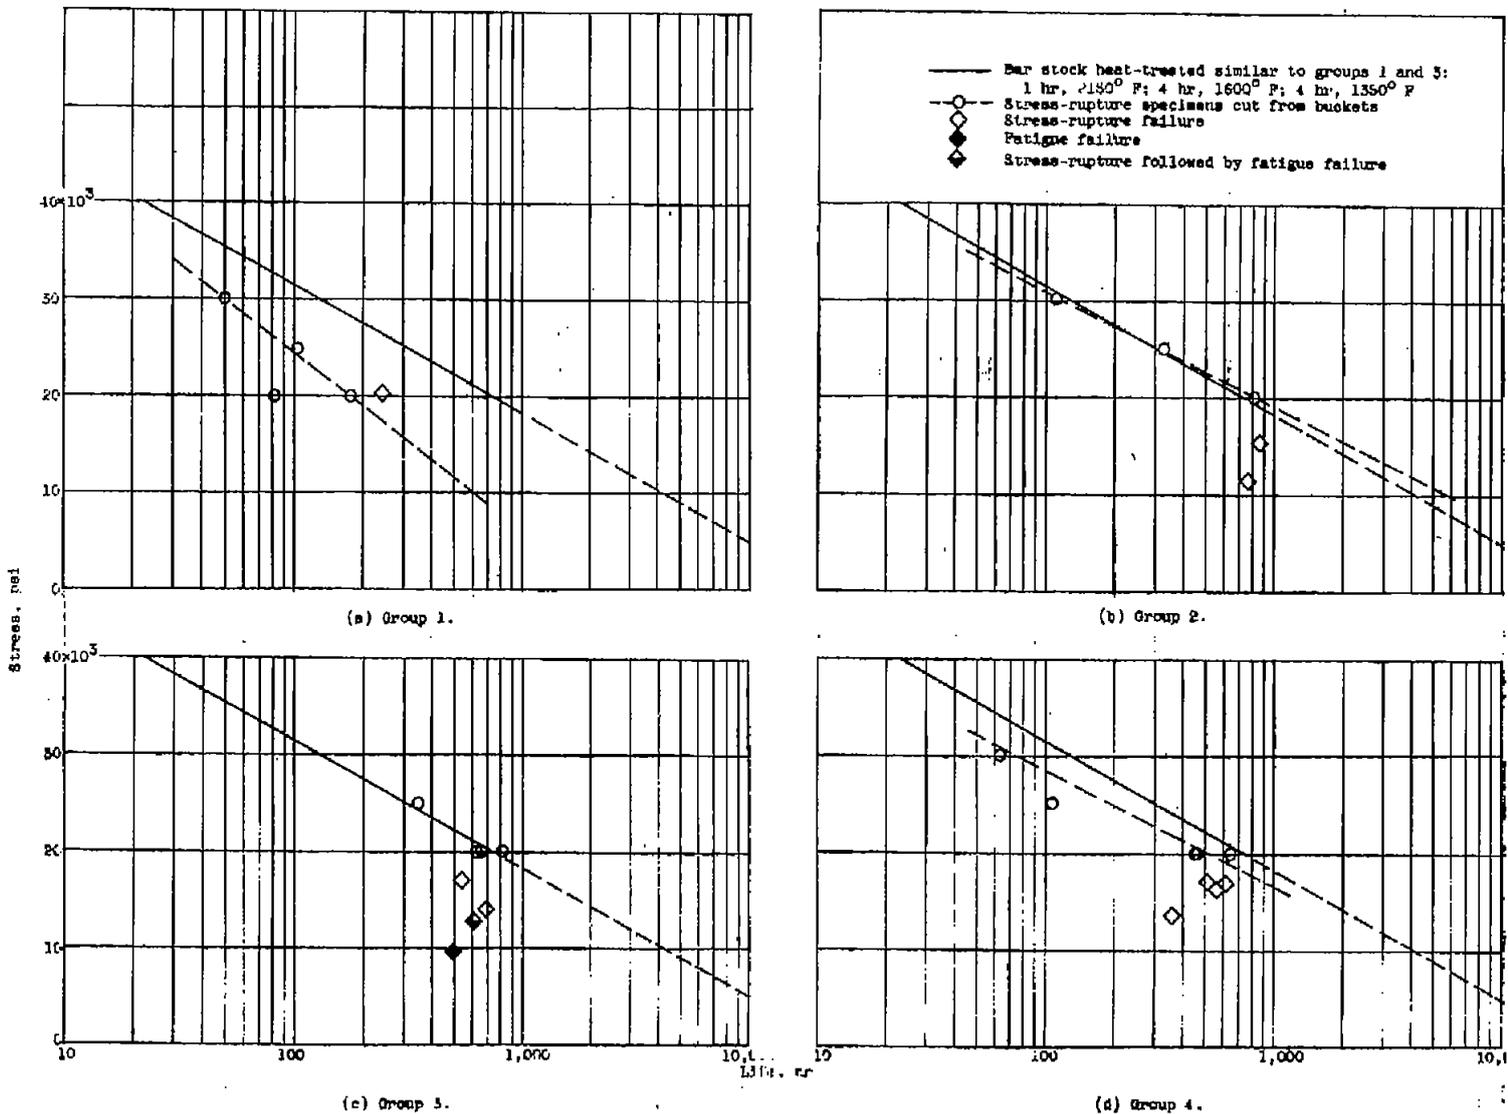
Figure 7. - Comparison of bucket life and stress-rupture life of bar stock and specimens cut from buckets at 1500° F test temperature. (Bucket life is plotted at stress level obtaining at origin of failure.)

The results of the stress-rupture tests of specimens cut from bucket airfoils are given in table III and figure 7. The stress-rupture properties of the specimens cut from the straightened buckets (group 1) were the poorest obtained. The stress-rupture lives of the specimens from the group of buckets given the flash-solution-treatment after the straightening operation (group 2) equal or exceed the stress-rupture lives of specimens cut from the group 3 buckets that performed best in reference 1 (see group 3 herein). The life of the buckets from group 4 herein (the second-best group of ref. 1) duplicated the results obtained in reference 1.

In the preceding study (ref. 1) and in almost all engine studies made at this laboratory, it has been found that bucket life is less than or equal to life of stress-rupture specimens cut from bucket airfoils for comparable stresses and temperatures. In the present investigation this was true for groups 2, 3, and 4 but not for the straightened buckets of group 1. The group 1 bucket life was considerably longer than the life predictable from stress-rupture properties. This may be seen in figure 7, where bucket life for the different groups is plotted (as in ref. 1) at the stress levels occurring at the failure origins.

Attempts have been made to explain this anomaly by various means. Metallographic studies revealed that the microstructures of the stress-rupture bars cut from central portions of buckets differed from structures at or near the leading and trailing edges. In general, more slip-line precipitation, finer grains, and less Widmanstätten structure occurred at or near the edges than occurred in the interior portions of the airfoils. The strength of the material in the leading- and trailing-edge regions may have been greater than that of the central portion tested in stress-rupture. However, it was not feasible to determine the stress-rupture strength of the leading- and trailing-edge material, because it is most difficult to obtain satisfactory test specimens from these areas.
