RESEARCH MEMORANDUM

ALTITUDE-WIND-TUNNEL INVESTIGATION OF A 4000-POUND-THRUST
AXIAL-FLOW TURBOJET ENGINE

II - OPERATIONAL CHARACTERISTICS

By William A. Fleming

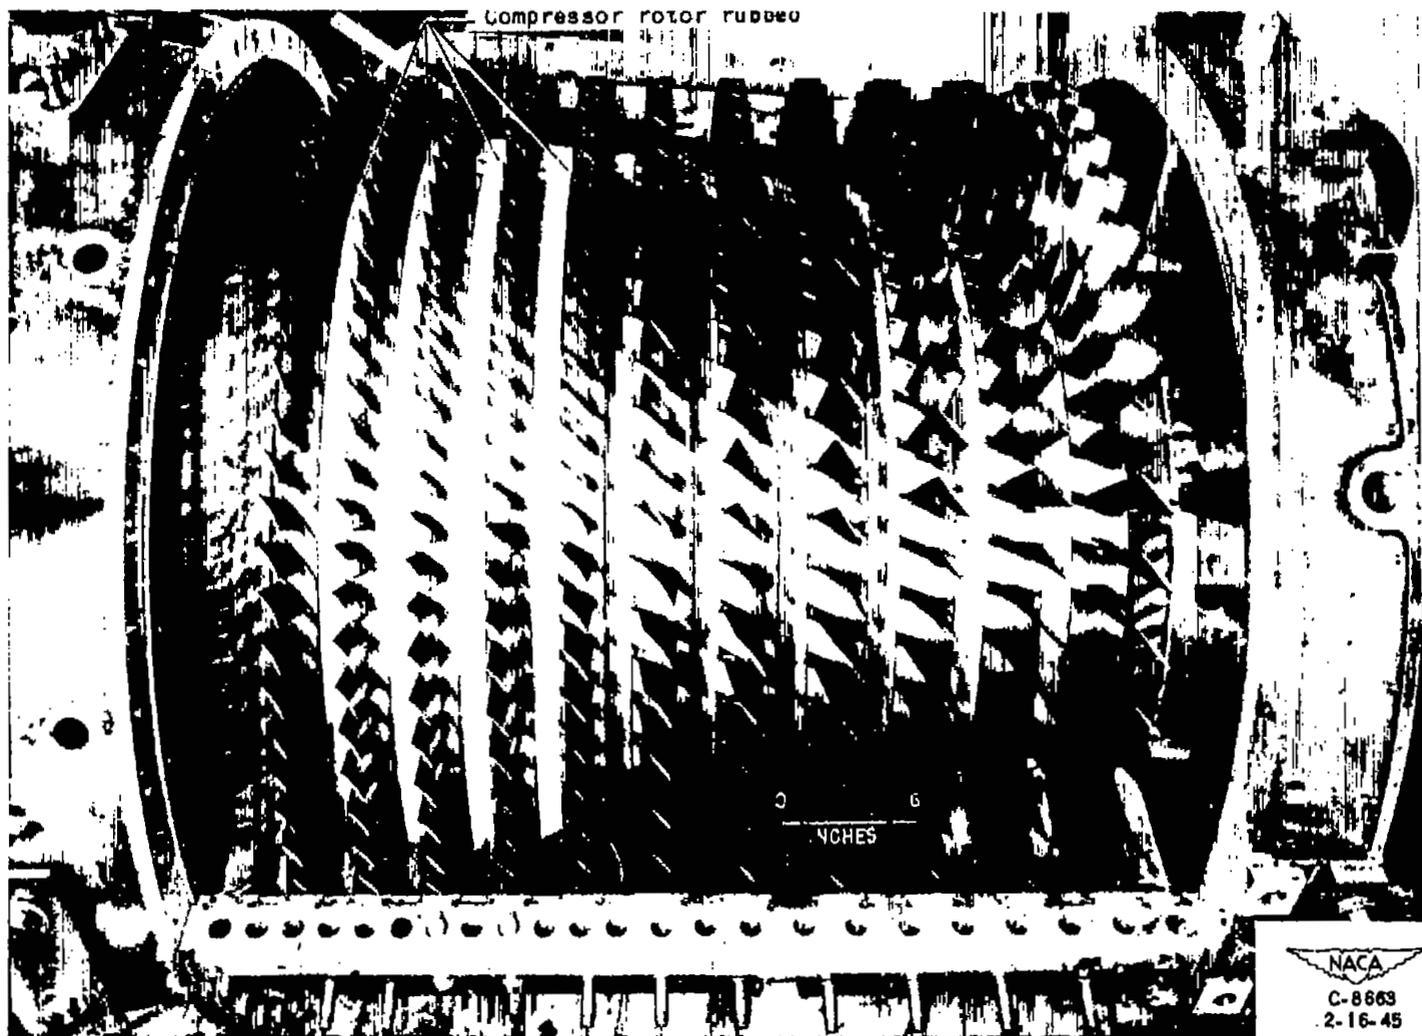
After 54 hours of testing with the low-flow compressor, the mid bearing, which is located at the rear of the compressor, failed. The engine had been operating for several minutes at a pressure altitude of 50,000 feet and engine speeds near 7000 rpm with the mid-bearing temperatures ranging from 275° to 335° F. The engine speed was increased and was being stabilized at 7450 rpm when the mid-bearing temperature reached 340° F and continued to rise rapidly. The fuel was shut off as quickly as possible, but the mid-bearing temperature immediately reached 392° F and soon rose to a maximum of 410° F. The temperature of the rear bearing just ahead of the turbine wheel reached a maximum of 360° F soon after operation of the engine was discontinued. The high temperature of the rear bearing was probably caused by heat transfer from the turbine wheel, which was still hot. While the engine was windmilling immediately after the fuel had been shut off, the amplitude of vibration of the engine indicated on the vibration meter greatly exceeded the allowable limit of 0.005 inch for normal operation.

An inspection of the mid bearing after the engine was disassembled revealed that all the plastic cages that held the balls in place had been ground into small pieces. Operation of the bearing at high temperatures had probably weakened the plastic cages and one of them failed, which enabled the balls to move about and crush the remaining cages. The tips of the rotor and stator blades on the rear stages of the compressor had rubbed after the mid bearing failed. Views of the compressor rotor and case after the blades rubbed are shown in figures 19 and 20.

Figure 19. - View of the compressor rotor after the mid-bearing failure showing the area where the stator blades rubbed the rotor.
