INVESTIGATION OF THE FATIGUE STRENGTH OF
FULL-SCALE AIRPLANE WING STRUCTURES

By Dwight O. Fearnow

NATIONAL ADVISORY COMMITTEE FOR AERONAUTICS

NACA RM L51D13a

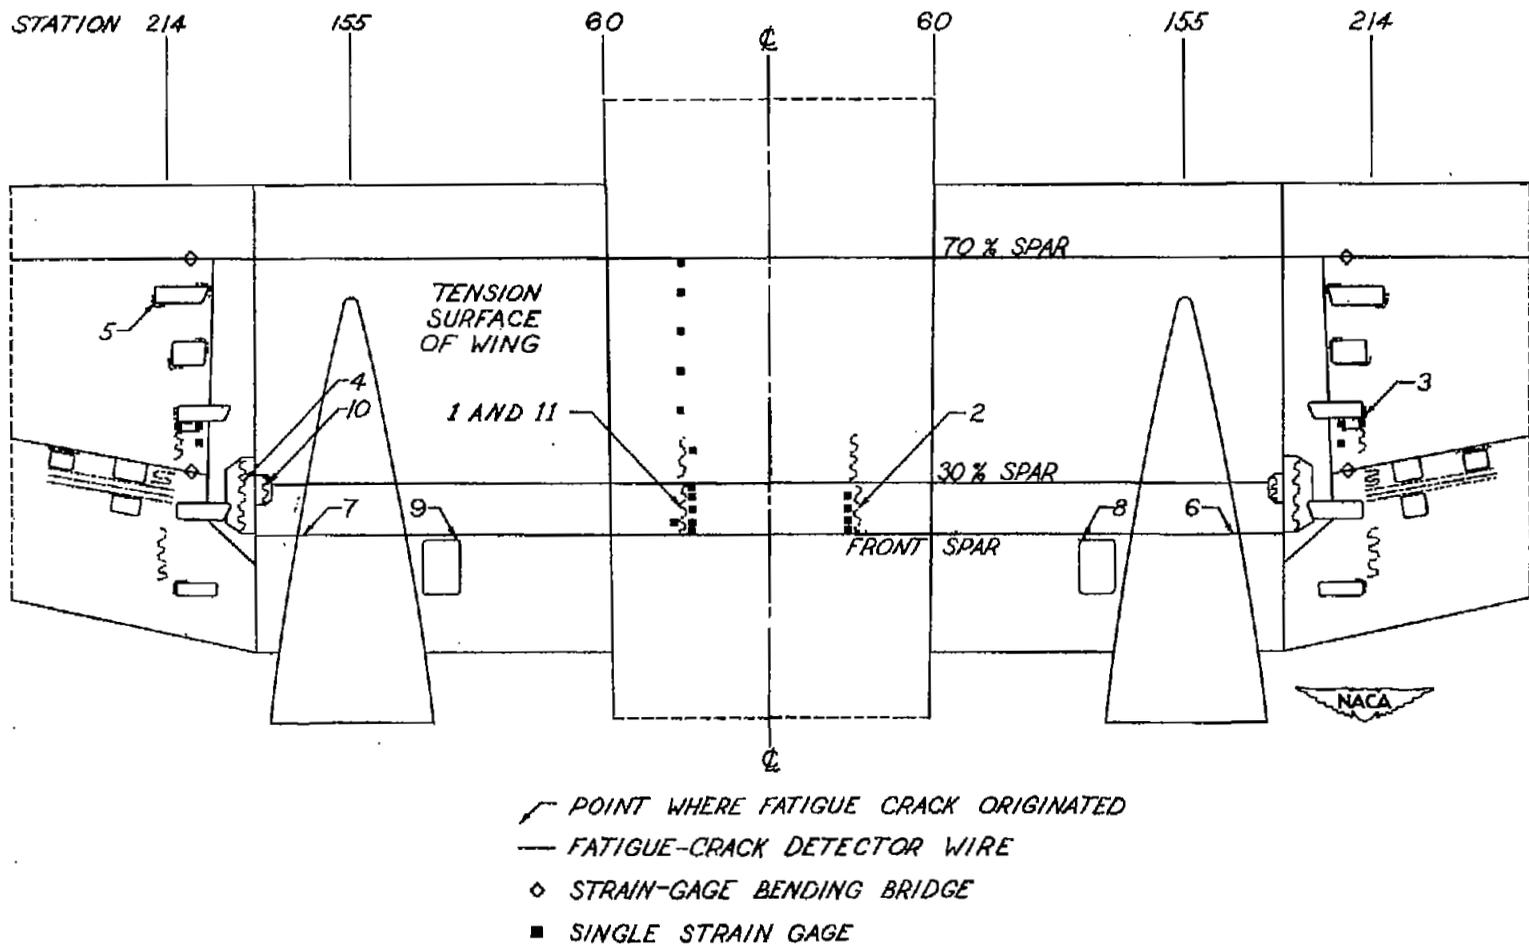
Description of fatigue cracks.- Figure 3 shows the location of the fatigue cracks on a plan view of the wing. The cracks are numbered in order of occurrence for purposes of identification. Cracks 1 to 5 were on the first specimen whereas cracks 6 to 11 were on the second specimen. In three instances involving seven of the 11 cracks, duplicate failures were obtained. Cracks 1, 2, and 11 occurred in riveted lap joints similarly located and constructed. Details of these joints are shown

Figure 3.- Nominal location of instrumentation and point of crack origin.

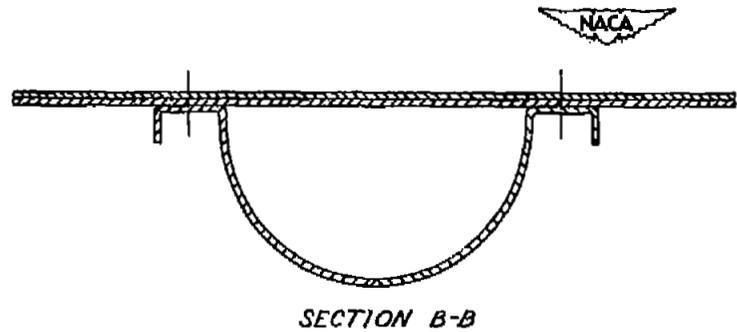
Figure 6.- Details of riveted joint where cracks 1, 2, and 11 originated.

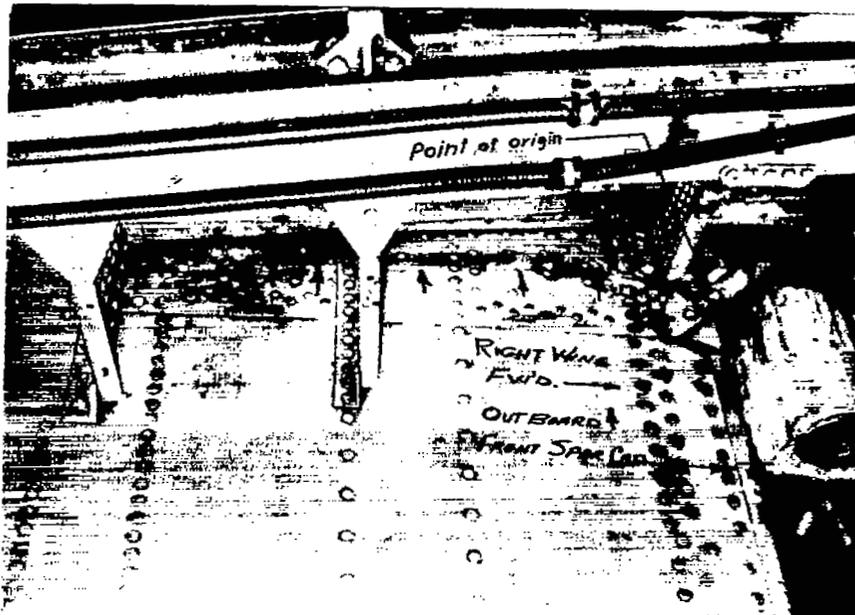
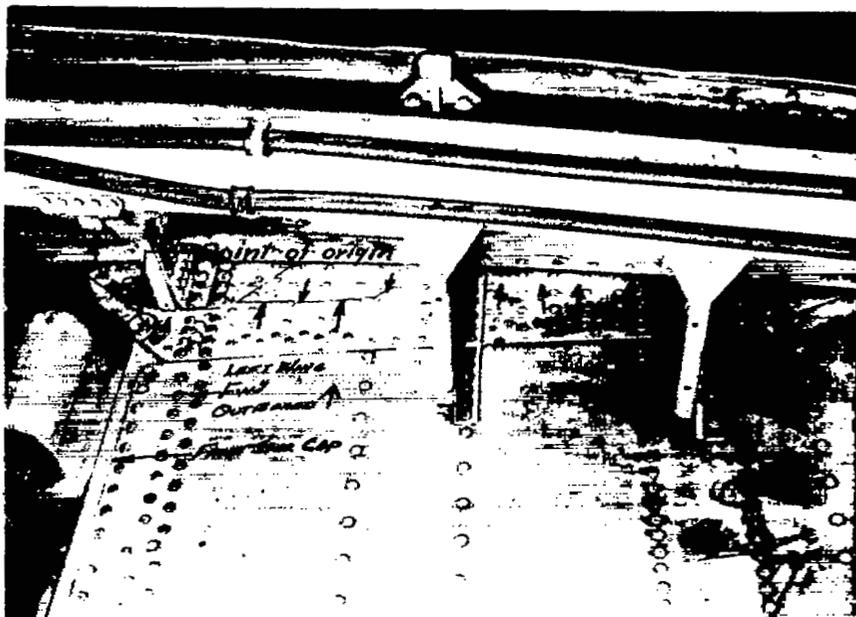
Cracks 4 and 10 occurred in the joggle of a reinforcement doubler plate while cracks 6 and 7 occurred at the outboard juncture of the wing and engine nacelles. Figure 11 shows a typical crack in the joggle of a doubler plate and figure 12 shows the similarity of the cracks which occurred at the juncture of wing and nacelle on both left and right semispans. It should be noted that cracks 6 and 7 started in half round notches in the doubler plate. These notches had apparently been cut to provide clearance for operation of the landing gear, and their addition placed a rivet very close to the edge of the sheet.

(a) View of crack 6.

(b) View of crack 7.

Figure 12.- Typical cracks at juncture of wing and engine nacelle.

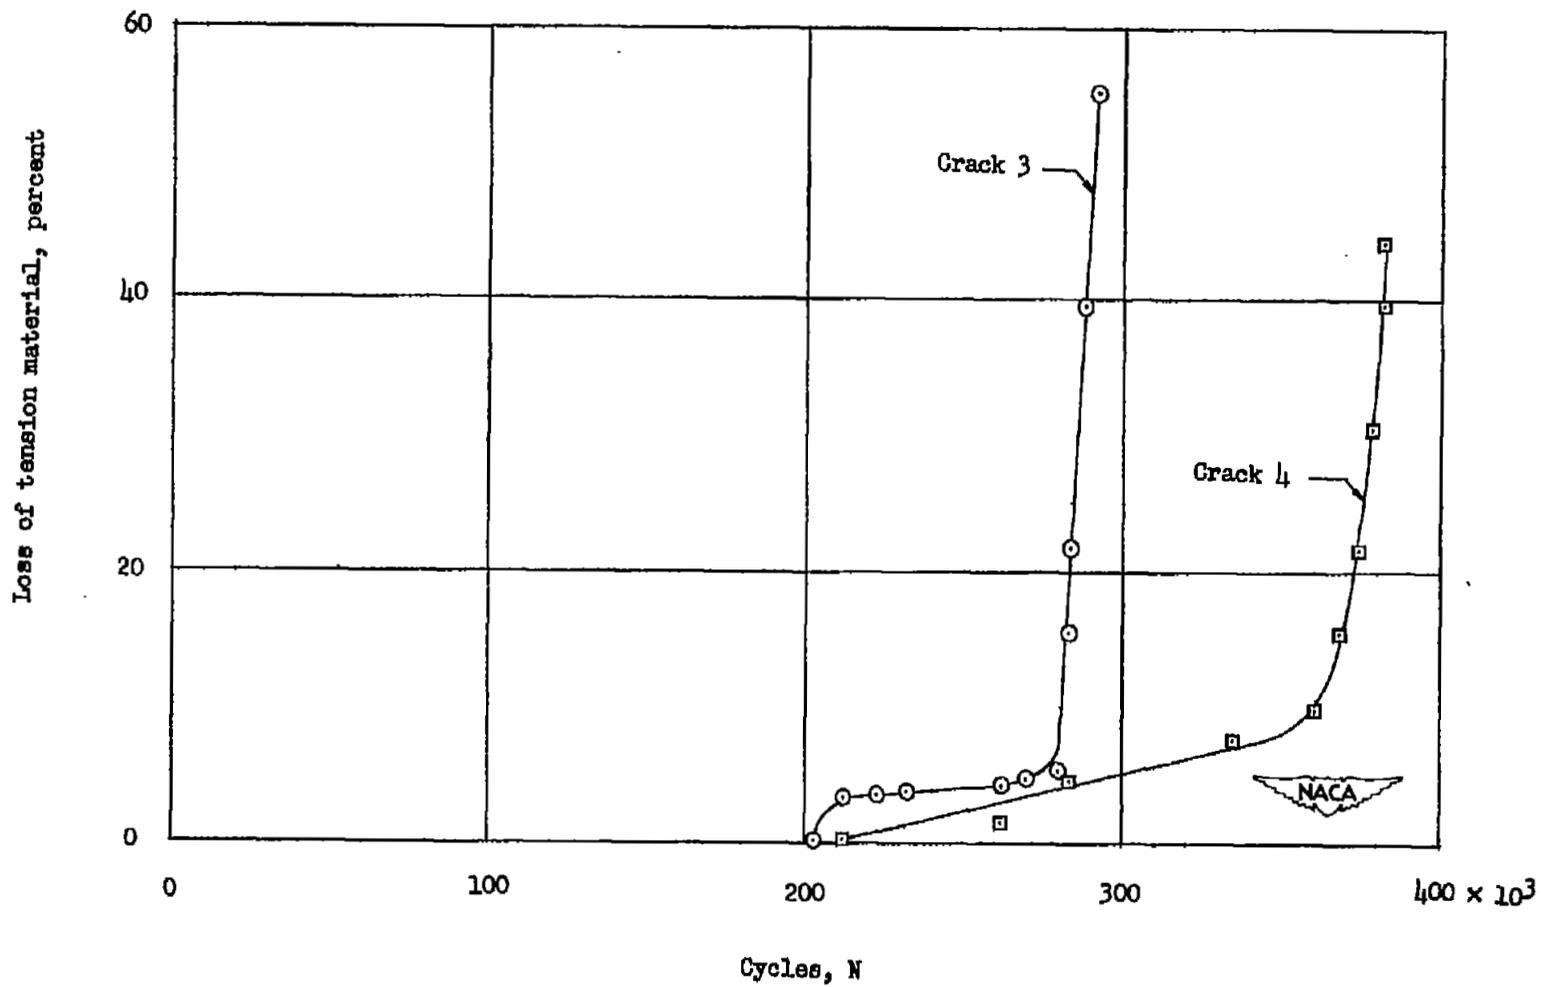
Rate of growth.- Cracks 3 and 4, which originated near station 214, were detected by fatigue-detector wires at an early stage and were allowed to grow until danger to the equipment was imminent. The rate at which the cracks grew is shown in figure 15 where the estimated loss of total tension material, in percent of cross-sectional area of the tension surface at this station, is shown as a function of cycles of applied load. It is interesting to note that the growth of the cracks

was relatively slow until about 7.5 percent of the tension material had failed. The slopes of the curves then become very steep, indicating a very rapid propagation of the crack.

Figure 15.- Growth of fatigue cracks 3 and 4.
