# RESEARCH MEMORANDUM

EFFECT OF FORGING TEMPERATURE AND HEAT TREATMENT  
ON THE PERFORMANCE OF INCONEL 700 BUCKETS AT  
1625° F IN A J33-9 TURBOJET ENGINE

By C. A. Gyorgak, D. F. Springsteen, and J. R. Johnston

Lewis Flight Propulsion Laboratory  
Cleveland, Ohio

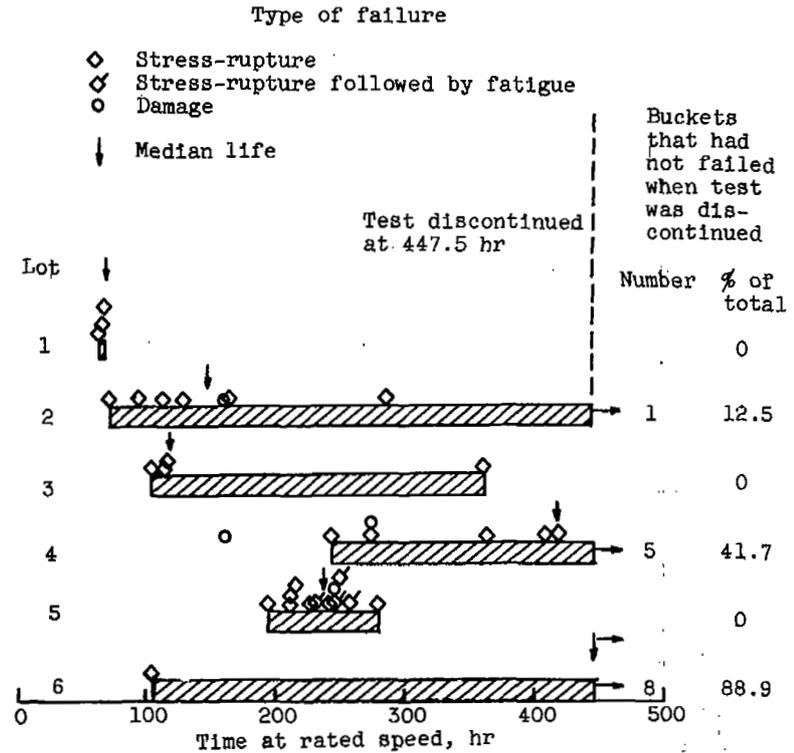
The results of the engine evaluation show that heat-treated Inconel 700 buckets can operate several hundred hours at a bucket temperature of 1625° F (in the critical zone). A comparison of engine performance of the six lots of Inconel 700 is presented in figure 6 and in table II.

Macro-examination of failed buckets revealed that failures occurred by several different mechanisms - stress-rupture, stress-rupture followed by fatigue, and damage. The classification of failure mechanisms as determined visually is reported in table II and figure 6.

Figure 6. - Effect of forging temperatures and solution treatments on performance of Inconel 700 turbine buckets in a J33-9 engine at material temperature of 1625° F.

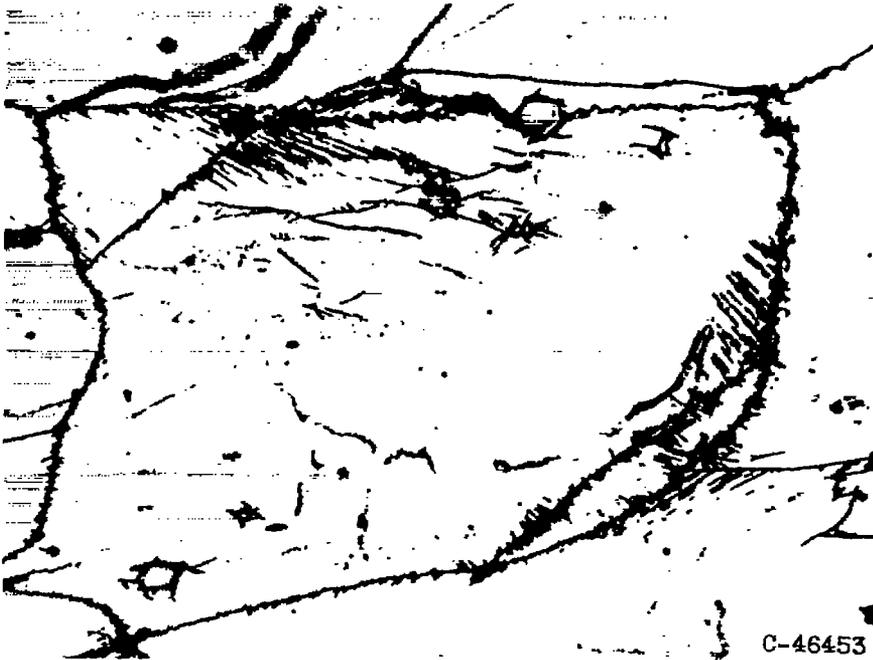
While the structures shown in figure 10 are typical, there were isolated regions within buckets that differed. Examples of these microstructures are presented in figure 11. Figures 11(a) and (b) show slipline precipitates present in the leading and trailing edges of buckets that were forged and aged only (not solution-treated). Various degrees of grain-boundary precipitation in the buckets of all lots are presented in figure 11(c). Precipitation of the magnitude shown in the lower part of figure 11(c) was very rare. The development of void formation at the interface between titanium carbonitride and the matrix in the buckets that were solution-treated at  $2275^{\circ}F$  can be seen in figure 11(d). Figure 11(e) shows a region with sawtooth grain boundaries.

The unusual form of the precipitates and microstructural configurations shown in figure 11 could not be related to the performance of any of the groups of buckets.

(a) Slipline precipitate found in the leading and trailing edges of lot 1 and lot 5 buckets.

(b) Feathery precipitate found in lot 1 and lot 5 buckets.

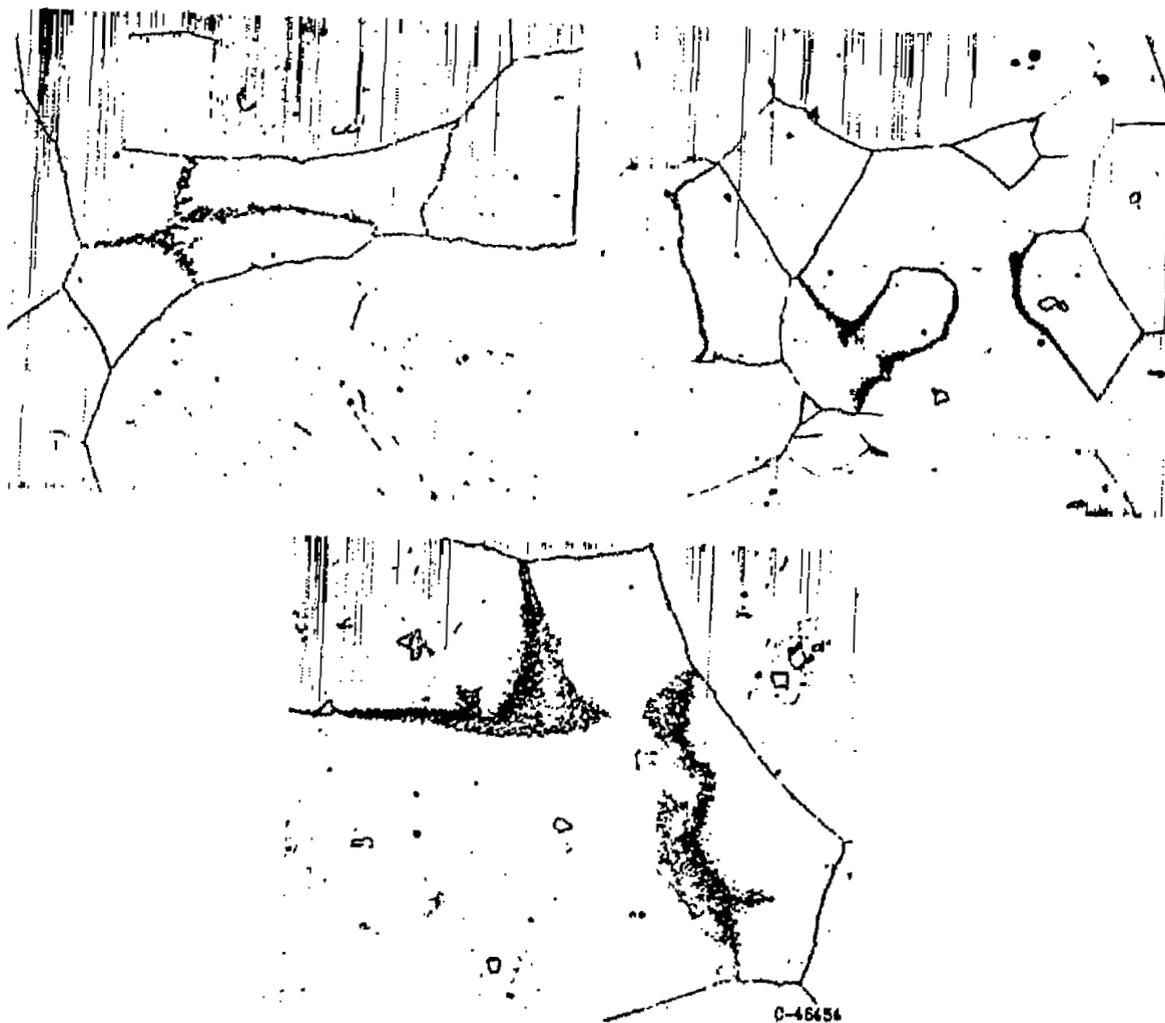
(c) Types of grain-boundary precipitation found in Inconel 700 buckets.

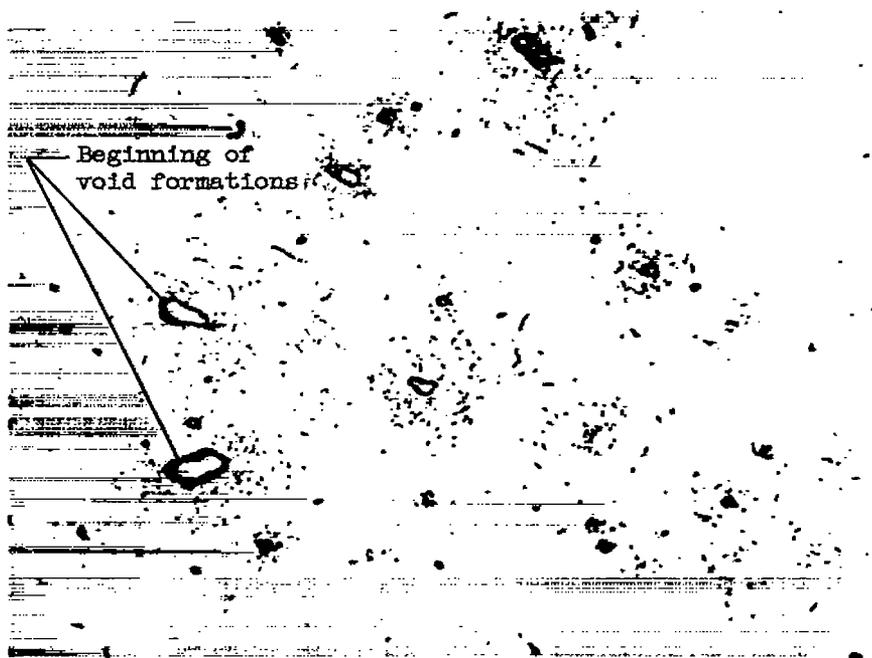
(d) Beginning of void formation in Inconel 700 buckets solution-treated at 2275° F.

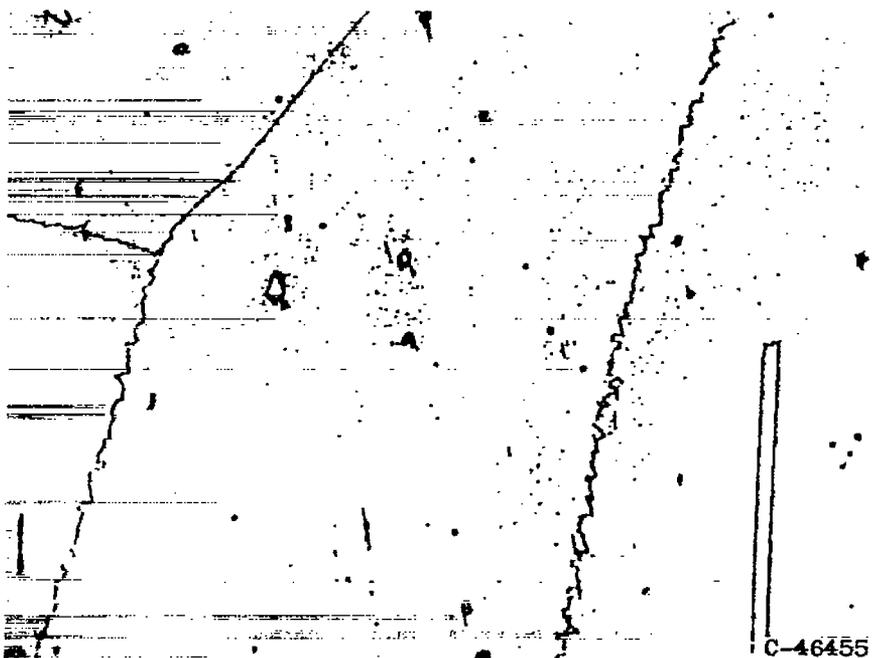
(e) Sawtooth grain boundaries found in Inconel 700 buckets.

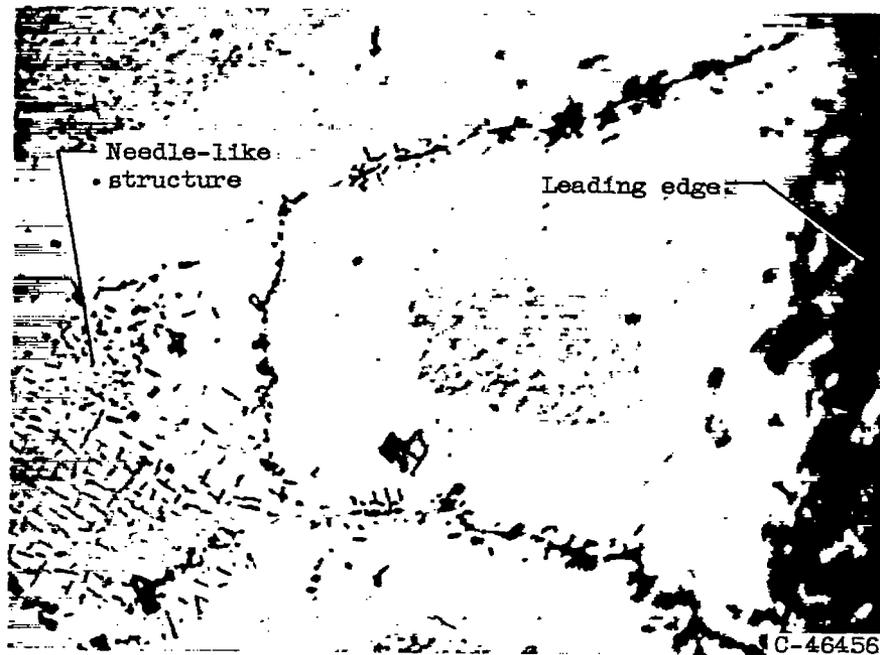
The microstructural studies also revealed that all operated buckets exhibited various degrees of surface depletion that appeared to be related to the operating time. An example of a depletion zone is shown in figure 14(a). Occasionally, needle-like structures (possibly chromium nitrides) were noted in the depletion zones, as shown in figure 14(b).

(b) Needle-like structure associated with the depletion zone of operated buckets. Original magnification, X1000.
