NACA RM E52L17a

RESULTS OF TURBOJET ENGINE OPERATION TESTS USING
A 50-50 MIXTURE OF JP-4 AND TRIBUTYL BORATE
AS THE FUEL

By Louis J. Schafer, Jr., and Francis S. Stepka

Lewis Flight Propulsion Laboratory
Cleveland, Ohio

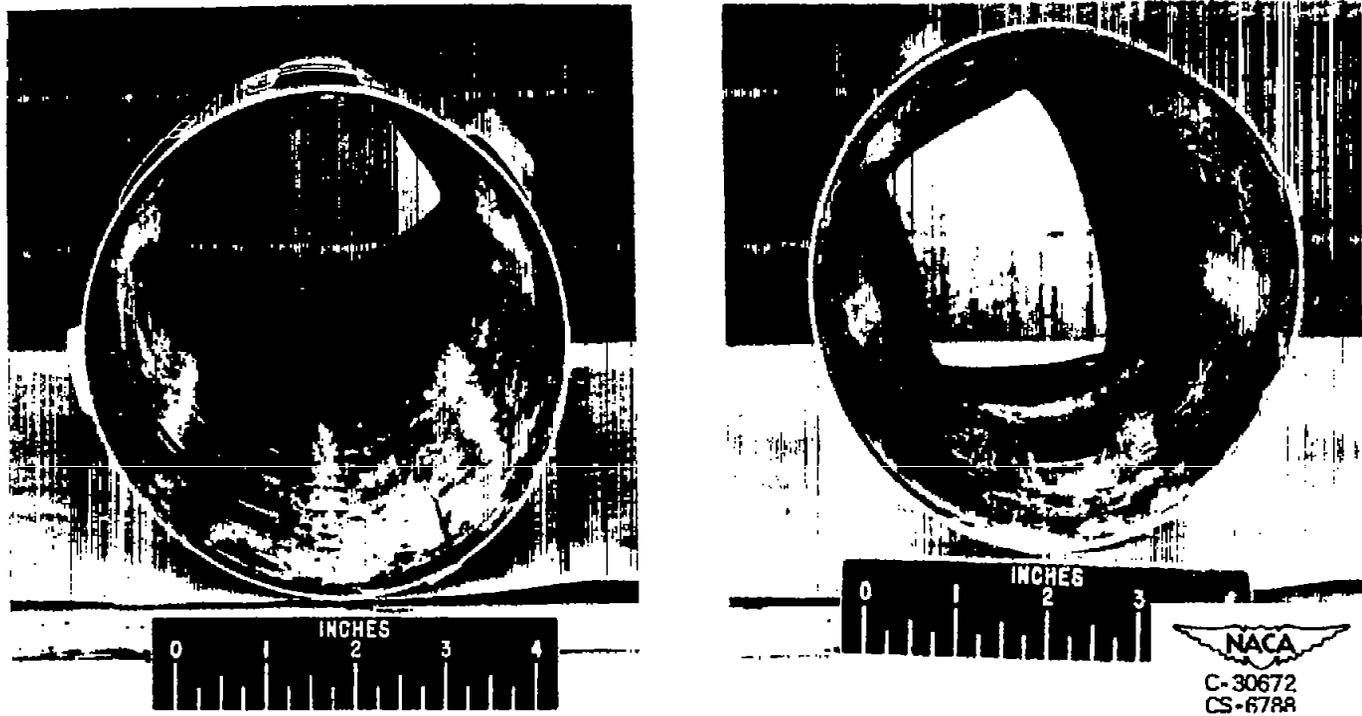
Two of the burner liners are shown in figure 2. These showed a buildup of deposits over small areas just downstream of the air holes in the liners. These deposits were the same type as those that were found in the burner domes and around the fuel nozzles. The rest of the surface of the burner liners had a thin rippled coating of boric oxide. The boric oxide was obviously molten on these surfaces of the liners and was flowing toward the nozzle diaphragm where it built up in clumps at the exit of the burner liners as is shown in figure 3. There was also evidence of molten boric oxide between the outer ring of the nozzle diaphragm and the engine casing shown in figure 3.

Figure 2. - Build-up of deposits on burner liners.

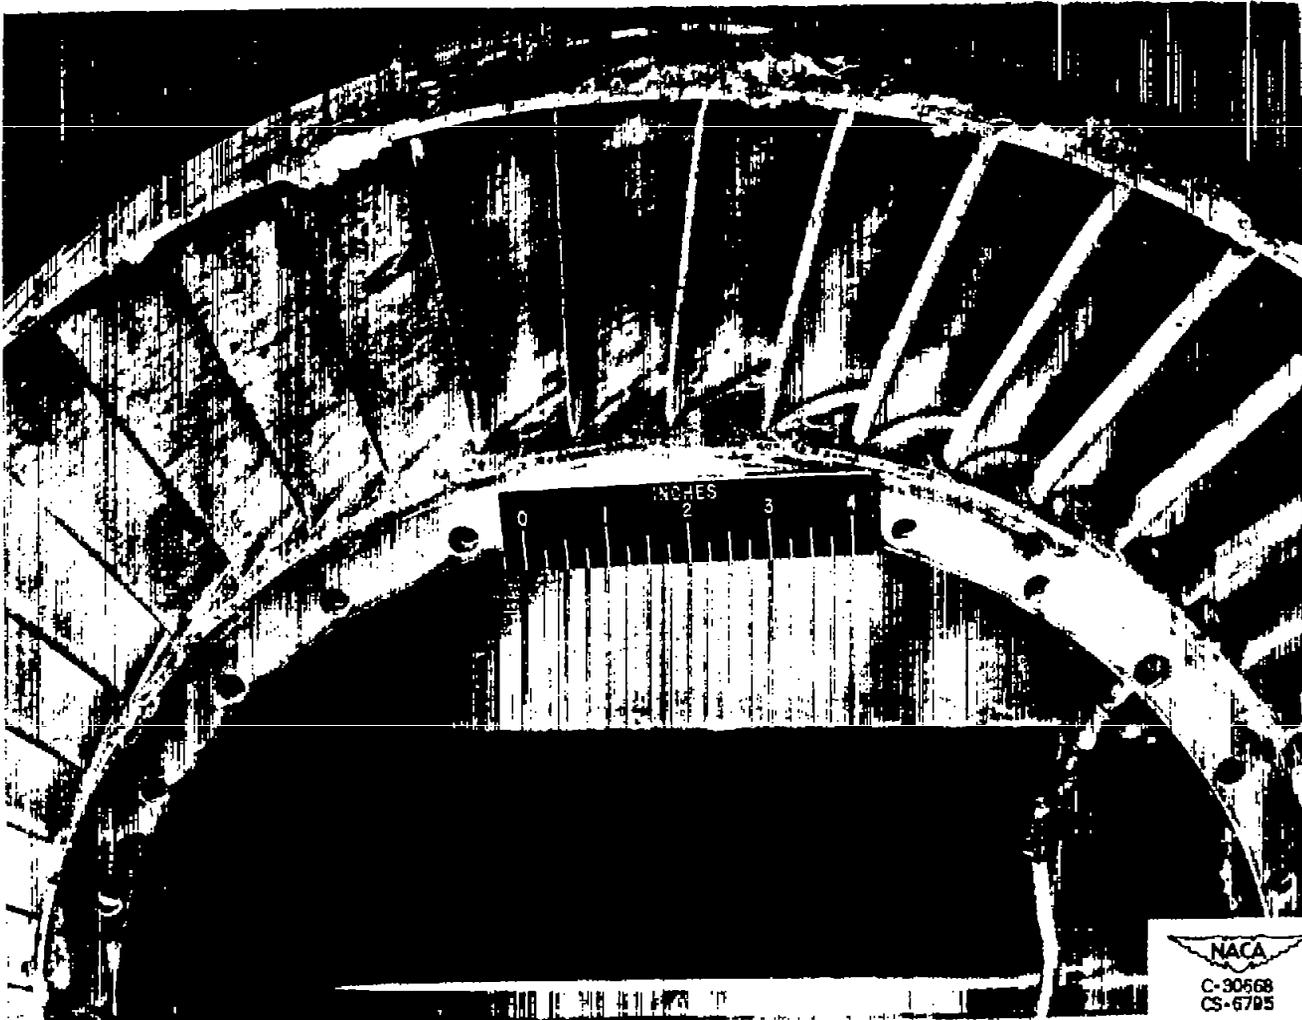
(a) Upstream side of diaphragm.

The deposit formations on the upstream and the downstream sides of the nozzle diaphragm are shown in figure 4. The deposits on this part are the molten type of deposit. The deposits on the nozzle blades were insignificant. Most of the deposit was found around the outside of the outer diaphragm ring where it would have no effect on the aerodynamic performance of the nozzles. There was also a coating of the deposit on the gas seal rings between the nozzle diaphragm and the turbine rotor.

Figure 4. - Build-up of deposits on nozzle diaphragm.

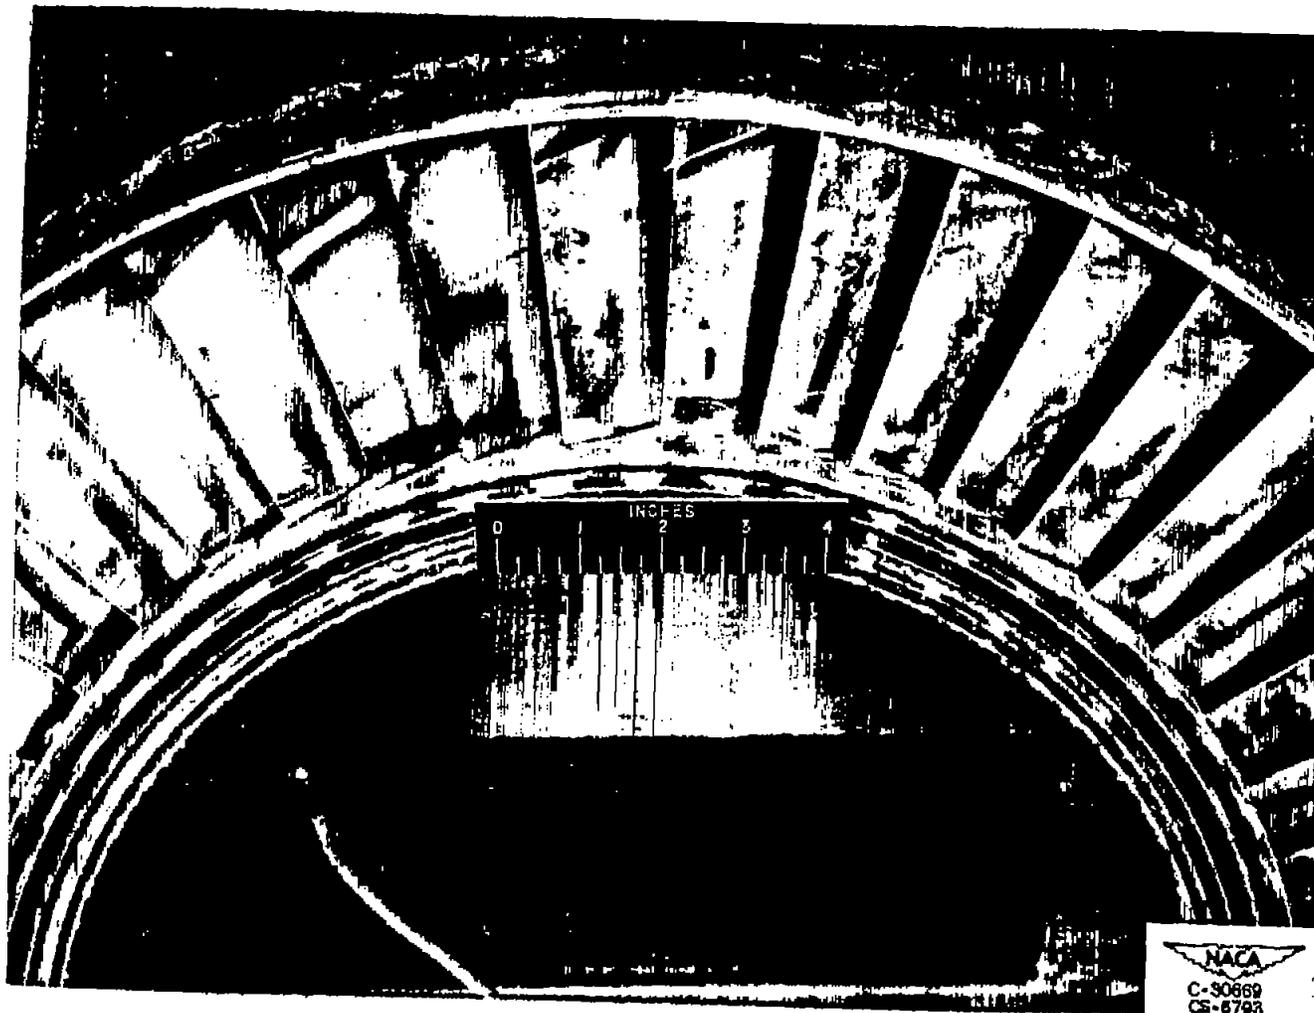
(b) Downstream side of diaphragm.

Figure 4. - Concluded. Build-up of deposits on nozzle diaphragm.

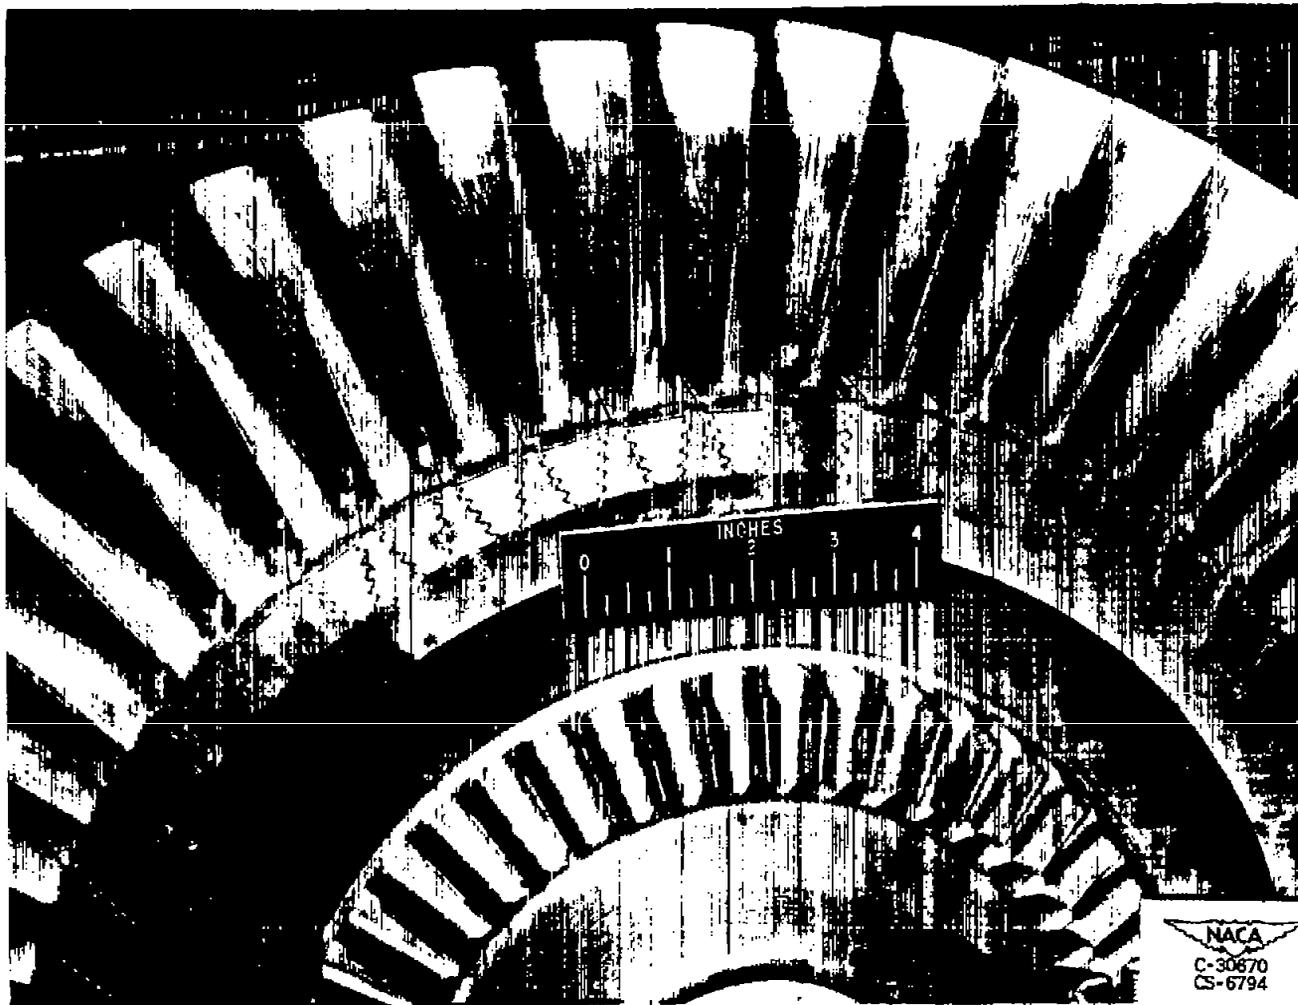
(a) Upstream side of rotor.

Photographs of the upstream and the downstream side of the turbine rotor are shown in figure 5. The deposits on this part were very thin.

The boric oxide that formed on the blades evidently was thrown off the blade tips. This flow of the deposits along the blade span is borne out by the nearly radial flow lines that can be seen on the blades in figure 5(a). The pressure surface of the rotor blades was covered with the deposits more completely than the suction surface. Only the tip half of the suction surface (fig. 5(b)) showed evidence of any coating. The turbine rotor disk had no coating of boric oxide on the upstream side but the downstream side showed a very thin, uniform coating.

Figure 5. - Build-up of deposits on turbine rotor.

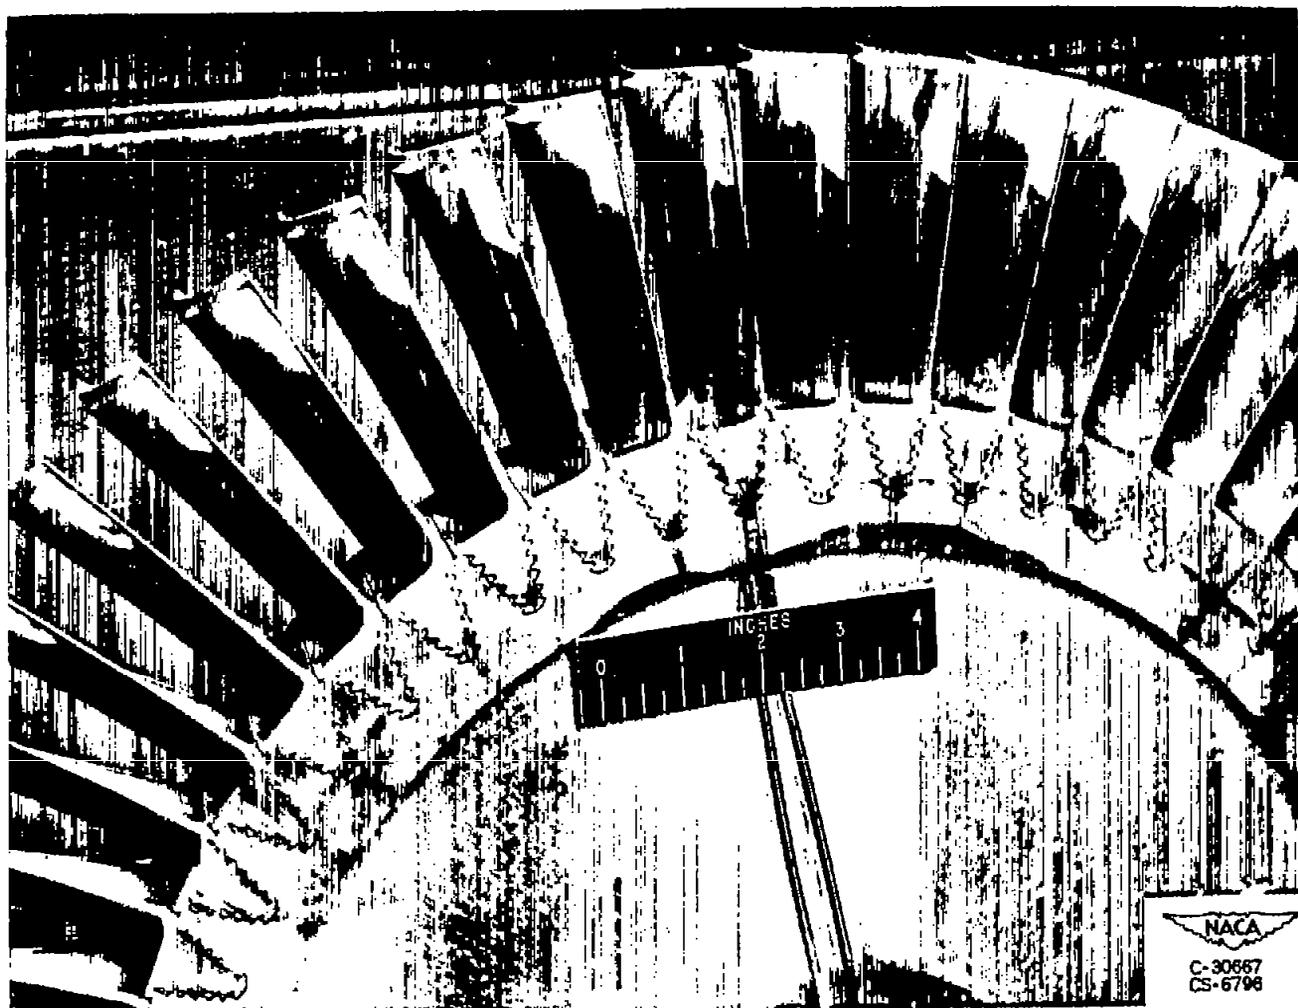
(b) Downstream side of rotor.

Figure 5. - Concluded. Build-up of deposits on turbine rotor.

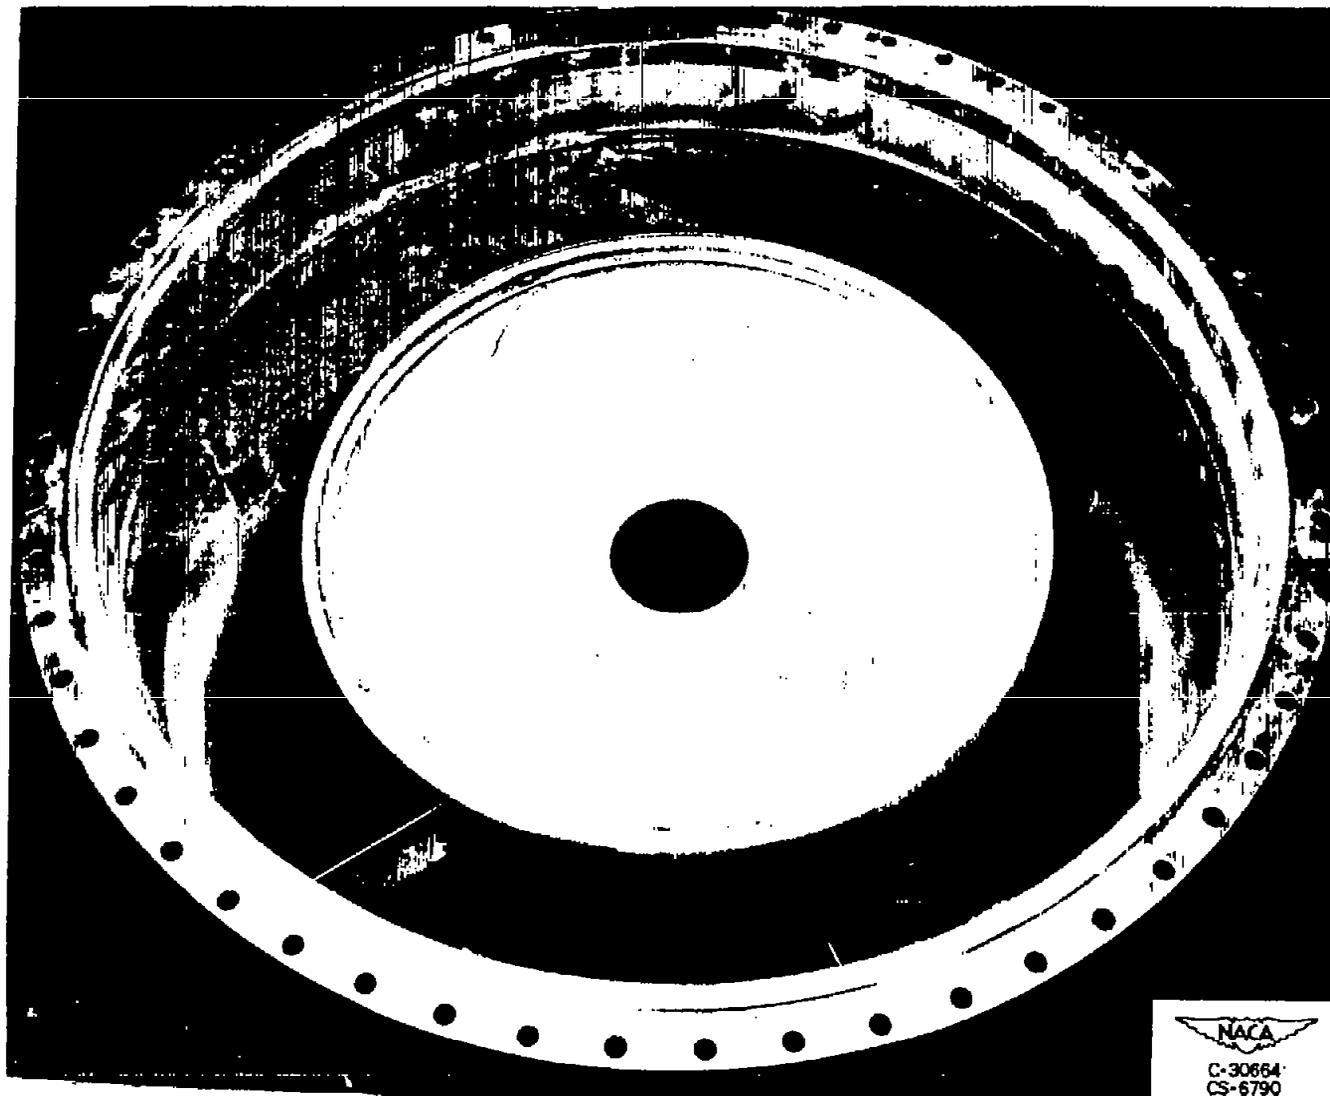
The tail cone (fig. 6) had a thin coating of boric oxide that had been thrown from the tips of the turbine rotor blades and flowed along the inside surface of the outer exhaust cone. Besides these streams of boric oxide there was a uniform thin coating over the entire inner surface of the tail cone.

Figure 6. - Build-up of deposits in exhaust tail cone.

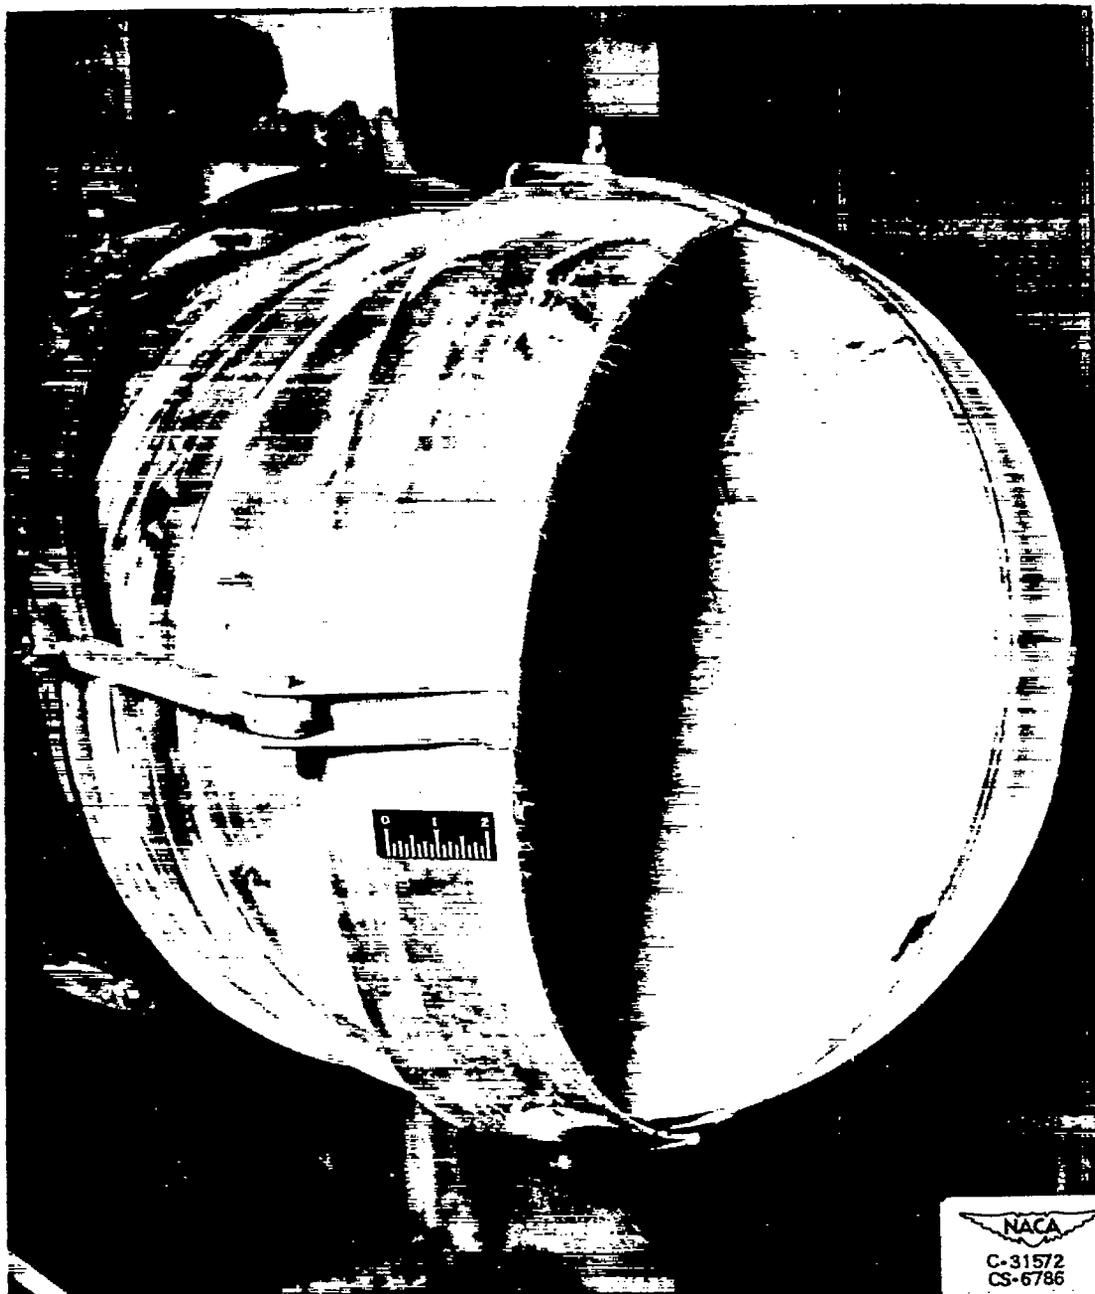
There was a thin coating over the inside surface of the tail pipe and a light fringe of the deposit at the exit of the tail pipe nozzle as shown in figure 7. The exhaust-gas thermocouples that were located in the tail pipe had a thick coating on their downstream side, but the coating did not affect the temperature measurements that were made with them.

Figure 7. - Build-up of deposits on exhaust tail pipe nozzle.
