NACA RM E9K17

TURBOJET-ENGINE EVALUATION OF AISI 321 AND AISI 347

STAINLESS STEELS AS NOZZLE-BLADE MATERIALS

By Floyd B. Garrett and Charles Yaker

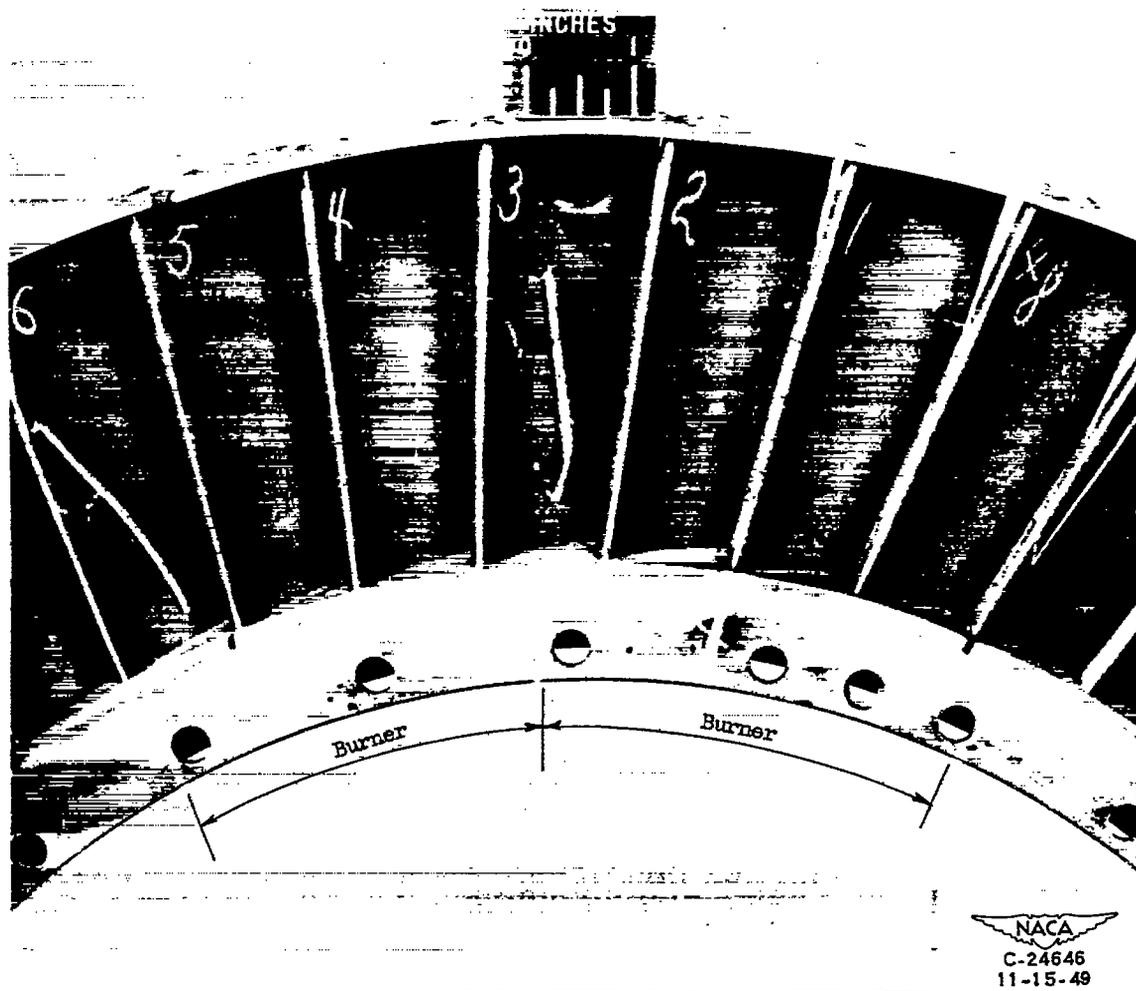
(a) Upstream face.

Examination of the nozzle diaphragms after operation revealed that a definite relation exists between burner location and blade cracks. Typical examples of the condition of the diaphragm blades after 319 cycles (106 hr, 20 min) of operation are shown in figure 2. These photographs clearly indicate that the severely cracked blades are generally located opposite the center of the burner outlet. Slight differences were noted between blades opposite various burners, which can be attributed to differences in combustion characteristics of the burners.

Figure 2. - Portion of nozzle diaphragm 3 after 319 cycles (106 hr, 20 min) showing blade condition with respect to burner locations.

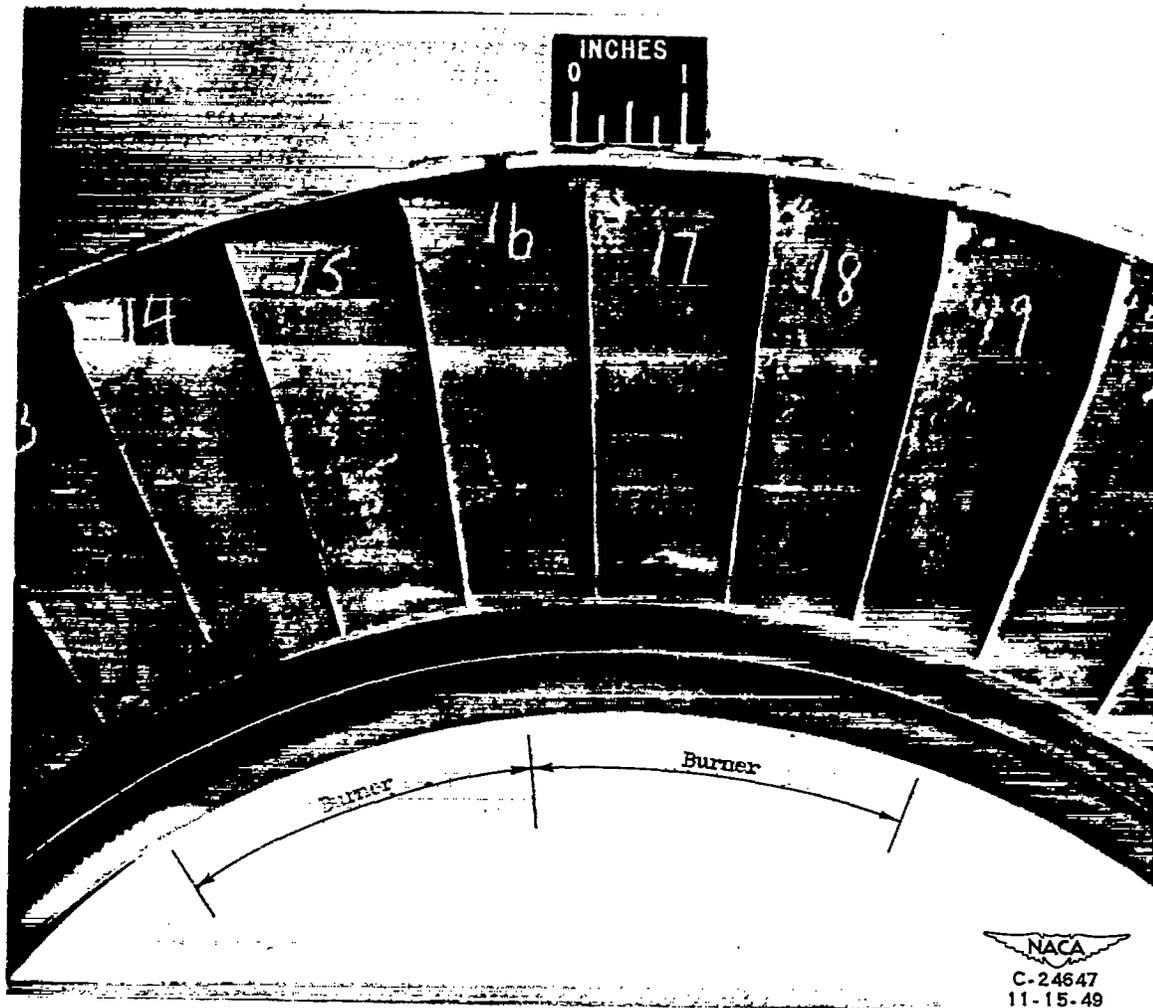
(b) Downstream face.

Figure 2. - Concluded. Portion of nozzle diaphragm 3 after 319 cycles (106 hr, 20 min) showing blade condition with respect to burner locations.

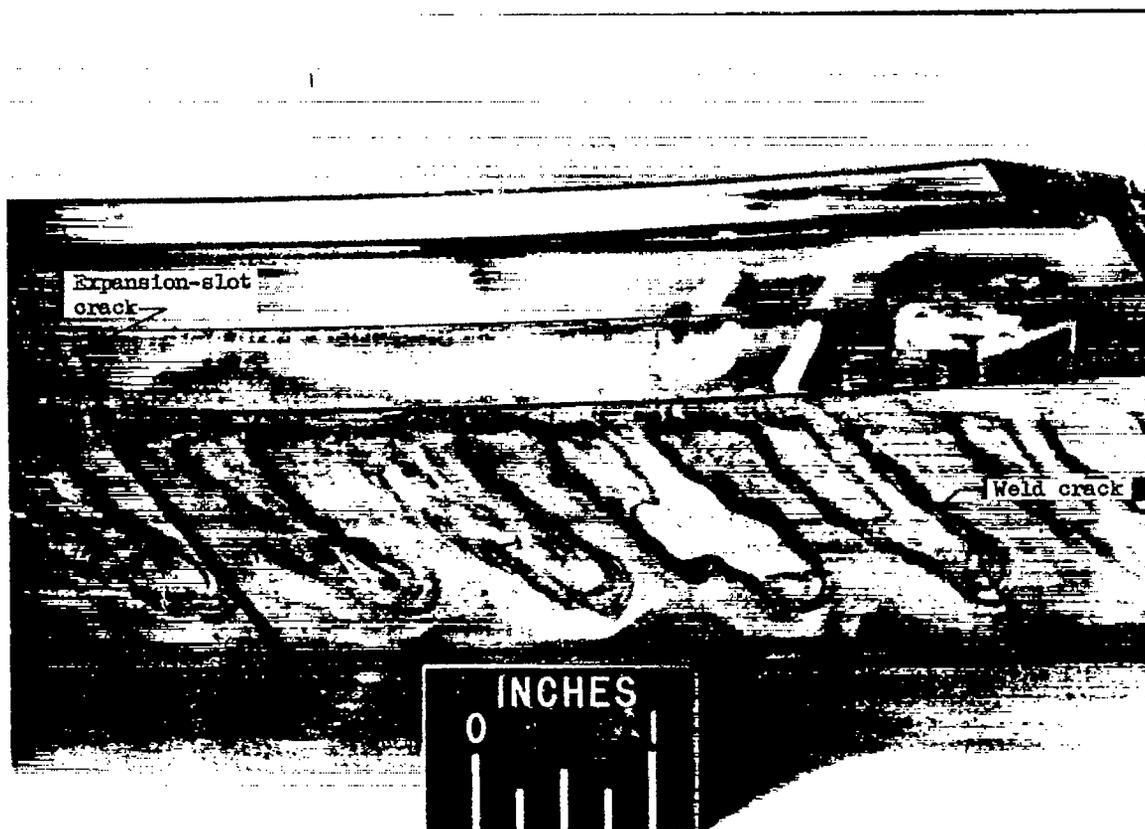
One of the more severe weld cracks is shown in figure 4. The location of the crack is typical of both types of weld. Shown also is a crack in the spacer ring at the end of the expansion slot. Cracks of this type were found at the end of all the expansion slots in the inner-spacer ring of nozzle diaphragm 3. Similar cracks were present in nozzle diaphragm 1 but not in nozzle diaphragm 2.

Failure of welds and inner-spacer ring. - The weld and inner-spacer-ring-slot cracks were probably caused by stresses resulting from unequal thermal expansion between blades due to differences in temperature between burner centers and edges and also differences in temperature from burner to burner. These conditions can possibly be eliminated by changes in design.

Figure 4. - Typical inner-spacer ring and weld cracks in nozzle diaphragm 3 after 319 cycles (106 hr, 20 min) of operation.

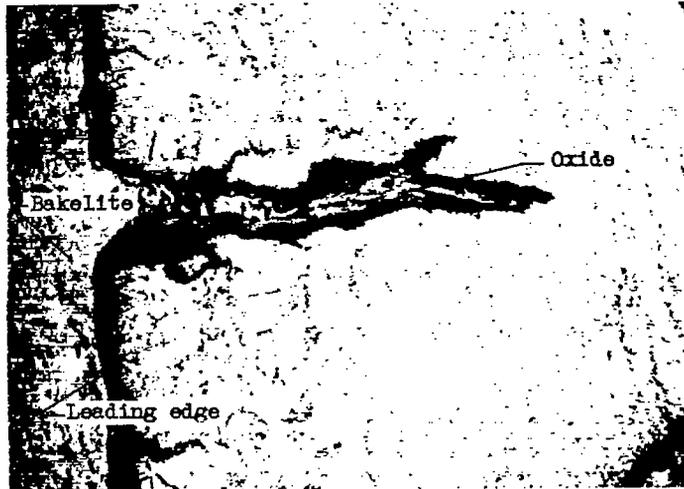
(a) AISI 321 stainless steel (titanium modified).

The structures of the two types of alloy before operation are shown in figure 5. Each structure consisted of small equiaxed grains of austenite containing small patches of complex carbides. Typical leading-edge cracks in the two alloys after 319 cycles (106 hr, 20 min) are shown in figure 6. This figure indicates that some intergranular penetration and precipitation have occurred at the leading edge of the AISI 347 blade. The AISI 321 blade shows no appreciable intergranular penetration. Each of the cracks shown is about 1/32 inch long. In the case of both blades, there were much longer cracks; and in the case of AISI 347 blades, the cracks

Leading edge. - Microexamination indicated that the leading-edge cracks of the two alloys (fig. 6) were different in nature. The AISI 347 blade cracks were similar to an intergranular creep type of failure and the AISI 321 blade cracks similar to corrosion-fatigue failure. The AISI 321 blades also revealed some intergranular cracks (fig. 9). In both cases, however, the number of cracks and their respective depths were of the same magnitude. The exact mechanism of cracking cannot be determined, but these failures can be regarded as resulting from the combined effects of constant thermal stress, alternating sudden thermal stress, and the oxidizing atmosphere.

Figure 6. - Typical leading-edge cracks after 319 cycles (106 hr, 20 min) of operation.  
X100.

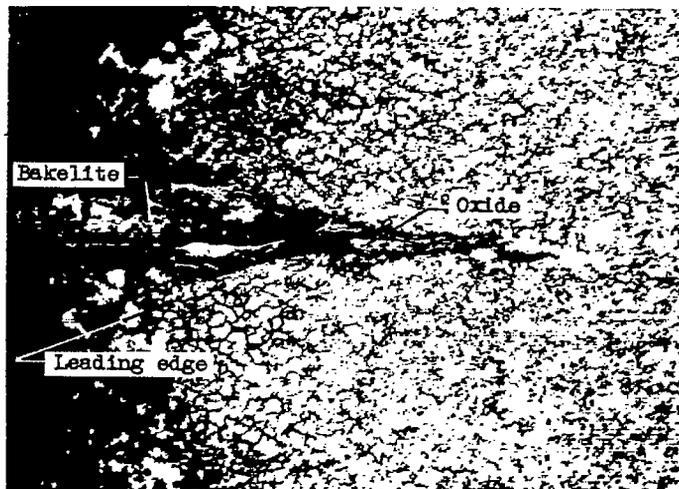
(b) AISI 347 stainless steel (columbium modified).

extended far beyond the area of intergranular penetration. A typical trailing-edge crack is shown in figure 7. This crack is representative of trailing-edge cracks in both types of alloy. In neither alloy did appreciable intergranular penetration of the trailing edge occur. The alloy structure along the crack (fig. 7(b)) shows evidence of a heavy intergranular precipitate. This precipitate was visible in the trailing edges of both types of blade and in the leading edge of the AISI 347 blades. Inasmuch as some blades were warped at the trailing edge, the edges were evidently highly stressed. The presence of large stresses probably increased the rate of precipitation in the grain boundaries near the trailing edge.

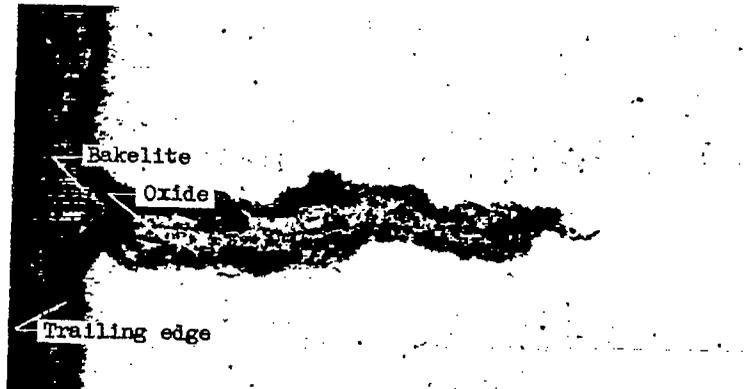
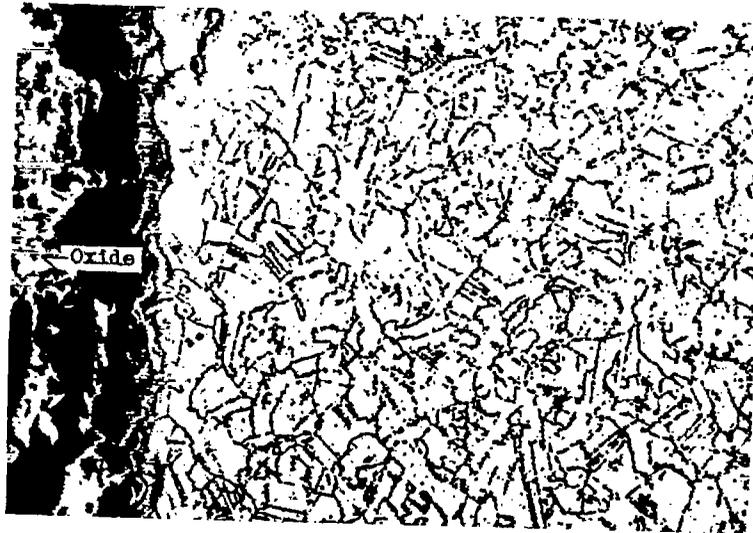
Trailing edge. - The cracks in the trailing edges are different from those in the leading edges. Instead of exhibiting a large number of cracks, as evidenced in the leading edge, there were only a few large cracks. Microexamination indicated a crack propagation similar to that produced by corrosion fatigue. Evidence of intergranular cracking, however, was also present. Because many of the blades had warped trailing edges, it is apparent that the thermal stresses were higher in the trailing edge than in the leading edge. This increase is due to the thinness of the trailing edge. These cracks may therefore result from stress only. Once cracks started, successive cycles resulted in deeper cracking, relieving the stress and leaving the rest of the edge crack free.

Figure 7. - Typical trailing-edge crack of AISI 347 stainless steel after 319 cycles (106 hr, 20 min) of operation.

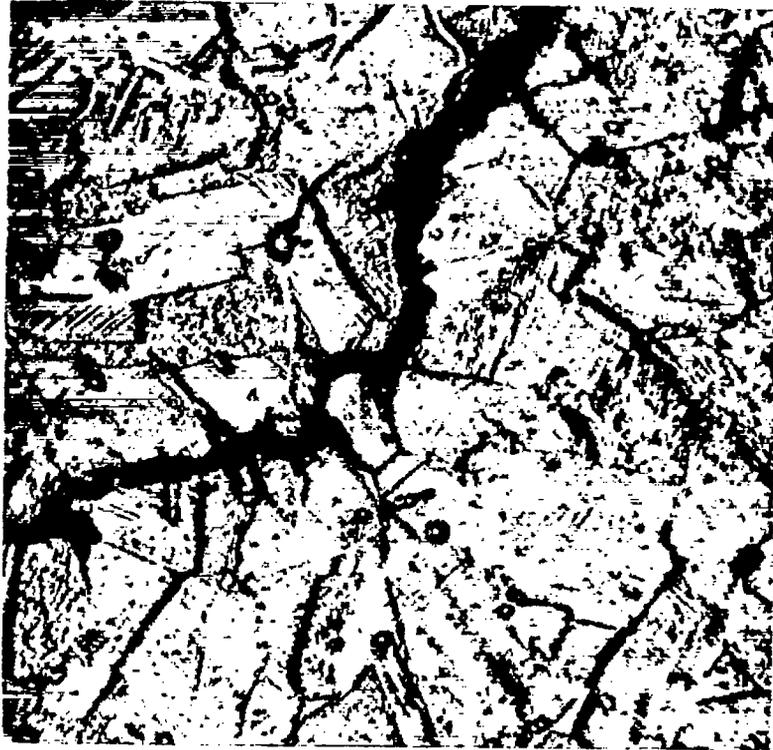
Examination of the cracked AISI 347 blade in nozzle diaphragm 2 indicated that the cracks in both the leading and trailing edges were intergranular. These cracks contained little or no oxide, inasmuch as they occurred between 70 (23 hr, 20 min) and 80 cycles (26 hr, 46 min) of operation with no further operation. The intergranular penetration at the tip of a crack, which is typical of cracks in both edges, is shown in figure 8. Two types of penetration beginning at the leading edge of a blade are indicated in figure 9. One type is intergranular penetration, and the other is surface pitting.

Figure 8. - Intergranular crack propagation in AISI 347 stainless steel after 80 cycles (26 hr, 40 min) of operation. Oblique illumination; X1000.

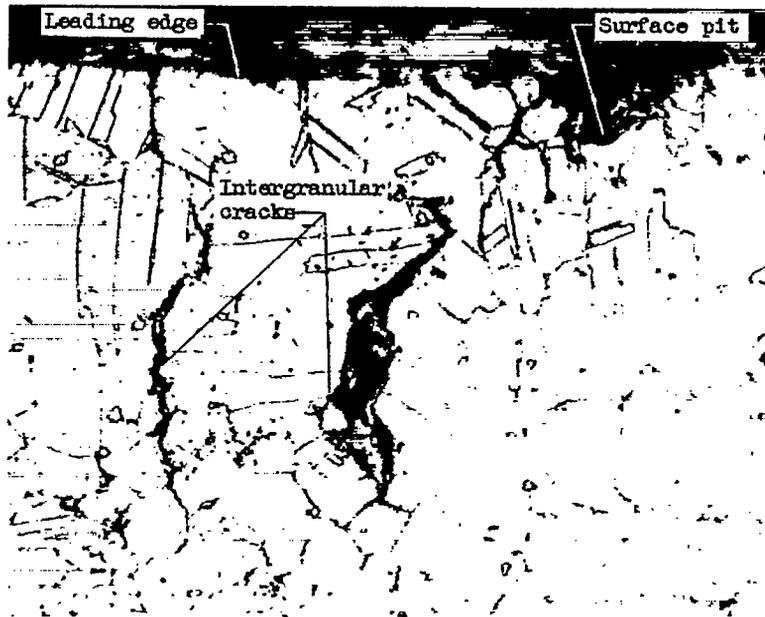
Figure 9. - Initial crack penetration in AISI 321 stainless steel after 319 cycles (106 hr, 20 min) of operation. X500.
