RESEARCH MEMORANDUM

AERODYNAMIC CHARACTERISTICS OF A PORTION OF THE

HORIZONTAL TAIL FROM A DOUGLAS C-74 AIRPLANE

WITH FABRIC-COVERED ELEVATORS

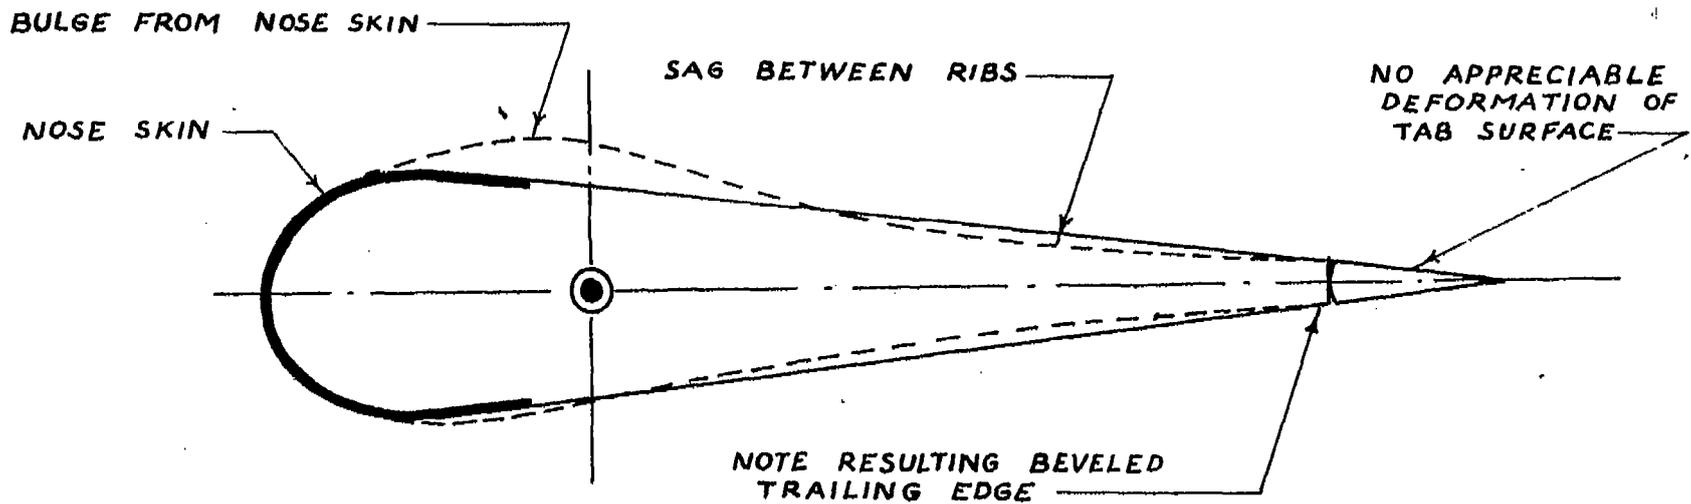
The first of these was one in which the elevator fabric, at the start of the testing, was attached to the ribs by small screws and drawn over the metal nose skin but attached to it only by doping. Early in the course of the tests the fabric pulled loose from the nose skin and a bulge developed which, upon increasing in size, began tearing the fabric from its fastenings to the fore parts of the ribs. The bulging and detachment from the ribs rapidly extended from about 5 to 40 percent of the elevator chord and, in extreme cases, bulging up to an estimated 4 inches in height occurred over about one-half of the test span. Fabric sag varying in

magnitude up to an estimated 1.5 inches in depth occurred between the ribs at the aft portion of the elevator over the complete test span. Typical bulging and sag of the elevator fabric for this condition is shown in figure 4. This first elevator condition will henceforth be referred to as the "original condition, fabric detached."

FIGURE 4. - TYPE OF SURFACE DEFORMATION FOR THE DOUGLAS C-74 ELEVATOR DURING TESTS IN THE AMES 16-FOOT HIGH-SPEED WIND TUNNEL FABRIC DETACHED CONDITION. $\alpha = 0^\circ$ $\delta_e = +2^\circ$ $M = 0.55$

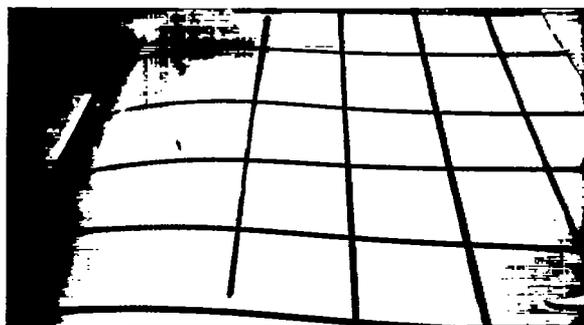
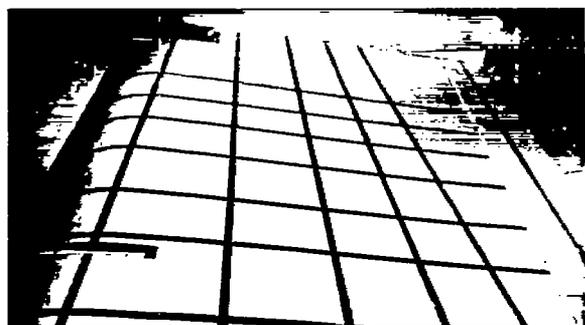
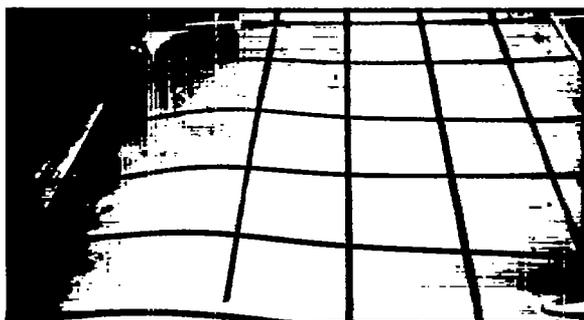
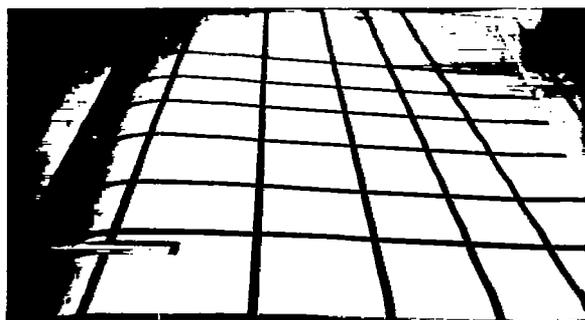
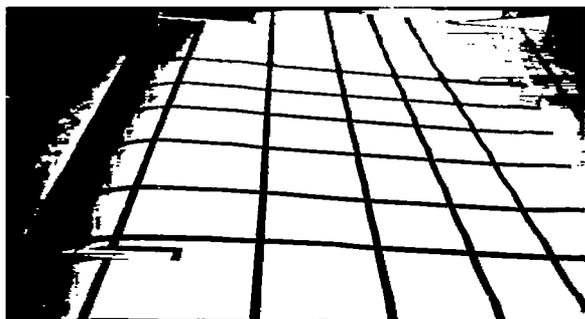
The fourth elevator condition was identical with the first, prior to testing, in representing the part directly off the airplane. However, the fabric on this elevator did not tear loose from the ribs and the bulging and sag were considerably less than that prevailing during tests of the first condition. (See fig. 5.) This fourth condition will be referred to as the "original condition." Control-tab characteristics were measured during this fourth set of tests.

(a) Fabric loose.

(b) Original condition.

Figure 5.- Photographs showing differences in bulging for the upper surfaces of two similar elevators tested in the Ames 16-foot high-speed wind tunnel.

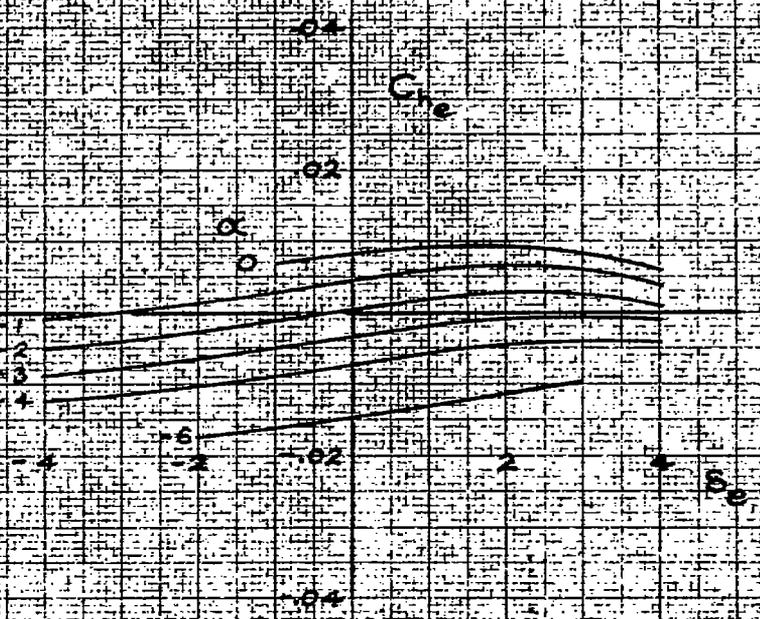
The variation of hinge-moment coefficient with elevator angle is presented in figures 6 to 9 for all the conditions tested. The positive variation for the fabric-detached (fig. 6) and the fabric-fastened conditions (fig. 7) is apparent. A negative slope is shown when the fabric was fastened with decreased rib spacing (fig. 8) and for the original condition (fig. 9), the predominant feature being a less negative slope with increase of Mach number. In some cases the tunnel-wall corrections were of such magnitude as to convert a negative slope into a positive one. Therefore, the absolute values of the coefficients, in each case, are subject to question.

FIGURE 6.— VARIATION OF ELEVATOR HINGE-MOMENT COEFFICIENT WITH ELEVATOR ANGLE FOR A SECTION OF THE HORIZONTAL TAIL FROM A DOUGLASS C-74 AIRPLANE. ORIGINAL CONDITION — FABRIC DETACHED. $M=0.2$

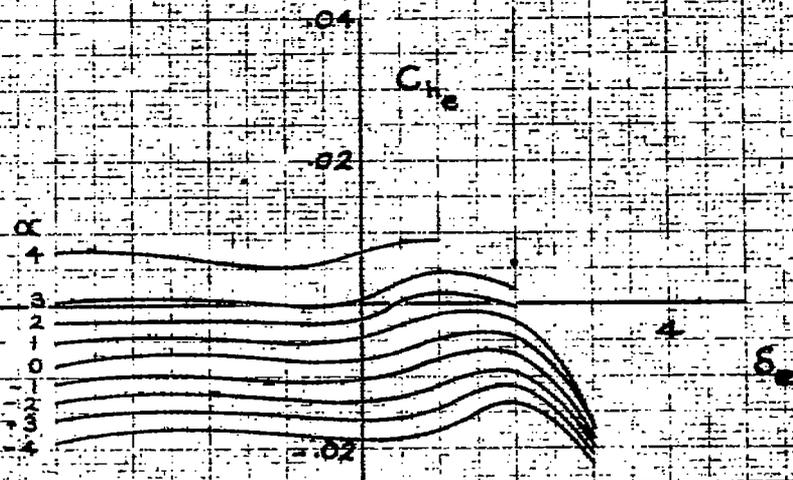
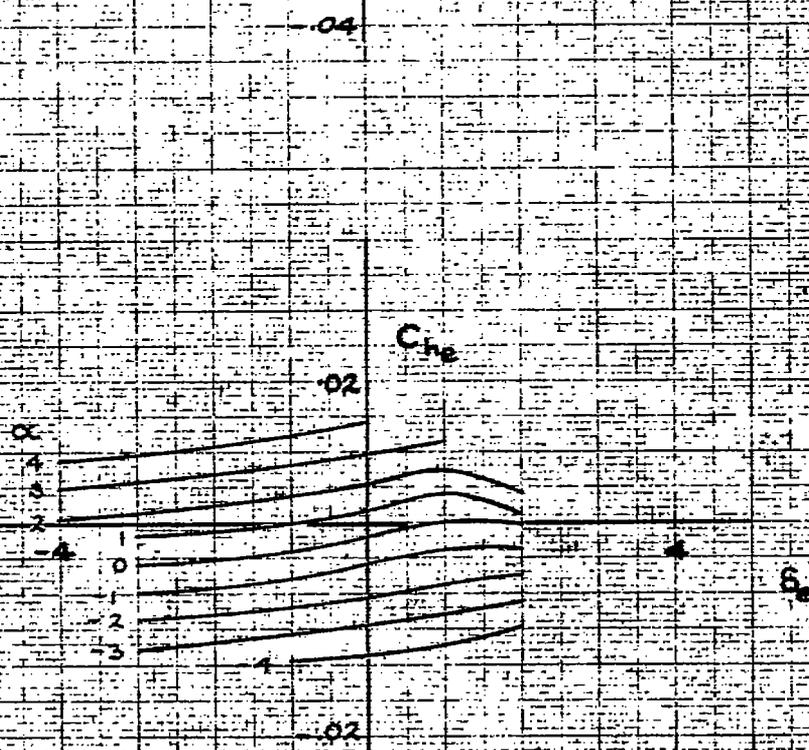
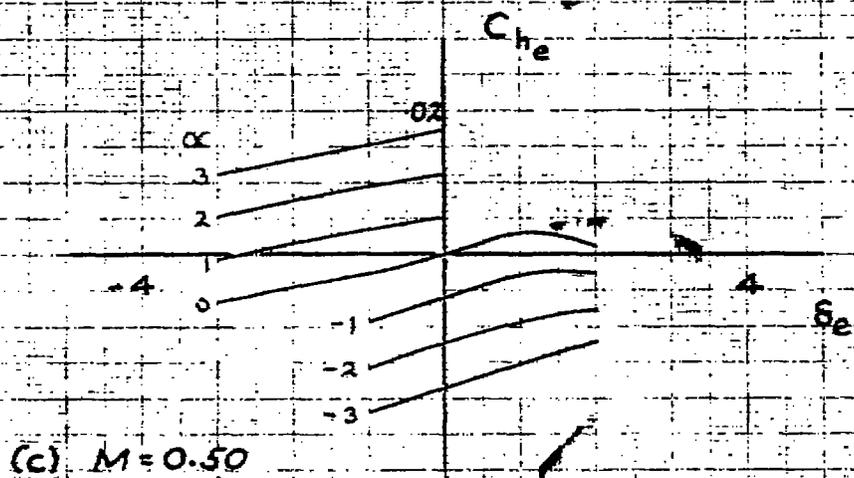
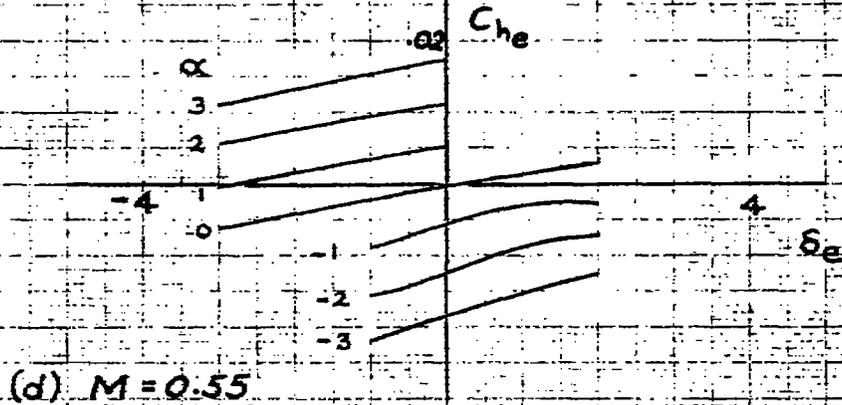
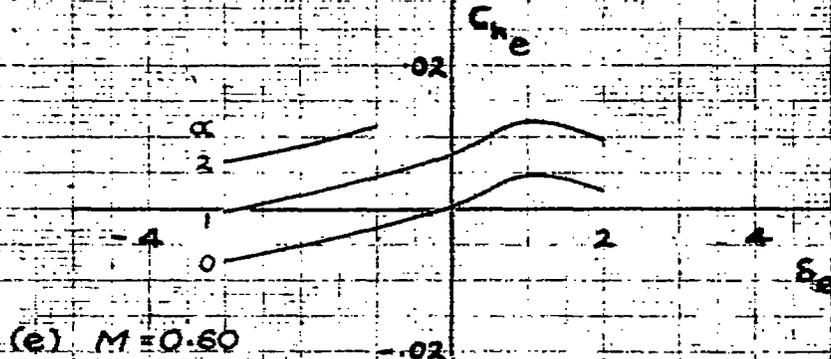
FIGURE 7. VARIATION OF ELEVATOR HINGE-MOMENT COEFFICIENT WITH ELEVATOR ANGLE FOR A SECTION OF THE HORIZONTAL TAIL FROM A DOUGLAS C-74 AIRPLANE. ORIGINAL CONDITION—FABRIC PASTERED.

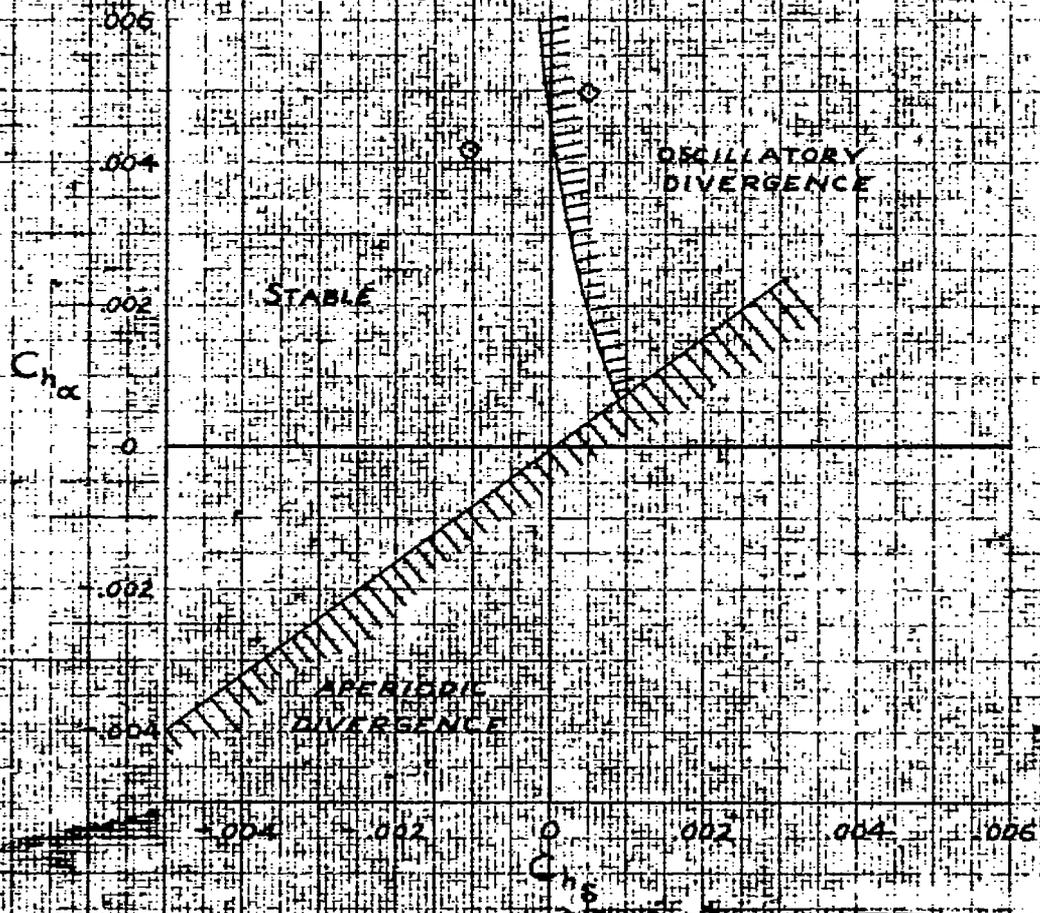
Figure 22 presents the results of an analysis of the dynamic pitching stability of the C-74 airplane made by the Douglas Aircraft Corporation according to the method of reference 3. The flight conditions for which the critical boundaries have been calculated are approximately those under which the accident occurred to the airplane. The experimental data included in the figure are for the fabric-fastened - decreased rib spacing and fabric-fastened conditions. Due to load limits, not enough data were available for the conditions without the fabric fastened to present more test results on the pitching-stability plot. The uncertainty of the tunnel-wall corrections is especially critical in applying this curve as only a slight error in their magnitudes could cause a shift of the experimental points, thereby either denoting stability or instability.

It is shown on figure 22 that either stable or unstable dynamic pitching-moment conditions of the airplane are possible, dependent on the extent to which elevator surface deformation occurs. Unfortunately, it is impossible to reach any definite conclusion from this curve due to the uncertainty of the absolute values of the data. It is evident, however, that for greater dynamic longitudinal stability more negative values of C_{hg} are required. The effect of bulge and sag, in general, was to cause more positive C_{hg} values. The bulging of the fabric over the nose of the elevator changed the nose balance shape to one of greater bluntness. A more blunt nose shape can produce more positive C_{hg} values (reference 1), which would be especially detrimental with a closely balanced elevator of this type. Adverse effects are also attributed, in part, to the beveled trailing-edge section resulting from sag of the fabric between ribs at the aft portion of the elevator. The beveled edge in this case was composed of the trim and control tabs whose surfaces did not deform appreciably under load. Results of flight tests of elevator sections have shown more positive C_{hg} values resulting from beveled trailing edges (reference 4). Wind-tunnel data for beveled trailing-edge elevators having overhanging balance and a blunt nose have shown overbalance at high Mach numbers (reference 5). Elimination of the overbalance, in that case, resulted upon changing to straight-sided elevators. The results obtained from tests of the C-74 elevator show that the only fabric condition in which C_{hg} remained negative with increase in Mach number was that where the surface deformation was held to a minimum by fabric fastening and decreased rib spacing. Fabric fastening and decreased rib spacing may not be the safest solution, however, as upon aging and deterioration of the fabric, it is possible that bulging and sagging may recur with accompanying

FIGURE 22. C-74 AIRPLANE ELEVATOR-FREE LONGITUDINAL STABILITY BOUNDARIES AT CONSTANT SPEED.

adverse effects. This consideration suggests the use of metal-covered elevators.

After fabric bulge and sag have been reduced to a minimum, still greater longitudinal dynamic stability of the airplane may be obtained by using a sharper nose section or by decreasing the area of the overhanging balance (reference 6). Similar results may also be obtained by extension of the trailing edge, a change which in effect amounts to a decrease in balance. It is recommended that should further tests be conducted for investigation of the effect of these modifications, a smaller model be used so that the absolute values of the aerodynamic coefficients can be obtained more accurately.
