RESEARCH MEMORANDUM

WIND-TUNNEL INVESTIGATION OF TRANSONIC AILERON FLUTTER

By Albert L. Erickson and Robert L. Mannes

NACA RM No. A9B28

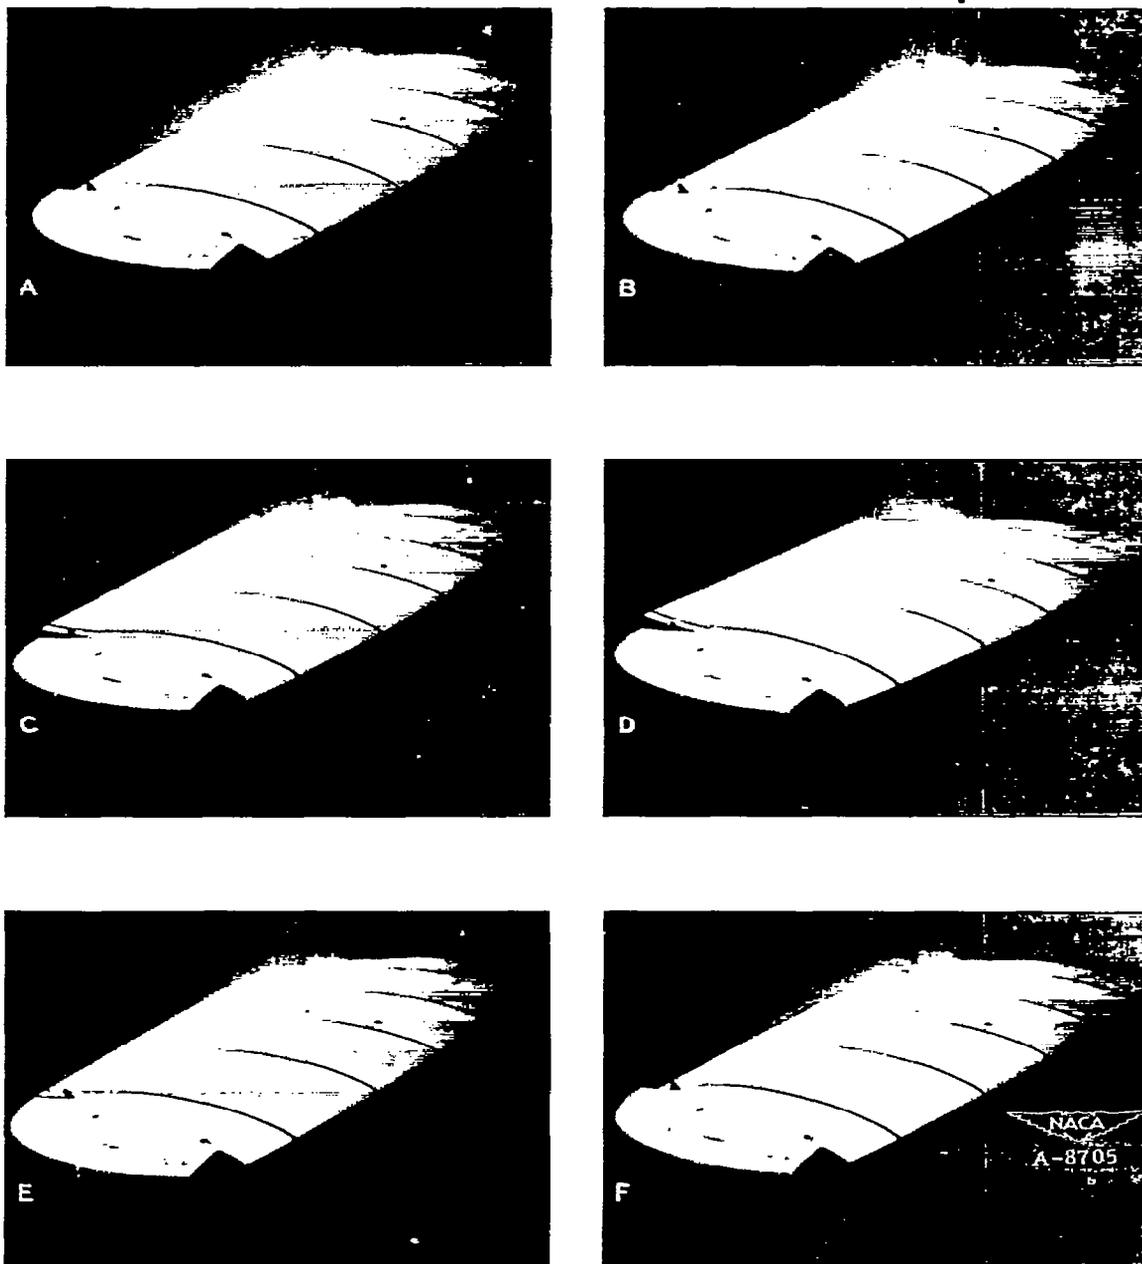
Figure 4.— Flutter of the aileron shown by successive pictures taken from a 128-frame-per-second motion picture.

Successive pictures of the wing and aileron during one cycle of flutter are shown in figure 4. These pictures are from a motion-picture record taken at 128 frames per second. The aileron displacement followed a sinusoidal pattern and led the wing torsional displacement by about 60° , as shown in figure 5. Later tests showed that the wing motion did not contribute to the basic flutter.

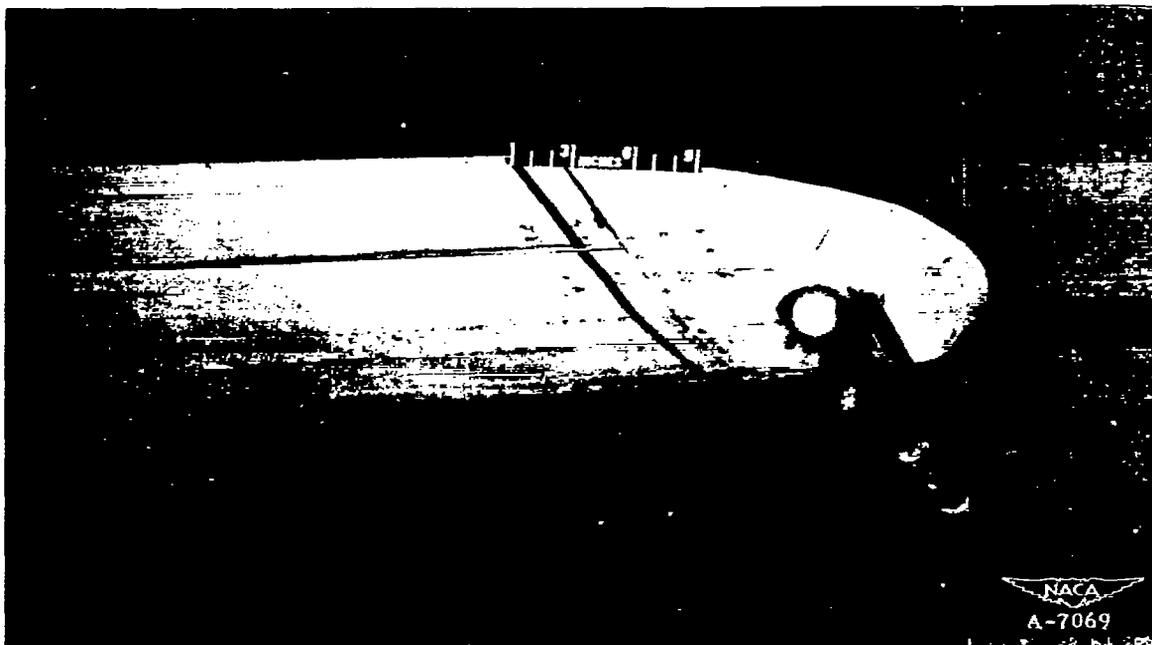
Figure 7.- Wing-tip boom mounted on the partial-span wing.

A boom was attached to the wing tip and extended forward into the air stream as shown in figure 7. This boom changed the natural frequency of the wing in bending from 15 to 13 cycles per second and in torsion from 51 to 26 cycles per second. It also caused a considerable change in the location of the apparent torsional nodes. (See fig. 8.) The locations of the apparent nodes were determined by the intersections of straight-line elements connecting the displacements indicated by the pickups. The torsional nodes indicated are approximately the true nodes. The apparent bending nodes, however, are of value only for comparative purposes. With the boom attached and the aileron fixed, the wing did not flutter. With the aileron free, the boom did not alter the aileron flutter (table I, runs 22 and 22A).

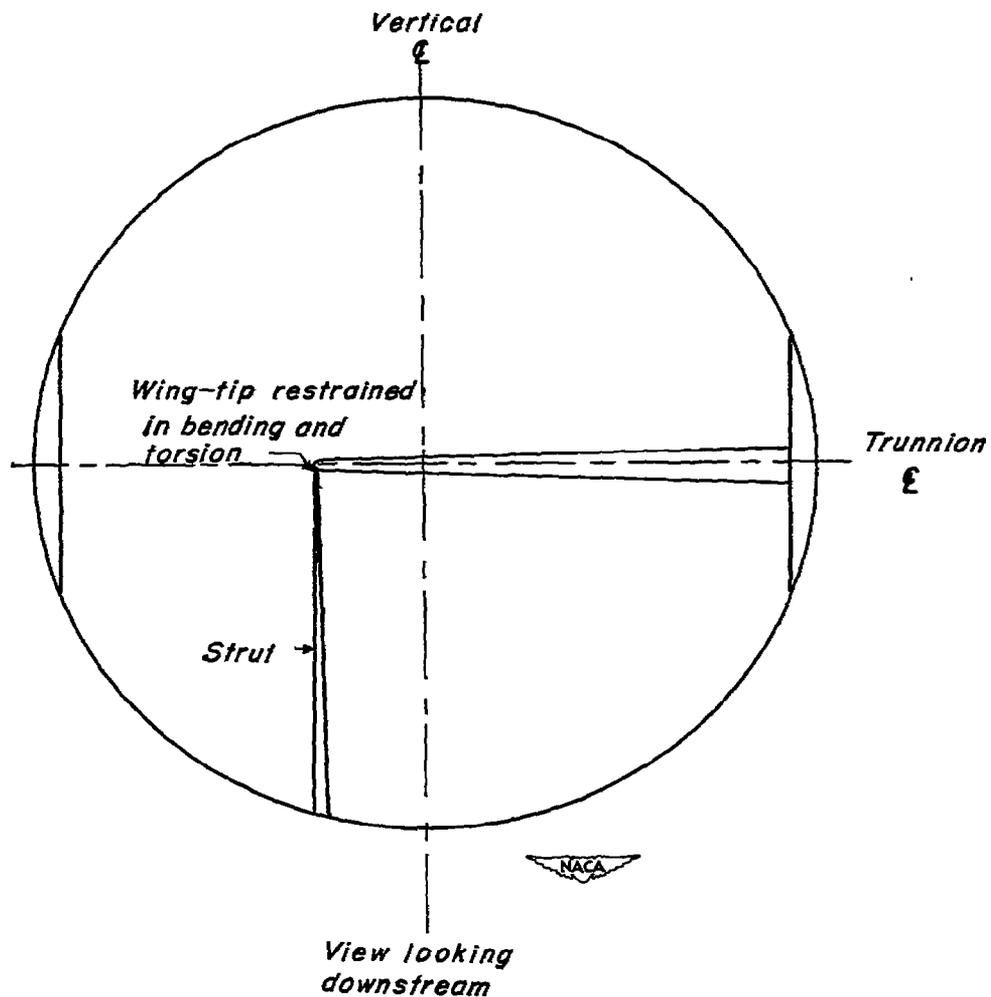
Figure 9.—The partial-span wing mounted in the 16-foot high speed wind tunnel with tip fastened to strut.

The boom was removed and the wing tip was fastened to a strut so that it was restrained in both bending and torsion. (See fig. 9.) Even this extreme change had no appreciable effect on the aileron flutter. The wing was not completely rigid during flutter although its motion was limited. (See table I, run 27.) Runs 5, 12, 22, 22A, and particularly runs 26 and 27, quite definitely proved that a new type flutter had been found - a type which required only one degree of mechanical motion.

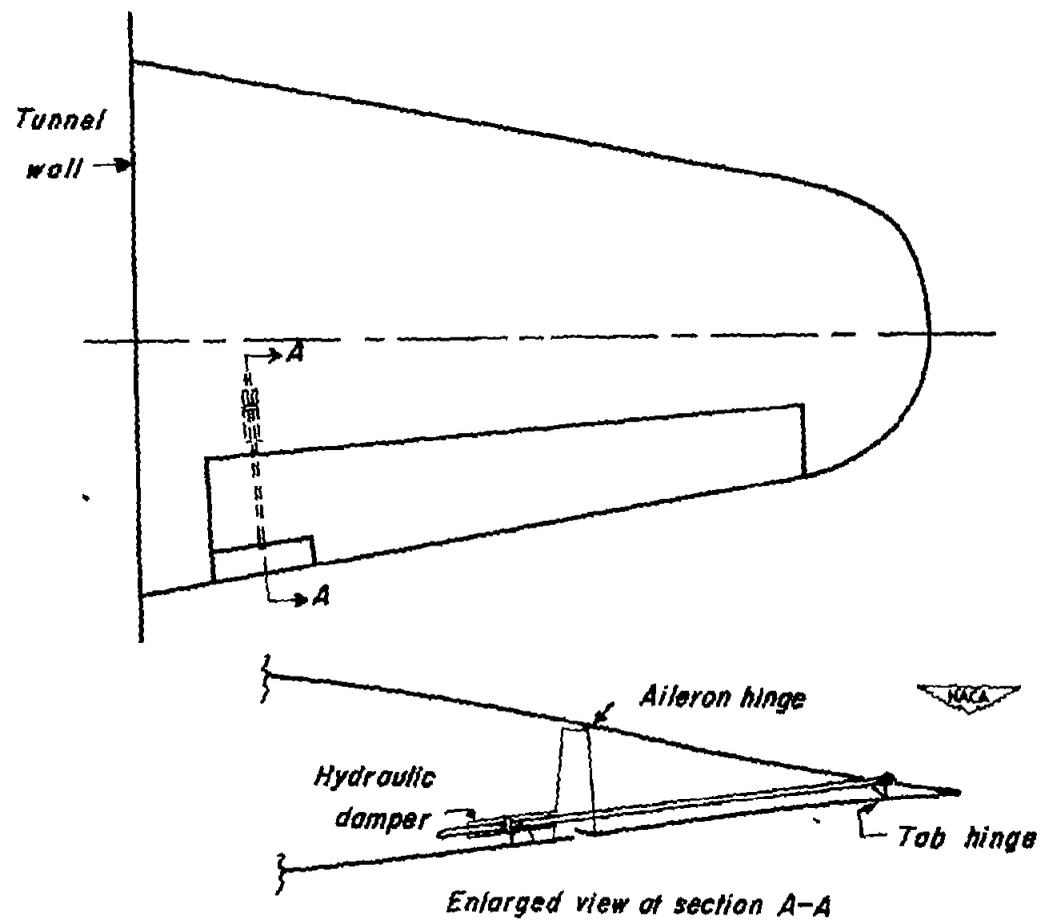
Figure 10.— Schematic drawing of antiservo tab with hydraulic damper

In an effort to damp the flutter aerodynamically, an antiservo tab was installed on the aileron, as shown in figure 10. This tab floated freely during slow motion of the aileron, but it worked against the aileron during flutter because of the damping cylinder in the linkage. Its effect, however, was not sufficient to prevent flutter. (See table I, runs 28 to 31.)

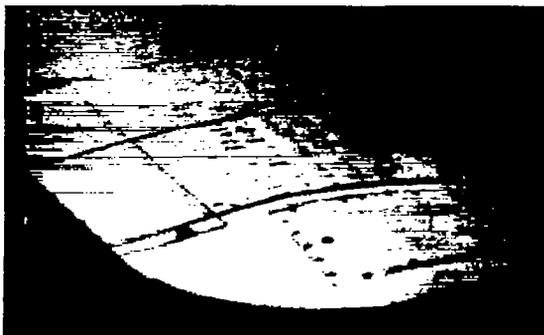
Figure 13.— Tuft studies on the partial-span wing showing change in flow separation for six aileron positions. Pictures are from a motion picture of the aileron flutter taken at 16 frames per second.

Motion pictures of tufts during flutter indicated separation on the aileron when it was approximately in its neutral position, with subsequent recovery when the aileron reached the maximum up-position. (See fig. 13.)

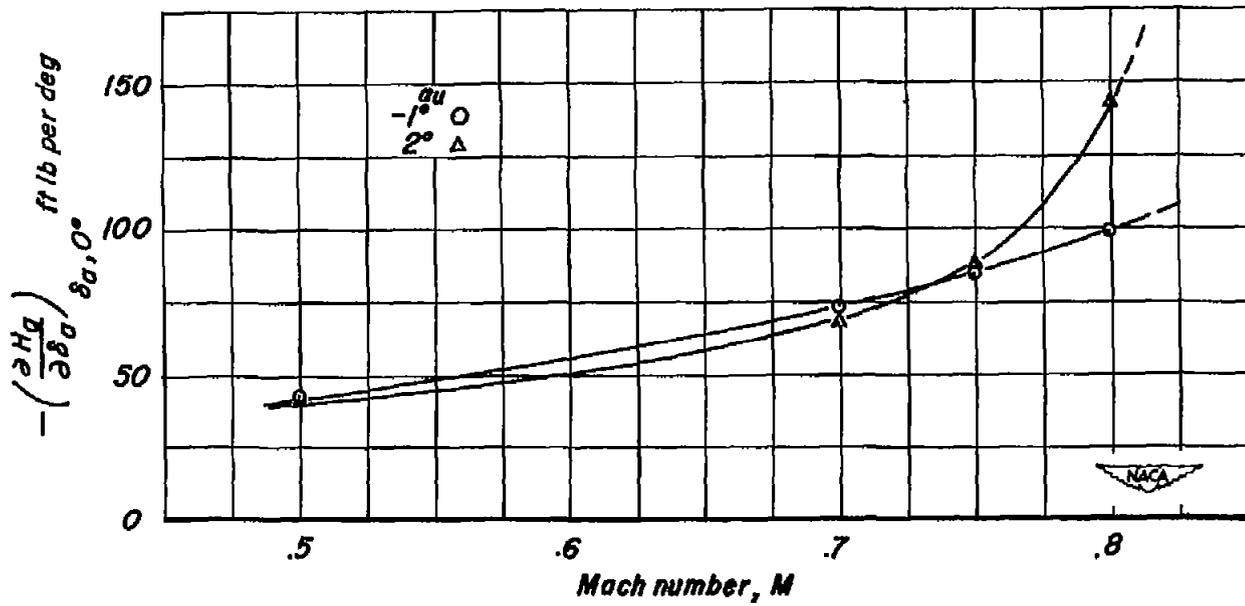
Figure 20.-Variation of alleron hinge-moment slope with Mach number at two angles of attack for the partial-span wing. $\delta_a, 0^\circ$.

reveals considerable increase in the slope $\left[-\left(\frac{\partial H_a}{\partial \delta_a}\right)_{\delta_a, 0^\circ} \right]$ at Mach numbers above 0.74 as the angle of attack was changed from -1° to 2° . The change in slope corresponds to about 25 foot-pounds per degree of aileron angle at the Mach numbers at which flutter occurred.

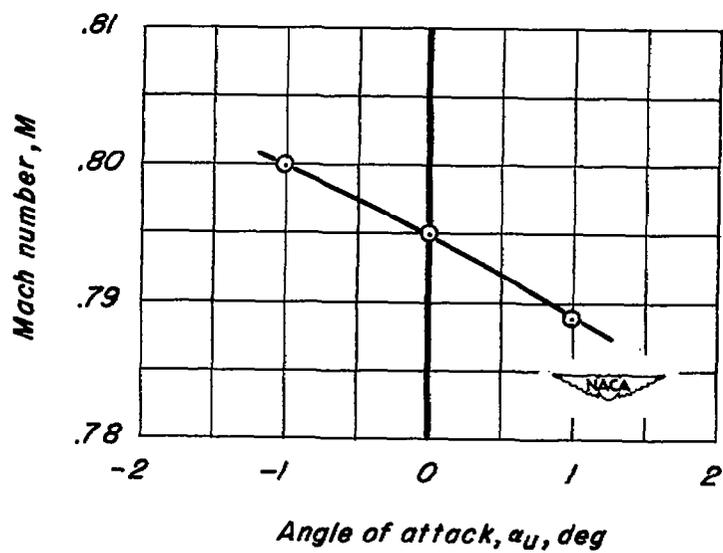
Figure 21.— Angles of attack and Mach numbers at which flutter occurred during tests of the partial-span wing with the aileron free.

Figure 21 shows the Mach number at which flutter started at three angles of attack, indicating that the flutter was probably influenced by the local critical Mach number. (See table I, run 5.)
