NACA RM E56K30

SURVEY OF MICROSTRUCTURES AND MECHANICAL PROPERTIES OF
OVER-TEMPERATURED S-816 TURBINE BUCKETS

FROM J47 ENGINES

By S. Floreen and R. A. Signorelli

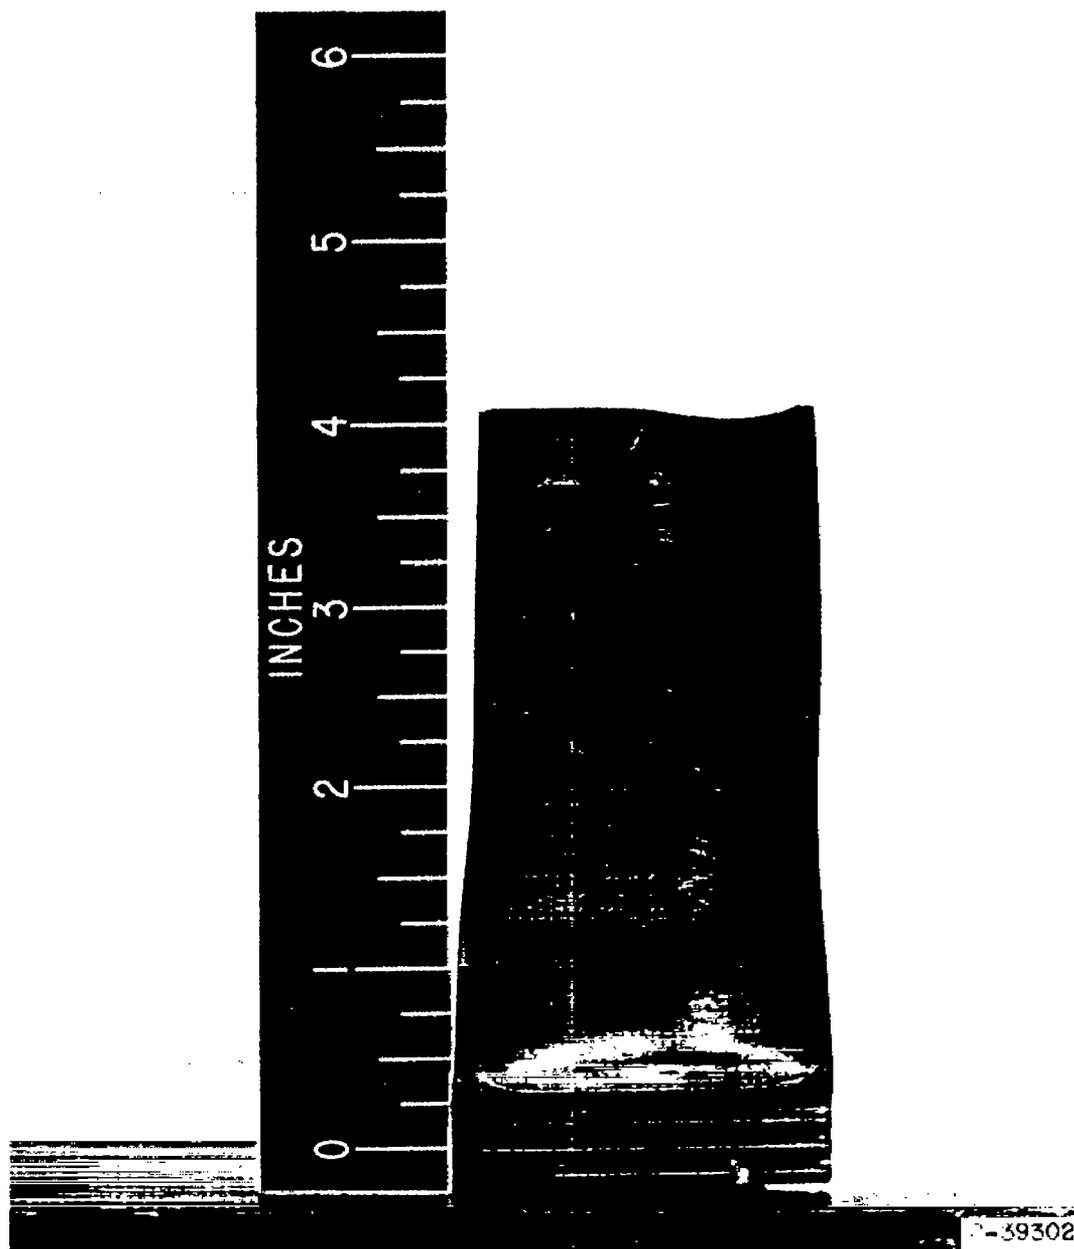
Figure 1. - Necked bucket.

Four of the buckets of unspecified overtemperature history were necked. A photograph showing an example of this necking is presented in figure 1. The necked buckets were 5, 6, 13, and 14 (table I).

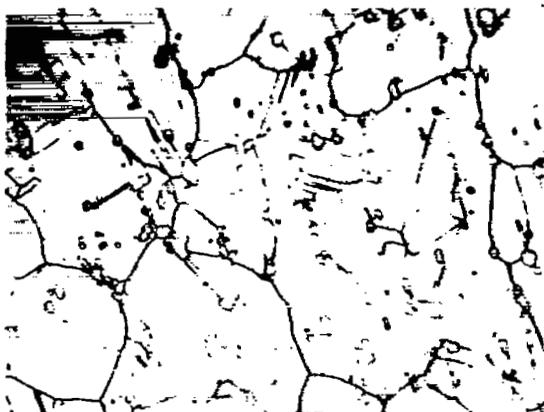
The microstructures of the new buckets were in most cases typical of those found in heat-treated S-816 bar stock. Several regions were found, however, where the microstructure appeared slightly overaged, as shown in figures 5(a) to (e). A cold-worked region was also found in one of the new buckets (24) as shown in figure 5(f).

(a) Bucket 21, mean middle.

(b) Bucket 21, hub trailing edge.

(c) Bucket 22, mean trailing edge.

(d) Bucket 24, tip leading edge.

(e) Bucket 25, hub trailing edge.
