NACA RM L50G10

FLIGHT MEASUREMENTS WITH THE
DOUGLAS D-558-II (BuAero No. 37974) RESEARCH AIRPLANE

LOW-SPEED STALLING AND LIFT CHARACTERISTICS

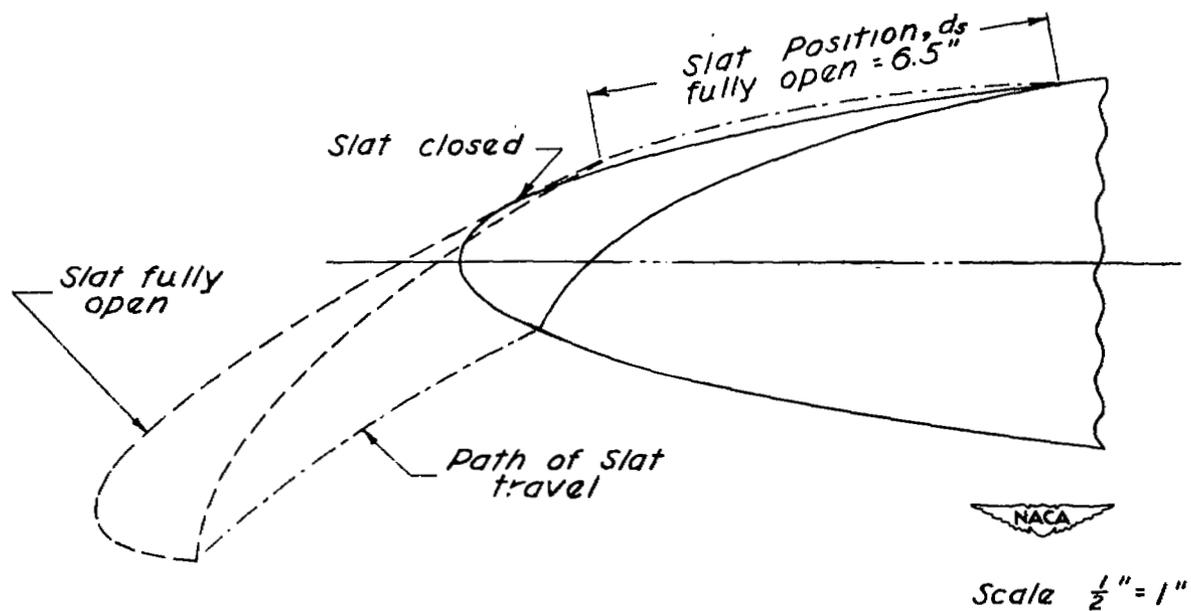
Figure 4.- Section of wing slat of Douglas D-558-II (BuAero No. 37974) research airplane perpendicular to leading edge of wing.

Both slats and fences are incorporated on the wing of the airplane. The wing slats can be locked in the closed position or they can be unlocked. When the slats are unlocked, the slat position is a function of the angle of attack of the airplane. Also, the slats on the left and right wings are interconnected and therefore, at any time, have the same position. A section view of the slat and the forward portion of the wing showing the motion of the slat with respect to the wing is shown in figure 4.

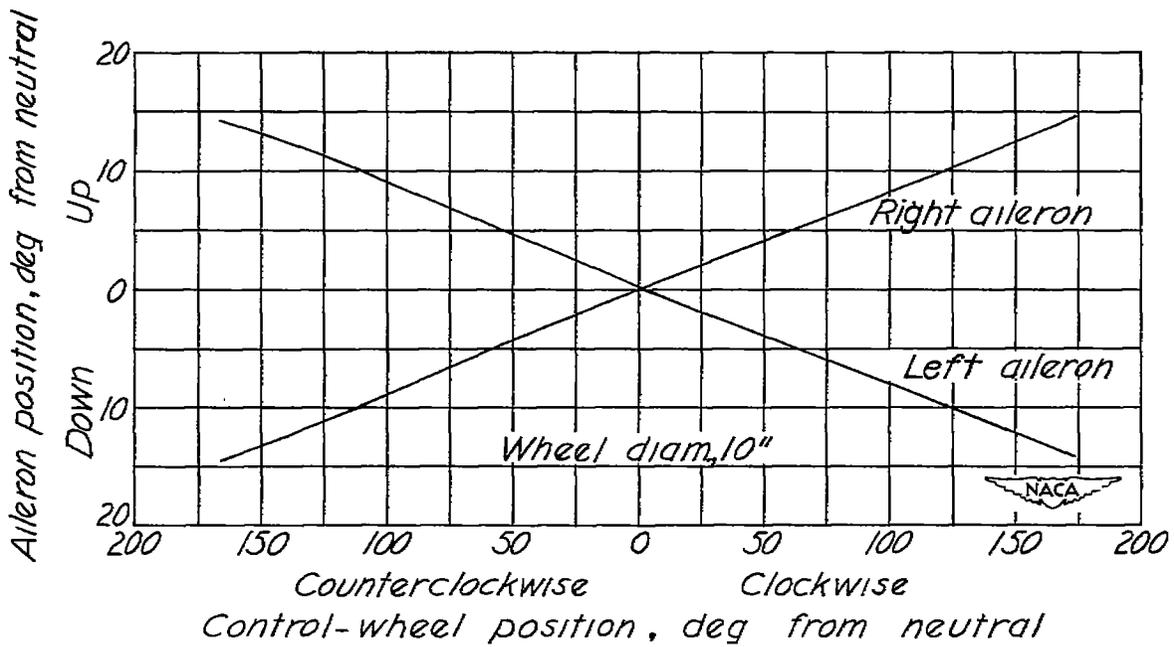
Figure 5.- Variation of left and right aileron positions with control-wheel position. No load on system.

The variations of aileron and elevator position with control-wheel position are shown in figures 5 and 6 and the variation of rudder position with right rudder pedal position is shown in figure 7. The friction in the control systems as measured on the ground under no load is shown in figures 8, 9, and 10. The friction measurements were obtained by measuring the control position and the control force as the controls were deflected slowly. The rate of control deflection was sufficiently low so that the control force resulting from the hydraulic dampers in the control system was negligible.

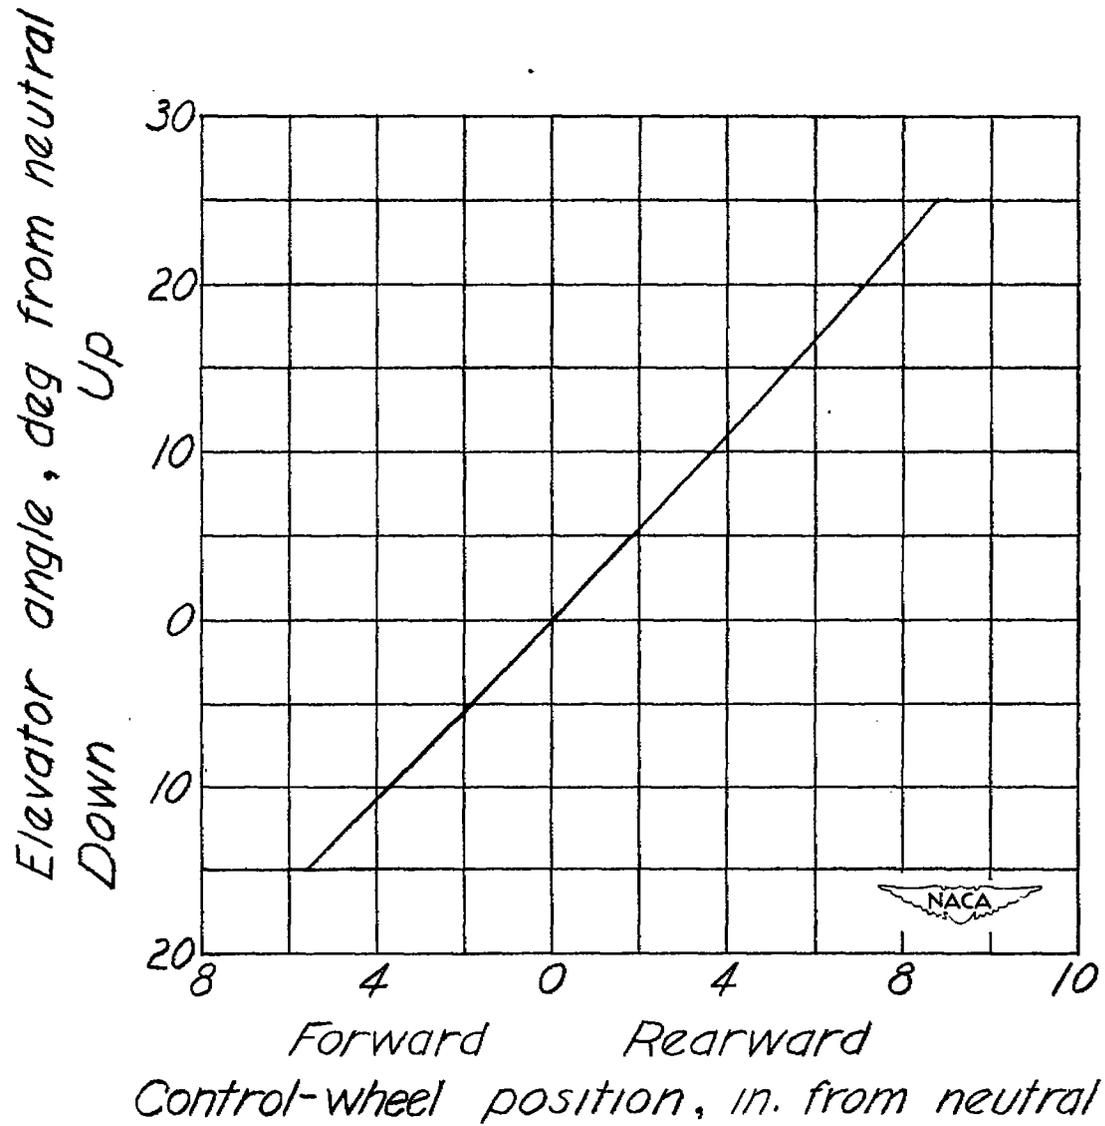
Figure 6.- Variation of elevator position with control-wheel position.
No load on system.

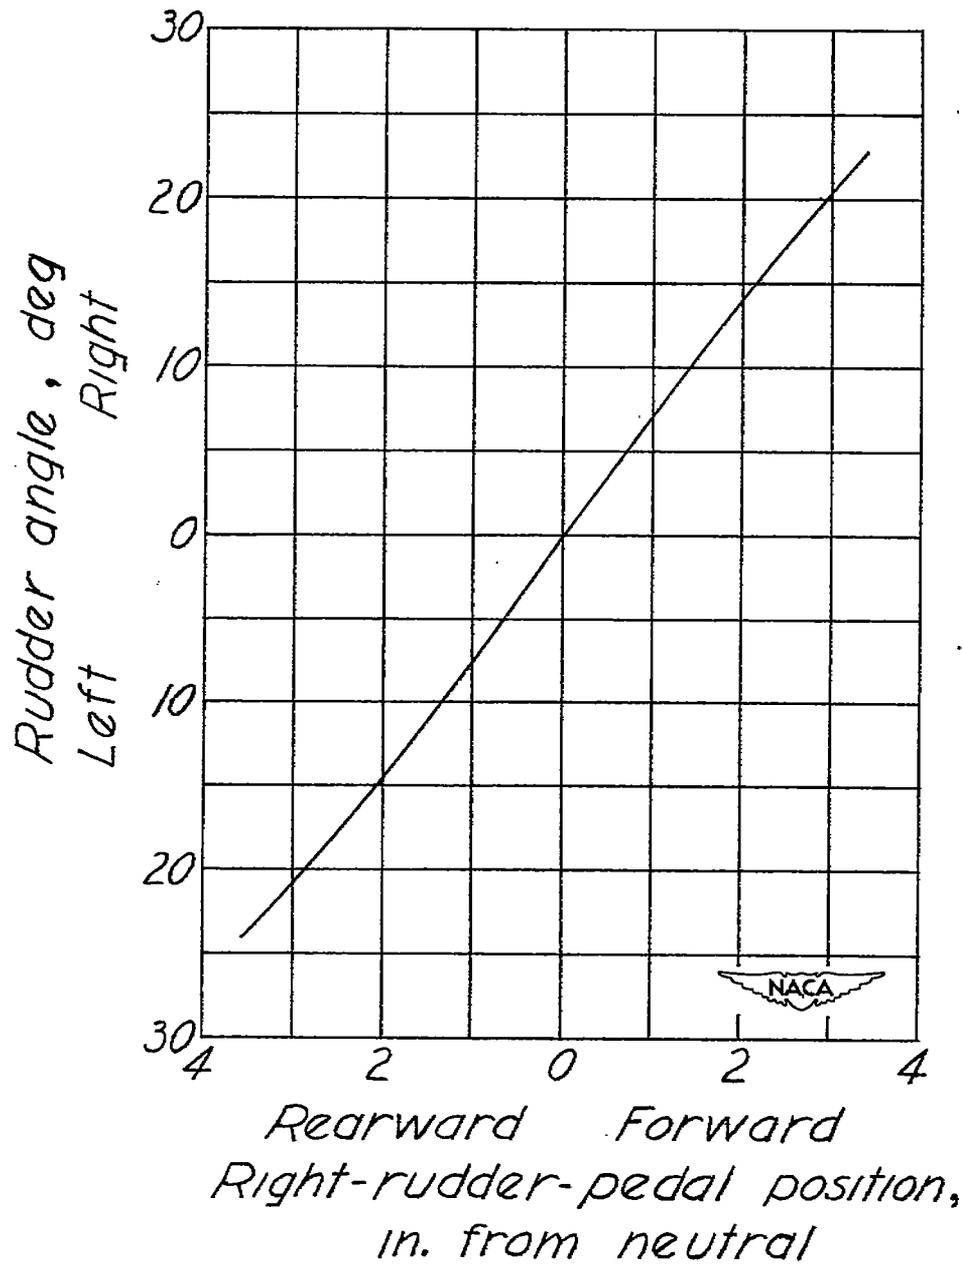
Figure 7.- Variation of rudder position with right-rudder-pedal position.
No load on system.

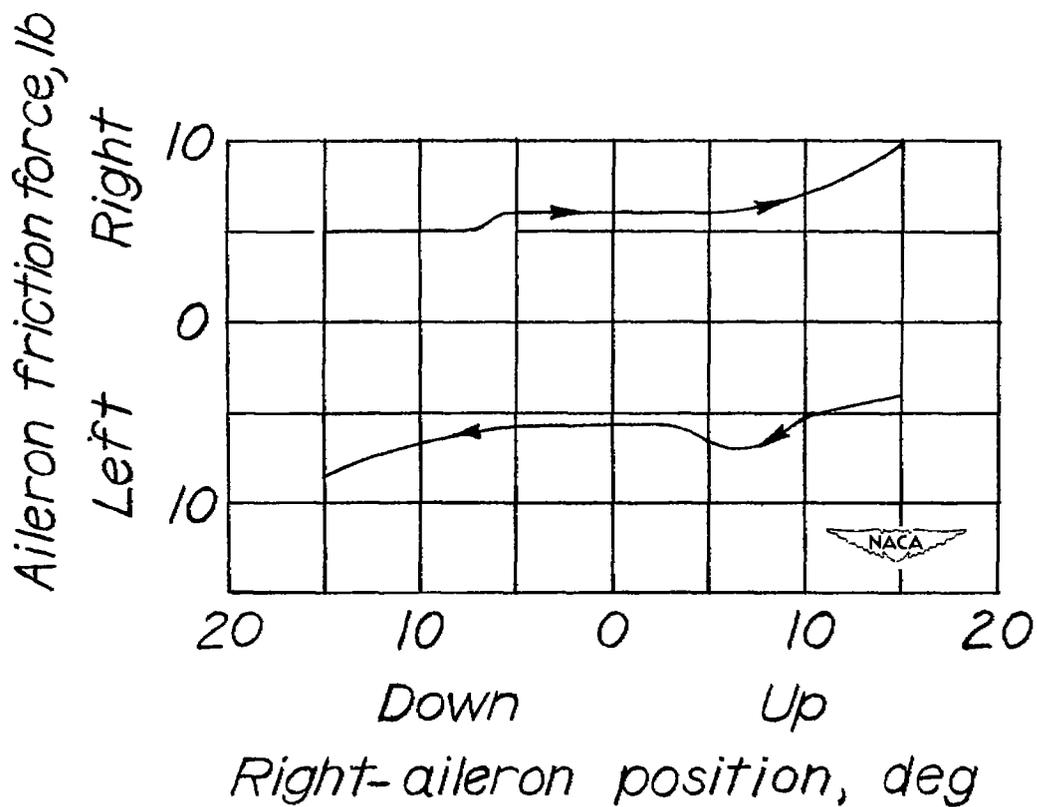
Figure 8.- Aileron-control force required to deflect ailerons on the ground under no load.

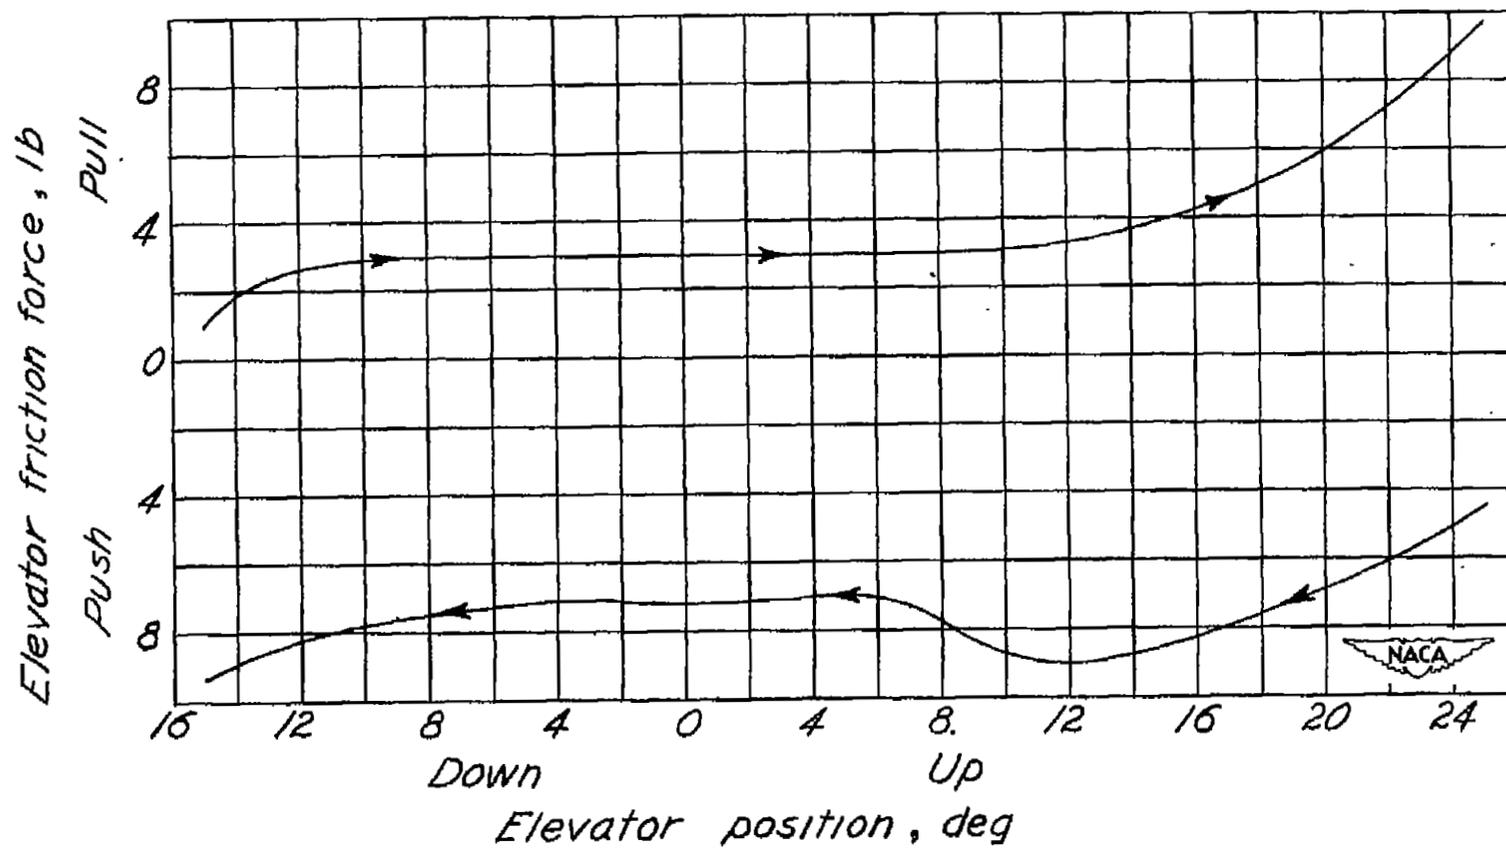
Figure 9.- Elevator-control force required to deflect elevator on the ground under no load.

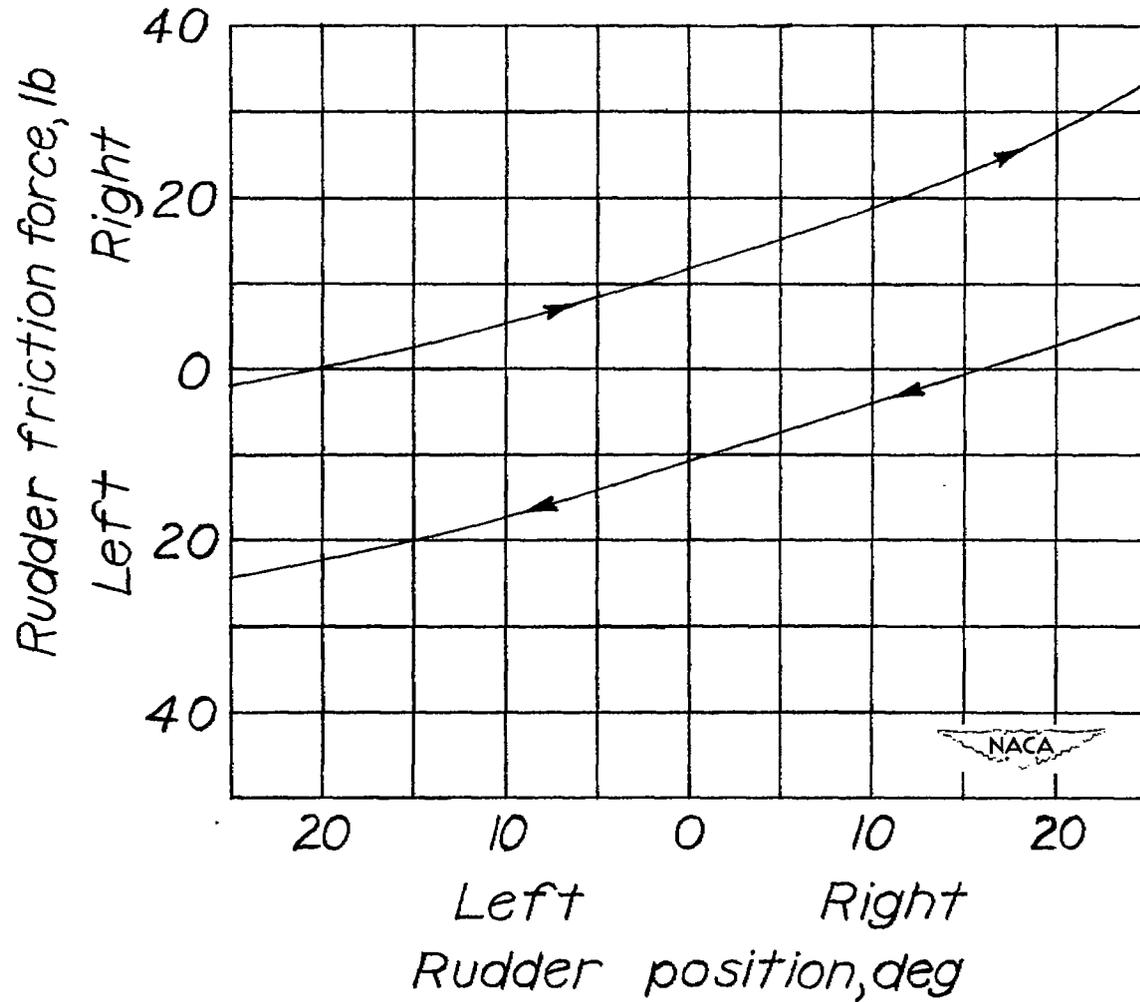
Figure 10.- Rudder-control force required to deflect rudder on the ground under no load.

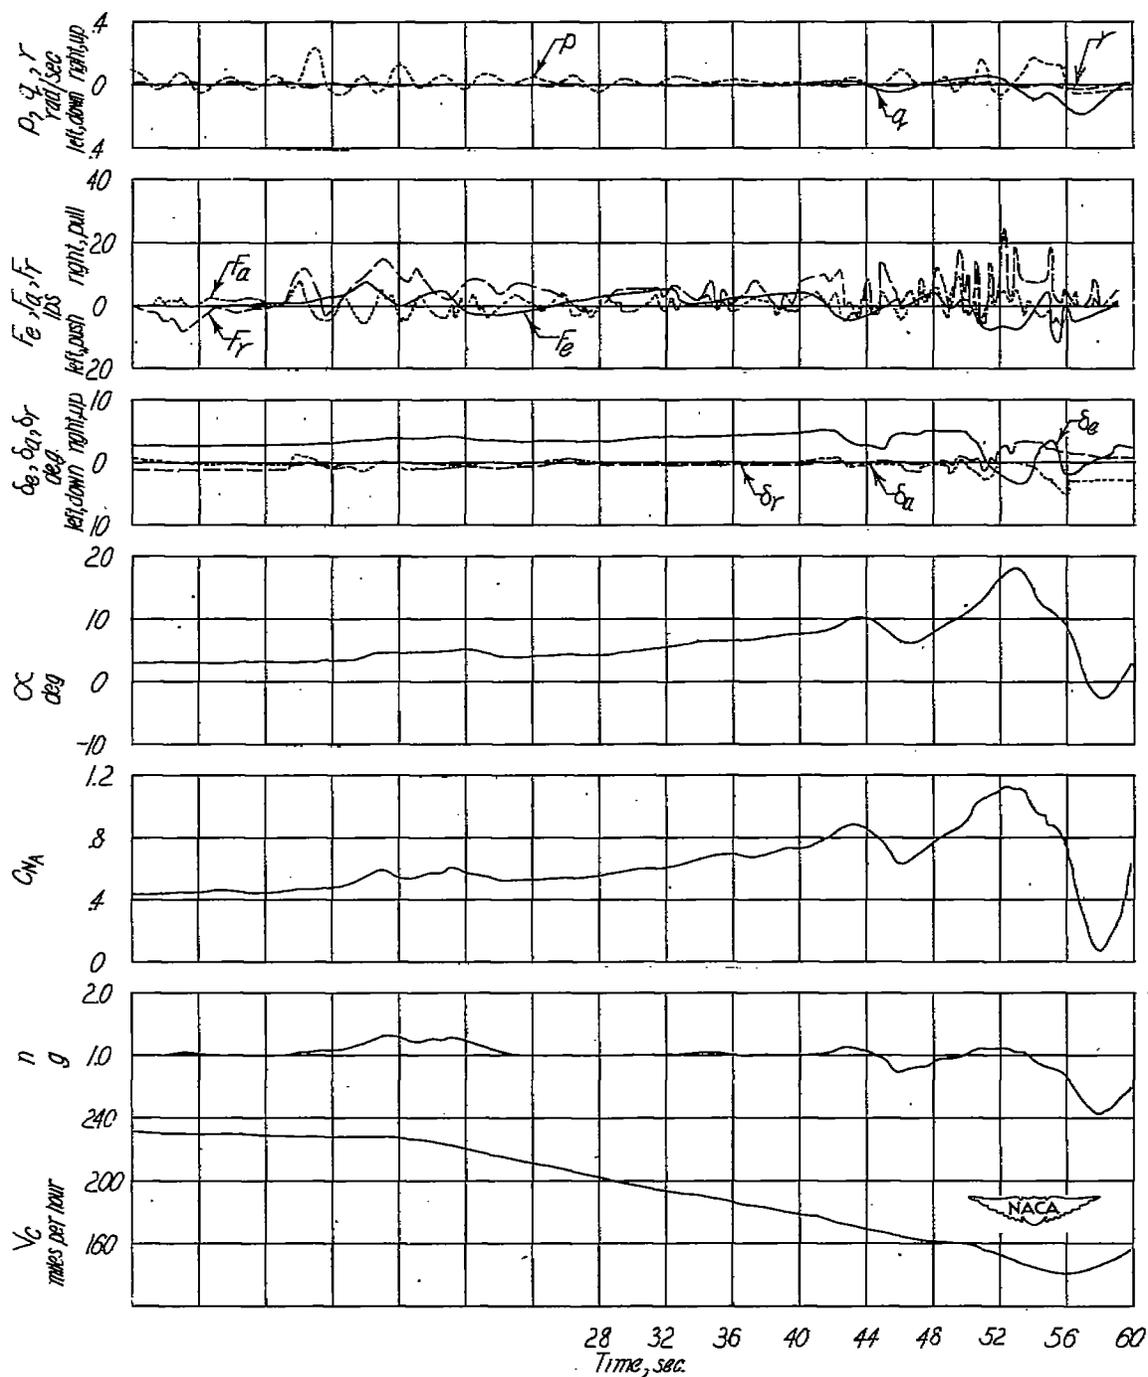
(a) Time history.

Figure 11.- Stall data for the Douglas D-558-II (BuAero No. 37974) research airplane. Flaps up; landing gear up; slats locked; inlet-duct flaps closed; stabilizer setting 1.95° ; center of gravity at 26.5 percent mean aerodynamic chord.

A time history of a stall in this configuration is presented in figure 11(a). Presented in figure 11(b) are photographs of tufts on the wing at various times during the stall. The black lines on the wing are parallel to the airplane center line and are located at intervals of 25 percent of the semispan of the exposed wings. The times listed in figure 11(b) correspond to the times of figure 11(a). The run was started at an indicated airspeed of about 230 miles per hour and the minimum speed reached was about 142 miles per hour. A lateral oscillation, which was predominantly a rolling motion, persisted throughout the run. The data indicate that the airplane became longitudinally unstable

at a normal-force coefficient of 0.8 and an angle of attack of about 9° which, for 1 g flight, corresponds to an airspeed of about 165 miles per hour. When the airplane became unstable the pilot was required to use large down-elevator deflections to control the pitching. In figure 11(a) at times between 50 and 53 seconds, the elevator was moved from 5° up to 3° down but the angle of attack increased from 11° to 18.2° . The highest normal-force coefficient reached was 1.13 at an angle of attack of about 17.5° .

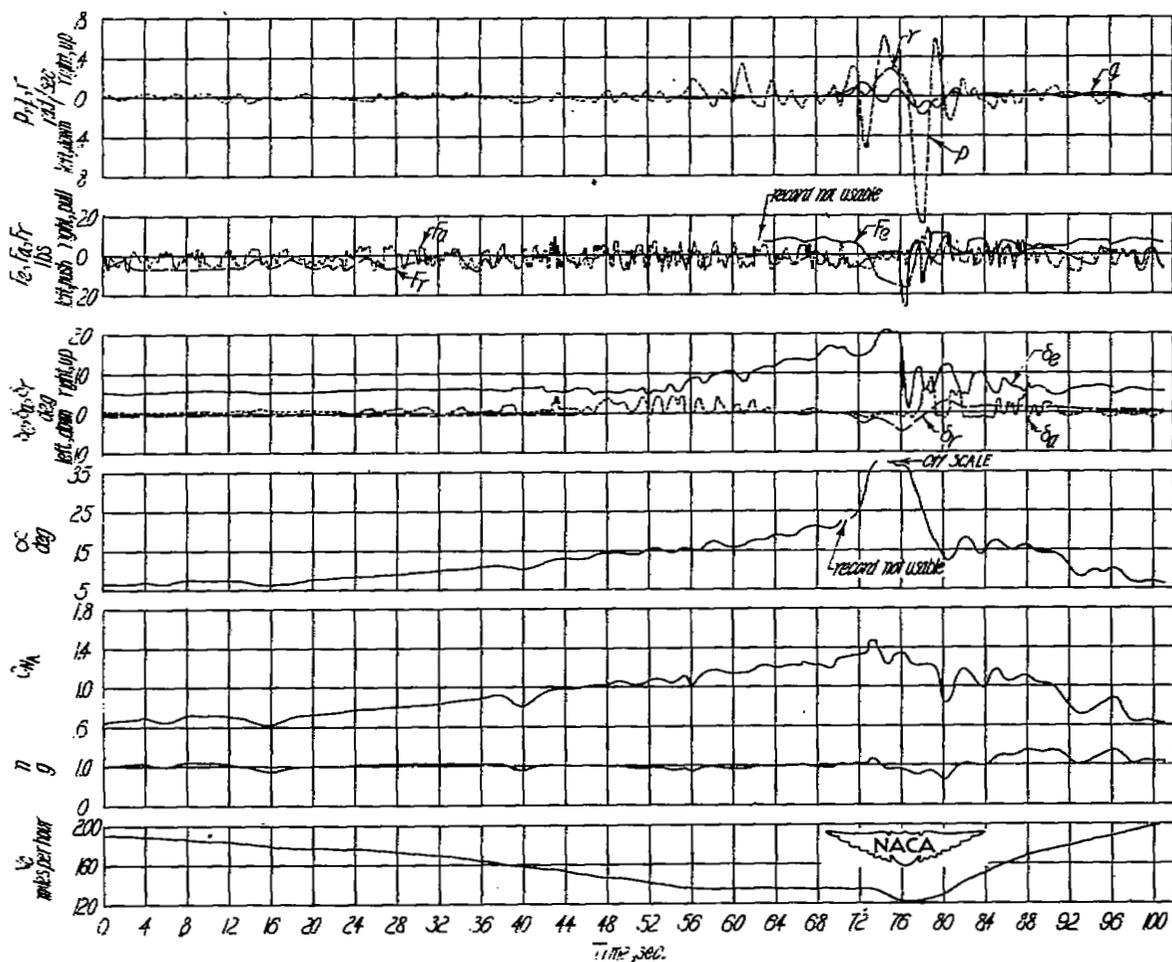
Figure 13.- Time history of a stall with the Douglas D-558-II (BuAero No. 37974) research airplane. Flaps up; landing gear up; slats unlocked; inlet duct-flaps closed; stabilizer setting 1.72° ; center of gravity at 26.7 percent mean aerodynamic chord.

The stall presented in figure 13 shows the same characteristics as that in figure 12(a), except that recovery was made after the airplane had reached a higher angle of attack. (The range of the angle-of-attack recorder was exceeded at 38° .) The approach to the stall was started at 190 miles per hour and recovery was made at 122 miles per hour. At the higher angles of attack the airplane was longitudinally unstable. At times between 70 and 72 seconds the elevator is moved down, but at the same time the angle of attack increases rapidly. Also at times between 72 and 75 seconds when the elevator is being moved up, the angle of attack is leading rather than lagging the elevator motion. The highest normal-force coefficient reached was 1.47 at an angle of attack of about 36° . Recovery from the stall was accomplished by moving the elevator down. The longitudinal instability which occurred in this airplane configuration at angles of attack greater than about 23° was not nearly so objectionable to the pilots as the instability which occurred in the slats-locked configuration previously discussed. With the slats locked the instability occurred at a much lower normal-force coefficient or angle of attack and the pitch-up was more rapid.

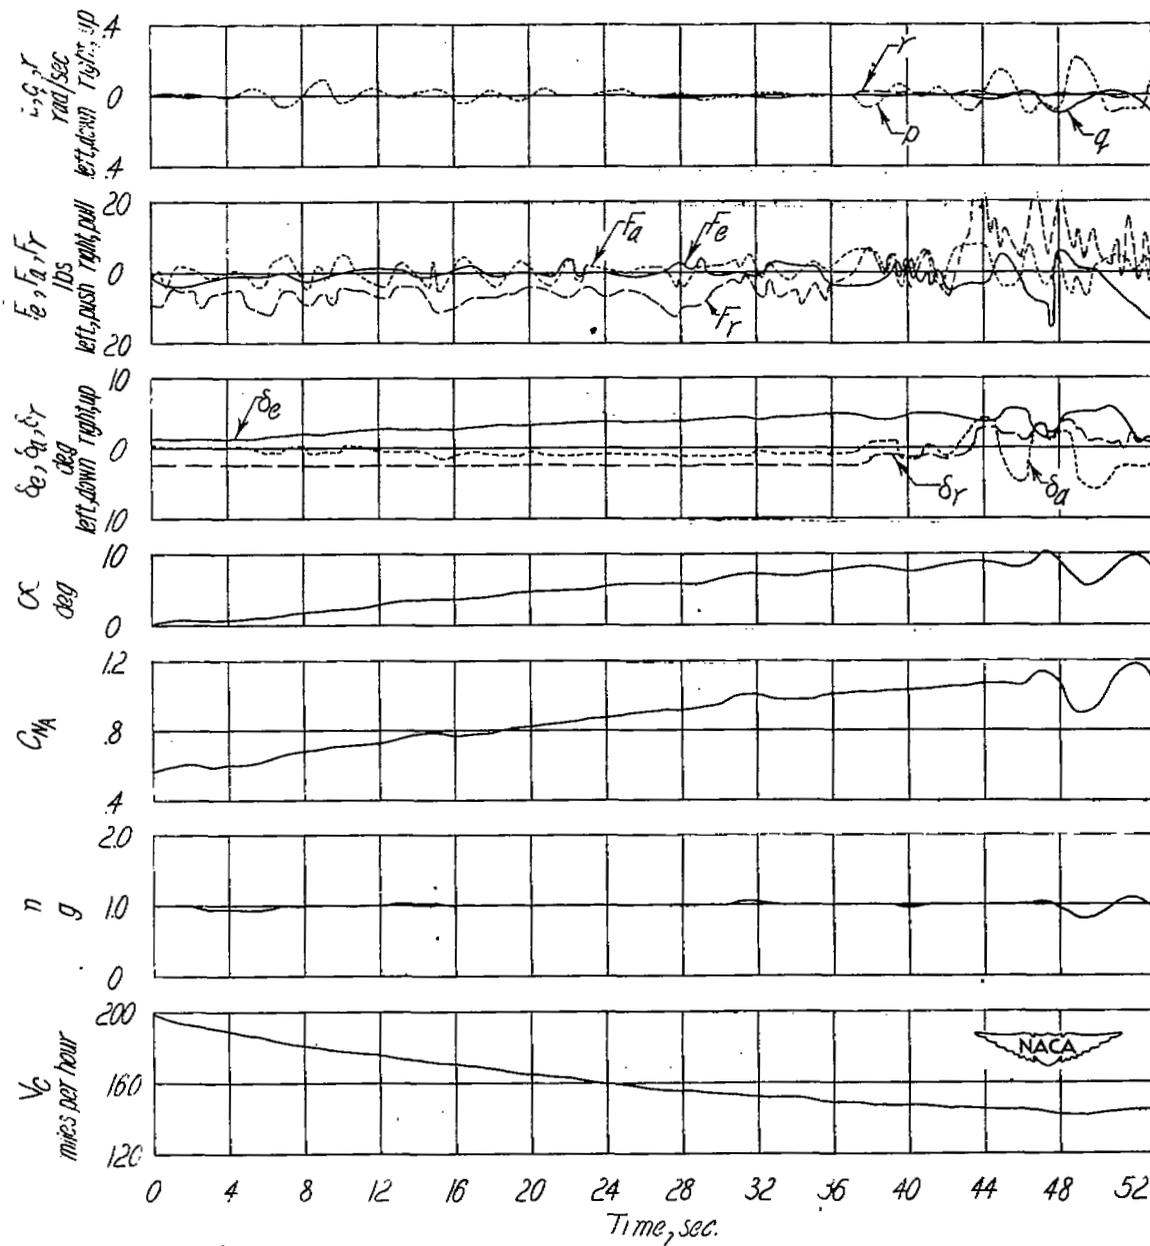
(a) Time history.

Figure 14.- Stall data for the Douglas D-558-II (BuAero No. 37974) research airplane. Flaps down; landing gear down; slats locked; inlet-duct flaps open; stabilizer setting 2.2° ; center of gravity at 26.1 percent mean aerodynamic chord.

Flaps down, landing gear down, inlet-duct flaps open, slats locked.-
Figure 14(a) presents a time history of a stall approach in this airplane configuration. The tuft pictures are presented as figure 14(b). The stall approach was started as an indicated airspeed of about 200 miles per hour and the minimum speed reached was about 142 miles per hour. As will be shown in a later time history, figure 15, considerably lower speeds and higher angles of attack have been reached in this airplane configuration in other runs, and therefore in the time history presented as figure 14(a) the airplane was not completely stalled. The tuft pictures of figure 14(b) also show that the wing of the airplane was only partially stalled at the highest angles of attack reached. A rolling oscillation of small amplitude was present throughout most of the run. The airplane was neutrally stable or slightly unstable longitudinally in the speed range from about 150 to 142 miles per hour. Inspection of the tuft pictures shows that stalling first occurred on the flaps. The tuft pictures at 47, 49, and 52 seconds show parts of the left and right wings to be alternately stalled and unstalled. The alternate stalling and unstalling of the wings appear to be associated with the rolling motion. When the airplane is rolling to the left at 47 and 52 seconds,

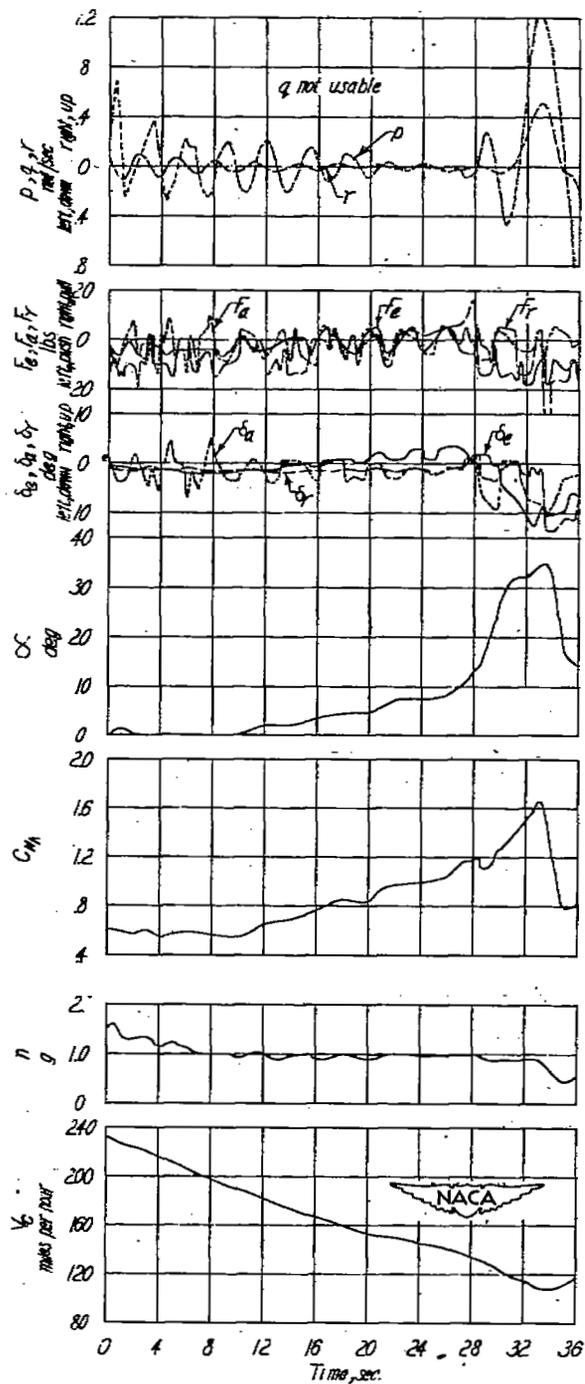
Figure 15.- Time history of a stall with the Douglas D-558-II (BuAero No. 37974) research airplane. Flaps down; landing gear down; slats locked; inlet-duct flaps open; stabilizer setting 0.7° ; center of gravity at 26.6 percent mean aerodynamic chord.

Figure 15 presents a time history of a stall approach and stall in the same airplane configuration during which much higher angles of attack were reached. The data show that at about 140 miles per hour (time 26.5 seconds) the airplane becomes very unstable longitudinally. In the time interval between 26.5 and 32.5 seconds the elevator was moved from 3.5° up to 12.5° down and during the same time the angle of attack increased from about 9° to 33° . The airplane experienced quite high rolling velocities at the higher angles of attack. A rolling velocity of about 1.2 radians per second to the right first occurred followed by a roll to the left. During the left roll the recording instruments were inadvertently turned off. After the rolling oscillation occurred the airplane went into a spin. The pilot was unable to effect recovery from the spin with the flaps and landing gear extended, but when the flaps and landing gear were retracted recovery was accomplished with the ailerons and rudder held against the spin.

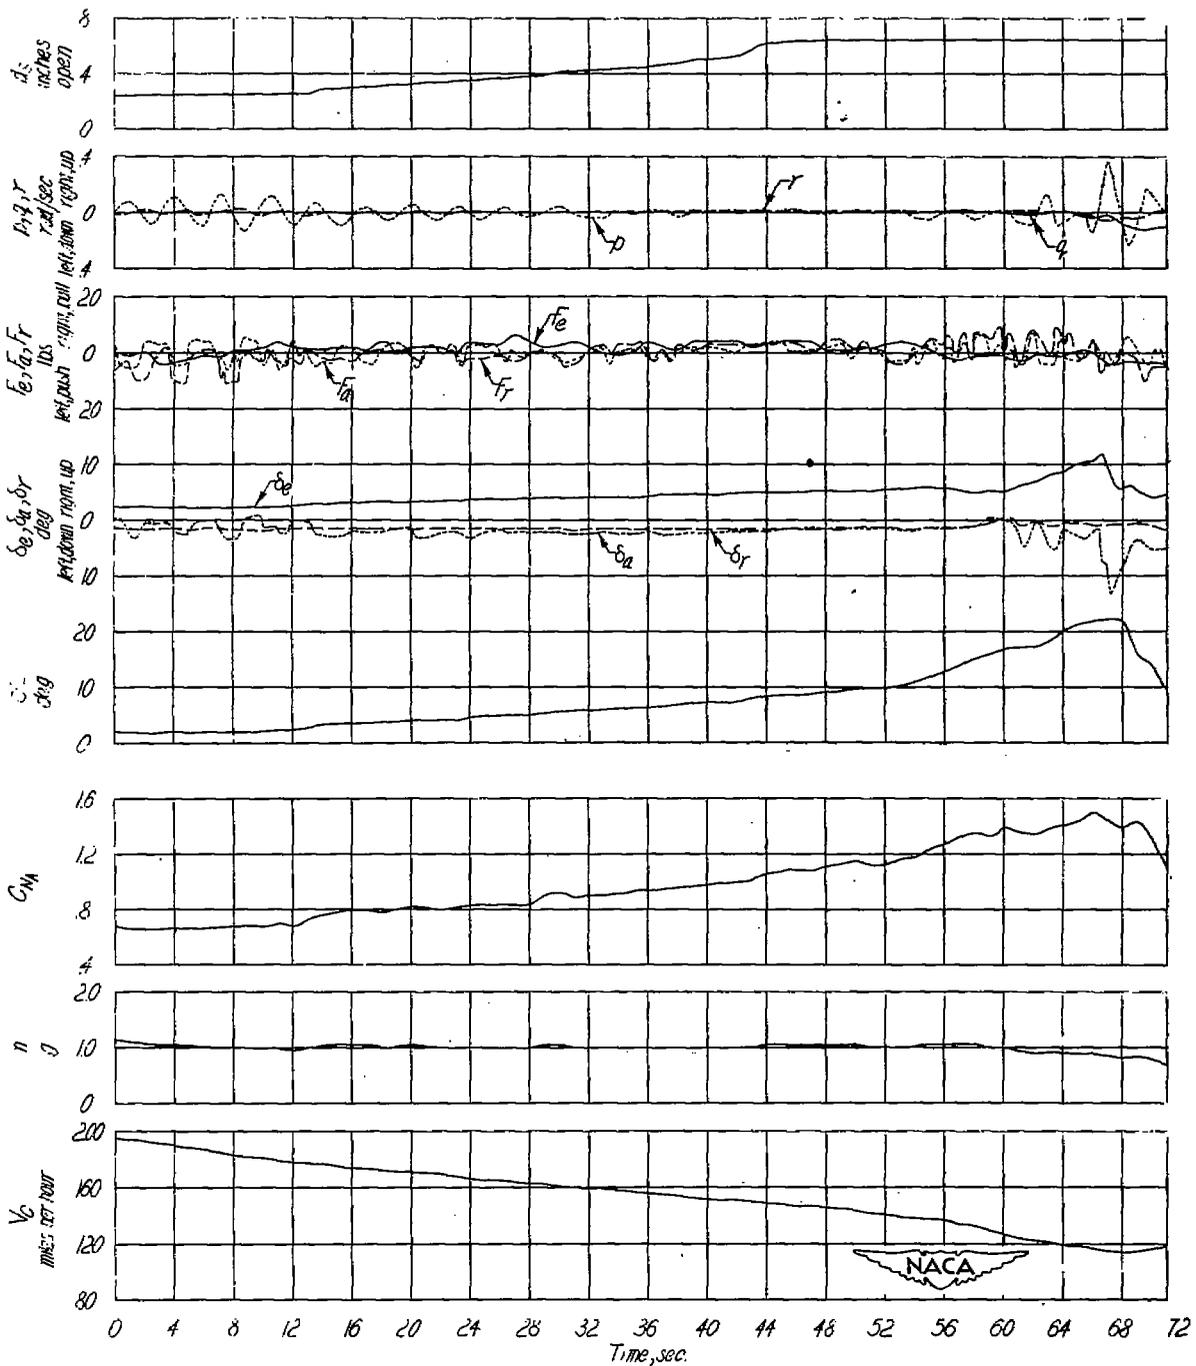
(a) Time history.

Figure 16.- Stall data for the Douglas D-558-II (BuAero No. 37974) research airplane. Flaps down; landing gear down; slats unlocked; inlet-duct flaps open; stabilizer setting 2.2° ; center of gravity at 26.2 percent mean aerodynamic chord.

Flaps down, landing gear down, inlet-duct flaps open, slats open.-
A time history of a stall approach in this airplane configuration is shown in figure 16(a) and the corresponding tuft pictures are presented in figure 16(b). The run was started at an indicated airspeed of 195 miles per hour and the minimum speed reached was 114 miles per hour. At the higher speeds the airplane performs a Dutch roll oscillation which damps out as the speed is decreased. This has been noted in many flights with the D-558-II airplane. With the flaps down at indicated speeds greater than about 190 miles per hour the pilots have not been able to make precision maneuvers with the airplane because of the poor damping of the Dutch roll oscillations; at speeds between about 150 and 190 miles per hour, the Dutch roll characteristics have not been nearly as troublesome.

The data indicate that the airplane is longitudinally stable in this configuration at indicated airspeeds greater than approximately 140 miles per hour. In the airspeed range from 140 to 130 miles per hour

the airplane has approximately neutral longitudinal stability and at indicated airspeeds less than 130 miles per hour the airplane is very stable longitudinally. The highest angle of attack reached in this run was about 22° and the normal-force coefficient at this angle of attack is 1.50. A rolling and yawing oscillation occurred at the higher angles of attack but the airplane motions during the oscillation were mild.

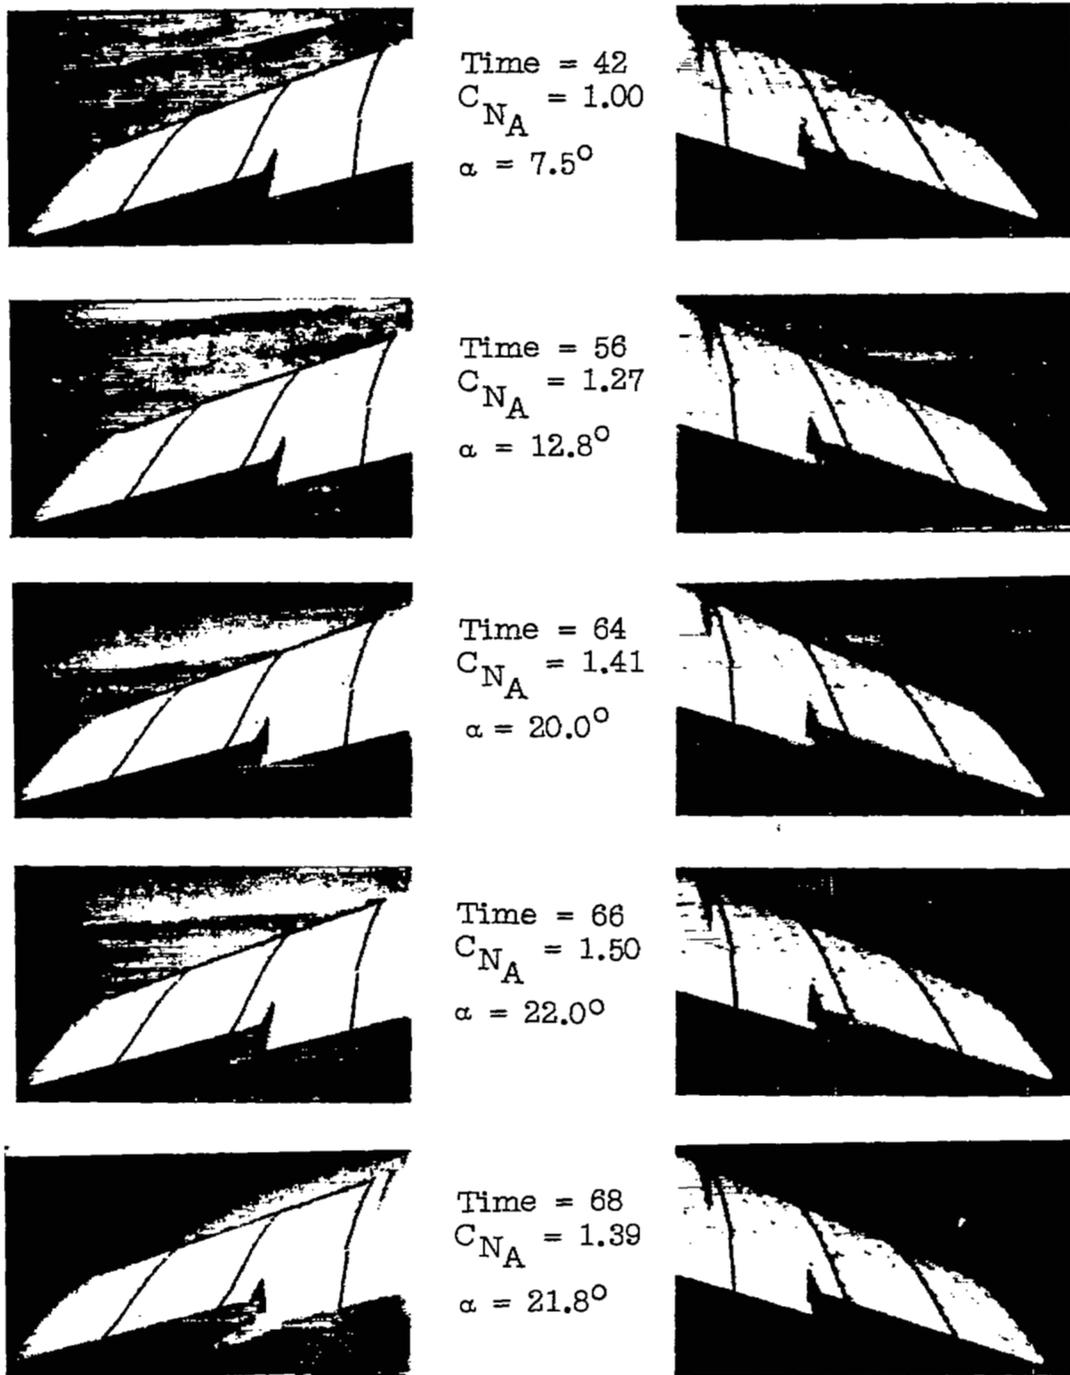
(b) Tuft pictures.

Figure 16.- Concluded.

Figure 16(b) shows that stalling first occurs on the flaps as was also the case with the slats locked (fig. 14(b)). As the angle of attack increases the slats appear to be quite effective in preventing separation as most of the stalling occurs over the inboard 50 percent of the exposed wing semispan. There is considerable outflow over the outer portions of the wing but the flow does not appear to be separated as it is inboard.

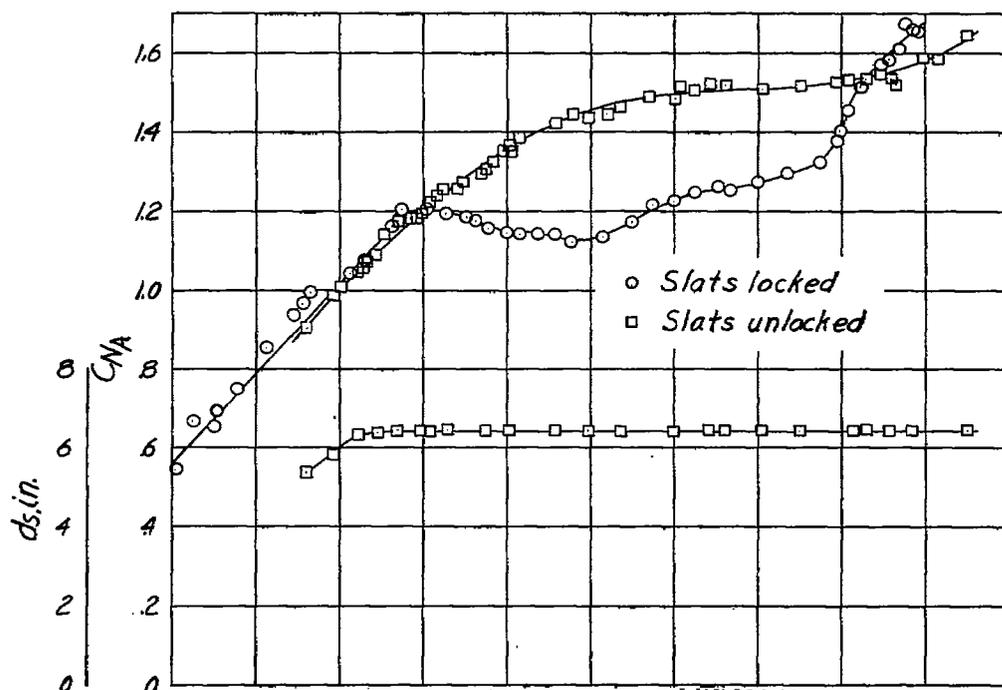
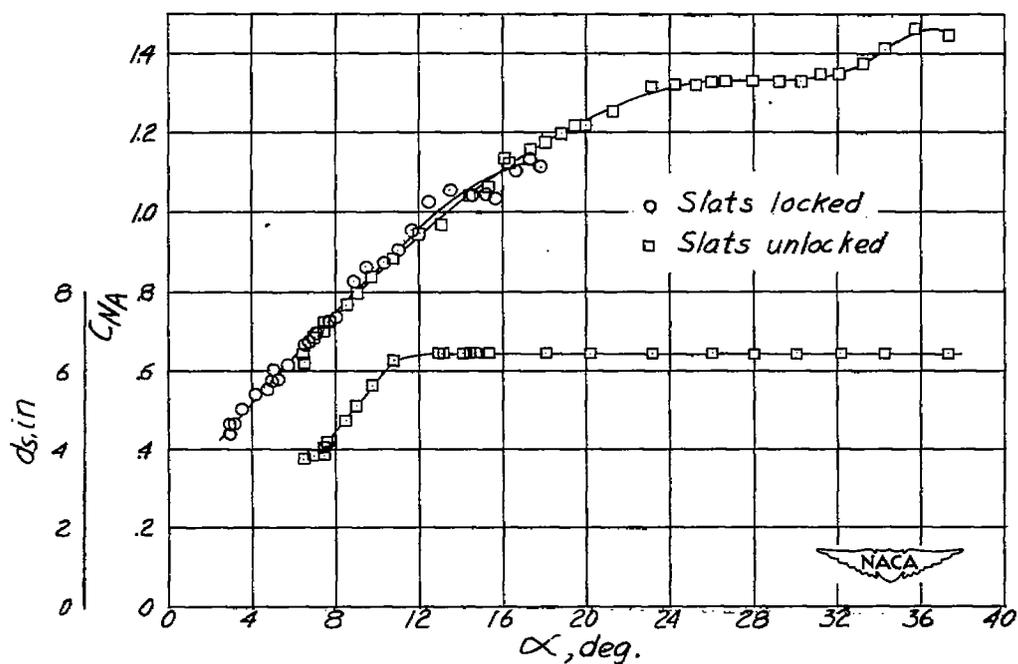
Figure 18.- Variation of airplane normal-force coefficient with angle of attack showing effect of slats.

From some of the runs previously presented as time histories of stalls, the variation of airplane normal-force coefficient with angle of attack was determined for the four different airplane configurations previously discussed. These data are presented in figures 18(a) for the flaps-up configurations and in 18(b) for the flaps-down configurations. The variation of slat position with angle of attack is also presented in figure 18.

At the lower normal-force coefficients, with the flaps up or down, unlocking the slats had no appreciable effect on the angle of attack required to produce a given normal-force coefficient. With the flaps up and the slats locked, the highest normal-force coefficient reached was about 1.13 at an angle of attack of about 18° . With the flaps up and the slats unlocked, the highest normal-force coefficient reached was

about 1.46 at an angle of attack of 36° . In the angle-of-attack range from about 23° to 30° the normal-force coefficient has a substantially constant value of 1.32. At the higher angles of attack, the lift coefficient would be considerably lower than the normal-force coefficient because of the large inclination of the normal-force vector with respect to the lift vector.

With the flaps down and the slats locked or unlocked (fig. 18(b)) the highest normal-force coefficient reached was about 1.65. This value of normal-force coefficient was reached at an angle of attack of 35.5° with the slats locked and 38° with the slats unlocked. However, in the angle-of-attack range from 12° to 32° , considerably higher normal-force coefficients can be reached at a given angle of attack with the slats unlocked than locked. For example, at an angle of attack of 25° the normal-force coefficient is about 1.5 with the slats unlocked and 1.25 with the slats locked.

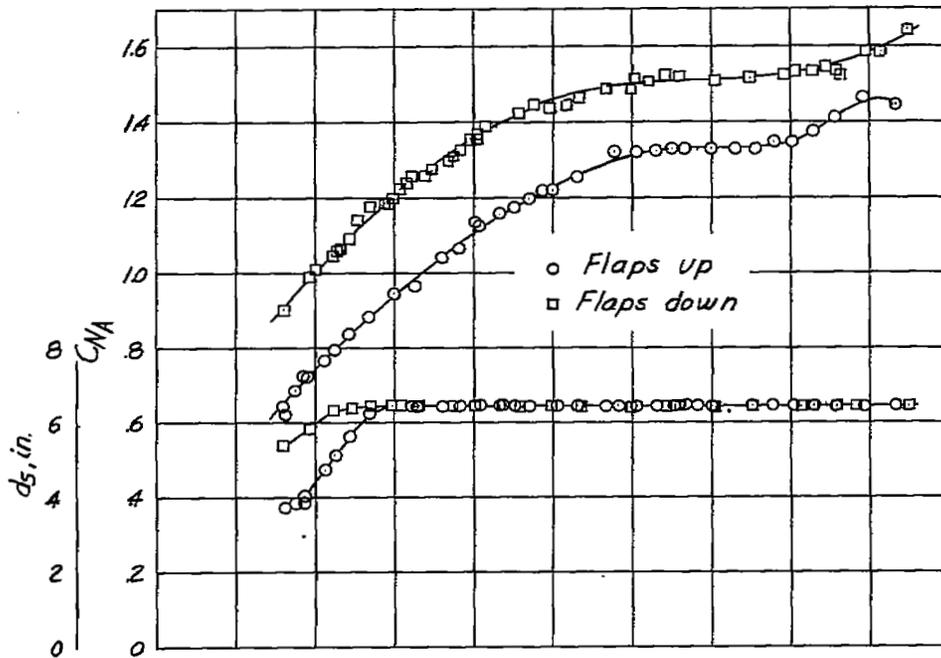
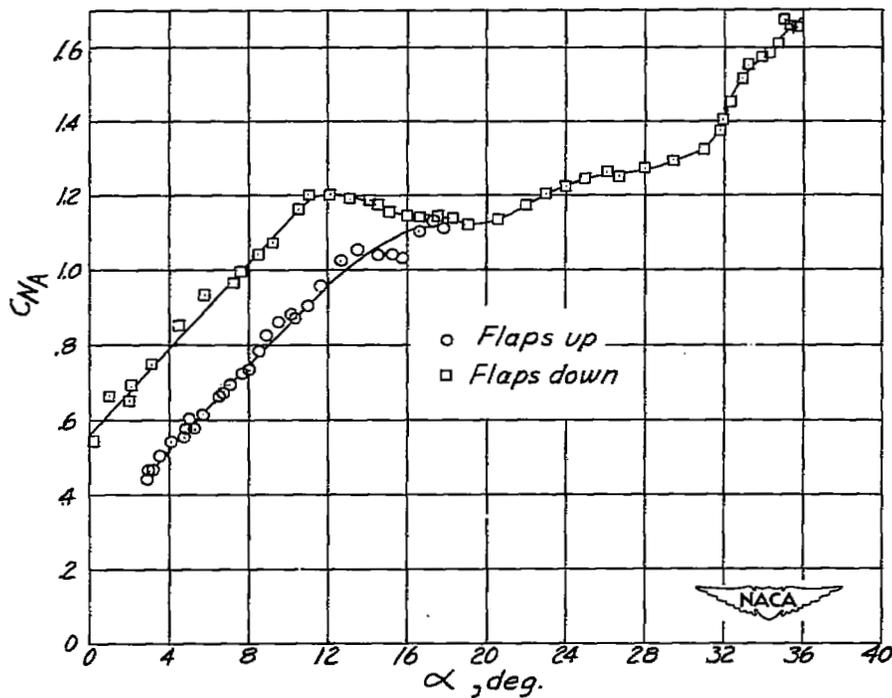
Figure 19.- Variation of airplane normal-force coefficient with angle of attack showing effect of flaps.

In order to show more clearly the effect of flap deflection on the lift characteristics the data of figure 18 have been replotted in figure 19. Figure 19(a) is for the slats-locked configuration and figure 19(b) is for the slats-unlocked configuration. At the lower angles of attack, with the slats locked or unlocked, deflecting the flaps will produce an increment in normal-force coefficient of about 0.26. With the slats locked at an angle of attack of 17° , the normal-force coefficient has approximately the same value, 1.13, with the flaps up or down. With the slats unlocked the flaps produce an appreciable increment in normal-force coefficient throughout the angle-of-attack range.
