NACA RM E51G13

RELATION OF ENGINE TURBINE-BLADE LIFE TO STRESS-RUPTURE  
PROPERTIES OF THE ALLOYS, STELLITE 21, HASTELLOY B, CAST

S-816, FORGED S-816, X-40, NIMONIC 80, REFRACTALOY 26,  
N-155, AND INCONEL X

By F. B. Garrett and C. Yaker

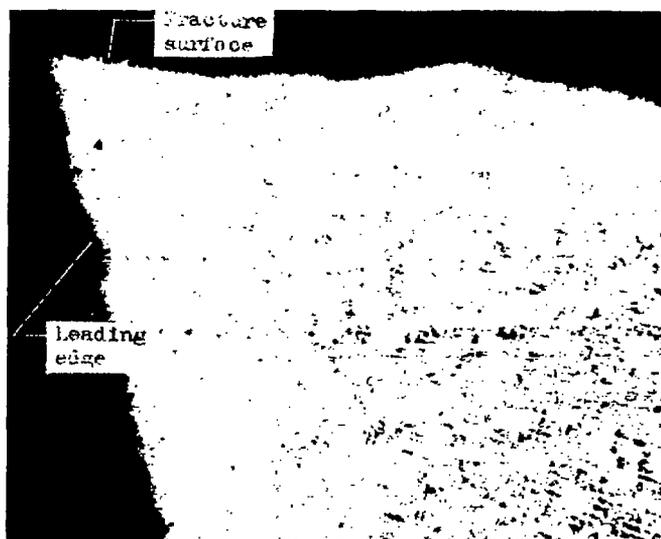
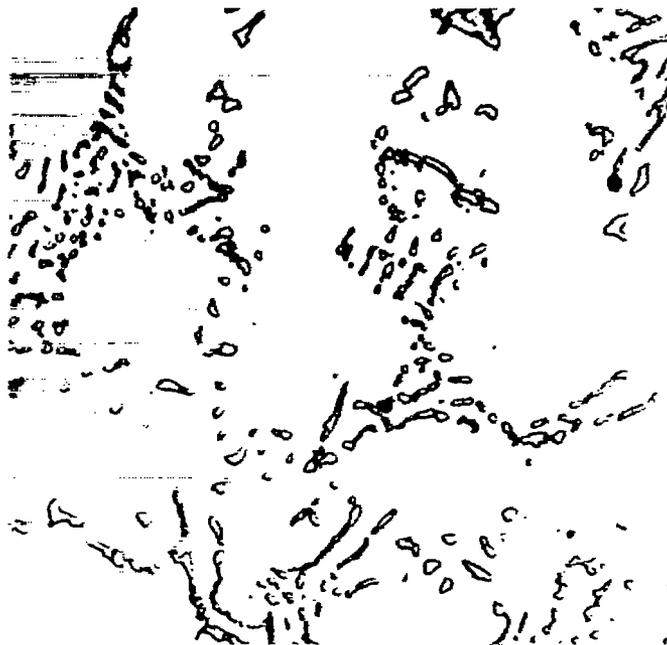
(a) Typical blade failure.

Figure 9. - Results of metallurgical examination of cast 8-816.

(b) Transcrystalline fracture at leading edges. Electrolytically etched in 10-percent chromic acid; X50.

(c) Structure before operation. Electrolytically etched in 10-percent chromic acid, X1000.

(d) Structure after operation. Electrolytically etched in 10-percent chromic acid, X1000.

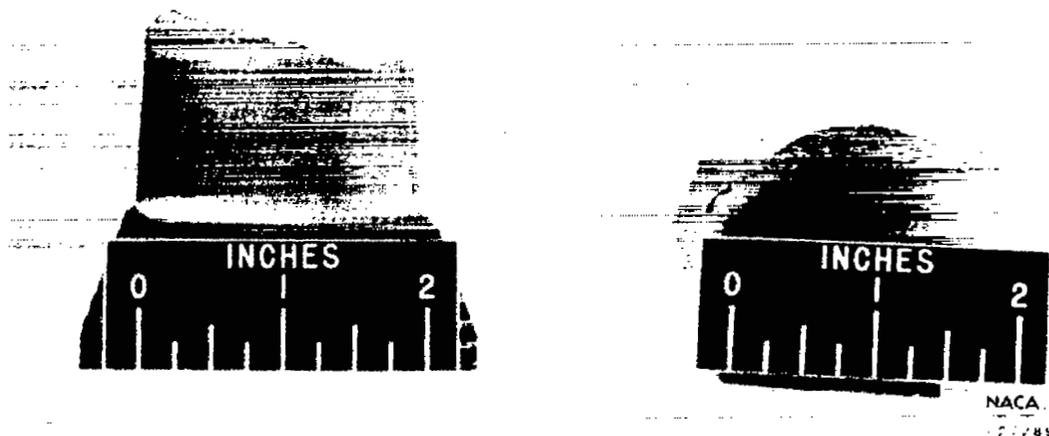
(a) Typical blade failure.

(b) Grain size. Electrolytically etched in 10-percent chromic acid, X100.

Figure 10. - Results of metallurgical examination of forged S-816 blade.

Intercrystalline cracking and fracture path at leading edge; X150.

Intercrystalline crack at leading edge; X250.

Transcrystalline fatigue fracture path nucleated by intercrystalline cracks; X250.

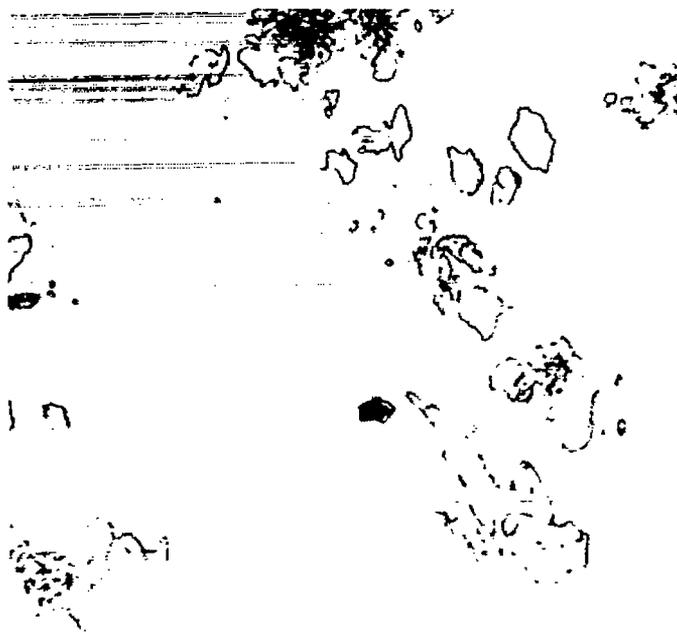
(a) Initial true blade failure after 99.4 hours of operation. Remaining blades did not fail.

(b) Transcrystalline fracture path at leading edge. Electrolytically etched in 10-percent chromic acid; X100.

Figure 11. - Results of metallurgical examination of X-40 blades.

(c) Structure before operation. Electrolytically etched in 10-percent chromic acid; X1000.

(d) Structure after operation. Electrolytically etched in 10-percent chromic acid; X1000.

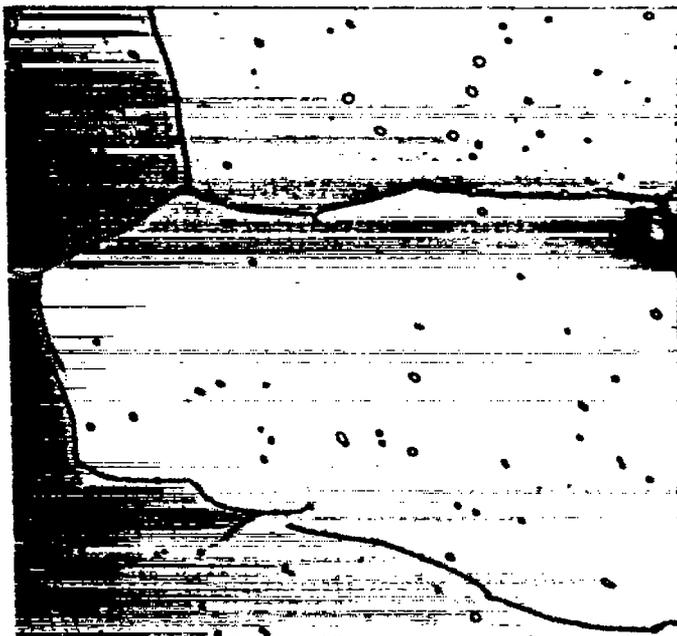
(a) Typical blades failure.

Figure 12. - Results of metallurgical examination of Nimonic 80 blades.

(b) Grain size throughout blades, A.S.T.M. 2 to 4. Electrolytically etched in 10-percent chromic acid; X100.

(c) Nature of fracture propagation. Electrolytically etched in 10-percent chromic acid; X150, oblique illumination.

(d) Structure before engine operation.  
Electrolytically etched in 10-percent  
chromic acid; X1000

(e) Structure after engine operation.  
Electrolytically etched in 10-percent  
chromic acid; X1000.

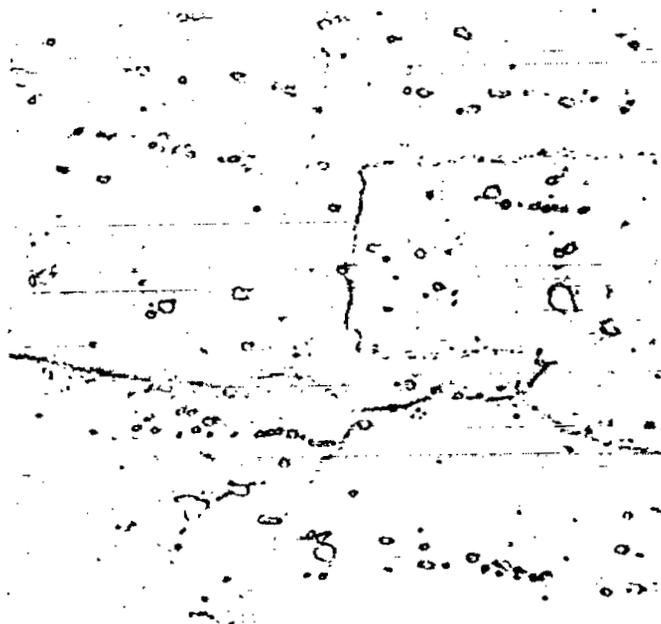
(a) Beginning of failure.

(b) Typical failure.

Figure 14. - Results of metallurgical examination of N-155 blades.

(c) Grain size. Electrolytically etched  
in 10-percent chromic acid; X100.

(d) Intercrystalline fracture and cracking.  
Electrolytically etched in 10-percent  
chromic acid; X100.

(e) Structure before operation. Electrolytically etched in 10-percent chromic acid; X100.

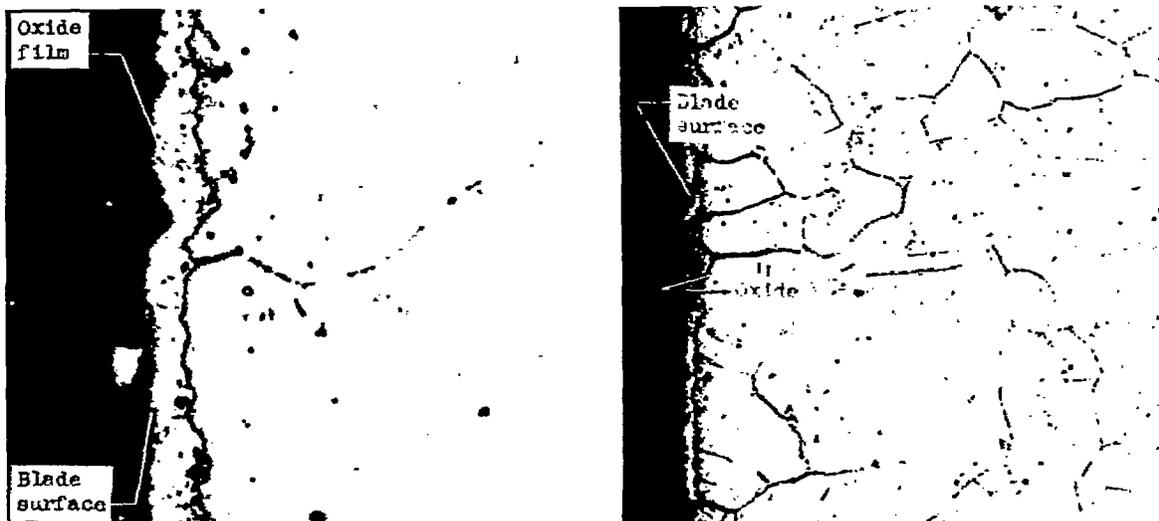
(a) Oxide film on blade surface; X250.

(b) Intergranular penetration of oxide on blade surface; X100.

(c) Oxide in grain boundaries and along fracture surface; X250.

Figure 20. - Oxide penetration of Refractaloy 26 during engine operation. Electrolytically etched in 10-percent chromic acid.

2. The engine life for the blades of the relatively high strength alloys, cast S-816, X-40 and Refractaloy 26, fell below the life predicted on the basis of the stress-rupture properties of the blades. In the case of the cast S-816 and X-40 blades, the low life was attributed to the influence of vibratory stresses in contributing to the failure of the blades. In the case of the Refractaloy 26 blades, the low life was attributed to corrosion accelerated by the vibratory and thermal stresses in the engine.
