# RESEARCH MEMORANDUM

TESTS OF AERODYNAMICALLY HEATED MULTIWEB WING  
STRUCTURES IN A FREE JET AT MACH NUMBER 2

TWO ALUMINUM-ALLOY MODELS OF 20-INCH CHORD  
WITH 0.064- AND 0.081-INCH-THICK SKIN

By George E. Griffith, Georgene H. Miltonberger,  
and Richard Rosecrans

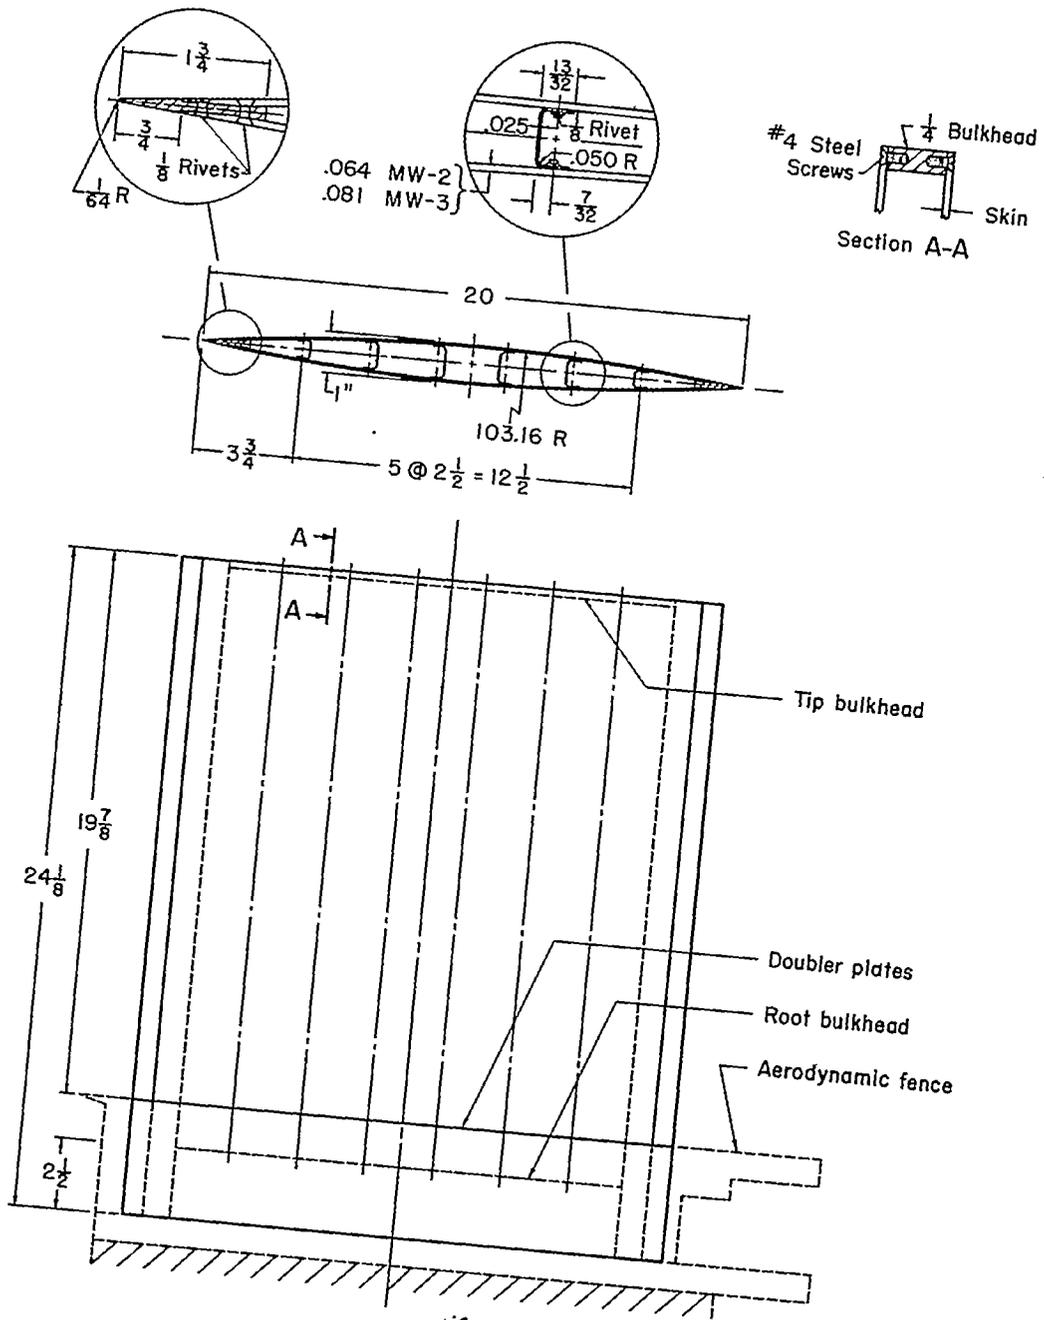
Figure 1.- Dimensions of multiweb wing models MW-2 and MW-3.

cantilever multiweb wings with 5-percent-thick, symmetrical, circular-arc airfoil sections (fig. 1). Model MW-2 had 0.064-inch-thick skin and model MW-3 0.081-inch-thick skin. All material was 2024-T3 (24S-T3) aluminum alloy except that the rivets were either 2117-T (A17S-T) aluminum alloy or Huck rivets and steel screws were used to attach the skins to the upper bulkhead. The surfaces of the models were sanded to provide a finish of approximately 15 microinches, root mean square, and were unpainted. Pertinent dimensions and details of construction of the models are given in figure 1.

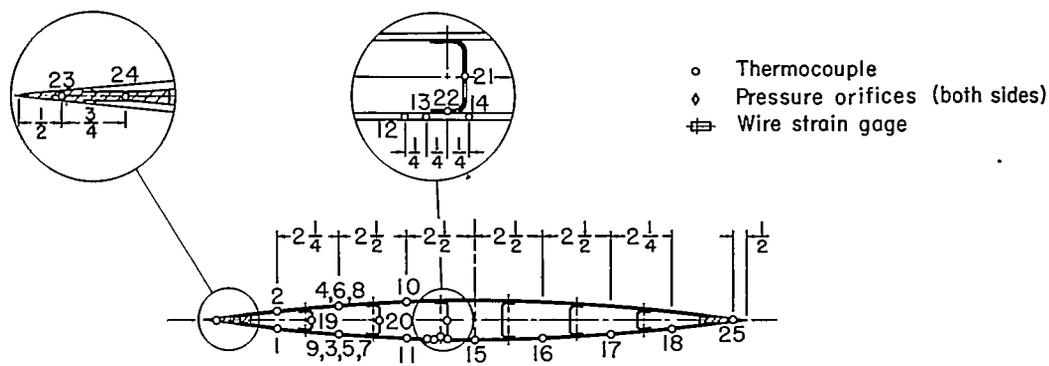
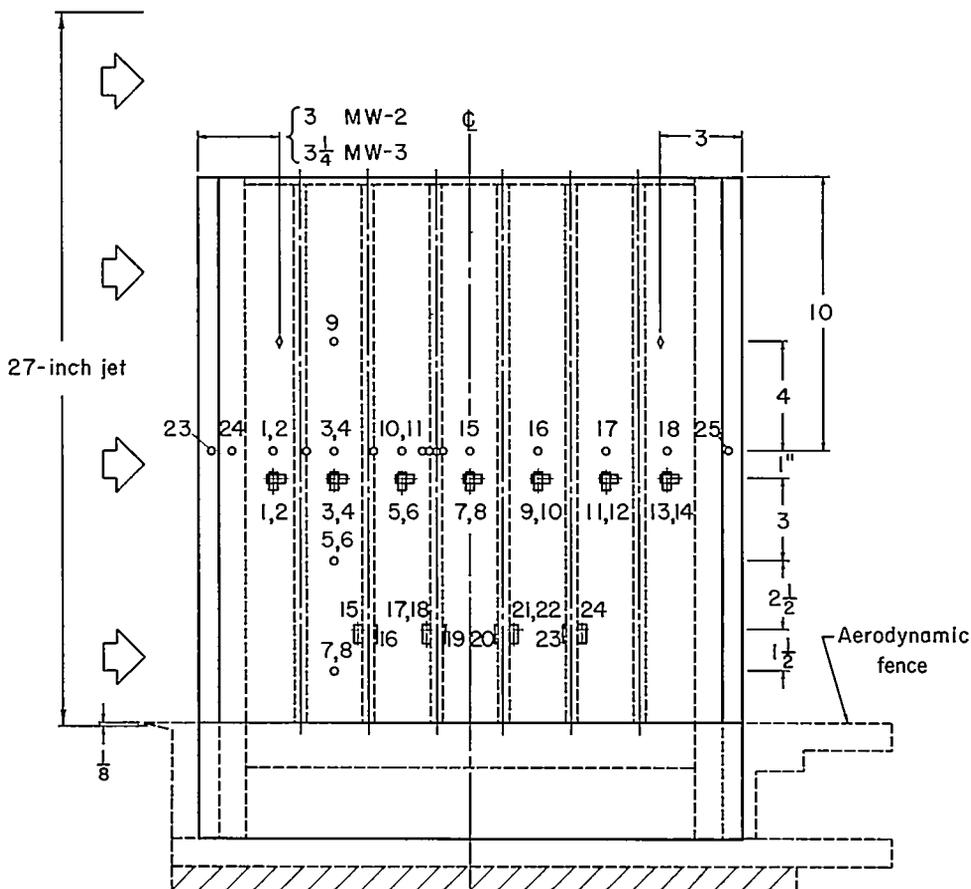
(a) Chordwise section 10 inches from tip.

(b) Plan view.

Figure 2.- Location of instrumentation for models MW-2 and MW-3. (Where two wire strain gages are listed, even-numbered gage is on far skin. Strain gages 16, 19, 20, and 23 are along web center line. The strain gages 11 inches from the tip are aligned in the chordwise direction on model MW-2 and in the spanwise direction on model MW-3.)

Each model was instrumented with 24 iron-constantan thermocouples, 4 pressure orifices, and 24 Baldwin SR-4 type AB-11 wire strain gages. (See fig. 2.) Locations were identical except that the strain gages attached to model MW-2 at the station 11 inches from the model tip were aligned in the chordwise direction, whereas the gages at these locations on model MW-3 were aligned in the spanwise direction, and, in addition, the forward pressure orifices for model MW-3 were located  $3\frac{1}{4}$  inches from the leading edge. Some instrumentation was inoperative at test time. (For details concerning the installation and accuracy of the instrumentation see the appendix.) Supplementary data were supplied through three 16-millimeter motion-picture cameras which operated at from about 75 to 230 frames per second.

copper tubing, approximately 18 inches in length, leading from an 0.059-inch-diameter orifice in the skin to a Statham pressure transducer outside the model. Tubing from both skins was connected to pressure transducers in such a manner that both pressure for the left side, looking upstream, and differential pressure (right side) were obtained at the two chordwise pressure stations shown in figure 2.

Strain gages.- Baldwin SR-4 type AB-11 wire strain gages were attached to the models (at the locations shown in fig. 2) in accordance with the manufacturer's specifications and cured to 250° F. The gages were then cycled twice to 300° F by inserting the models in an oven and gradually increasing the temperature from 80° F to 300° F in 2 hours, with the temperature being maintained at 300° F for approximately 12 minutes, allowing the models to cool, and repeating the process. During the second cycle the zero shifts of the individual gages were measured. Although model temperatures in excess of 300° F were anticipated, the curing temperatures were not allowed to exceed 300° F in order to minimize changes in the mechanical and physical properties of the 2024-T3 material. Since these strain gages are non-temperature-compensating, calibration data were obtained for sample gages cured in the same manner, but the calibration data were necessarily obtained under steady-state conditions. The calibration tests indicated that a marked difference in zero shift takes place beyond 300° F (for gages which have never previously exceeded this temperature). Moreover, this zero shift can be of the order of magnitude of the indicated strain, varies from gage to gage, and is dependent upon the gage temperature, which may not be accurately known. In addition to the aforementioned factors there are others which adversely affect the interpretation of the strain-gage results.

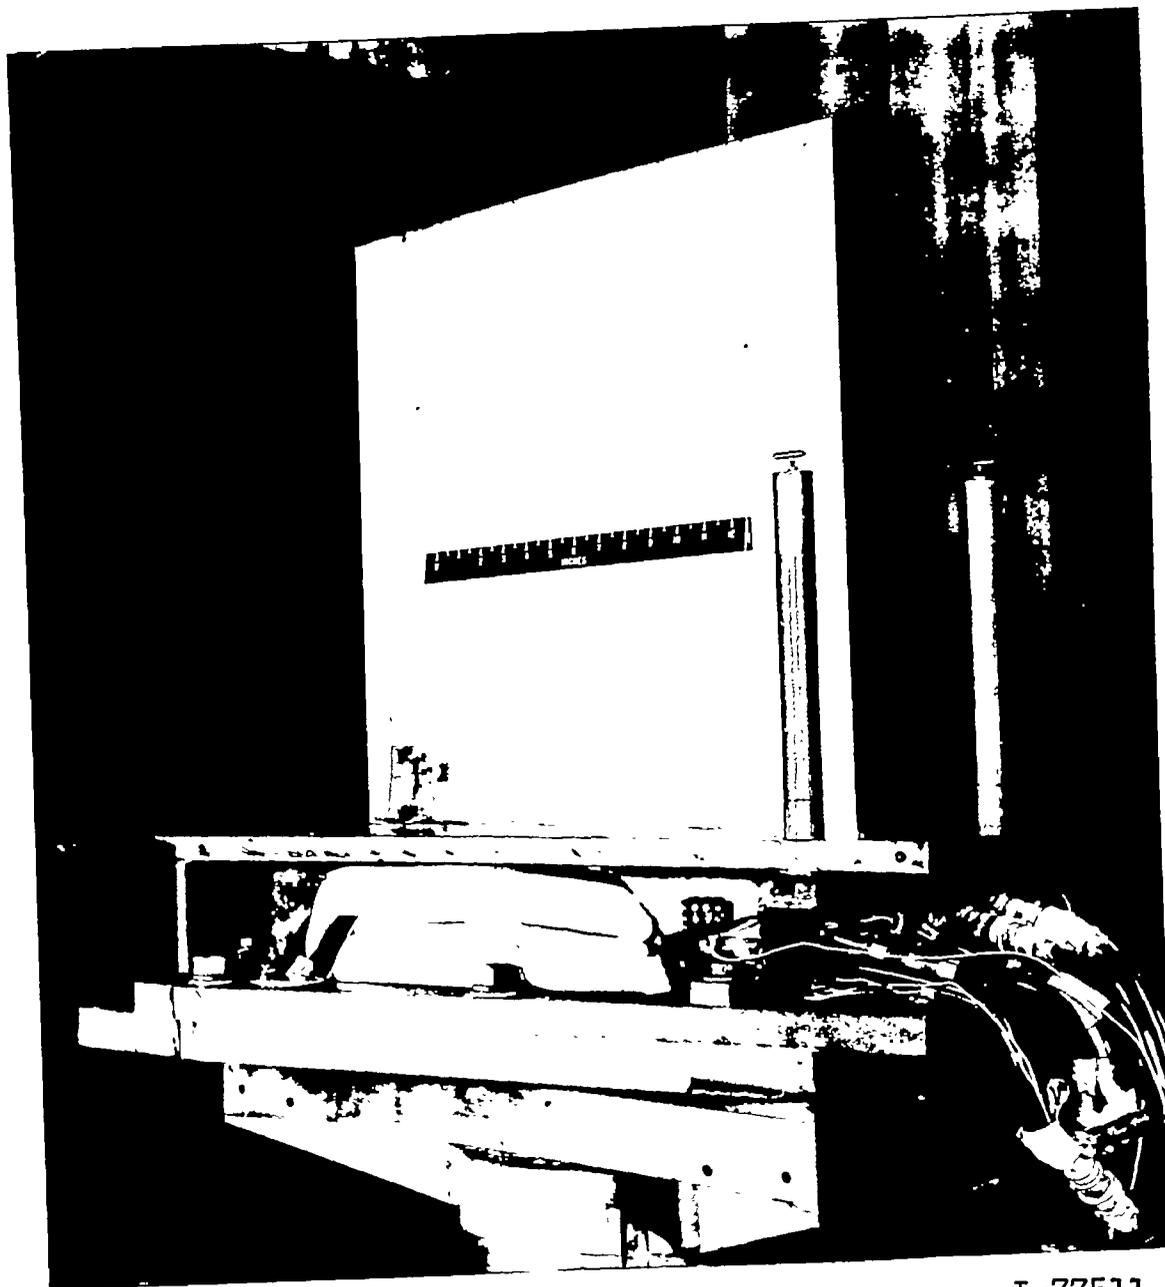
L-77511

Figure 3.- Model in place at nozzle exit prior to test. (Stagnation-temperature probes can be seen behind model.)

Model MW-2.- Model MW-2 was mounted vertically in the jet (root downward) at an angle of attack of  $0.2^\circ$  with its leading edge 2 inches downstream of the nozzle-exit plane (figs. 2 and 3). The model extended 20 inches into the airstream so that both the top of the doubler plates and the top of the fence (figs. 1 and 2) were about  $1/8$  inch above the lower jet boundary. After surviving the initial disturbance of the jet (see the appendix) the model remained steady until approximately 10 seconds at which time a vibratory motion took place; test conditions ended shortly thereafter (10.8 seconds) and during the shutdown phase of the jet the model experienced a partial failure.

Stagnation temperature.- The stagnation temperature was obtained by averaging during the time of test conditions the average temperature of the two probes located just aft of the models (fig. 3). (This method is somewhat different from that used to obtain the stagnation temperature for the test on model MW-1; a short discussion of the reasons for so doing appears in the appendix.) Variations of the average probe temperature with time are given in figure 5. In these plots the apparent delay of approximately 0.7 second in reaching test conditions is due to time lag (see the section "Accuracy" in the appendix). The peak values shown in the plots at approximately 1 second are believed due to the stagnant mass of air in the heat accumulator; this air is somewhat hotter than that which follows it out of the jet when the control valve is opened.

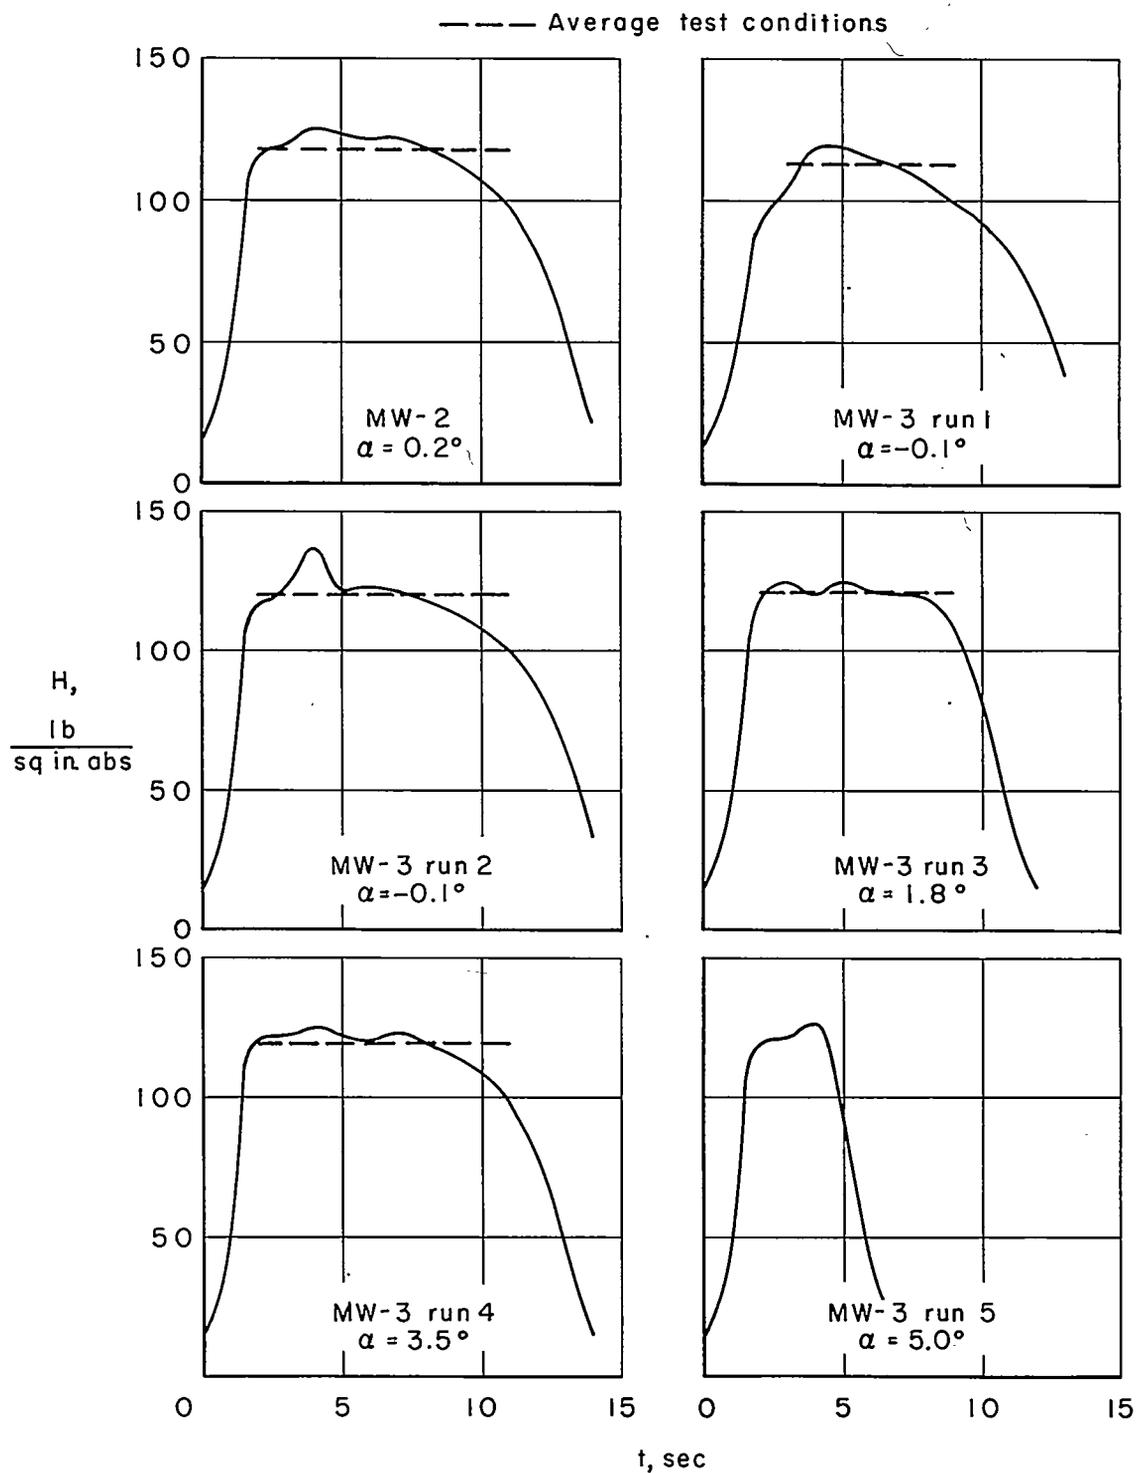
Figure 4.- Stagnation pressures.

Stagnation pressure.- Variations of the stagnation pressures with time for all test runs are given in figure 4. Fluctuations of these pressures during the tests indicate that test conditions (assumed to exist whenever  $H \geq 100$  lb/sq in. abs.) were almost but never fully stabilized. The values reported in table I are average stagnation pressures during test conditions, except that for run 5 on model MW-3 the stagnation pressure is that obtained at the time of failure.

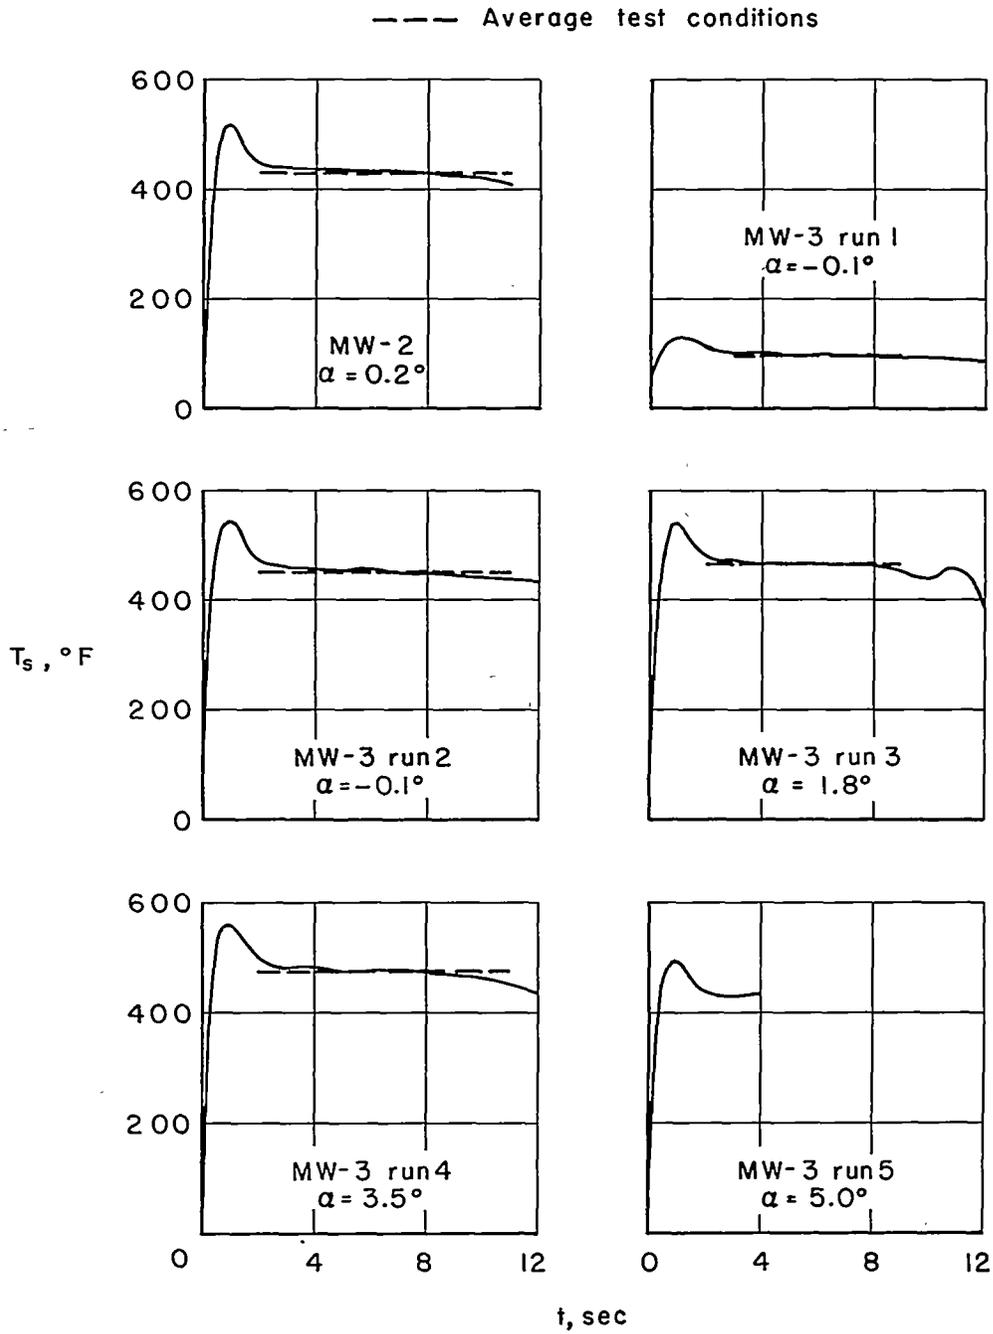
Figure 5.- Stagnation temperatures.

From the foregoing discussion it is evident that some uncertainty accompanies the determination of an accurate test stagnation temperature. However, since the probes were located in the stream near the models and at the approximate height of most of the model instrumentation, an average of the probe temperatures was considered the most accurate indication of the test conditions. These temperatures, averaged during test times, are listed in table I. Plots of these stagnation temperatures are also given in figure 5.

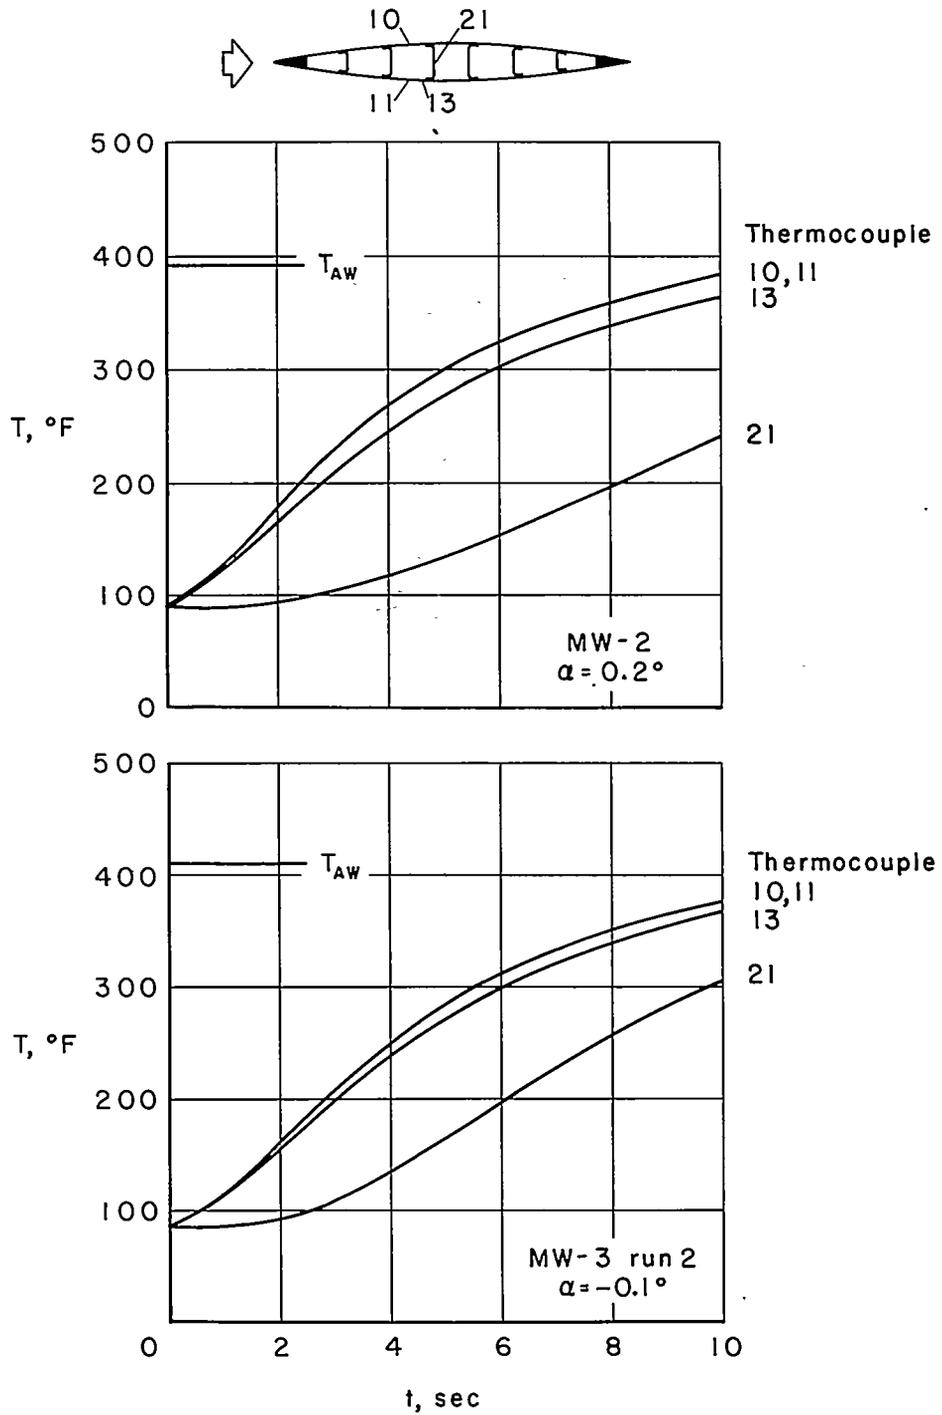
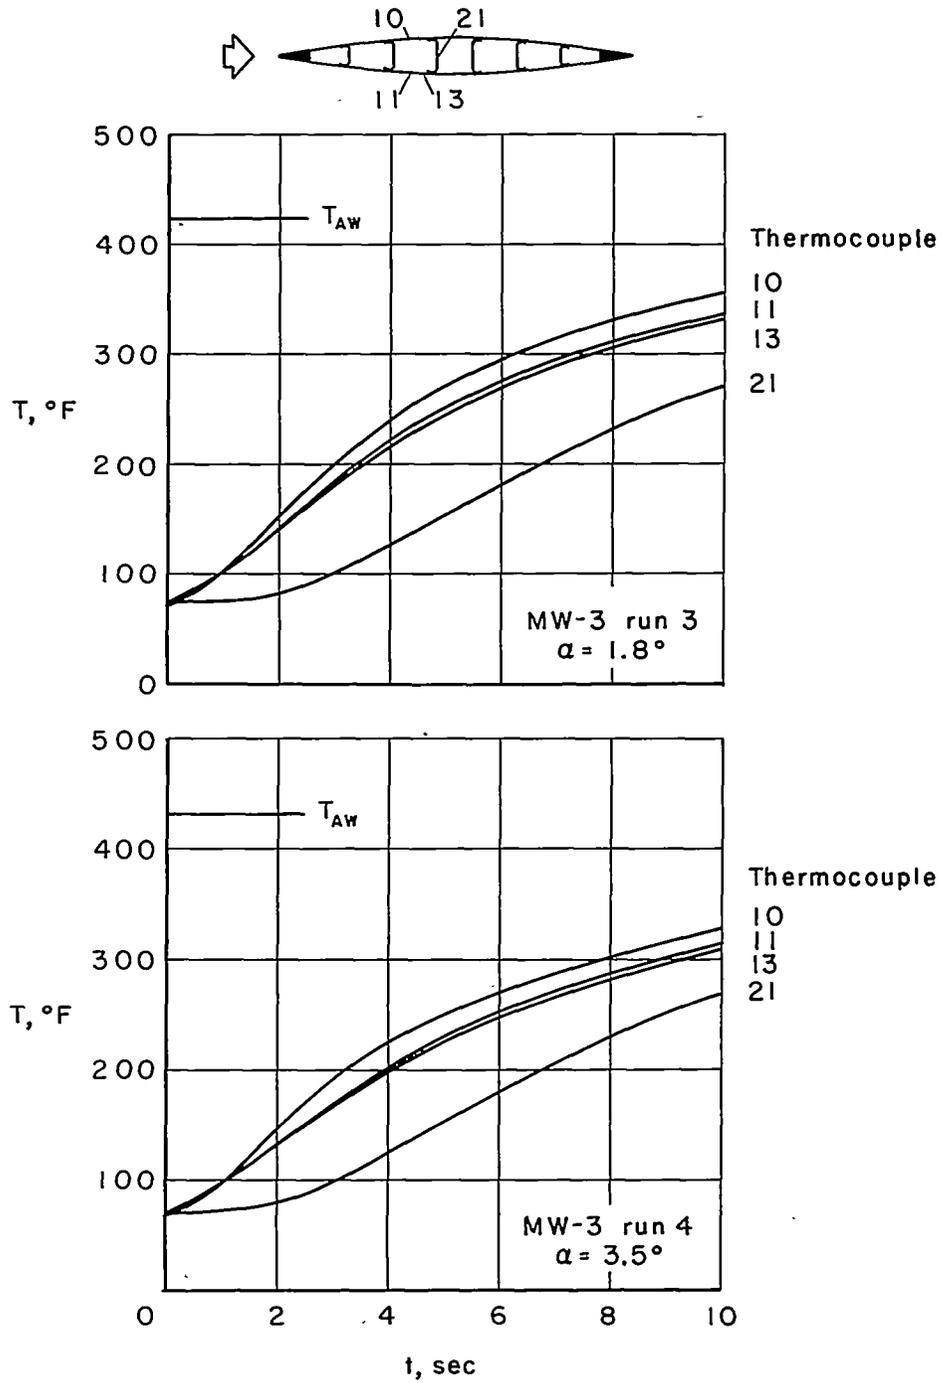
Figure 6.- Typical model temperatures.

Plotted in figure 6 are some experimentally obtained temperatures which illustrate the effects of heat conduction from the skin to the interior of the model. The skin near the web (thermocouple 13) loses

heat to the interior and consequently has a somewhat lower temperature than the skin uninfluenced by heat conduction (thermocouples 10 and 11 - the average temperature of these two thermocouples has been plotted, since the individual temperatures differ by only a few degrees). For a point at the midheight of a web (thermocouple 21), heat is first conducted along the skin and then down into the web; hence, there is appreciable lag between the temperature at this point and the adjacent skin temperatures - the same is true for thermocouples 19 and 20 (not shown).

For test runs 2, 3, and 4 (hot runs at angles of attack of -0.1°, 1.8°, and 3.5°) sample skin and web temperatures are shown in figure 6. The increase in skin thickness (from 0.064 inch for model MW-2 to 0.081 inch for model MW-3) should result in lower skin temperatures (for the same stagnation temperature), but in more heat being conducted into the interior than for model MW-2; hence the temperature differences between skin and web were not so great as for model MW-2 with its thinner skin. As was expected, for runs 3 and 4 (angles of attack of 1.8° and 3.5°) thermocouple 10 on the under side of the model experienced a faster temperature rise than thermocouple 11 (on the upper side). Again, the plots illustrate that steady-state conditions were not reached in the tests.

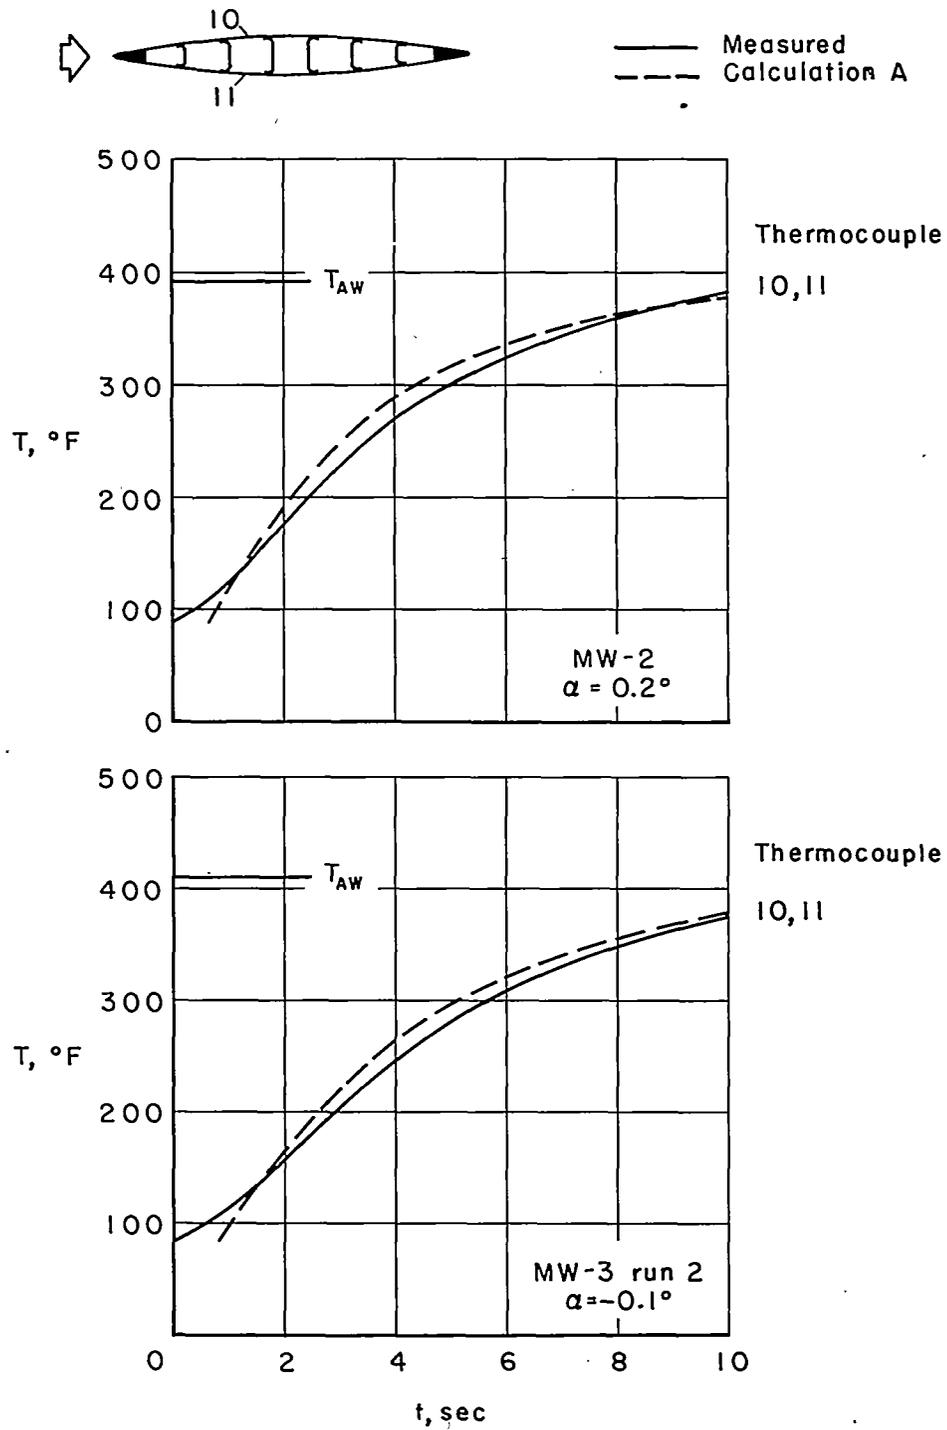
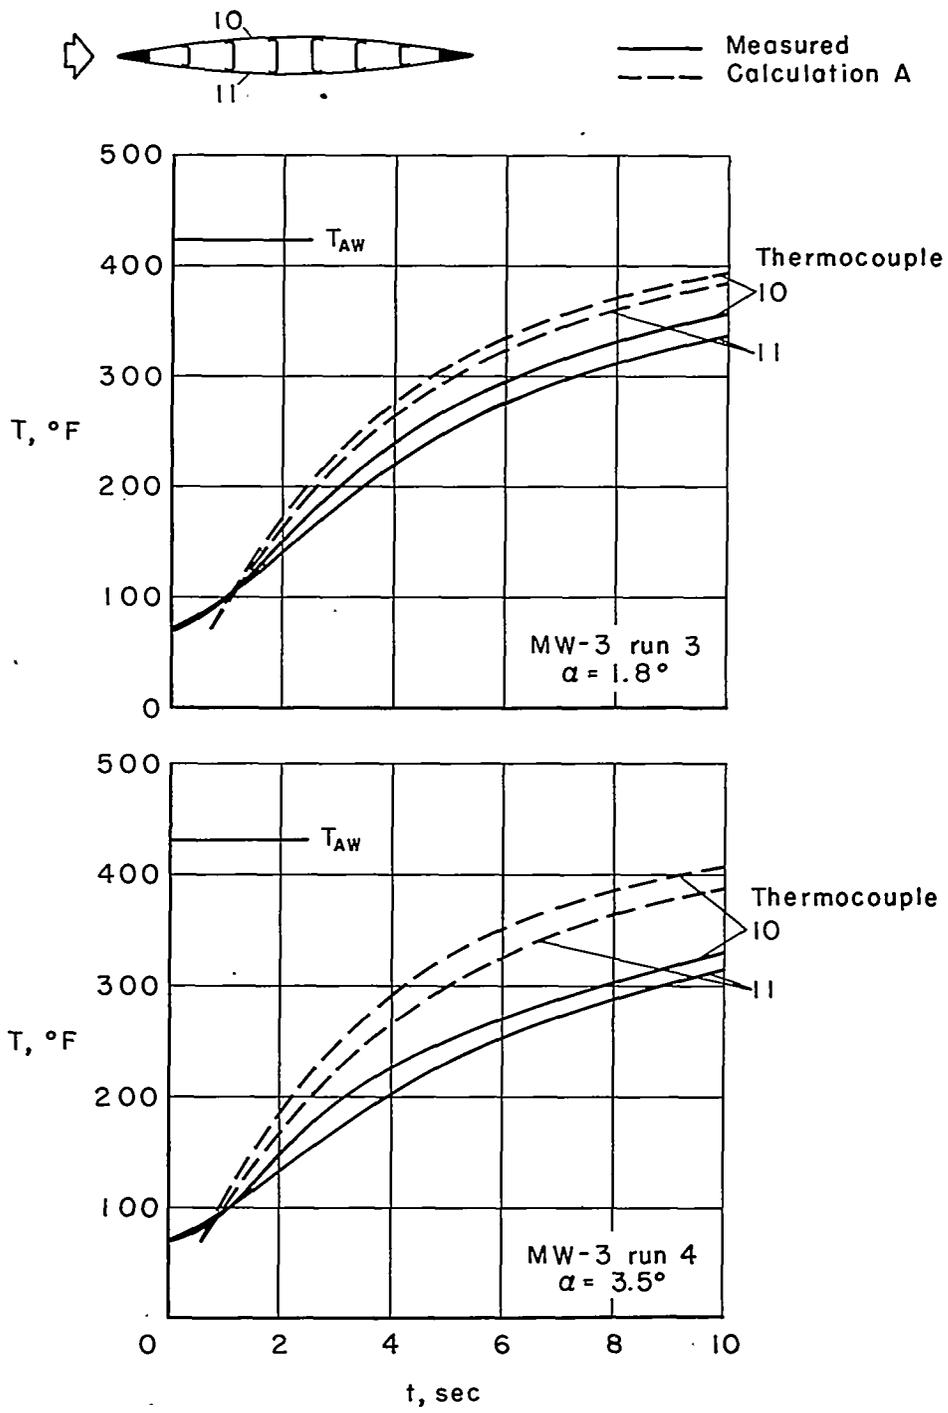
Figure 7.- Comparison of measured and calculated skin temperatures.

Skin temperatures (calculation A).- Comparisons between calculated and experimental skin temperatures are shown in figure 7 for only the skin locations corresponding to thermocouples 10 and 11. In the calculations the effects of conduction, radiation, and temperature variation through the skin thickness were considered negligible. The equation giving the temperatures is

Fairly good agreement between the calculated and test temperatures is evidenced in figure 7 for the tests on model MW-2 and model MW-3 run 2. In these plots the test values are the averages of thermocouples 10 and 11. For model MW-3 runs 3 and 4 (fig. 7), wherein the model was subjected to angles of attack of  $1.8^\circ$  and  $3.5^\circ$ , the agreement is not very good, particularly so for the latter test. The differences in the temperatures of the two skins are about the same as the differences obtained from the calculations, but the magnitudes of the temperatures show poor agreement. This poor agreement could be due in part to some error in the test stagnation temperatures used in establishing  $h$  and  $T_{AW}$ , or possibly to some effect of angle of attack not considered in calculating  $h$  and  $T_{AW}$ , or to some error in the measured temperatures due to weakening of the bond between the thermocouple and the metal brought about by vibrations associated with repeated testing.

The results shown in figure 7 are representative of the overall agreement between calculated and test temperatures for all skin locations uninfluenced by heat conduction to other parts of the models.

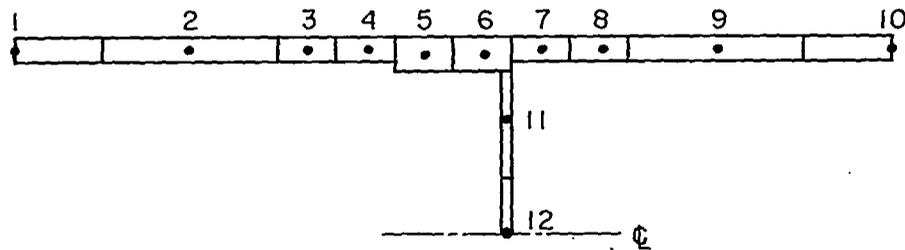
(a) Leading- or trailing-edge section.

(b) Skin and web combination.

Figure 8.- Subdivision of wing cross section for temperature-distribution calculations.

Temperature distributions (calculation B).- Temperature histories for the complete chordwise cross sections of the models, corresponding to the test on model MW-2 and to test run 2 on model MW-3, were calculated by using a numerical procedure similar to that of reference 5. The model cross sections were each divided into eight segments of two types, one for the leading or trailing edge (plus adjacent skin) and the other for any skin and web combination (see, for example, ref. 6). The dividing lines between segments were chosen such that at these points heat conduction along the skin could be considered negligible. The segments for the solid leading or trailing edges and attached skin were then subdivided into 11 elements and any skin and web combination into 12 elements, as shown in figure 8. Values of the heat-transfer coefficient and adiabatic wall temperature obtained using local flow conditions and the turbulent-flow formulas of reference 4 were used in the calculations. No attempt was made to evaluate joint effects. The results, in the form of chordwise temperature distributions at both 3 and 8 seconds for the skin temperatures and the temperatures at the center line of the solid leading and trailing edges and of the webs, are presented in figures 9 and 10 with the corresponding experimental values. In addition, a few calculated temperature histories are compared with test values in figure 11.

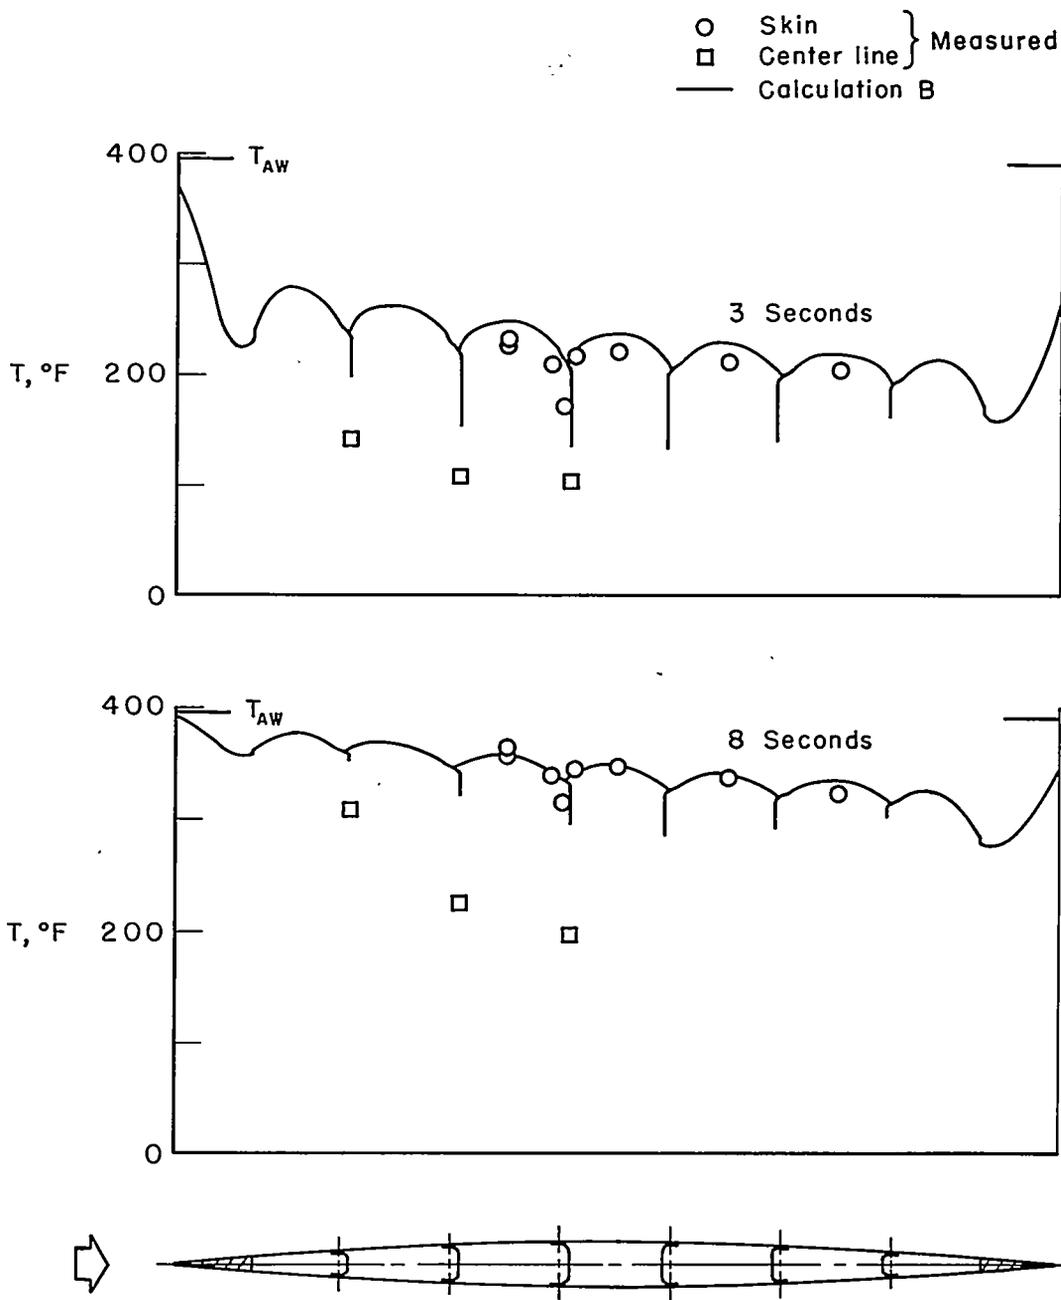
Figure 9.- Temperature distribution of entire cross section of model MW-2.

Figures 9 and 10 show that the overall agreement between calculated and experimental values is fairly good for the skin temperatures of model MW-2 and both the skin and interior temperatures for run 2 on model MW-3. However, the calculations considerably overestimate the web temperatures for model MW-2. Part of this discrepancy may be due to resistance to the conduction of heat across the joint between skin and web not accounted for in the calculations. Comparison of a few calculated and experimental temperature histories given in figure 11 again illustrates that the agreement is generally fair except that the values for the web temperatures of model MW-2 are in poor agreement.

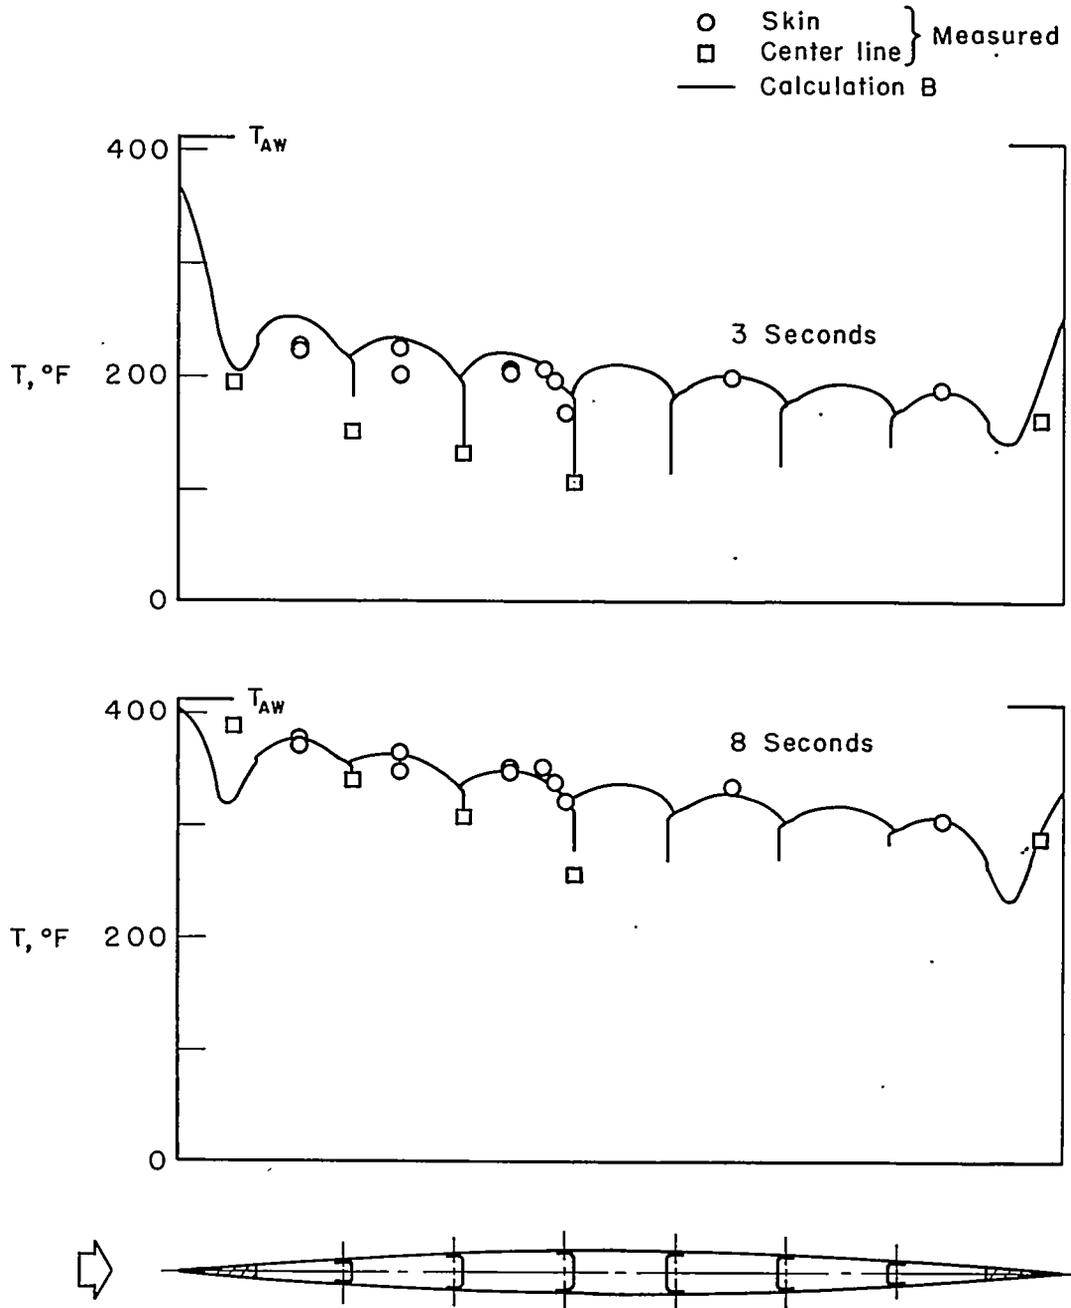
Figure 10.- Temperature distribution of entire cross section of model MW-3, run 2.

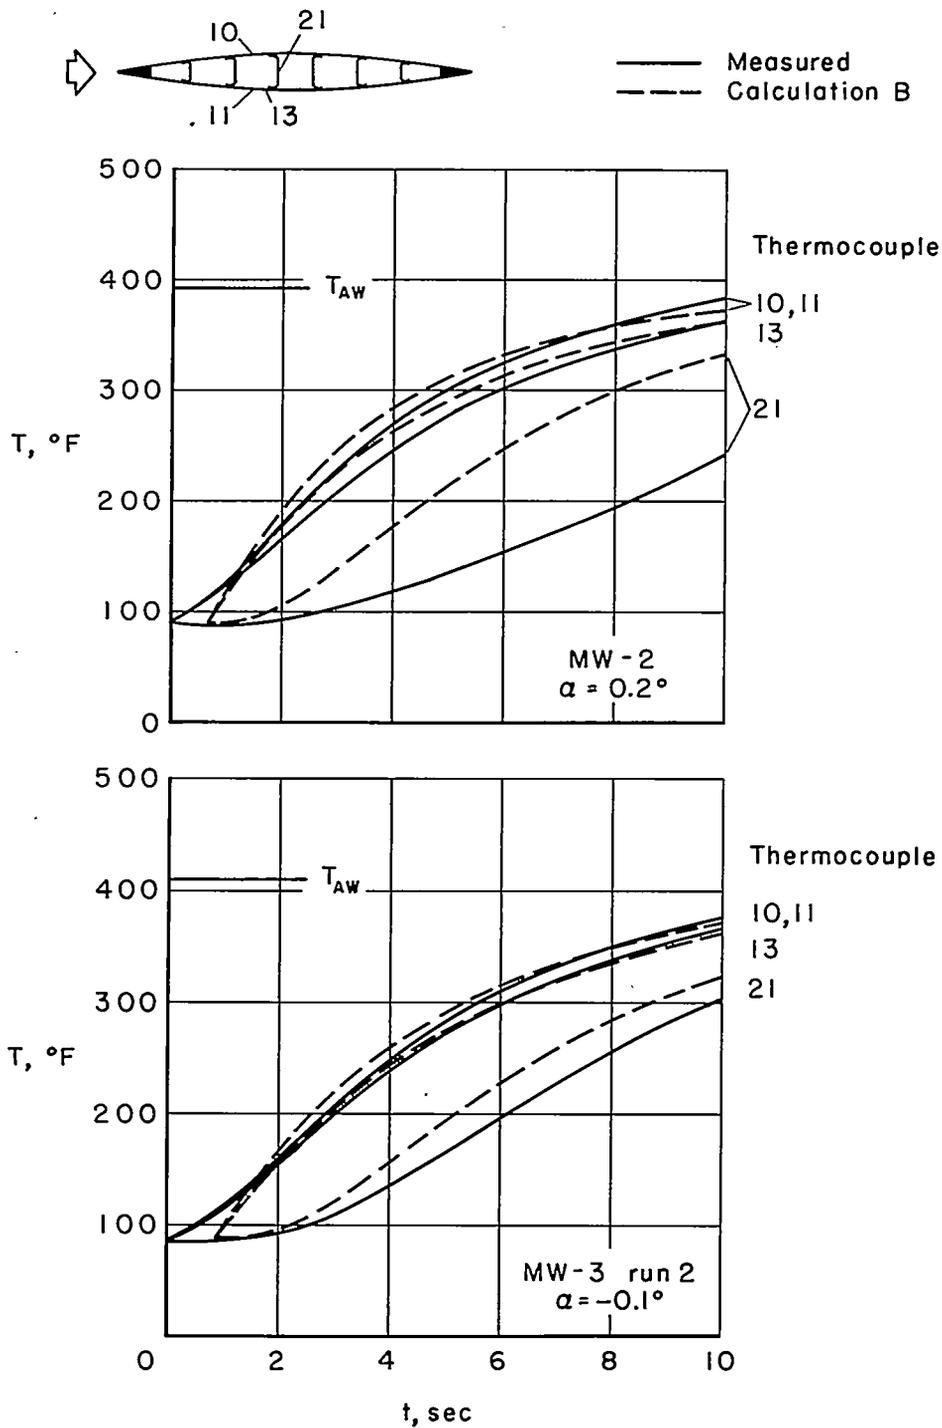
Figure 11.- Comparison of measured and calculated model temperatures.

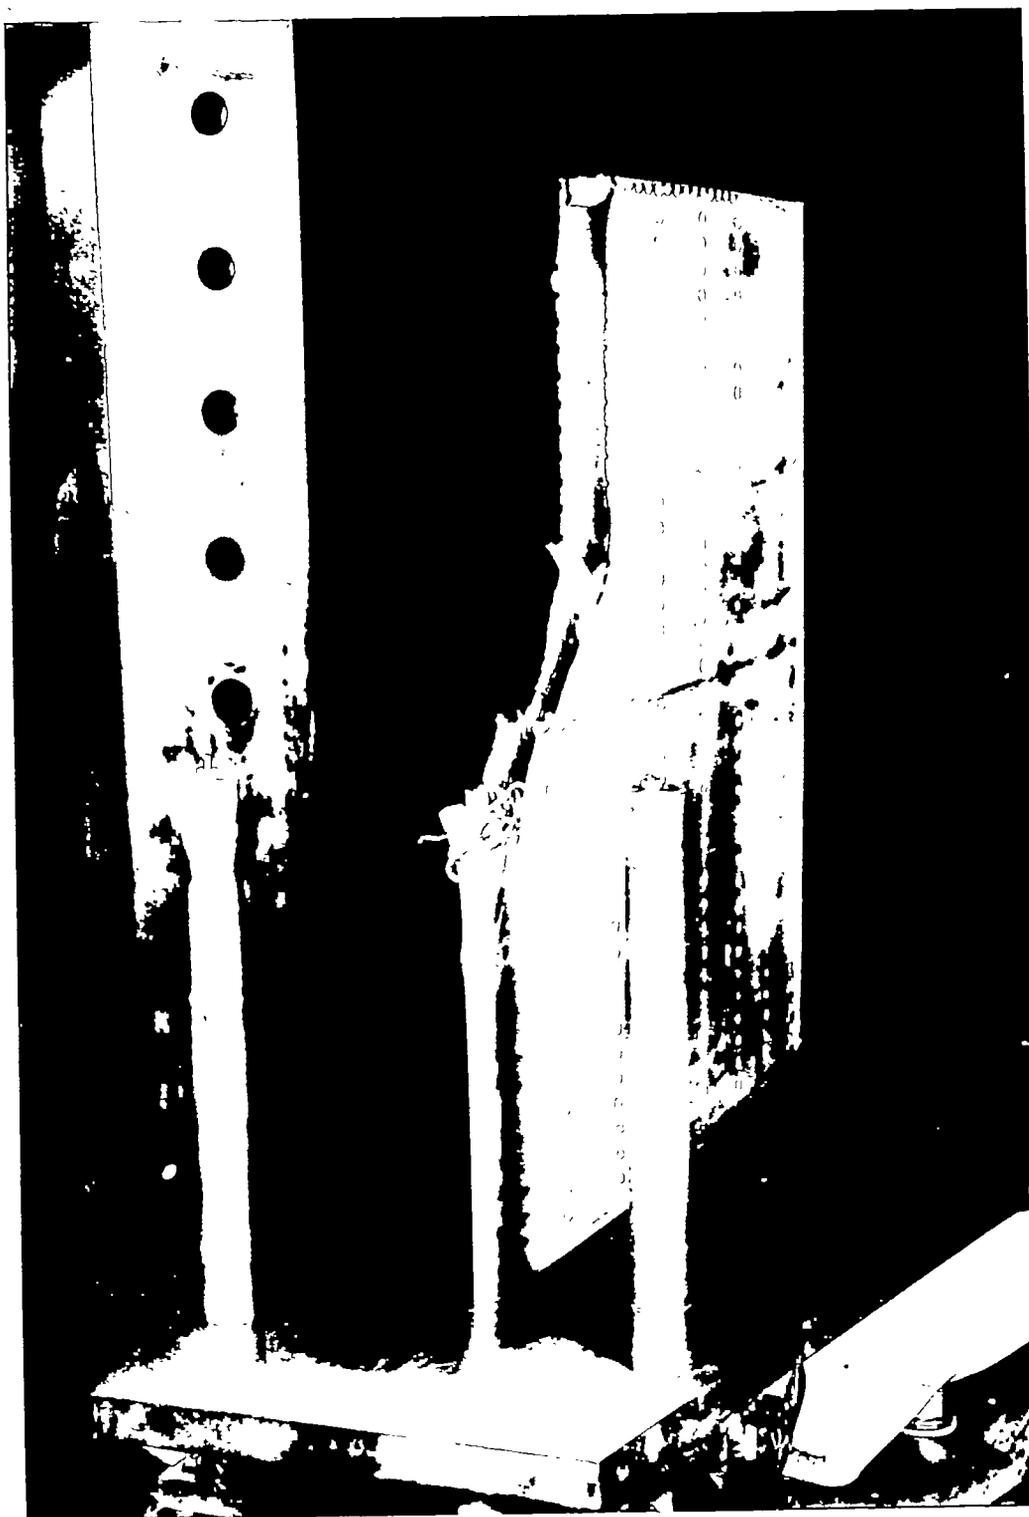
I-77204

Figure 13.- Model MW-2 after test.

Model MW-2.- After experiencing some random vibrations due to the characteristic initial disturbance of the jet (see the appendix), model MW-2 remained steady until 9.8 seconds. At this time, as indicated by the motion pictures taken by cameras placed above the model and by the frequency, phasing, and amplitudes of the skin strain gages across the chord 11 inches from the tip, the model began to flutter at 226 cycles per second in a mode with about  $1\frac{1}{2}$  waves along the chord and with the maximum amplitude near the trailing edge - a flag-waving action involving chordwise bending of the airfoil section that has been called chordwise flutter (refs. 2 and 8). Motion pictures taken from opposite sides of the model indicated that at approximately the same time, 10.0 seconds, a buckle had developed in the rearmost panel of both skins. At 10.8 seconds the stagnation pressure dropped below 100 lb/sq in. abs and test conditions were considered as having ended at this time. Shortly thereafter, at 11.5 seconds, and with the model still fluttering, the motion pictures showed the initial signs of failure to be a fracture of the tip rib and tearing of the adjacent skins just forward of the trailing edge. The piece of the tip rib tore away and was followed by tearing away of pieces of skin and the top part of the solid trailing-edge member. This was followed by further tearing of both skins in the next-to-last bay from the top of the model to about midsemispan, tearing away of an additional piece of skin and the trailing-edge member, and finally by the departure of the upper half of the next-to-last web. This last action occurred at 13.5 seconds by which time the entire upper rear corner had torn away. From about 13.5 to 14.2 seconds the model experienced additional disturbances associated with the shutdown characteristics of the jet. The failing action just described is illustrated in figure 12 by six frames taken from the motion pictures, and the model after the test is shown in figure 13.

The primary cause of failure was the aerodynamic heating since the model survived the starting disturbances without damage and then remained steady until the induced thermal stresses reduced the effective stiffness of the model (ref. 9) and caused it to flutter. At approximately the same time that the model began to vibrate, chordwise buckling of the skin developed in the rearmost bay; however, the exact order of flutter and skin buckling cannot be stated with certainty. The flutter could have been caused directly by thermal stresses which were insufficient to produce buckling but which were nevertheless sufficient to reduce the effective stiffness of the model to a point where flutter occurred, or the thermal stresses could have caused skin buckling (also a reduction in stiffness) which triggered off the model flutter. In either event the primary cause of failure was the aerodynamic heating. The flutter that
