# RESEARCH MEMORANDUM

TESTS OF AERODYNAMICALLY HEATED MULTIWEB WING  
STRUCTURES IN A FREE JET AT MACH NUMBER 2

TWO ALUMINUM-ALLOY MODELS OF 20-INCH CHORD  
WITH 0.064- AND 0.081-INCH-THICK SKIN

By George E. Griffith, Georgene H. Miltonberger,  
and Richard Rosecrans

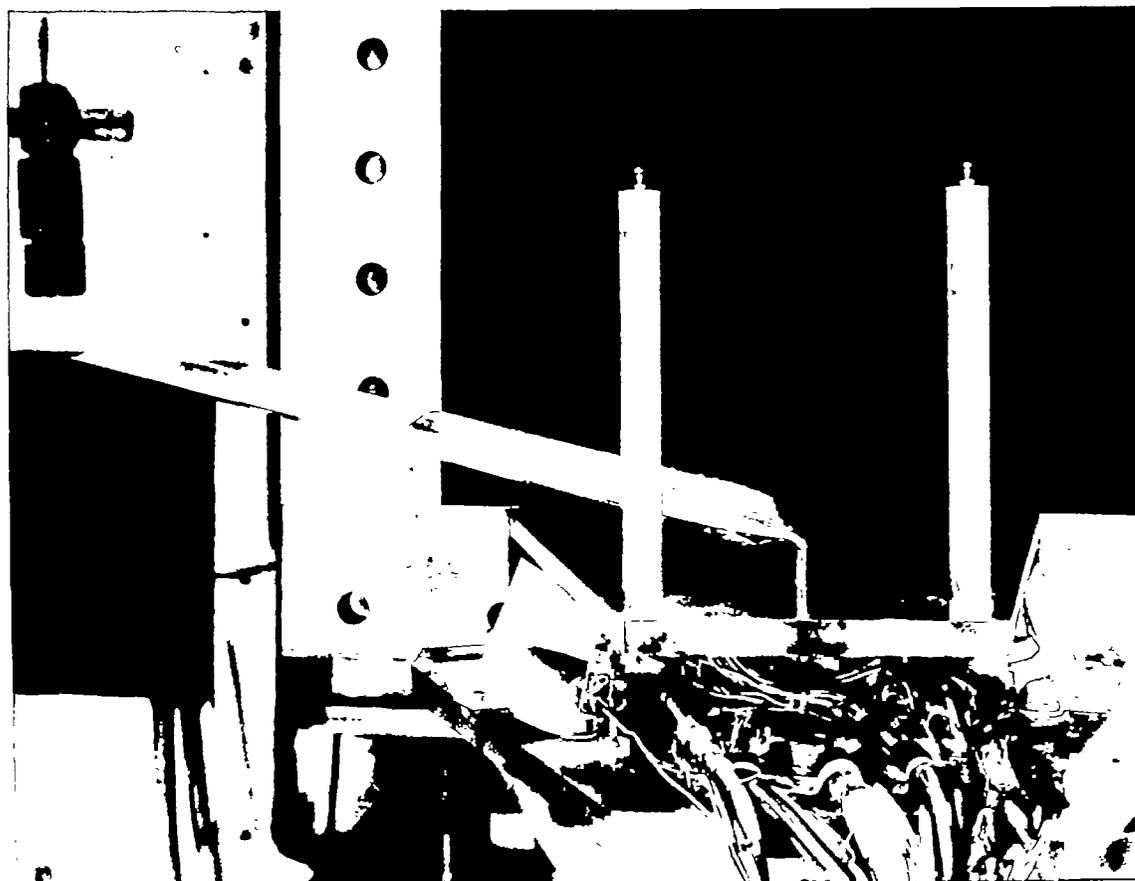
Figure 14.- Model MW-3 after failure. L-77699

Model MW-3.- Beginning at 0.2 second after the air began to flow through the jet, model MW-3 (at an angle of attack of  $5^\circ$ ) vibrated, mainly in bending, at approximately 65 cycles per second until the initial normal shock reached the leading edge of the model. At this time, 1.0 second, the model steadied. The normal shock wave had moved to the model midchord at 1.2 seconds, then moved downstream and disappeared. The model continued to remain steady until 1.8 seconds, at which time test conditions had been reached and the aerodynamic forces had become sufficiently large to produce compressive buckling of the skin at the root section. At this time the model collapsed on its side to the position shown in figure 14.

The failure was almost entirely independent of any aerodynamic-heating effects, since the maximum measured temperature rise ( $70^\circ$  F) was insufficient to produce any noticeable changes in the properties of the material and the temperature differences in the structure (approximately  $35^\circ$  F near the middle of the model) were so small that only negligible thermal stresses had developed. Thus the failure was almost solely due to aerodynamic loading. At the time of failure the aerodynamic forces had increased to slightly beyond the prescribed value ( $H = 106$  lb/sq in. abs), and the calculated force of about  $6.7$  lb/sq in. ( $970$  lb/sq ft) was sufficient to cause the skin to wrinkle completely across the chord and to crush the webs on the compression side of the model. As soon as the skin wrinkled the aerodynamic forces pushed the model completely over on its side.
