NACA RM E52L15

PRELIMINARY INVESTIGATION OF COMBUSTION OF DIBORANE  
IN A TURBOJET COMBUSTOR

By W. B. Kaufman, J. B. Gibbs  
and J. R. Branstetter

Lewis Flight Propulsion Laboratory  
Cleveland, Ohio

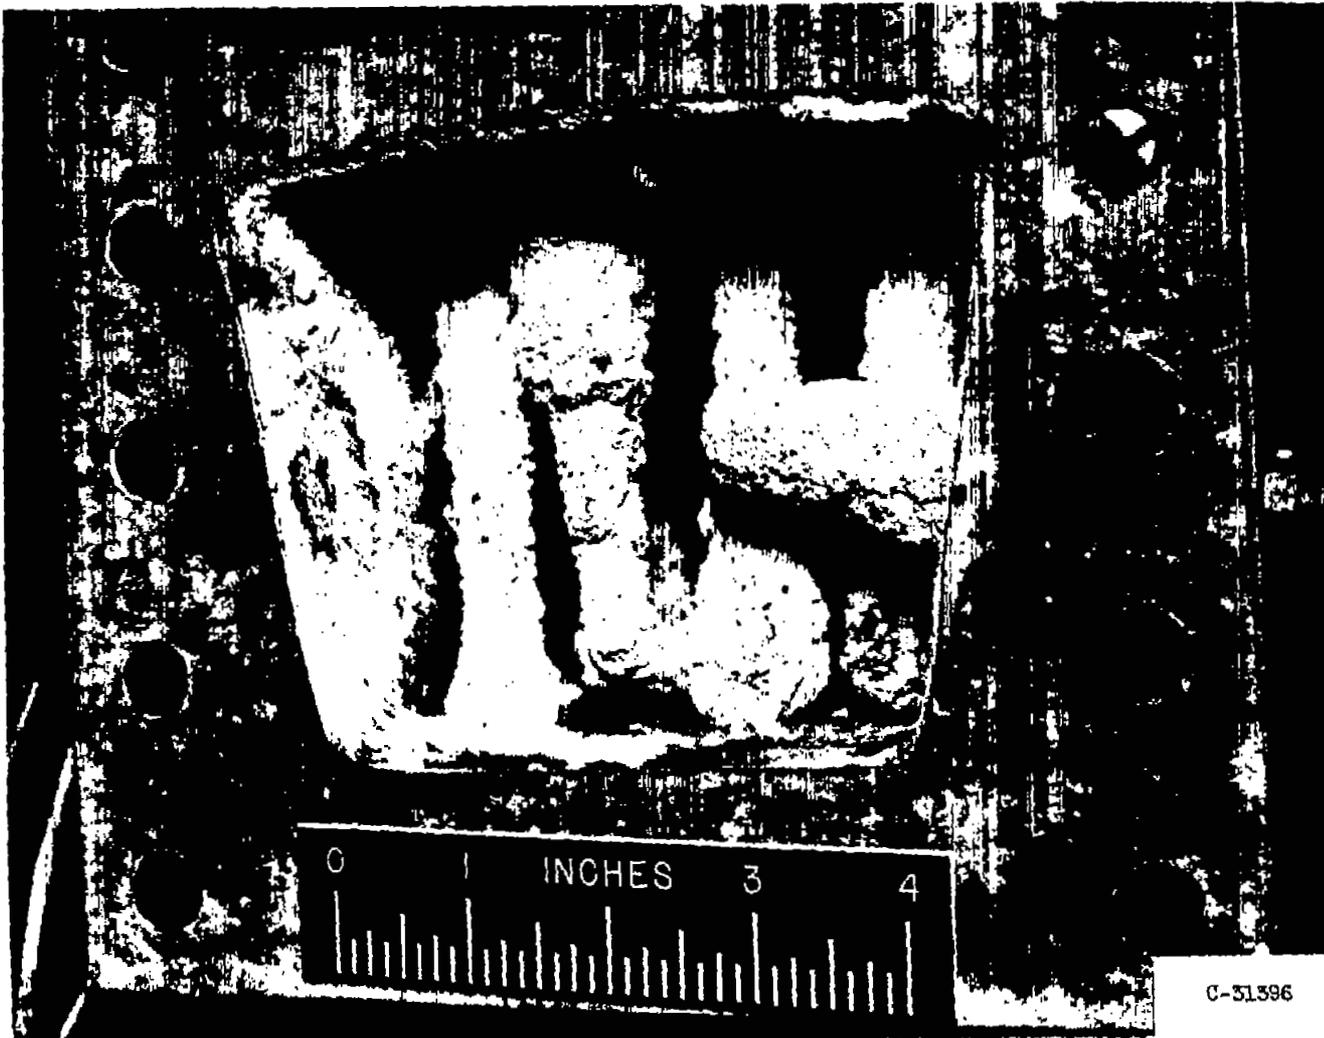
(a) After 10.8 minutes at test condition B.

Figure 10. - Deposits on the outlet thermocouples of model 8 combustor.

After operation at condition B with an average outlet temperature below the melting point of  $B_2O_3$ , the thermocouple rakes at station C-C were covered with heavy crystalline deposits as shown in figure 10(a). After operation at condition C with an average outlet temperature above the melting point of  $B_2O_3$ , the outlet thermocouples showed no appreciable deposits (fig. 10(b)).

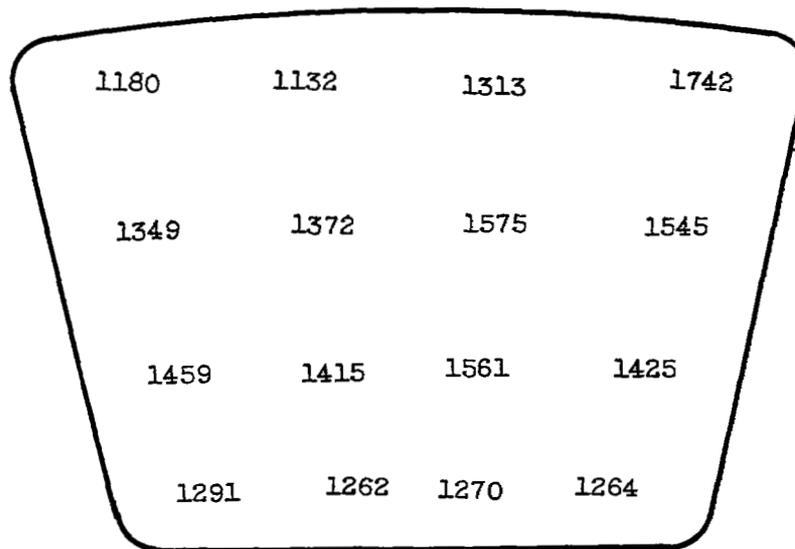
(a) Test condition B.

(b) Test condition C.

Figure 13. - Outlet temperatures for model 6 combustor.  
Temperatures in degrees F.

The outlet temperature profiles at the two test conditions are presented in figure 13. The temperature profiles were more uniform than those obtained with models 2 through 5. The maximum difference between individual thermocouple readings was 168° F at condition B and 610° F at condition C. These temperature profiles are very similar to those obtained with production-model combustors.
