RESEARCH MEMORANDUM

EFFECT OF MAGNITUDE OF VIBRATORY LOAD SUPERIMPOSED ON
MEAN TENSILE LOAD ON MECHANISM OF AND TIME TO
FRACTURE OF SPECIMENS AND CORRELATION
TO ENGINE BLADE

By Robert R. Ferguson

Lewis Flight Propulsion Laboratory
Cleveland, Ohio

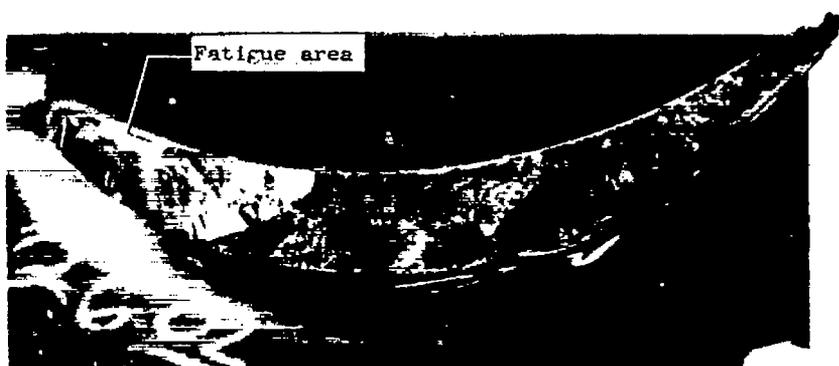
(b) Fatigue fracture.

Figure 1. - Types of turbine-blade fracture observed in engine tests (reference 3).

of the blades resembled the texture of the fracture of specimens tested in stress rupture in that the fracture was rough, jagged, and intercrystalline (fig. 1(a)). The airfoil surface adjacent to the fracture also showed intercrystalline cracking. The blade fractures of this type were referred to as "stress-rupture" fractures. The fractured surface on other blades resembled the fractures characteristic of fatigue in that the fracture had an area that was smooth and transcrystalline (fig. 1(b)), with the airfoil surface adjacent to the fracture not showing any additional cracking. These fractures were referred to as "fatigue" fractures. On other blades the fractures appeared to be a combination of the previous two in that the fracture surface comprised a small area that was rough and intercrystalline followed by a smooth transcrystalline area (fig. 1(c)). The airfoil surface adjacent to the fracture again showed some intercrystalline cracking. In this case, fracture was believed to start first as a stress-rupture crack that acted as a stress raiser causing the mechanism of the crack propagation to change from stress rupture to fatigue. These fractures were referred to as "stress rupture followed by fatigue". (In all cases the blade failed finally in tension because the load-carrying area had become too small. Thus all blades will show a large area of rough fracture surface.)

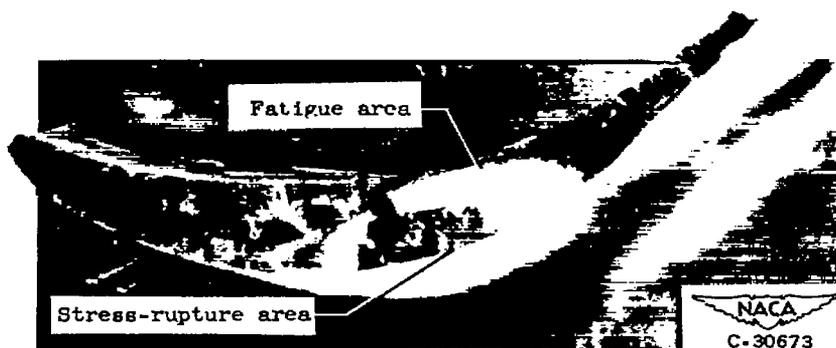
(c) Stress rupture followed by fatigue fracture.

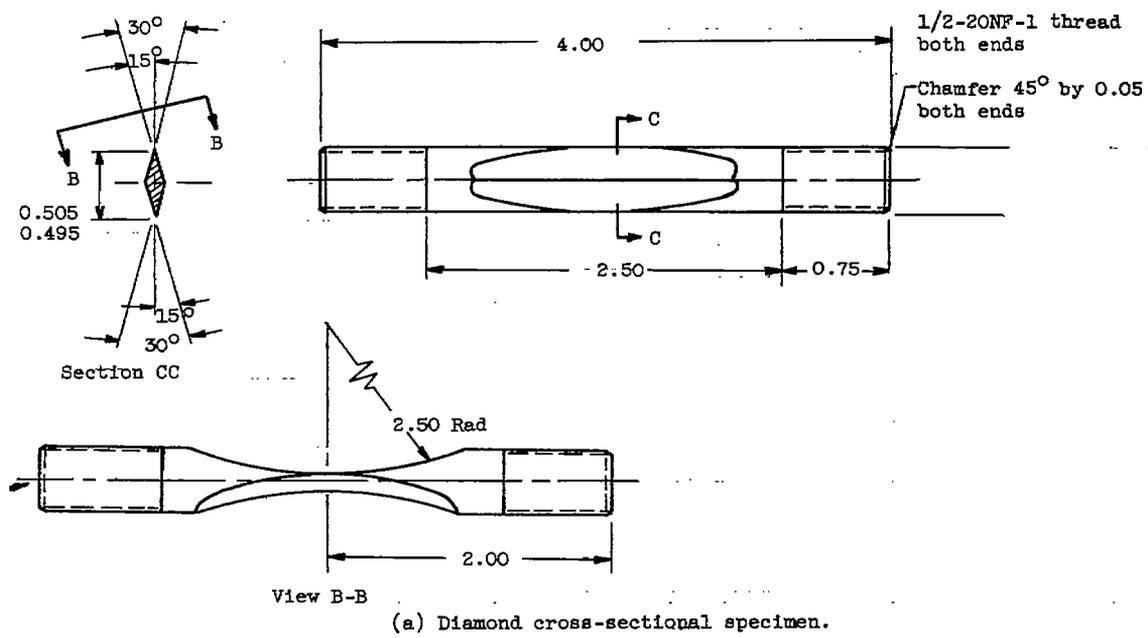
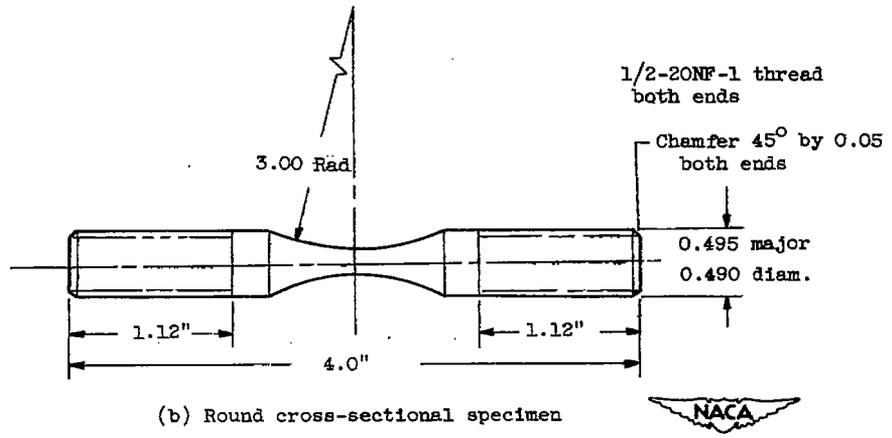
Figure 2. - Fatigue specimens used.

The alloys investigated and their compositions are listed in table I. The heat treatments given the alloys, the grain size and the hardness after heat treatment, and the type of specimen tested for each alloy are given in table II. Specimens of Stellite 21, X-40, and S-816 with diamond cross sections were cast at a pouring temperature of 2700° to 2750° F and a mold preheat temperature of 1500° F by centrifugal casting. The specimens of each material tested were from the same mold. These cast specimens had the dimensions shown in figure 2(a) except that the sharp edge on the diamond was from 0.005 to 0.010 inch in width. The cast specimens were vapor blasted with number 80 grit quartz at an air pressure of 120 pounds per square inch. Round cross-sectional specimens (fig. 2(b)) of S-816, N-155, Refractalloy 26, and Inconel X were machined from heat-treated bar stock. A few diamond cross-sectional specimens of S-816 and N-155 of the shape shown in figure 2(b) except for a 3/8-inch length of uniform cross section at the center were also machined from bar stock. The test section of the machined specimens were polished with successively finer grades of emery paper and finished with grade 2/0 in the axial direction.

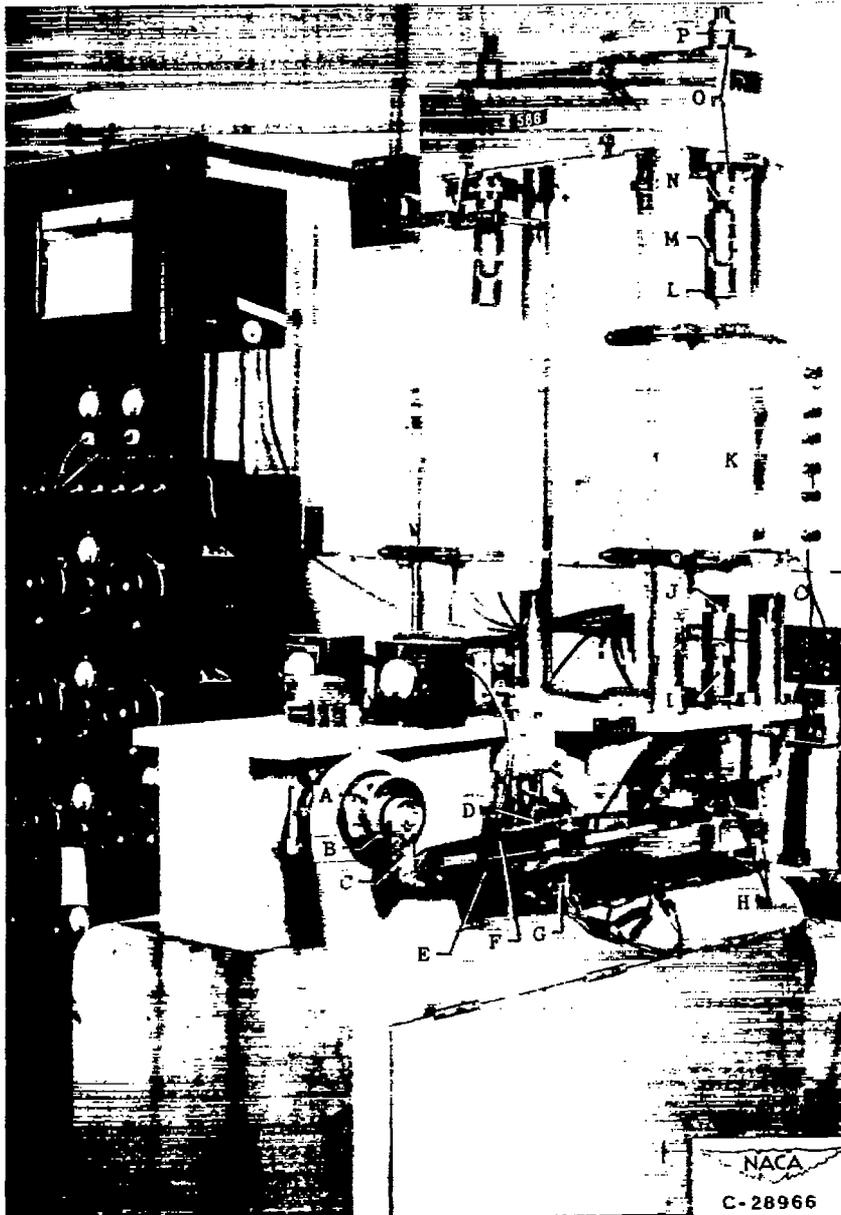
- A Drive pulley
- B Adjustable cam
- C Connecting rod
- D Contact
- E Loading lever
- F Calibrated dial bar
- G Contact
- H System of fulcrums
- I Universal joint
- J Specimen adapter
- K Furnace
- L Specimen adapter
- M Universal joint
- N Nut
- O Piston
- P Nut

Figure 3. - Fatigue machine modified for testing at elevated temperatures.

Fatigue testing equipment. - The fatigue tests were conducted on direct repeated-stress testing machines which imposed an axial load (5000 lb max.) at the rate of 2000 cycles per minute. Figure 3 is a photograph of one of the machines that has been modified for testing at elevated temperatures. This machine is so designed that two specimens can be tested independently at the same time and is equipped with a load maintainer that sustains the same specimen load during a test by compensating for the creep of the specimen.

A loading lever E, actuated by the connecting rod C, the adjustable cam B, and the drive pulley A, applies the variable load (fig. 3). The force is transmitted by a parallelogram system of four steel-plate fulcrums H, designed to produce straight-line motion and axial loading of the specimen. The upper end of the specimen assembly is connected to a hydraulic operated piston O.

The ends of the specimen are threaded into specimen adapters J and L. The specimen adapter assembly is then placed inside the furnace K and the threaded ends of the specimen adapters screwed into the universal joints I and M. The upper end of the specimen assembly is fastened to the piston O by nuts N and P.

The mean tensile load is applied with the cam throw at zero to the specimen by upward operation of piston O, and is measured by means of the calibrated dial bar F in terms of the bending induced in the loading lever. The cam throw is then adjusted so that as the cam is slowly rotated by hand, the desired maximum and minimum loads - measured by the dial bar - are applied. Contact D is then positioned above the loading lever to just clear the top of the loading lever at its most upward position and contact G is positioned below the loading lever to just clear the bottom of loading lever at its most downward position. During operation at temperature, the elongation of the specimen reduces the deflection at the middle of the load lever resulting in the lever striking contact G. An electric charge is dissipated through the contact which causes piston O to move in upward direction until the loading lever clears the bottom contact on its downward stroke. Contact D operates piston O in the downward direction if the loading stresses become too high.

The furnace K which is used to maintain the specimen at temperature is of the shunt-wound type to permit the control of the heat distribution.

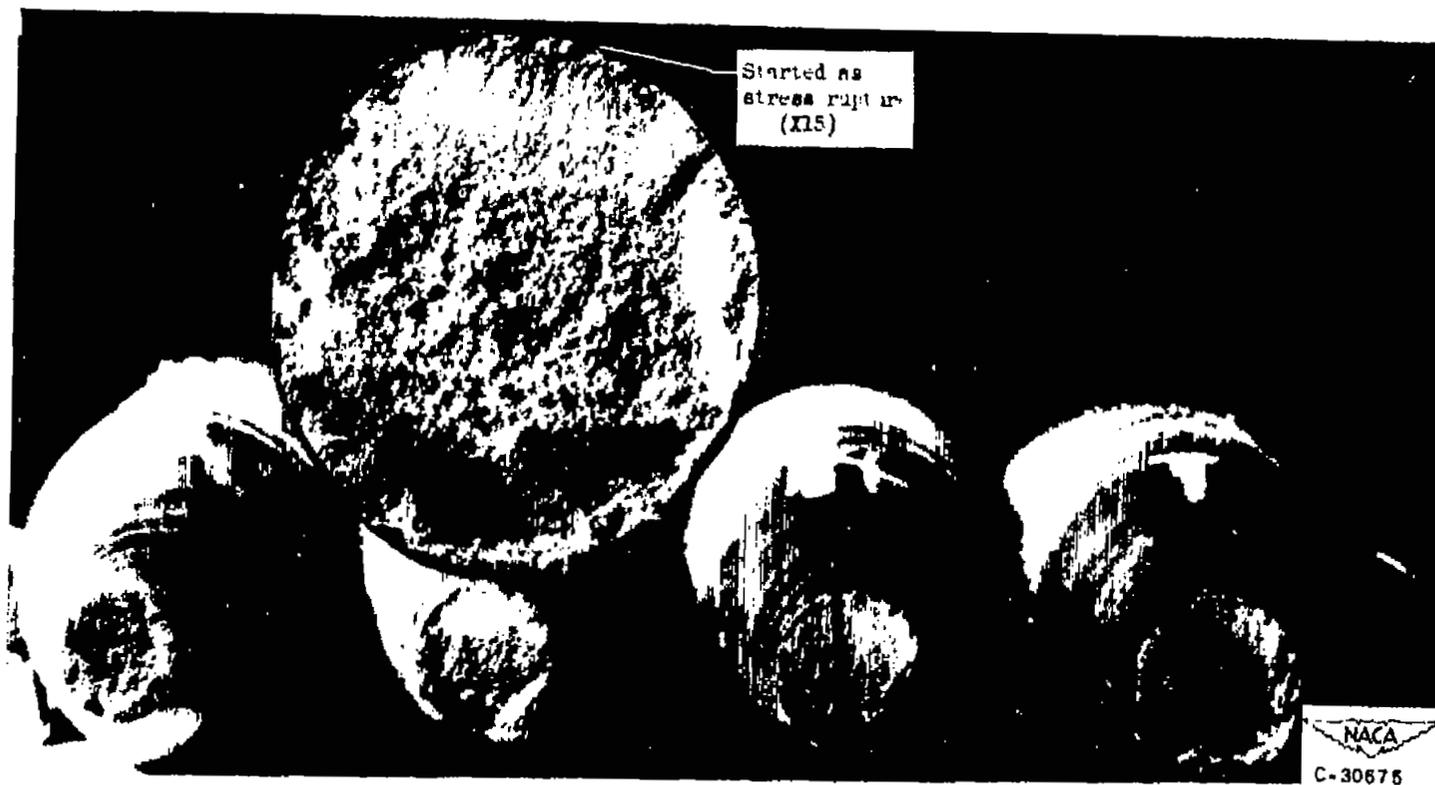
Vibratory load, psi	±0	±5000	±10,000	±15,000
Fracture type	Stress rupture	Stress rupture followed by fatigue	Fatigue	Fatigue

(a) Wrought S-816, round cross-sectional specimen.

Figure 5. - Effect of magnitude of vibratory load on fractures observed in tensile fatigue evaluation. Mean load, 22,000 pounds per square inch; X4.25.

Photographs showing the appearance of typical fractures for some of the other alloys tested at different alternating stresses are shown in figure 5. The stress-rupture area in the S-816 specimen which failed by stress rupture followed by fatigue was so small that examination of the fracture at a magnification was necessary to detect the stress-rupture zone that initiated the fatigue zone (figs. 5(a) and 5(b)). The fractures of the specimens of Inconel X and Refractalloy 26 had a coarse granular appearance (figs. 5(c) and 5(d)). The areas in the specimens of Refractalloy 26 that failed by fatigue still had this granular appearance except that many of the areas had large flat facets approximately normal to the direction of loading (fig. 5(d)). All specimens of Inconel X failed by stress rupture; however, the roughness of the surface of the fractures decreased with increasing alternating stress (fig. 5(c)).

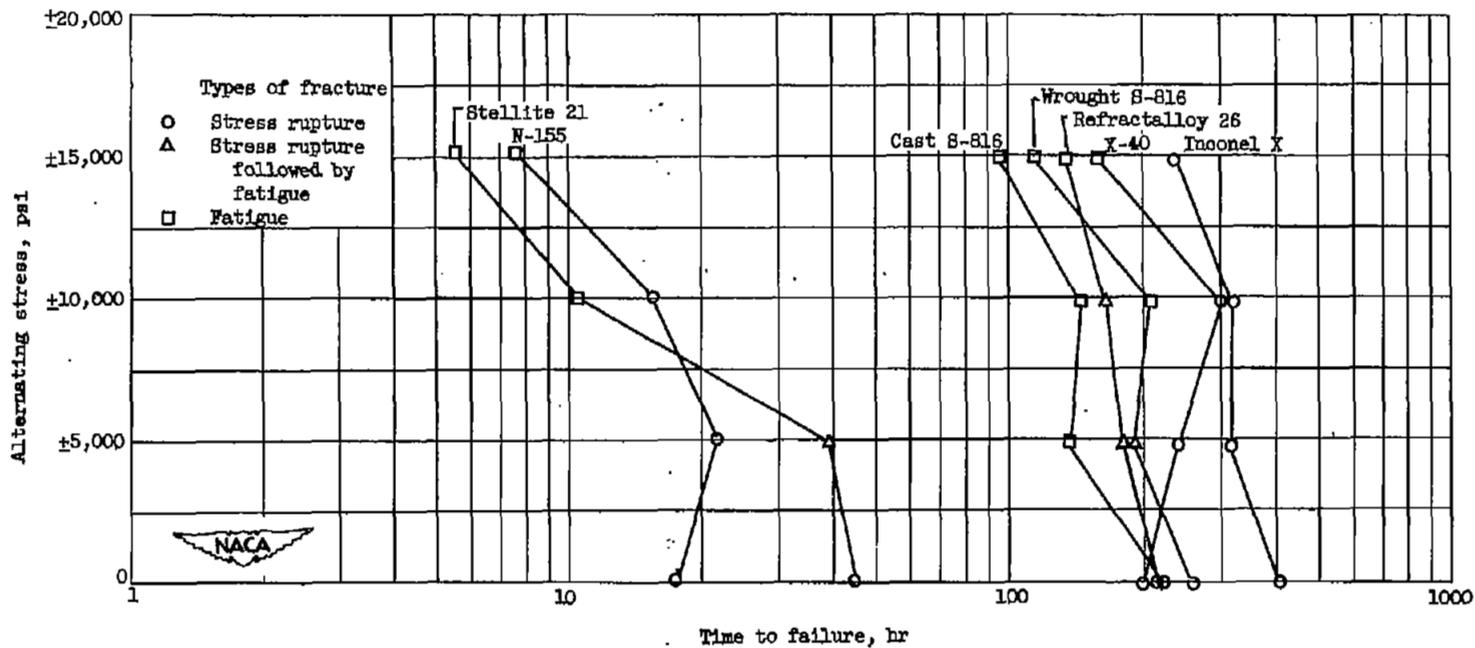
Figure 6. - Effect of alternating stress on type of fracture and time to failure. Temperature, 1500° F; mean stress, 22,000 pounds per square inch.

Effect of alternating stress on specimen life. - The variation of specimen life with the alternating stress at which the specimen was tested is shown in figure 6.

Six of the seven alloys investigated appear to show a general trend toward decrease in life with increasing alternating loads as would be expected. The only exception is X-40. In the case of this alloy it seems likely that the scatter of data is very large as it is not expected that the life will be increased by 50 percent with an alternating stress of 10,000 pounds per square inch over that of an alternating stress of zero. If this scatter is indicative, considerably more tests would be required to establish the shape of this curve clearly.

When the remaining six alloys are considered at an alternating stress of ± 5000 pounds per square inch, the change in life varies from a 22-percent increase for N-155 to a 37-percent decrease for cast S-816. Only N-155 showed an increase in life. A similar increase in life for N-155 was found in other fatigue tests reported in reference 4. From these data it might be expected that superimposing a vibratory stress of ± 5000 pounds per square inch on a blade would result in a decrease in life of generally less than 37 percent. This value appears large until it is noted that, based on reported rupture data for these alloys, a 1000-pound-per-square-inch increase in the centrifugal stress alone would decrease the life about 30 percent on an average.

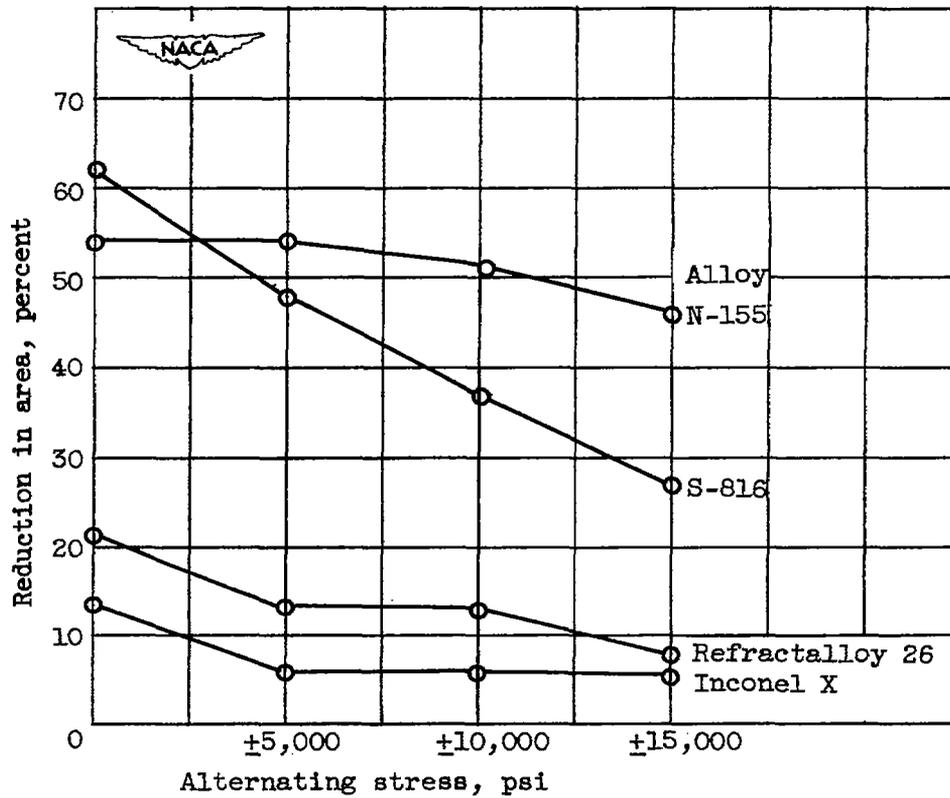
Figure 7. - Effect of alternating stress on reduction of area of fractured specimens.

Effect of alternating stress on reductions of area of fractured specimens. - A plot of the reduction of area of the fractured specimens against the alternating stress at which the specimens of wrought alloy was tested is shown in figure 7. Superimposing an alternating stress on a mean tensile stress resulted in less reduction of area at fracture. The wrought alloys S-816, Inconel X, and Refractalloy 26 had 50 percent less reduction of area at an alternating stress of $\pm 15,000$ pounds per square inch than at an alternating stress of zero.

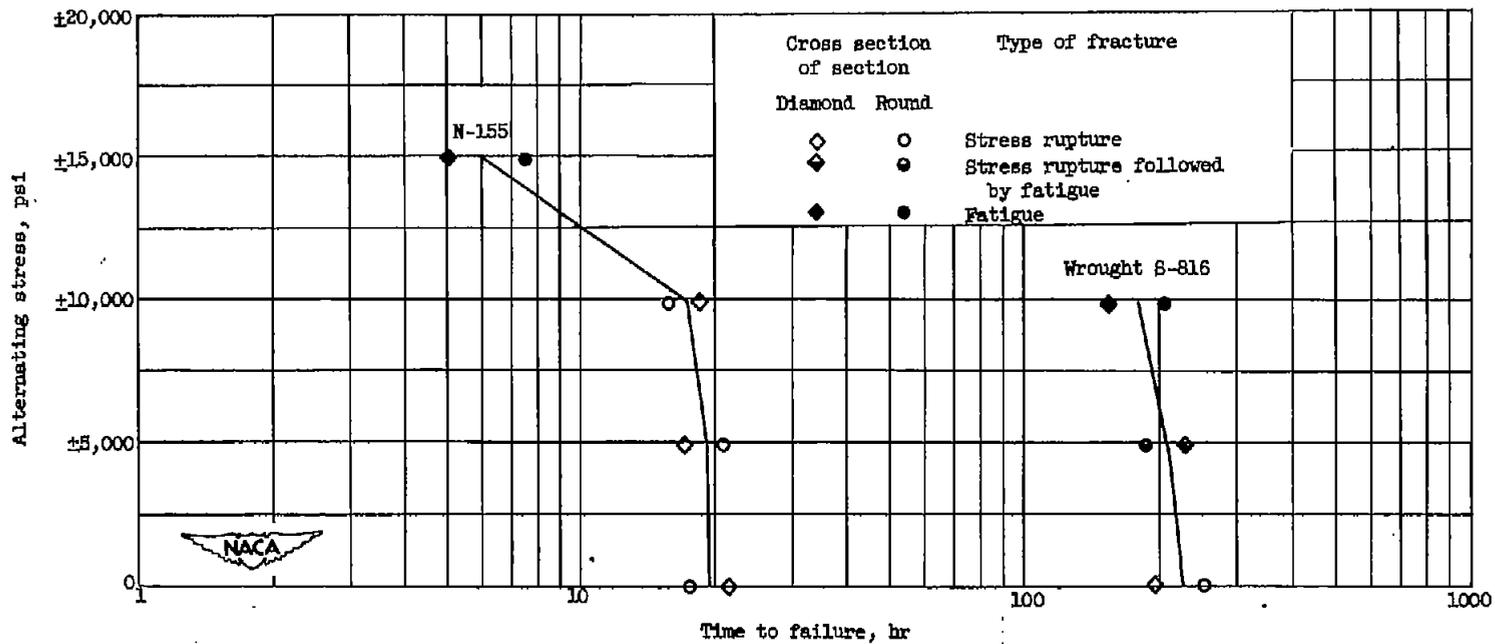
Figure 8. - Effect of specimen shape on time to failure. Temperature, 1500° F; mean stress, 22,000 pounds per square inch.

Effect of specimen shape on life. - The test results obtained on the specimen of N-155 and S-816 with diamond and round cross sections are tabulated in table III and plotted in figure 8.

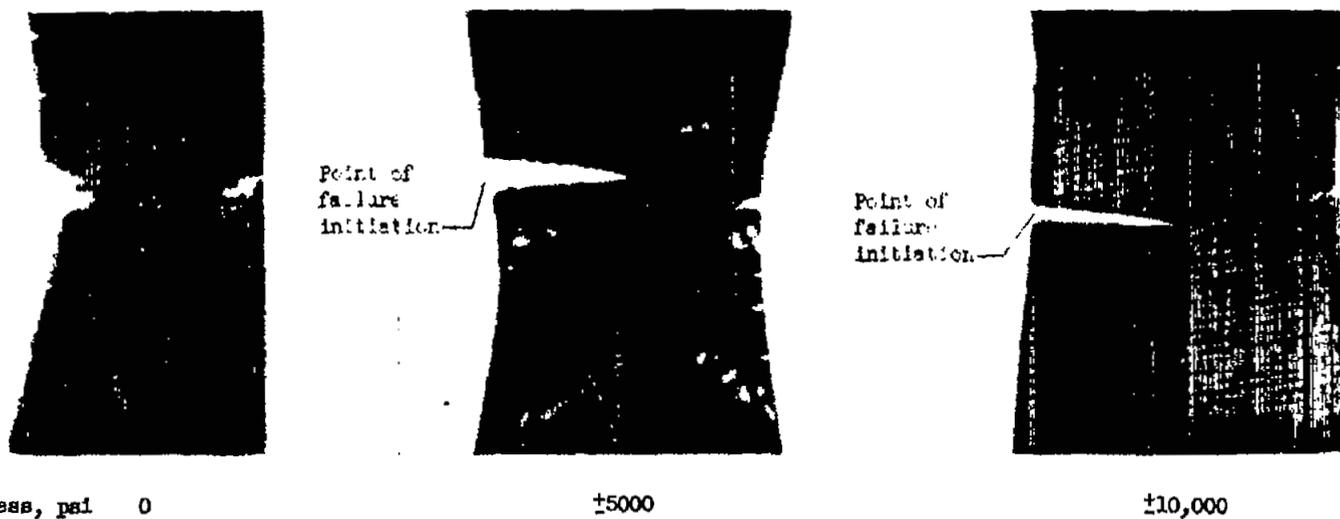
(a) Diamond cross-sectional specimens; X3.75

Figure 9. - Effect of alternating stress on surface cracking of round and diamond cross-sectional specimens of wrought S-816.

The sharp edges on the wrought S-816 diamond-shaped specimen at an alternating stress of zero were more susceptible to the development of cracks than the flat surfaces on this specimen or the rounded surfaces on the S-816 round-shaped specimen at an alternating stress of zero (fig. 9). The round specimen contains no surface cracks aside from those next to the fracture; the diamond specimen contains many cracks along the sharp edges. The same phenomenon was observed on cast diamond and round Stellite 21 specimens in stress-rupture test at 1500° F for effect of specimen shape on stress-rupture life (reference 5). No effect of shape on stress-rupture life was found and it was concluded that the cracks that developed on the sharp edges of the diamond specimens did not reduce the life because of the static loading. However, it was suggested that in the case of an alternating load the cracks on the sharp edges of the diamond specimen may act as stress raisers and result in a reduction of life.

The diamond-shaped specimens of S-816 tested at ± 5000 pounds per square inch and $\pm 10,000$ pounds per square inch still had approximately the same life as the round specimens tested at these alternating stresses. No edge cracks were visible on these specimens along the edge at which failure started (fig. 9). Edge cracks were visible on the diamond-shaped specimens on the opposite edge from which failure started. These cracks probably developed after failure started and were caused by the higher stresses due to the reduced cross-sectional area supporting the applied loads. . 2534
