NACA RM L53E27

TEST OF AN AERODYNAMICALLY HEATED MULTIWEB WING

STRUCTURE (MW-1) IN A FREE JET

AT MACH NUMBER 2

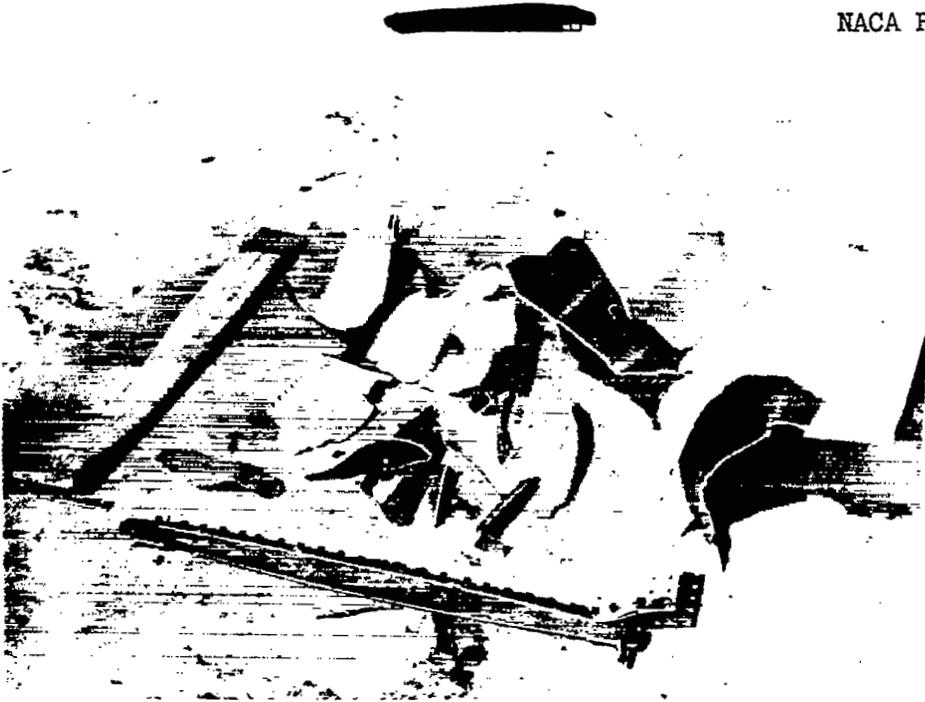
(a) Pieces separated during test.

(b) Pieces attached to mounting fixture.

Figure 5.- Remains of model after test.

The process described is illustrated in figure 4 by six frames selected from the motion picture, and the remains of the model after the test are shown in figure 5. The times given in figure 4 and in the above description were obtained by correlating the movie with the recorders by means of the times at which the various thermocouples failed and should be considered approximate.
