LANDING AND TAXIING TESTS OVER VARIOUS
TYPES OF RUNWAY LIGHTS

By Robert C. Dreher and Sidney A. Batterson

Langley Aeronautical Laboratory
Langley Field, Va.

NACA RM L58C28a

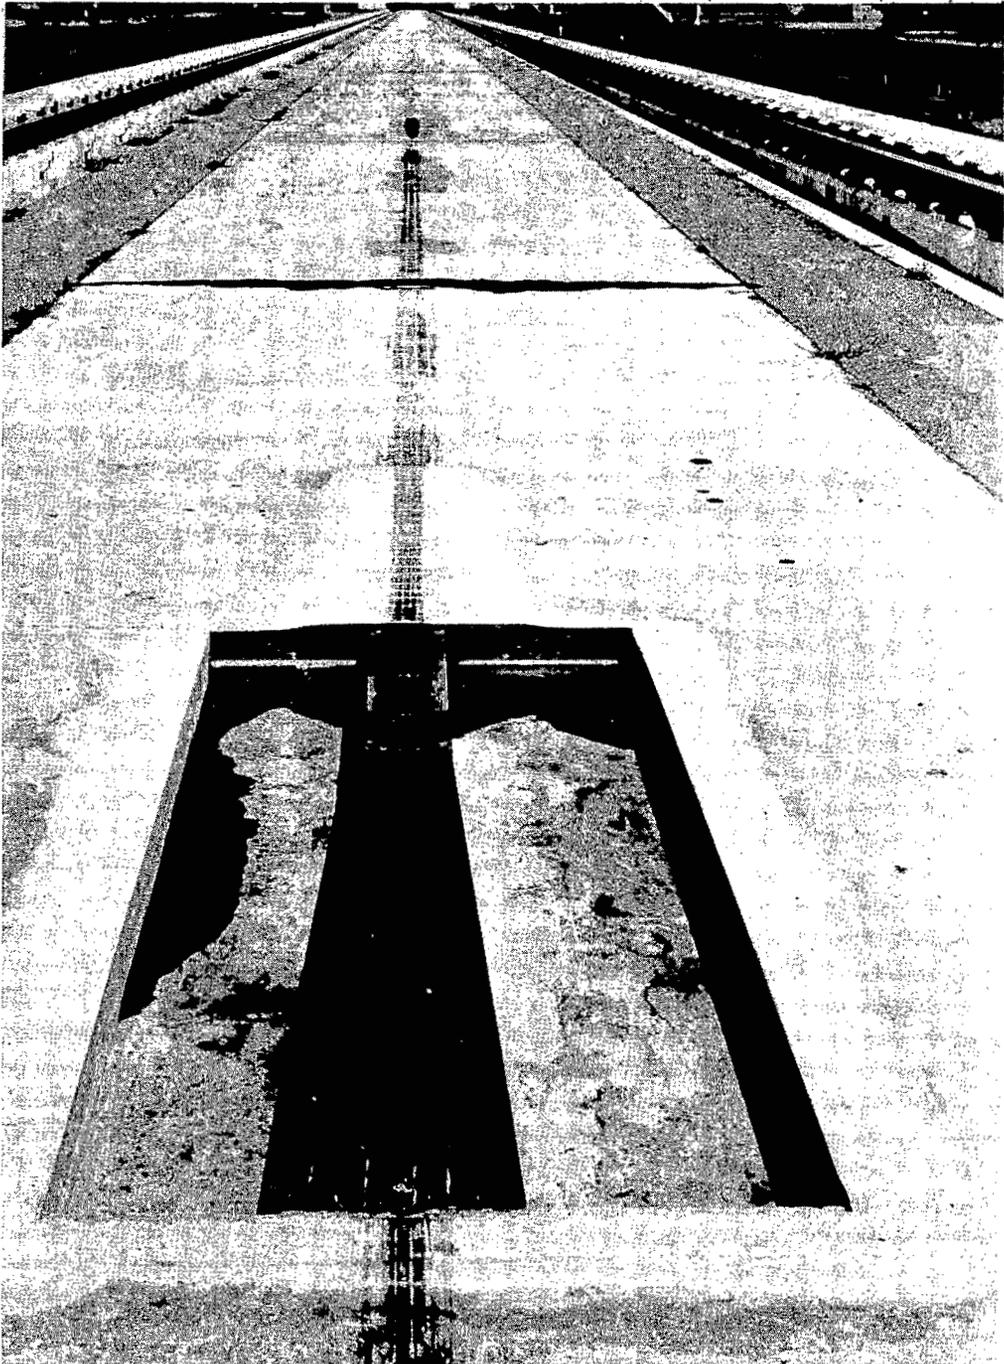
L-57-3475

Figure 1.- Elfaka light unit installed in runway at Langley landing-loads track (position A).

This investigation was carried out with five different lights (figs. 1 to 5). Figures 1 and 2 are the Elfaka and Westinghouse lights which are proposed for installation in the runway landing areas. Figures 3 to 5 show the edge lights.

Tests were made on the Elfaka light mounted in three different positions in the runway. The positions will be referred to as A, B, and C. Figure 1 shows the light mounted in position A. In this position, the longitudinal center line of the light coincided with the center line of the runway, and the landing gear wheel traveled in the trough directly down the center of the grating. Position B was obtained by shifting the entire light 1 inch transversely so that the tire rolled along the top of one of the ribs in the grating. For position C the light was rotated $8\frac{1}{3}^\circ$ (clockwise when viewed from above) to obtain a diagonal traverse of the grating. In this position, the wheel entered midway between

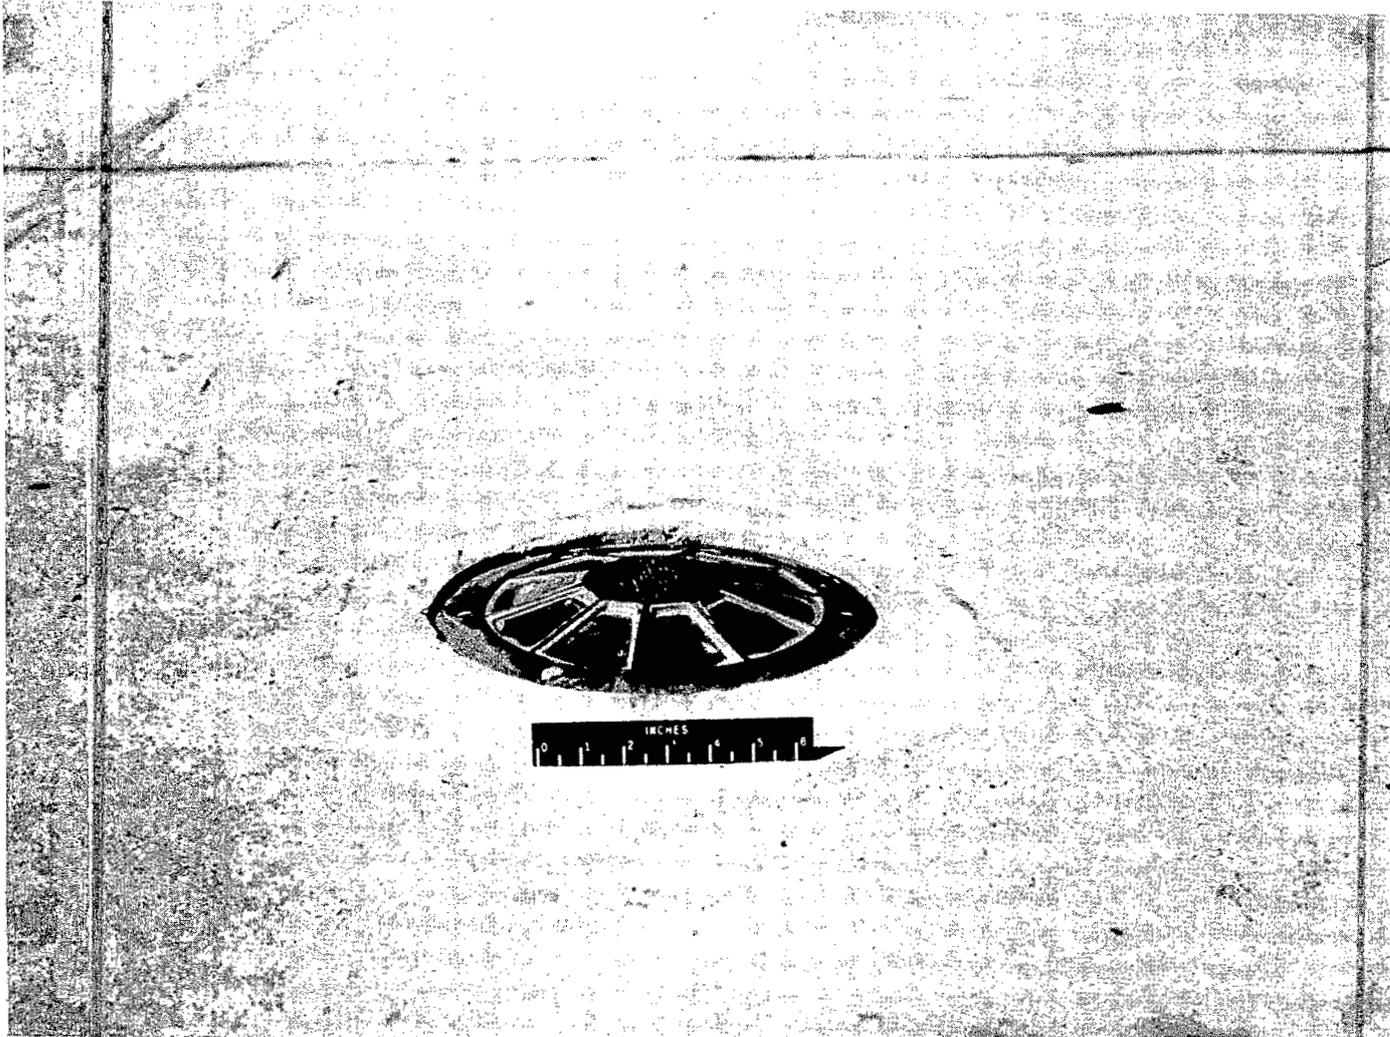
L-57-4070
Figure 2.- Westinghouse light unit installed in runway at Langley landing-loads track.

The Westinghouse light (Westinghouse Electric Corp., Pittsburgh 30, Pa.), shown in figure 2, is 12 inches in diameter and protrudes $7/8$ inch above the runway surface. Light from a source located directly beneath the cover is transmitted along the runway by a system of lenses which are built into the glass top. Since raising the light improves its illumination characteristics, tests were also made with this light raised $5/8$ inch. Figure 8 is a photograph of the Westinghouse light raised $5/8$ inch.

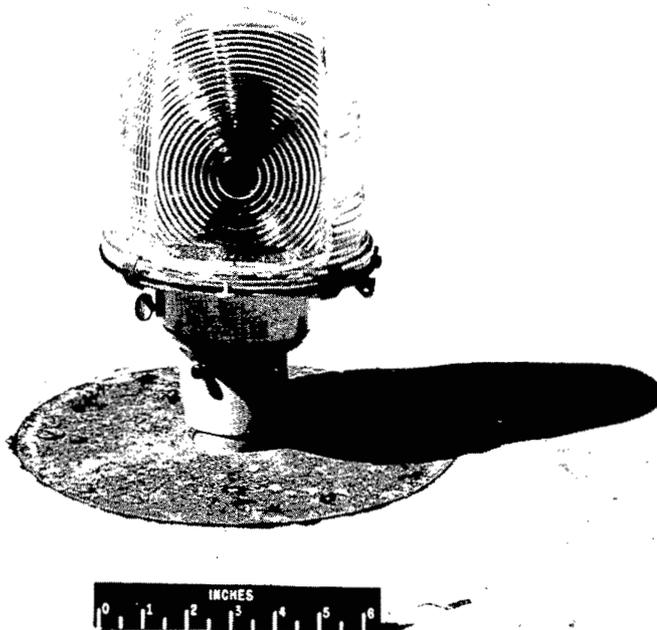
L-57-4065
Figure 4.- C-1 elevated light installed in runway at Langley landing-loads track.

The C-1 light (Westinghouse Electric Corp. and Revere Electric Mfg. Co., Chicago 40, Ill.), shown in figure 4, is approximately $12\frac{1}{2}$ inches high and is mounted on a frangible coupling. The coupling is made to fracture approximately $1/4$ inch above ground level upon collision.

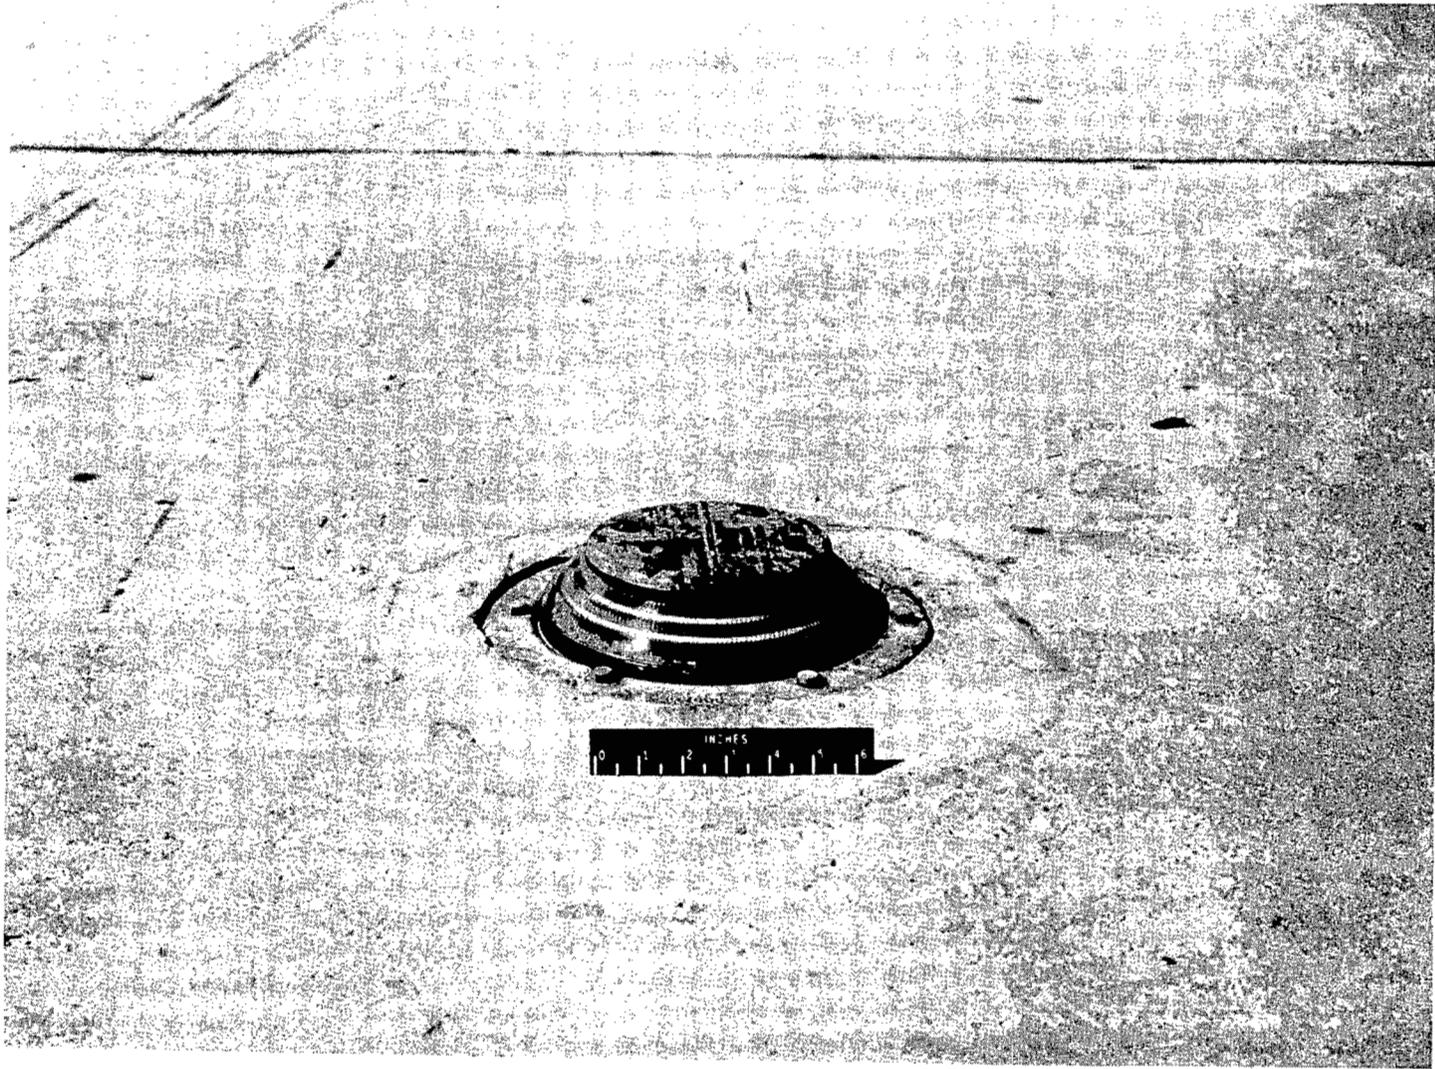
Figure 5.- ANL-9 light installed in runway at Langley landing-loads track. L-57-4068

The ANL-9 light (Revere Electric Mfg. Co.), shown in figure 5, is approximately $9\frac{1}{4}$ inches in diameter and protrudes 3 inches above the runway surface. The light source is located below the runway and reflected in the desired direction through a system of lenses in the glass portion of the top.

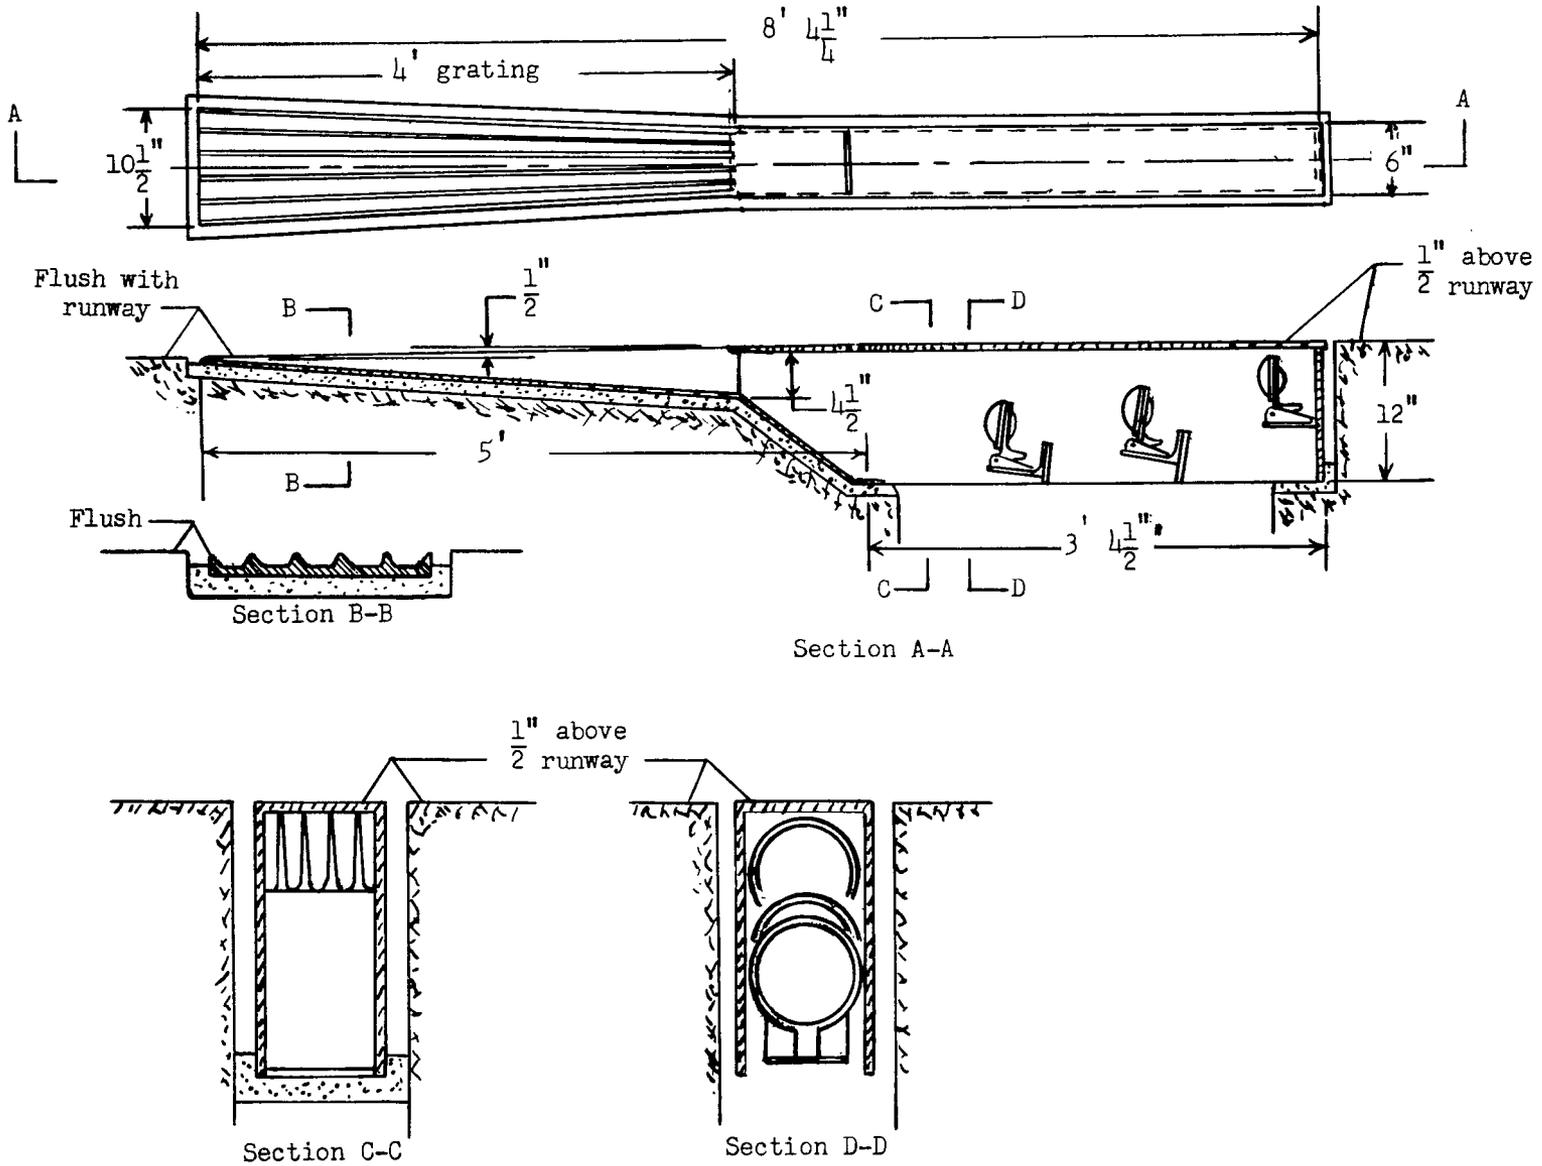
Figure 6.- Elfaka light unit.

Figure 6 is a drawing of the Elfaka light (Structural Concrete Products Corp., New York 16, N. Y.) and shows the pertinent dimensions. The light source is located under the flat steel plate and shines out through the grating. The front of the grating is level with the runway surface and the grating rises $1/2$ inch from front to rear. The surface of the flat metal plate lies $1/2$ inch above the runway. When installed, the concrete surrounding the light on the sides as well as in the rear is sloped down to the runway at an angle of about 1° . In order to simplify changing the orientation of the light in the runway, the unit tested was a casting made with the actual light as a pattern but with some modifications to the under side. In addition, the length of the 6-inch-wide steel plate at the end of the grating was reduced from approximately 4 feet to 2 feet. Figure 7 is a drawing of the unit used for these tests.

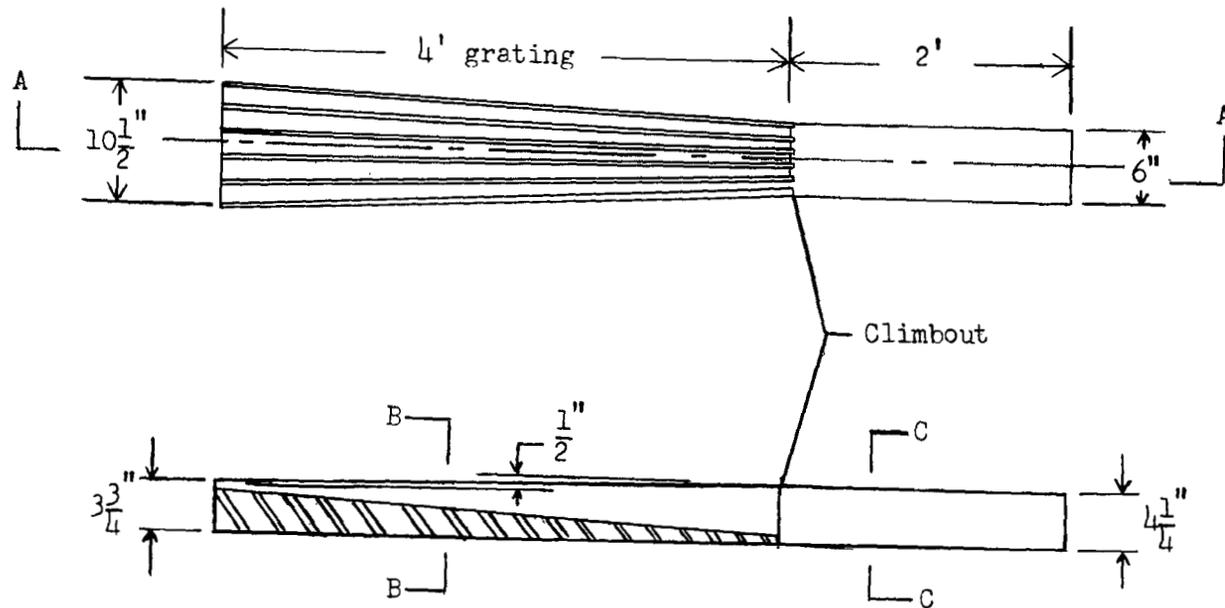
Figure 7.- Simulated Elfaka light unit used during tests at Langley landing-loads track.

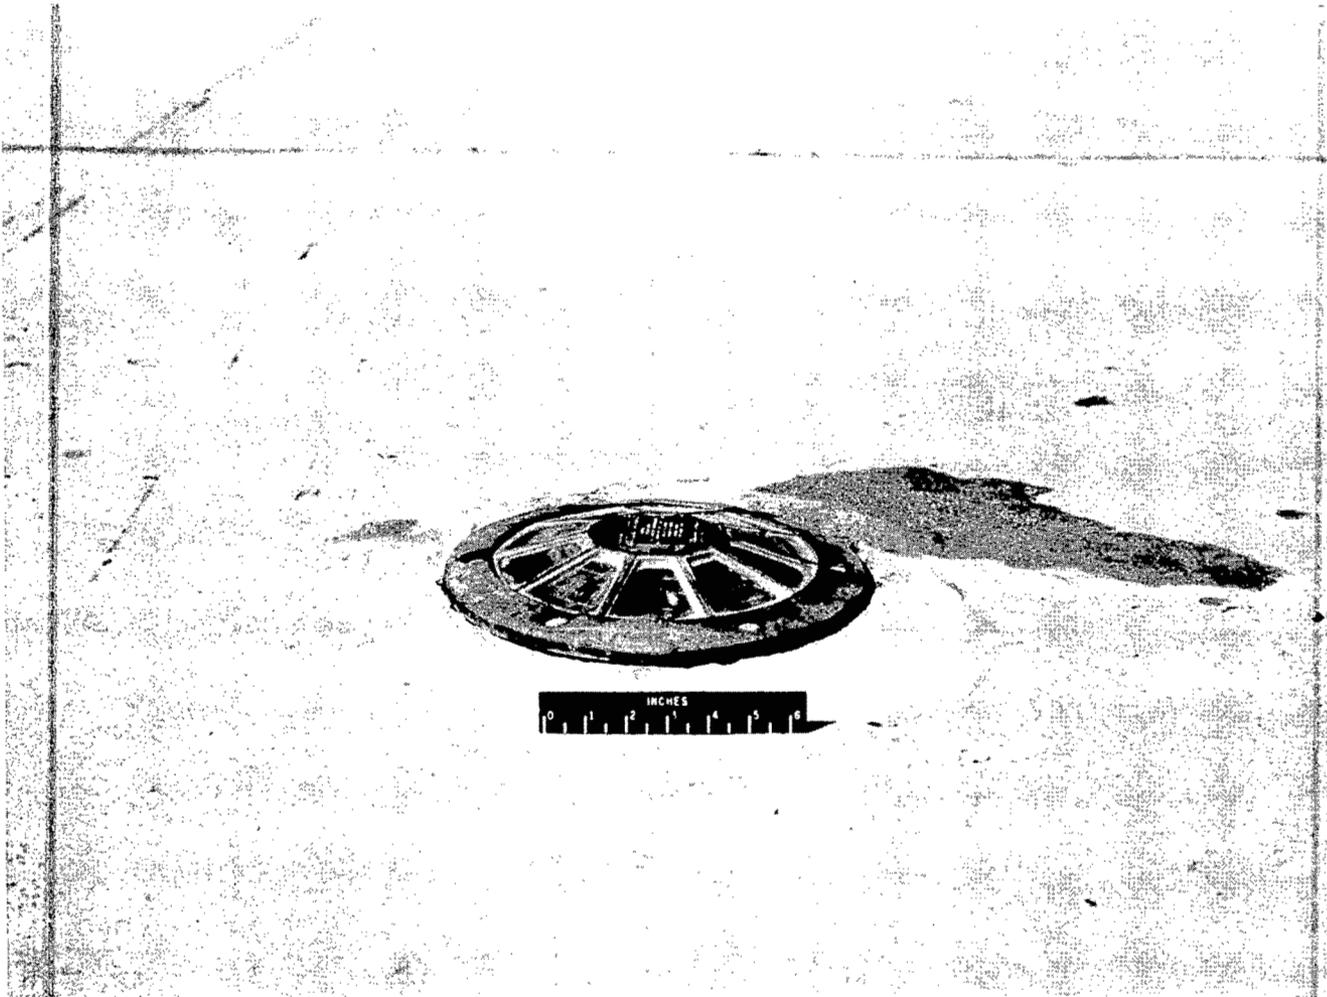
L-57-4069

Figure 8.- Westinghouse light unit installed in runway at Langley landing-loads track raised $5/8$ inch.

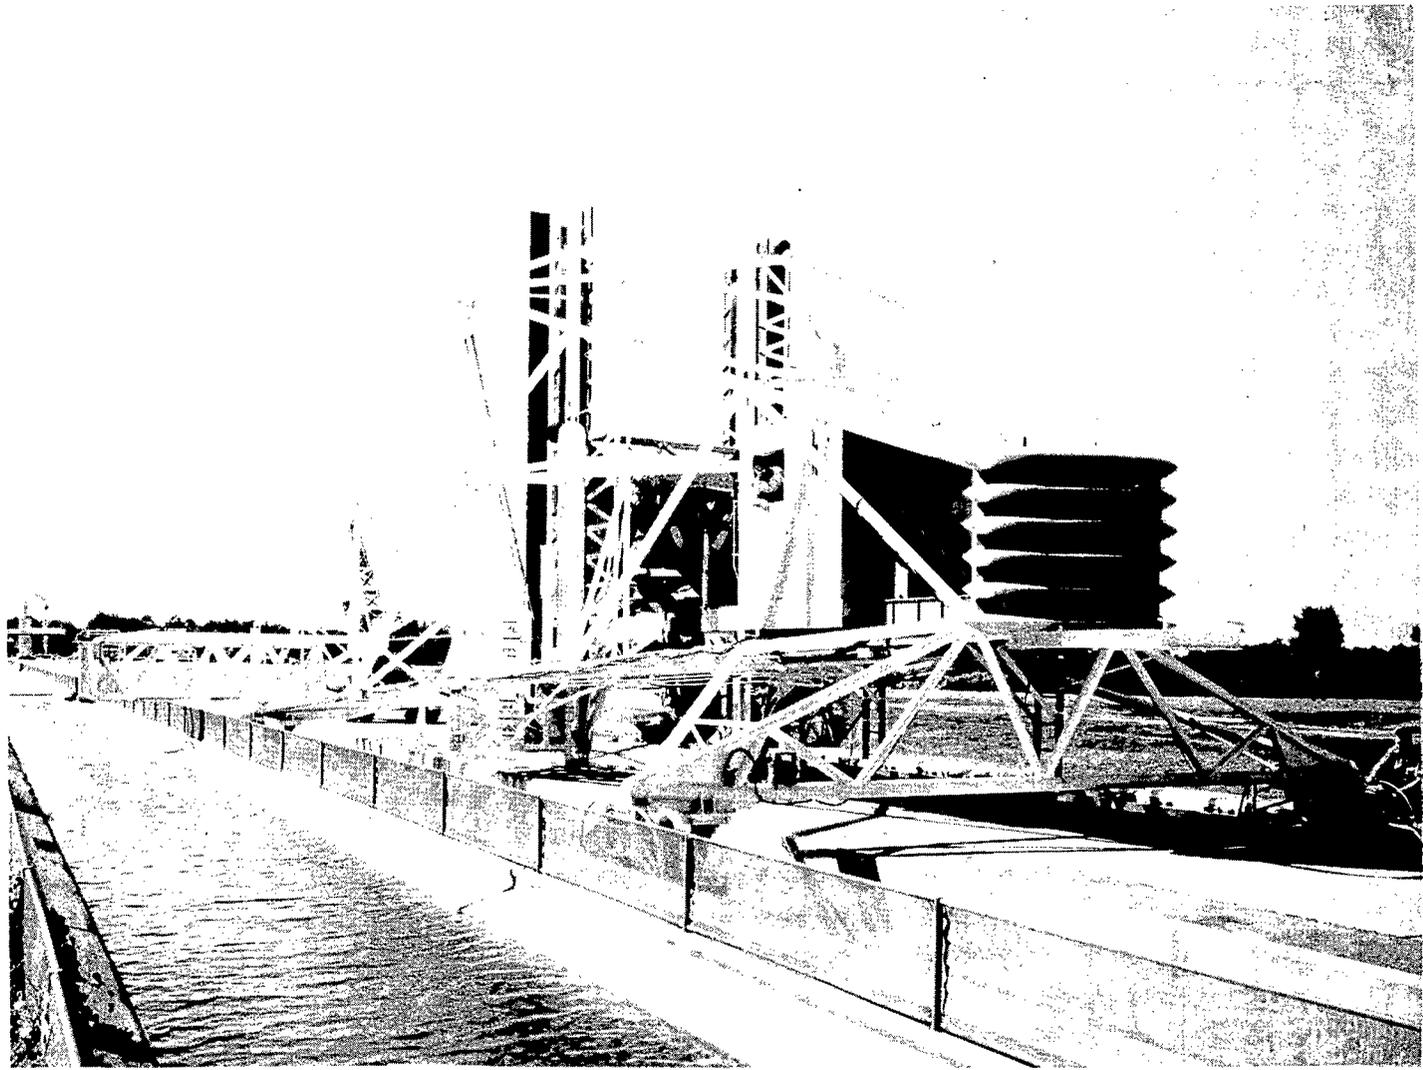
Figure 9.- Carriage of Langley landing-loads track. L-95476

The tests were made by simulating actual landings and taxi runs during which the landing gear wheel ran over the lights. The landing gear was mounted on the carriage at the Langley landing-loads track which was brought up to the desired horizontal velocity by means of a hydraulic jet catapult. (See ref. 1.) Figure 9 is a photograph of the carriage, which is 60 feet long, 30 feet wide, and weighs approximately 100,000 pounds. The carriage straddles a concrete runway having surface characteristics which are representative of most presently used runways. All the lights tested were mounted in this runway. In the landing-impact tests initial touchdown occurred on and in the vicinity ahead of the light. During the taxi tests initial touchdown was made well ahead of the light. Two landing gears were used during the test, an F-94C nose landing gear and a B-57 main gear.

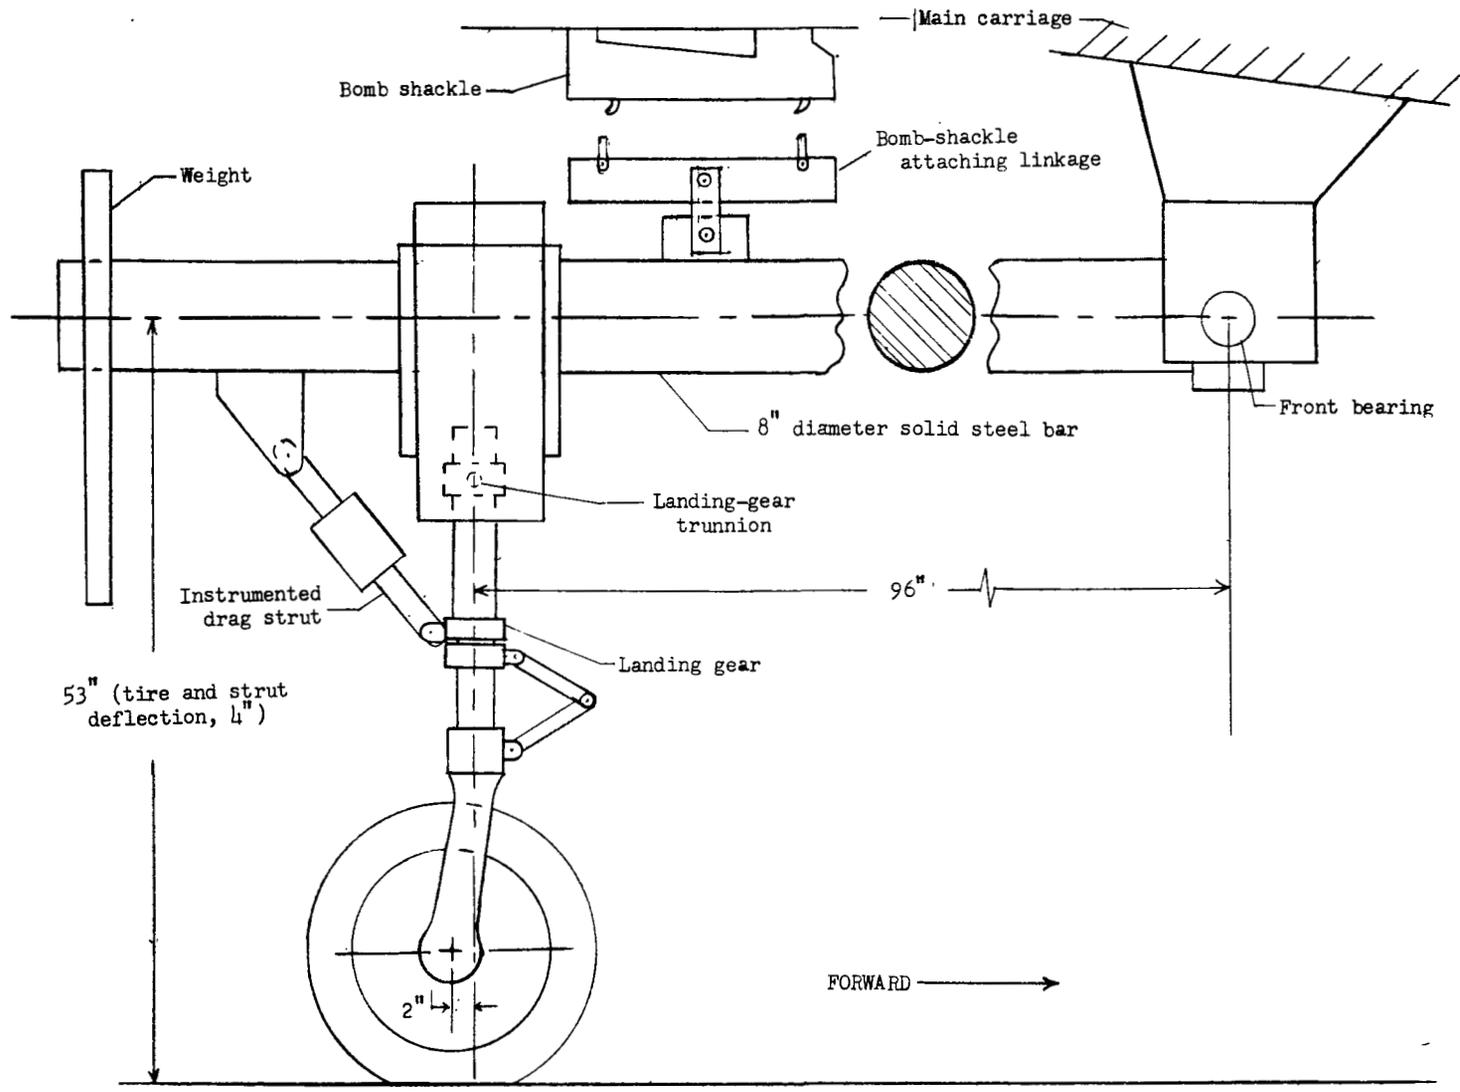
Figure 10.- Schematic drawing of F-94C test apparatus with landing gear normal to runway.

Figure 10 is a schematic drawing of the F-94C nose-landing-gear test apparatus which was used to attach the landing gear to the carriage. The nose landing gear was mounted rigidly near the end of an arm which pivoted

Instrumentation was provided to measure the vertical and drag loads developed upon striking the lights. Strain-gage accelerometers were mounted on the apparatus in the locations shown in figure 13. Also shown in this figure is the load cell used to measure the load in the drag strut. The vertical load developed between the tire and the lights on the runway was obtained by summing the vertical inertia reactions of the upper and lower masses at the desired instant of time. Drag loads applied to the tire were obtained by summing the horizontal component of load measured by the drag strut and the inertia reaction of an effective lower mass in the drag direction. An effective lower mass must be used for determining drag loads since in this direction there is no clearly defined boundary between the upper and lower masses as exists in the vertical direction. The value obtained for the lower mass was 1.39 slugs. The method used for determining the effective lower mass is described in the appendix. A correction was applied to the drag strut load to eliminate the effect of the moment caused by the vertical load acting 2 inches behind the strut vertical axis. (See fig. 10.)

The apparatus shown in figure 10 was set up with the tire clear of the ground and the landing gear vertical. A drag load was applied to the wheel axle and suddenly released. During the ensuing vibration, measurements were obtained of the lower mass acceleration and the load in the drag strut. The values of the horizontal component of load in the drag strut were plotted against axle accelerations obtained at the same time. These data are shown in figure 26. The slope of the line indicates the value of the effective lower mass acting in the drag direction. Figure 26 shows that this value was, for all practical purposes, independent of shock strut displacement.

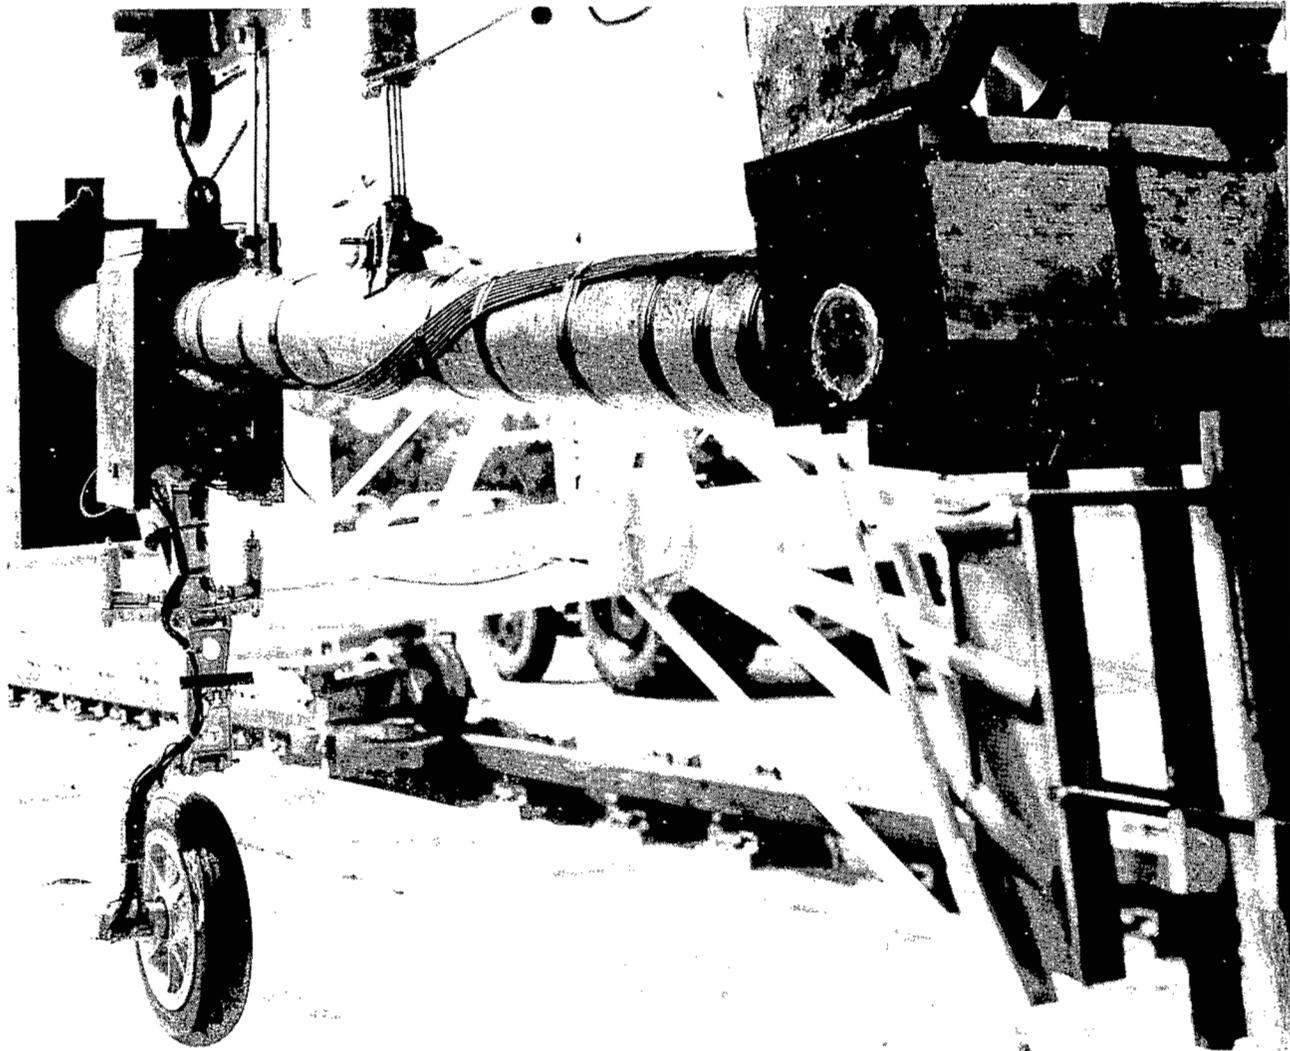
L-57-3477

Figure 11.- F-94C nose landing gear mounted for testing at Langley landing-loads track.

in a vertical plane about a bearing attached to the main carriage. The steel plate attached to the arm added sufficient weight to simulate the maximum static load condition. The landing gear was normal to the arm and was supported at its two trunnion points and at the drag link attachment. This method of support held the yaw attitude of the upper part of the landing gear fixed rigidly at 0° . The only restraints to yawing of the wheel were the shimmy damper and wheel trail angle. Figure 11 is a photograph of the F-94C nose landing gear mounted for testing.

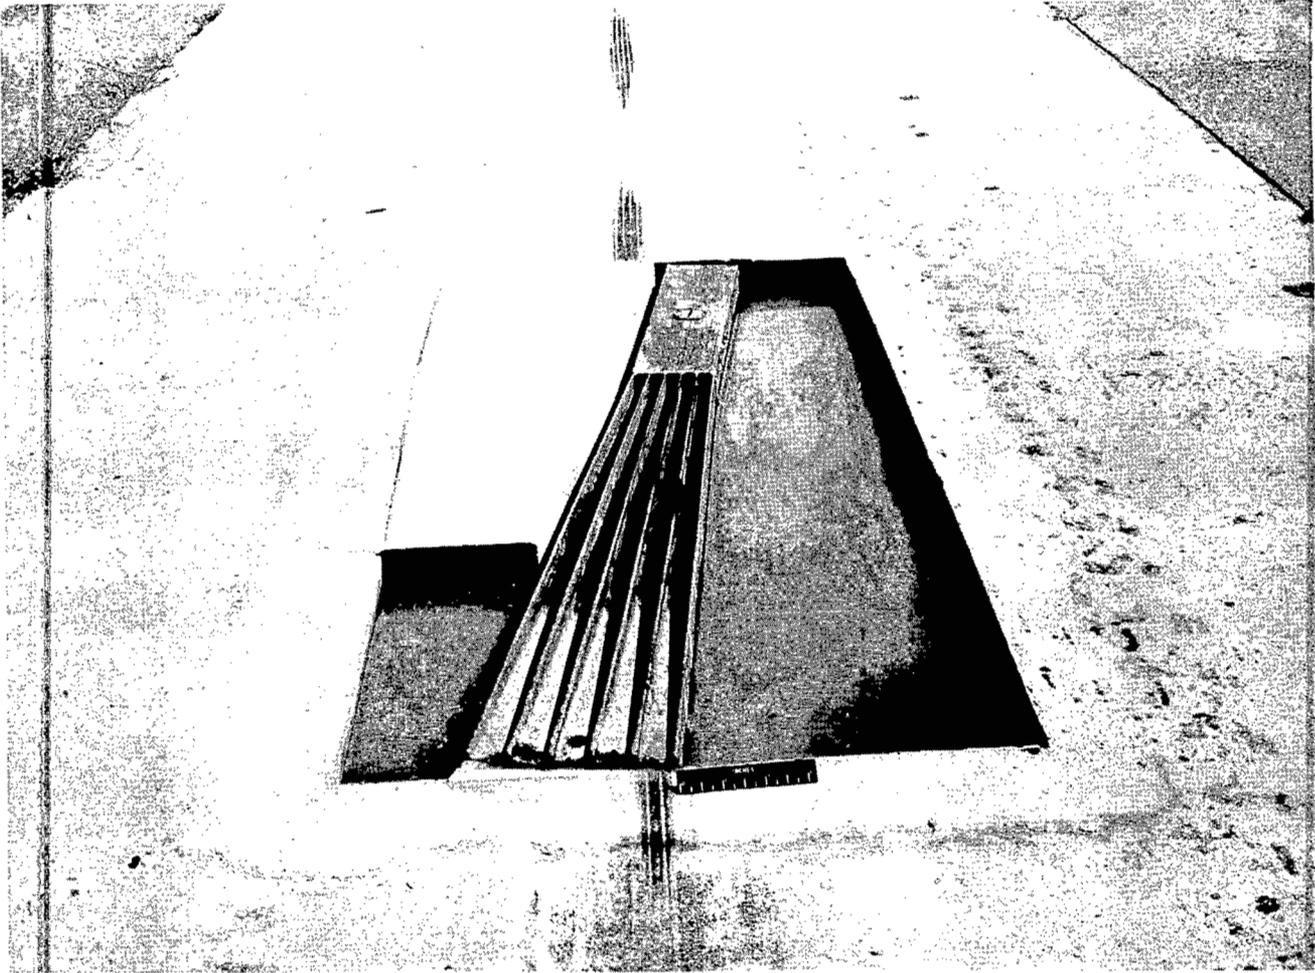
Figure 12.- Installation of Elfaka light unit yawed $8\frac{1}{3}^{\circ}$ (position C). L-57-4062

the first two ribs on the right side of the grating (right side as viewed from an airplane approaching the light). Figure 12 is a photograph of the light in position C. In all the positions concrete was placed around the light so that the wheel experienced the same changes in elevation while traveling over the light and adjacent concrete as occur on an actual installation.

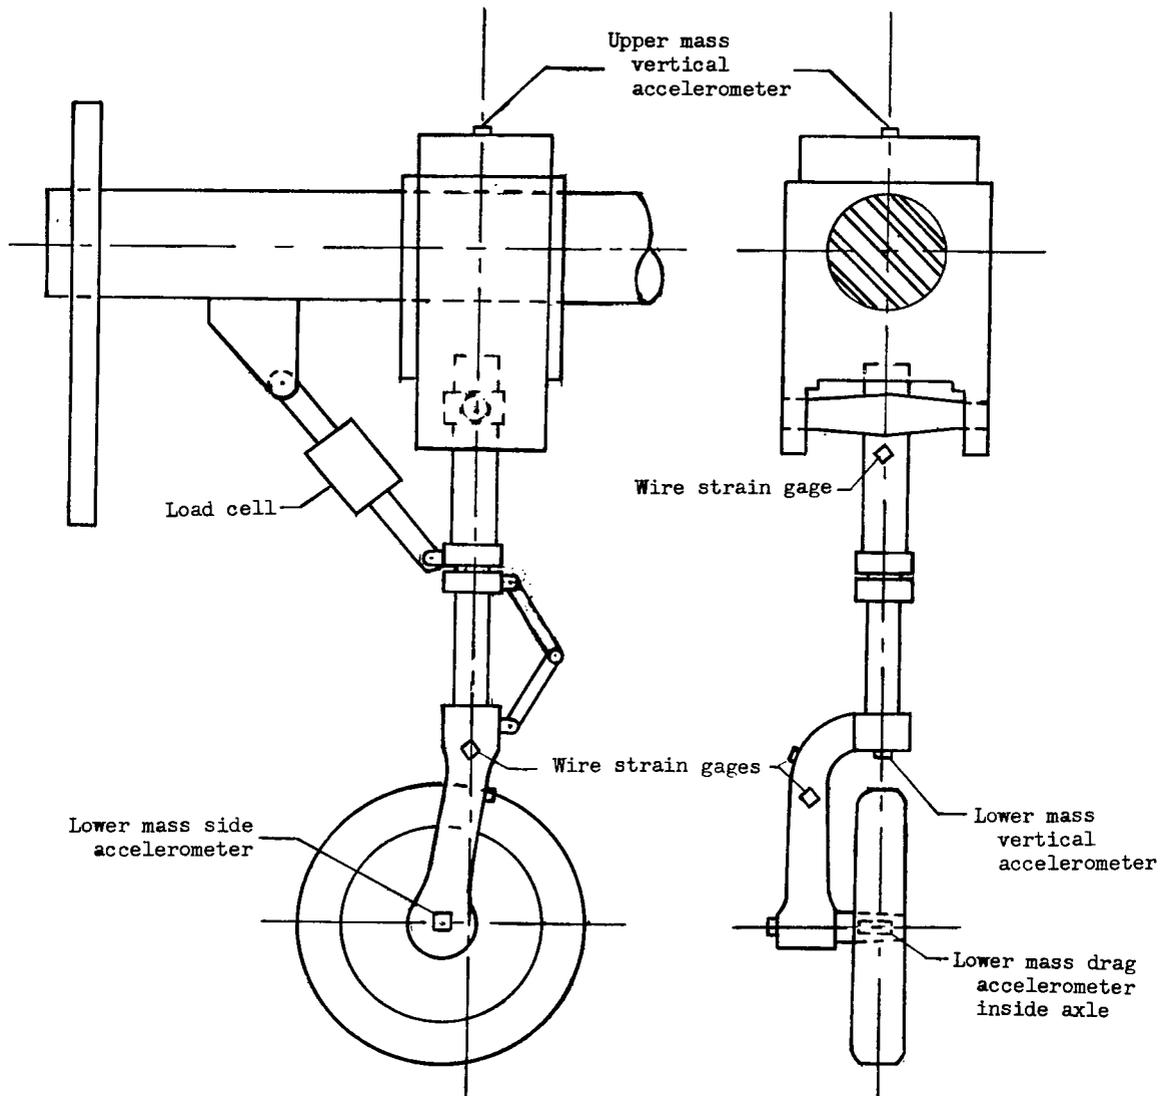
Figure 13.- Sketch of F-94C nose landing gear showing instrument locations.

Although wire resistance strain gages were mounted on the nose landing gear in the locations shown in figure 13, they were not used during a large part of the investigation. About midway in the test program the connections to these gages were destroyed during an impact with one of the lights. Since only low values of unit stress had been recorded up to this point, these gages were not put back into service.

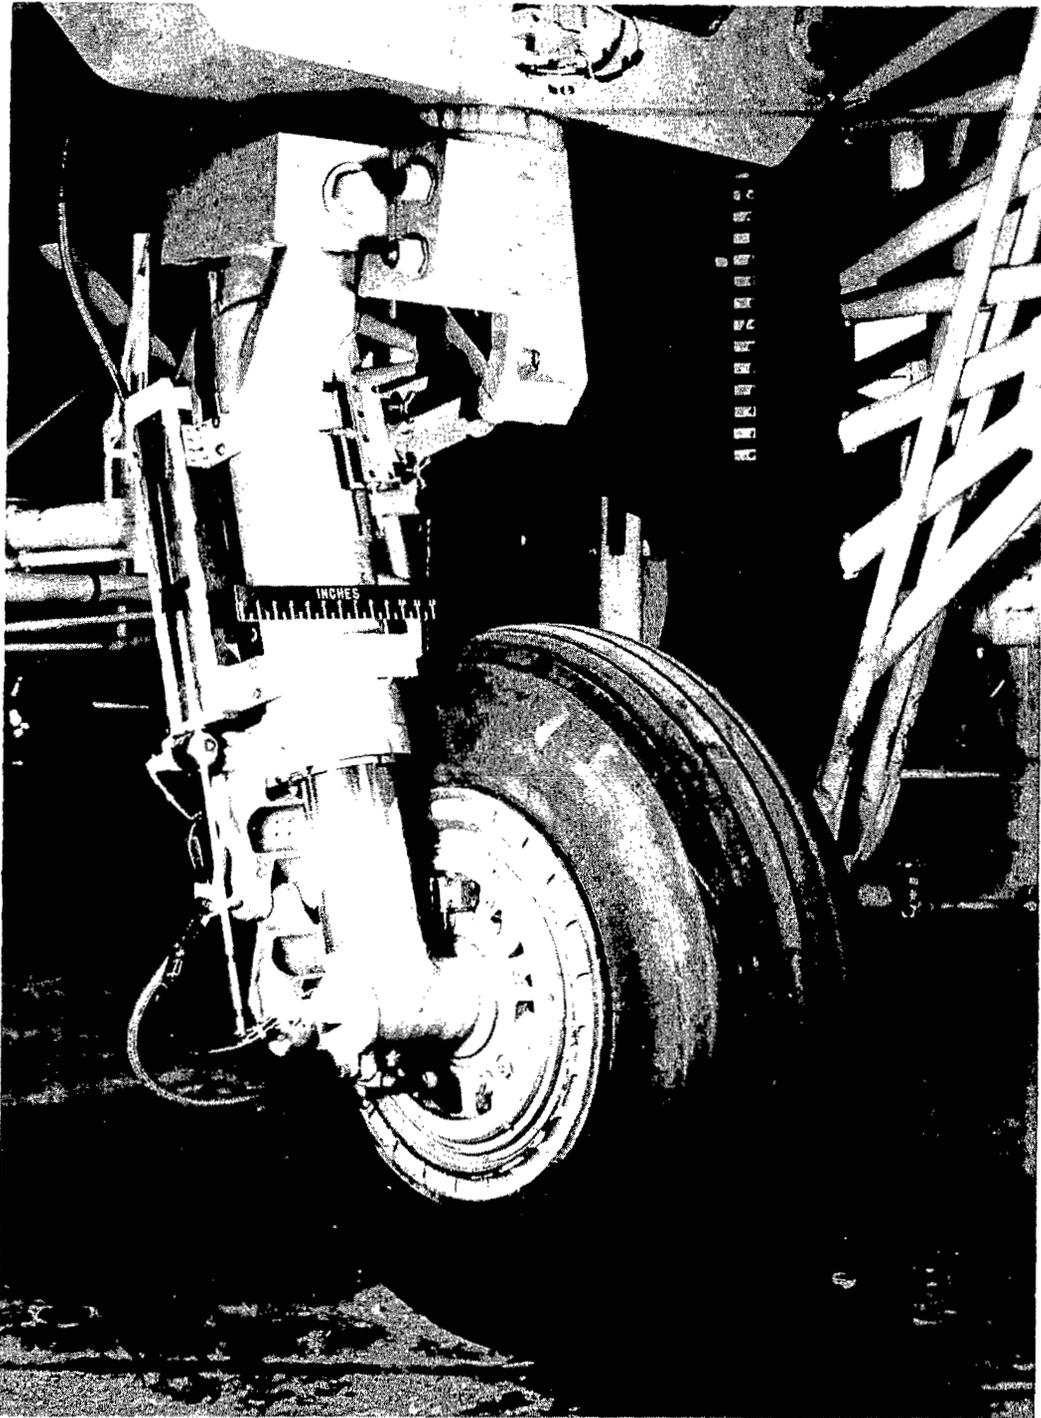
Figure 14.- B-57 main landing gear mounted for test. L-57-1338

A limited investigation, consisting only of taxi tests, was made with the B-57 main landing gear. Figure 14 is a photograph of this gear mounted on the carriage. The static weight on the tire was 20,000 pounds, and the weight of the lower or unsprung portion of the gear was 534 pounds. The landing gear was equipped with a 44x13, type VII, 26-ply-rating tire. The tire pressure was 140 pounds per square inch, and the pressure in the oleo-pneumatic shock strut when fully extended was 292 pounds per square inch. All runs were made with this landing gear arbitrarily inclined forward at a fixed angle of 15° to the vertical. The horizontal and vertical loads between the tire and the lights were measured by a dynamometer built into the main carriage. Appropriate inertia corrections were made through the use of accelerometers mounted on the landing gear.

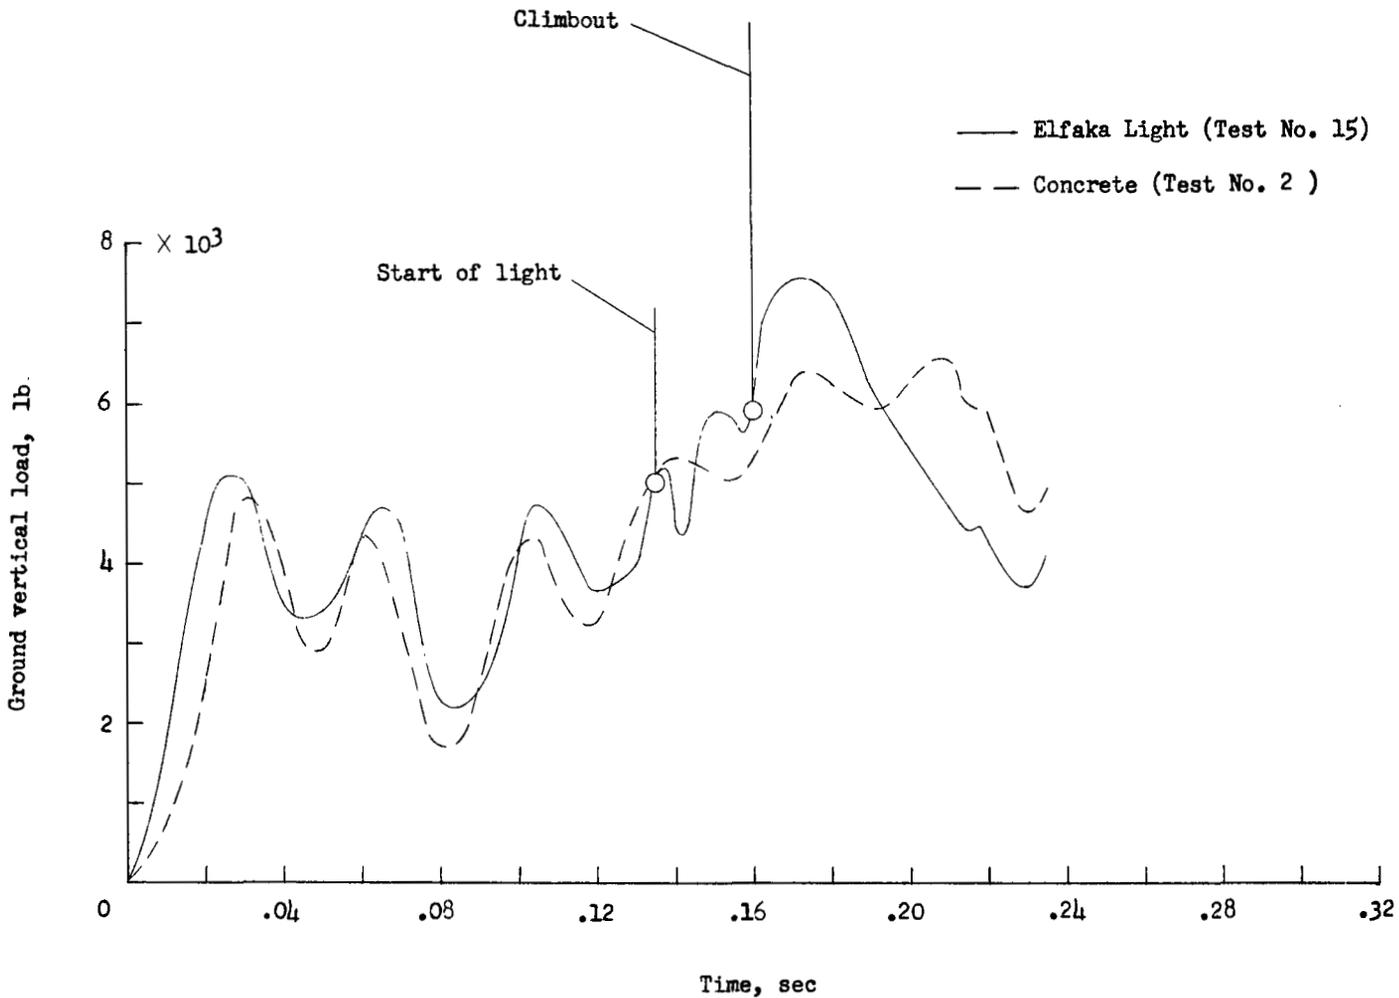
Figure 15.- Time histories of the vertical loads developed on the F-94C nose landing gear during landing impacts on plain concrete and on Elfaka light. Vertical velocity, 5.7 feet per second; horizontal velocity, approximately 150 feet per second.

Elfaka light unit.- In tables I and II and in figure 15, it can be seen that, in general, larger values of maximum vertical load were obtained during landings on the Elfaka light than on plain concrete. This was caused primarily by the tire, which had been forced down into the grating, being forced to climb out onto the flat metal plate. (See fig. 7.) The maximum drag loads listed in the tables show that smaller loads were developed on the light than on concrete. It was also found that for certain test conditions, the wheel developed marked yawing oscillations while negotiating the light.

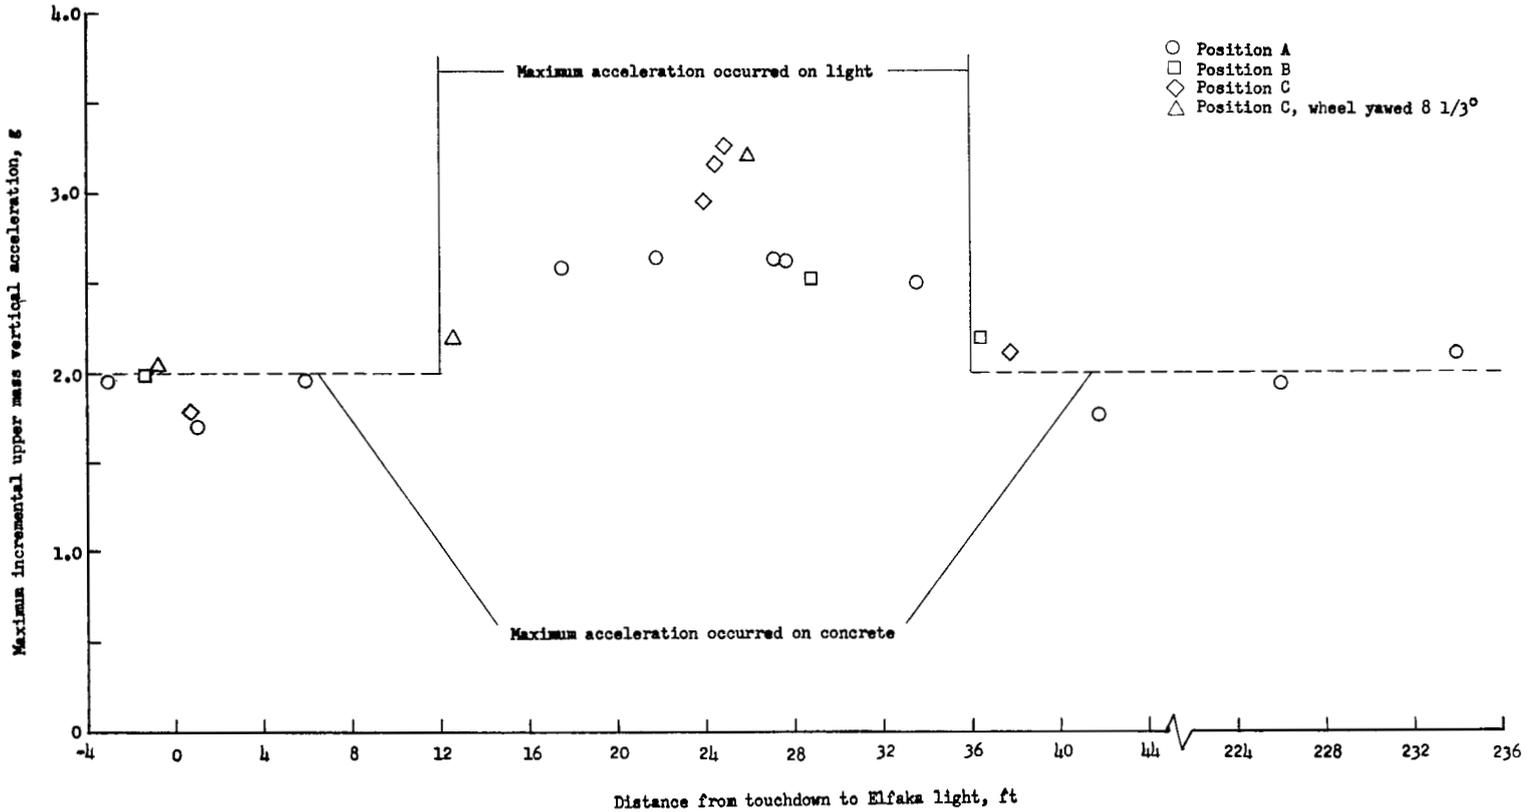
Figure 16.- Variation of maximum incremental upper mass vertical acceleration with distance from touchdown to Elfaka light during landing tests of F-94C nose landing gear. Horizontal velocity range 153 to 167 feet per second; vertical velocity 5.7 feet per second.

The effect of the light on vertical load is illustrated in figure 16 where the maximum incremental upper mass vertical acceleration is plotted against the distance between initial touchdown and the Elfaka light unit. Upper mass accelerations are presented rather than the actual vertical loads, because small irregularities in the runway cause appreciable distortions of the load data. Maximum acceleration occurred on the light only for the group of tests in which touchdown ranged between 12 and 34 feet in front of the light, and in each of these tests the maximum acceleration occurred at climbout. This figure and figure 17 shows that the acceleration caused by climbout was as much as 60 percent greater than the acceleration developed during landings on plain concrete. Furthermore, the largest accelerations were obtained during landings made on the yawed light. Figure 16 also indicates that the loads are independent of the lateral position of the wheel on the light, since the same load was obtained when the wheel traveled along the ridge of the grating and in the trough. A comparison of the two triangle points, for which touchdown occurred at 12.5 and 26 feet in front of the light, show that the maximum load is larger when climbout occurs late in the impact. This is illustrated in figure 18 which shows time histories of the vertical accelerations obtained during these two tests.
