LANDING AND TAXIING TESTS OVER VARIOUS
TYPES OF RUNWAY LIGHTS

By Robert C. Dreher and Sidney A. Batterson

Langley Aeronautical Laboratory
Langley Field, Va.

NACA RM L58C28a

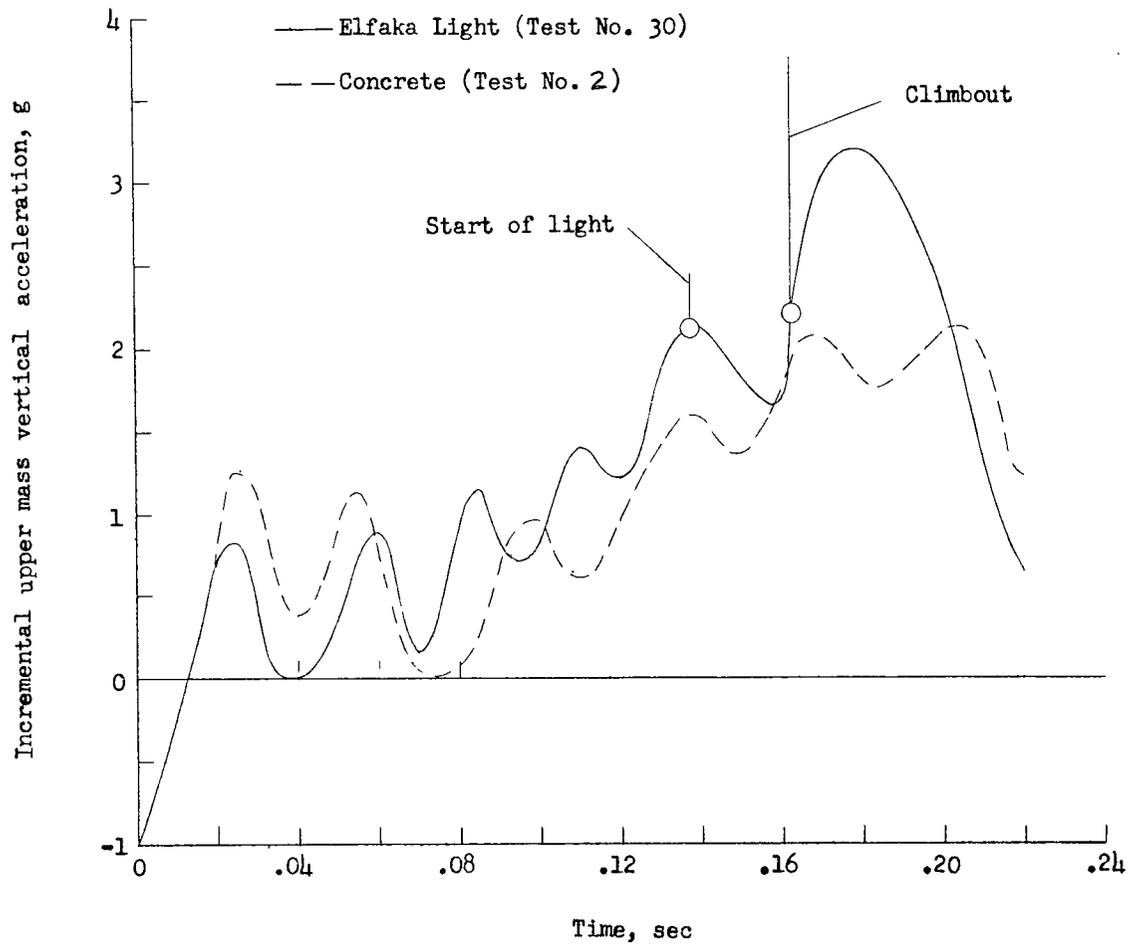
Figure 17.- Time histories of incremental upper mass vertical acceleration developed on F-94C nose landing gear during landing impacts on plain concrete and on Elfaka light. Vertical velocity, 5.7 feet per second; horizontal velocity, approximately 150 feet per second.

The effect of the light on vertical load is illustrated in figure 16 where the maximum incremental upper mass vertical acceleration is plotted against the distance between initial touchdown and the Elfaka light unit. Upper mass accelerations are presented rather than the actual vertical loads, because small irregularities in the runway cause appreciable distortions of the load data. Maximum acceleration occurred on the light only for the group of tests in which touchdown ranged between 12 and 34 feet in front of the light, and in each of these tests the maximum acceleration occurred at climbout. This figure and figure 17 shows that the acceleration caused by climbout was as much as 60 percent greater than the acceleration developed during landings on plain concrete. Furthermore, the largest accelerations were obtained during landings made on the yawed light. Figure 16 also indicates that the loads are independent of the lateral position of the wheel on the light, since the same load was obtained when the wheel traveled along the ridge of the grating and in the trough. A comparison of the two triangle points, for which touchdown occurred at 12.5 and 26 feet in front of the light, show that the maximum load is larger when climbout occurs late in the impact. This is illustrated in figure 18 which shows time histories of the vertical accelerations obtained during these two tests.

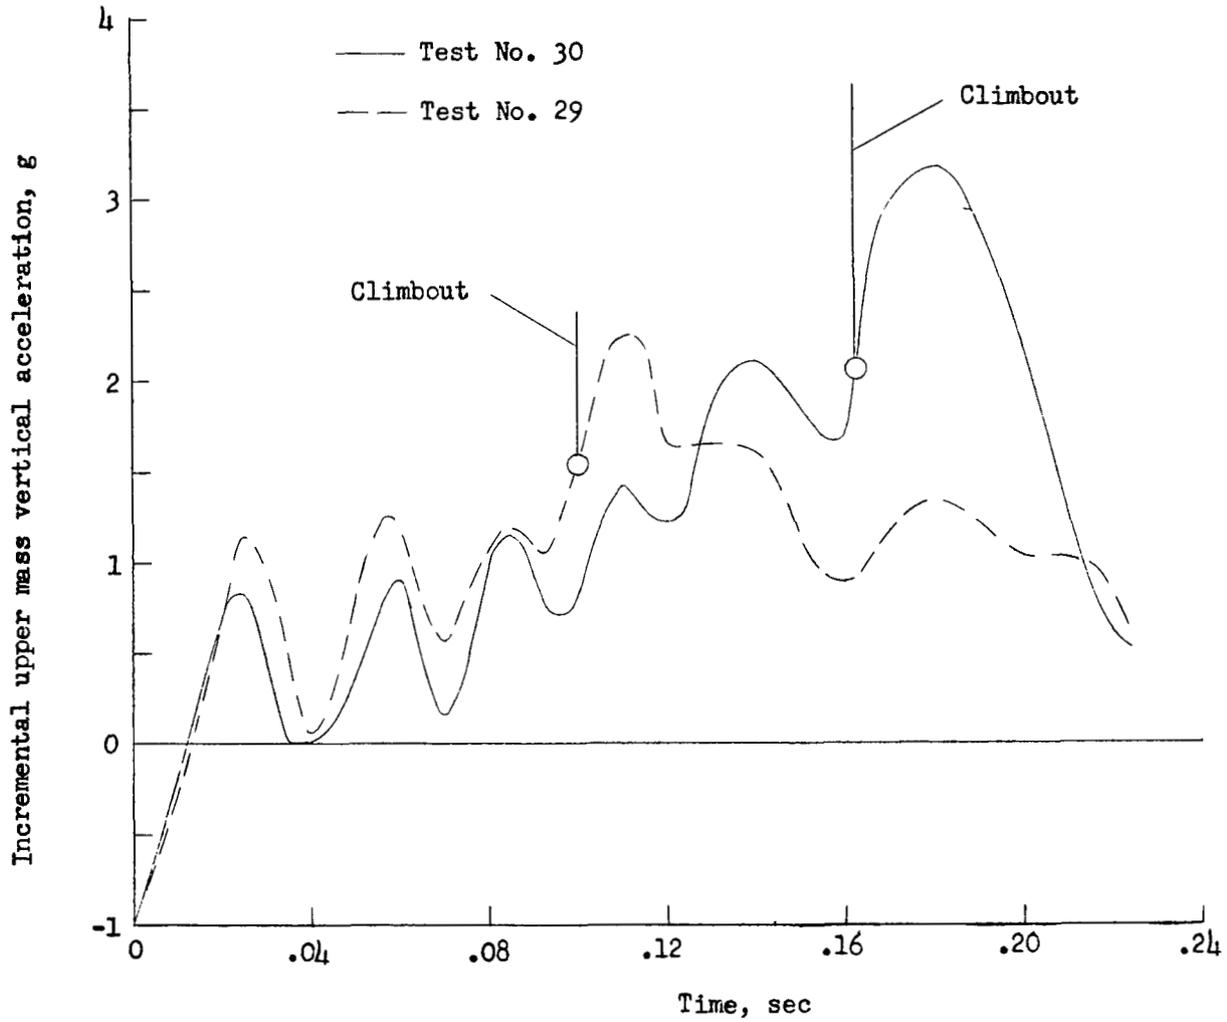
Figure 18.- Time histories of incremental upper mass vertical acceleration developed on F-94C nose landing gear during landing impacts on Elfaka light. Vertical velocity, 5.7 feet per second; horizontal velocity, approximately 150 feet per second.

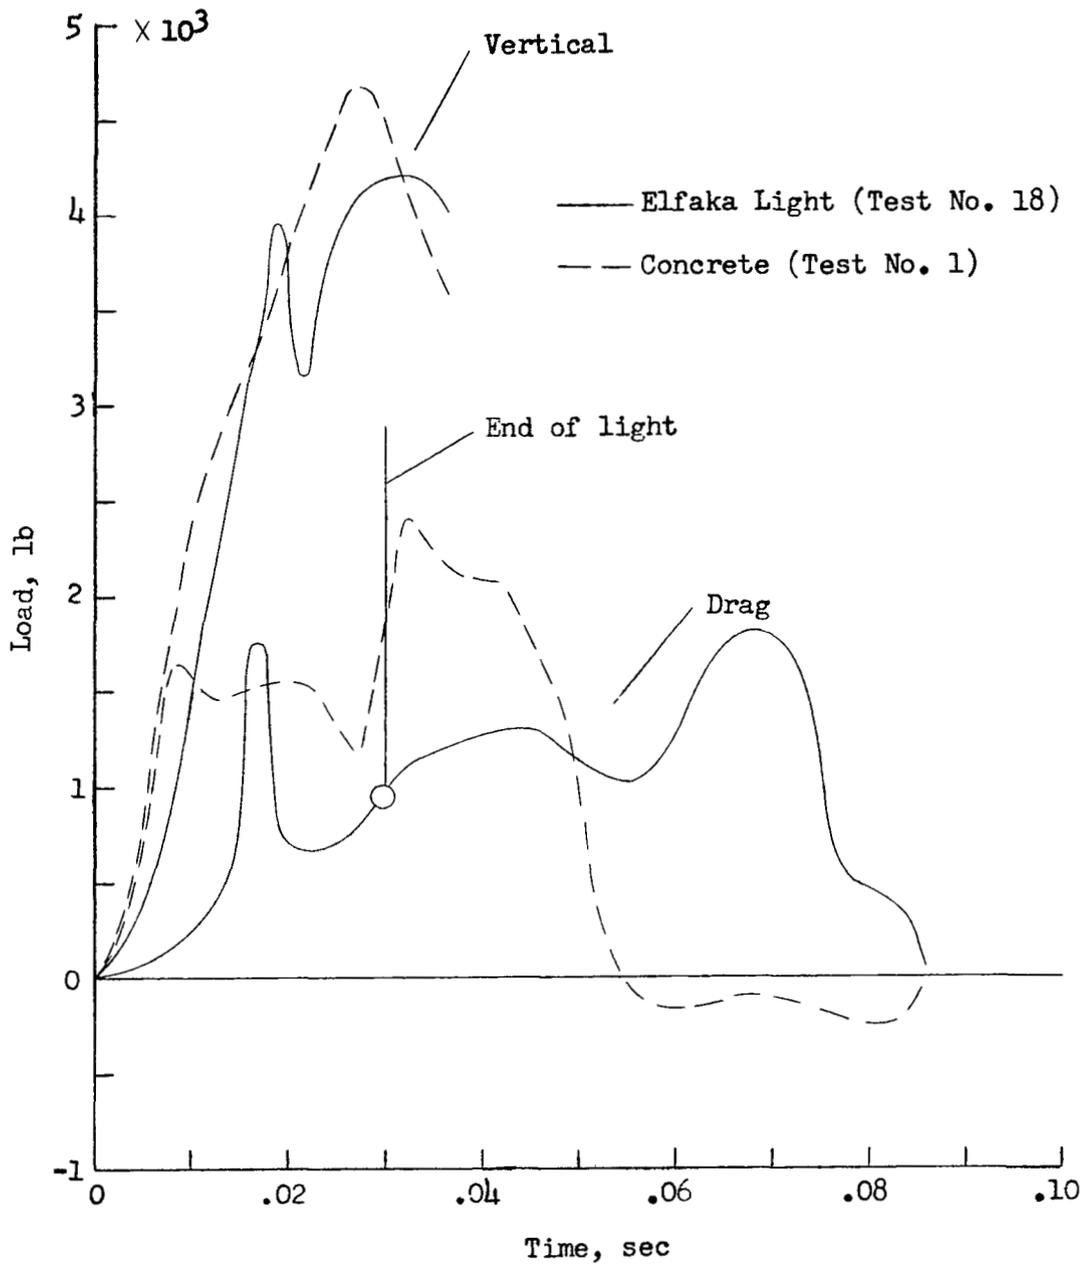
Figure 19.- Comparison of vertical and drag loads developed on F-94C nose gear during landing impacts on concrete and the Elfaka light.

The effect of the light on drag load was apparent only during the period in which the wheel was being spun up to full rolling velocity. Figure 19 shows that with the exception of an initial high peak, caused by climbout, the drag load developed on the light was much smaller than on concrete. Since the vertical loads for both tests were substantially the same while the wheel was negotiating the light, the spin-up coefficient of friction developed on the light was smaller than on concrete.

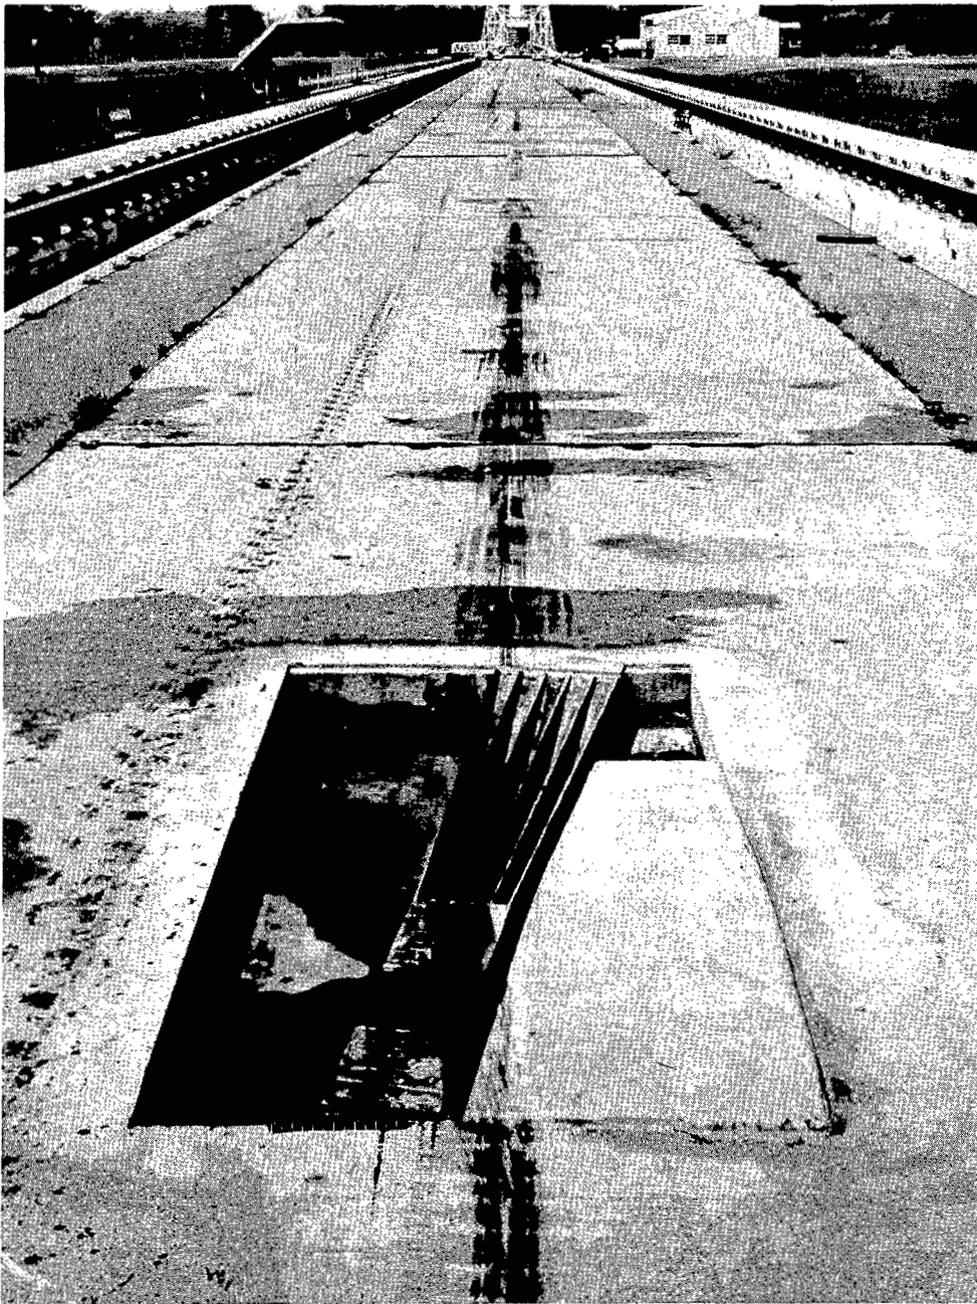
L-57-3688

Figure 20.- Photograph of track left by F-94C nose-landing-gear wheel while negotiating yawed Elfaka light (position C). (Wheel entered light at grating.)

High-speed moving pictures (1,000 frames per second) showed rather violent yawing oscillations of the wheel during the tests in which the light was yawed and initial touchdown occurred either on the grating or less than a foot in front of it. In this group of tests, the largest oscillations occurred during the yawed wheel landings. Figure 20 is a photograph of the track made by the wheel during one of these runs and shows that the landing gear experienced a considerable amount of side deflection while passing over the light.

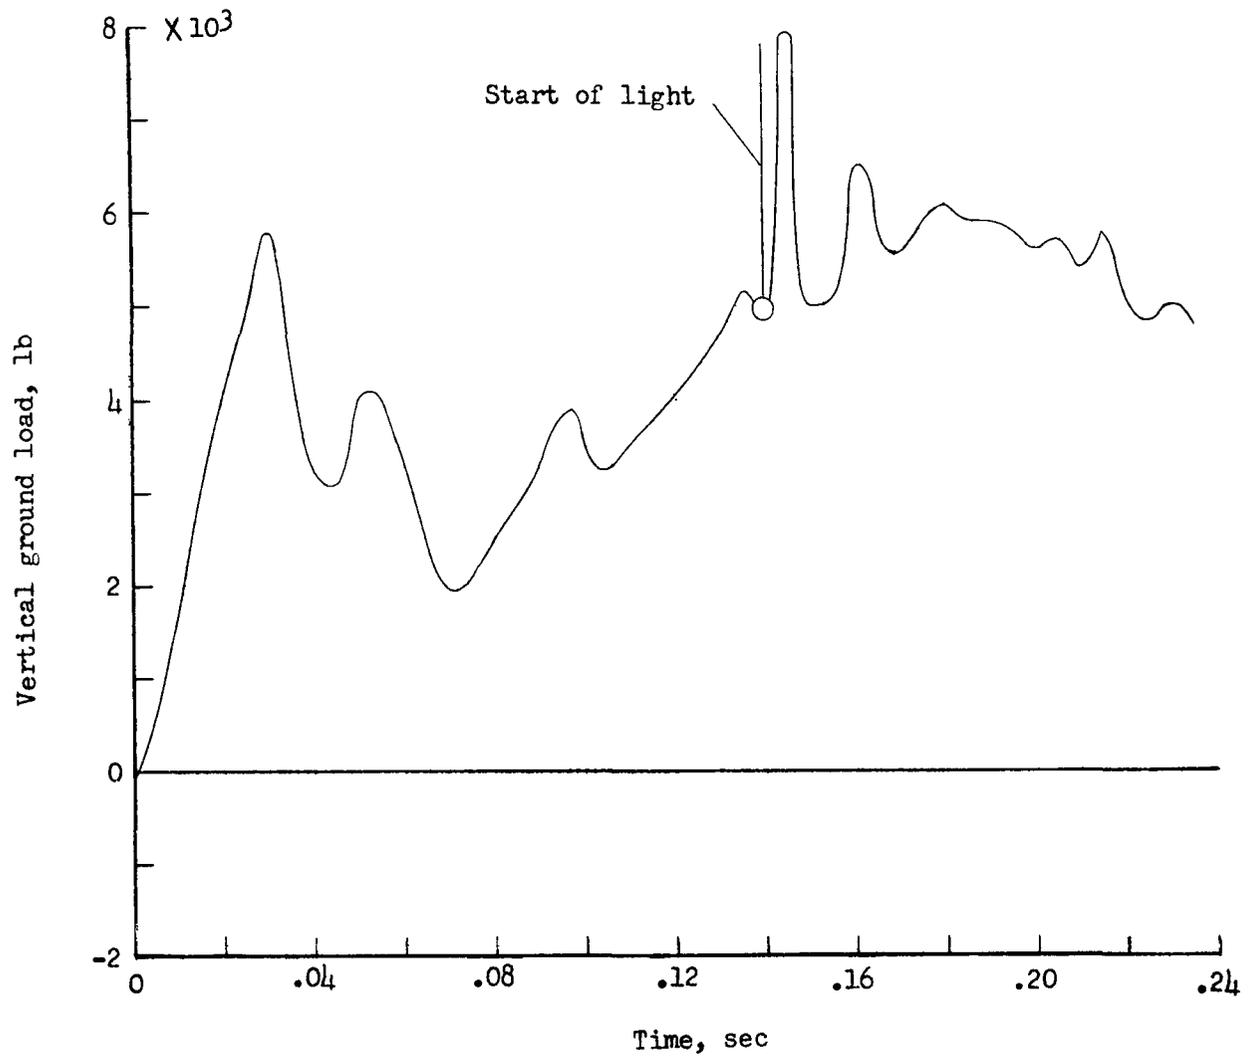
Figure 21.- Time history of vertical load obtained on F-94C nose landing gear during landing impact on Westinghouse light (test 36).

Westinghouse light.- The values in table II and figure 21 show that the maximum vertical load developed during a landing impact on the normal Westinghouse light installation is approximately the same as those obtained for the unyawed Elfaka light. The tables also indicate that the maximum vertical loads developed during taxi tests over this light were almost as large as the maximum impact loads obtained during the landing tests made on plain concrete. Figure 22(a) shows the large lower mass vertical acceleration obtained during one of these tests and indicates that these loads are primarily caused by the rapid rise experienced by the wheel while rolling over the light. It can be seen in figure 22(b) that raising the light $5/8$ inch caused some increase in the vertical and drag loads; however, the most significant result was the large increase in the upper mass vertical accelerations.

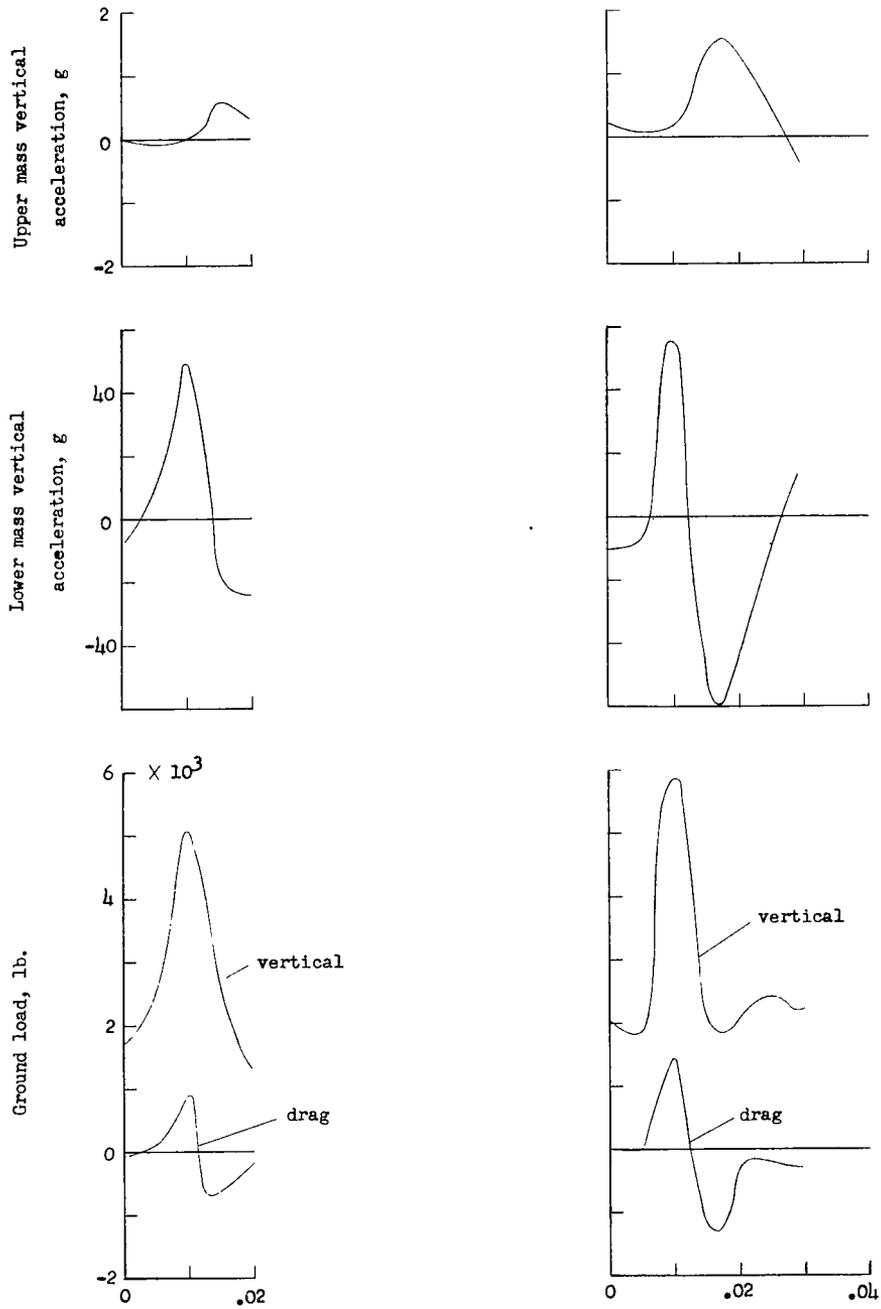
(a) Normal installation, test 32. (b) Raised 5/8 inch, test 38.

Figure 22.- Time histories of loads and vertical accelerations obtained on F-94C nose landing gear during taxi test over the normal and raised Westinghouse light installations.

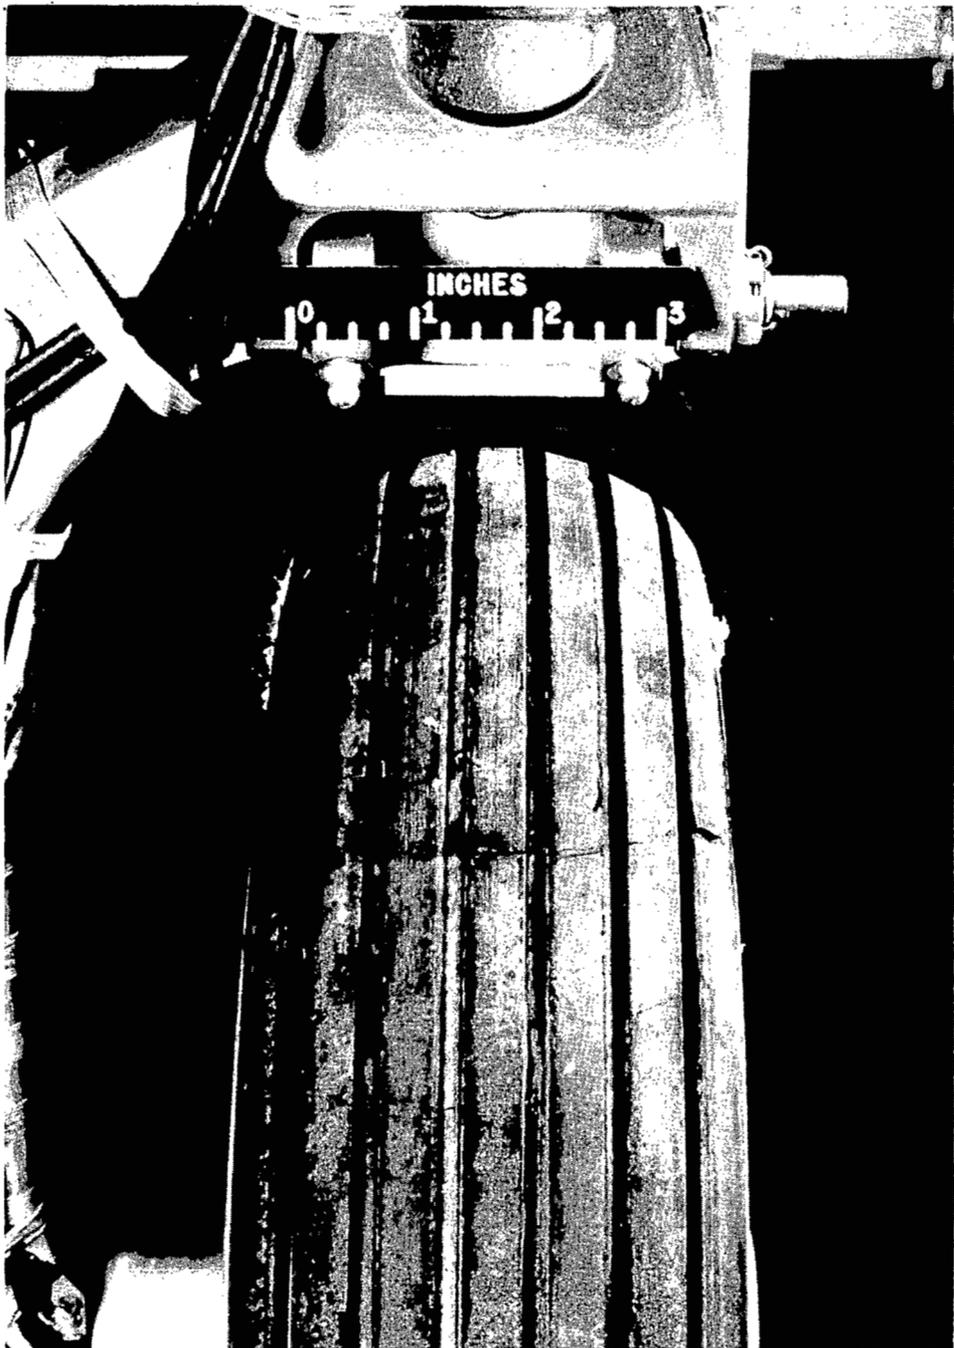
L-57-3669
Figure 23.- Cut in F-94C nose gear tire caused by taxiing over
AGA expendable-top light.

AGA expendable-top edge light.- One taxi test was made over the AGA expendable top light. The loads developed in the landing gear while rolling over this light were small, however, some tire damage occurred during this run. Figure 23 is a photograph of the tire taken immediately after the run and shows the cuts caused by rolling over this light. Figure 24 is a photograph of the light taken immediately after the test.

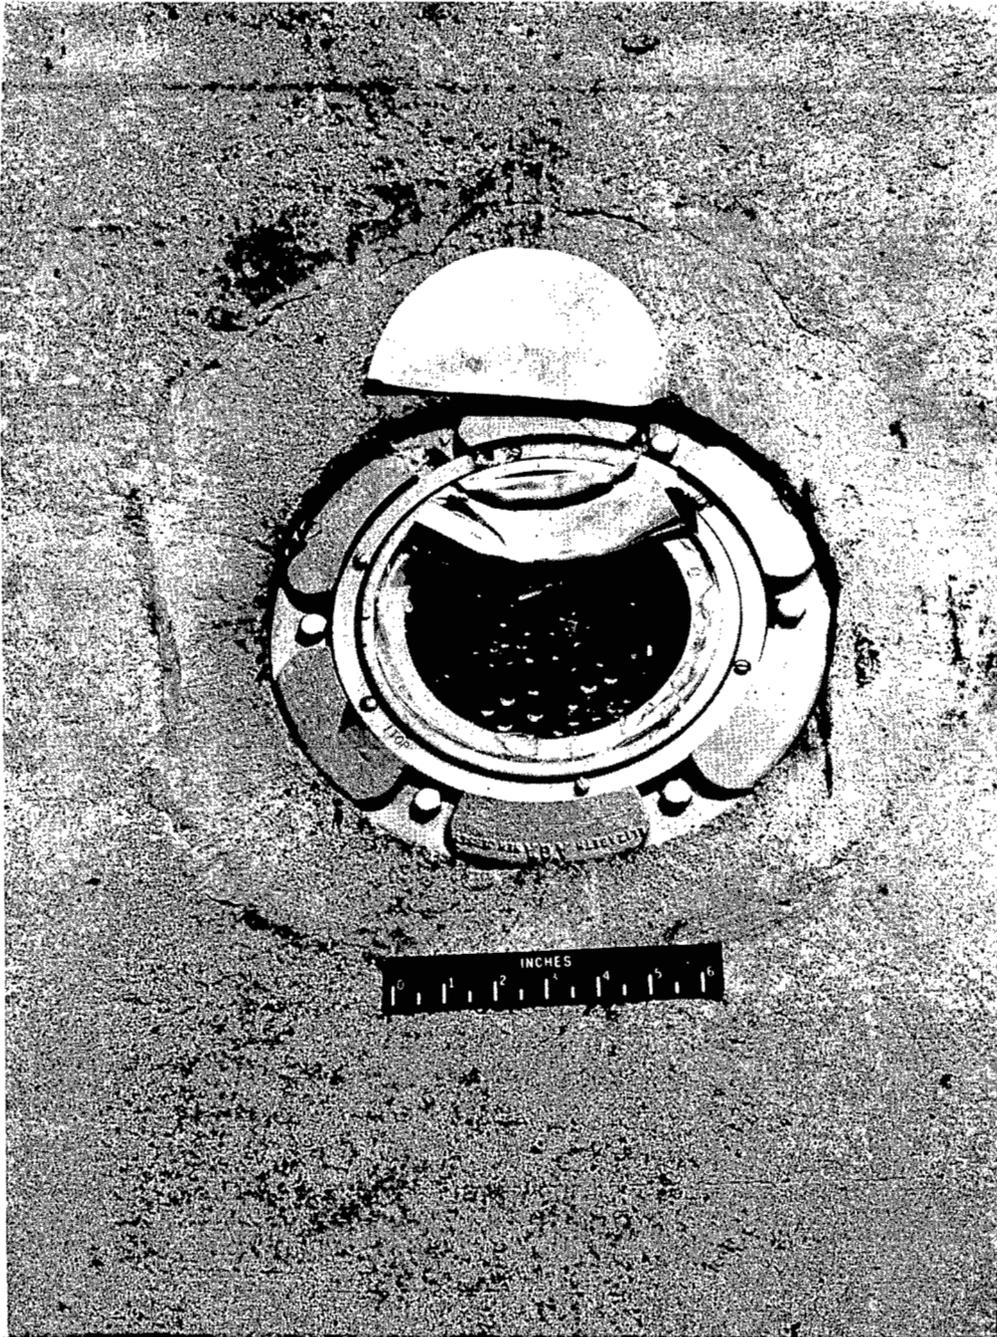
Figure 24.- AGA expendable-top light after F-94C nose wheel roll-over test. L-57-3672

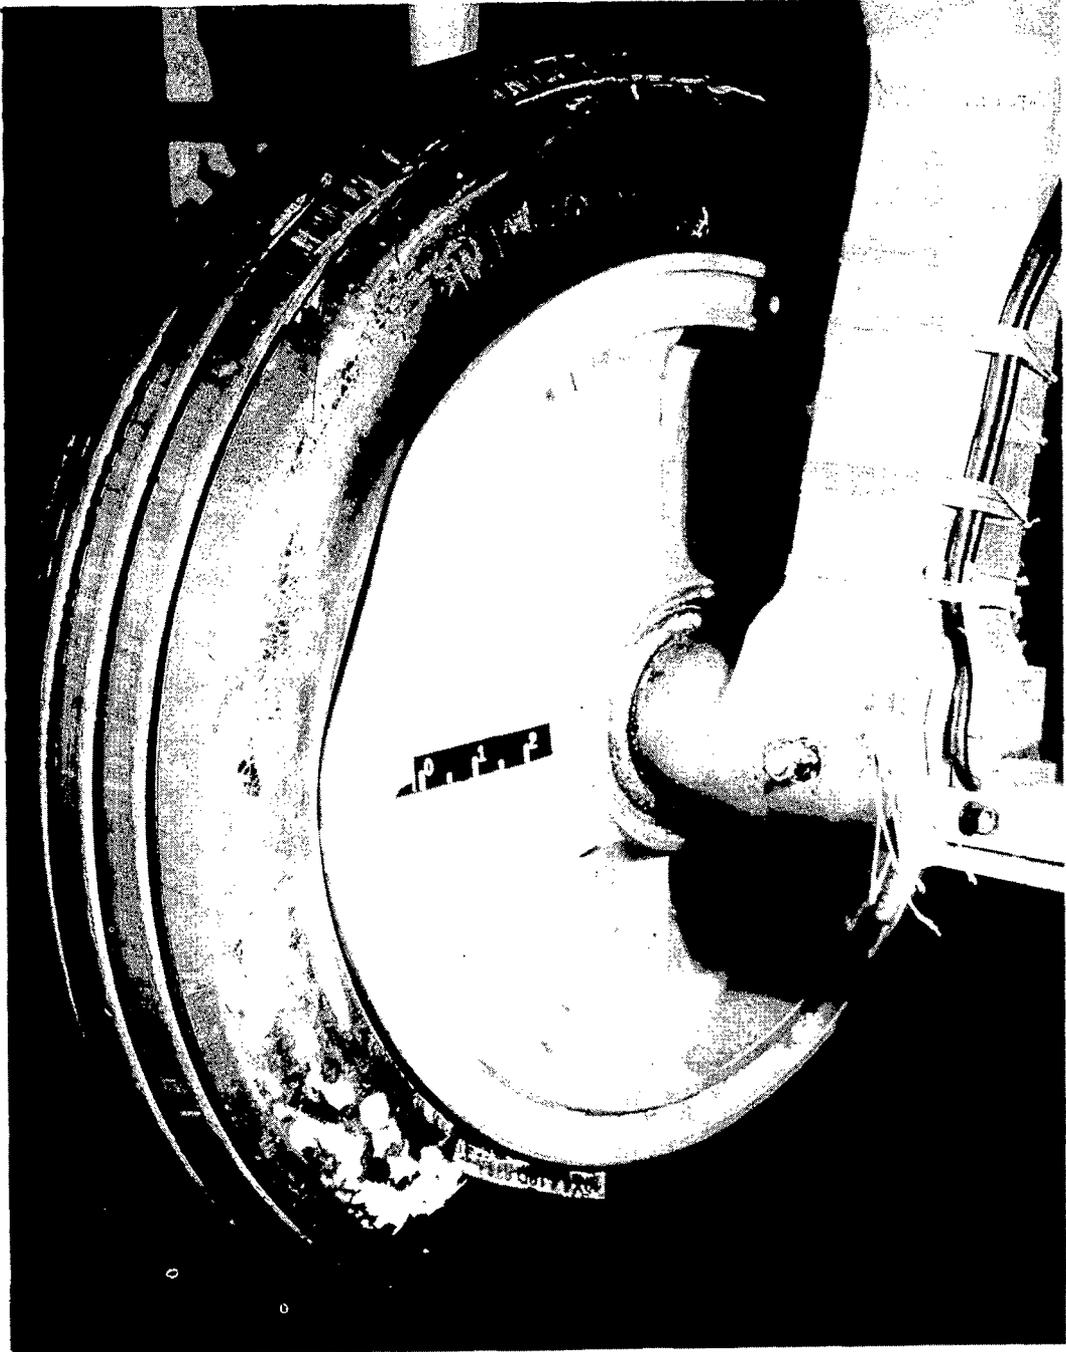
L-57-3717
Figure 25.- View of damage sustained by F-94C nose wheel after striking AN-L-9 light.

ANL-9 edge light.- One taxi test was made over the ANL-9 semiflush light. During this run the rim of the landing gear wheel was bent while passing over the light. Figure 25 is a photograph of the wheel damage which occurred during the run.

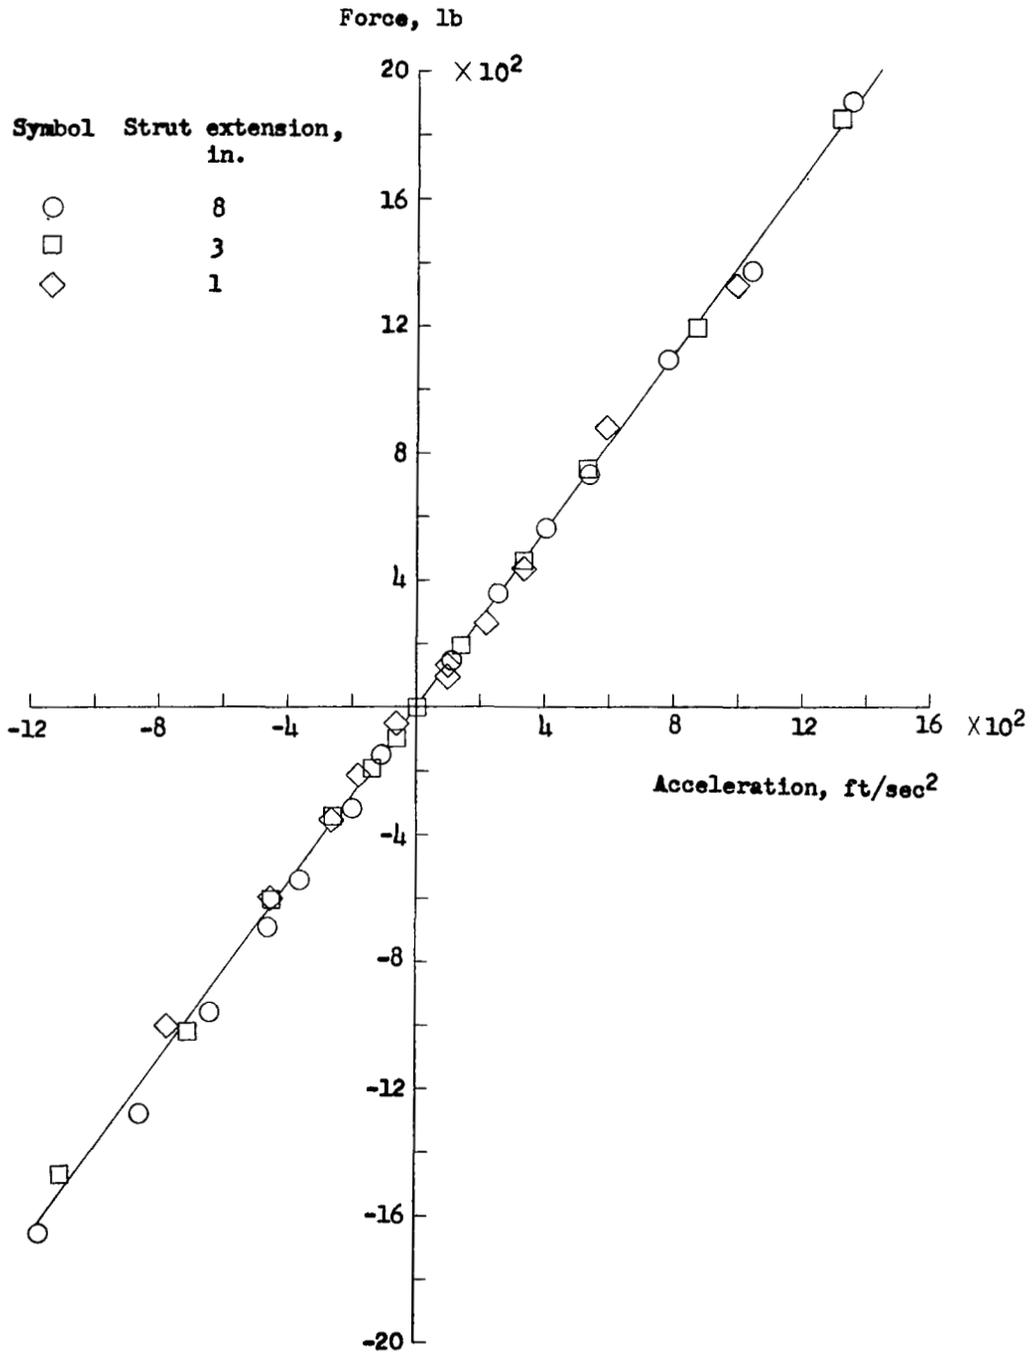
Figure 26.- Variation of horizontal component of force in drag strut with horizontal acceleration of axle during free vibration tests of F-94C nose landing gear.

The apparatus shown in figure 10 was set up with the tire clear of the ground and the landing gear vertical. A drag load was applied to the wheel axle and suddenly released. During the ensuing vibration, measurements were obtained of the lower mass acceleration and the load in the drag strut. The values of the horizontal component of load in the drag strut were plotted against axle accelerations obtained at the same time. These data are shown in figure 26. The slope of the line indicates the value of the effective lower mass acting in the drag direction. Figure 26 shows that this value was, for all practical purposes, independent of shock strut displacement.
