FLIGHT MEASUREMENTS OF LATERAL AND DIRECTIONAL  
STABILITY AND CONTROL CHARACTERISTICS  
OF THE GRUMMAN F8F-1 AIRPLANE

TED NO. NACA 2379

H. L. Crane and J. P. Reeder

Langley Memorial Aeronautical Laboratory  
Langley Field, Va.

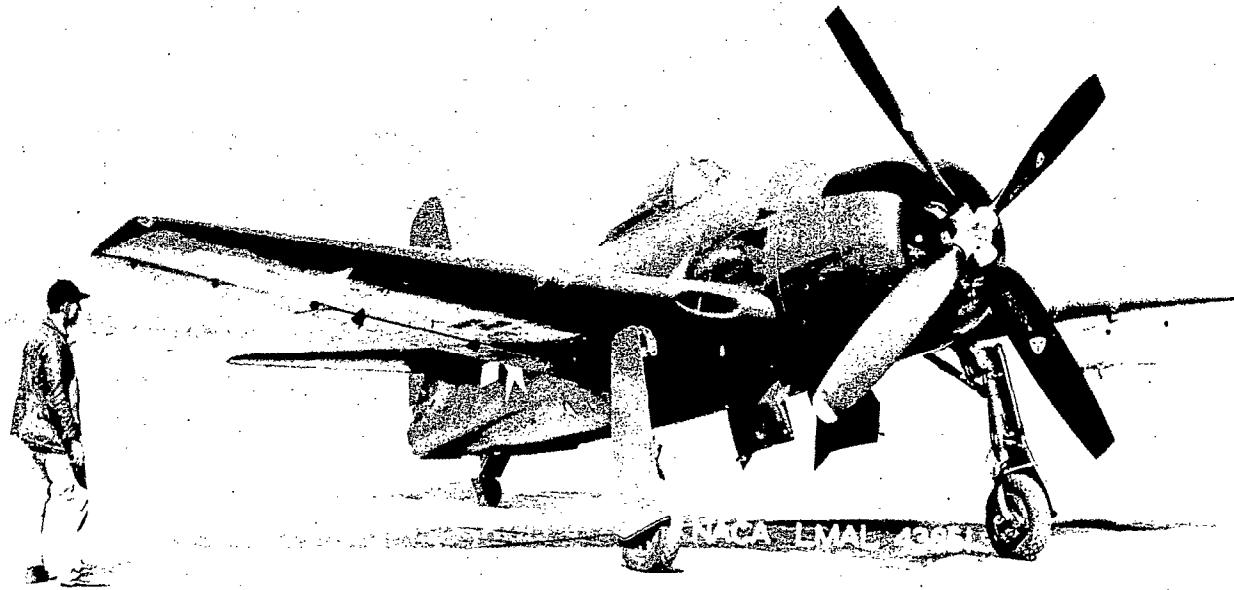
(a) Without belly tank.

Figure 1.- Three-quarter front view of Grumman XF8F-1 airplane.

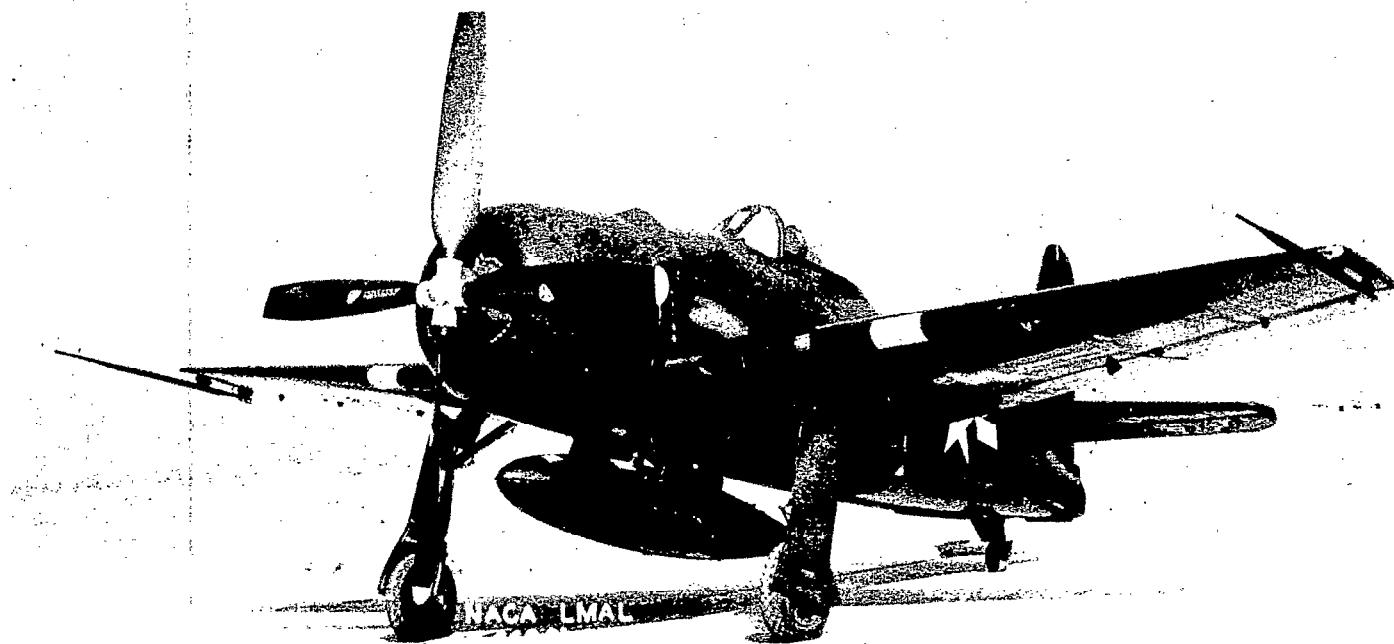
(b) With belly tank.

Figure 1.- Concluded.

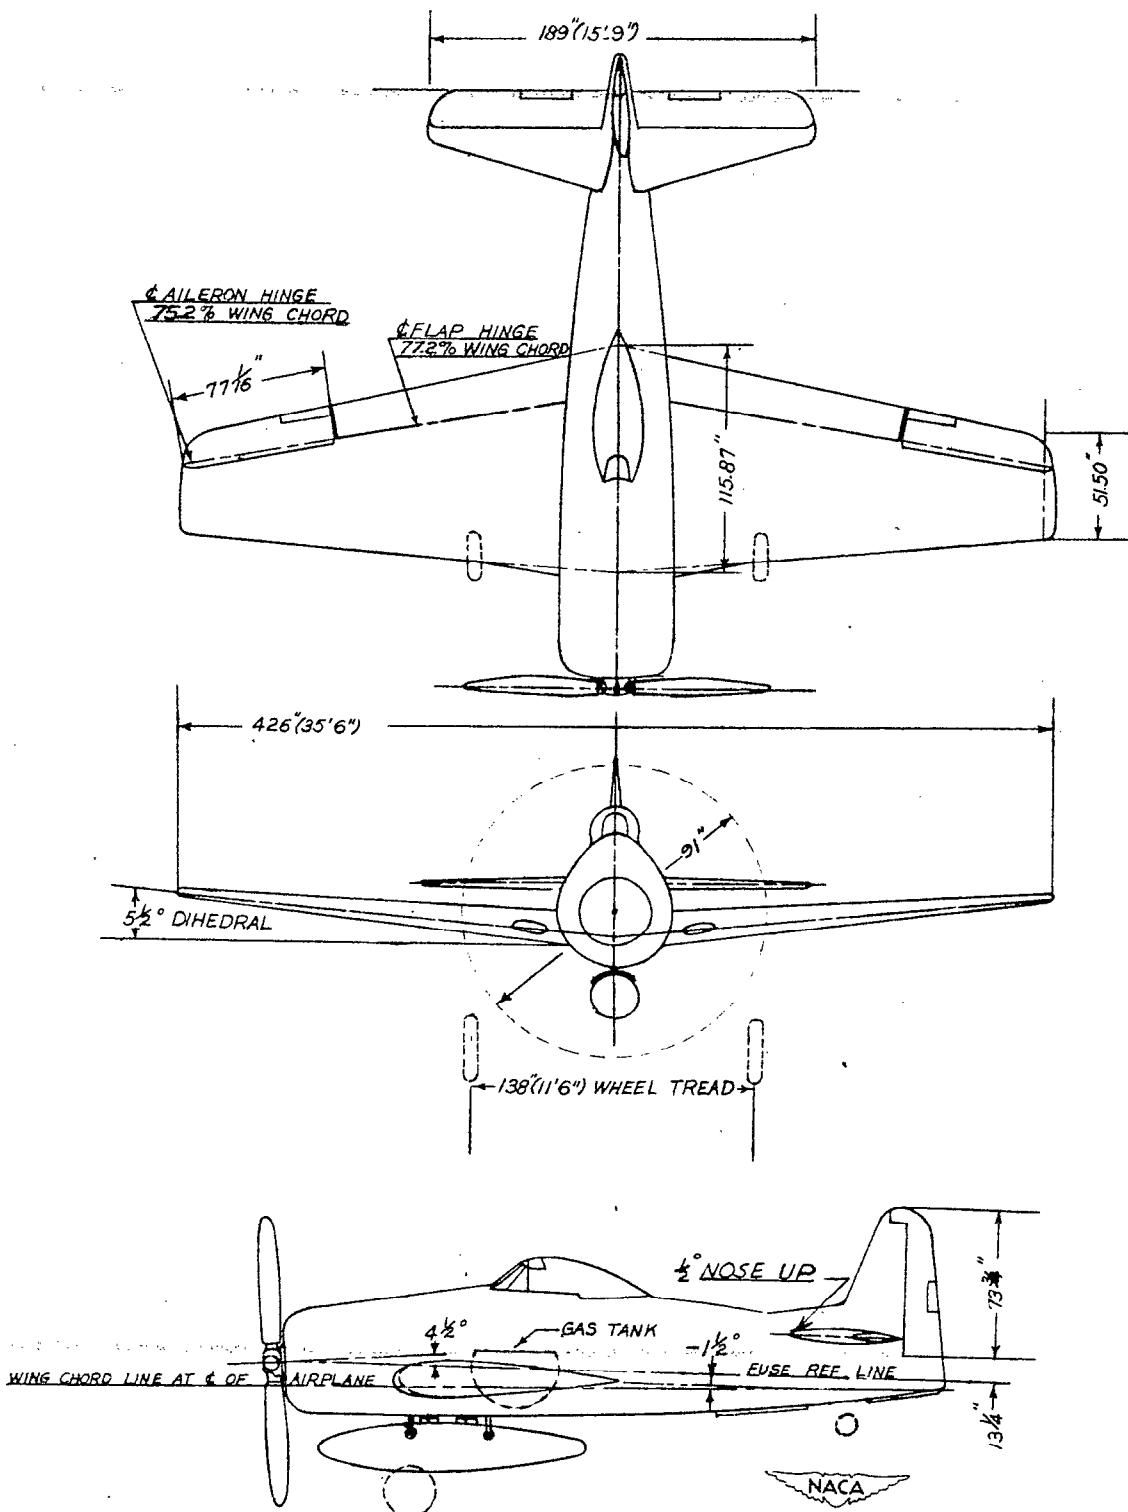
(a) Three-view drawing with tail configuration number 1.

Figure 2.- Drawings of F8F-1 airplane.

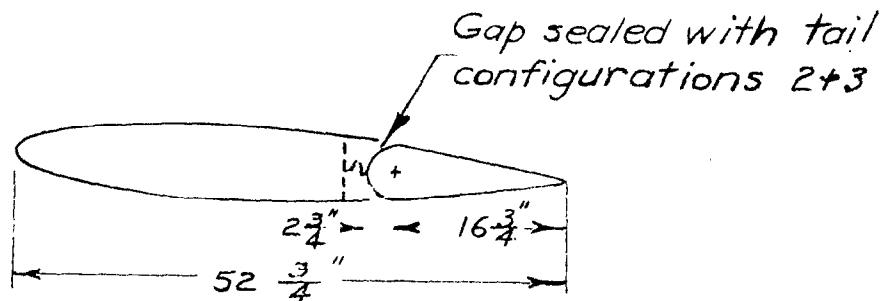
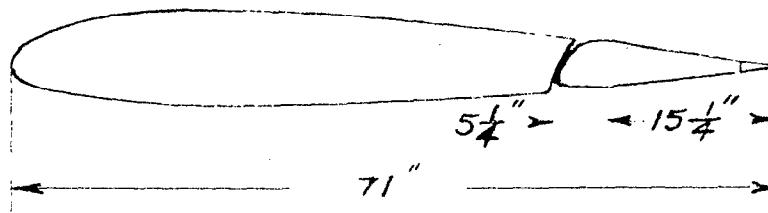
Vertical tail, 21 inches above fuselage reference line

Horizontal tail, 15 inches from center line

Wing and aileron, 64 inches from tip.

(b) Section views through aerodynamic surfaces of F8F-1 airplane.

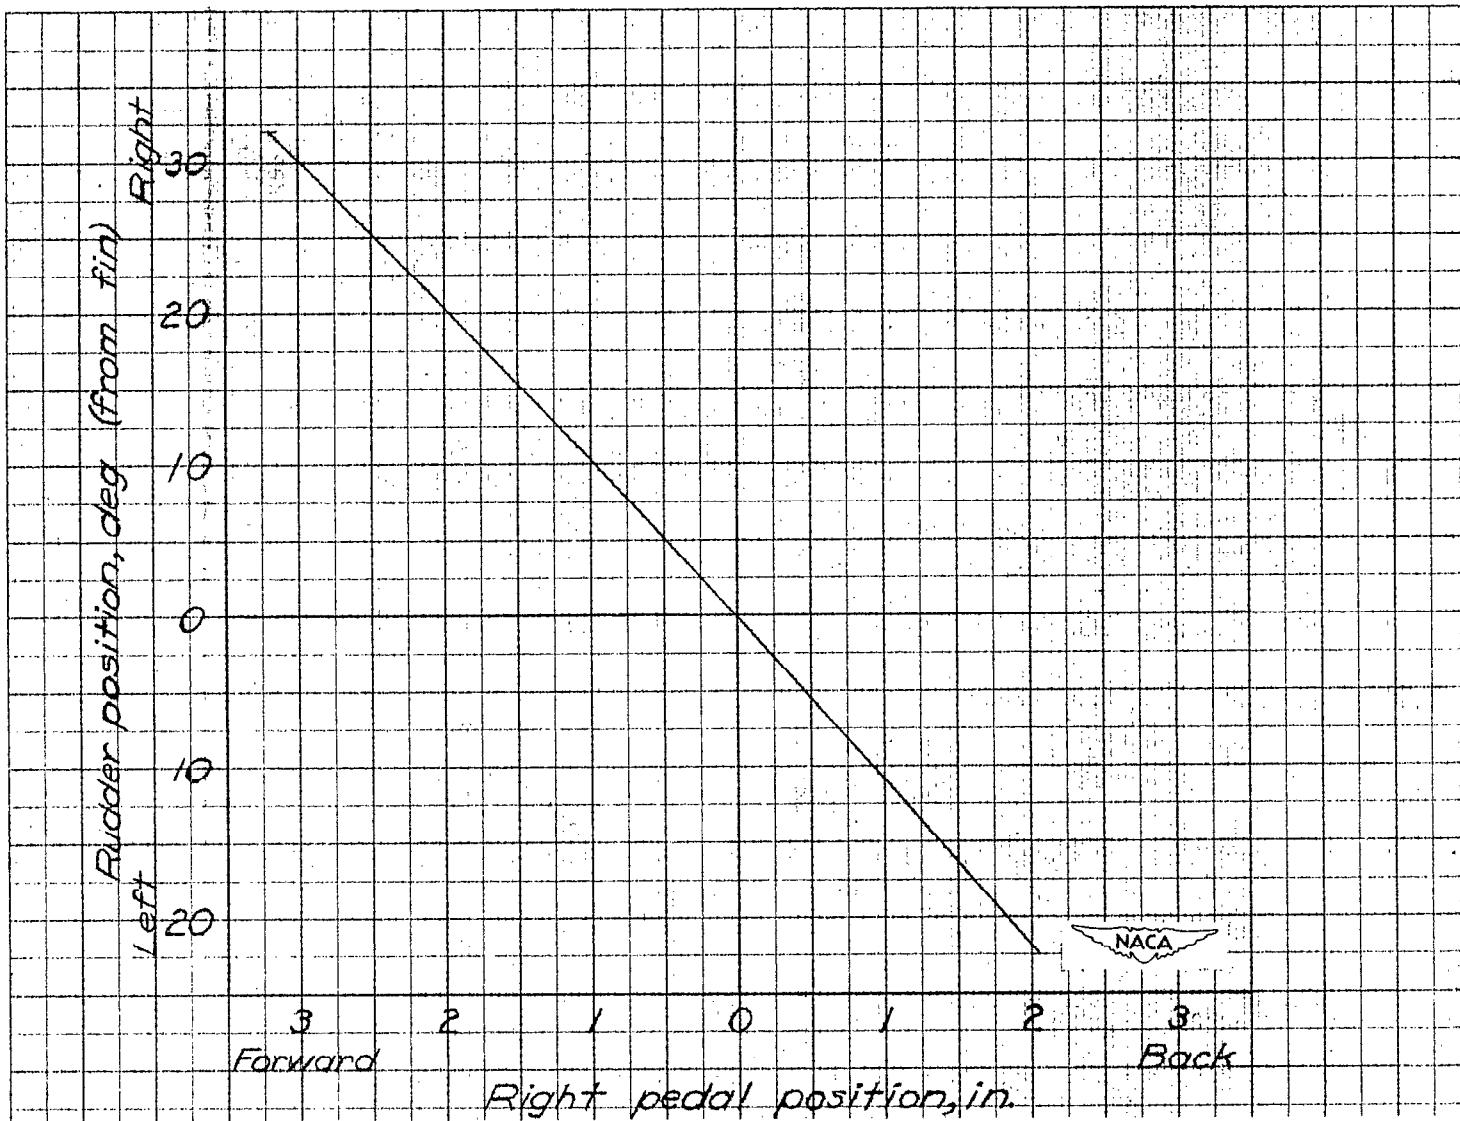
Figure 3.- Linkage between rudder and rudder pedal, F8F-1 airplane.

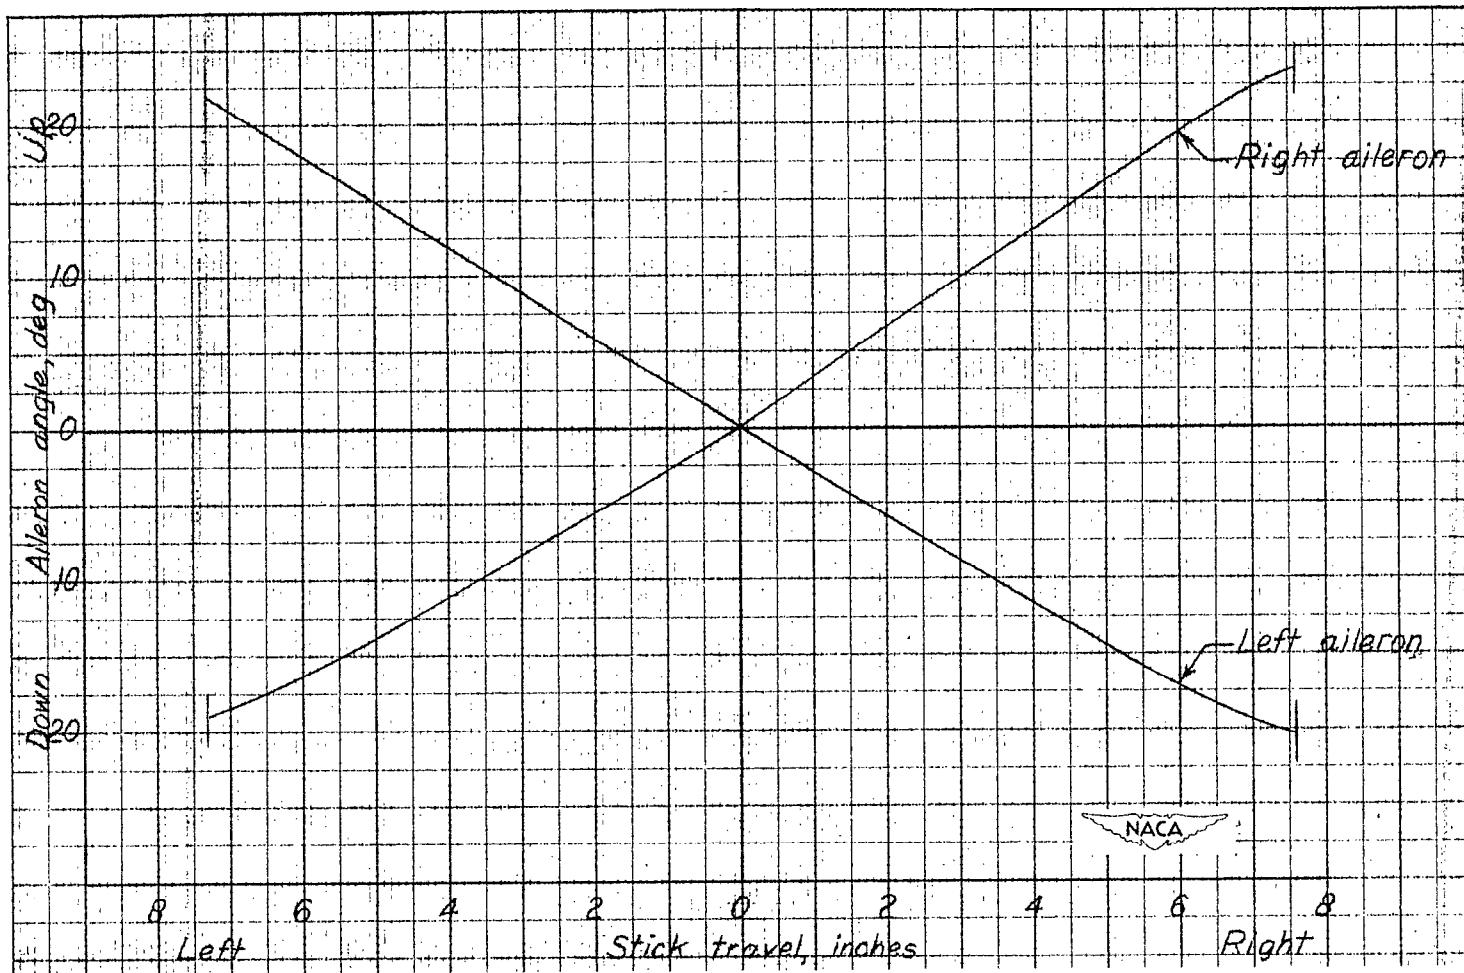
(a) Variation of aileron deflection with stick position  
(no aerodynamic load).

Figure 4.- Characteristics of the aileron control system of an F8F-1 airplane (Bu. Aero. No. 90461).

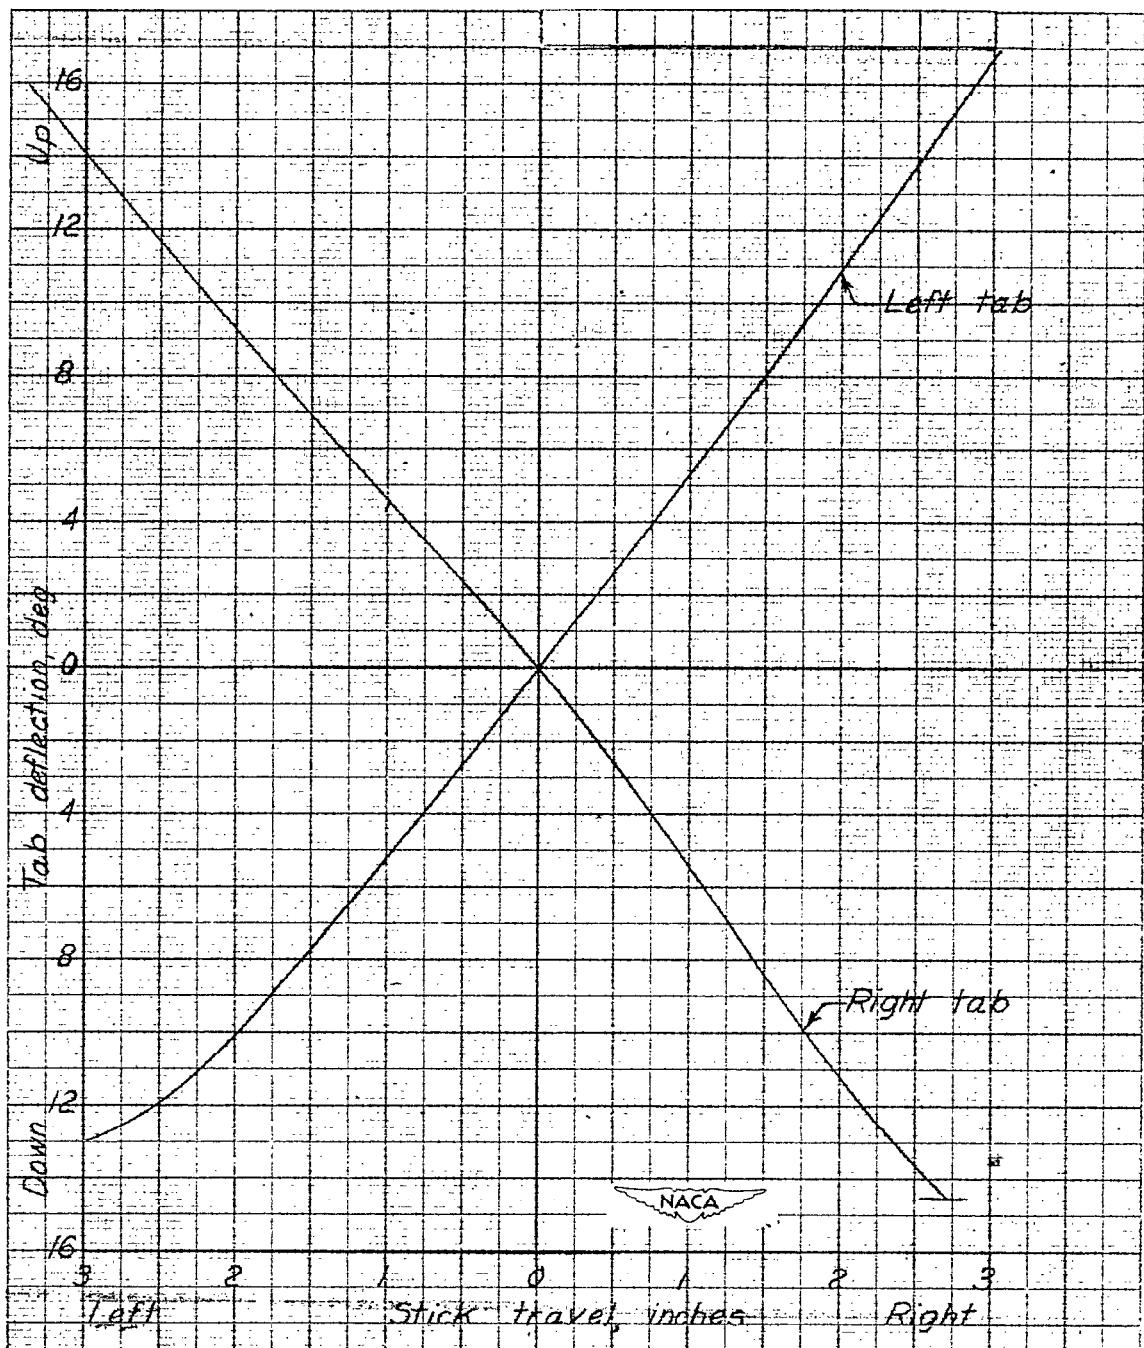
- (b) Variation of aileron-spring-tab deflection with stick position with ailerons locked.

Figure 4.- Continued.

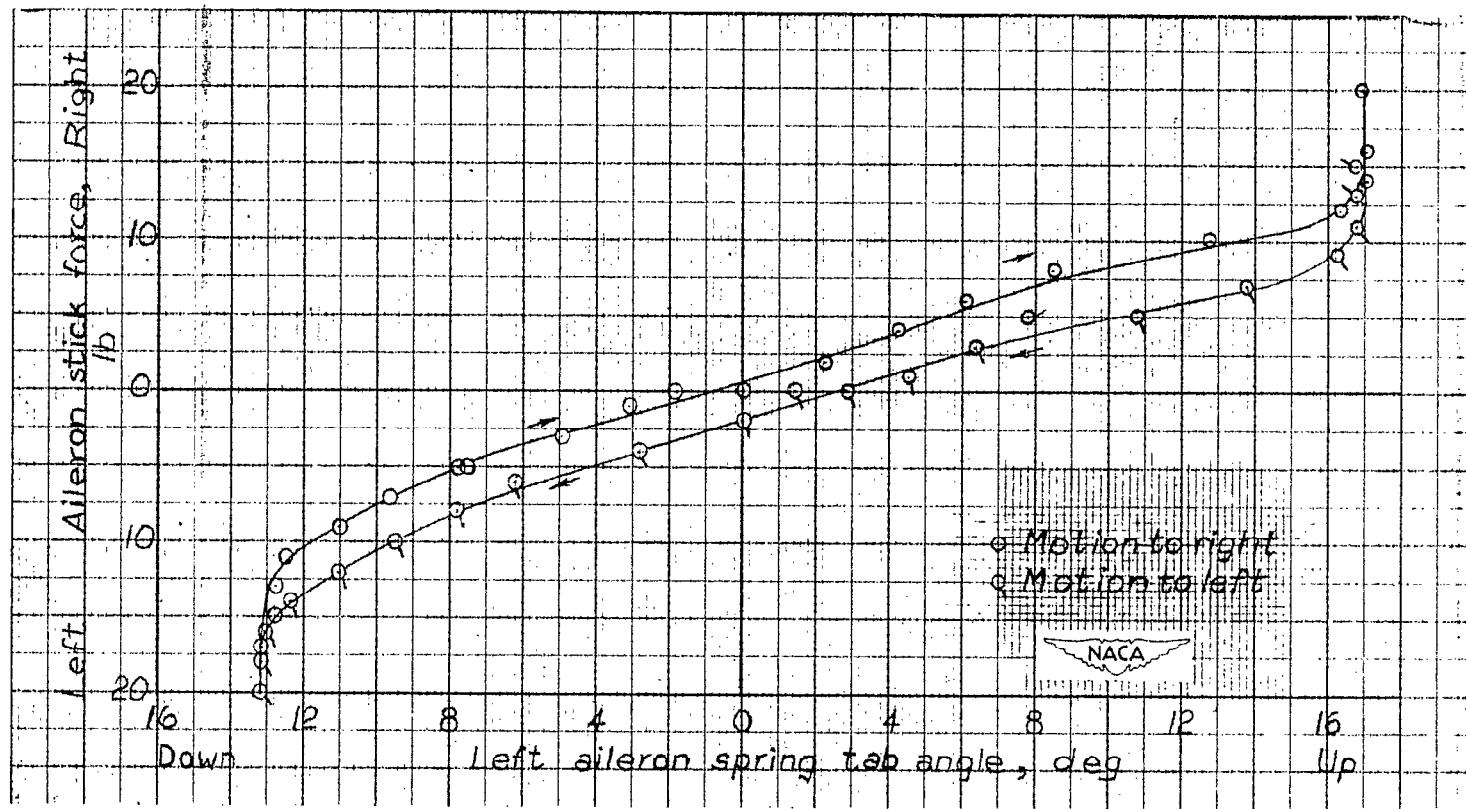
(c) Variation of left aileron-spring-tab deflection with stick force with left aileron fixed.

Figure 4.- Continued.

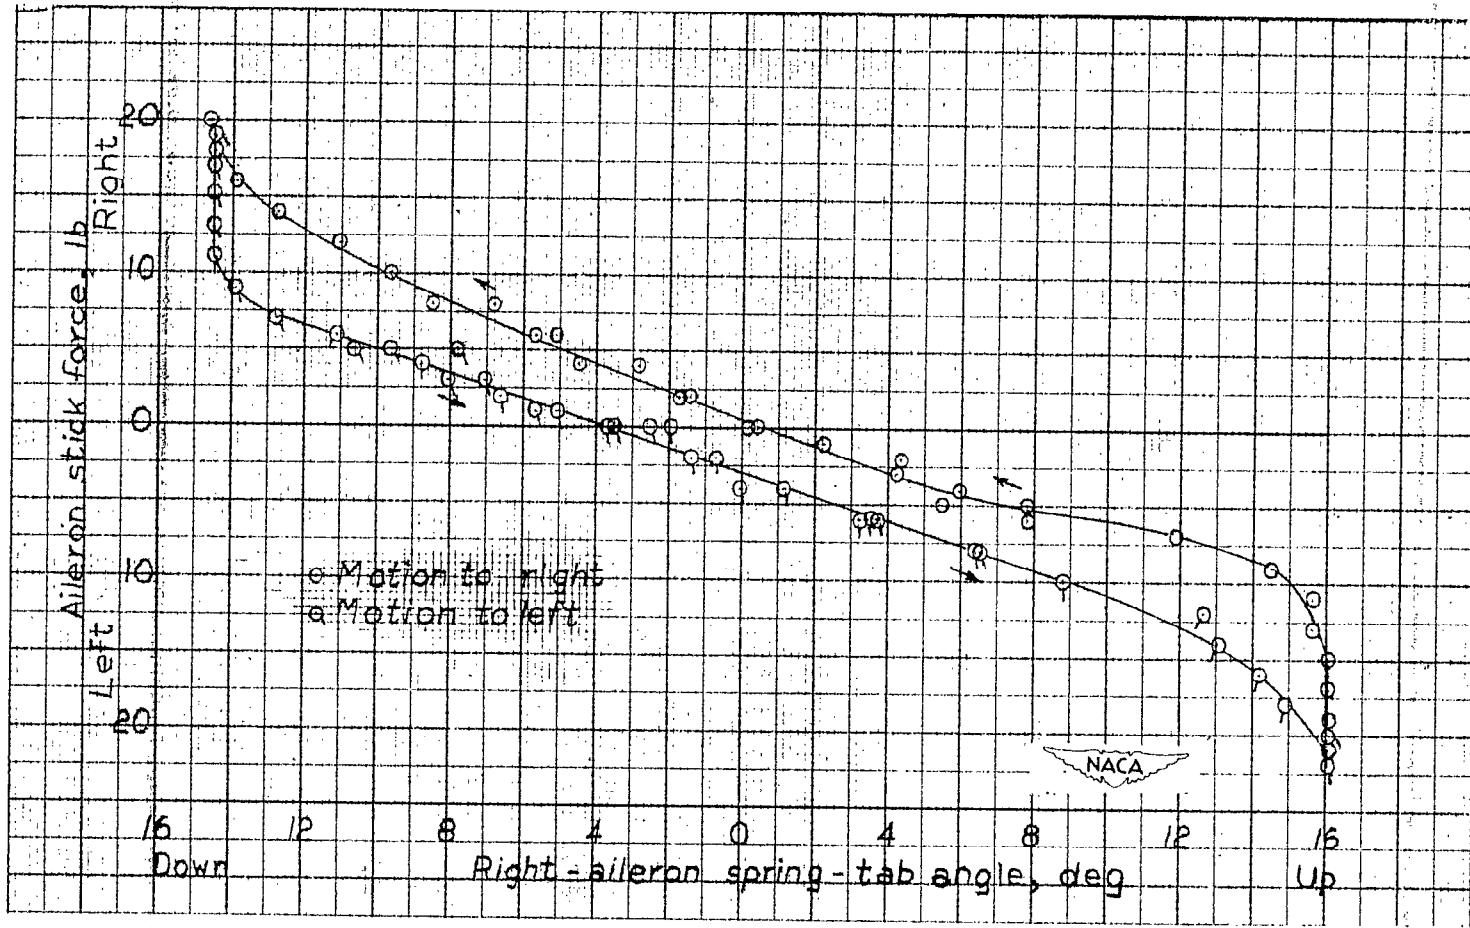
(d) Variation of right aileron-spring-tab deflection with stick force with right aileron fixed.

Figure 4.- Concluded.

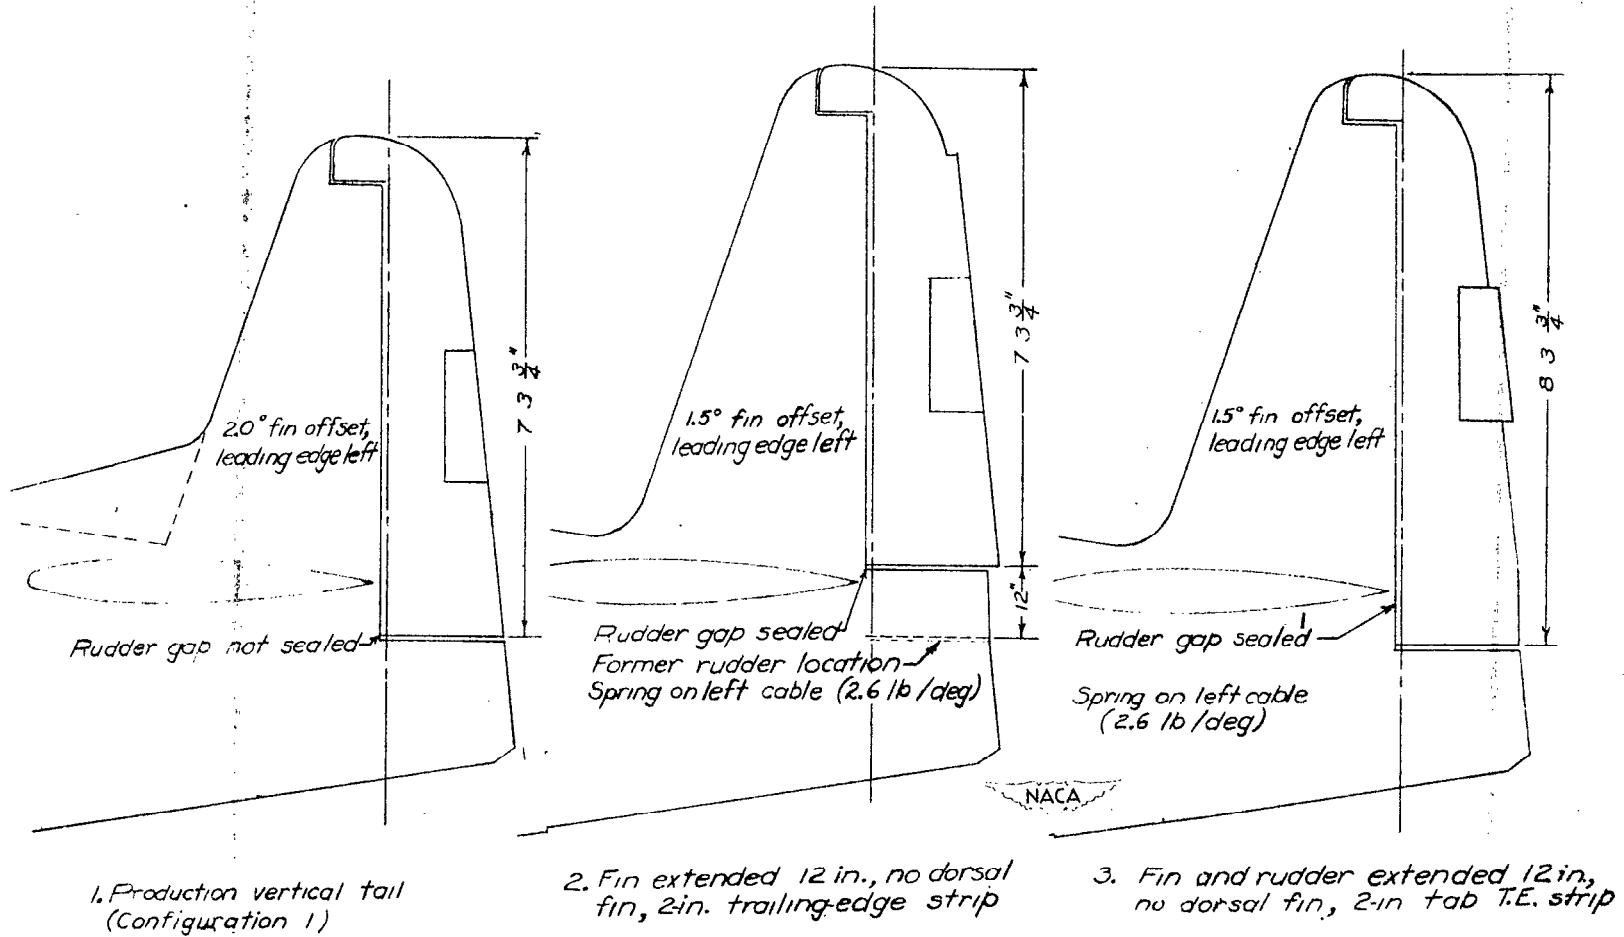
(a) Plan view.

Figure 5.- Sketches of the three tail configurations.

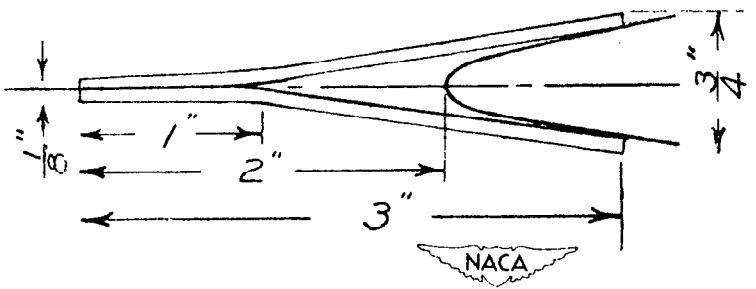
(b) Sketch of rudder trailing-edge extension used on tail configuration 2.

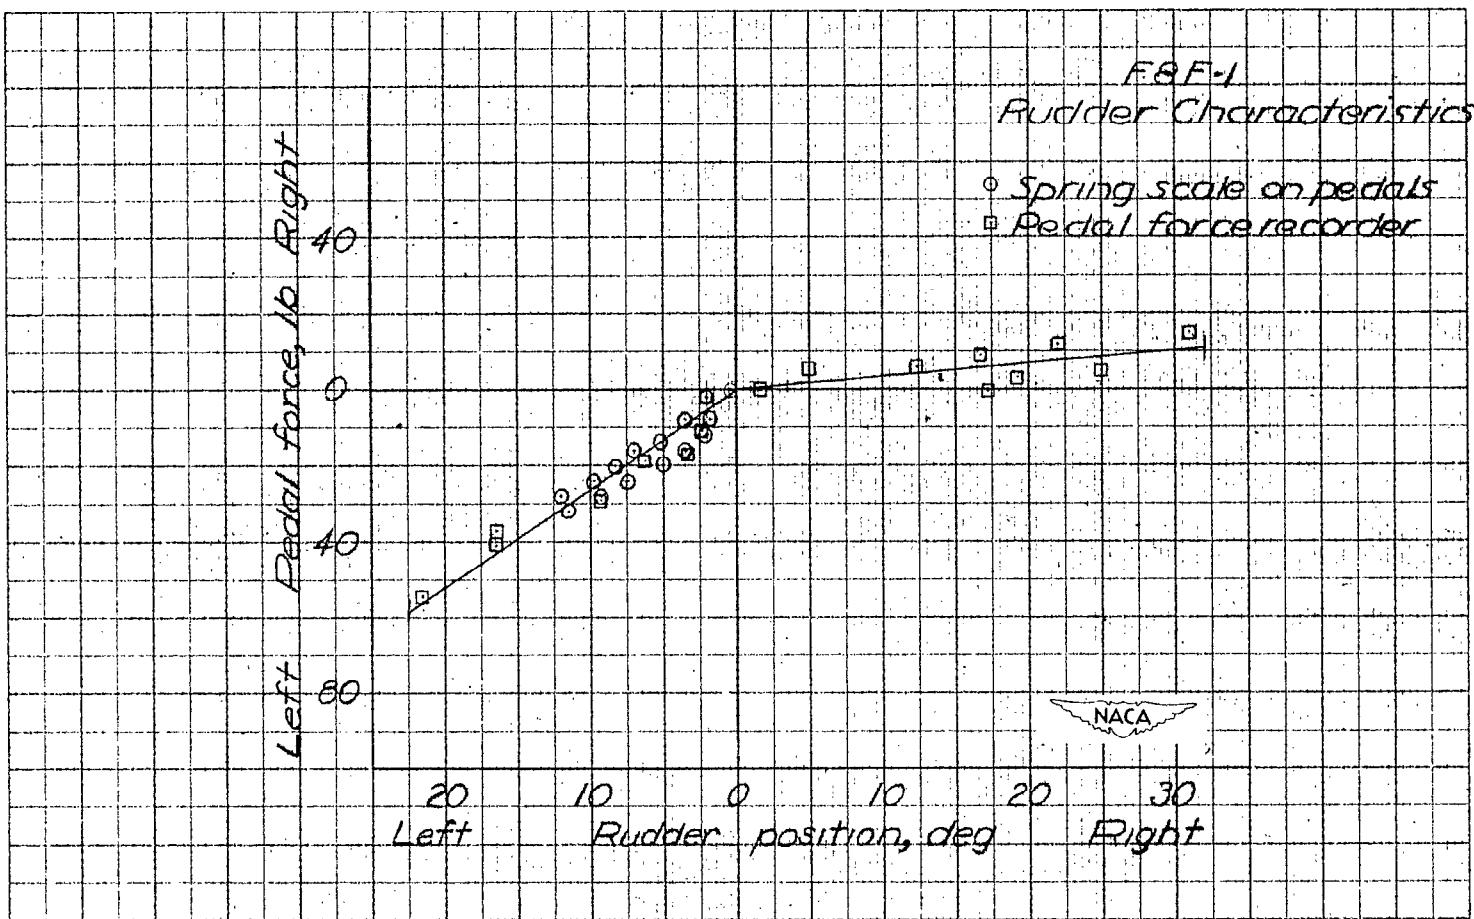
Figure 6.- Variation of rudder pedal force with rudder position, F8F-1 airplane (BuAero No. 94873) with spring on left rudder cable.

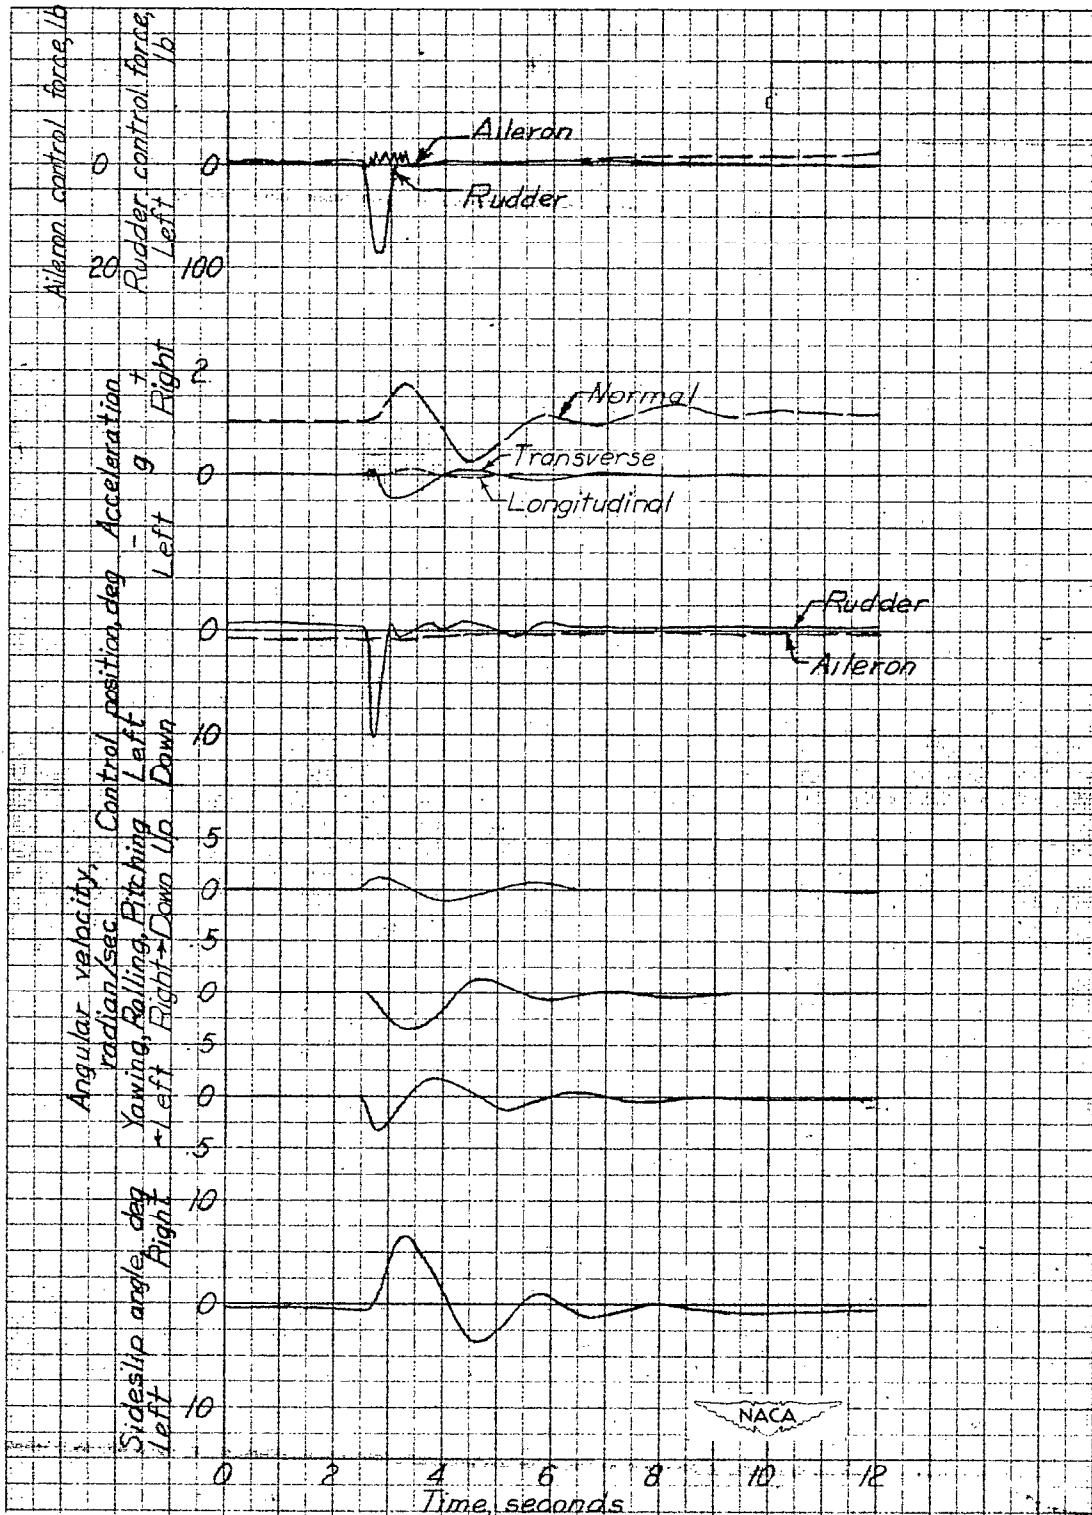
Figure 7.- Oscillations of F8F-1 airplane in the clean condition with power for level flight at 290 miles per hour at an altitude of 5000 feet, caused by a left rudder kick and release. (Tail configuration 1, belly tank off.)

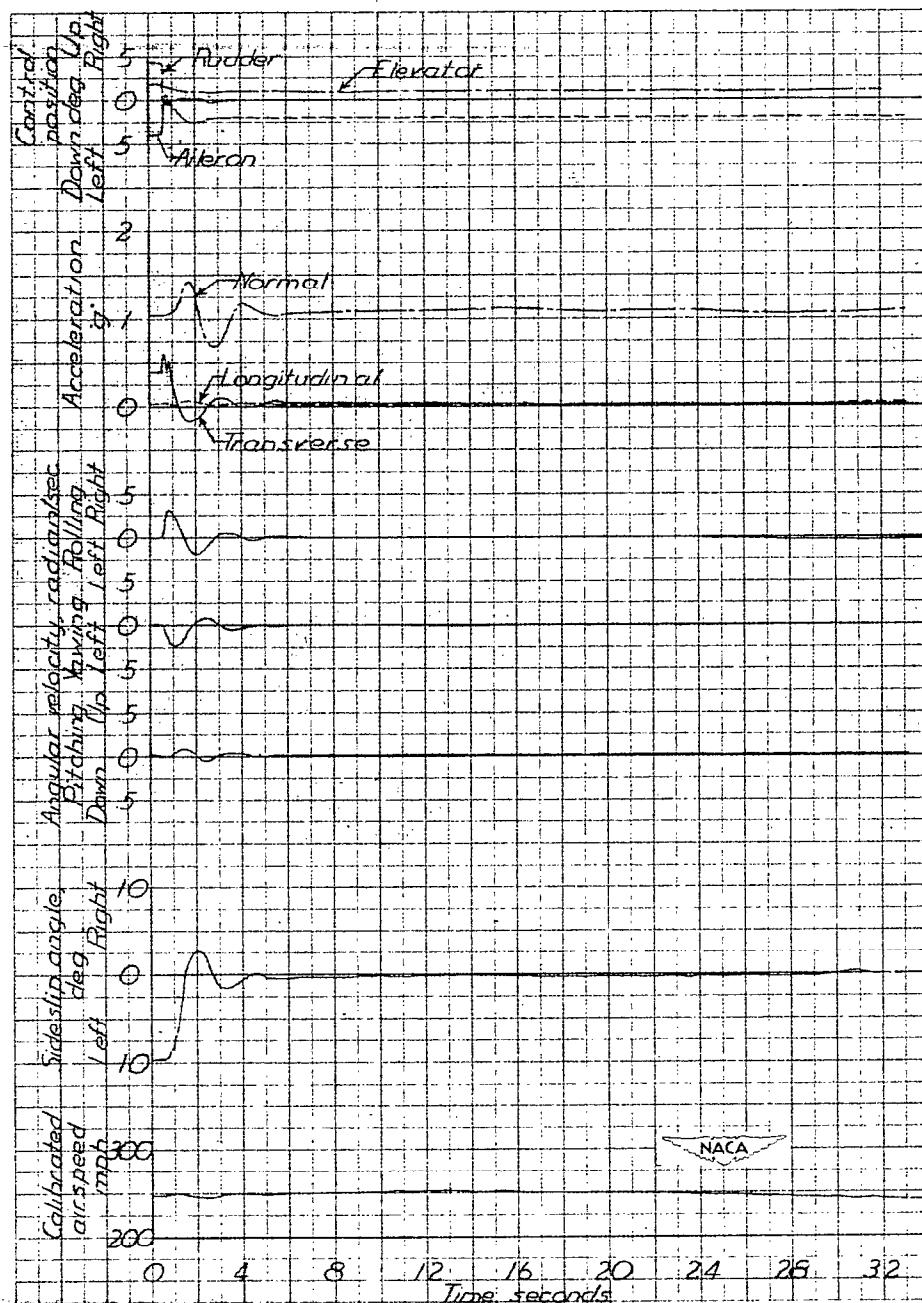
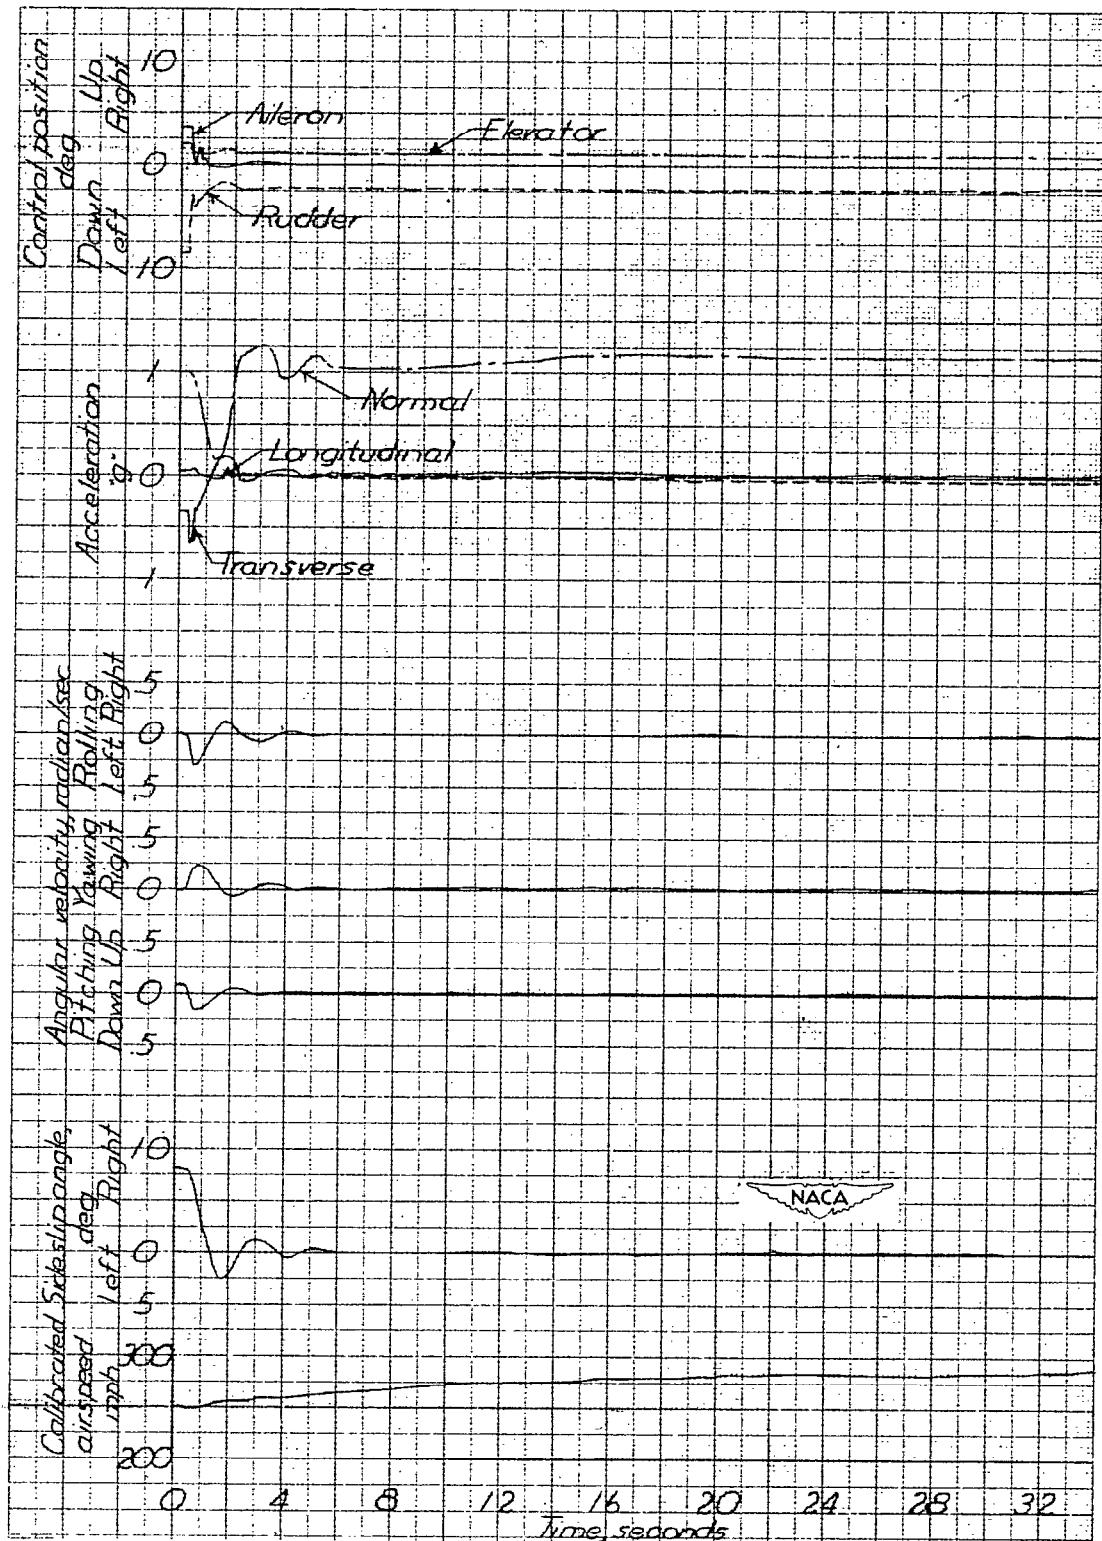
(a) From left sideslip.

Figure 8.- Oscillations of F8F-1 airplane in the clean condition with power for level flight at 250 miles per hour at an altitude of 5000 feet caused by releasing the controls in steady sideslips. (Tail configuration 3 with belly tank on.)

(b) From right sideslip.

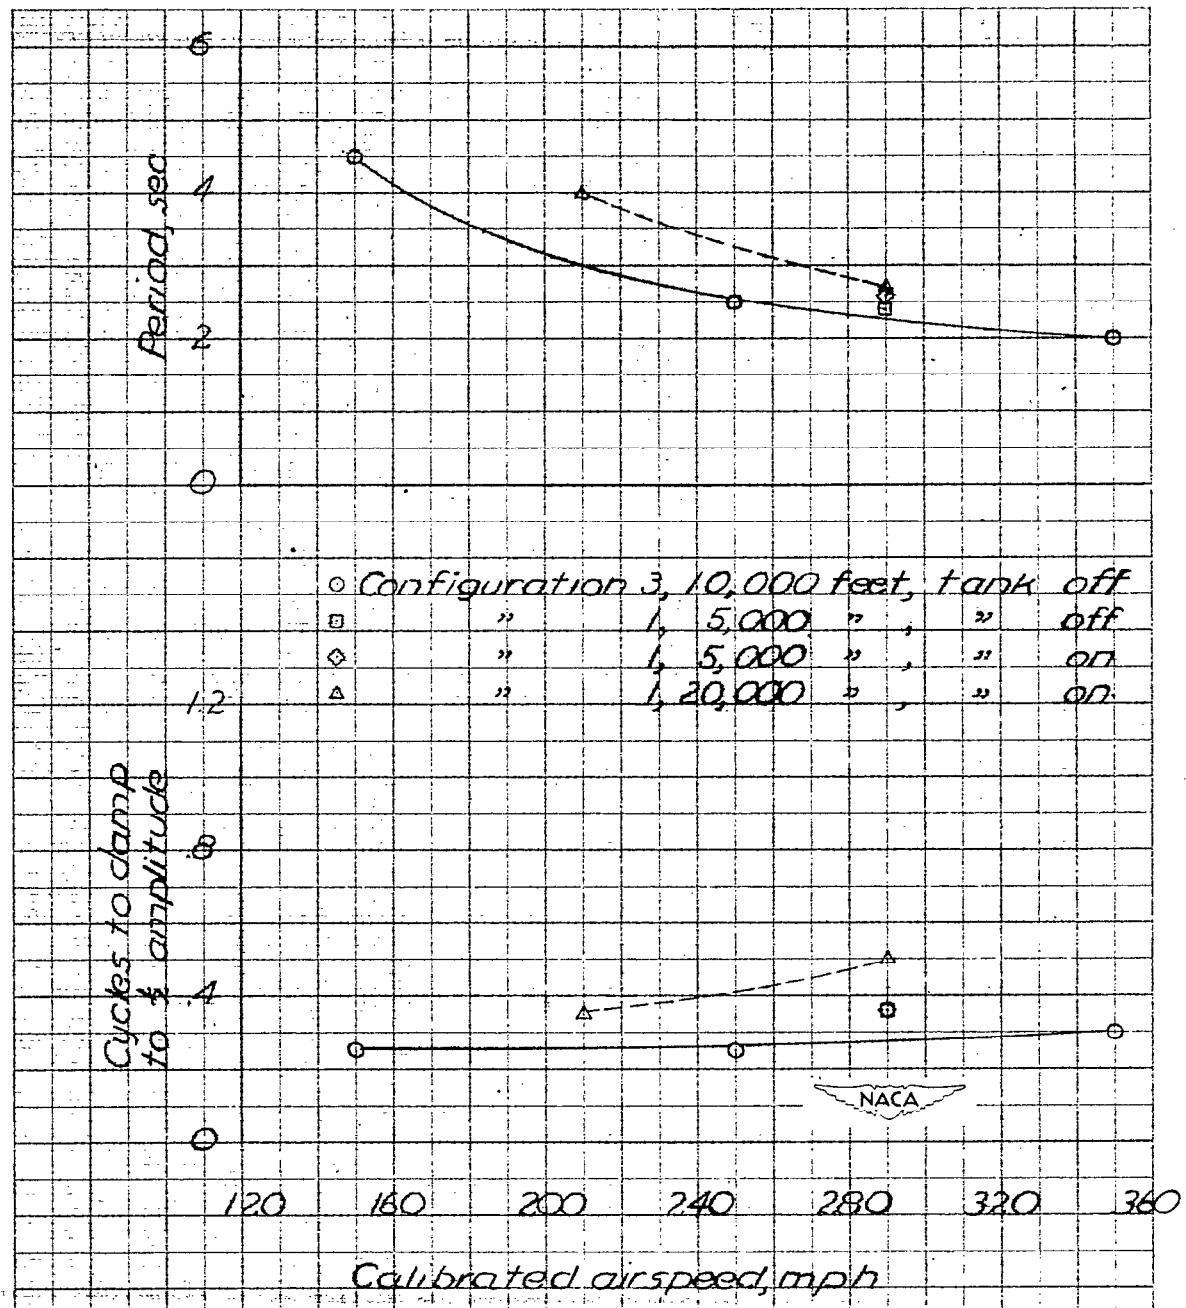
Figure 9.- Variation with speed of the period and rate of damping of lateral oscillations in the clean condition with power for level flight, F8F-1 airplane.

Control-free lateral oscillations were made to determine the effect of speed, altitude, of the belly tank, and vertical-tail configuration. These tests were made in the clean condition with power for level flight either by abrupt deflection and freeing of the rudder or by releasing the controls in steady sideslips. Figures 7 and 8 present time histories of typical oscillations of each type. Summary plots which show the period of the lateral oscillations and the number of cycles required to damp to one-half amplitude as a function of speed are shown in figure 9.

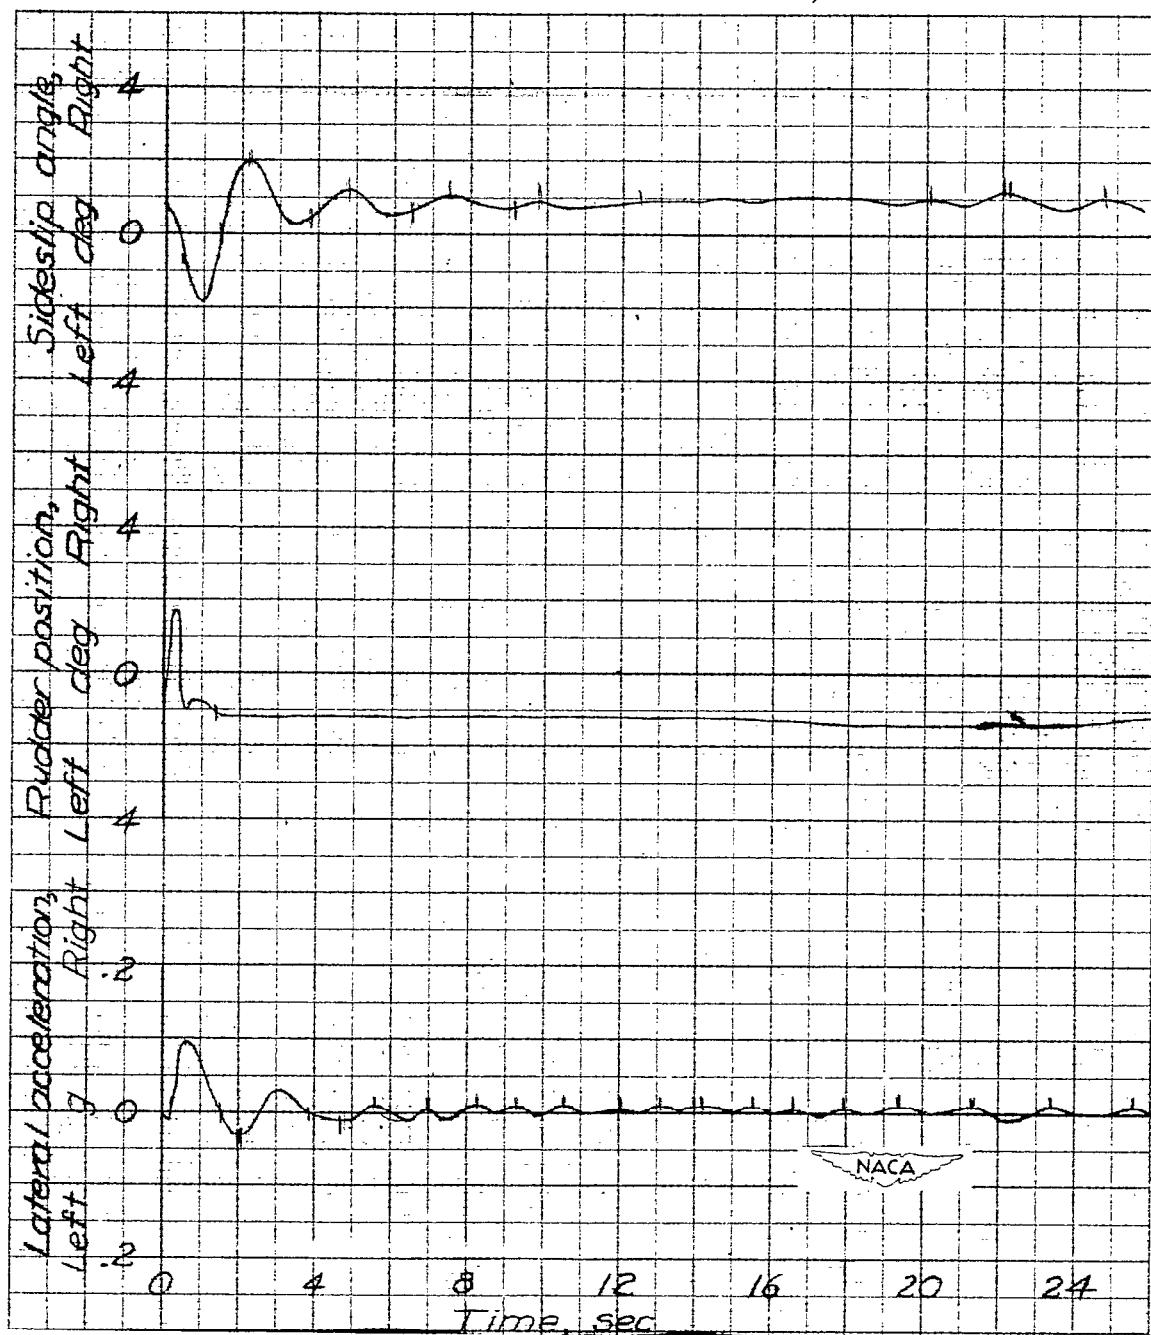
- (a) Induced by a rudder kick at 250 miles per hour with fuselage tank approximately half full and an empty belly tank installed.

Figure 10.- Time histories of lateral oscillations in smooth air due to fuel sloshing, F8F-1 airplane with tail configuration 3.

rudder kick and was obtained with an empty belly tank installed and with the fuselage tank approximately half full (at a speed of 250 miles per hour). In some cases the oscillation was noted mainly in terms of lateral acceleration (fig. 10(a)) and in other cases the oscillation occurred in the three measured components of acceleration (fig. 10(b))

Variations of propeller pitch and fuel sloshing were considered as possible causes of the oscillation. The first possibility was eliminated by obtaining the oscillation with the propeller set against the low-pitch stops. It was then found that the oscillation could be induced by a maneuver such as an abrupt turn entry. During the oscillation there was a fluctuation of the fuel gage which led to the conclusion that the oscillation was due to fuel sloshing.
