FLIGHT MEASUREMENTS OF LATERAL AND DIRECTIONAL  
STABILITY AND CONTROL CHARACTERISTICS  
OF THE GRUMMAN F8F-1 AIRPLANE

TED NO. NACA 2379

H. L. Crane and J. P. Reeder

Langley Memorial Aeronautical Laboratory  
Langley Field, Va.

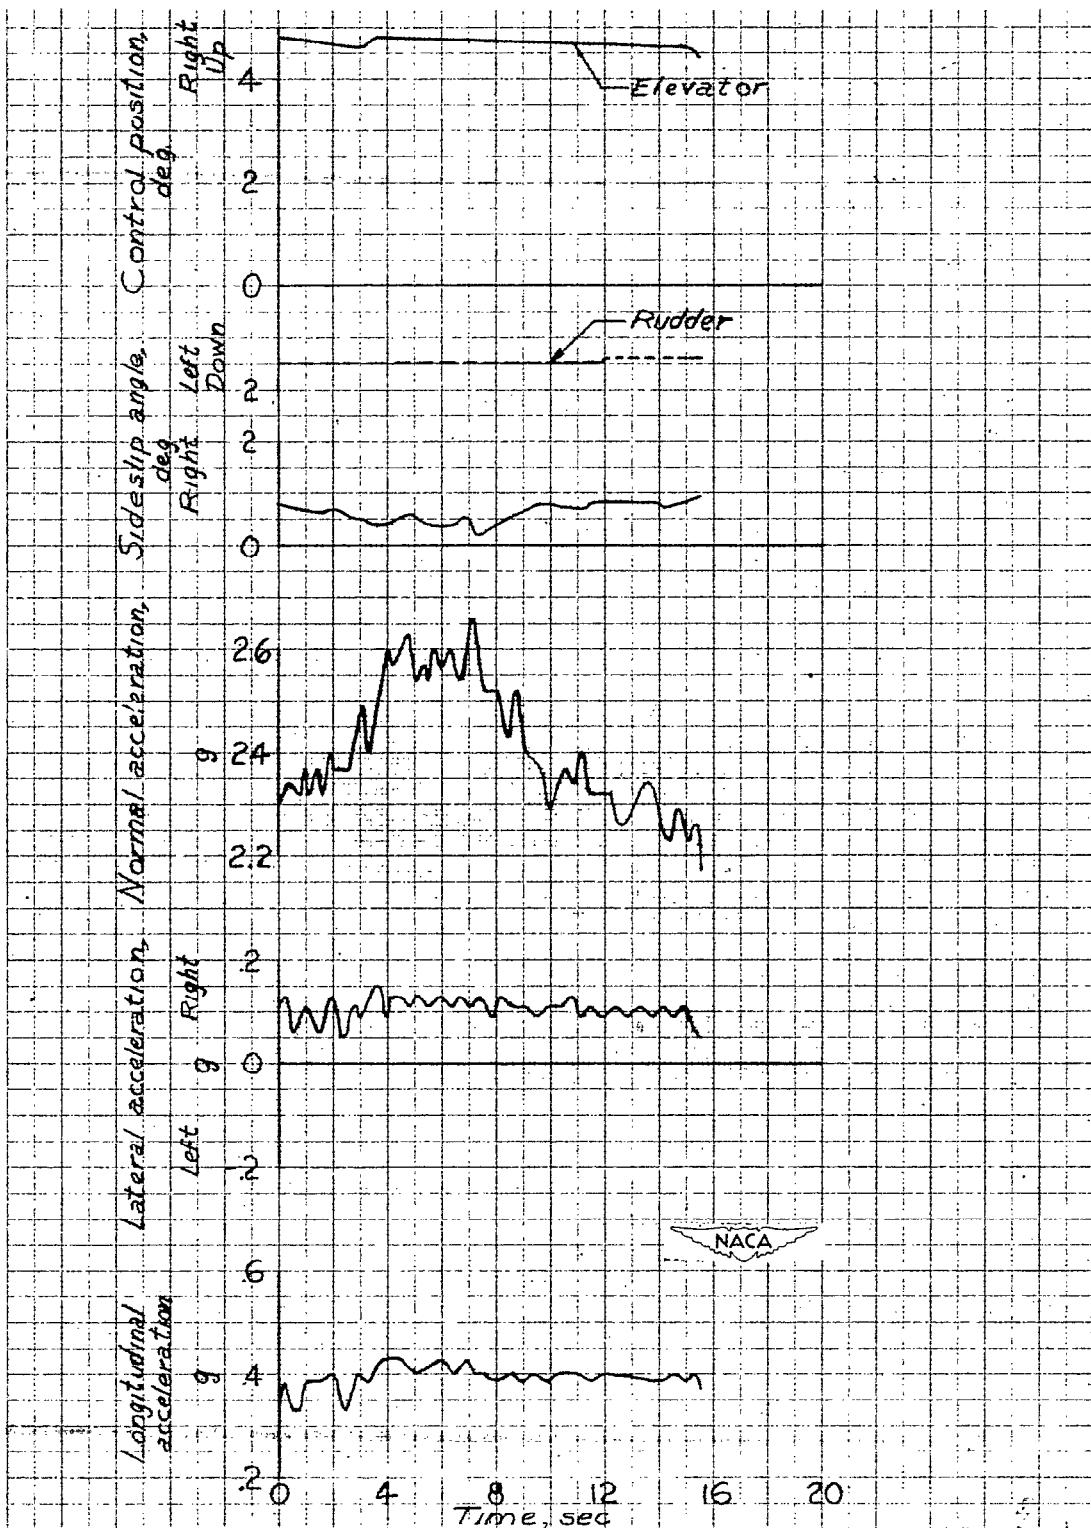
(b) Induced by rapid turn entry at 250 miles per hour with fuselage tank approximately half full.

rudder kick and was obtained with an empty belly tank installed and with the fuselage tank approximately half full (at a speed of 250 miles per hour). In some cases the oscillation was noted mainly in terms of lateral acceleration (fig. 10(a)) and in other cases the oscillation occurred in the three measured components of acceleration (fig. 10(b))

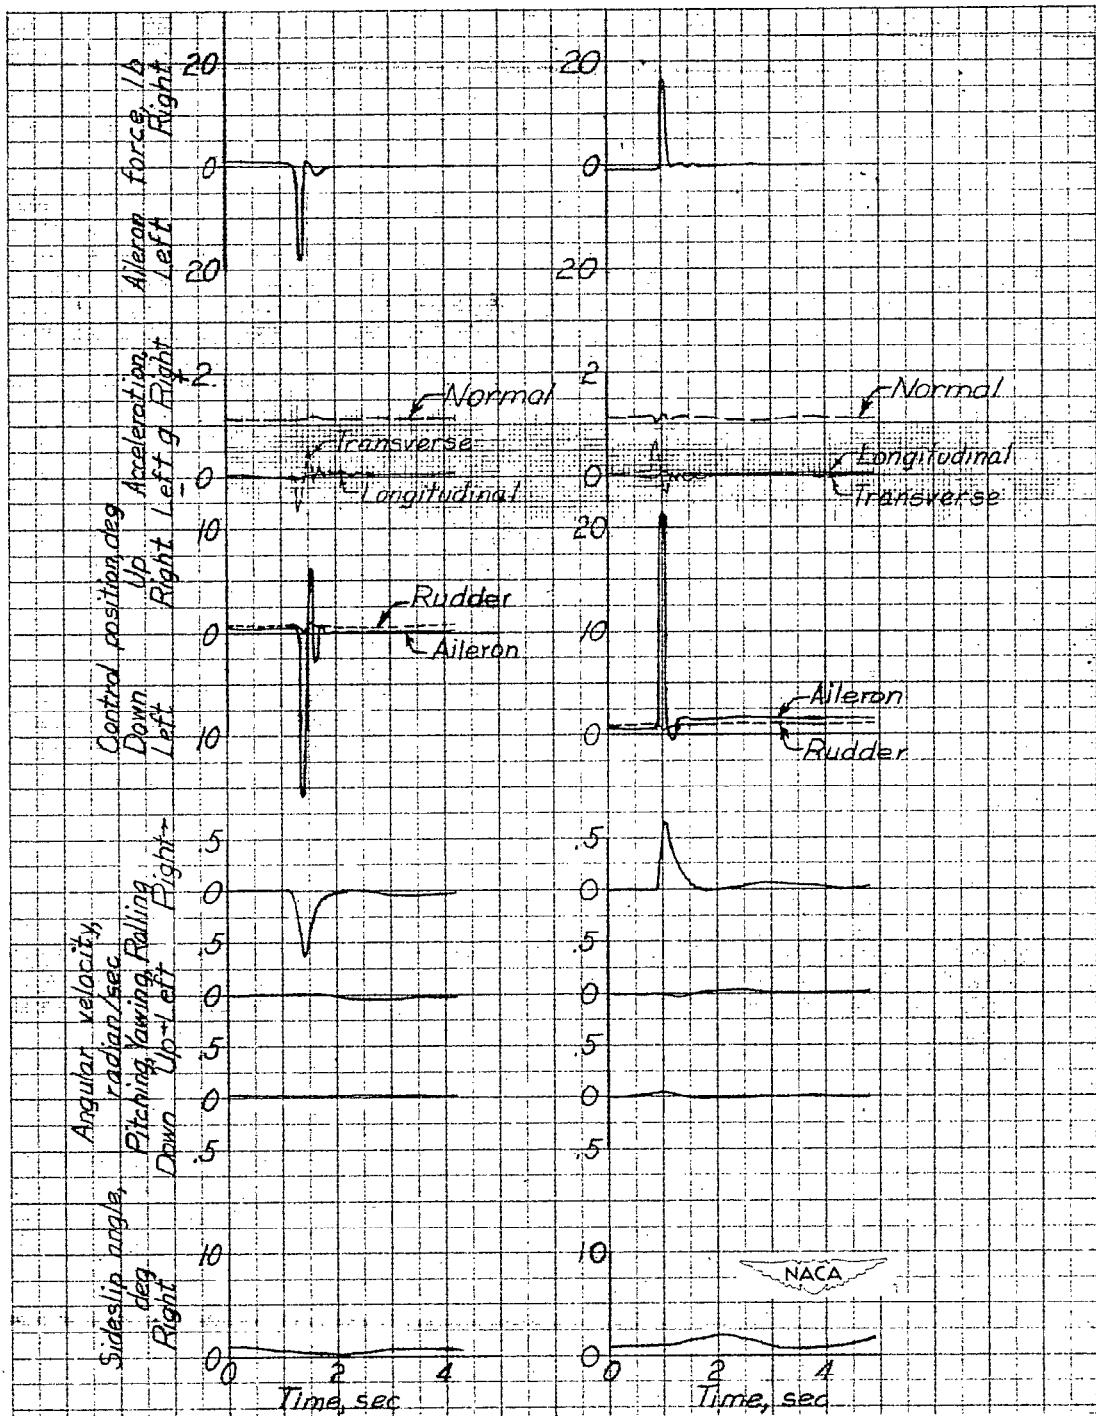
Figure 11.- Time histories of oscillation produced by abrupt left and right aileron deflection and release, F8F-1 airplane with tail configuration 1; belly tank installed. (290 mph)

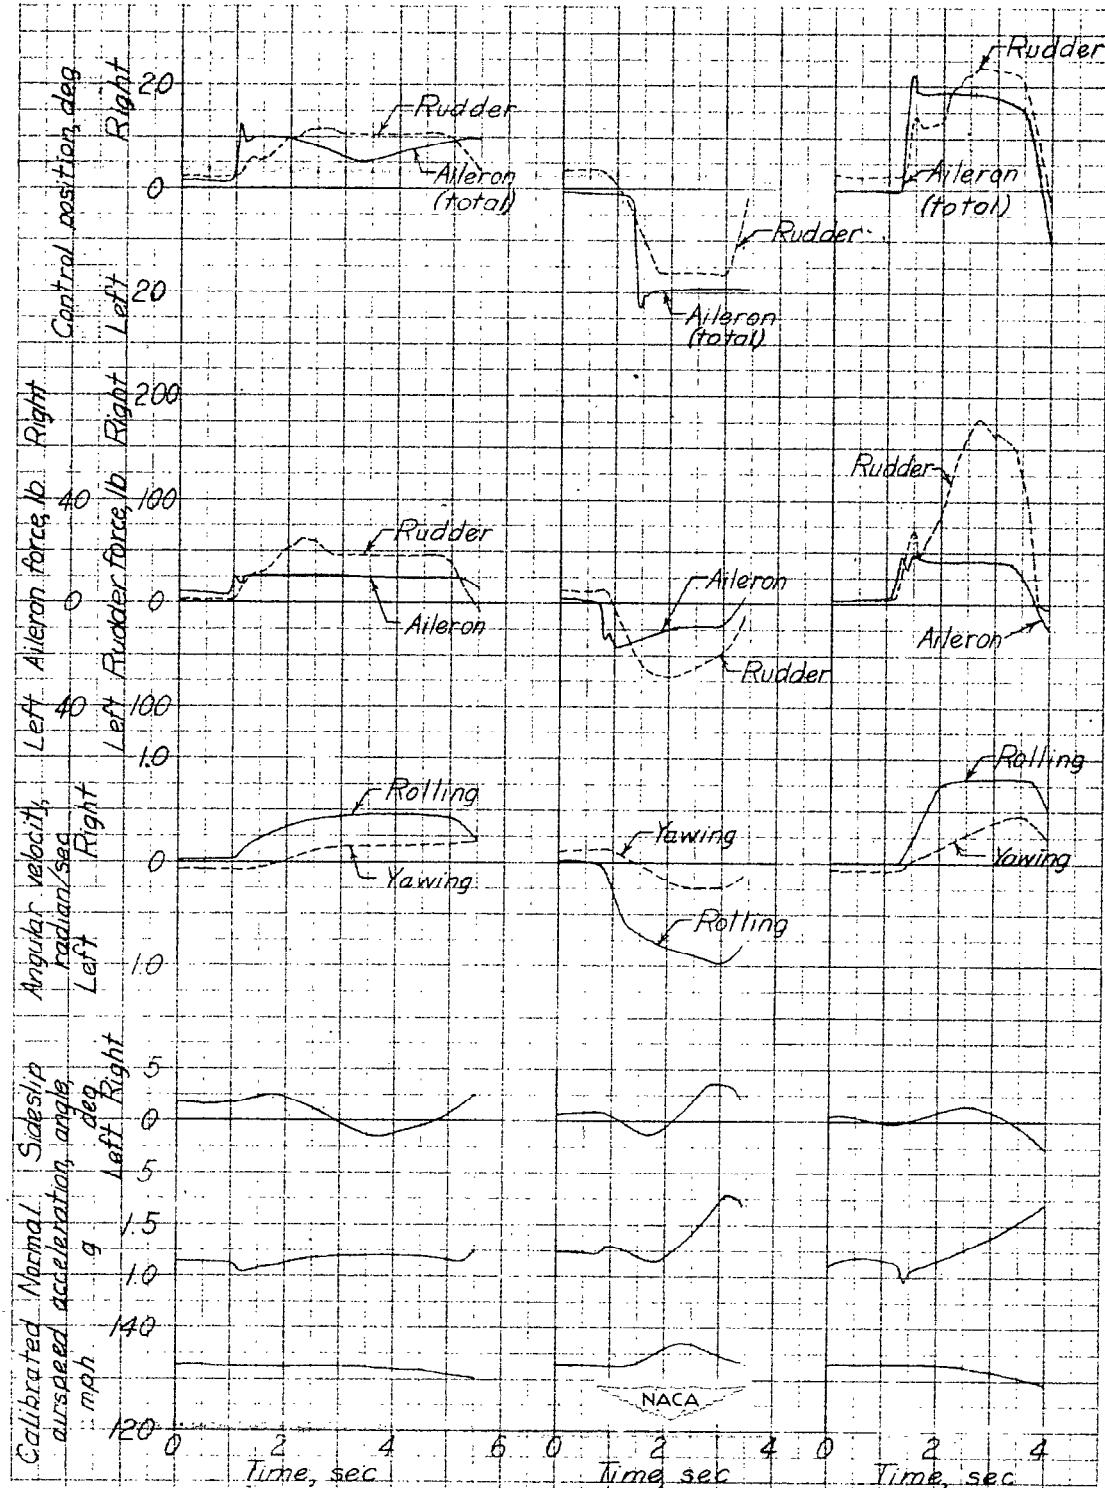
Figure 12.- Time histories of coordinated rolls out of 45° banked turns at 135 miles per hour in the clean condition with power for level flight (15 in. Hg at 2300 rpm) at 5000 feet, F8F-1 airplane with tail configuration 1, without belly tank.

The sideslip due to deflection of the ailerons with rudder fixed and the rudder required to overcome adverse aileron yaw were measured in rolls out of 45° banked turns. Figure 12 contains time histories of rolls out of turns which were made by applying approximately two-thirds aileron deflection at 5000 feet in the clean condition with belly tank off using power for level flight at 135 miles per hour. In these rolls the pilot attempted to coordinate the rudder and ailerons to maintain zero sideslip. Similar roll-outs made with full aileron and rudder deflection showed that there was a little more than sufficient rudder control to overcome the yawing moment due to ailerons. The rudder control force did not exceed 180 pounds during these maneuvers.

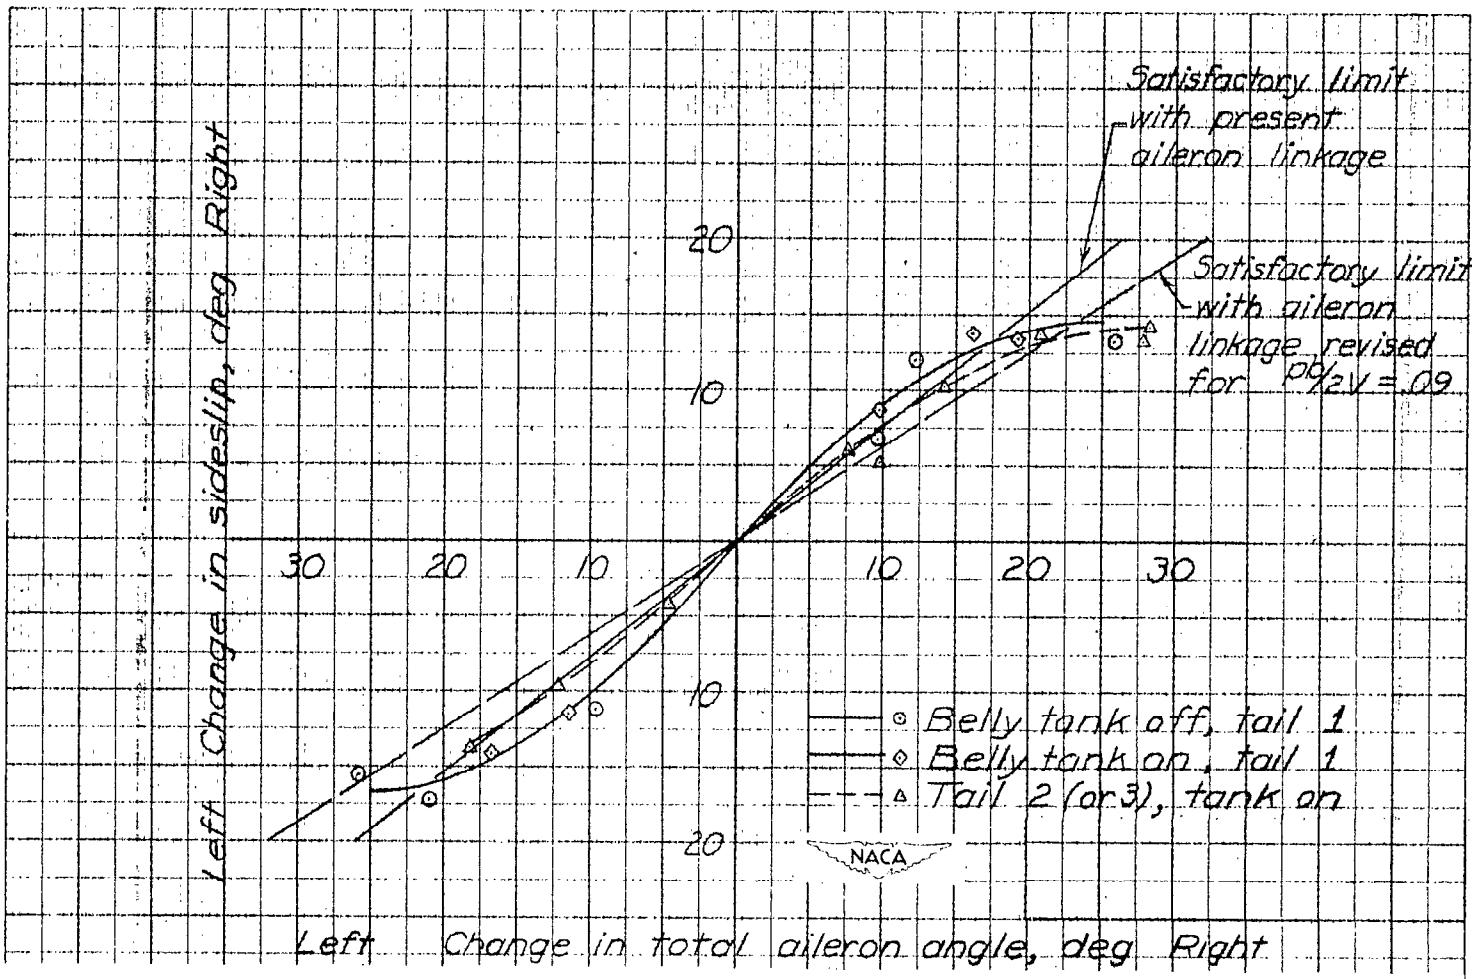
Figure 13.- Rudder-fixed rolls out of 45 degree banked turns at 135 miles per hour in the clean condition with power for level flight (15 in. Hg at 2300 rpm) at 5000 feet, F8F-1 airplane.

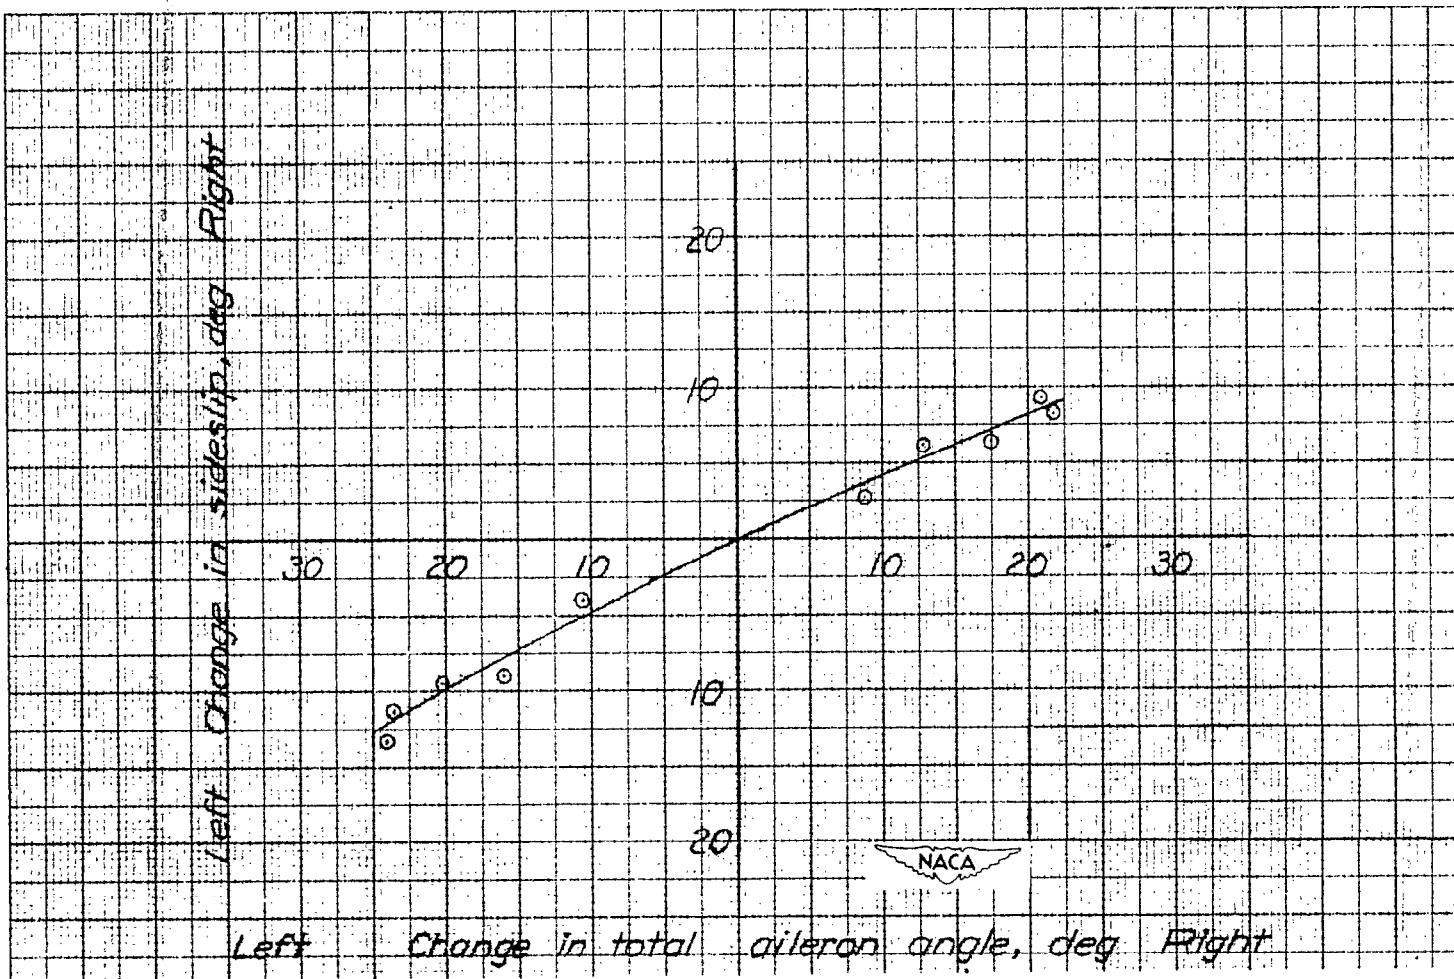
(a) Plot of change in sideslip angle against change in total aileron angle.

Figure 14.- Rudder-fixed rolls out of 3 g turns at 290 miles per hour in the rated-power clean condition (41 in. Hg at 2600 rpm) without belly tank, F8F-1 airplane with tail configuration 1.

Rudder-fixed rolls out of 3g turns at an indicated airspeed of 290 miles per hour at 5000 feet were made in the rated power, clean condition with tail configuration 1. The data obtained are plotted in figure 14. In these maneuvers the pilot attempted to maintain a constant acceleration as the airplane rolled. The pitching moments caused by sideslip and by yawing velocity during the roll made it difficult for the pilot to maintain exactly constant acceleration, and as a result the data obtained show some scatter. Figure 14(a) contains a plot of the change in sideslip angle as a function of the change in total aileron angle. In figure 14(b) the same data are plotted in another form as the variation of  $\Delta\beta/C_N$ , the change in sideslip angle divided by the normal-force coefficient, with  $pb/2V$ . Plotting in this form makes possible a comparison of the directional stability of different airplanes without regard to the effect of normal-force coefficient on the change in sideslip angle or to relative aileron size.

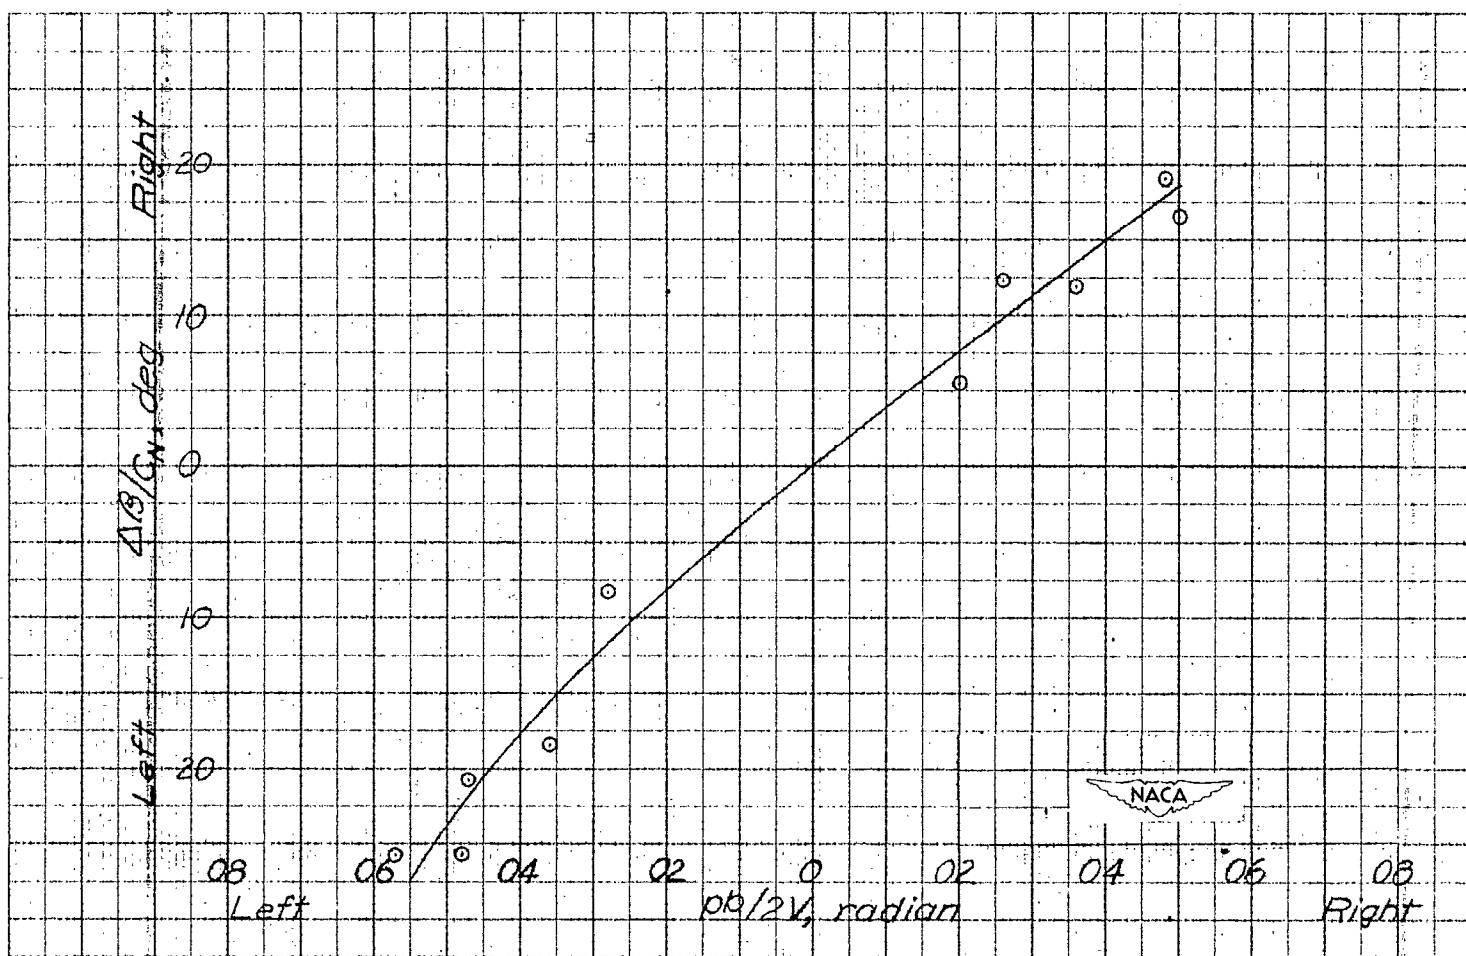
(b) Plot of change in sideslip angle divided by normal force coefficient against maximum  $pb/2V$ .

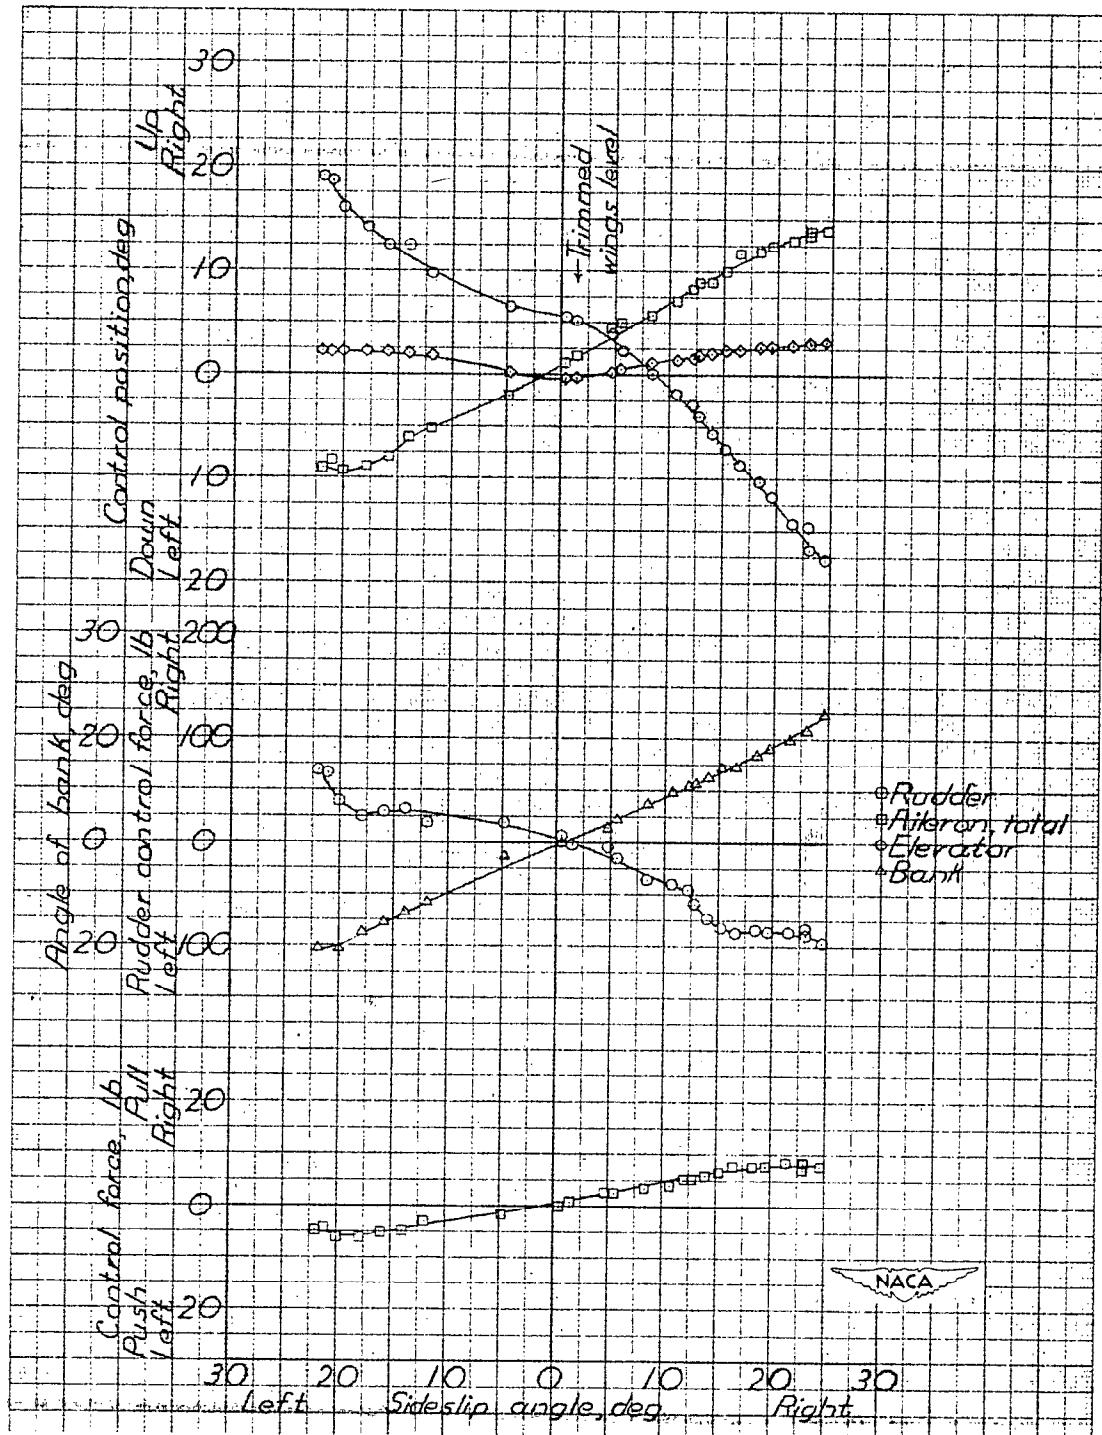
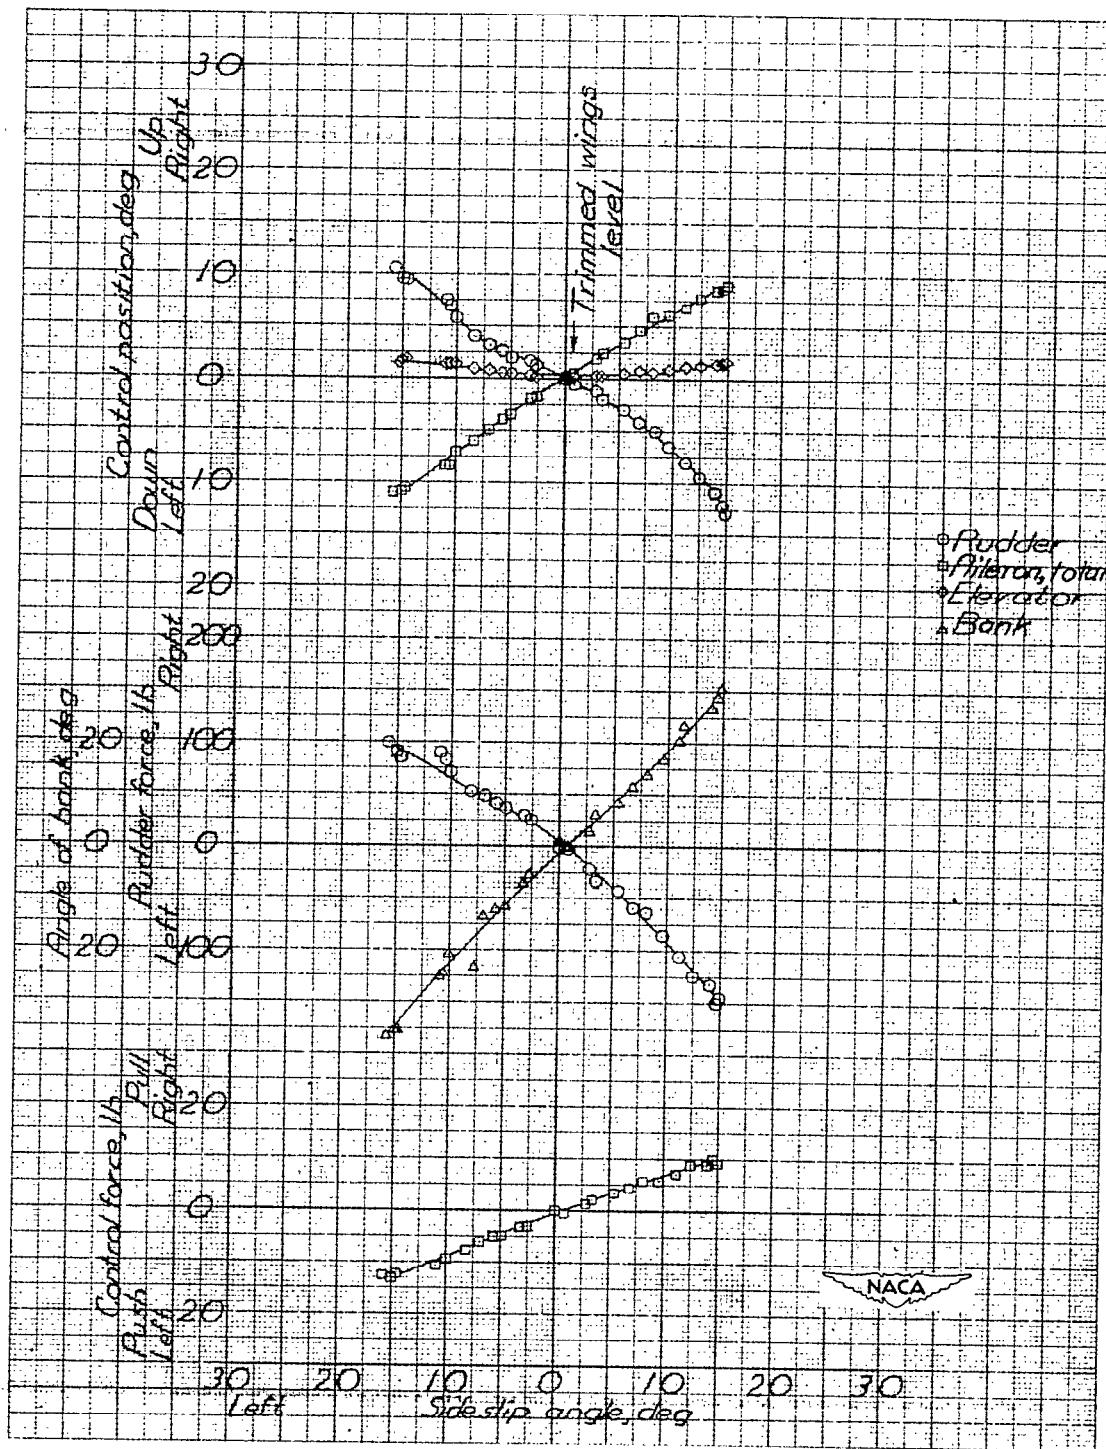
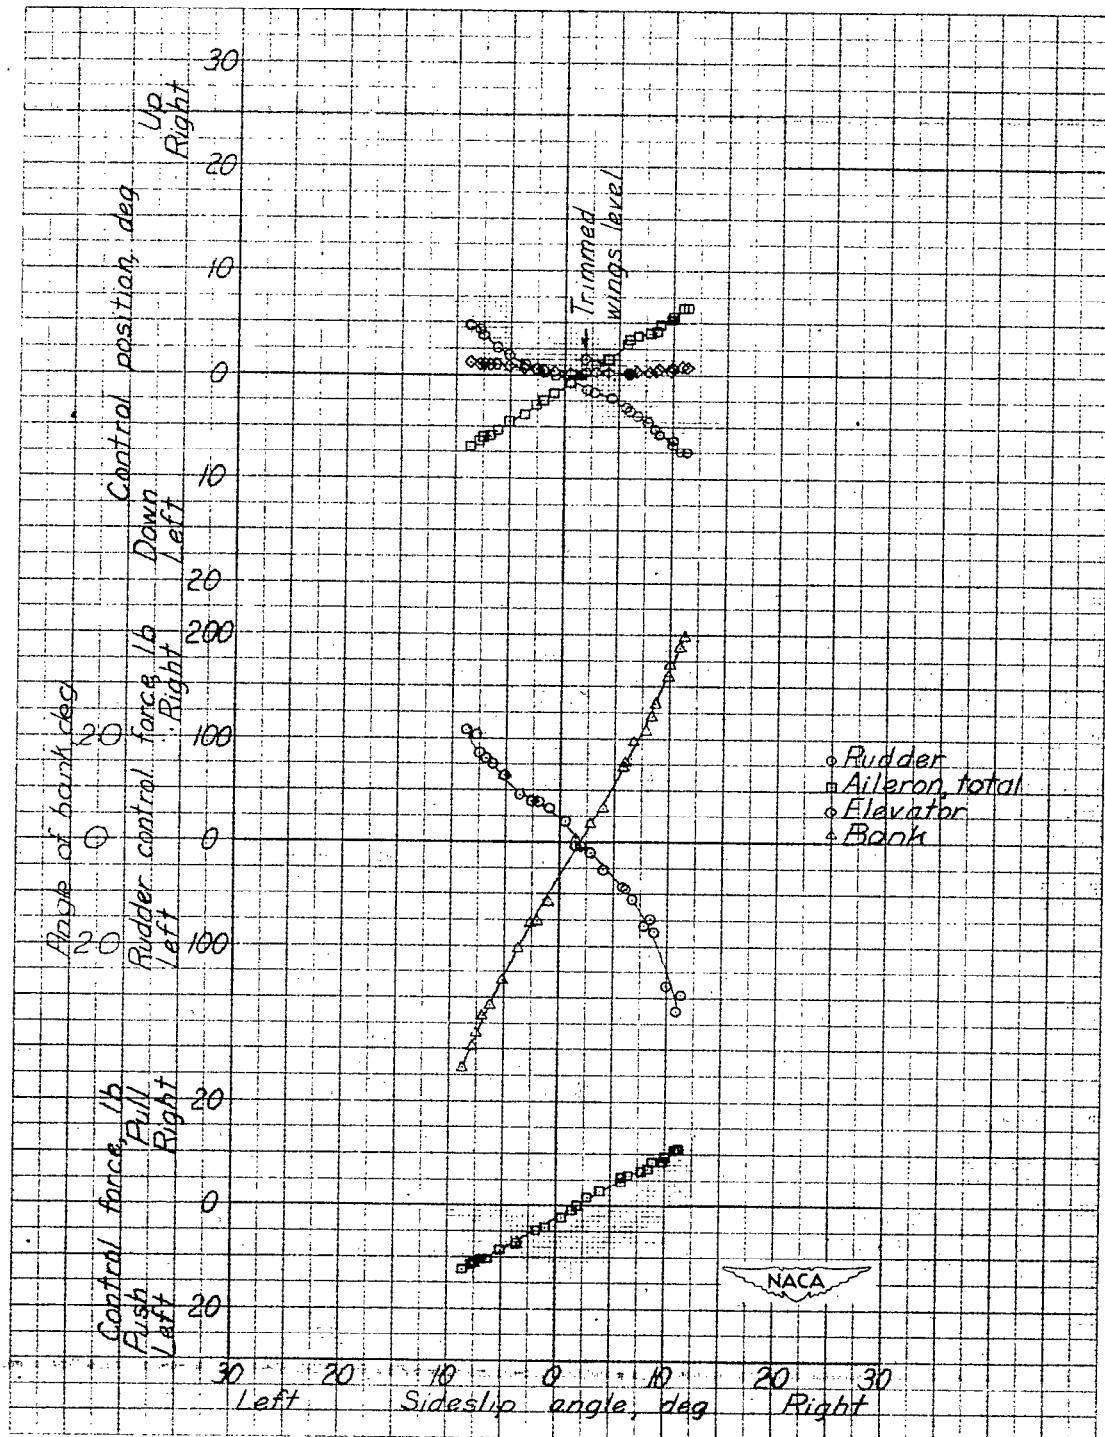
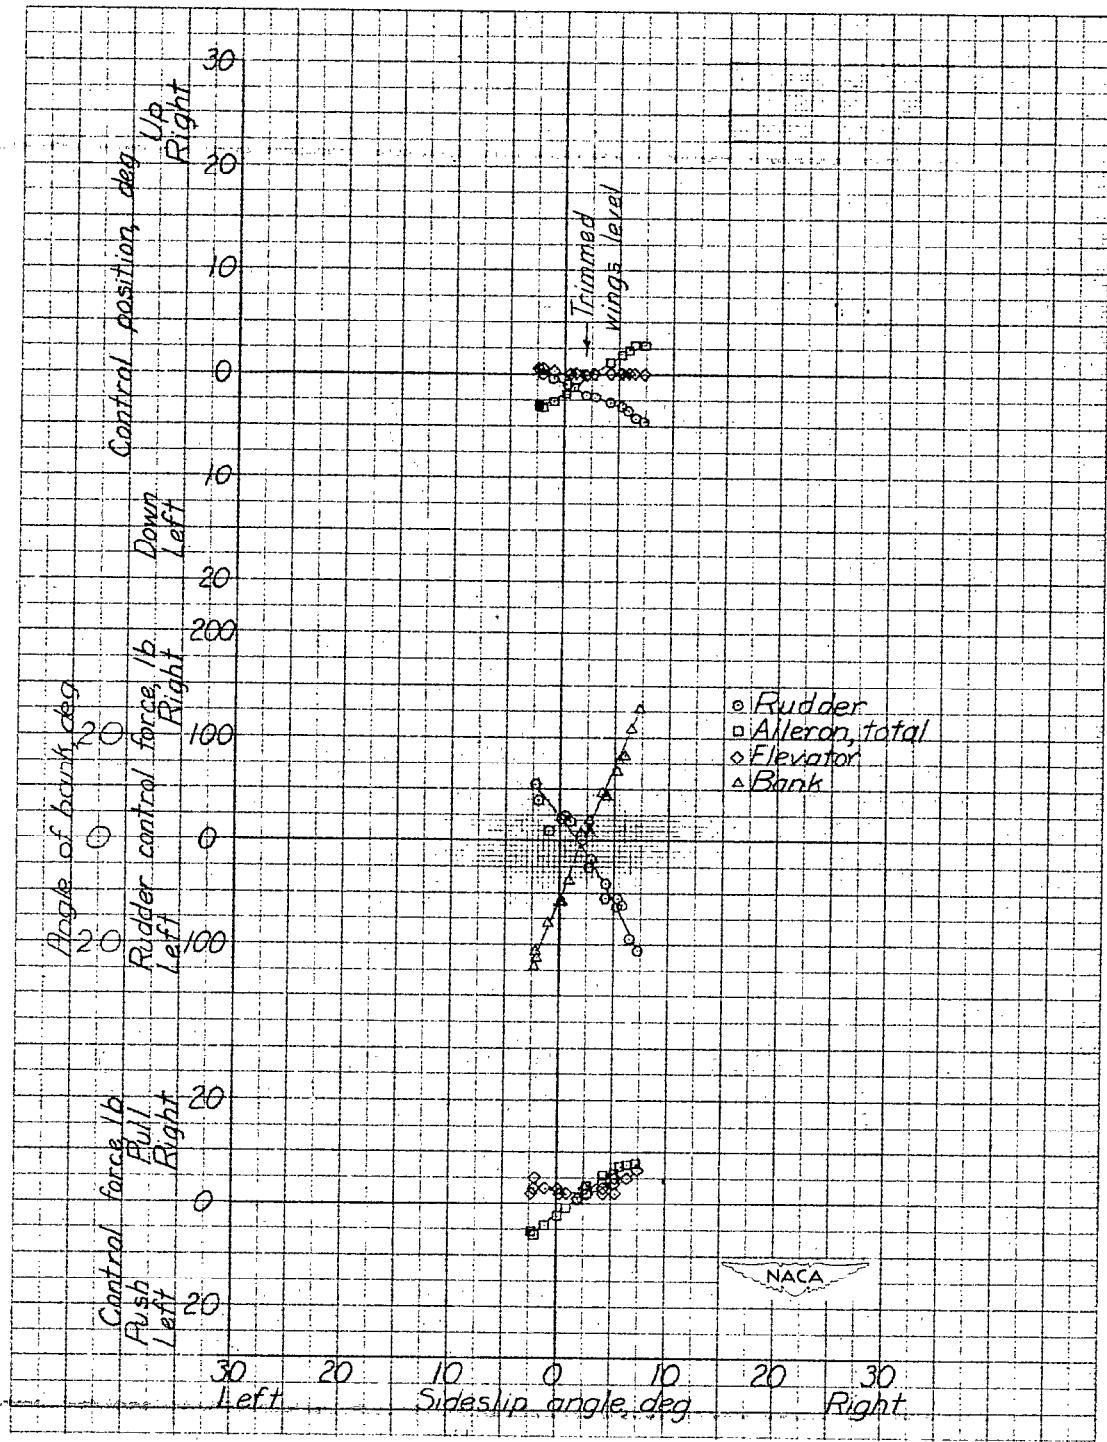
(a) 150 miles per hour, oil cooler open.

Figure 15.- Sideslips in the rated-power, clean condition (41 in. Hg at 2600 rpm) at 5000 feet with belly tank off, cowl closed, canopy closed, F8F-1 airplane with tail configuration 1.

(b) 245 miles per hour, rudder tab  $0.5^\circ$  left, oil cooler closed.

(c) 345 miles per hour, oil cooler closed.

(d) 395 miles per hour, rudder tab  $2.0^{\circ}$  right, oil cooler closed.

The sideslip data which gave measurements of directional stability (variation of rudder angle and force with sideslip angle), dihedral effect (variation of aileron angle and force with sideslip angle), pitching moment due to sideslip (variation of elevator angle and force with sideslip angle), and the side-force characteristics (variation of angle of bank with angle of sideslip) are shown in figures 15 to 22 for tail configuration 1.

Side-force characteristics.- The variation of angle of bank with angle of sideslip, which is a measure of the side-force characteristics, is presented in figures 15 to 21. The requirement that the direction of bank should always be the same as the direction of sideslip was satisfied in all flight conditions at all speeds.
