FLIGHT MEASUREMENTS OF LATERAL AND DIRECTIONAL  
STABILITY AND CONTROL CHARACTERISTICS  
OF THE GRUMMAN F8F-1 AIRPLANE

TED NO. NACA 2379

H. L. Crane and J. P. Reeder

Langley Memorial Aeronautical Laboratory  
Langley Field, Va.

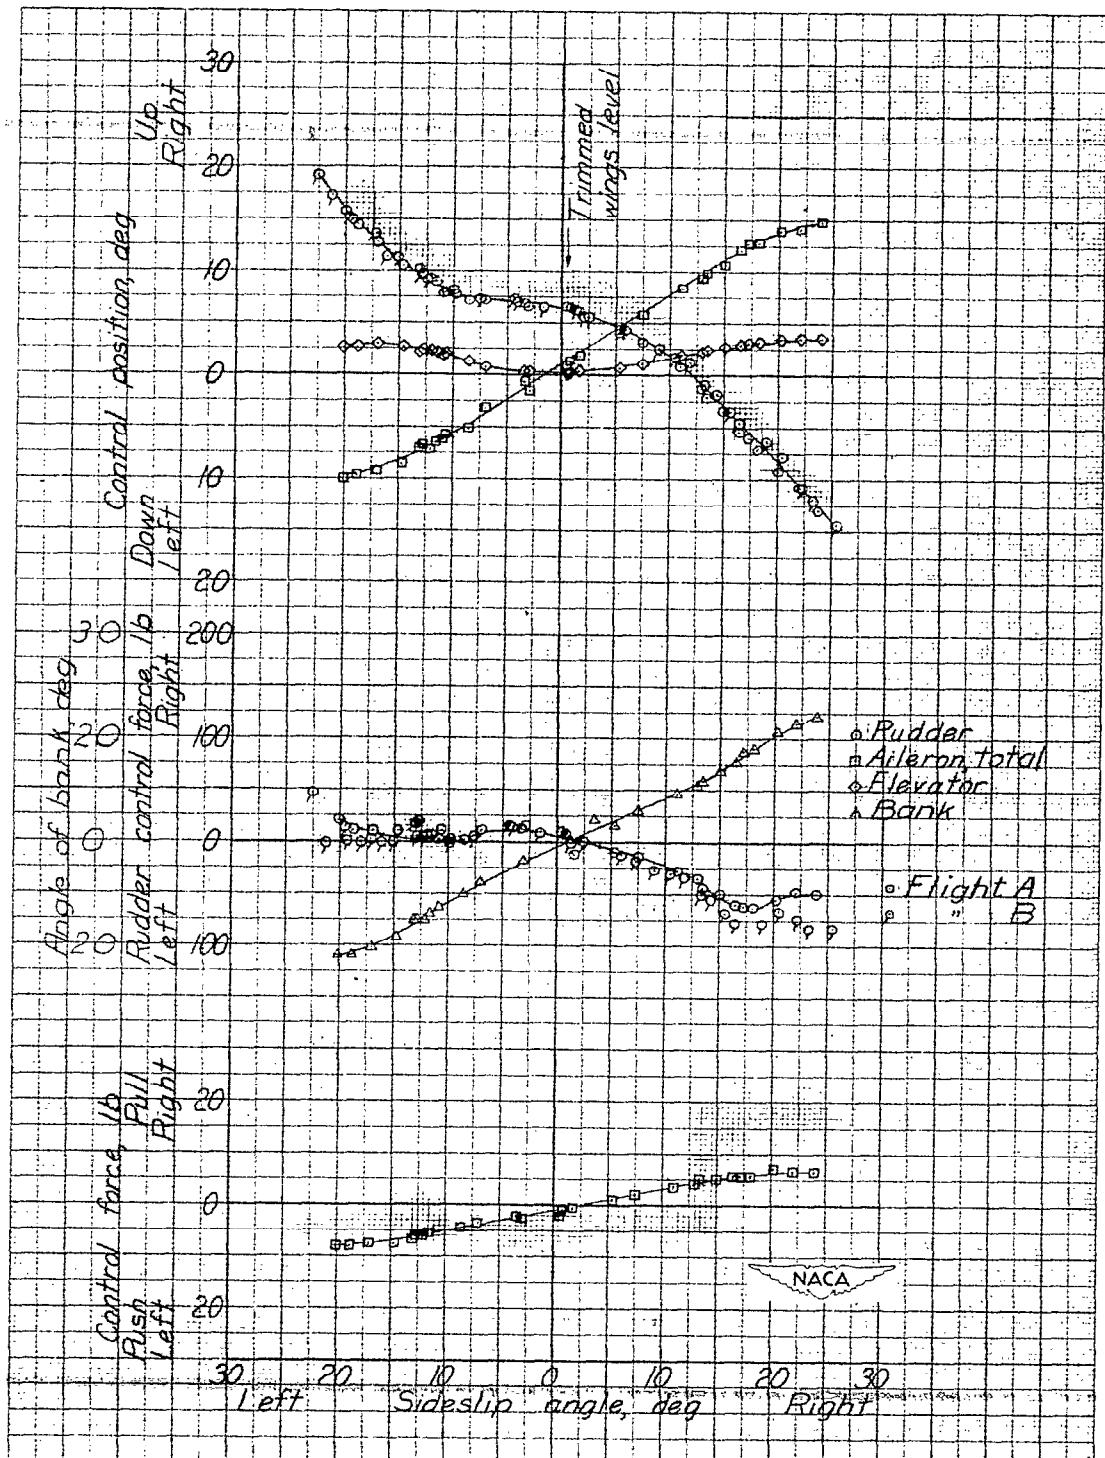
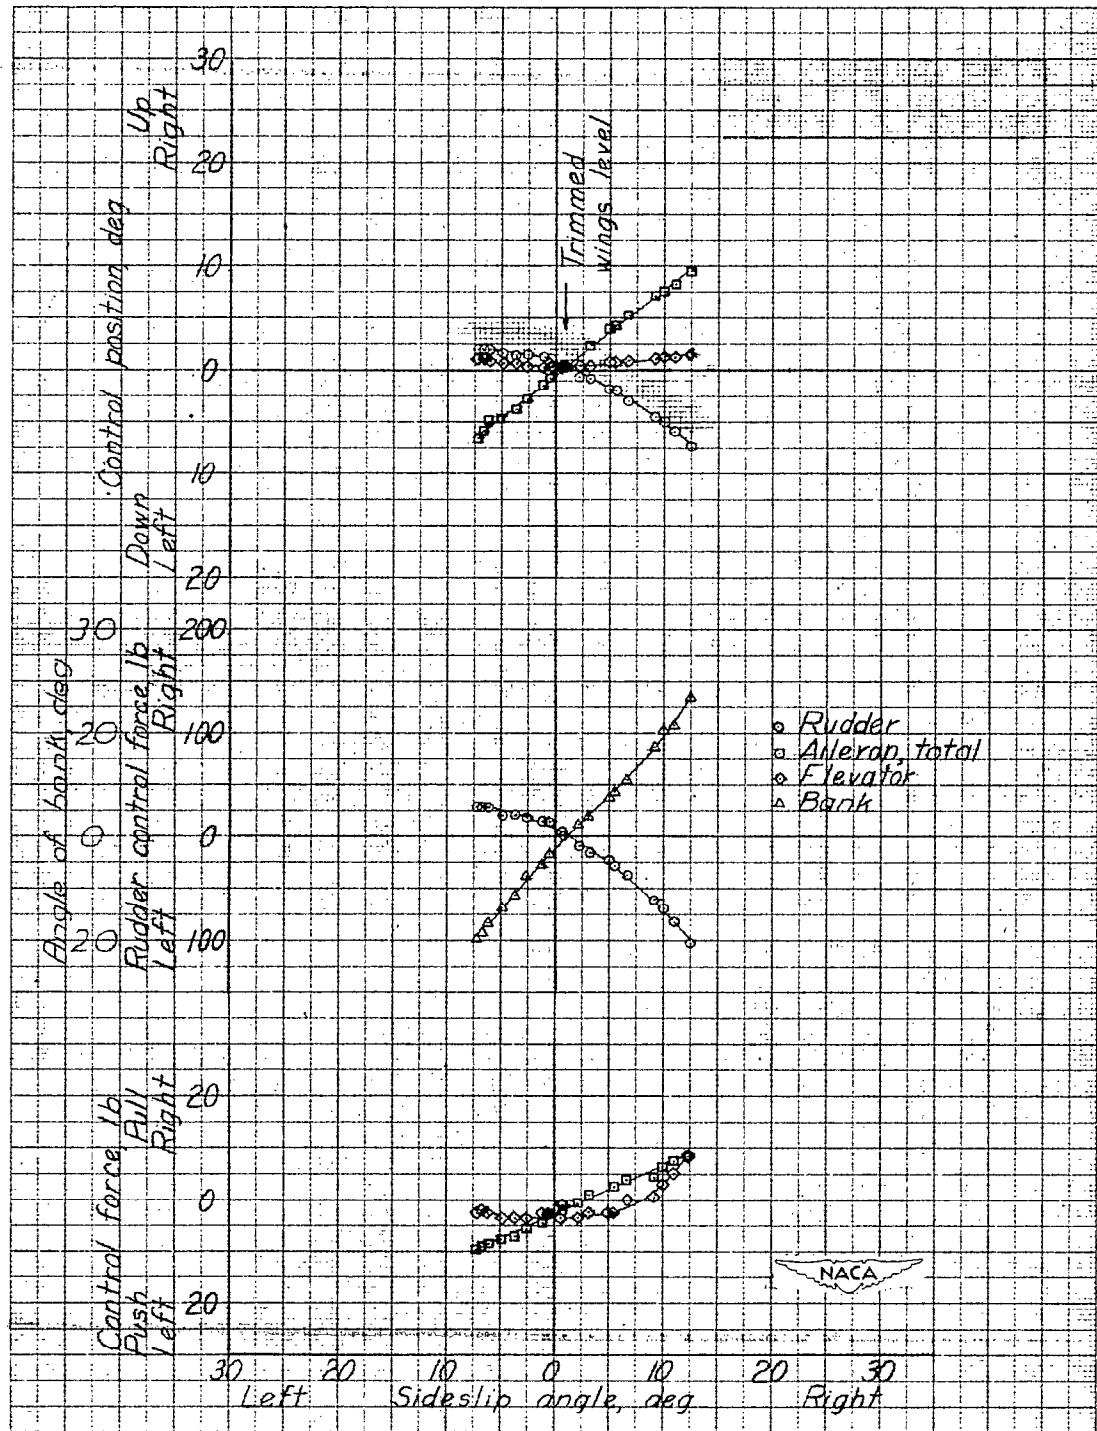
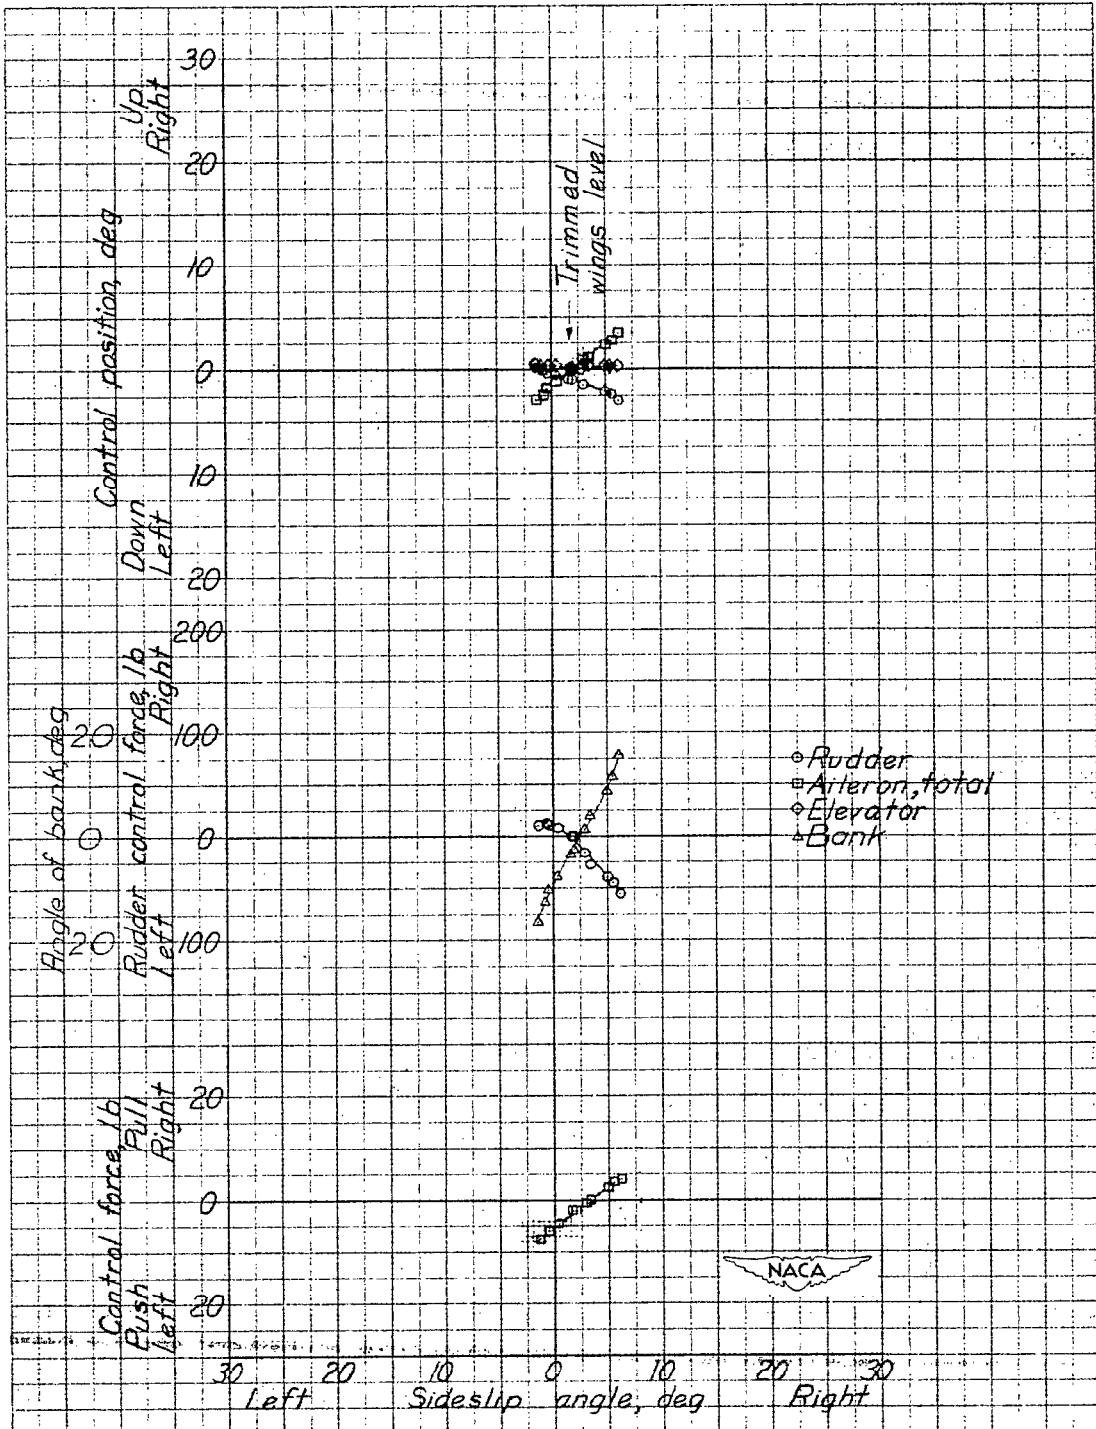
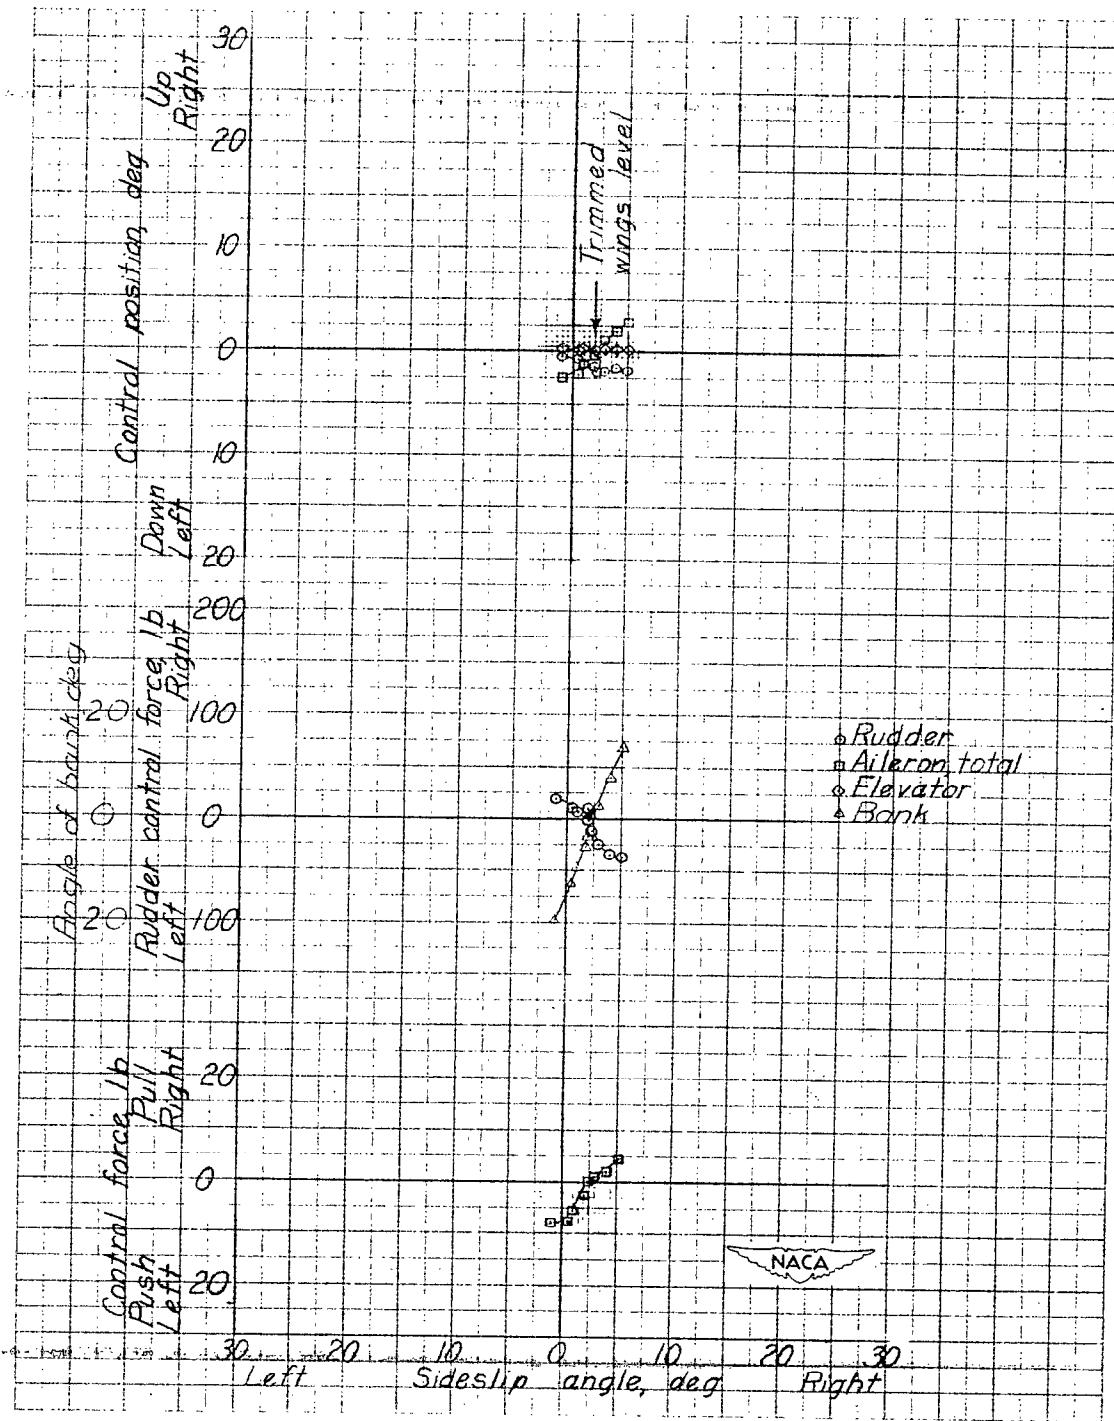
(a) 150 miles per hour, rudder tab  $14.0^\circ$  left, oil cooler open.

Figure 16.- Sideslips in the rated-power, clean condition (41 in. Hg, 2600 rpm) at 5000 feet with belly tank on, cowl closed, canopy closed, F8F-1 airplane with tail configuration 1.

(b) 245 miles per hour, rudder tab  $1.3^{\circ}$  left, oil cooler closed.

(c) 345 miles per hour, rudder tab  $0.3^\circ$  right, oil cooler closed.

(d) 395 miles per hour, rudder tab  $1.7^\circ$  right, oil cooler closed.

The sideslip data which gave measurements of directional stability (variation of rudder angle and force with sideslip angle), dihedral effect (variation of aileron angle and force with sideslip angle), pitching moment due to sideslip (variation of elevator angle and force with sideslip angle), and the side-force characteristics (variation of angle of bank with angle of sideslip) are shown in figures 15 to 22 for tail configuration 1.

As a general rule, decreasing the power or lowering the flaps increased the directional stability. The effect of altitude on the directional stability was determined by comparison of the data of figure 22 which were obtained at an altitude of 20,000 with those of figures 16(b) and 16(c) for an altitude of 5000 feet. The comparison showed that  $d\delta_r/d\beta$  for small angles of sideslip was reduced from approximately 0.25 at 5000 feet to 0.1 at 20,000 feet (300 mph, tank on).

Side-force characteristics.- The variation of angle of bank with angle of sideslip, which is a measure of the side-force characteristics, is presented in figures 15 to 21. The requirement that the direction of bank should always be the same as the direction of sideslip was satisfied in all flight conditions at all speeds.

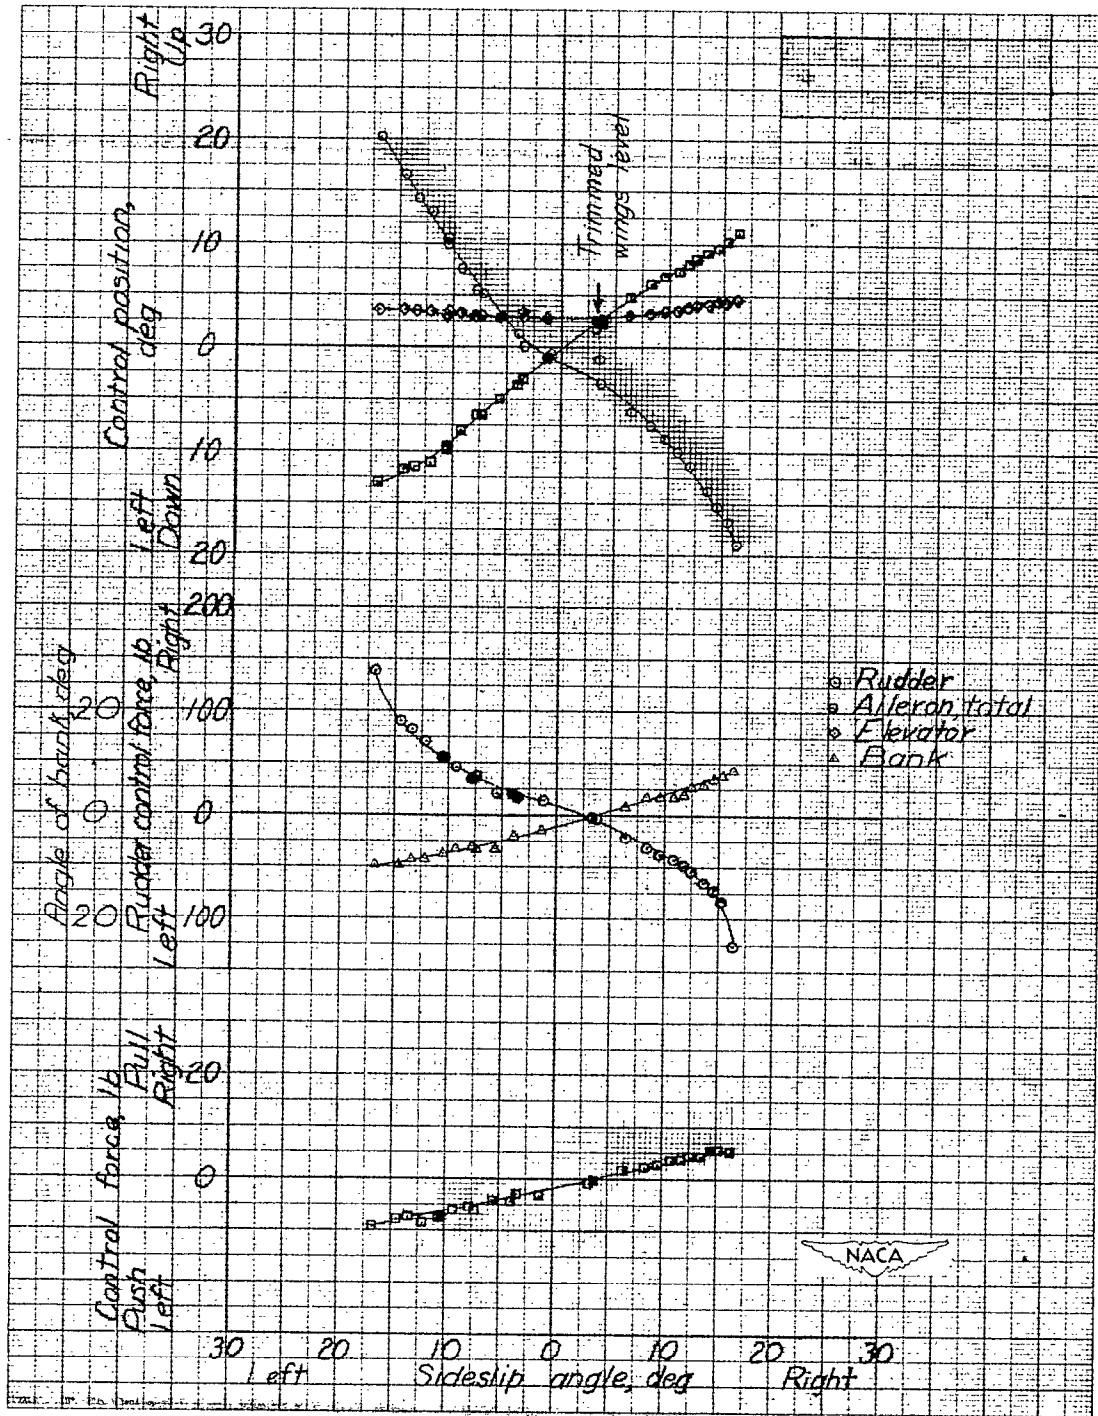
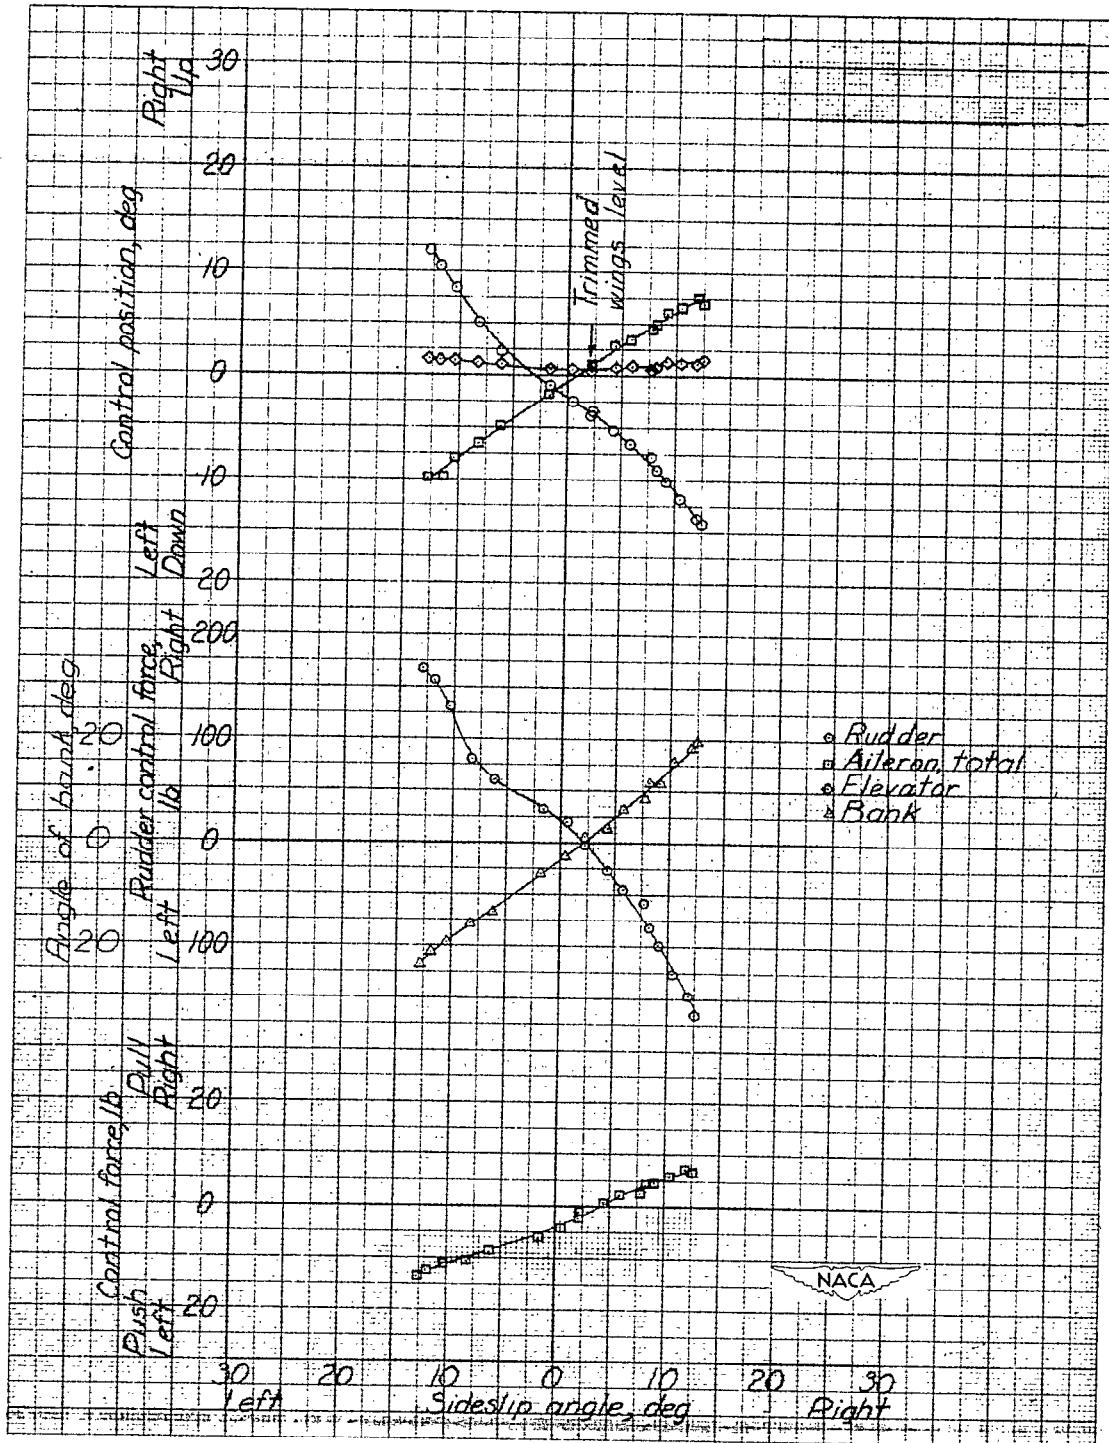
(a) 150 miles per hour, rudder tab  $5.7^\circ$  right.

Figure 17.- Sideslips in the clean, engine-idling condition at 5000 feet with belly tank off, cowl closed, oil cooler closed, canopy closed, F8F-1 airplane with tail configuration 1.

(b) 245 miles per hour, rudder tab  $5.7^\circ$  right.

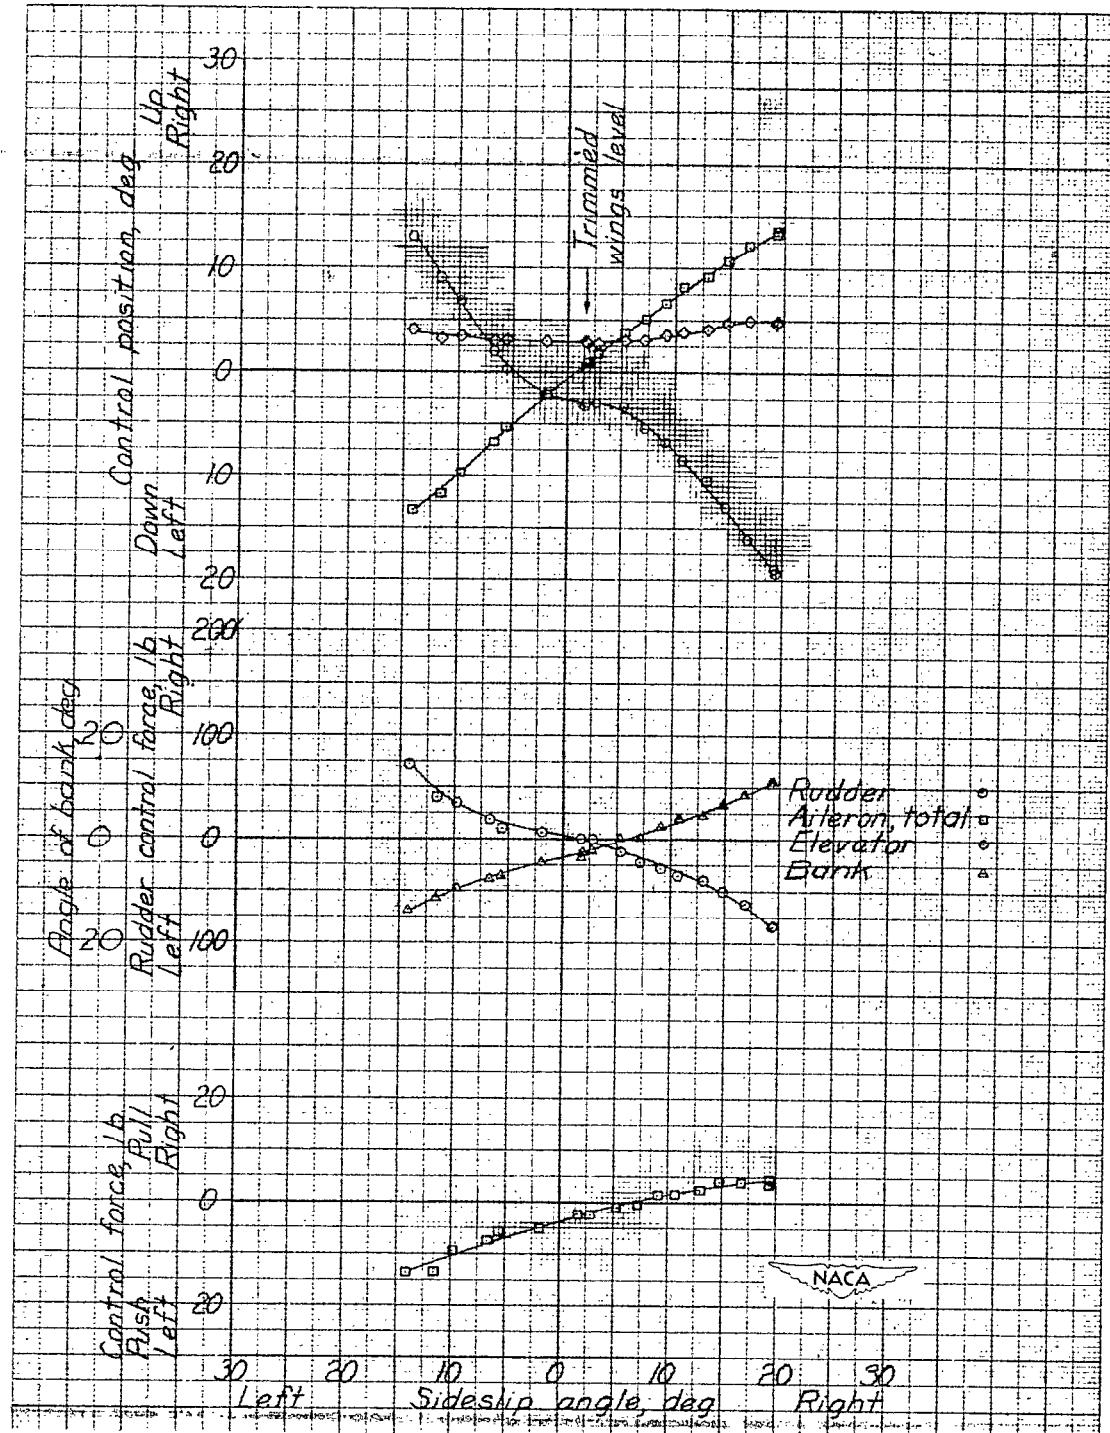
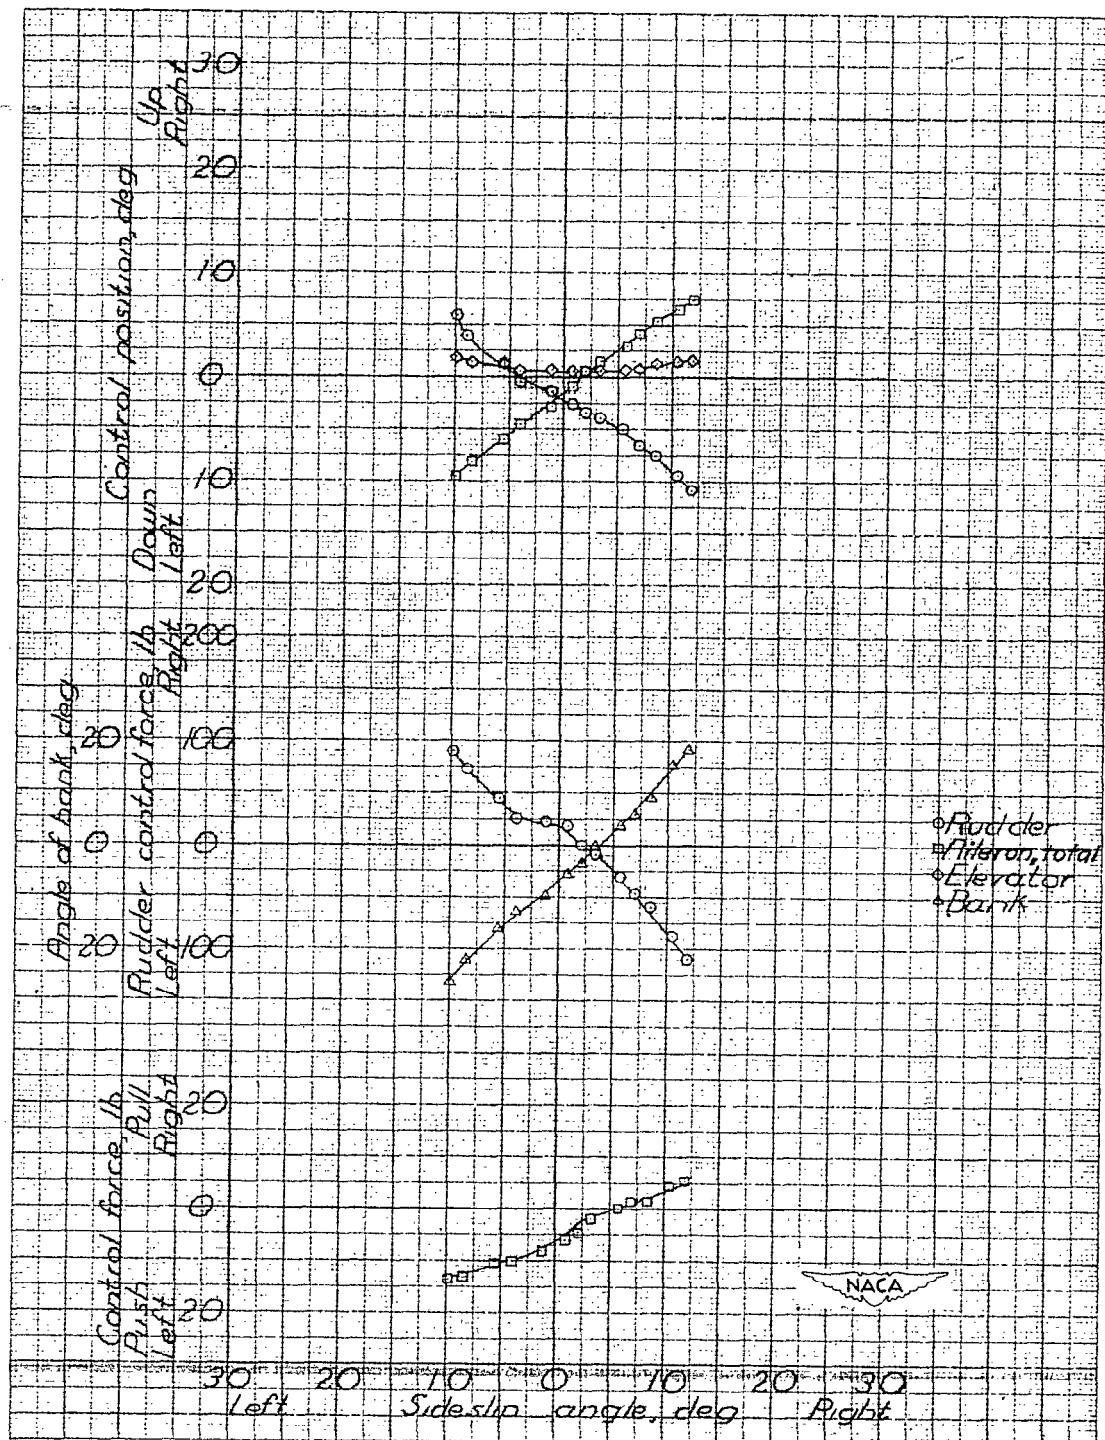
(a) 150 miles per hour, rudder tab  $5.7^\circ$  right.

Figure 18.- Sideslips in the clean, engine-idling condition at 5000 feet with belly tank on, cowl closed, oil cooler closed, canopy closed, F8F-1 airplane with tail configuration 1.

(b) 245 miles per hour, rudder tab  $6.3^\circ$  right.

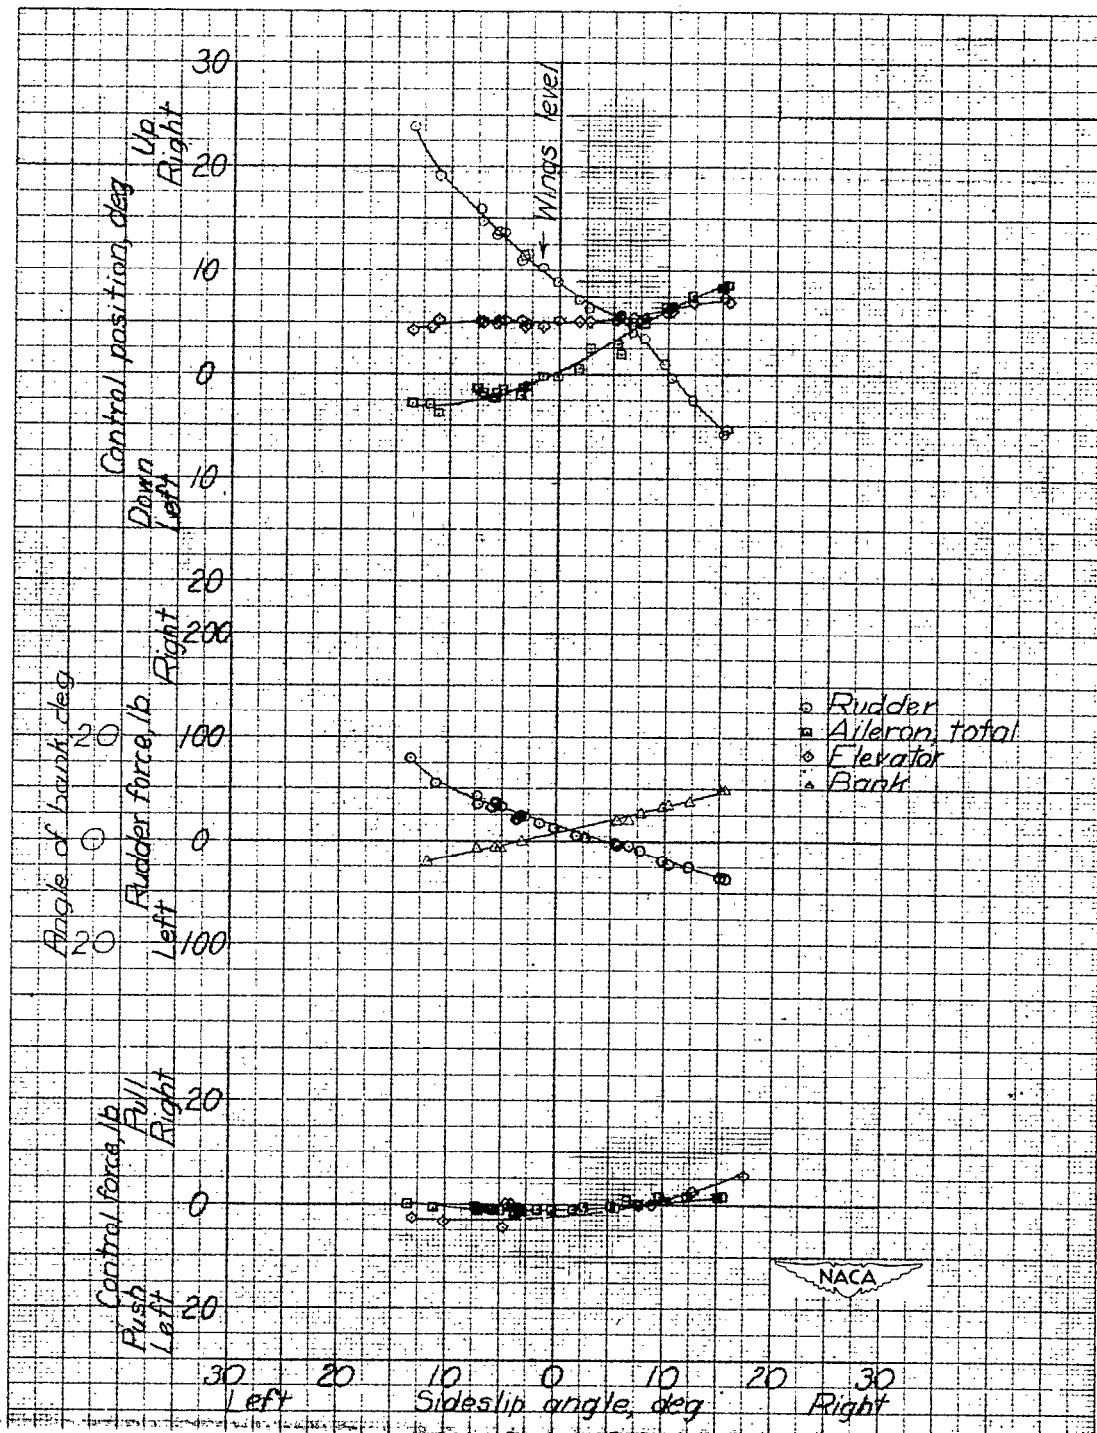
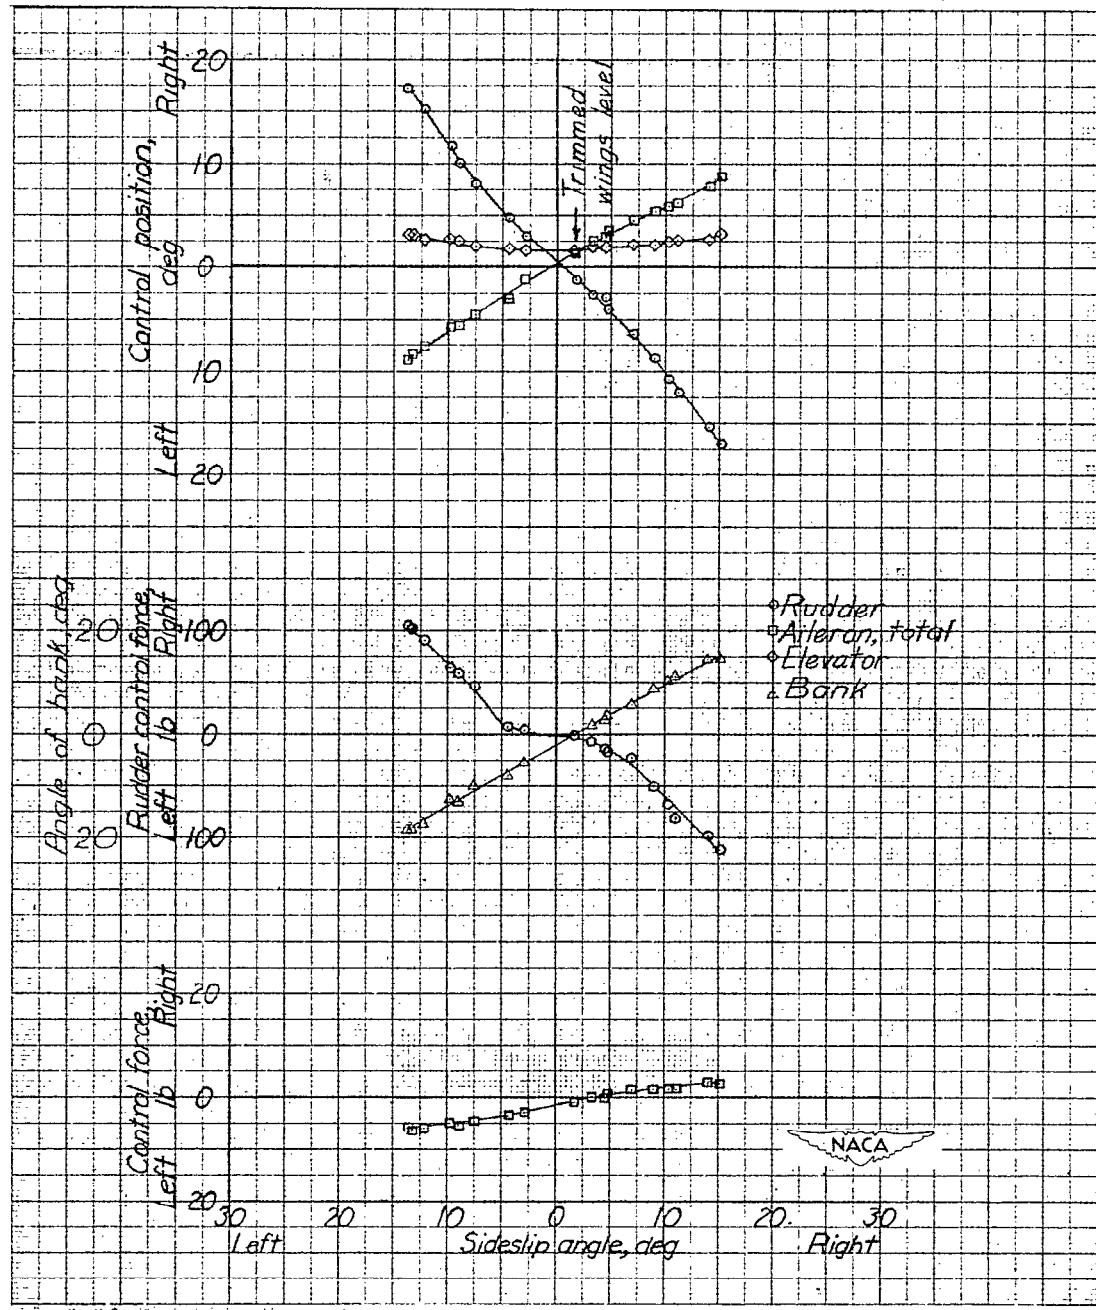
(a) 90 miles per hour, rudder tab  $17.5^\circ$  left (full tab).

Figure 19.- Sideslips in the power-approach condition (20 in. Hg at 2300 rpm) flaps and landing gear down at 5000 feet with belly tank off, cowl closed, oil cooler closed, canopy open, F8F-1 airplane with tail configuration 1.

(b) 150 miles per hour, rudder tab  $0.8^\circ$  right.

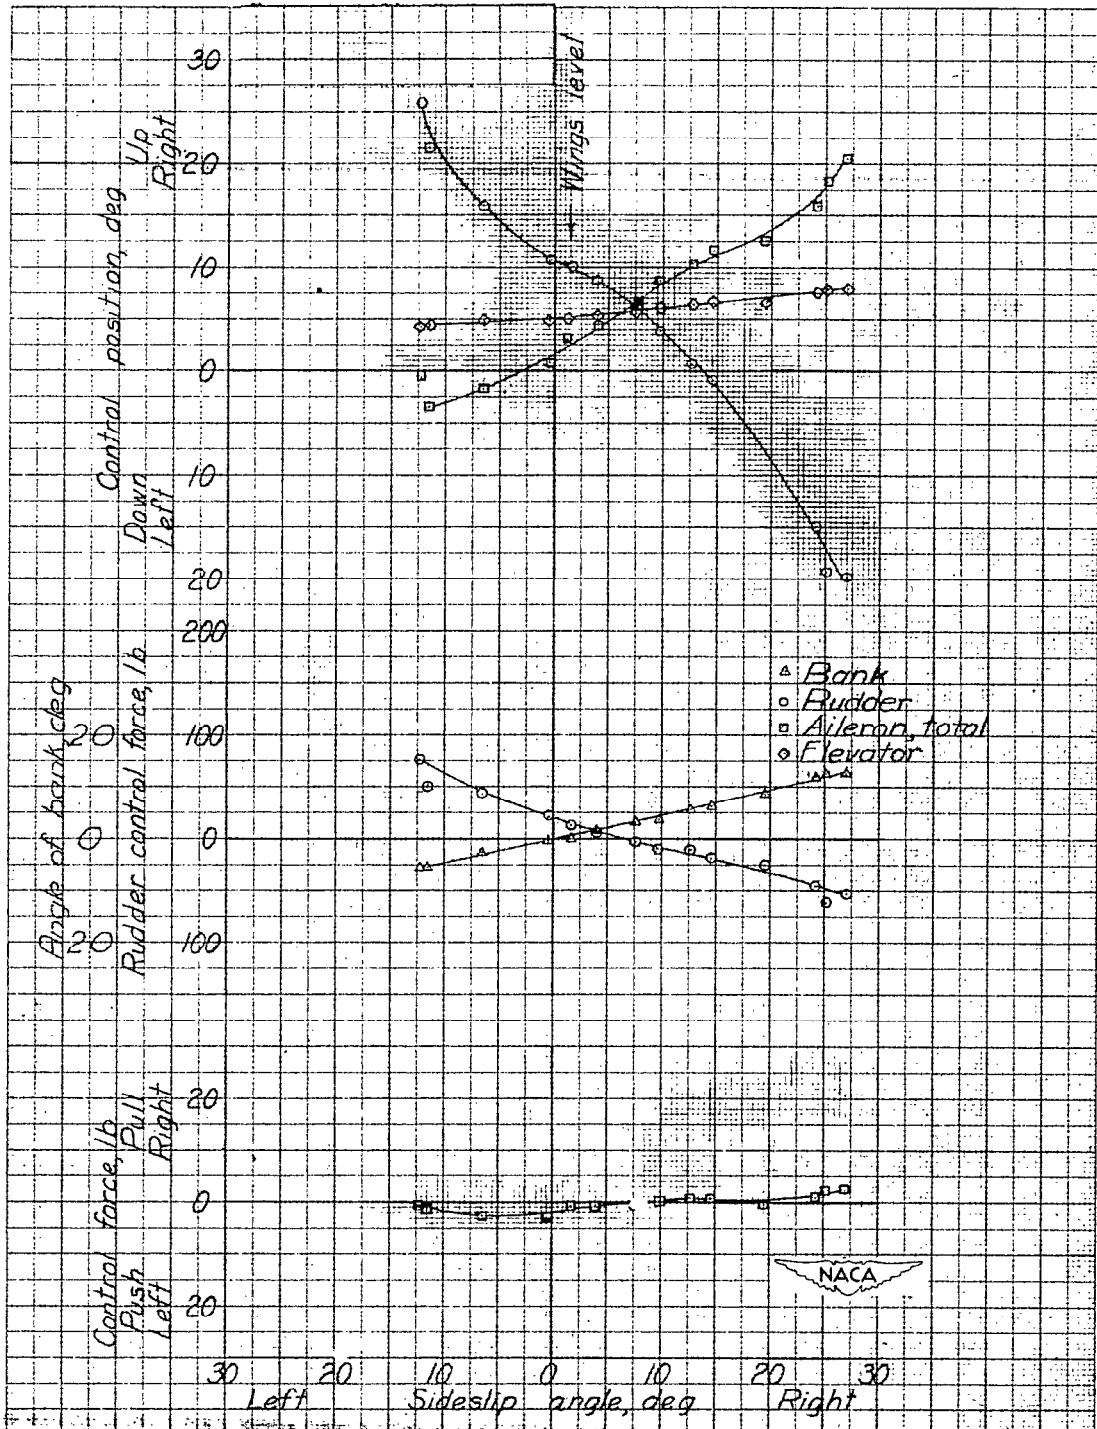
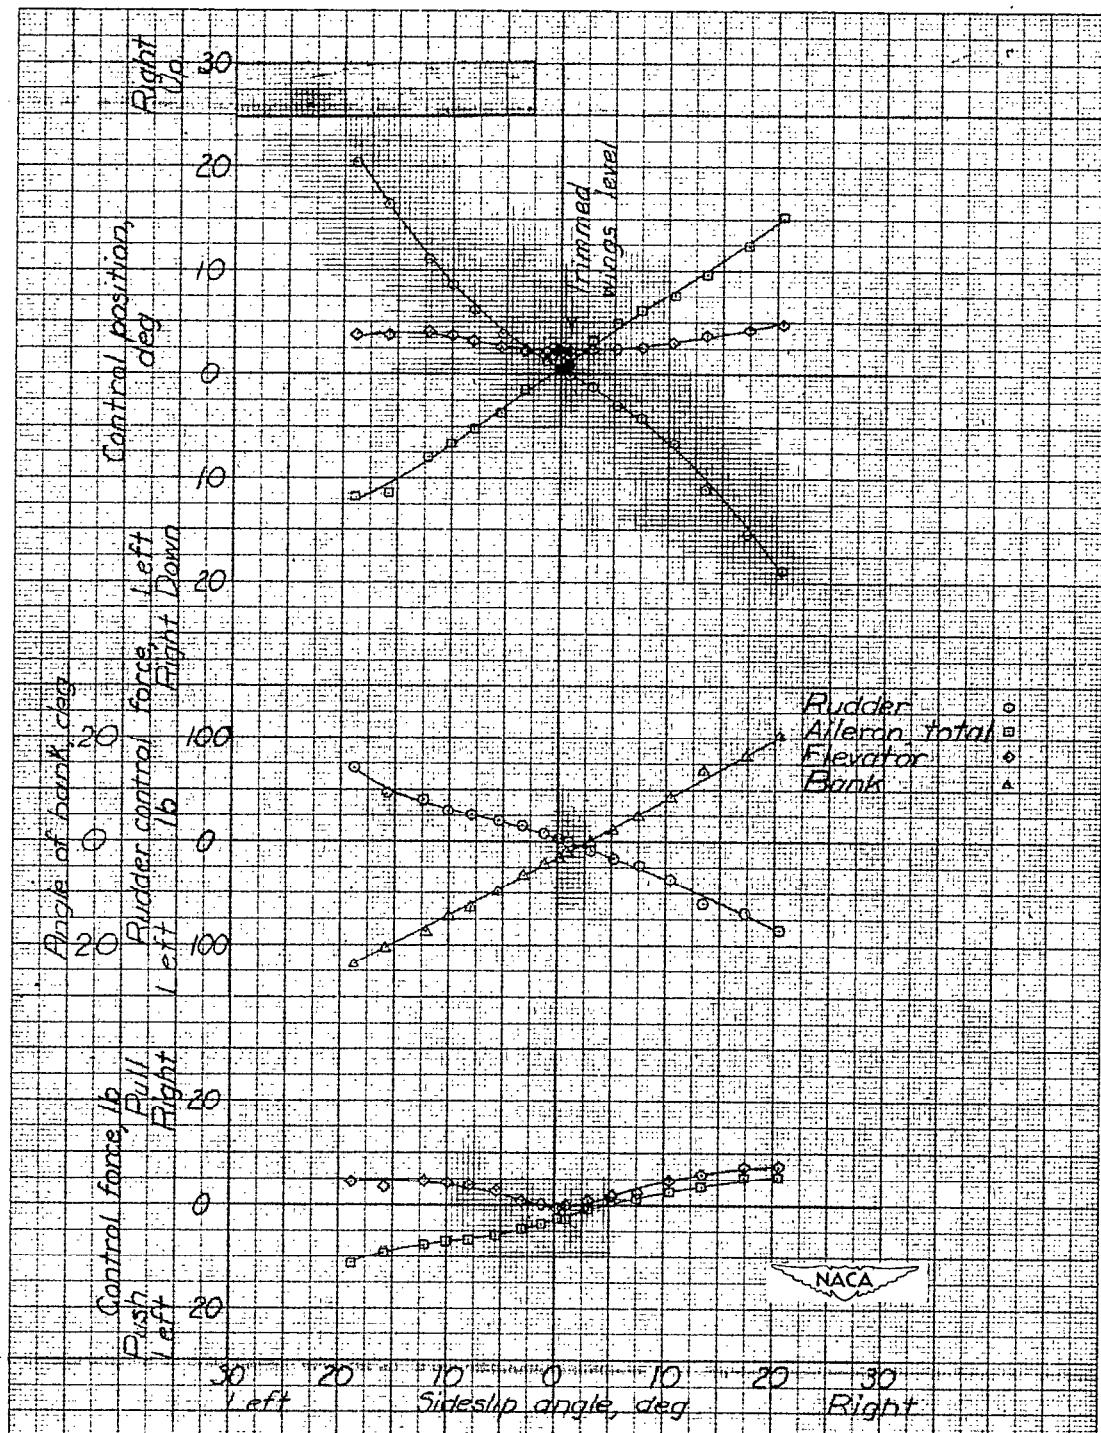
(a) 90 miles per hour, rudder tab  $17.5^\circ$  left (full tab).

Figure 20.- Sideslips in the power-approach condition (20 in. Hg at 2300 rpm) with flaps and landing gear down at 5000 feet, with belly tank on, cowl closed, oil cooler closed, canopy open, F8F-1 airplane, with tail configuration 1.

(b) 150 miles per hour, rudder tab  $2.3^\circ$  left.

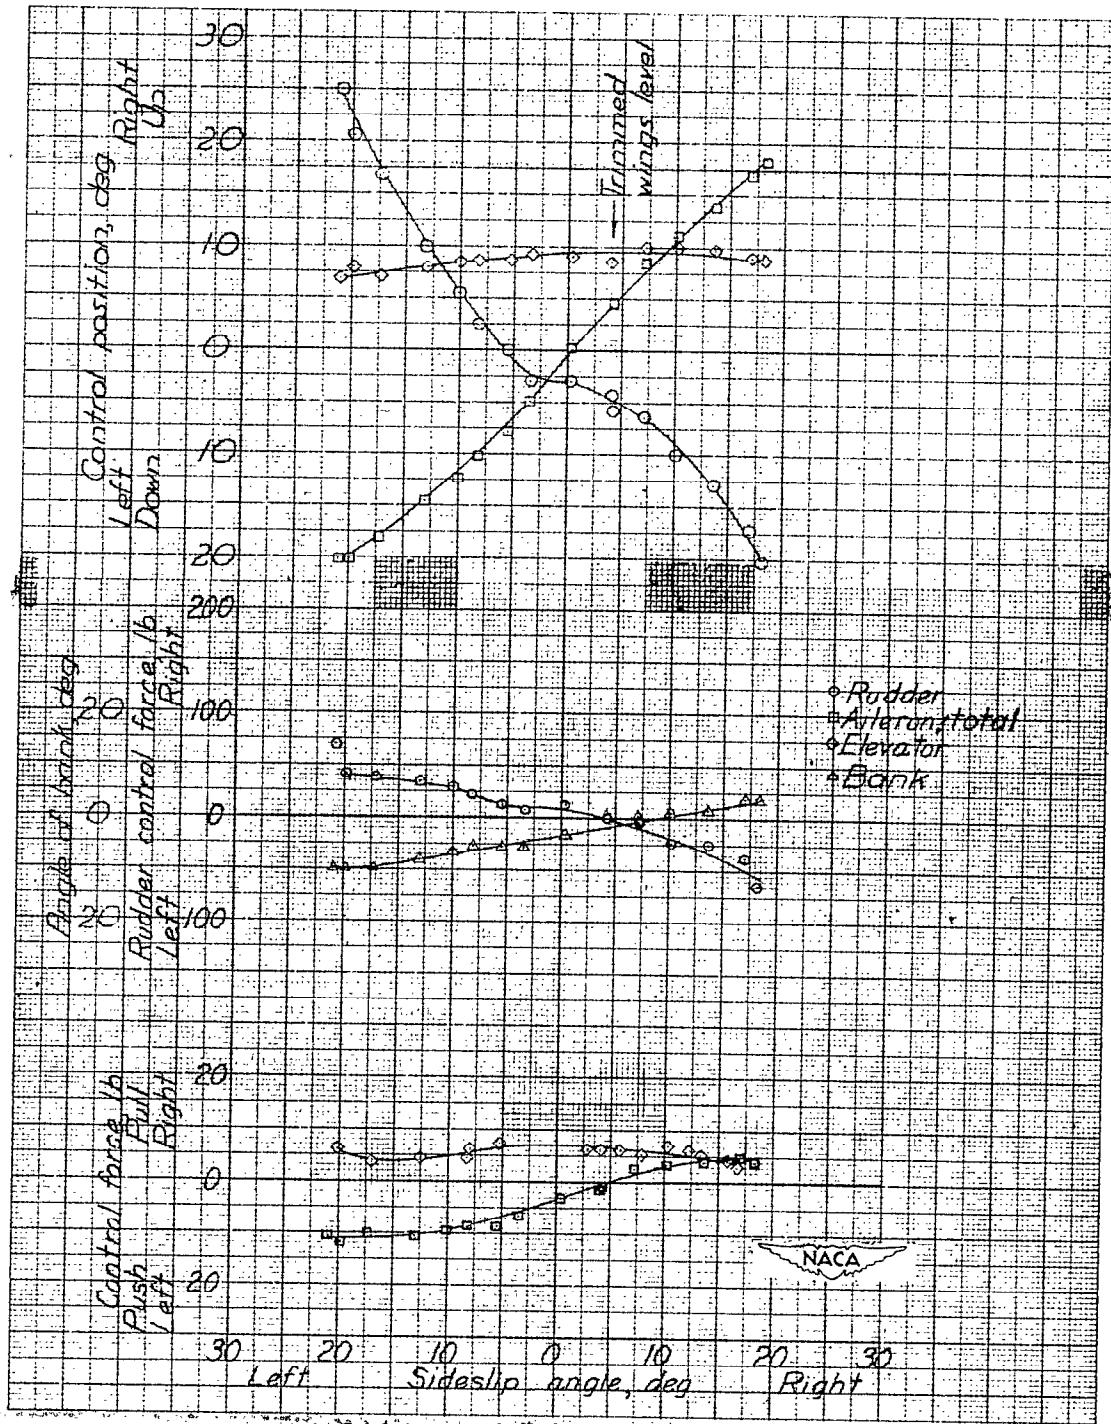
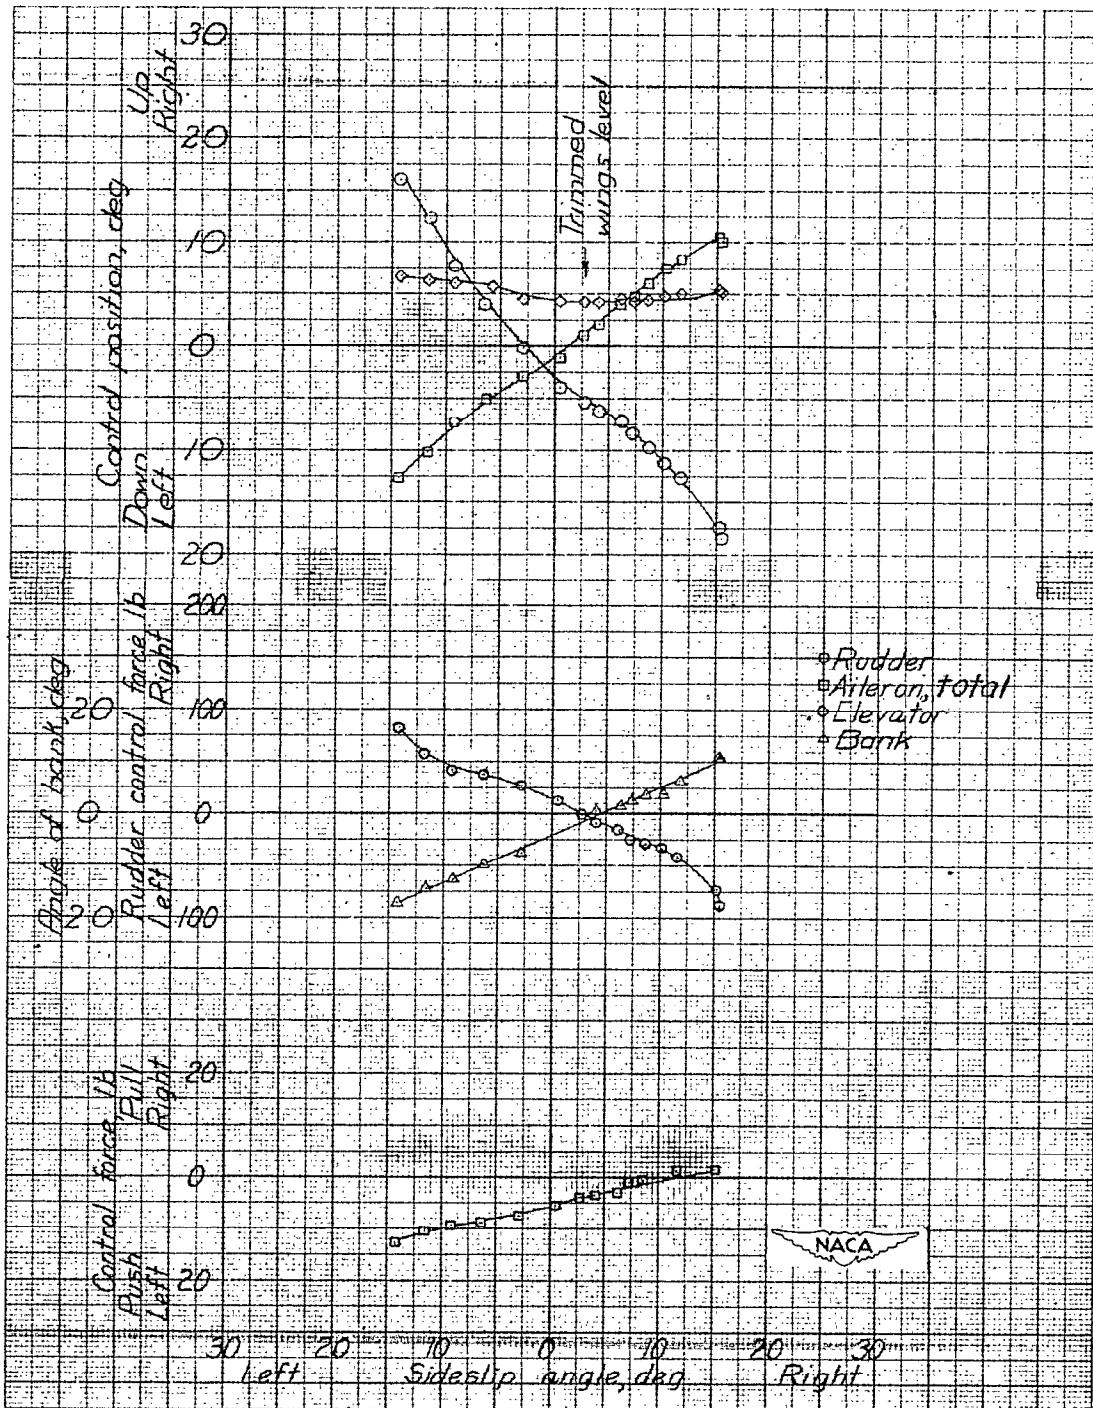
(a) 105 miles per hour, rudder tab  $14.7^\circ$  right.

Figure 21.- Sideslips in the landing condition with engine idling and flaps and landing gear down at 5000 feet, with belly tank on, cowl closed, oil cooler closed, canopy open, F8F-1 airplane with tail configuration 1.

(b) 150 miles per hour, rudder tab  $12.8^\circ$  right.
