FLIGHT MEASUREMENTS OF LATERAL AND DIRECTIONAL  
STABILITY AND CONTROL CHARACTERISTICS  
OF THE GRUMMAN F8F-1 AIRPLANE

TED NO. NACA 2379

H. L. Crane and J. P. Reeder

Langley Memorial Aeronautical Laboratory  
Langley Field, Va.

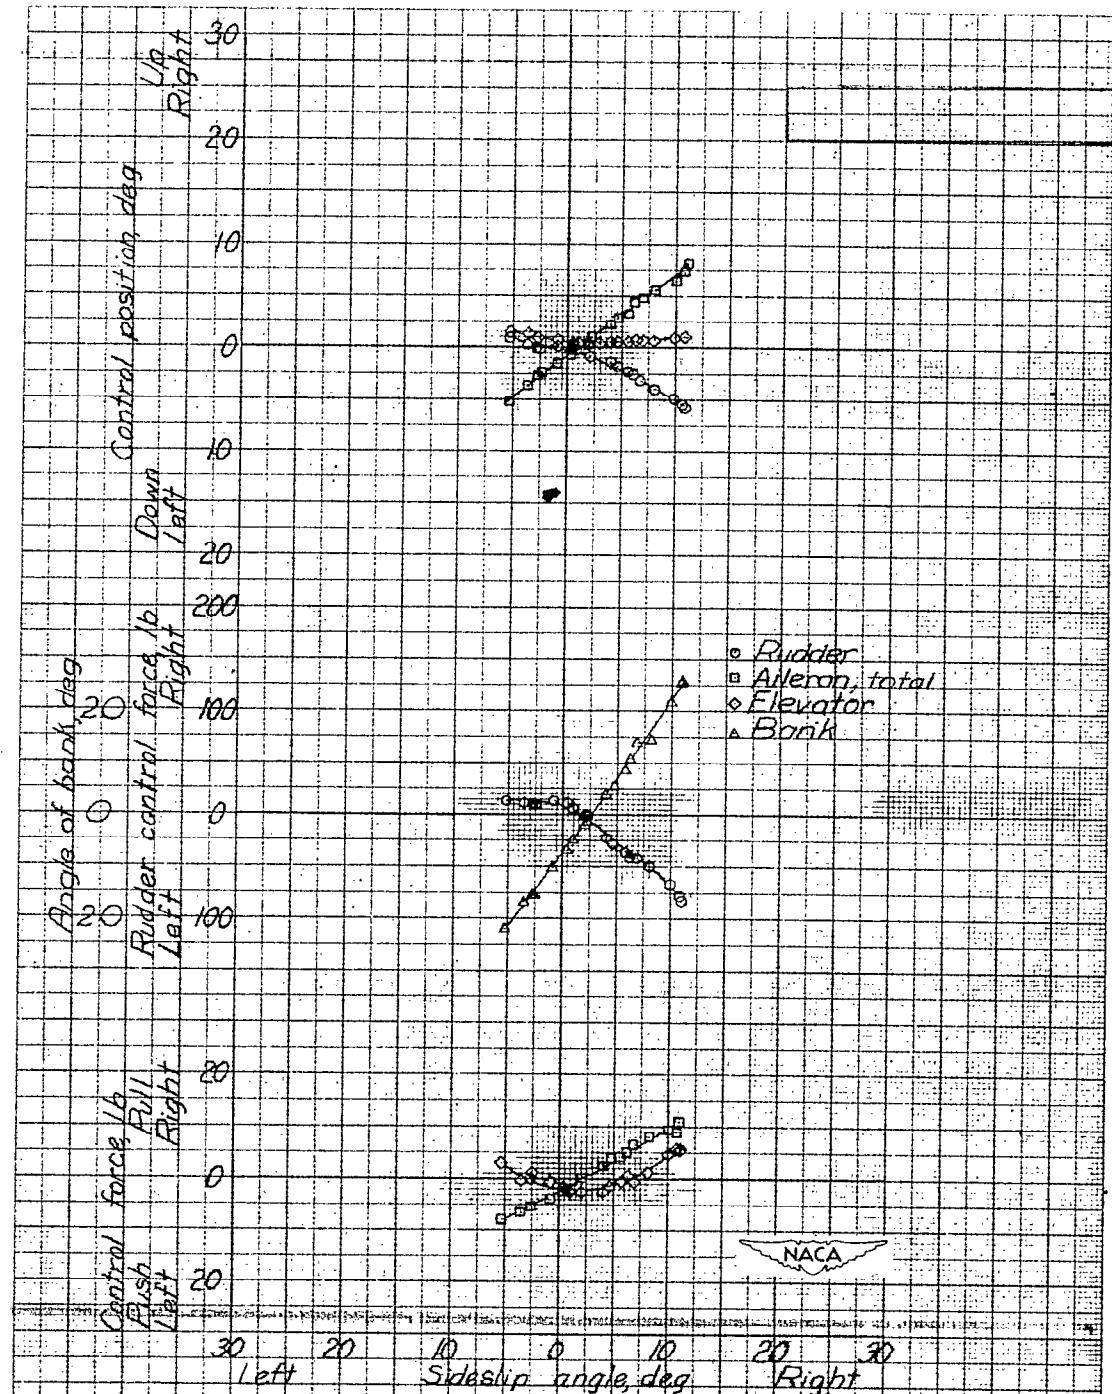
Figure 22.- Steady sideslips at 20,000 feet in the rated-power, clean condition (41 in. Hg at 2600 rpm) at 300 miles per hour with belly tank on. F8F-1 airplane with tail configuration 1.

The sideslip data which gave measurements of directional stability (variation of rudder angle and force with sideslip angle), dihedral effect (variation of aileron angle and force with sideslip angle), pitching moment due to sideslip (variation of elevator angle and force with sideslip angle), and the side-force characteristics (variation of angle of bank with angle of sideslip) are shown in figures 15 to 22 for tail configuration 1.

As a general rule, decreasing the power or lowering the flaps increased the directional stability. The effect of altitude on the directional stability was determined by comparison of the data of figure 22 which were obtained at an altitude of 20,000 with those of figures 16(b) and 16(c) for an altitude of 5000 feet. The comparison showed that  $d\delta_r/d\beta$  for small angles of sideslip was reduced from approximately 0.25 at 5000 feet to 0.1 at 20,000 feet (300 mph, tank on).

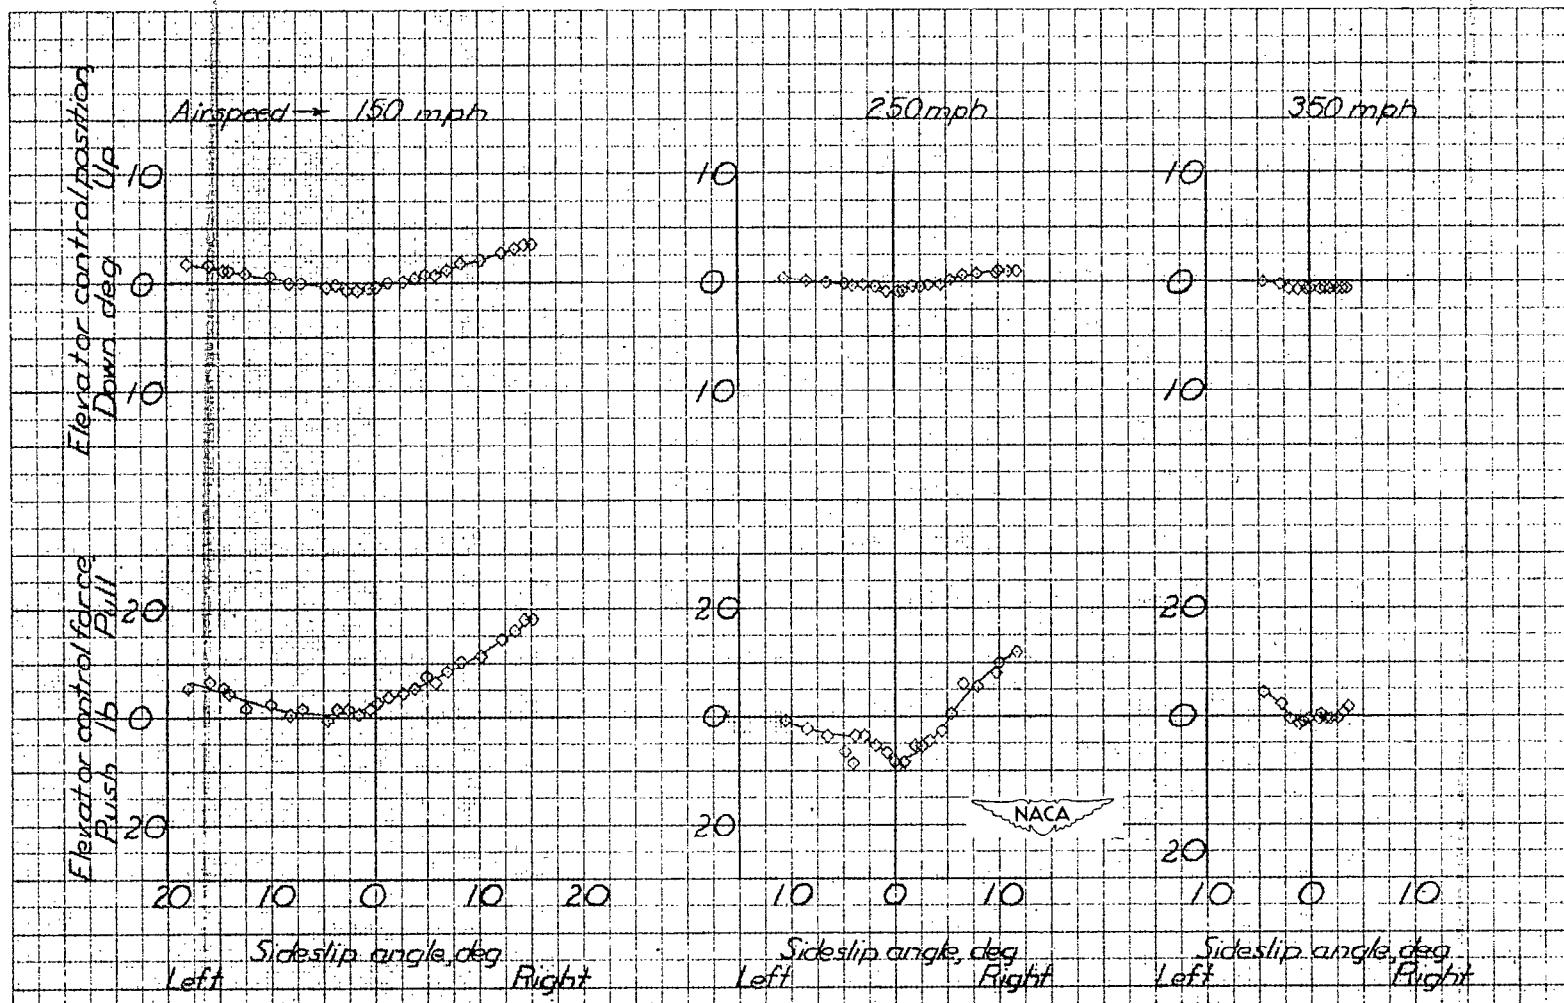
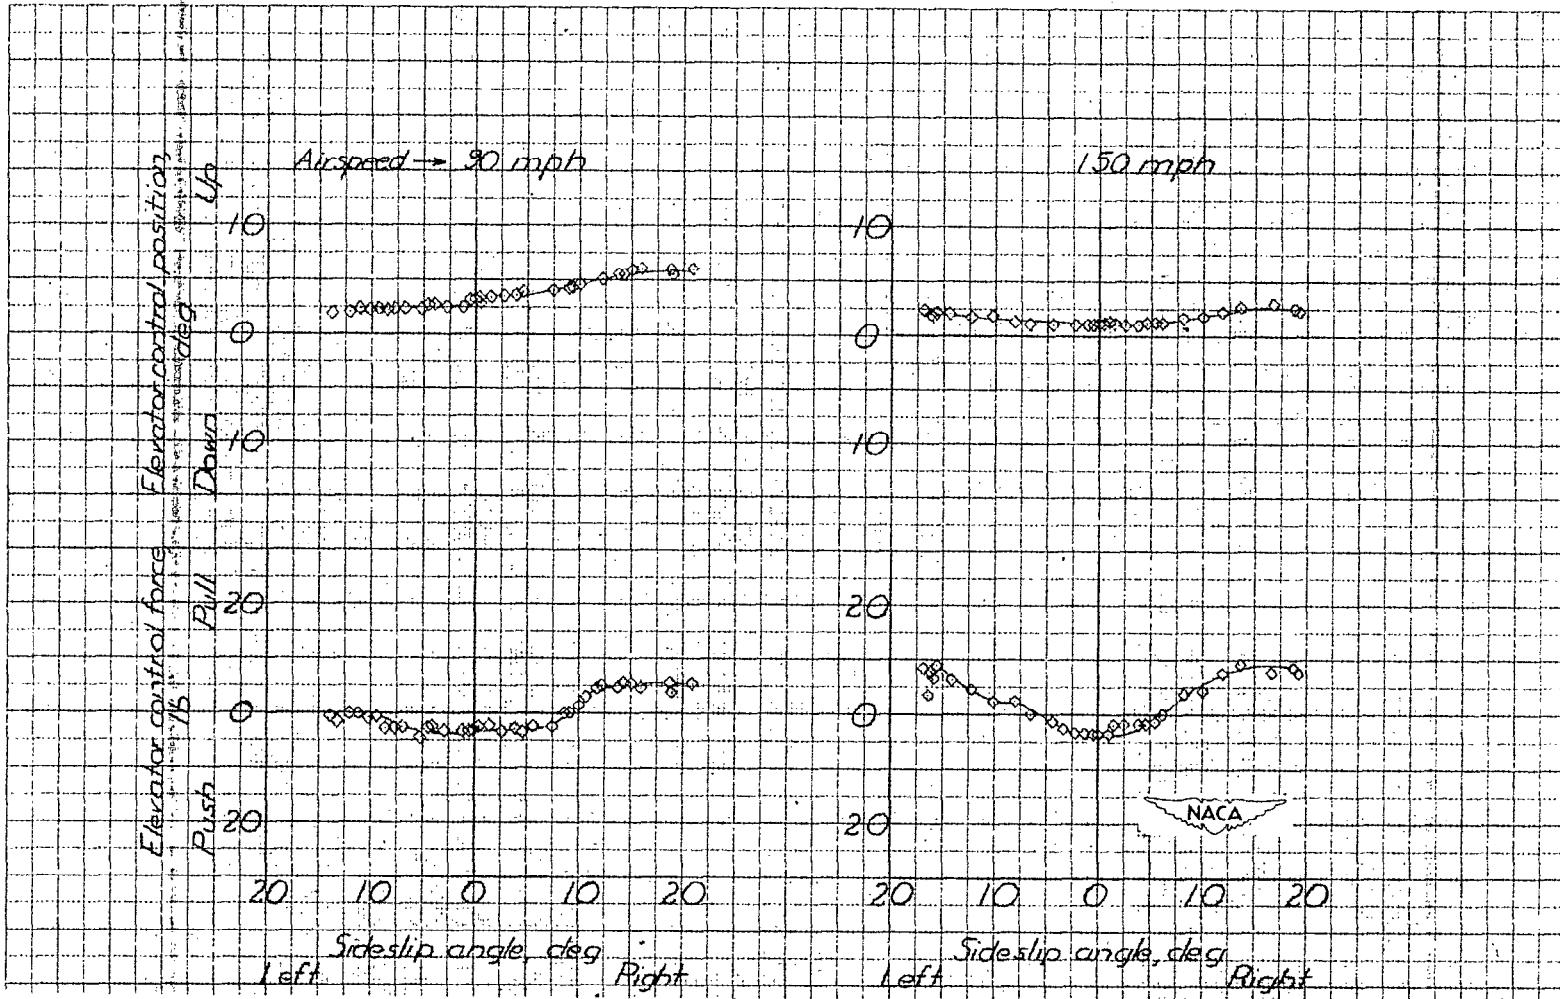
(a) Rated-power, clean condition.

Figure 23.- Variation of elevator position and control force with angle of sideslip. F8F airplane with tail configuration 2.

(b) Power-approach condition.

Pitching moment due to sideslip.- The variation of elevator position with angle of sideslip was usually not large. The variation of elevator force with angle of sideslip is not presented in all cases because the elevator-force recorder used during the tests of tail configuration 1 was found to be unreliable. However the data obtained with tail configuration 2 (fig. 23) indicate that a fairly large pull force was required to maintain longitudinal trim in sideslips. This effect was greatest in right sideslips.

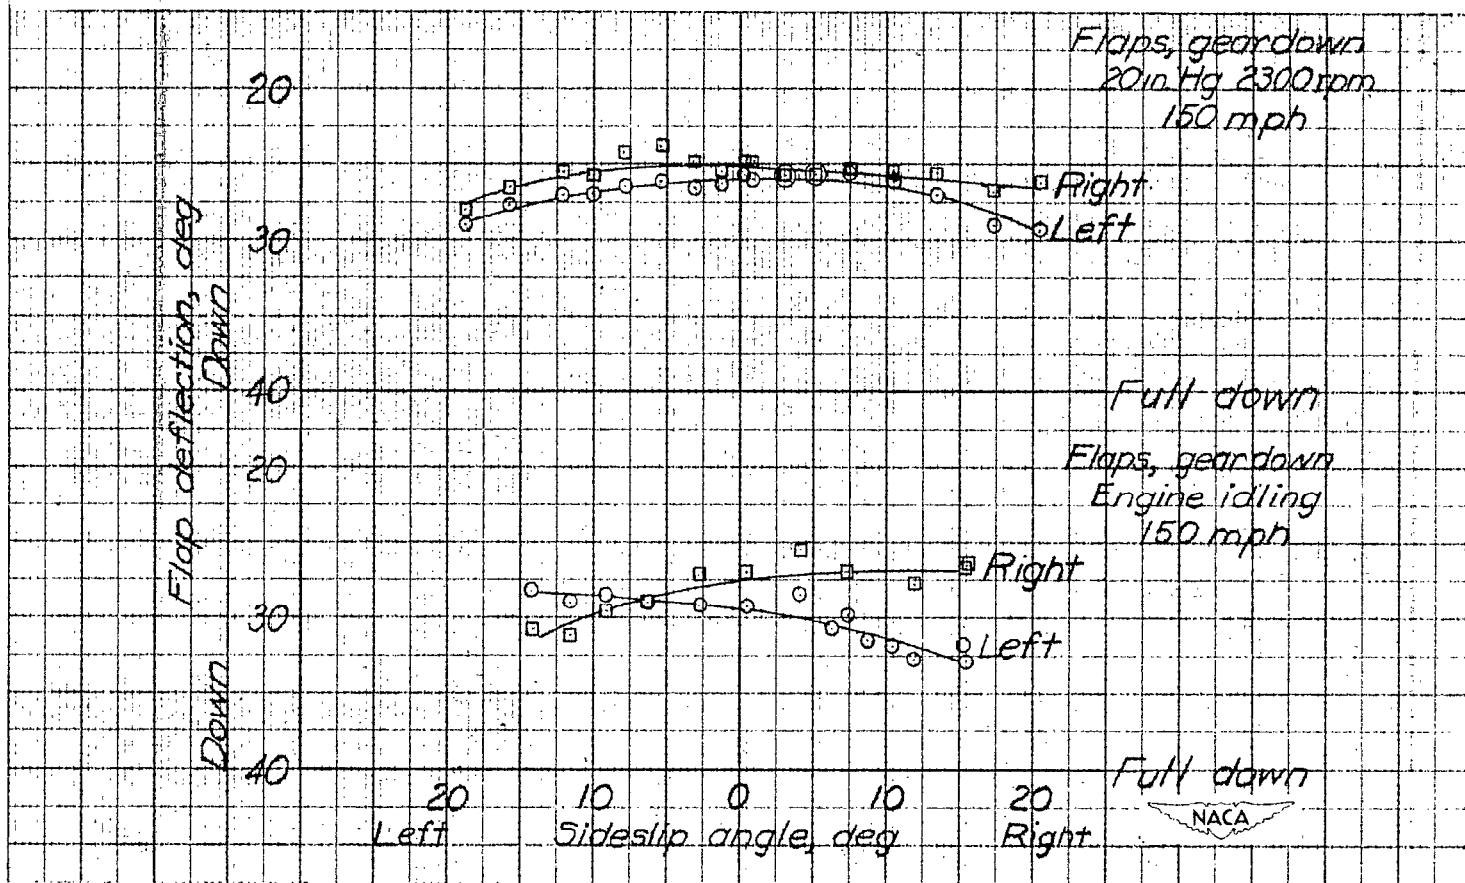
Figure 24.- Flap blow-up in sideslips at 150 miles per hour, belly tank on, F8F-1 airplane.

Effect of sideslip on flap deflection.- The landing flaps on the F8F-1 airplane were spring-loaded to permit them to blow up as the airspeed increased and thus to prevent overloading. Figure 24 presents data obtained during the sideslip tests which show the variation of flap deflection with angle of sideslip for two power settings at 150 miles per hour.

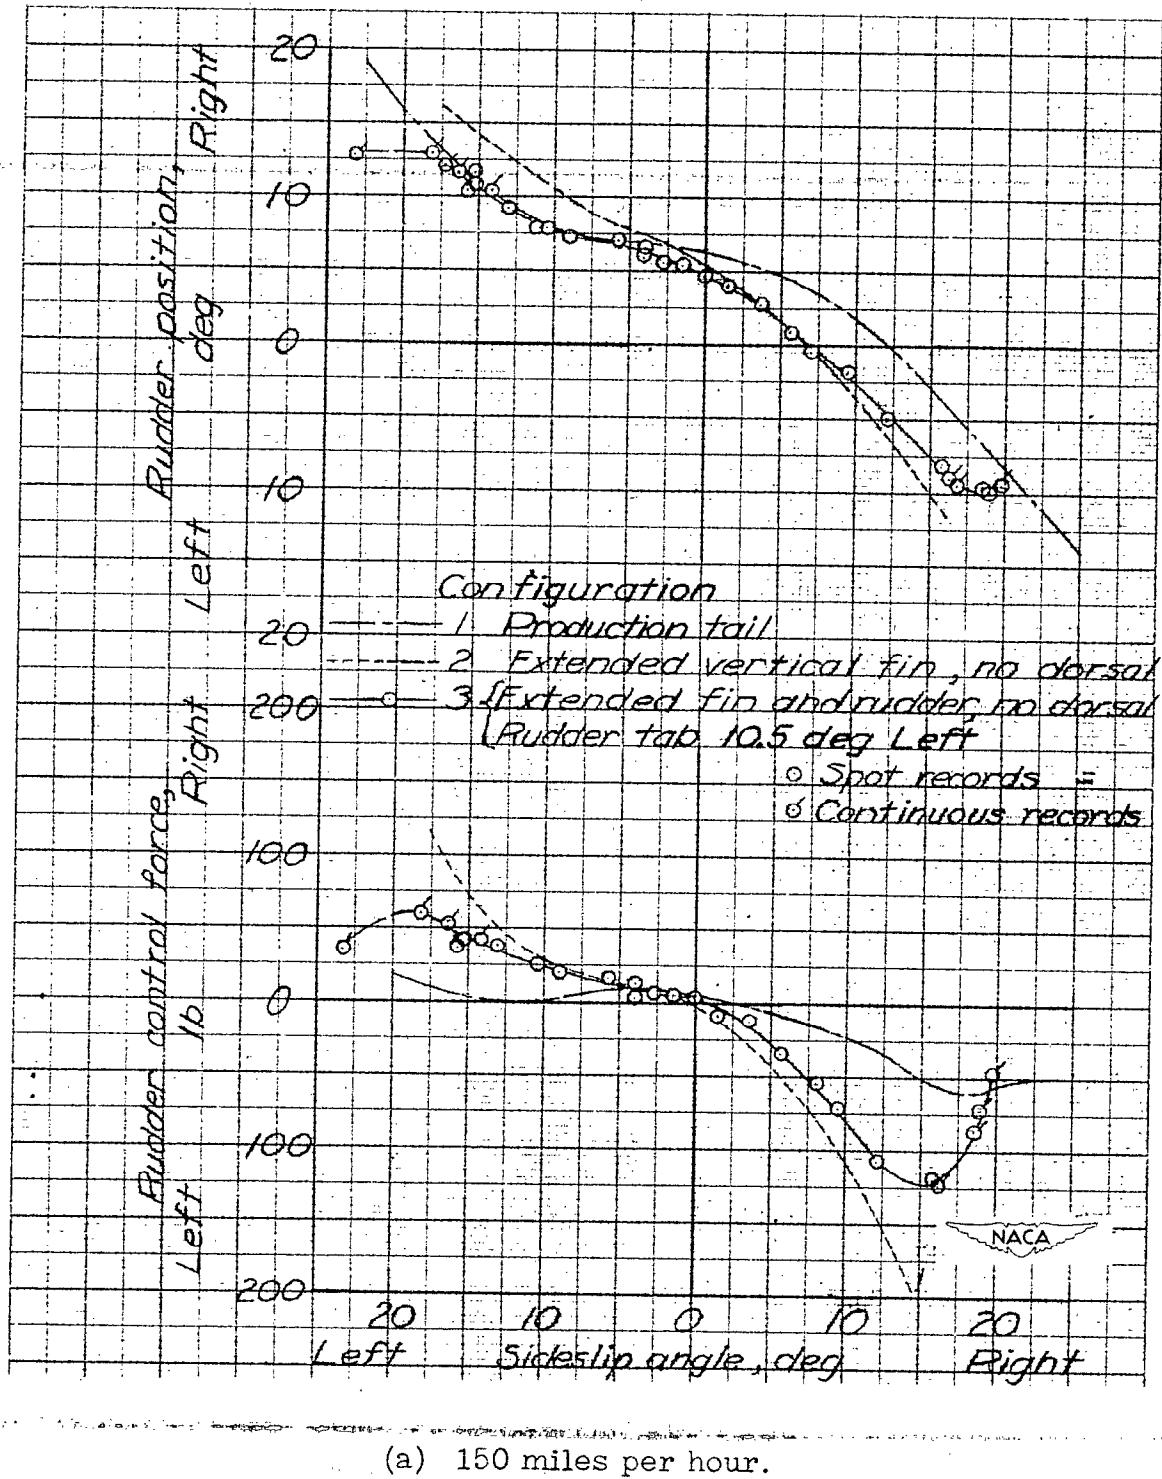
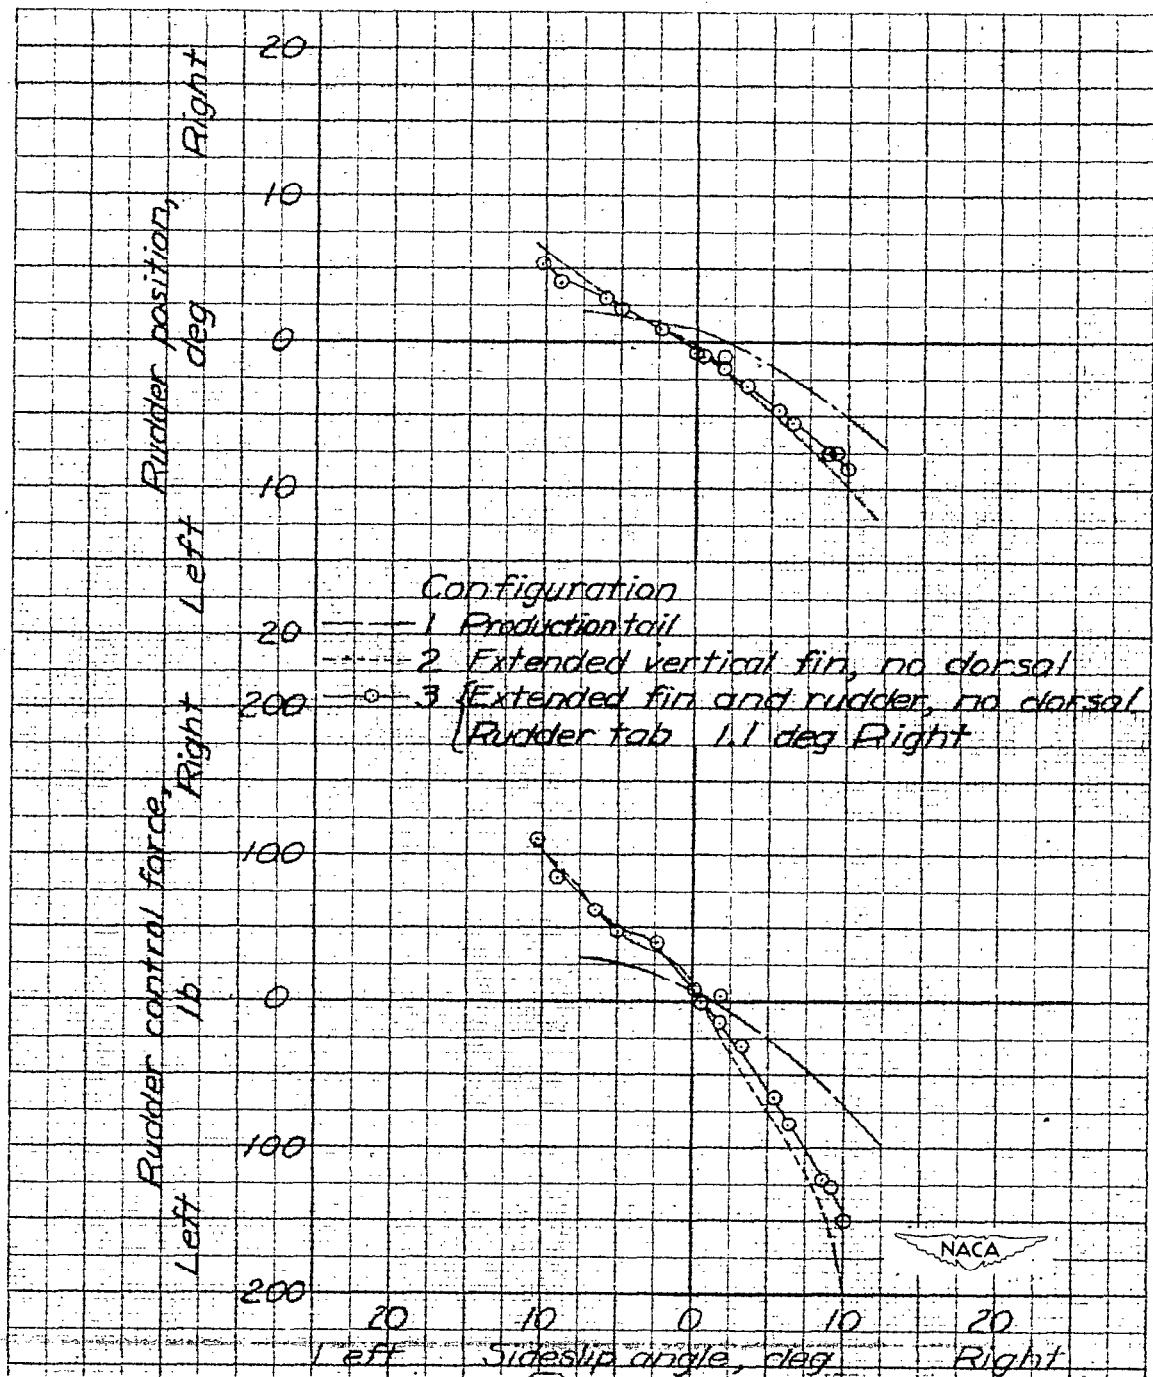
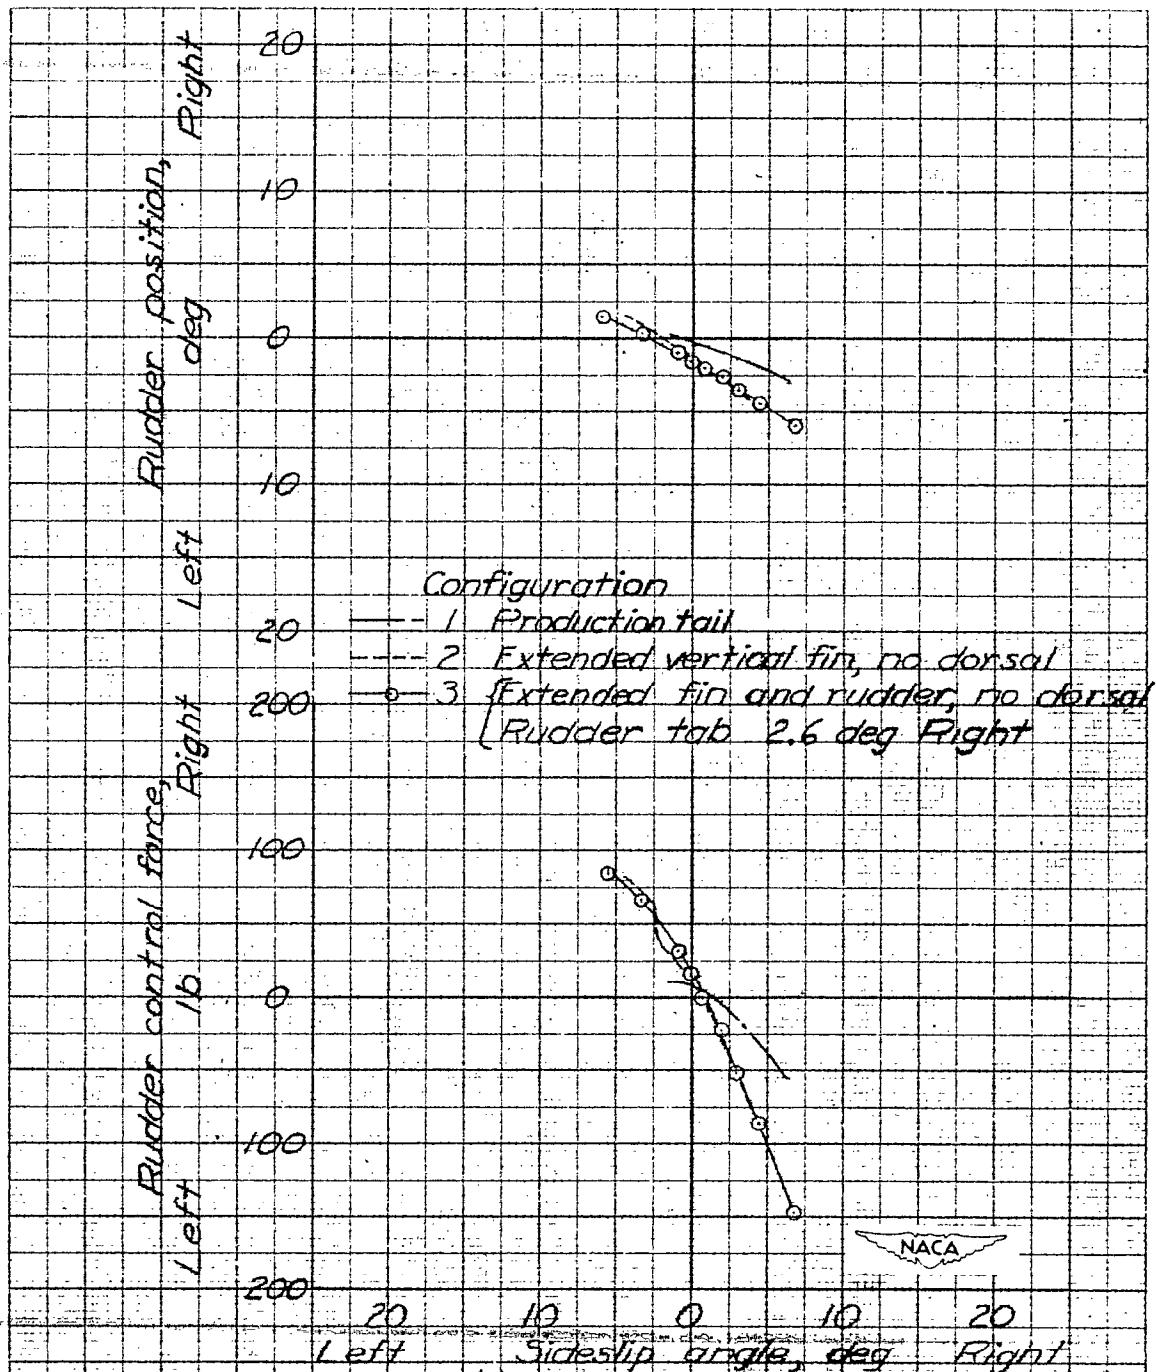
Figure 25.- Steady sideslip characteristics in the rated-power, clean condition (41 in. Hg at 2600 rpm) with three vertical tail configurations. F8F-1 airplane.

Figures 25 and 26 present a comparison of the directional stability characteristics with the three vertical-tail configurations with the belly tank installed. The data of figures 25 and 26 indicate that either vertical-tail configuration 2 or configuration 3 improved the directional stability at small sideslip angles where there had been a deficiency with tail configuration 1. In the rated-power, clean condition at 150 miles per hour (fig. 25(a)) where the control-free directional stability in left sideslips had been zero with tail configuration 1, there was definite positive control-free stability with either tail configuration 2 or 3.

Comparison of the curves of rudder force and position against angle of sideslip in figures 25 and 26 shows that tail configurations 2 and 3 produced increases in directional stability. The following table presents the values of the directional-stability parameters,  $d\delta_r/d\theta$ , the rate of change of rudder position with angle of sideslip, and  $dF_r/d\theta$ , the rate of change of rudder control force with angle of sideslip, measured between  $0^\circ$  and  $5^\circ$  with the three vertical tails in two flight conditions with belly tank installed at several speeds. The minimum slopes usually occurred between  $0^\circ$  and  $5^\circ$  left sideslip.

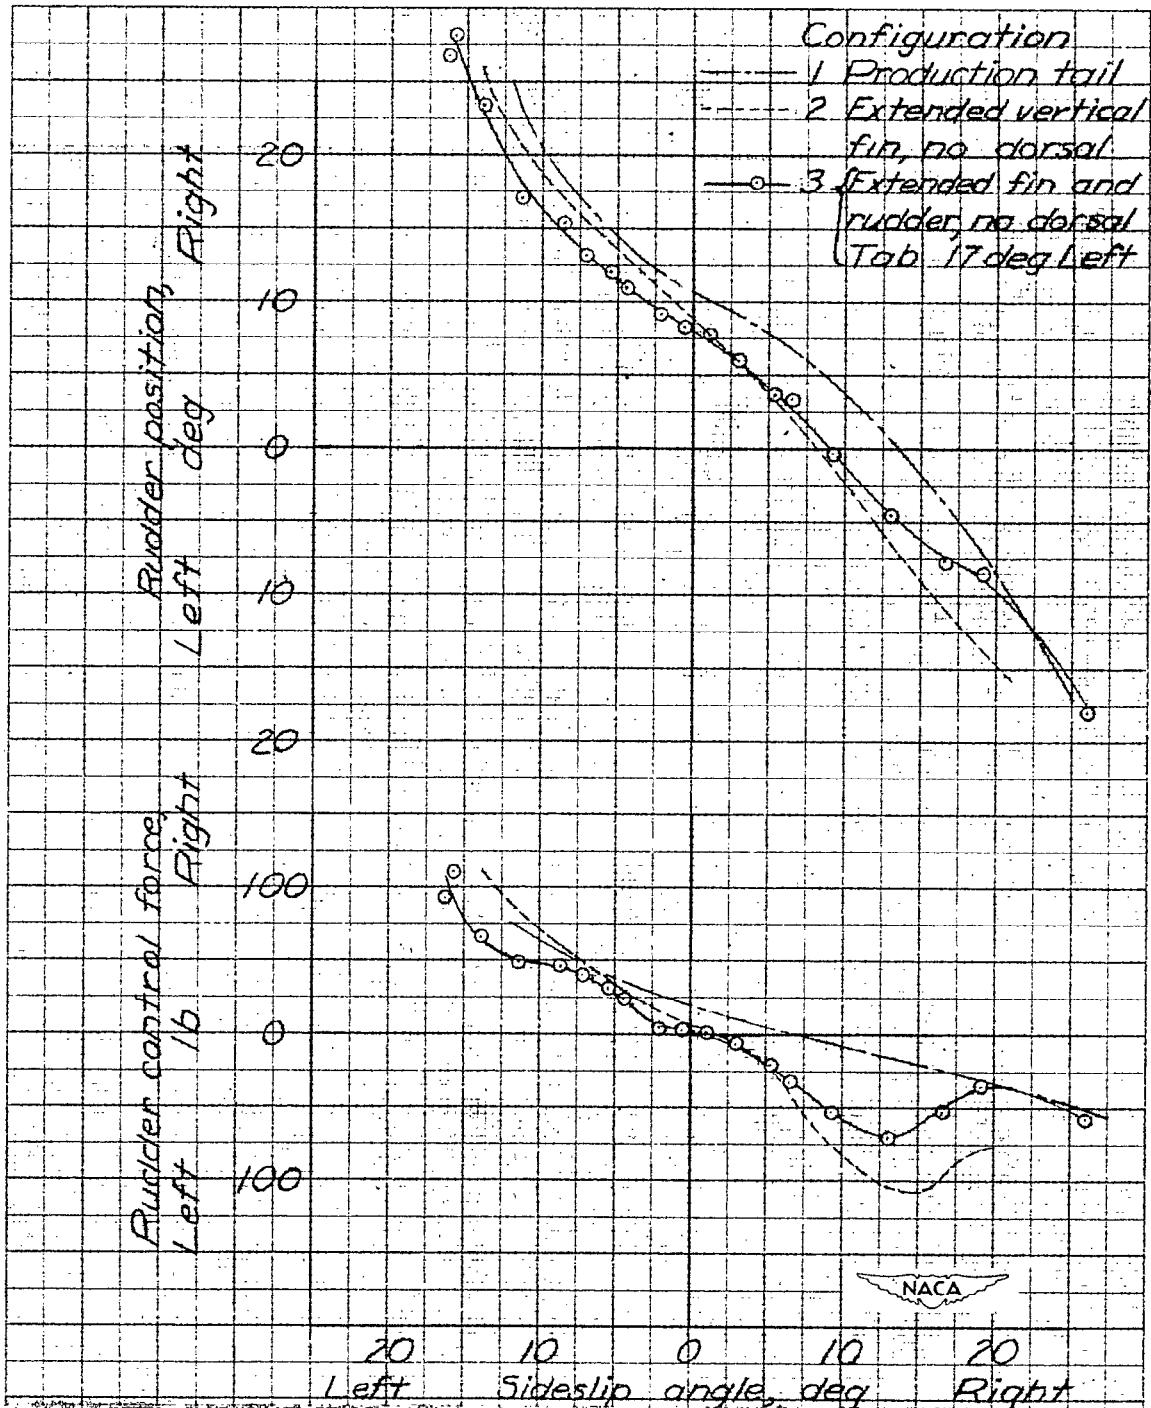
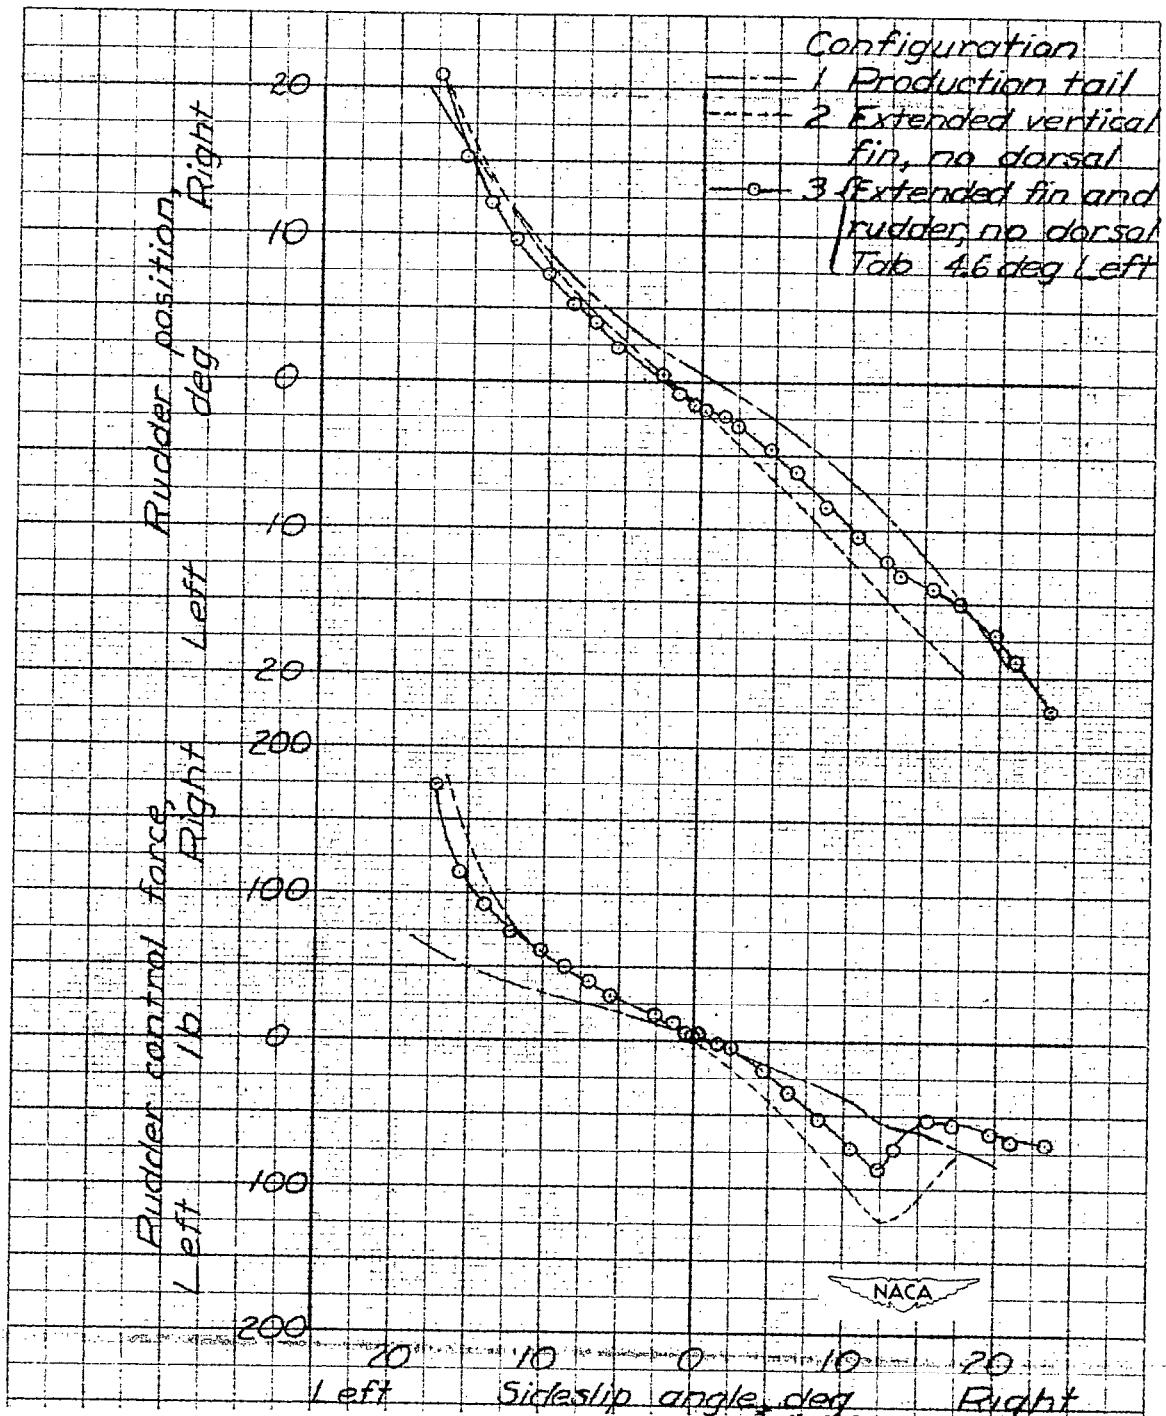
Figure 26.- Steady sideslip characteristics in the power-approach condition (18-20 in. Hg at 2300 rpm), flaps and landing gear down with three vertical tail configurations F8F-1 airplane.

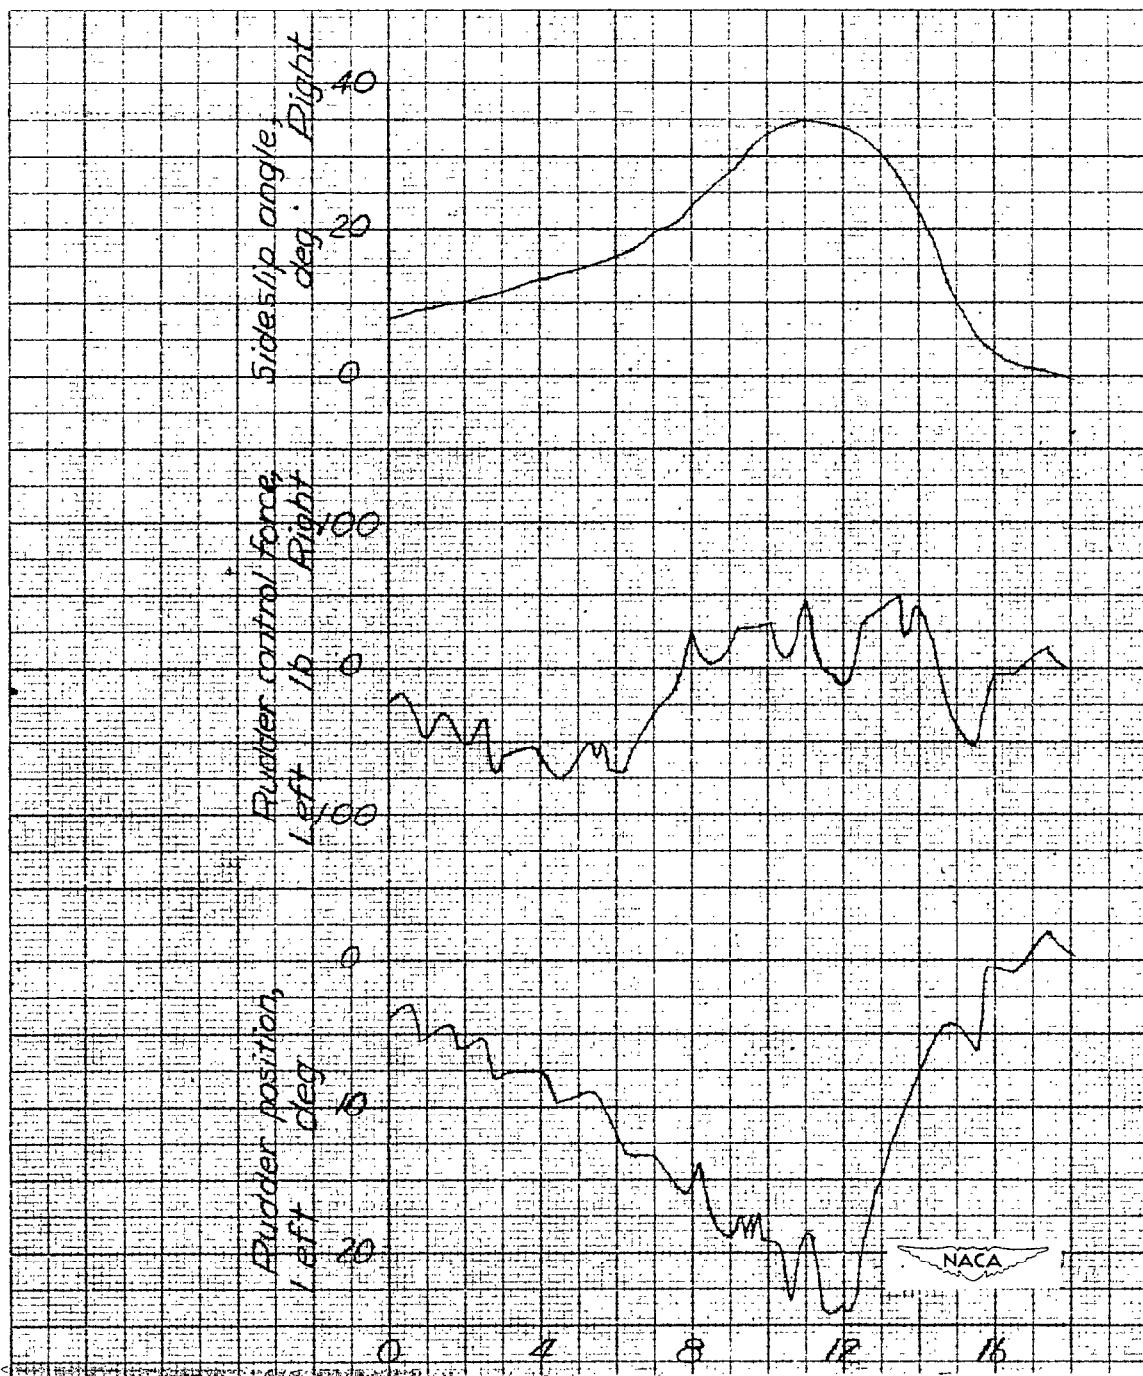
Figure 27.- Time history of right sideslip at approximately 120 miles per hour in the power-approach condition (30 in. Hg, 2200 rpm, flaps and landing gear down) during which rudder overbalance occurred, F8F-1 airplane with tail configuration three, belly tank on.

In right sideslips of about 15°, there was a tendency toward rudder overbalance with tail configurations 2 and 3 at low speeds. This tendency was counteracted somewhat by the spring in the left rudder cable so that no overbalance occurred in the range of angles of sideslip covered by the data presented in figures 25 and 26. However, a small amount of rudder overbalance has been measured with tail configuration 3 when there was a small yawing velocity at angles of sideslip from 20° to 35° right in the power-approach condition at low speeds. A time history of such data is presented in figure 27. The tendency toward rudder-force reversal was hardly noticeable with tail configuration 1 which had a dorsal fin. It is believed that retention of the original dorsal fin on tail configurations 2 and 3 would have greatly reduced the tendency toward rudder-force reversal.

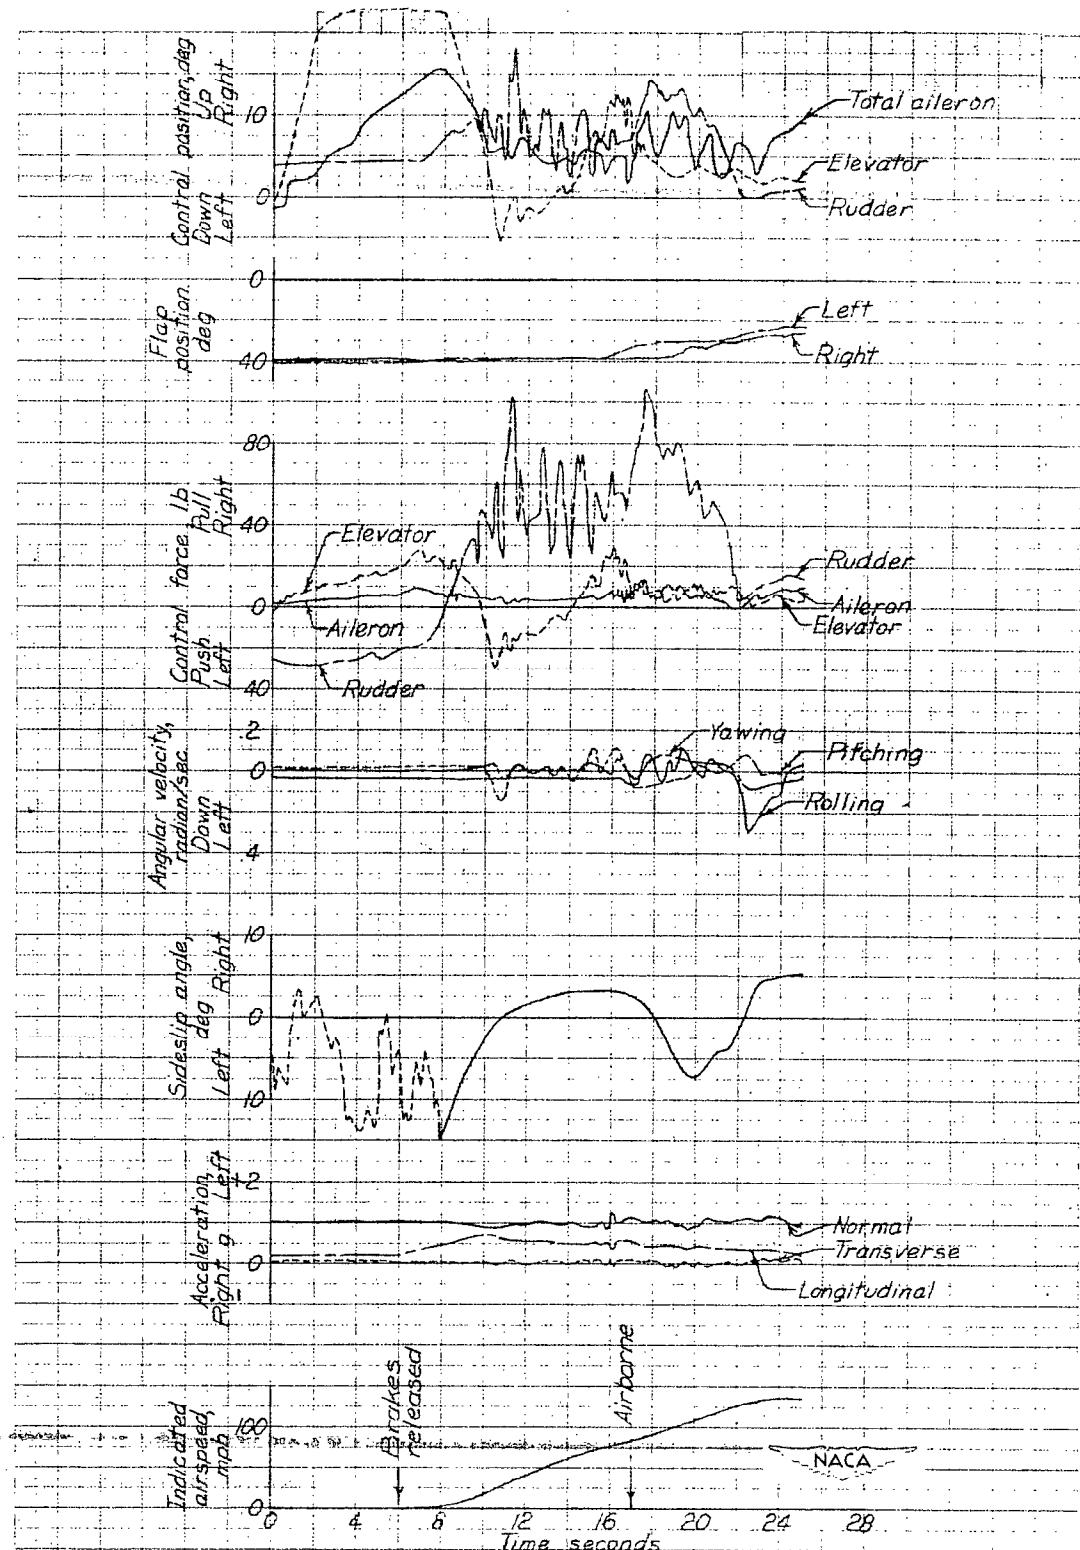
Figure 28.- Time history of simulated carrier take-off (54 in. Hg, 2800 rpm), by a service pilot. F8F-1 airplane with tail configuration 1.

No take-offs or landings were recorded in a 90° cross wind. Figures 28 to 30 present time histories of take-offs made with tail configurations 1 and 3 and a landing made with tail configuration 1. No indication of a lack of directional control or of excessive rudder forces was obtained.

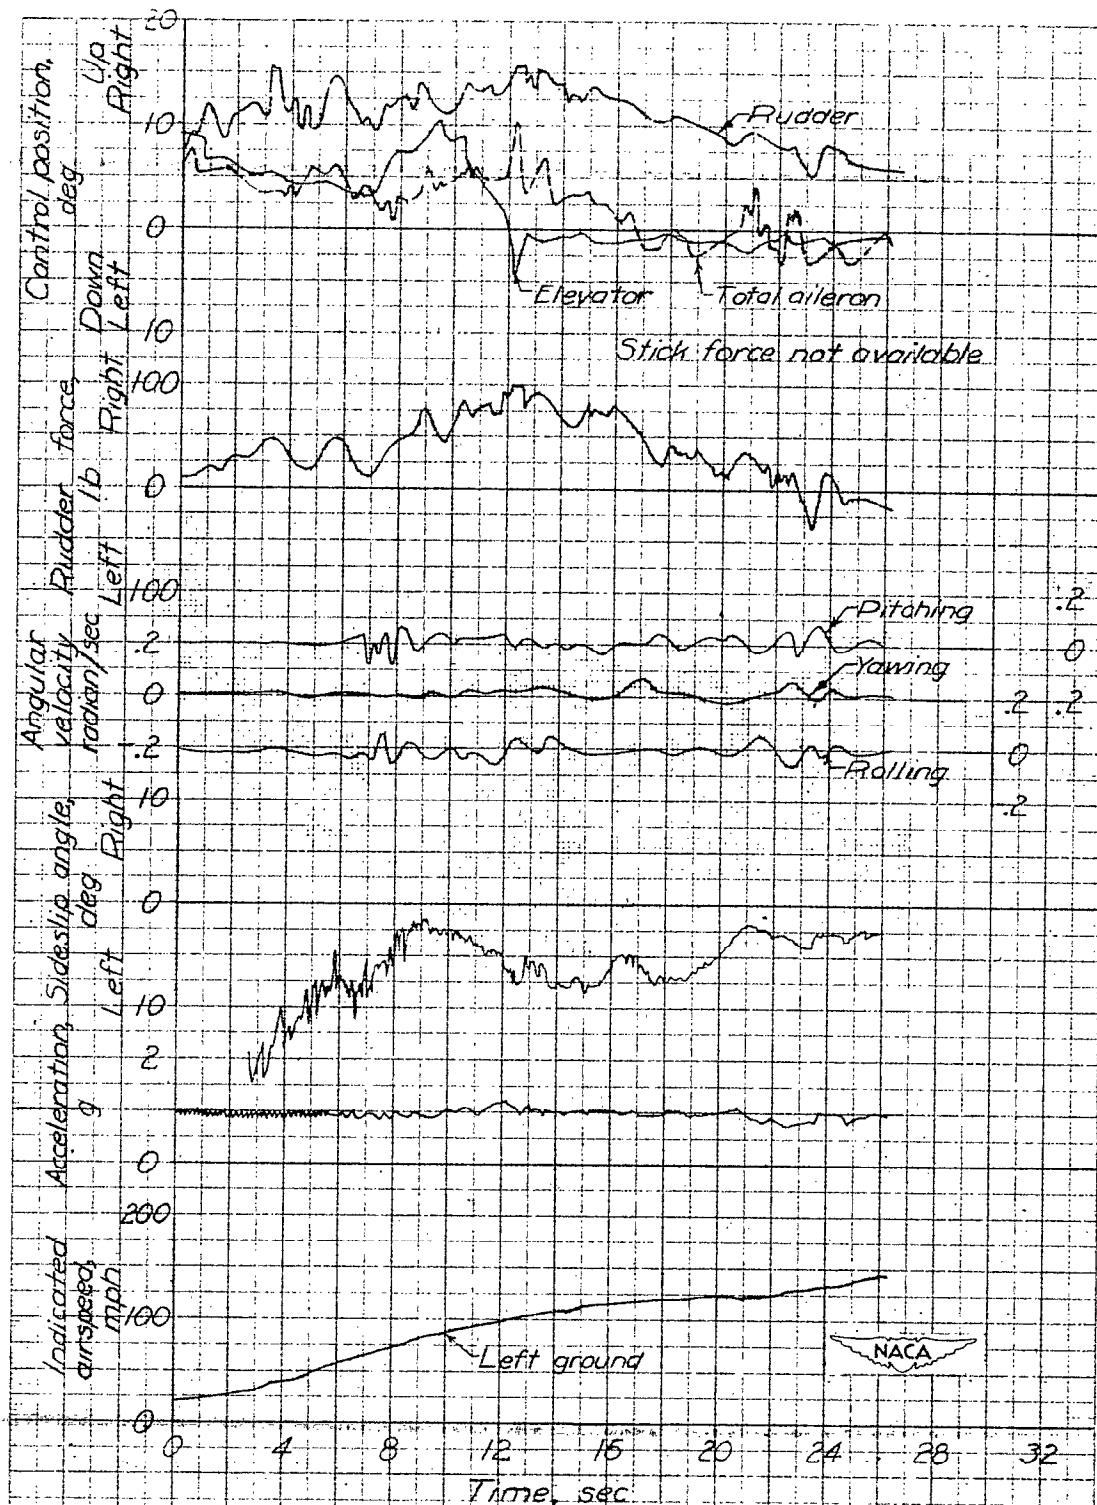
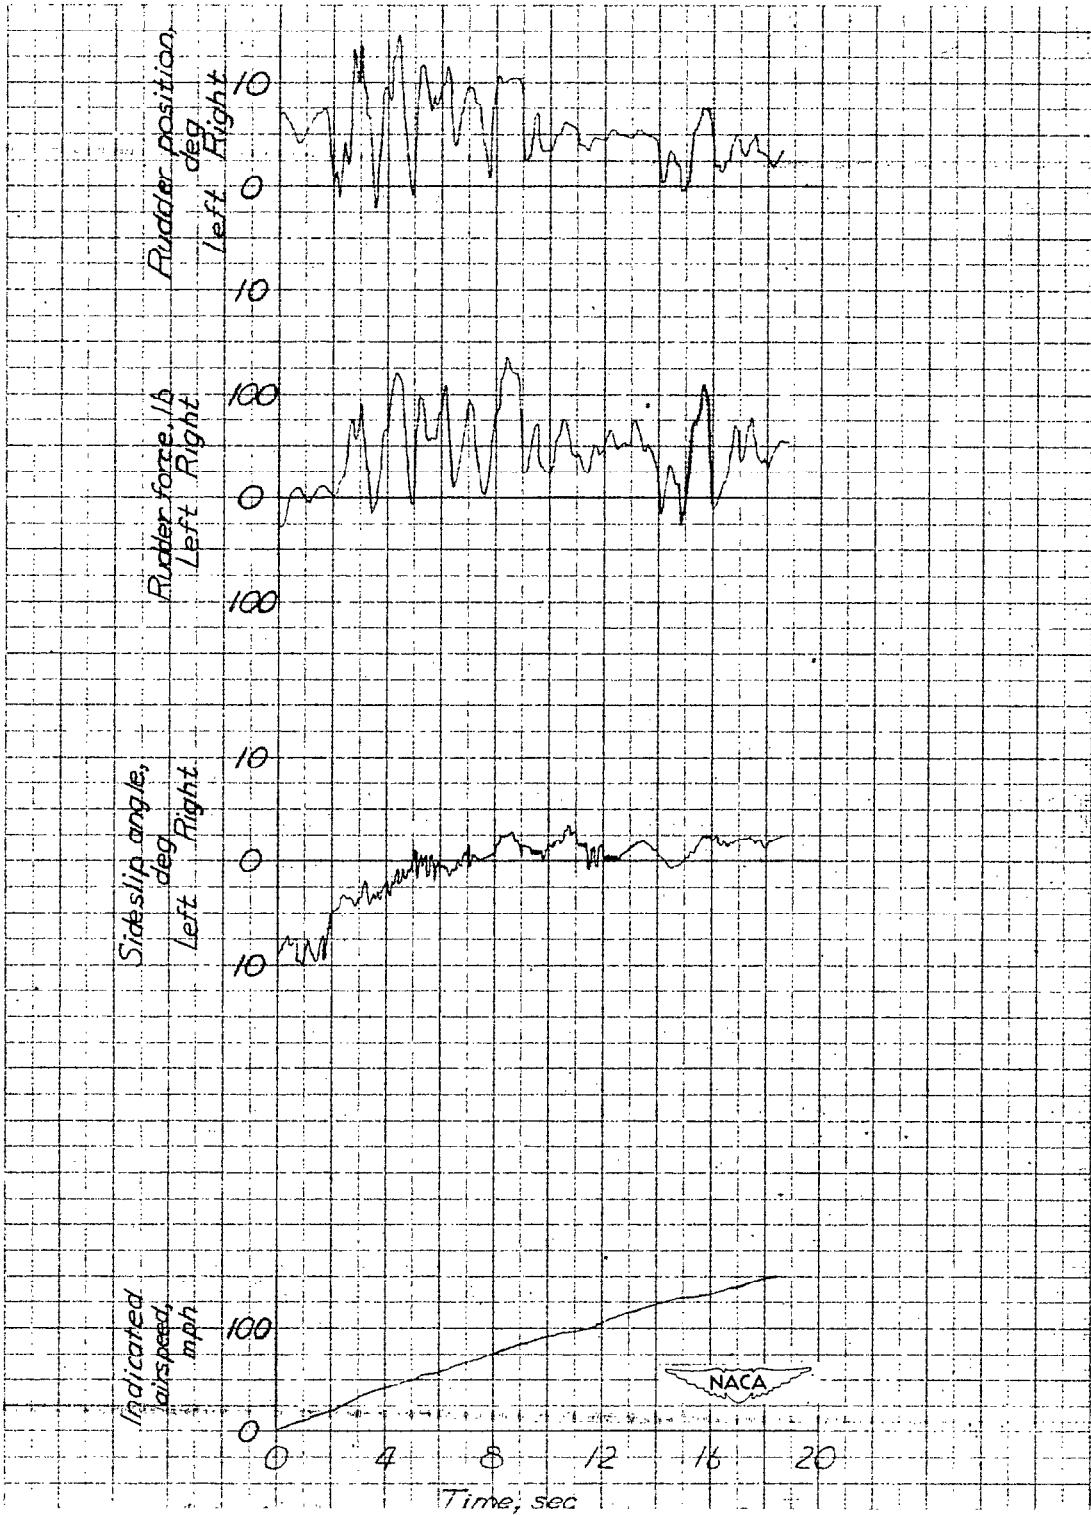
(a) Made by NACA pilot.

Figure 29.- Time histories of take-offs, F8F-1 airplane with tail configuration 3.

(b) Made by service pilot. (Elevator and aileron records eliminated for clarity.)
