FLIGHT MEASUREMENTS OF LATERAL AND DIRECTIONAL  
STABILITY AND CONTROL CHARACTERISTICS  
OF THE GRUMMAN F8F-1 AIRPLANE

TED NO. NACA 2379

H. L. Crane and J. P. Reeder

Langley Memorial Aeronautical Laboratory  
Langley Field, Va.

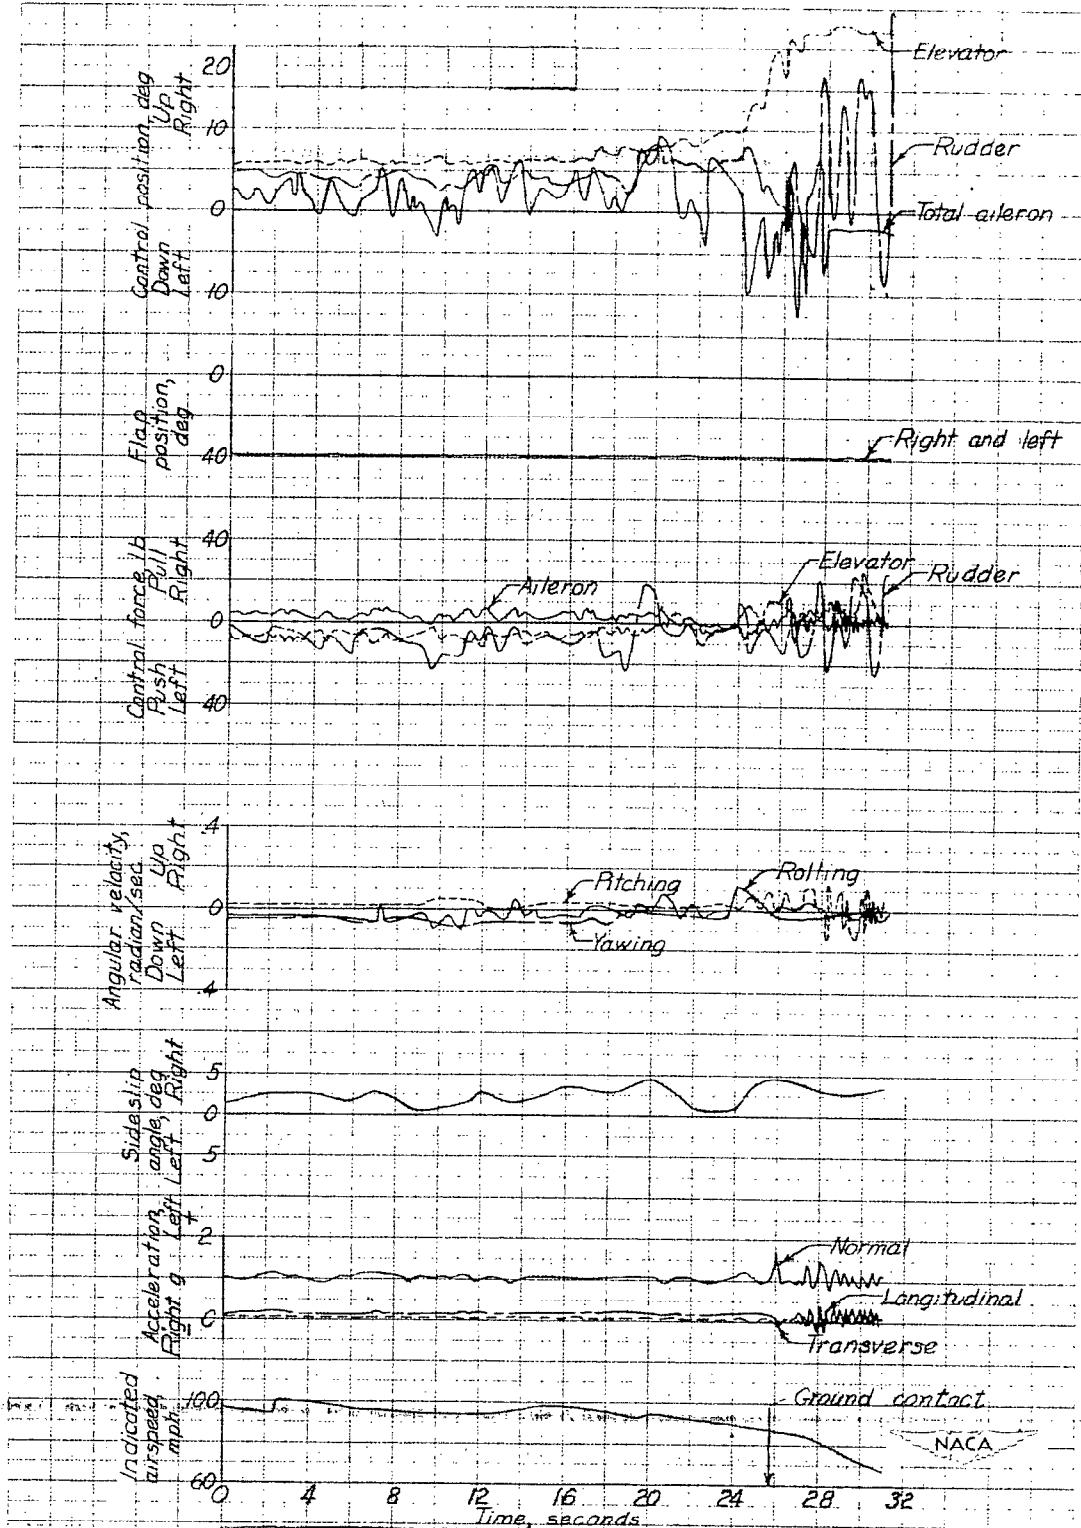
Figure 30.- Time history of simulated carrier landing (22 in. Hg, 2400 rpm), F8F-1 airplane, with tail configuration 1, made by service pilot.

No take-offs or landings were recorded in a 90° cross wind. Figures 28 to 30 present time histories of take-offs made with tail configurations 1 and 3 and a landing made with tail configuration 1. No indication of a lack of directional control or of excessive rudder forces was obtained.

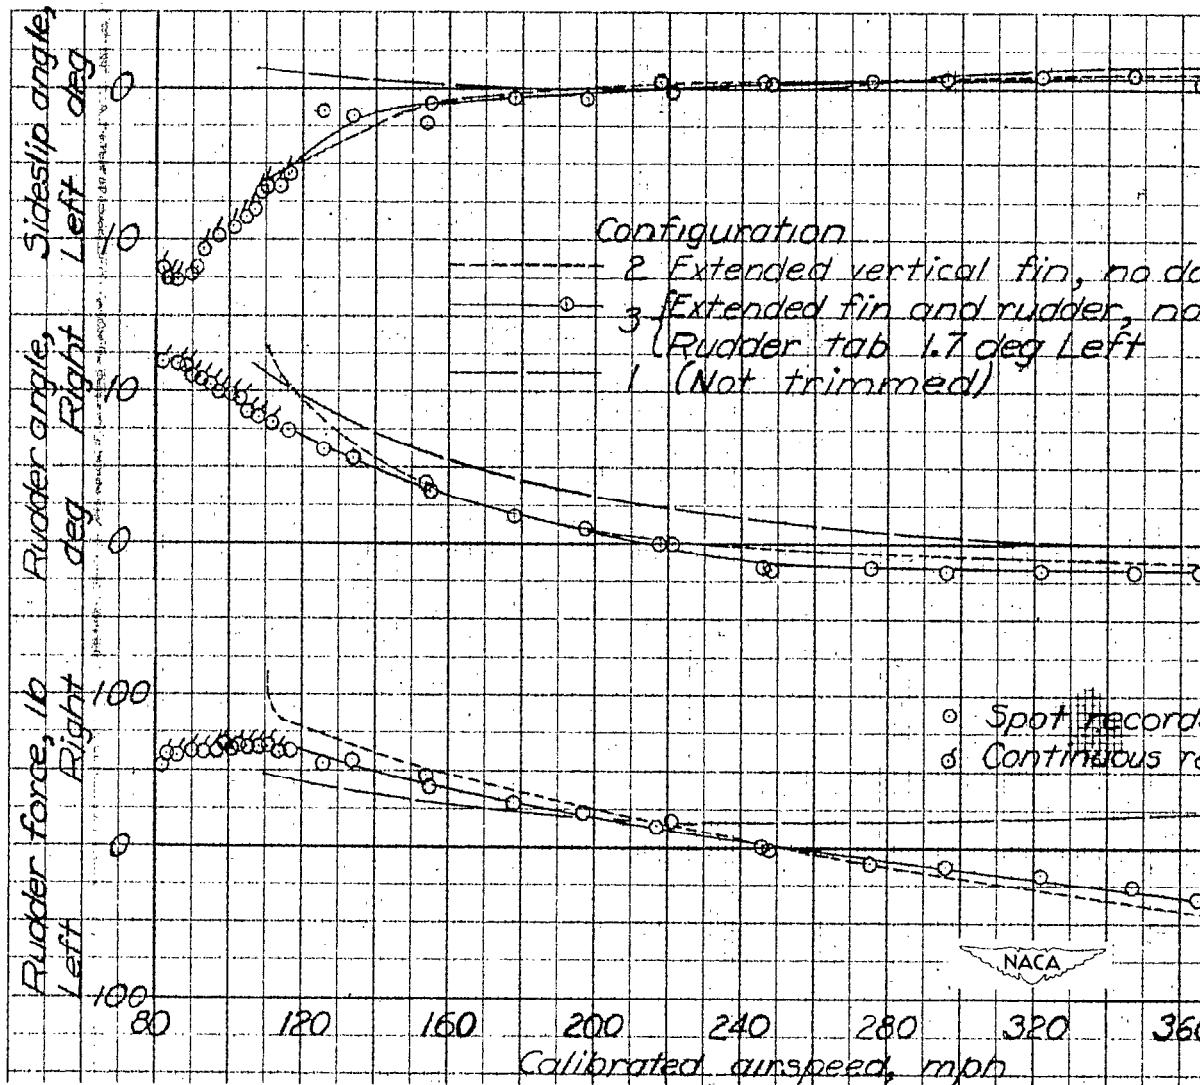
Figure 31.- Directional trim characteristics in the rated-power, clean condition (2600 rpm), with three vertical tail configurations, F8F-1 airplane.

Figures 31 and 32 present the variation of directional trim characteristics over the test speed ranges in the rated-power clean, and the wave-off conditions for all three tail configurations. The change of rudder force with speed between the stall and a speed of 400 miles per hour in the rated-power clean condition for a trim speed of 250 miles per hour was approximately 60 pounds with tail configuration 1 (calculated from the data of fig. 31), 160 pounds with tail configuration 2, and 110 pounds with tail configuration 3. The rudder-force change with speed satisfied the Navy requirement for diving flight. However, a desirable reduction in the force variation with speed could be effected by use of a springy tab.

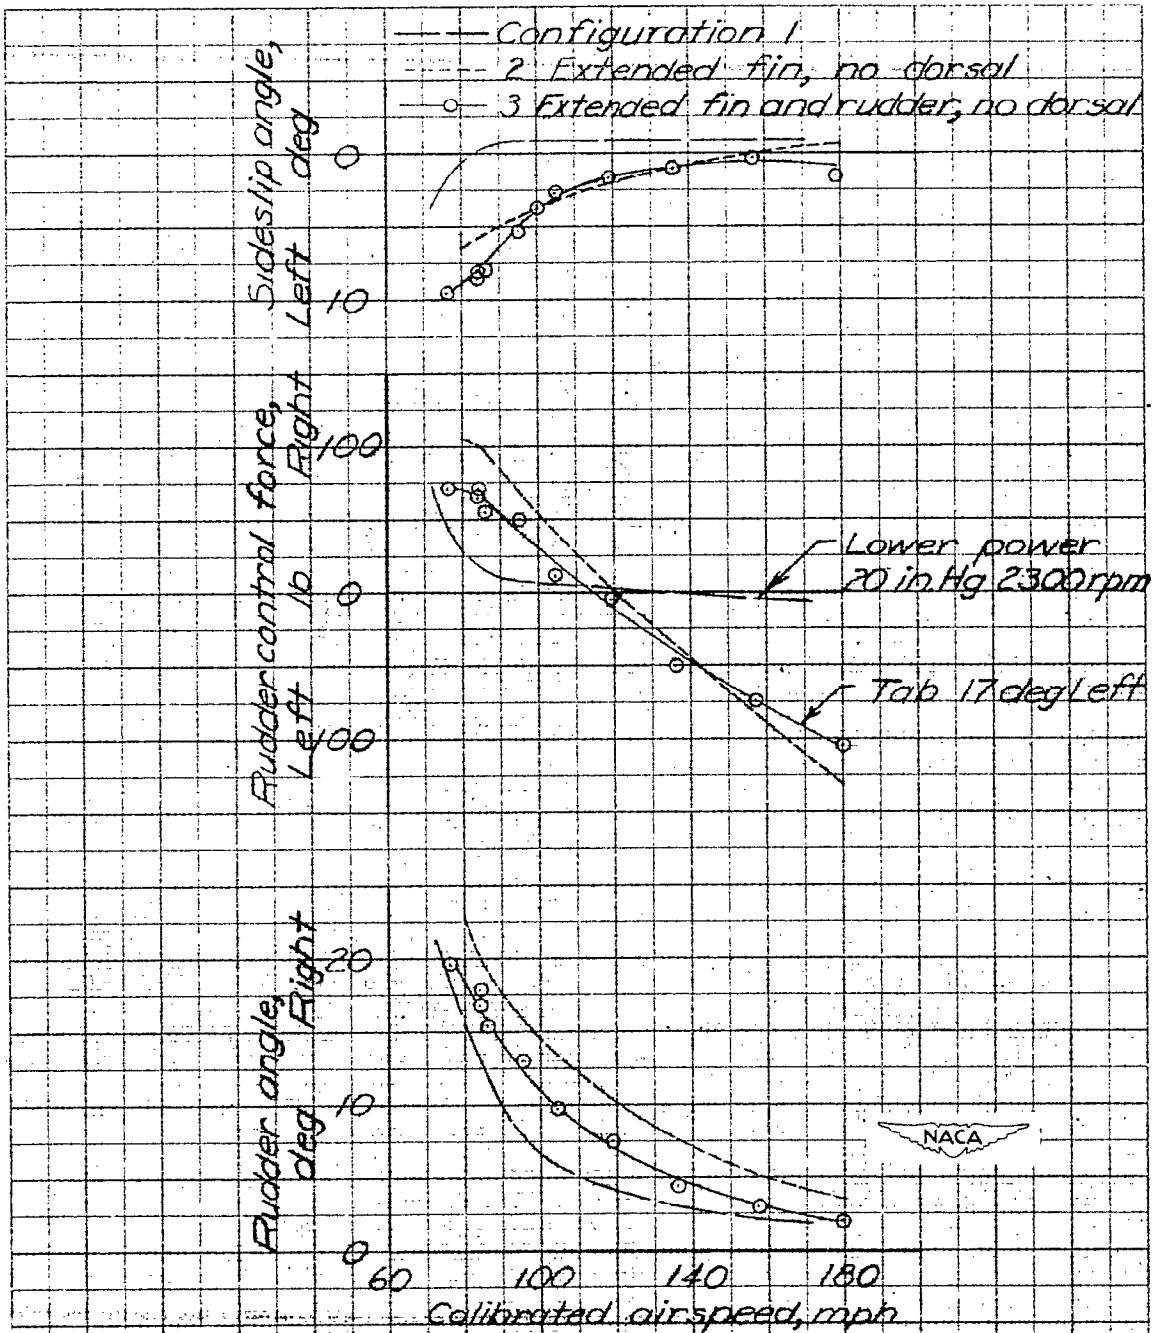
Figure 32.- Directional trim characteristics in the wave-off condition, flaps and landing gear down and normal rated power (41 in. Hg at 2600 rpm), with two modified vertical tail configurations, F8F-1 airplane.

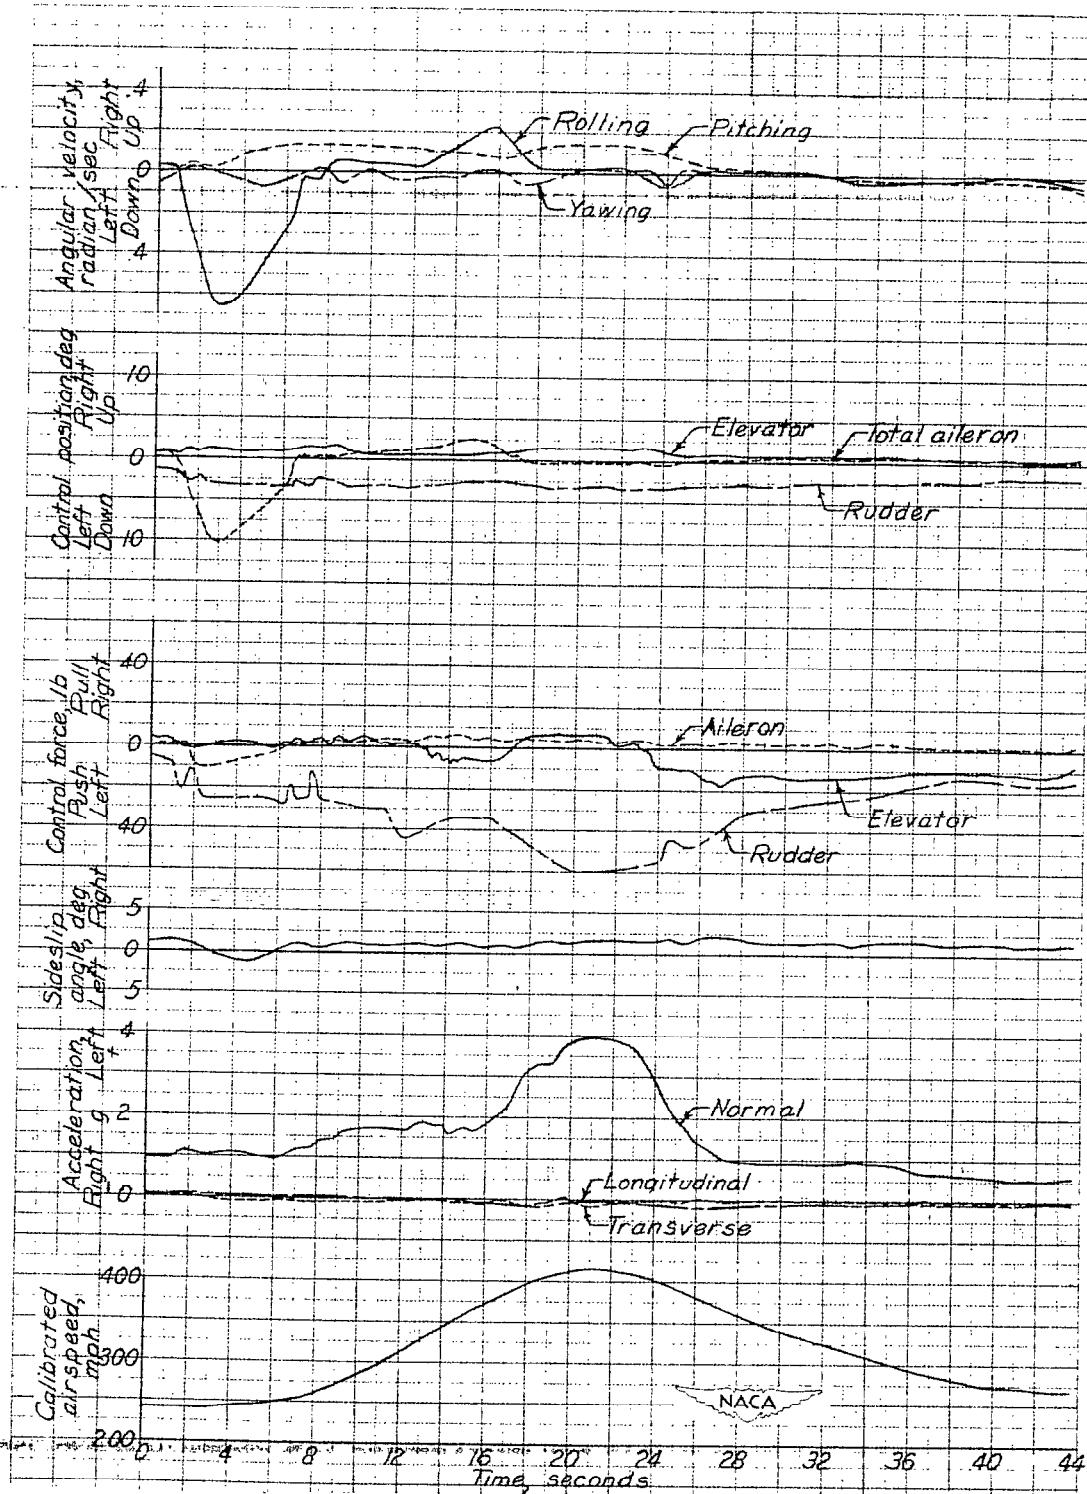
(a) With tail configuration 1, made by service pilot.

Figure 33.- Time histories of strafing runs, F8F-1 airplane with belly tank on, oil coolers closed.

In order to investigate how well the F8F-1 could hold an aiming point, strafing runs on fixed targets have been made. Two time histories typical of the data obtained are presented in figure 33. Figure 33(a) illustrates a strafing run which was made by a service pilot in an F8F-1 airplane with belly tank installed and with tail configuration 1.

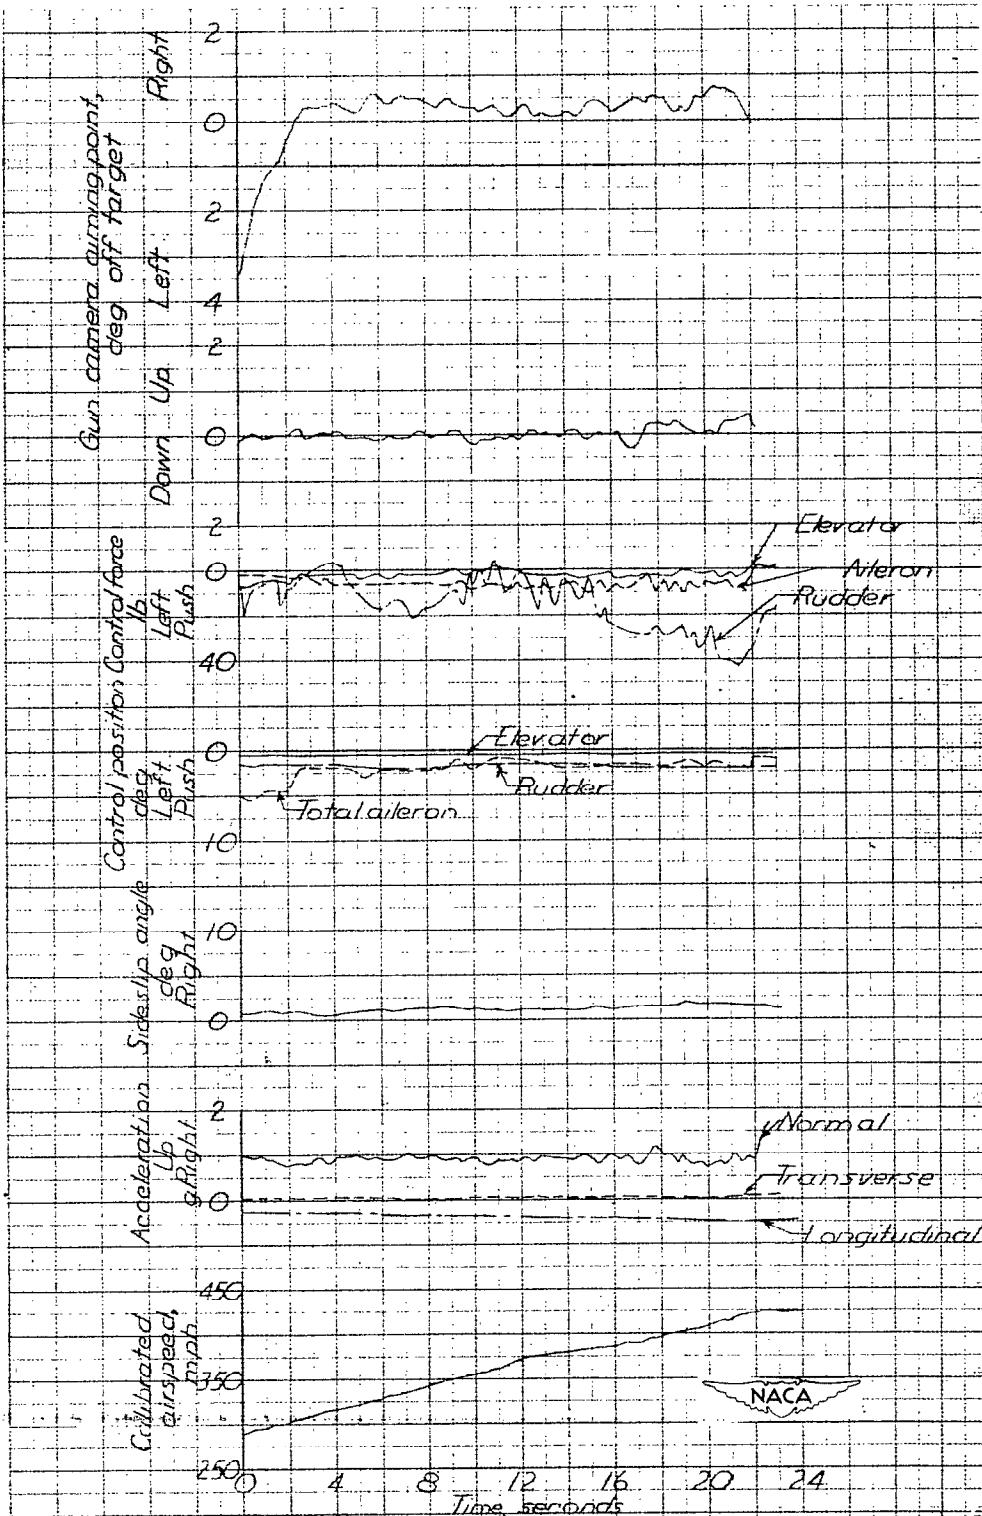
(b) With tail configuration 3, made by NACA pilot.

In later tests a gun camera synchronized with the other recording instruments was used to obtain a record of relative motion between the aiming point and the target. Figure 33(b) illustrates a strafing run which was made by an NACA pilot in an F8F-1 airplane with belly tank installed and with tail configuration 3. The gun camera and sideslip data of figure 33 show that throughout the range of speeds covered (250 to 400 miles per hour) the airplane was subject to pitching and yawing motions of approximately  $\pm 0.2^\circ$  amplitude.

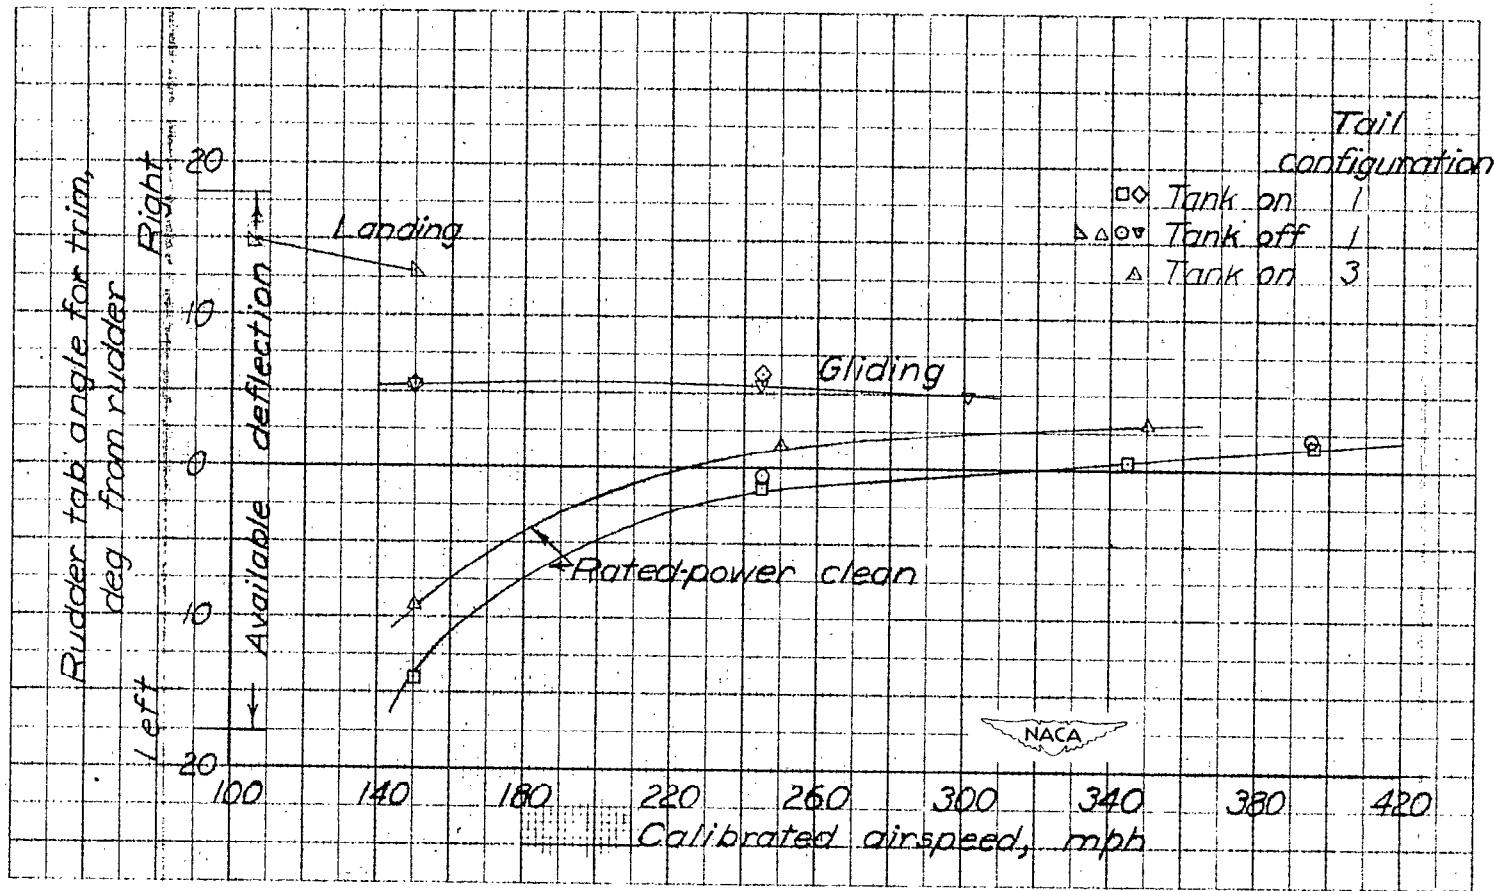
Figure 34.- Variation of rudder tab angle for trim with airspeed, F8F-1 airplane.

Data on the variation of rudder-tab angle for trim with airspeed are presented in figure 34. A table of minimum directional trim speeds for the various tail configurations follows:

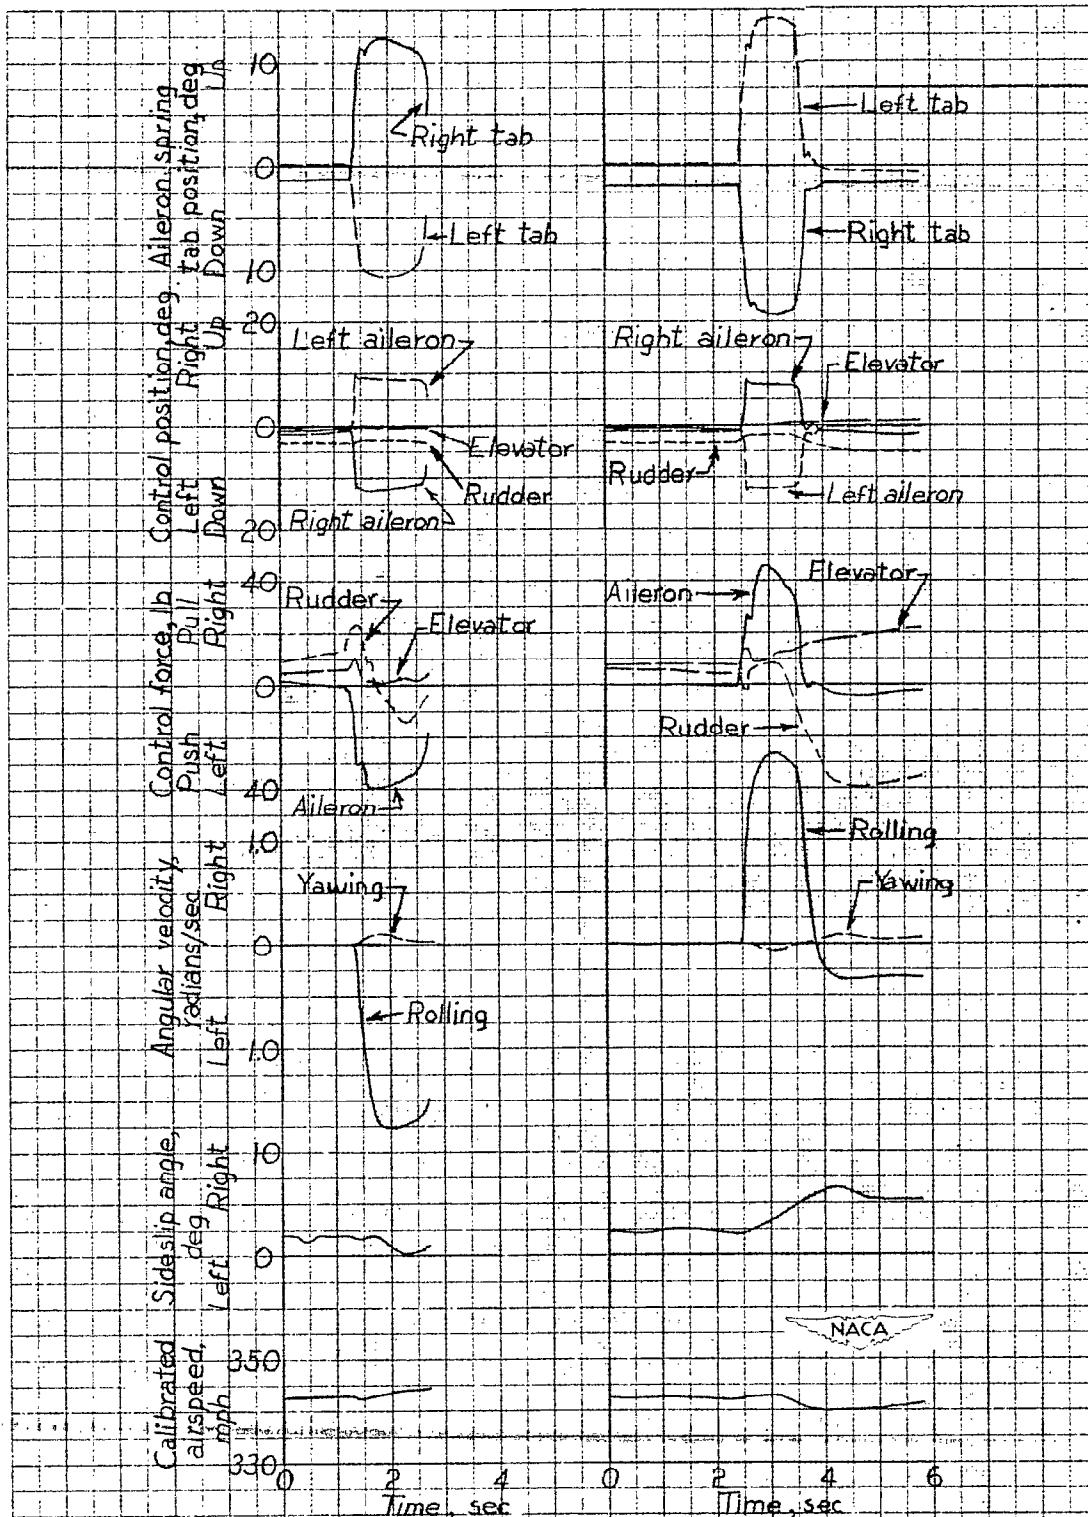
Figure 35.- Time histories of rolls at approximately 340 miles per hour, rated power, flaps and gear up. F8F-1 airplane.

Figure 35 presents time histories of typical aileron rolls obtained at 340 miles per hour in the rated-power, clean condition. The variation of rolling effectiveness and control force with total aileron deflection are presented in figure 36 for each flight condition and speed investigated. Figure 37 shows the variation of right-aileron spring-tab angle with right-aileron deflection in aileron rolls with power for level flight in the clean condition at speeds from 148 to 397 miles per hour. The variation with airspeed of rolling velocity at 10,000 feet, total aileron angle, and helix angle  $pb/2V$  for a control force of 30 pounds and for full stick deflection is presented in figure 38. The variation of lateral trim force with speed is given in figure 39.

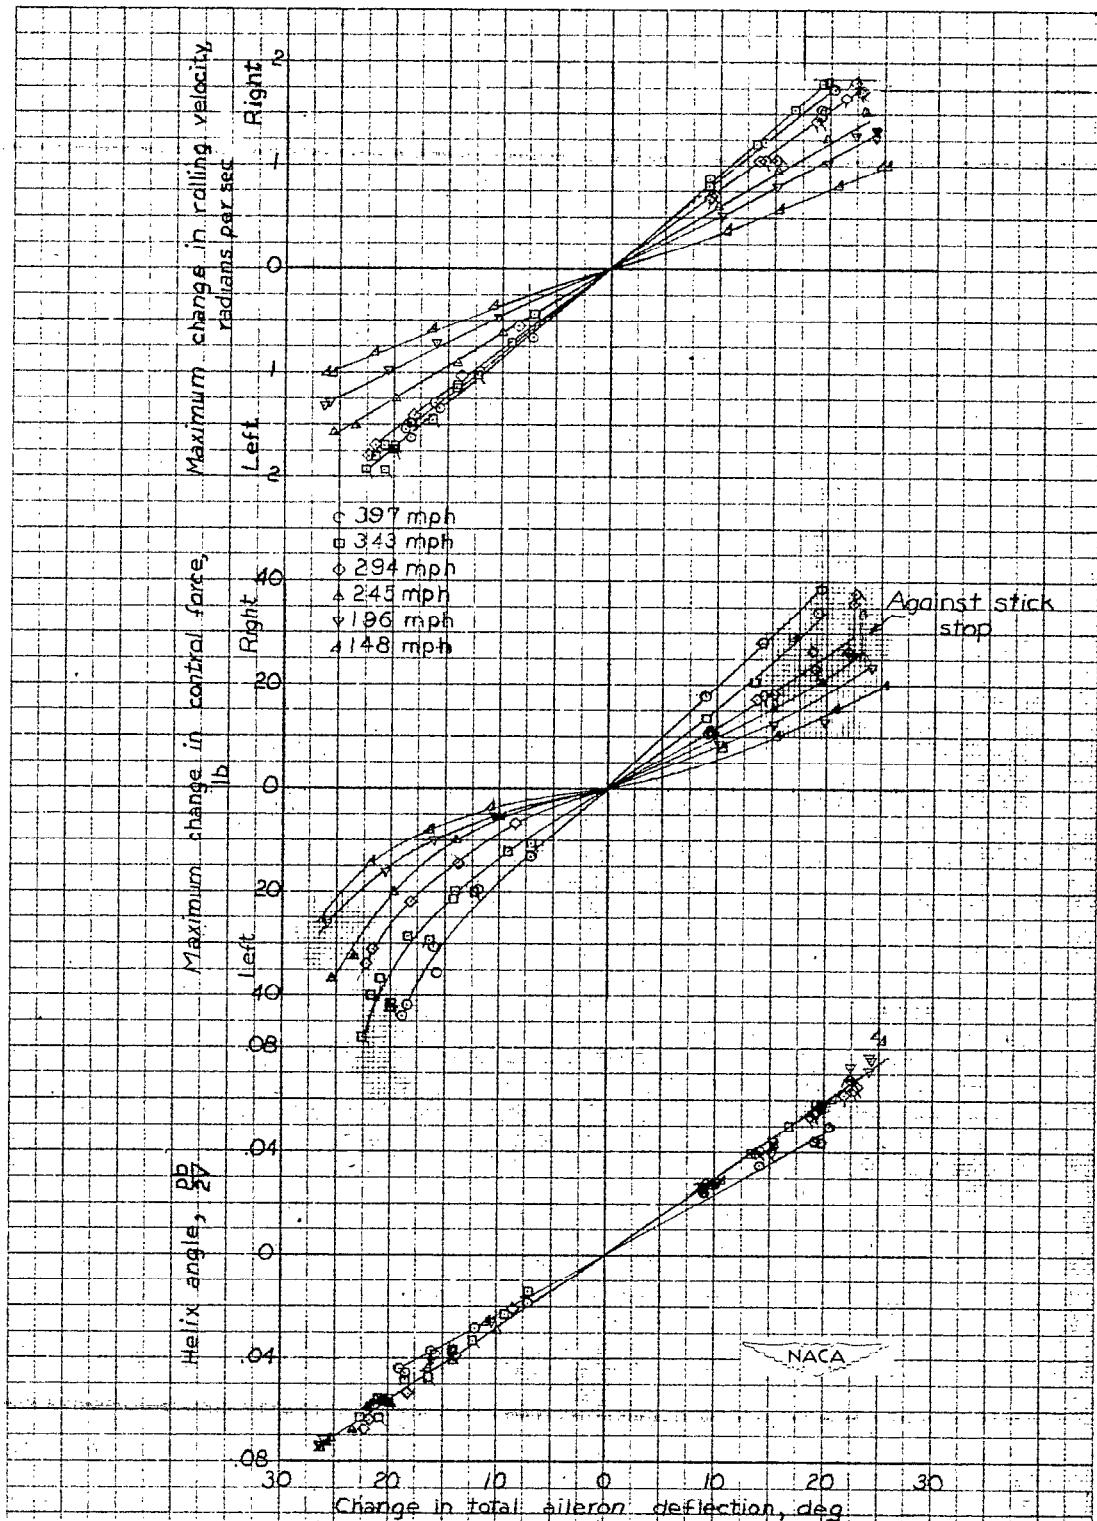
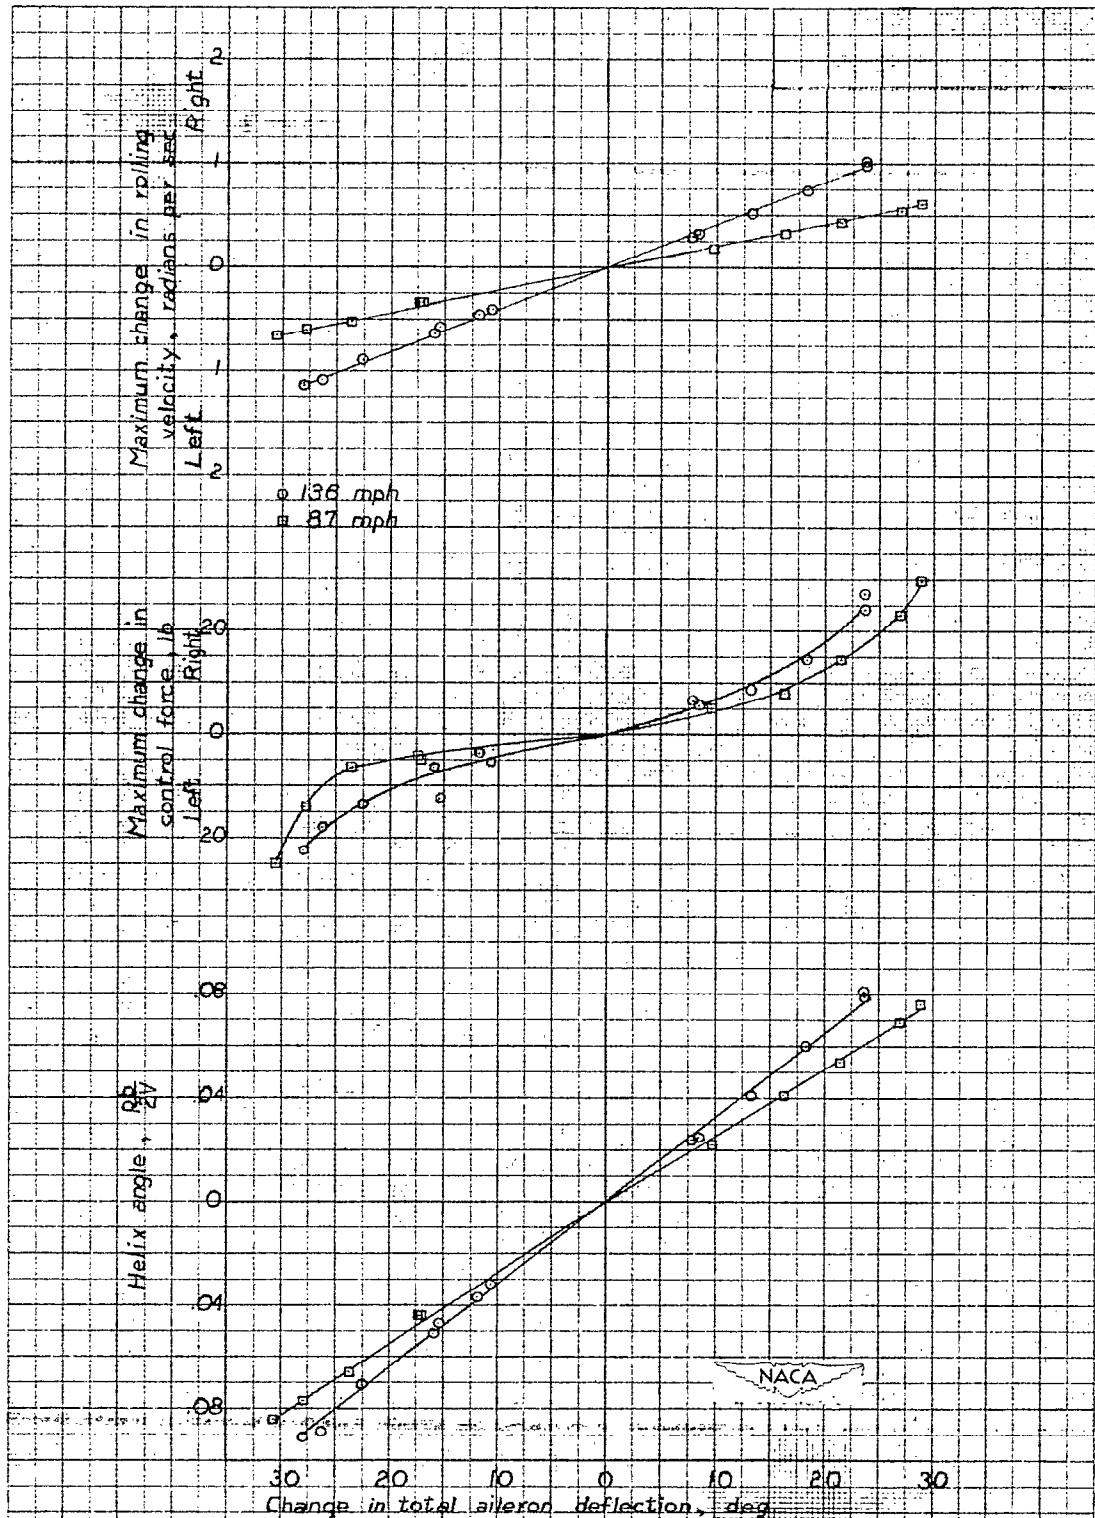
Figure 36.- Aileron characteristics in rolls at 5000 feet, F8F-1 airplane.

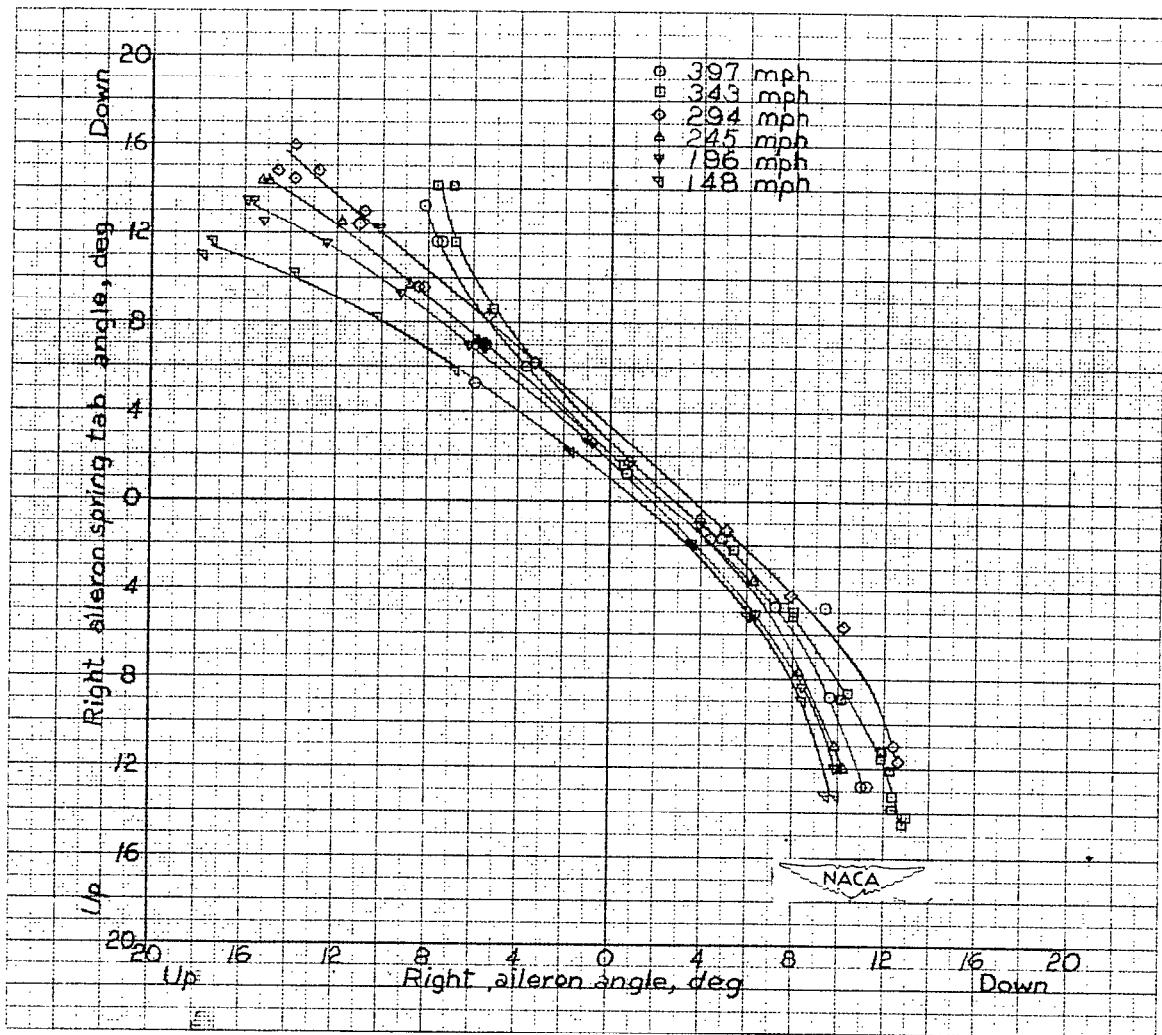
Figure 37.- Variation of right aileron spring tab angle with right aileron angle. Power for level flight, flaps and gear up. F8F-1 airplane.

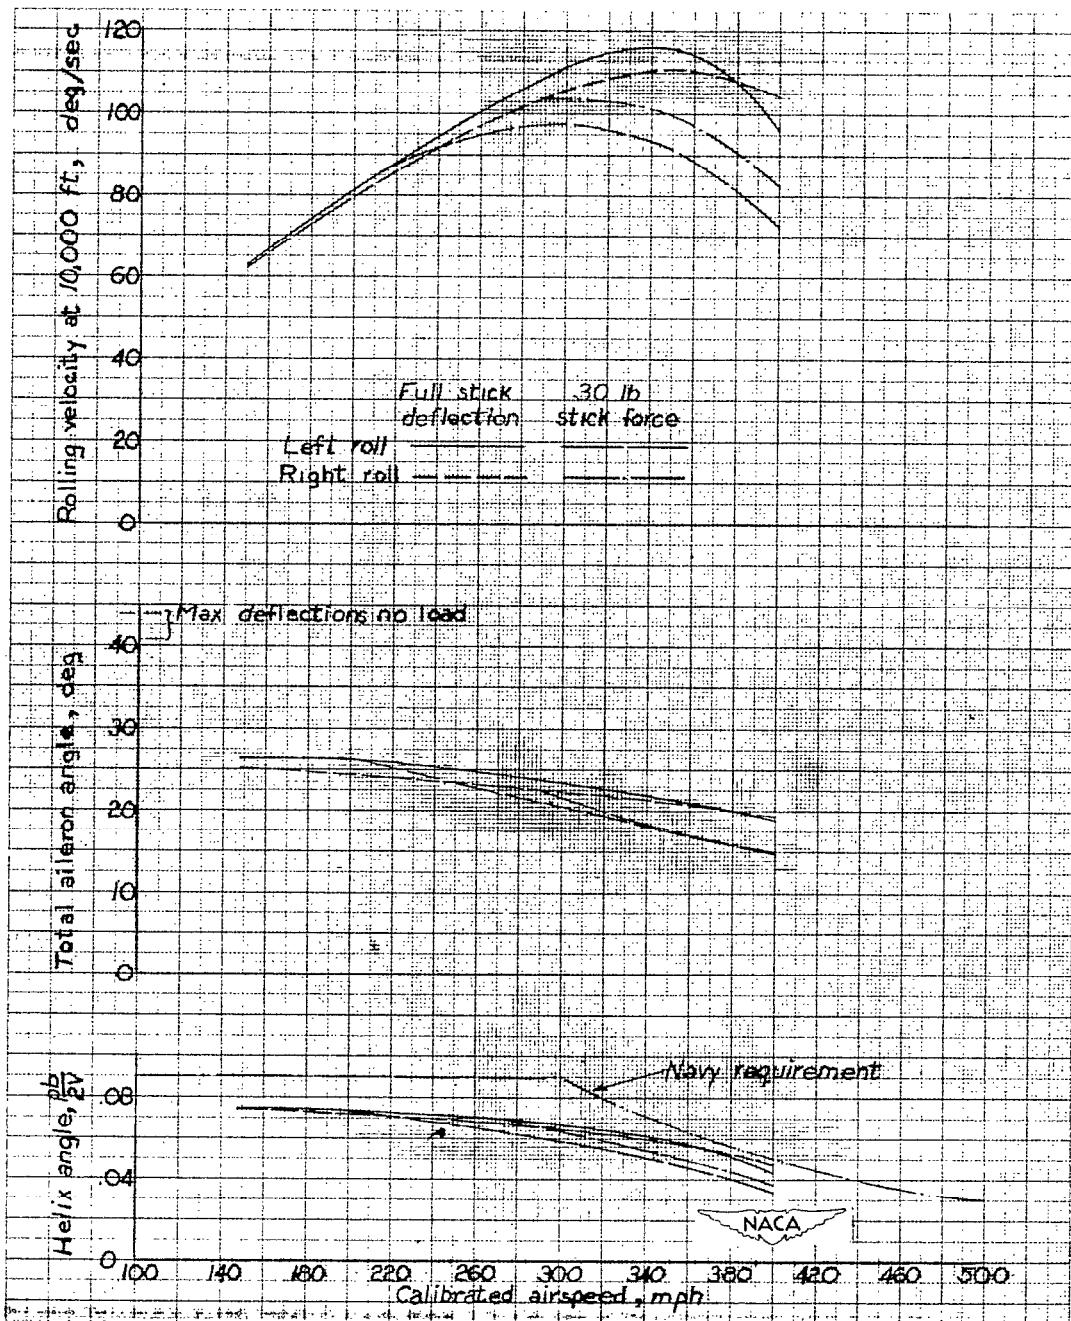
Figure 38.- Variation of rolling velocity at 10,000 feet, total aileron angle, and helix angle with indicated airspeed, power for level flight, flaps and gear up. F8F-1 airplane.

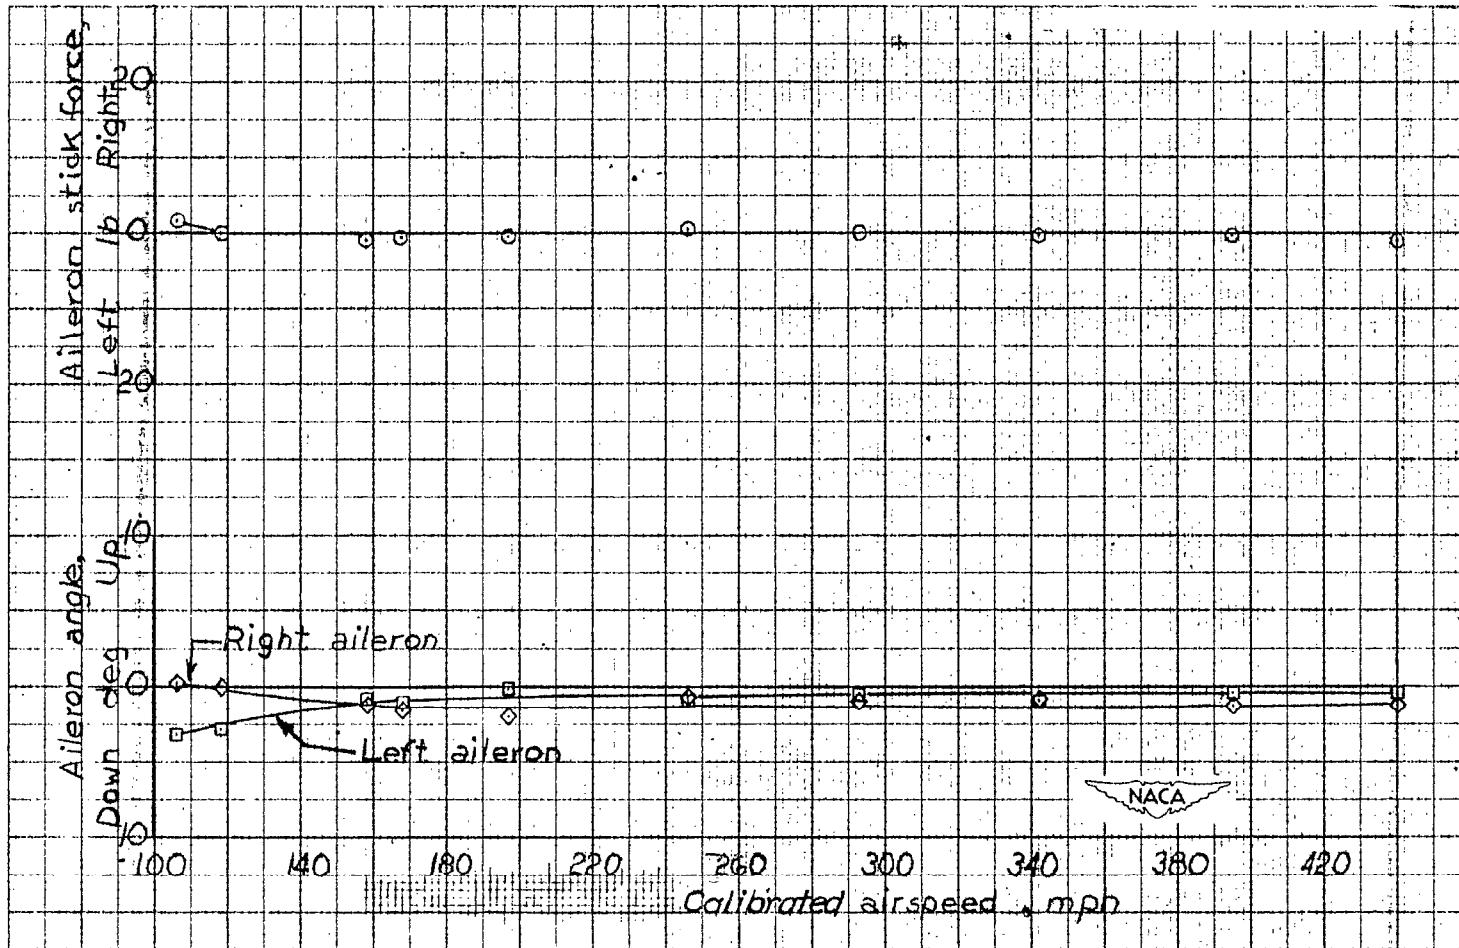
Figure 39.- Variation of aileron stick force and aileron angle with indicated airspeed, rated power, flaps and gear up, F8F-1 airplane (90461).

(g) Figure 39 indicates that the variation of aileron trimming force with speed was small. The aileron trimming tab was found to be adequate.
