REPORT No. 622

A PHOTOGRAPHIC STUDY OF COMBUSTION AND KNOCK IN A SPARK-IGNITION ENGINE

By A. M. ROTHEROCK and R. C. SPENCER

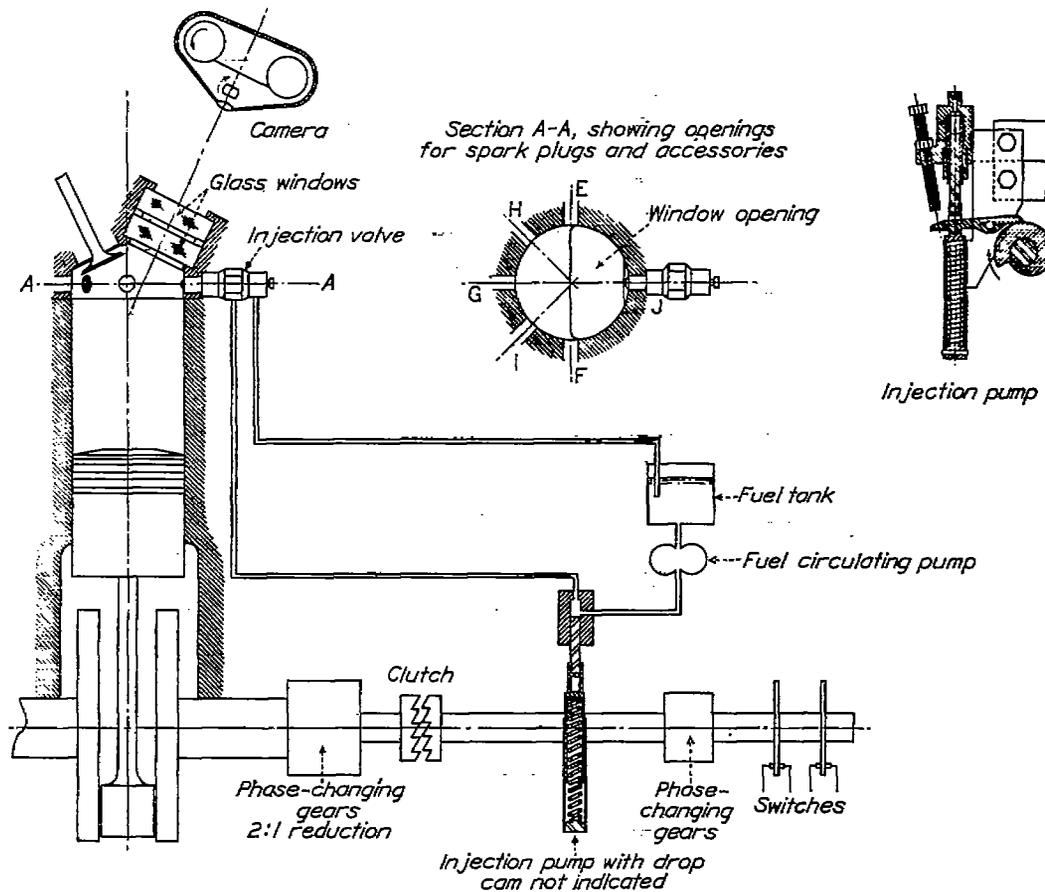
FIGURE 1.—Diagrammatic sketch of combustion apparatus.

The observation window, roughly $2\frac{1}{2}$ by 5 inches (fig. 1), consists of two heavy glass plates with an air space between them. Compressed air is admitted to the space between the plates.

The injection system, a cross section of which is included in figure 1, is spring-operated. The spring is held compressed by a rocker arm, holding the lapped plunger retracted and leaving a port uncovered in the side of the sleeve. Fuel is circulated under pressure by a primary pump through the sleeve and thence to the injection valve, which is arranged to permit continuous circulation of the fuel (reference 4). For the injection of the fuel, the rocker arm is released by a drop cam. The fuel is delivered to the injection valve at a pressure of about 2,500 pounds per square inch.

The high-speed motion pictures reproduced in figure 4 show the effect of air-fuel ratio on nonknocking flame propagation with spark plugs at E and F (fig. 1). These tests were made at an engine speed of 1,500 r. p. m. The irregular flame fronts are characteristic of all the flame photographs that have been taken. The rate of flame propagation was somewhat slower for the lean mixtures, and two distinctly different types of after-burning were present in the rich and lean mixtures.

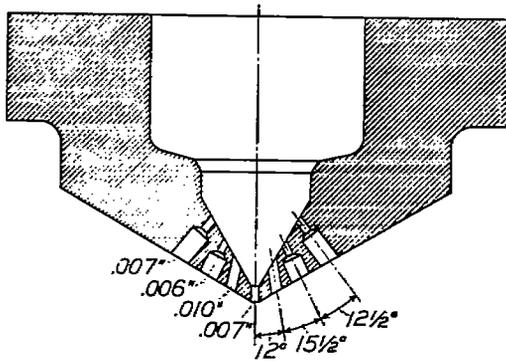
FIGURE 2.—The seven-orifice nozzle.

The fuel quantity is regulated by changing the length of the plunger travel. During most of the tests, a seven-orifice injection nozzle (fig. 2) was used. This nozzle is similar to the one used by Schey and Young in the work reported in reference 5. The injection valve was mounted opposite the intake valves so that the fuel was injected counter to the intake air flow. Injection was timed to start 20° after top center on the intake stroke and the injection period was about 120°.

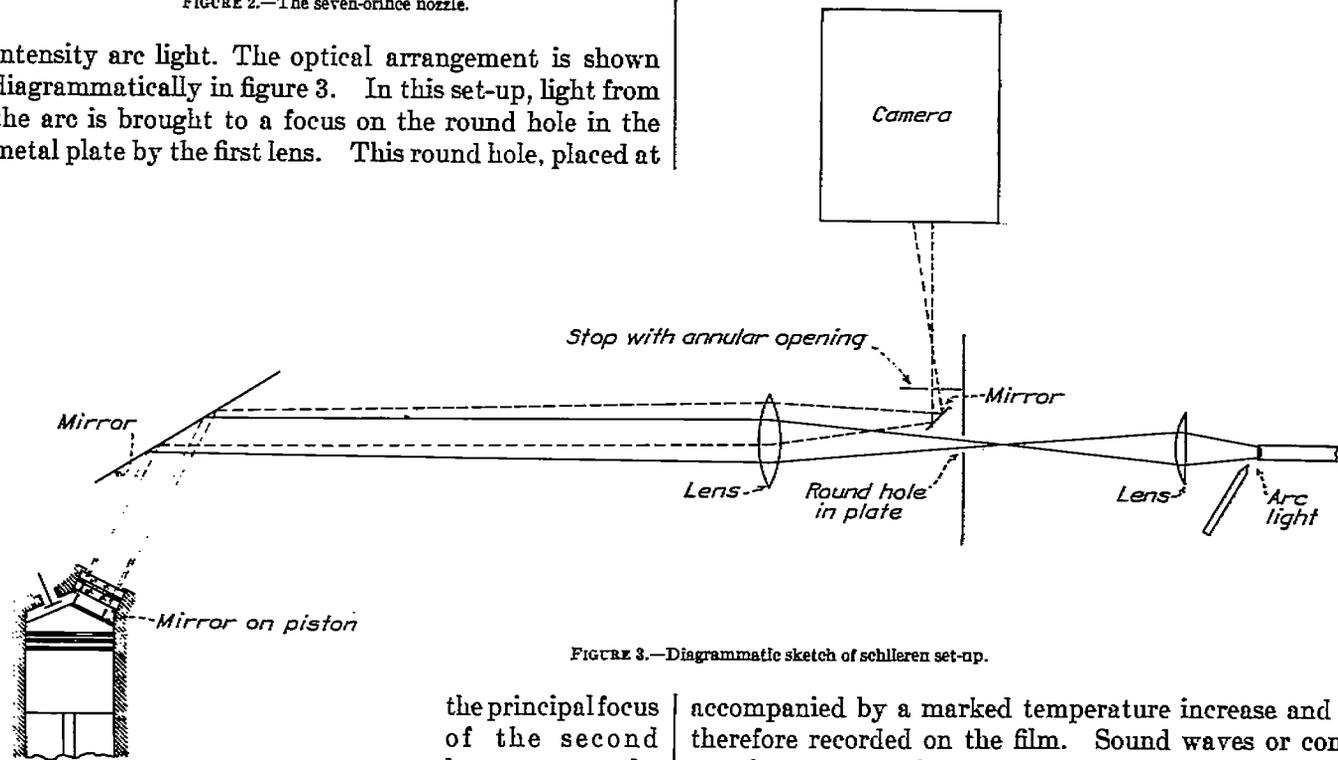
FIGURE 3.—Diagrammatic sketch of schlieren set-up.

intensity arc light. The optical arrangement is shown diagrammatically in figure 3. In this set-up, light from the arc is brought to a focus on the round hole in the metal plate by the first lens. This round hole, placed at

the principal focus of the second lens, serves as the source of light. Light passing through the second lens is rendered parallel and is directed into the combustion chamber by the mirror and reflected back slightly offset from its original path by the mirror on the piston. The settings of the mirrors are such that the light is brought back through the second lens and to a focus slightly to one side of the original source. Thus it is possible to insert a small mirror in the optical path just before the light comes to a focus and to reflect the entire beam at a right angle. The round stop to obtain the schlieren effect is placed in the plane of the image, allowing only an annular ring of light to pass. The film drum of the camera is placed at the image of the combustion chamber formed by the second lens. A stop with a 1/8-inch slit is placed in front of the film drum, so that the image

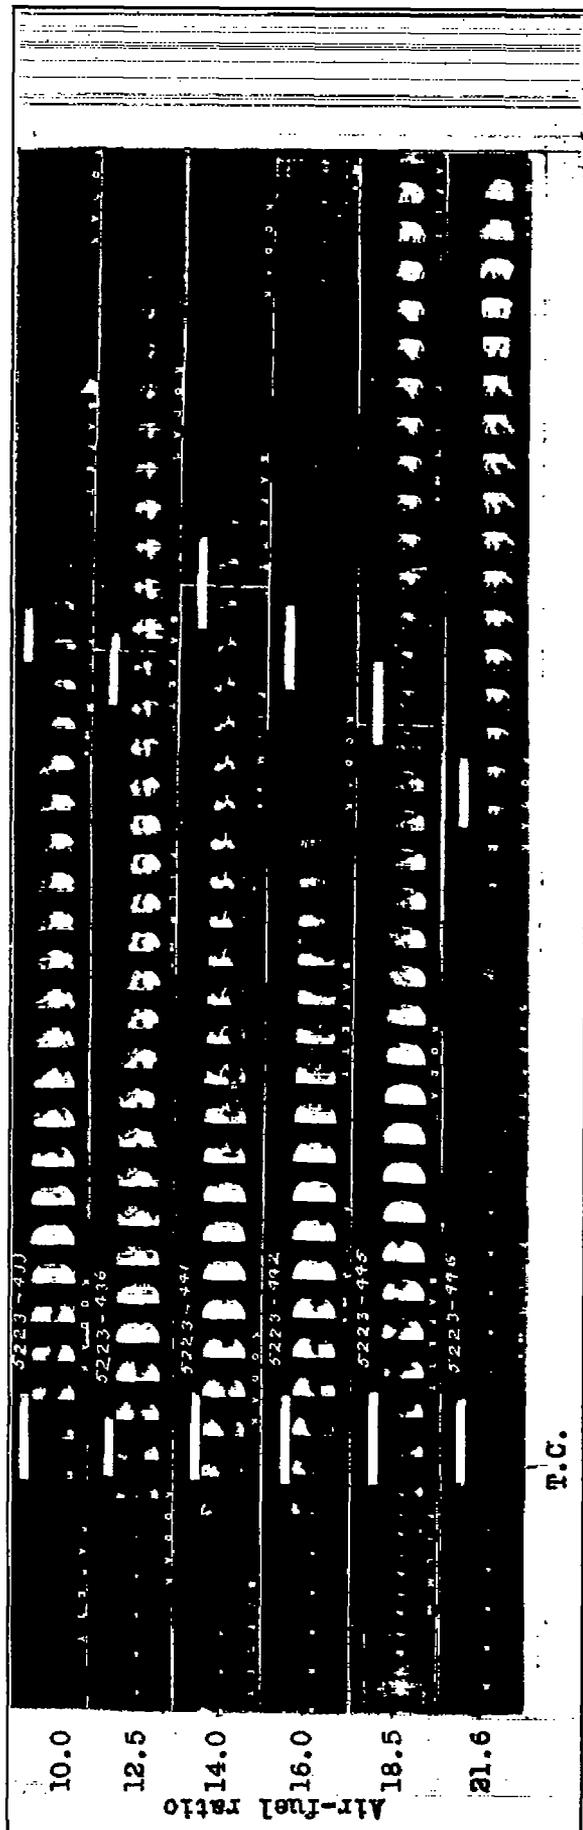
FIGURE 4.—Effect of air-fuel ratio on flame propagation. White marks on upper edge of each film correspond to T. C. and 90° A. T. C. Engine speed, 1,500 r. p. m.; two spark plugs; 87-octane fuel.

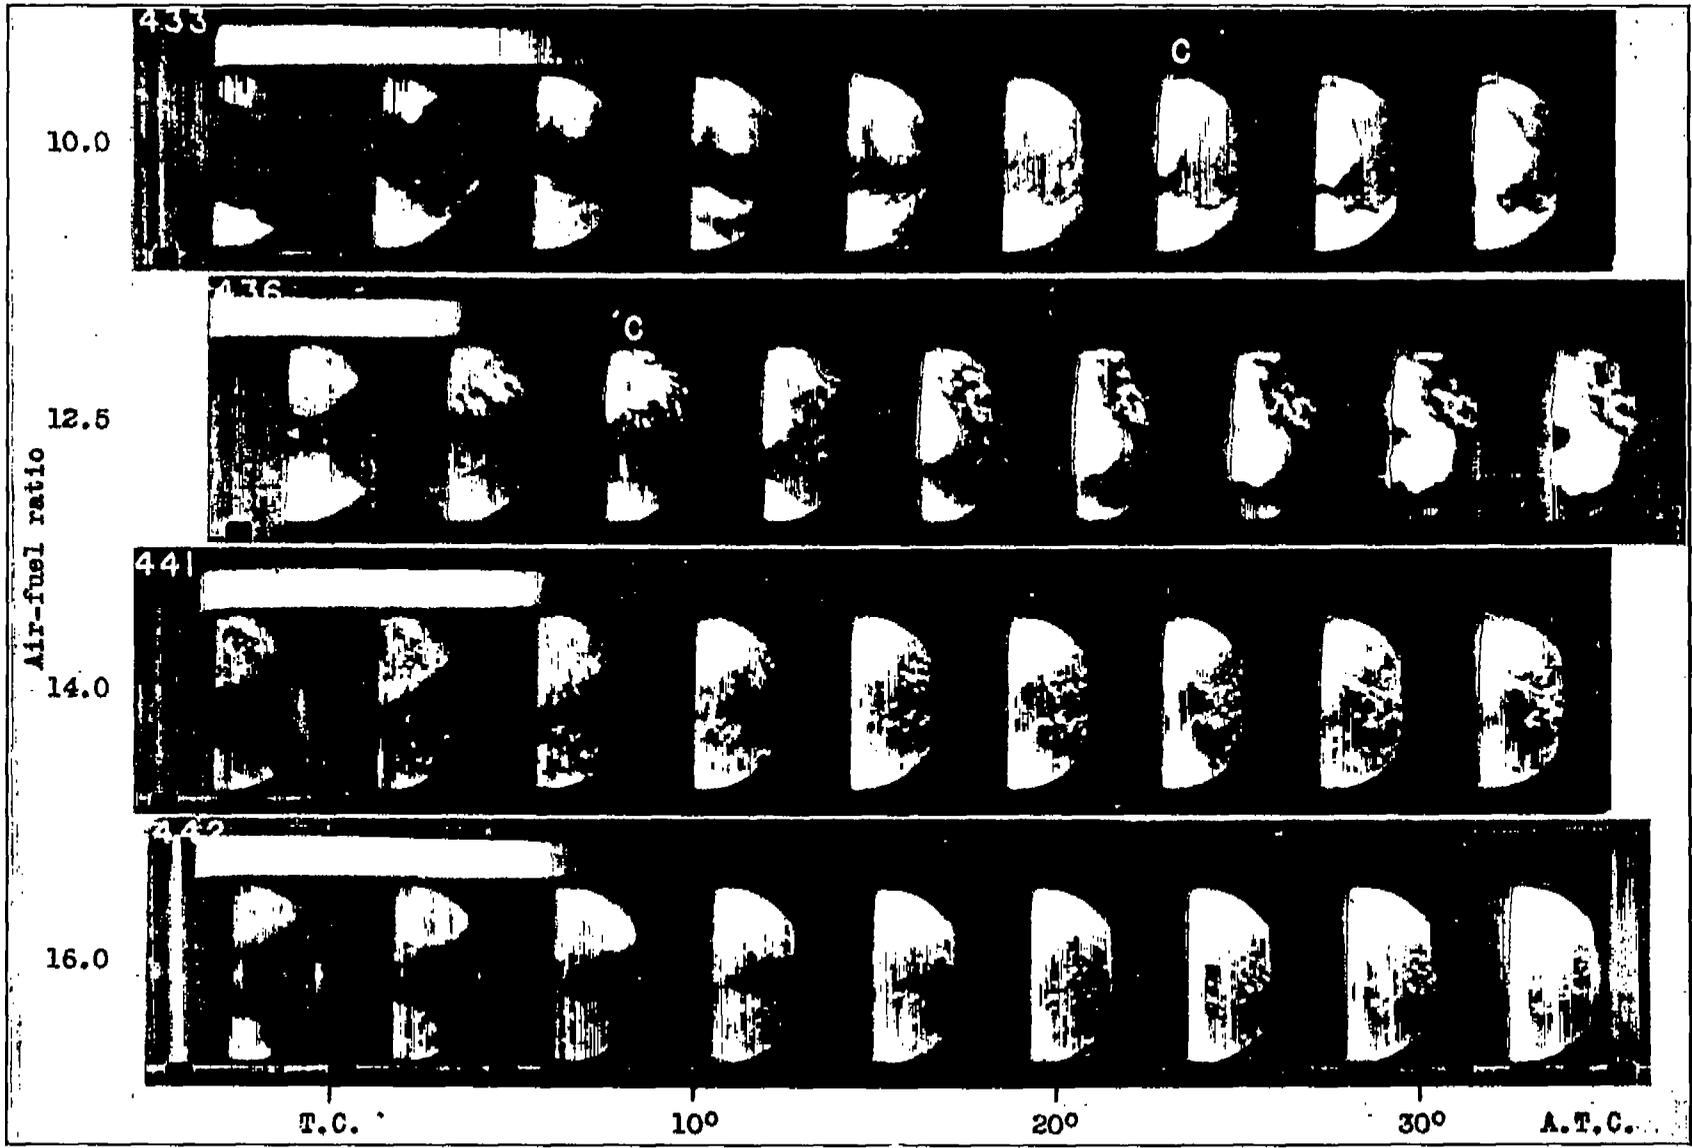
FIGURE 5.—Effect of air-fuel ratio on flame propagation. Enlargements of high-speed motion pictures of figure 4 for air-fuel ratios of 10, 12.5, 14, and 16. Engine speed, 1,500 r. p. m.; two spark plugs; 87-octane fuel.

Details of the photographs are shown to better advantage in the enlargements in figures 5 and 6. In figure 5, at air-fuel ratios of 10 and 12.5, after the flame apparently passed through part of the chamber, an area of very bright illumination appeared behind the flame front as in the frames marked C, and in the succeeding frames this area spread rapidly across the window. In the last frames of the enlargements this bright area is the most prominent feature of the photograph. These areas, which appear suddenly and spread rapidly, do not behave like other regions of brightness, such as the region in the lower part of the window at an air-fuel ratio of 10 and the other bright spots that appear in many of the pictures. Withrow and Rassewiler observed a somewhat similar effect in their tests (reference 2) and attributed it to burning lubricating oil. This explanation appeared reasonable in their case because the brightness appeared as soon as the flame reached the edge of the cylinder. The piston and cylinder of the N. A. C. A. combustion apparatus, however, are lubricated by graphite and the apparatus has no oil in the crankcase. Hence, some other explanation must be sought. The effect appeared only at the richer mixtures and is probably associated with incomplete combustion. For the ratios of 18.5 and 21.6 the flame completely crossed the chamber; then, after the charge had apparently been burned, "afterburning" began and continued until long after the exhaust valves opened. To the eye the exhaust appeared a brilliant violet color.

Duration of the reaction.—The afterburning (as distinct from postignition) shown in figure 5 for rich mixtures indicates that a reaction causing a reillumination of parts of the charge may occur after the flame front has passed through the charge. The two streak schlieren photographs of figure 14 and all the spark schlieren photographs indicate that some reaction which changes the density of the charge or, more precisely, the refractive index, continues for some time after the combustion front has passed through the charge. This interpretation of the schlieren photographs presupposes that no extreme curvature or tilting of the combustion front occurs. If the combustion advanced across the chamber as a narrow tongue, with a region of unburned charge between the inflamed region and the window, then the upper surface would appear as a dark area in

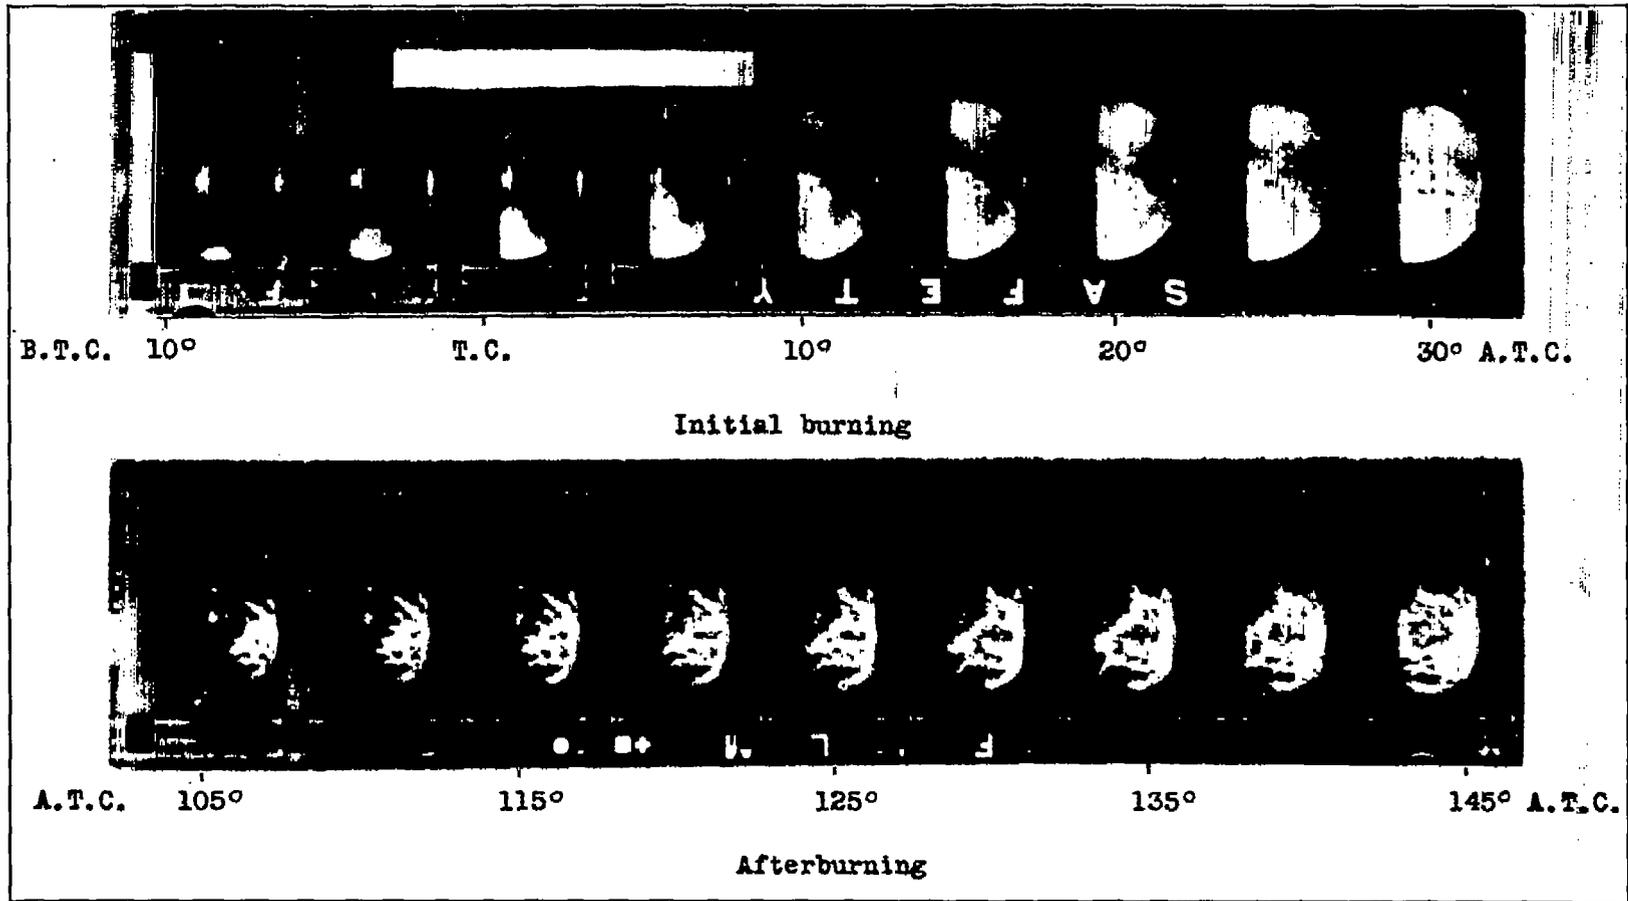
FIGURE 6.—Afterburning of lean mixture, after flame has traversed charge. Air fuel ratio, 18.5; exhaust valves open 125° A. T. C.; engine speed, 1,500 r. p. m.; two spark plugs; 87-octane fuel.

Enlargements of the burning at the air-fuel ratio of 18.5 are shown in figure 6, and it can be seen that the flame had traversed the chamber by 30° after top center. The afterburning, as shown in the figure, always originates near the spray nozzle and is probably caused by the sudden addition of a small amount of fuel to the hot combustion gases, which still contain oxygen. Records of the pressure in the injection system indicated that a secondary injection of fuel might occur more than one crankshaft revolution after the start of the main spray. One other possible source of fuel is the well between the nozzle seat and the spray orifices. Approximately 0.003 gram of fuel is trapped in this well. It is not known whether such a small quantity of fuel vaporizing into the combustion gases could cause the intense illumination shown in the figures. Further tests are being conducted on the effects of air-fuel ratio.

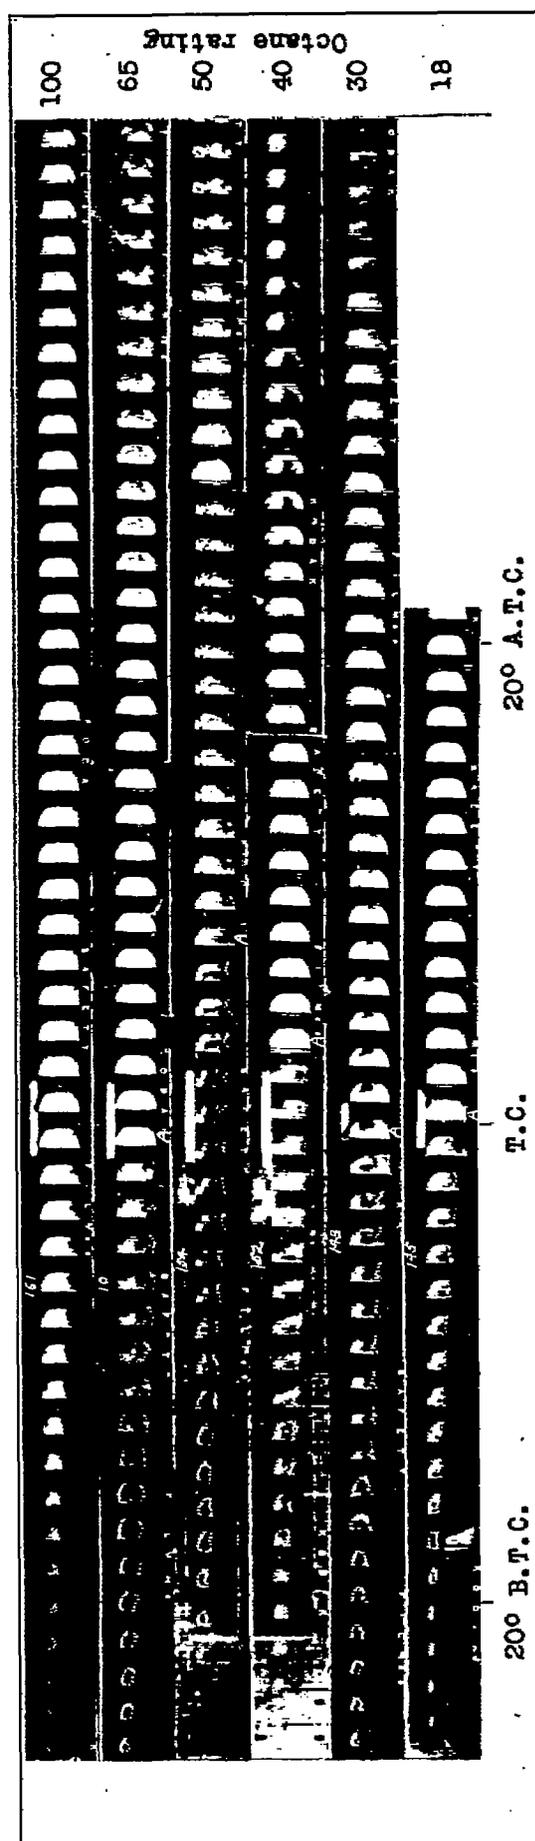
FIGURE 7.—High-speed motion pictures showing effect of fuels of different octane ratings on combustion knock. Air-fuel ratio, 14; A, first evidence of knock; engine speed, 600 r. p. m.; one spark plug.

The high-speed motion pictures in figure 7 show the flames for fuels of different octane ratings with one spark plug at E. The outlines of the flames, for the first several frames, have been marked by a series of white dots for purposes of reproduction. Details of the photographs are more easily seen in the enlargements of figures 8 and 9. The photographs show an even illumination and a uniform rate of flame propagation for the nonknocking burning with the 100-octane fuel. For the knocking explosions, there was a sudden and definite increase in the intensity of illumination at the time in the cycle that knock occurred. This sudden increase in brightness at the time of occurrence of knock is characteristic of all the knocking explosions and increases in intensity with increasing violence of knock. It is not to be confused with the bright light given off by the 100-octane fuel, which has a very high actinic value, the inflamed area being very bright and uniform throughout the entire explosion. The first appearance of the bright illumination is indicated by the frame marked A. It will later be shown that the time of appearance of the bright light coincides exactly with the appearance of pressure waves, hence may be used to indicate the first appearance of knock.

The records for octane ratings of 18 and 30 show a sudden inflammation of the end gas just prior to the appearance of the bright illumination. The photographs for the 40- and 50-octane fuels also indicate that a sudden inflammation of the end gas took place but, in this case, the sudden increase in flame travel and the sudden increase in illumination are shown in the same frame. The record for 65-octane fuel shows that the flame proceeded at a uniform rate across the chamber; then, after the chamber was filled with flame, the characteristic bright light associated with knock appeared. As nearly as can be determined, the violent vibrations that appear on indicator cards of knocking explosions correspond in point of time to the appearance of this bright light. The vibrations shown on the indicator cards for the 65-octane fuel were more violent than those for explosions of some of the fuels of lower octane ratings.

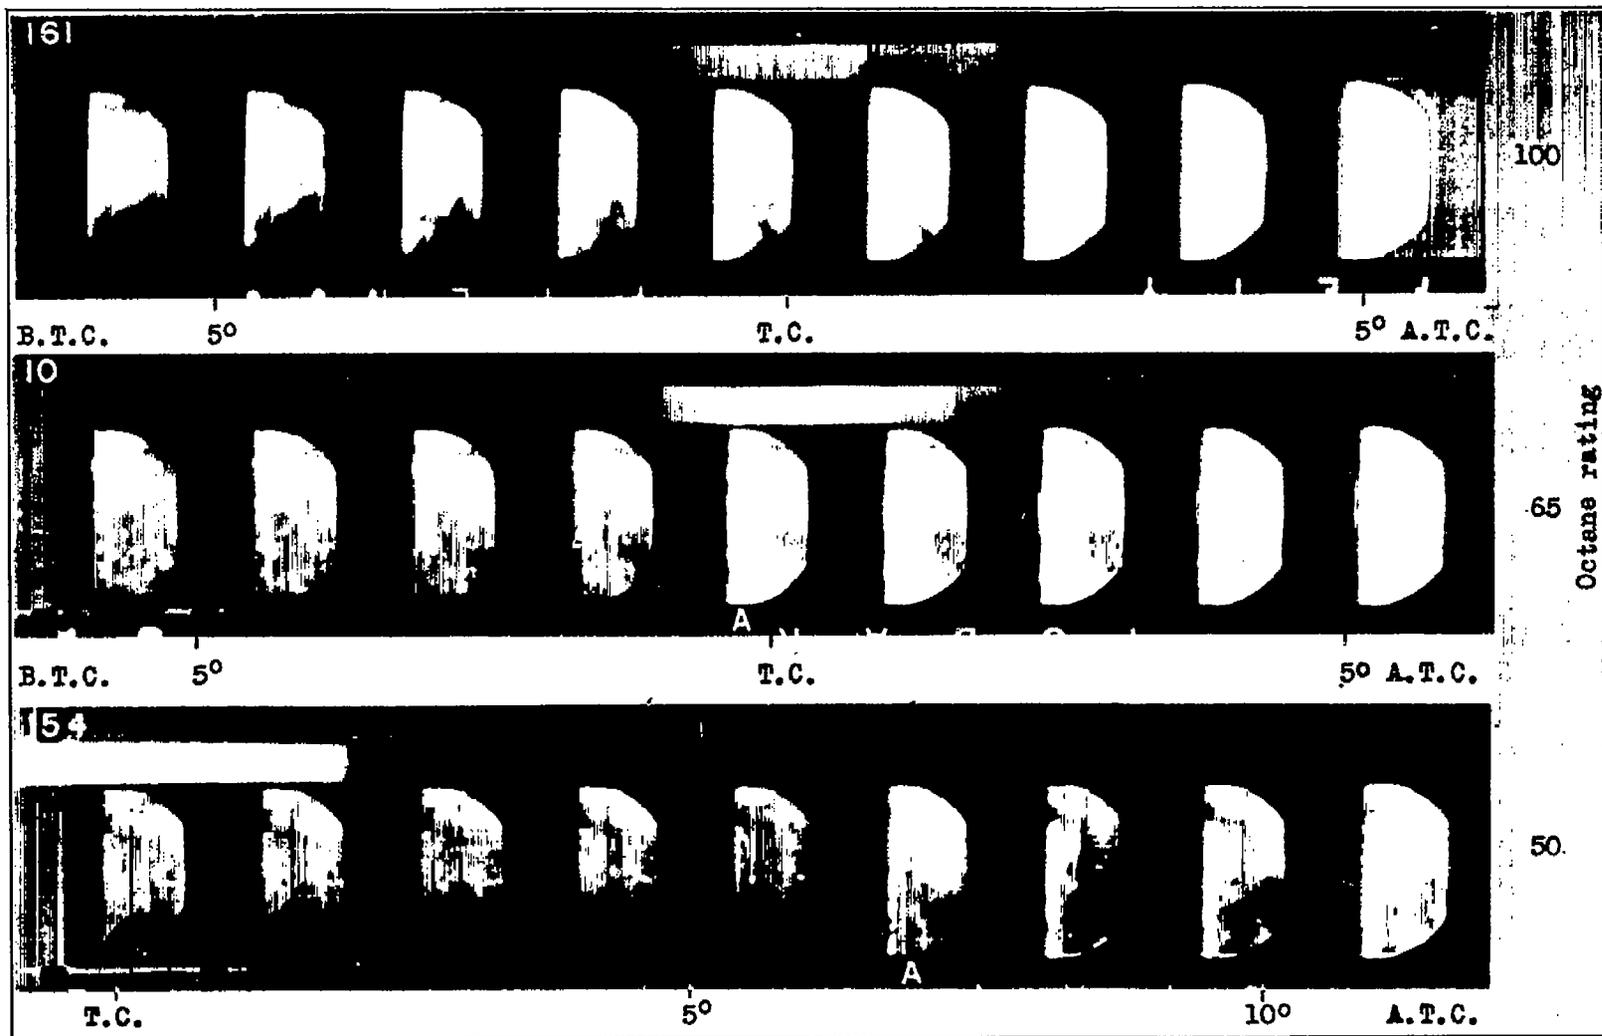
FIGURE 8.—Enlargements of high-speed motion pictures showing effect of different octane ratings on combustion knock. Air-fuel ratio, 14; A, first evidence of knock; engine speed, 500 r. p. m.; one spark plug. Octane ratings, 100, 65, and 50.

Relation of auto-ignition to knock.—Some of the photographs shown herein indicate that auto-ignition of the last part of the charge to burn occurred during some of the more severe knocking explosions. (See figs. 9 and 10.) This result is in accordance with the findings of Withrow and Rassweiler reported in reference 2. In a number of other instances, however, the combustion front appeared to be across the chamber before the occurrence of knock, as is shown in figures 8 and 10 (record 82) to 17. The explosions shown in figures 16

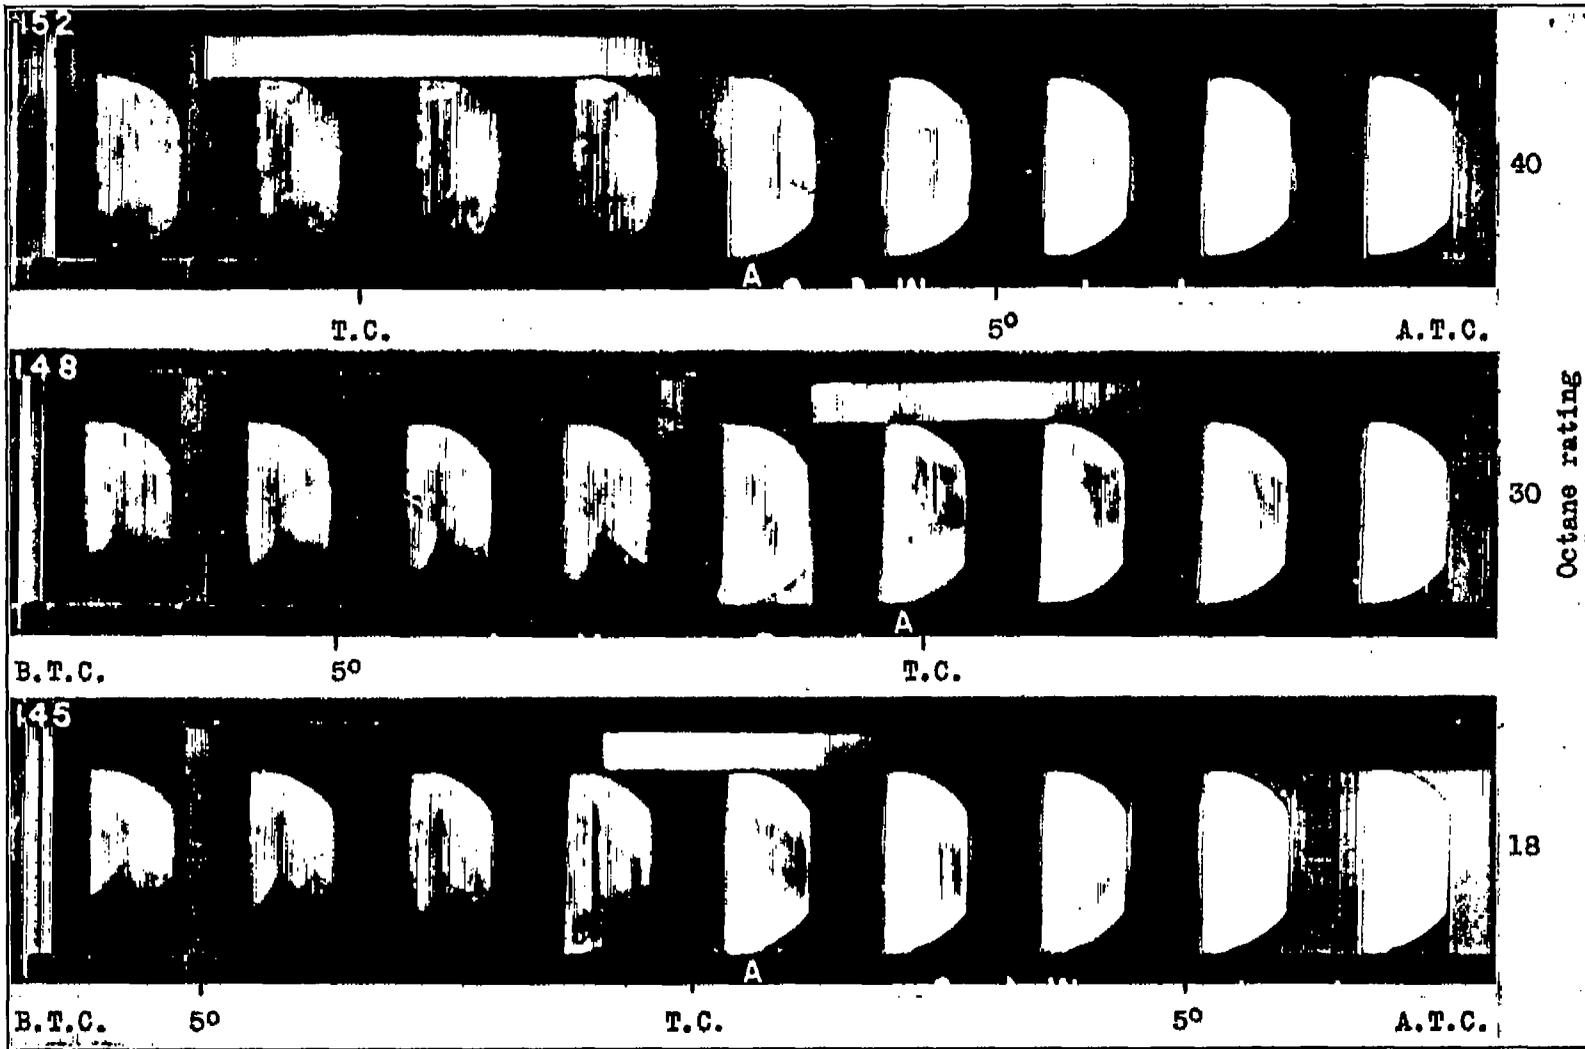
FIGURE 9.—Enlargements of high-speed motion pictures showing effect of different octane ratings on combustion knock. Air-fuel ratio, 14; A, first evidence of knock; engine speed, 500 r. p. m.; one spark plug. Octane ratings, 40, 30, and 18.

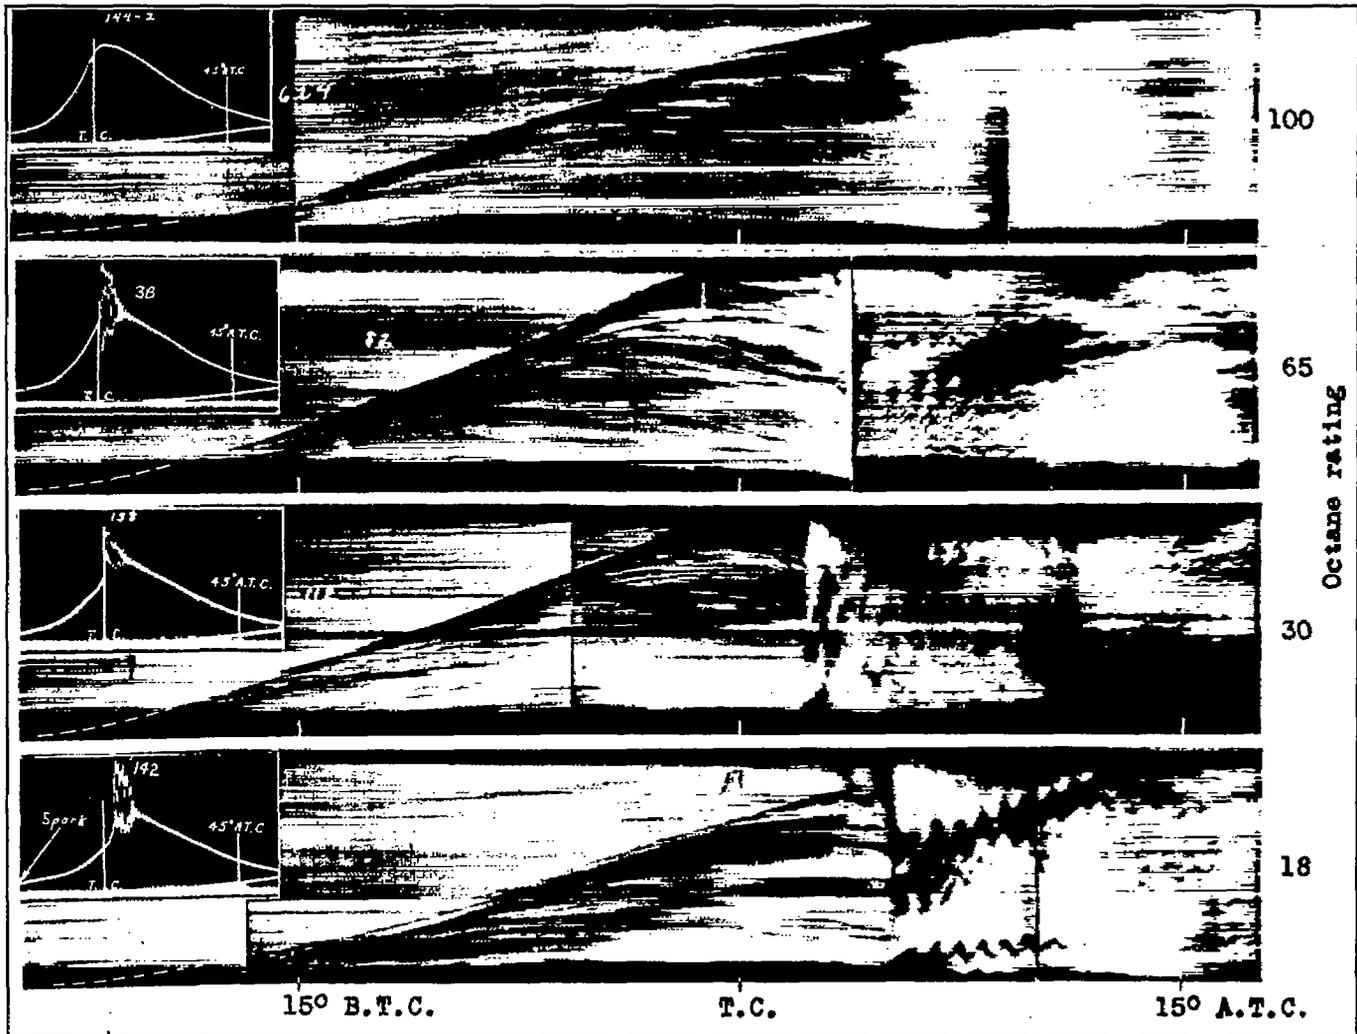
FIGURE 10.—Indicator cards and schlieren photographs showing effect of different octane ratings on combustion knock. Air-fuel ratio, 14; engine speed, 500 r. p. m.; one spark plug.

Figure 10 is a composite of indicator cards and streak schlieren photographs, taken with fuels of different octane ratings. The spark plug (at E, fig. 1) was located at the bottom of the strip as it is shown in the figure. For 100-octane fuel, the rate of combustion-front travel was somewhat slower than the rate for the other fuels. This result may or may not be significant. There is no indication of any vibration in the gas. The maximum pressure shown by the indicator card for the 100-octane fuel is about 800 pounds per square inch.

Each of the other three records shows knocking explosions with the characteristic gas vibrations, the frequency of which corresponds approximately to the frequency recorded on the indicator cards. The slit through which the photographs were taken did not

bands is the same as the frequency of the waves in the schlieren record, visible in the right-hand portion of the record; they begin simultaneously with the pressure waves and are believed to be caused by successive reillumination of the charge as the pressure waves passed through it. Therefore either a sudden appearance of a brighter light, as at A in figure 7, or the appearance of pressure waves may be used to indicate the start and occurrence of knocking.

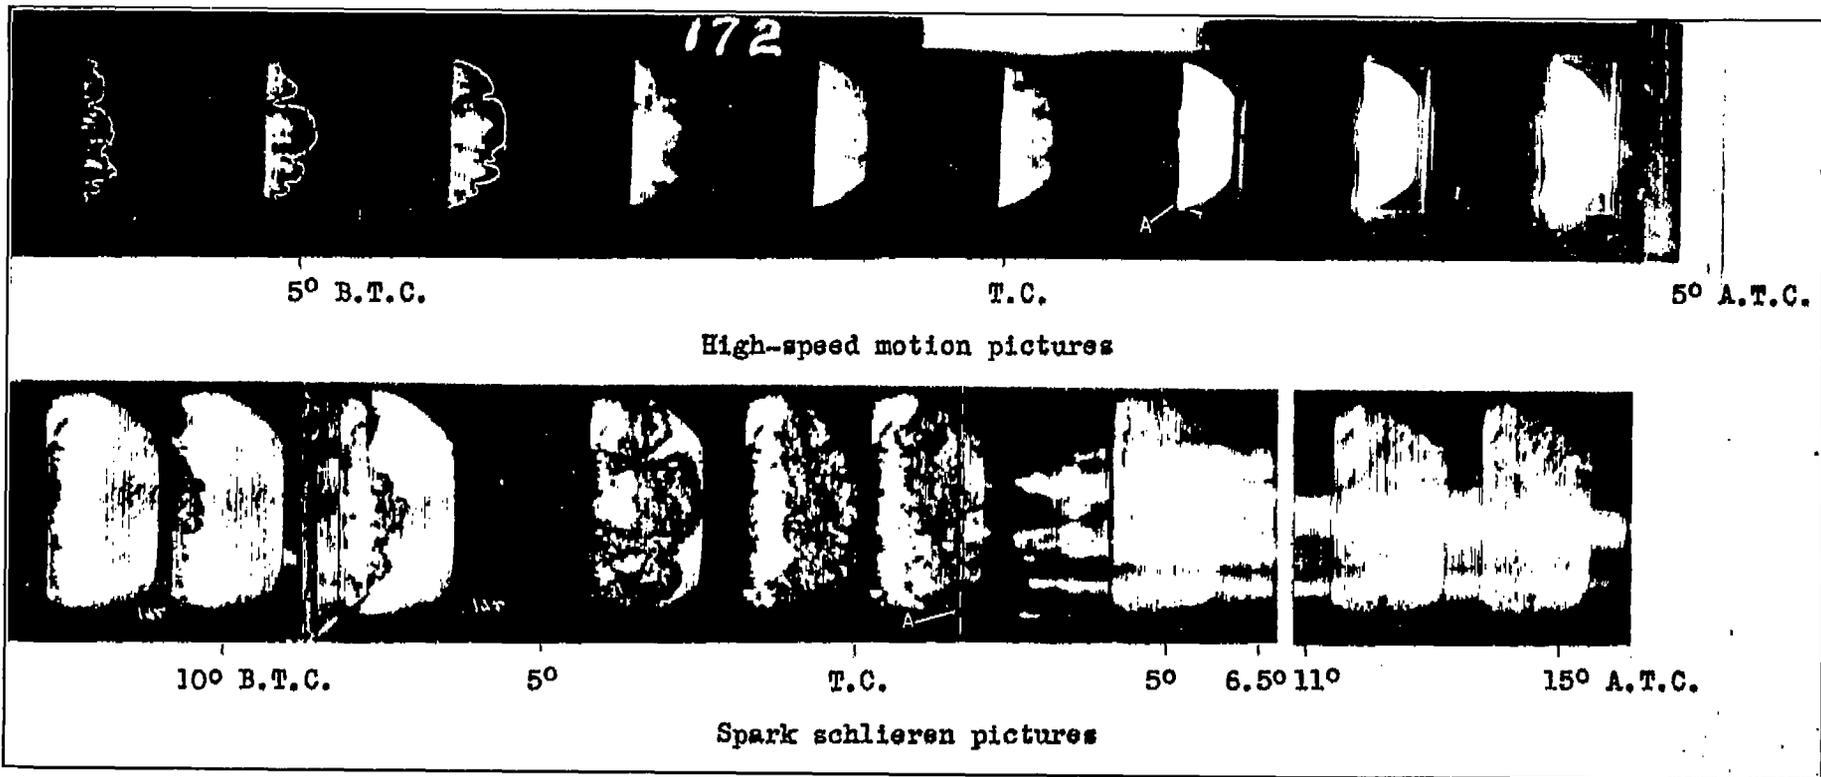
FIGURE 12.—High-speed motion pictures and spark schlieren photographs taken simultaneously, showing flame propagation and knock. Air-fuel ratio, 14; A, first evidence of knock; engine speed, 500 r. p. m.; one spark plug at back of chamber; 65-octane fuel.

Motion pictures of the flame and spark schlieren motion pictures taken simultaneously but from slightly different angles are reproduced in figure 12 for a single spark plug at position G. When the refractive index of the charge is uniform throughout, the spark schlieren field appears uniformly illuminated except for spots, lines, and shaded areas caused, respectively, by dirty spots, strain lines, and irregularities in the mirror or window surfaces. When combustion appears in the field, it is visible because of the temperature change and, with the type of schlieren arrangement used, the combustion front appears darker than the field. The region back of the combustion front also appears dark

In the photographs of figure 12, since the spark plug was located at the back of the chamber, the combustion was halfway across the chamber before it was visible. The first frame on the left of the schlieren series shows the field as it appeared before the flame reached the window. The irregular dark region along the left-hand edge of the window, which might at first be taken for the combustion front just appearing in the field, was caused by the fuel spray that struck the upper edge of the mirror and evaporated, leaving a slight deposit of dust and carbon particles. The combustion front appears first in the second frame. The third frame shows the front still farther across the window and, in the fourth frame, the combustion front had almost crossed the window, with some areas of unburned charge still remaining. In this frame, the clear spaces back of the reaction zone (on the left in the figure) first appeared. The reaction zone in this case appeared to cover somewhat more than half of the $2\frac{1}{2}$ -inch width of the window. In the next frame (fifth from the left), the combustion front had crossed the window and the rear edge of the reaction zone had become more even, leaving a clear space between the edge of the window and the rear of the reaction zone. The reaction zone advanced very little between the fifth and sixth frames and, immediately after the sixth frame, knock occurred. The time of occurrence of knock was determined by the fogging of the film by the sudden bright light accompanying knock. Line A indicates the beginning of the fogged streaks. The point where the streaks start, of course, is the point at which the light from the knocking combustion at the left-hand edge of the window first struck the film.

It should be noted particularly, when the spark schlieren pictures are compared with the flame pictures, that the outlines of the combustion front as shown by the schlieren pictures appear to correspond very closely to the outlines of the visible flame in the flame pictures. The third frame from the left of the flame photographs and the fourth frame of the schlieren photographs correspond fairly closely in point of time.

In the first three frames of the motion picture, the flame front has been outlined in white for purposes of reproduction. By the fourth frame, the flame had covered most of the chamber and, in the next two frames, it covered the chamber and the intensity of illumination increased. Knock then occurred, and the brilliant illumination was first evident in the frame marked A, just after top center.
