## REPORT No. 862

# AN INVESTIGATION OF A THERMAL ICE-PREVENTION SYSTEM FOR A TWIN-ENGINE TRANSPORT AIRPLANE

### SUMMARY

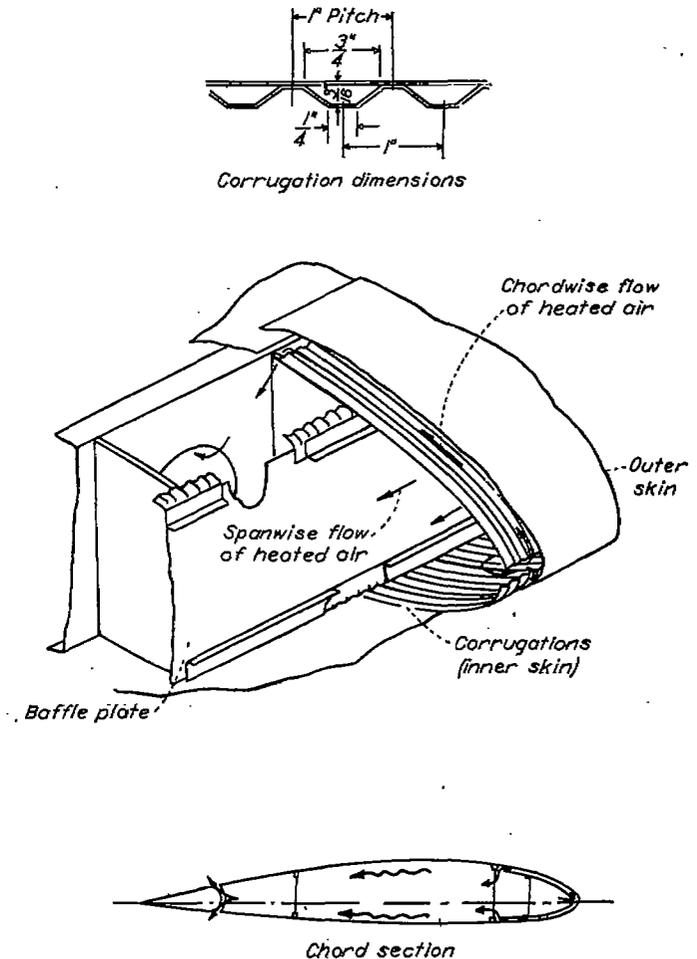
For the test airplane, the inner surface at the wing and empennage leading edges (fig. 2) extends to 10 percent of the chord, is corrugated to form chordwise air passages, and is separated at the leading edge to allow entrance of the

FIGURE 2.—Structural details of a typical wing or empennage thermal ice-prevention system employing heated air.

A typical section of the wing outer-panel leading edge as revised for thermal ice-prevention is shown in figure 12. The construction is basically the same as that presented in the analysis section (fig. 2) with the exceptions that the nose ribs are shown and a nose rib liner has been added. This liner was found to be required in order to reduce the pressure drop in the spanwise distribution duct caused by the nose ribs. The corrugated inner skin extends to the 10-percent-chord point and the heated air enters the chordwise passages through a gap at the leading edge between the upper and lower segments of the inner skin. After leaving the corrugation passages, the heated air circulates throughout the wing interior, passing through reinforced holes in the spar webs, and is discharged through the aileron and flap slots. For the wing tips, the type of leading-edge construction is similar to that employed for the outer panel with the exception that the corrugated inner skin was replaced by a dimpled type which was more adaptable to the double-contour forming necessary. In the case of the wing inboard panels, the corrugated inner

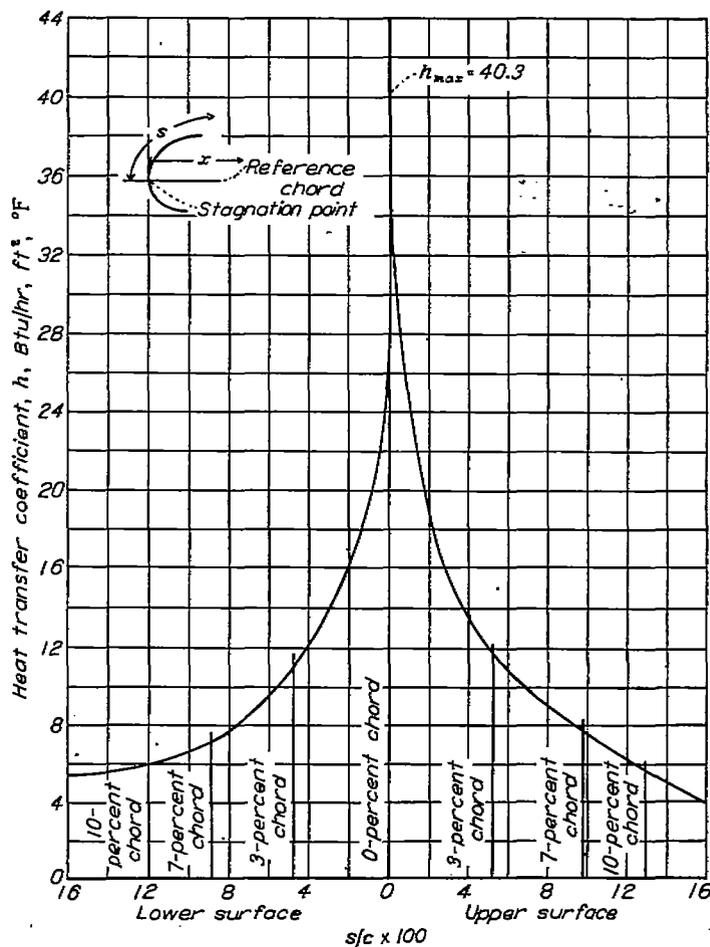
FIGURE 3.—Calculated external heat-transfer coefficient from pressure-belt data for wing station 187.

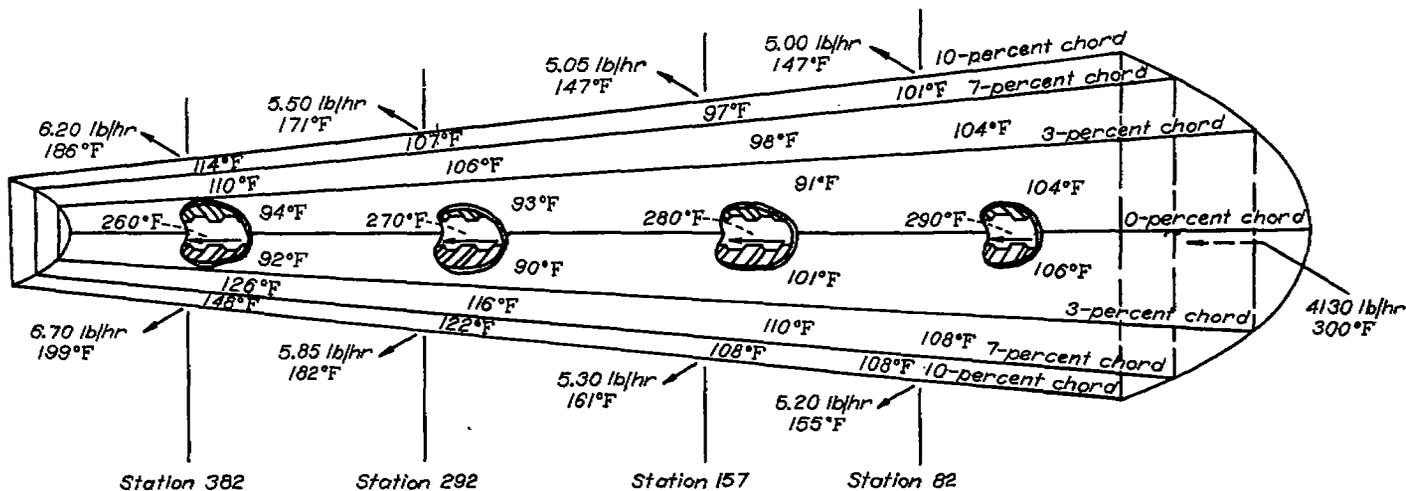
Free-air temperature = 0°F  
 Heat available above 0°F = 30,000 Btu/hr  
 Heat removed from leading-edge surface = 115,500 Btu/hr or 1220 Btu/hr per ft<sup>2</sup>

FIGURE 4.—Calculated heat and air-flows and leading-edge skin temperature rises for the wing thermal ice-prevention system.

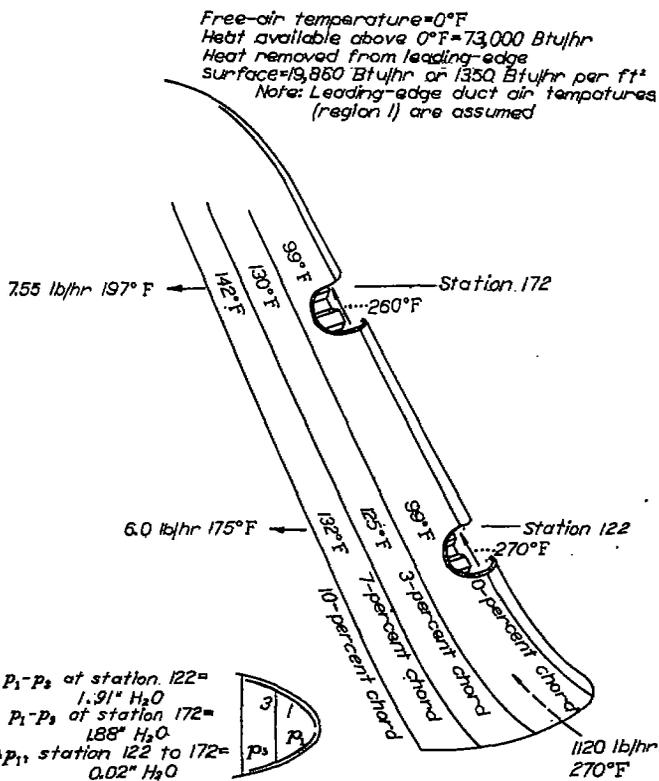
FIGURE 5.—Calculated heat and air-flows and leading-edge temperature rises for the vertical fin thermal ice-prevention system.

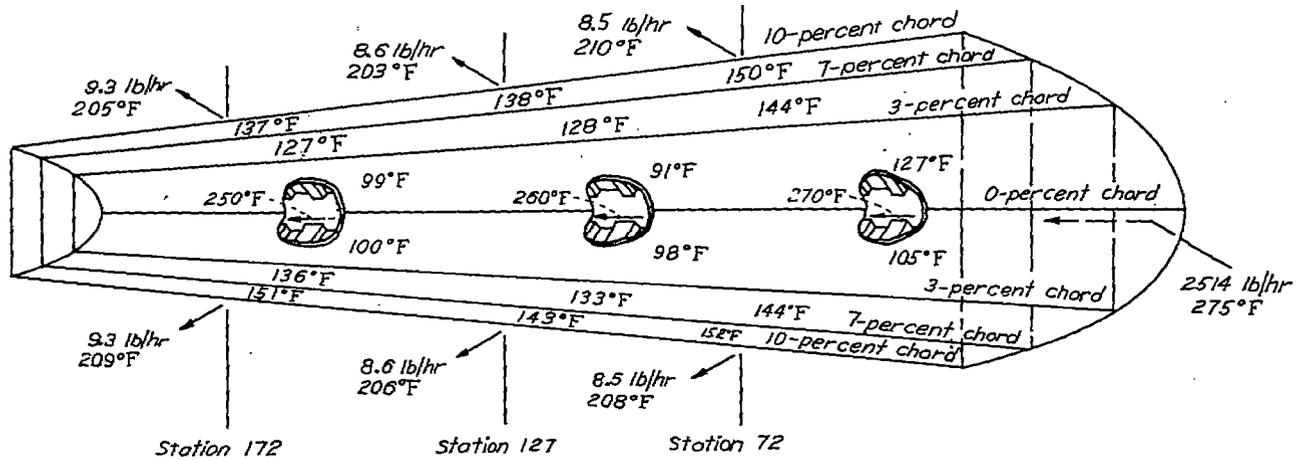
Free-air temperature = 0°F  
 Heat available above 0°F = 167,000 Btu/hr  
 Heat removed from leading-edge surface = 32,640 Btu/hr or 1730 Btu/hr per ft<sup>2</sup>

FIGURE 6.—Calculated heat and air-flows and leading-edge skin temperature rises for the horizontal stabilizer thermal ice-prevention system.

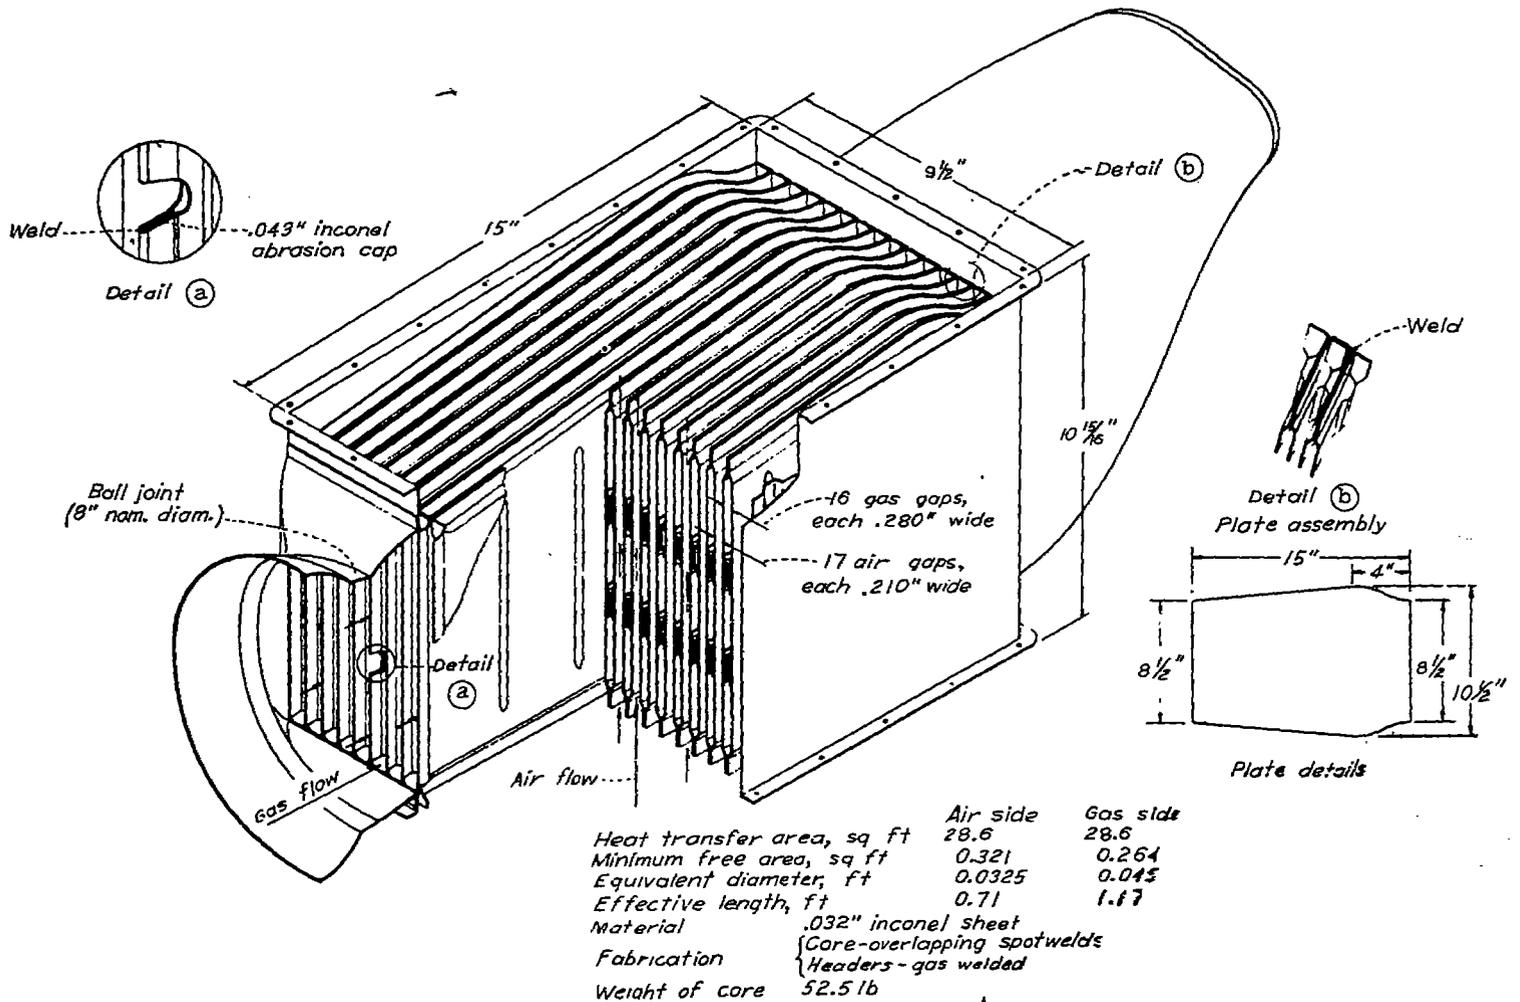
FIGURE 7.—Details of primary heat exchangers for the test airplane.

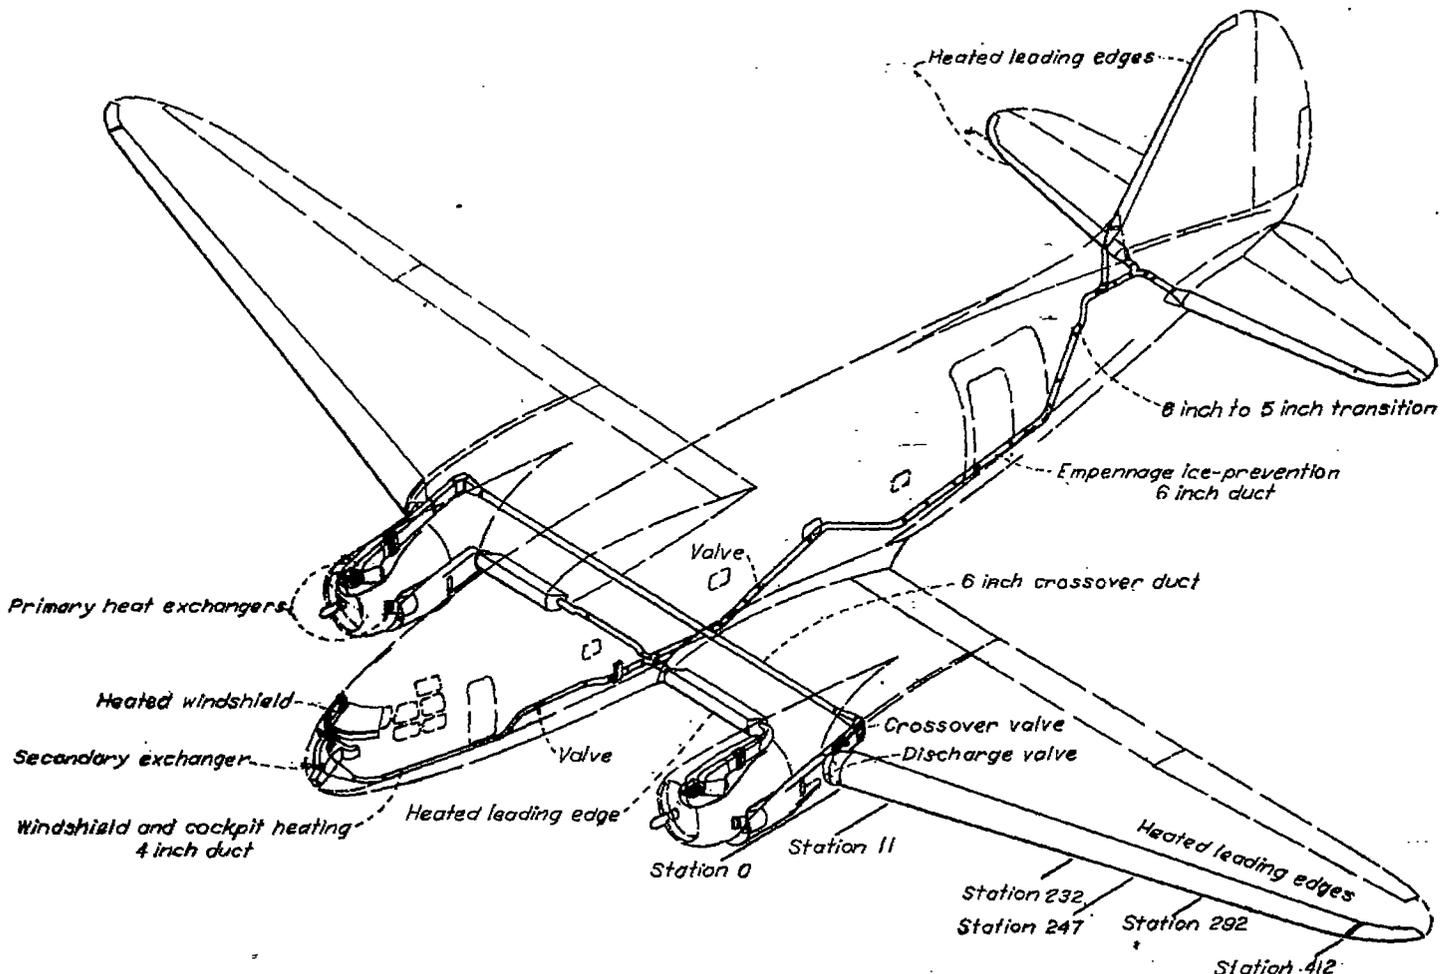
FIGURE 8.—General arrangement of thermal ice-prevention equipment in the test airplane

The heated-air distribution system is shown in figure 8. In the case of the outboard exchangers, the heated air is admitted to the wing outer-panel ice-prevention system at a point just outboard of the nacelles. For single-engine operation of either engine, the heated air can be divided between the right and the left wing outer-panel systems by operation of crossover valves located as shown in figure 8. The heated air from the inboard exchangers passes through the leading edge of the inboard panels in 6-inch-diameter ducts to a common junction on the left side of the fuselage. A portion of the air is diverted from the ducts in the inboard panels to supply the inboard-panel leading-edge ice-prevention system. From the junction in the fuselage, the heated air is directed forward through a 4-inch duct to the secondary-exchanger in the airplane nose, and aft through a 6-inch duct to the empennage. These supply ducts were all insulated with asbestos paper and a rock-wool-type covering. Several valves, usually of the butterfly type, were located throughout the heated-air supply system in order to control the distribution of the air flow.

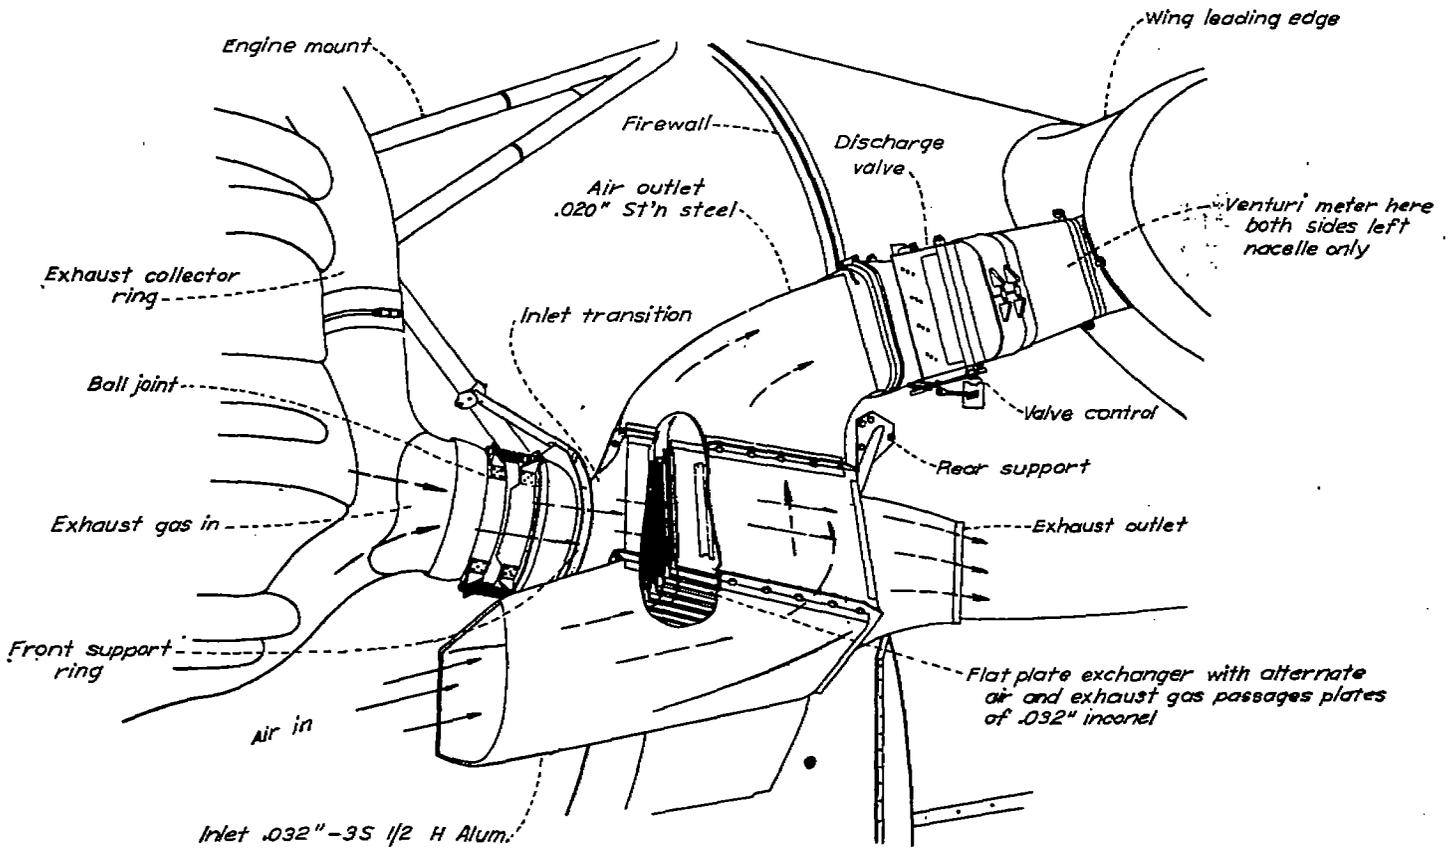
FIGURE 9.—Location of the heat exchangers on the test airplane.

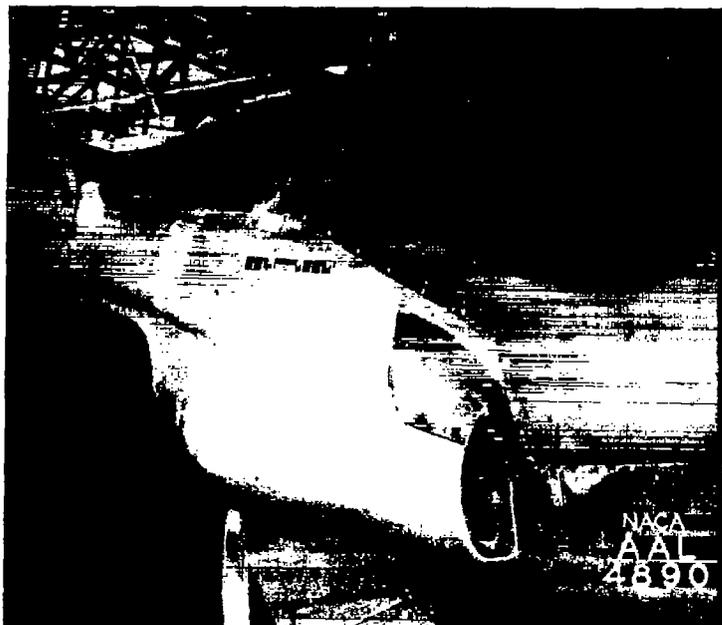
FIGURE 11.—Typical heat exchanger installation with fairing.

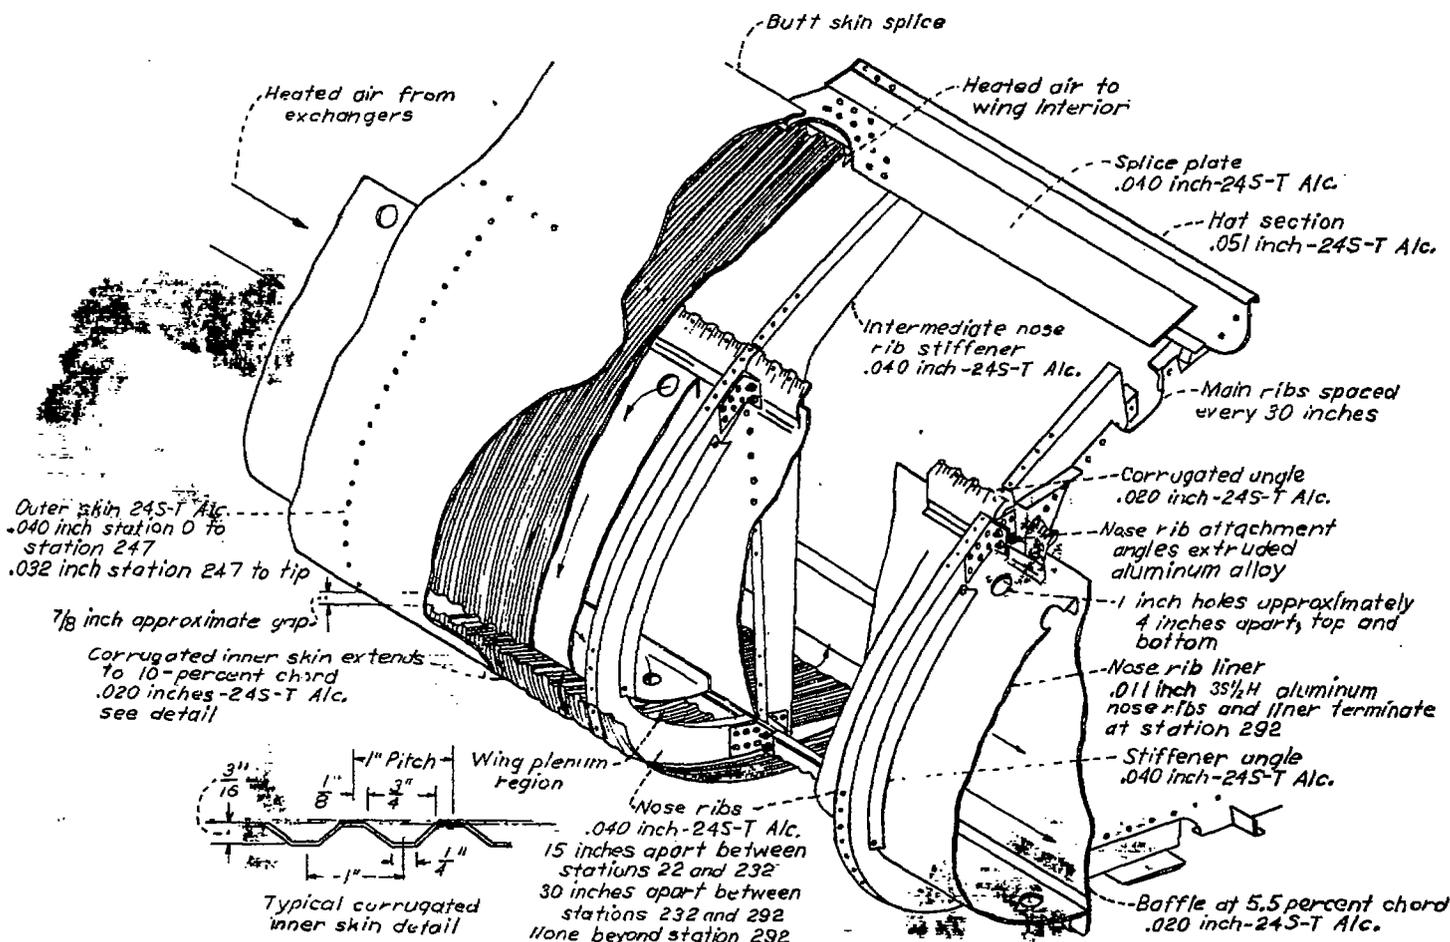
FIGURE 12.—Typical wing outer-panel leading-edge section as revised for thermal ice prevention.

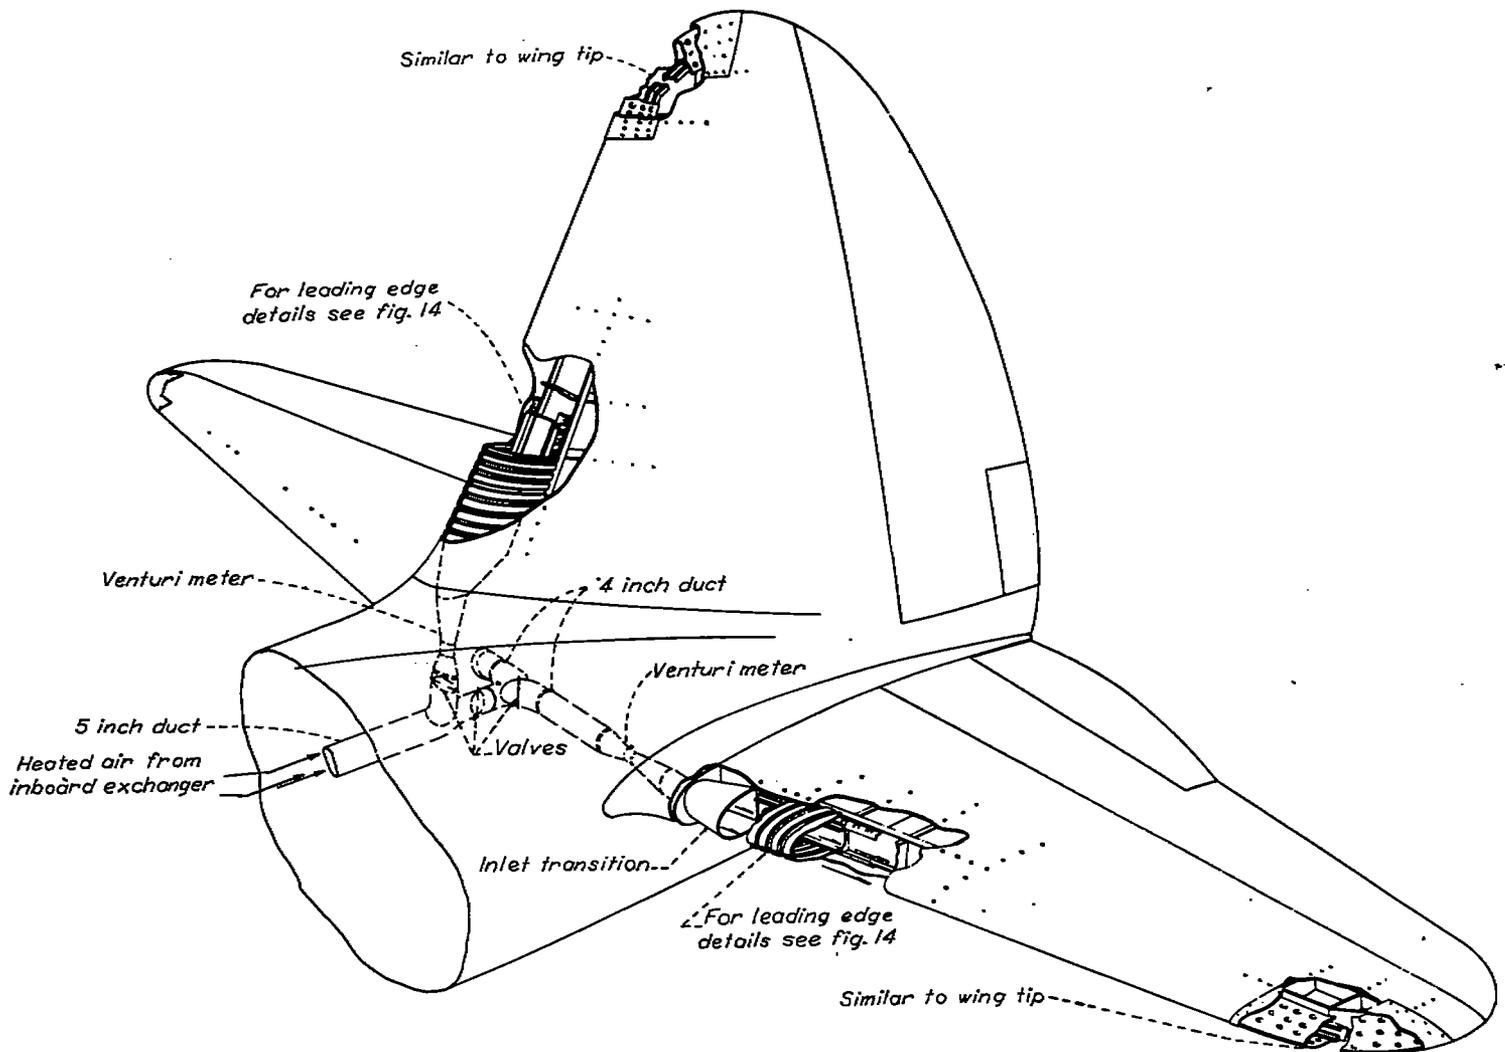
FIGURE 13.—General lay-out of thermal ice-prevention equipment in the empennage of the test airplane.

The general arrangement of the thermal ice-prevention equipment in the empennage is shown in figure 13. Distribution of the heated air is controlled by adjustment of the three butterfly valves shown in the figure. The revisions to the stabilizer and fin leading edges are identical and a typical section is shown in figure 14. The corrugated inner skin extends to 10 percent of the airfoil chord and the corrugation passages are identical in size to those for the wing. After leaving the leading-edge region, the heated air circulates in the stabilizer or fin interior and is discharged at the elevator or rudder slot. The dimpled skin type of construction employed in the wing-tip revisions was also used for the stabilizer and fin tips.

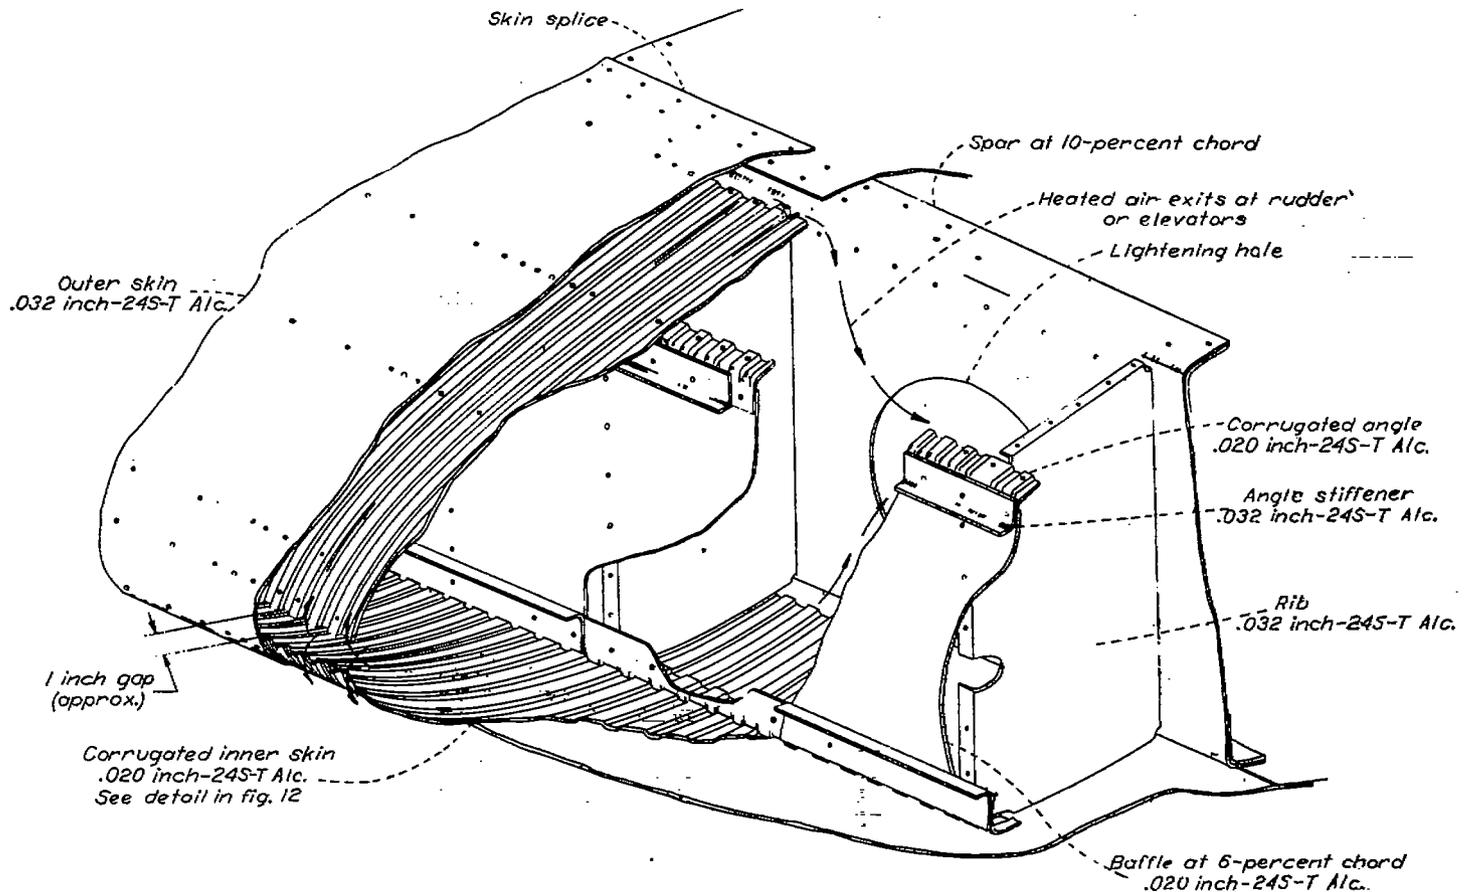
FIGURE 14.—Details of test airplane stabilizer and fin leading edges as revised for thermal ice prevention.

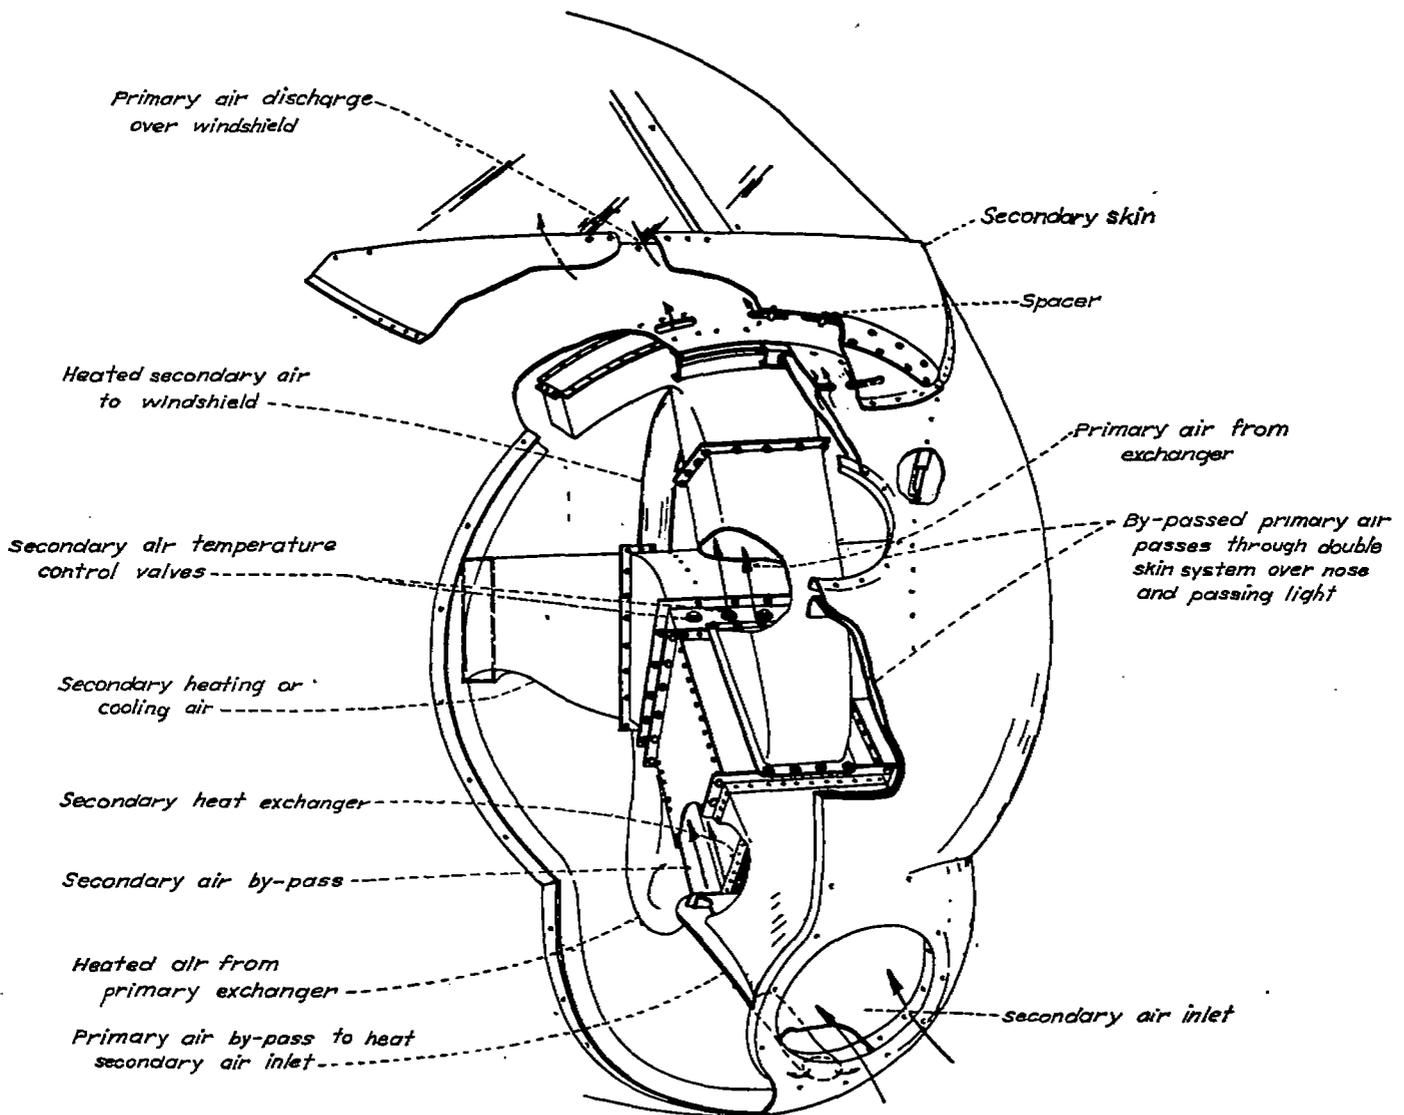
FIGURE 15.—Details of heat-exchanger installed in nose of the airplane to provide secondary heated air for windshield and cockpit heating.

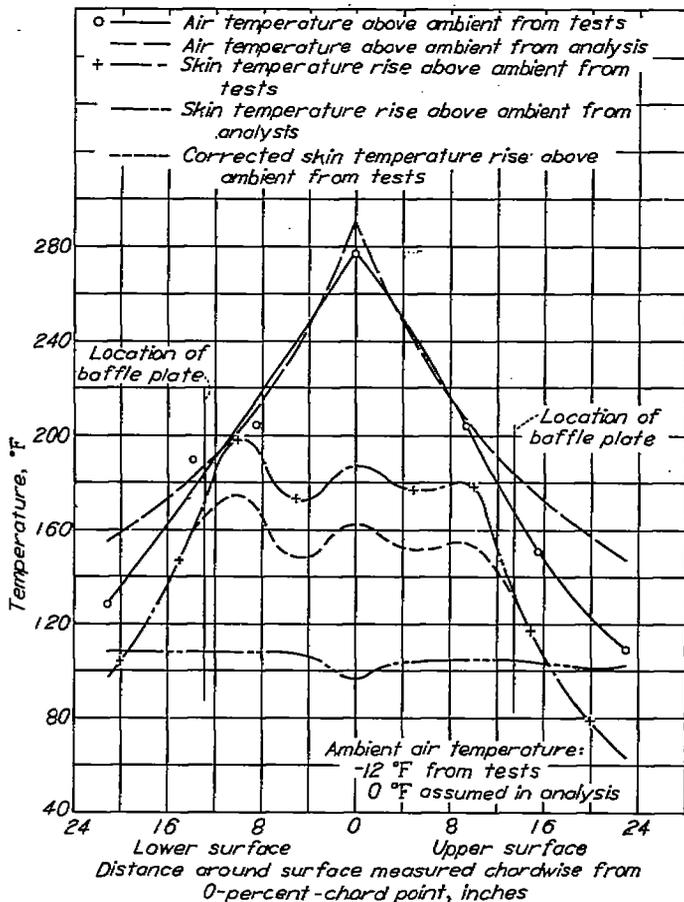
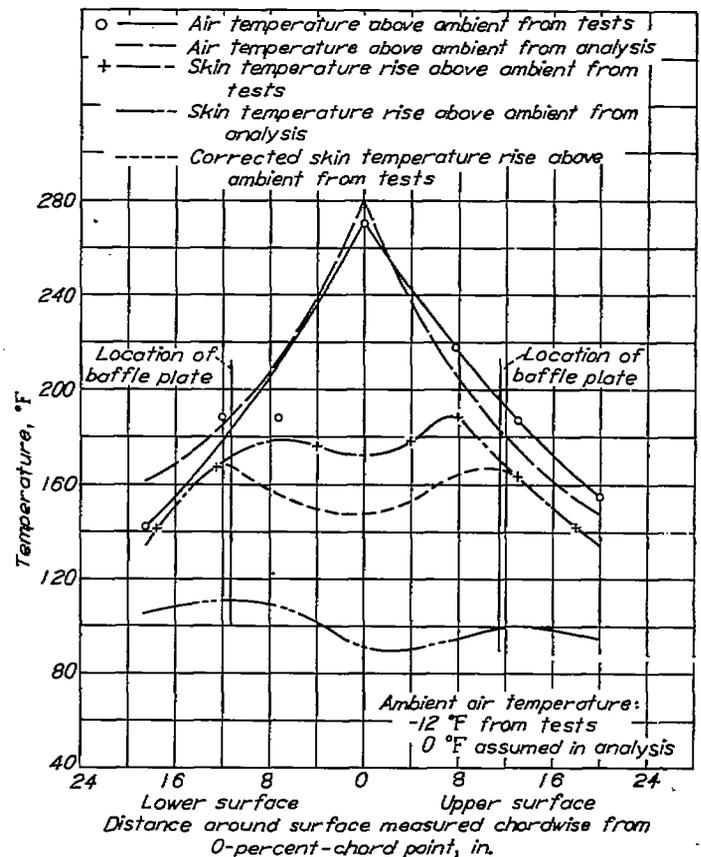
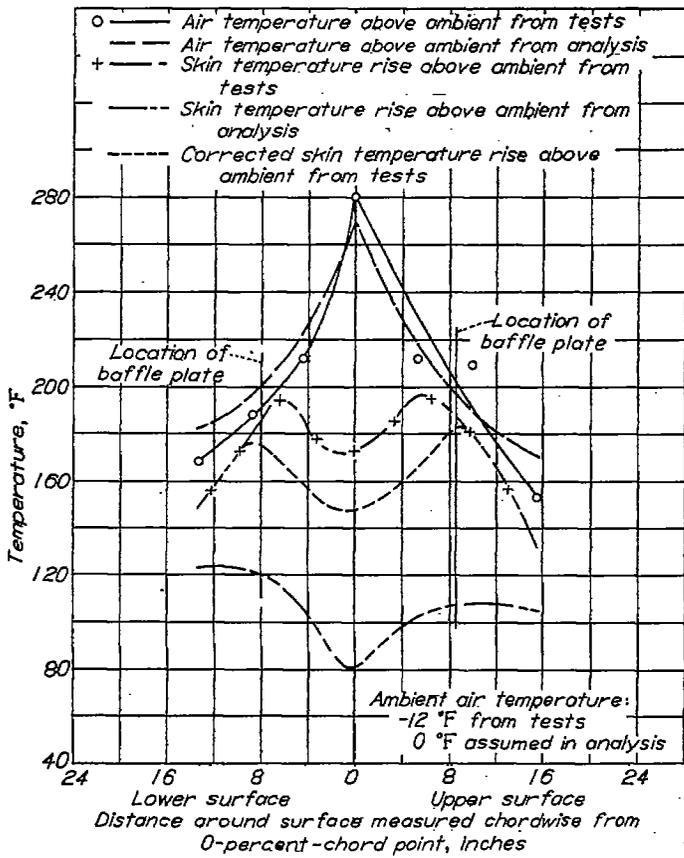
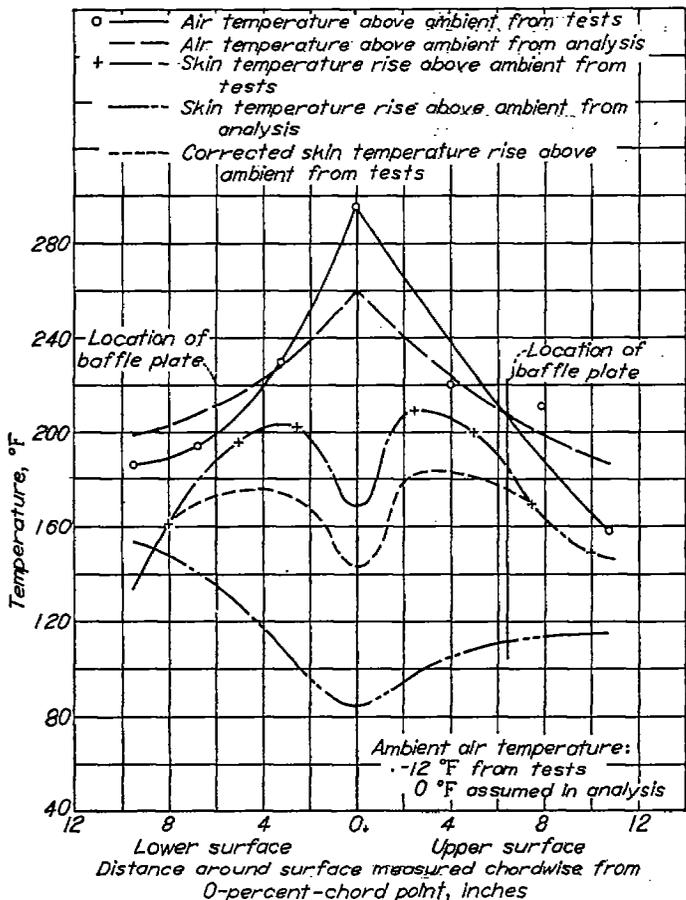
FIGURE 16.—Comparison of analytical and experimental test results of air- and skin-temperature rises above ambient-air temperature for wing station 84.

FIGURE 17.—Comparison of analytical and experimental test results of air- and skin-temperature rises above ambient-air temperature for wing station 159.

FIGURE 18.—Comparison of analytical and experimental test results of air- and skin-temperature rises above ambient-air temperature for wing station 290.

FIGURE 19.—Comparison of analytical and experimental test results of air- and skin-temperature rises above ambient-air temperature for wing station 380.

16, 17, 18, and 19. The skin-temperature correction shown in these figures was based on the washer-surface thermocouple tests previously discussed. The test results are taken from data recorded during flight 61, run 5 (table I), which approximated the analytical design conditions. During this run the total heated-air-flow rate was 4,015 pounds per hour to the left-wing outer panel, as compared with an analytic flow rate of 4,130 pounds per hour, and the temperatures of the air entering the corrugations agreed closely with the assumed air temperatures. The air-temperature rise through the exchanger was 369° F (69° F above the temperature rise of the analysis), resulting in a thermal output of 362,000 Btu per hour. This is 20 percent higher than the anticipated value of 300,000 Btu per hour. Nevertheless, the air-temperature change from the exchanger outlet to the corrugation inlets was sufficient to give approximately the corrugation air-inlet temperatures of the analysis at all but one station (380). Furthermore, the temperature of the air entering the corrugation at station 380 was higher than at any other station. These two facts, together with a consideration of the leading-edge construction (fig. 12), indicate that some of the heat was transferred from the air in passing between the nose-rib liner and the corrugations to the corrugation inner surfaces, and ultimately to the outer skin, causing a decrease in heated-air temperature from the leading-edge duct to the corrugation inlets. Since the nose-rib liner ends at station 292, this effect would not prevail at station 380, and the temperature of the air at the corrugation entrance would be substantially the same as in the leading-edge duct at this point.

The rapid decrease in skin-temperature rise shown in figures 16, 17, 18, and 19 in the region immediately aft of the baffle plate is probably a result of two effects. The first and

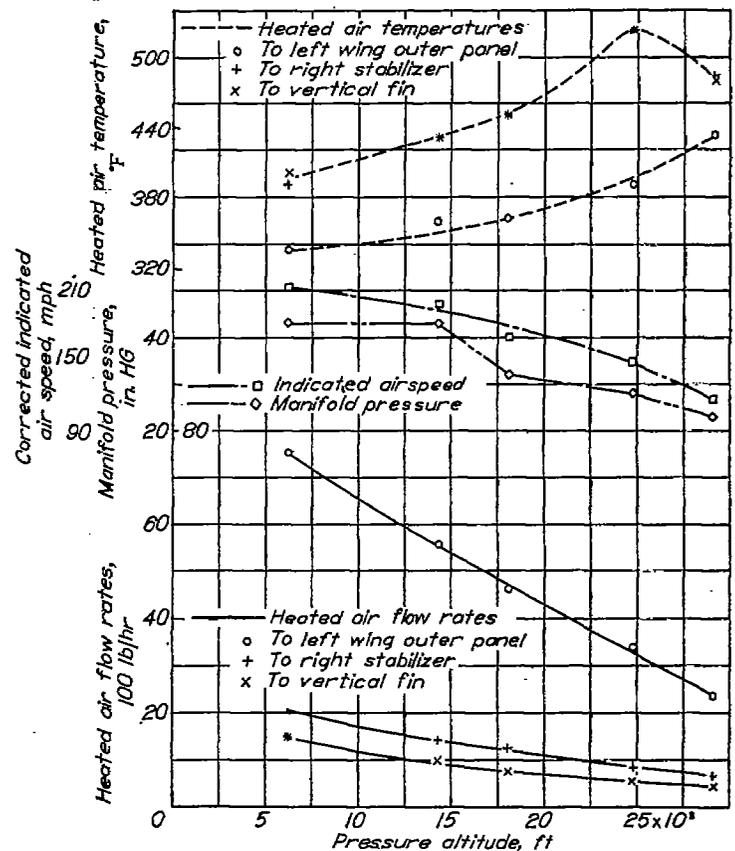
FIGURE 20.—Variation of heated air flow rates and temperatures, indicated airspeed and manifold pressure with pressure altitude test condition 3: Full throttle; twin engine operation.

been presented for condition 3 of table I only. Figure 20 illustrates the variation with altitude of the flow rates and temperatures of the air delivered to the left-wing outer panel, the right stabilizer, and the vertical fin, and also the variation with altitude of manifold pressure and indicated airspeed. Figures 21 through 23 present, respectively, the chordwise skin- and air-temperature distribution at wing station 159, stabilizer station 125, and fin station 124. Figure 24 illustrates the variation with altitude of the average skin temperature forward of the baffle plates for the left-wing outer panel, the right stabilizer, and the vertical fin. The ambient-air-temperature variation with altitude for the full-throttle tests is also included in figure 24.

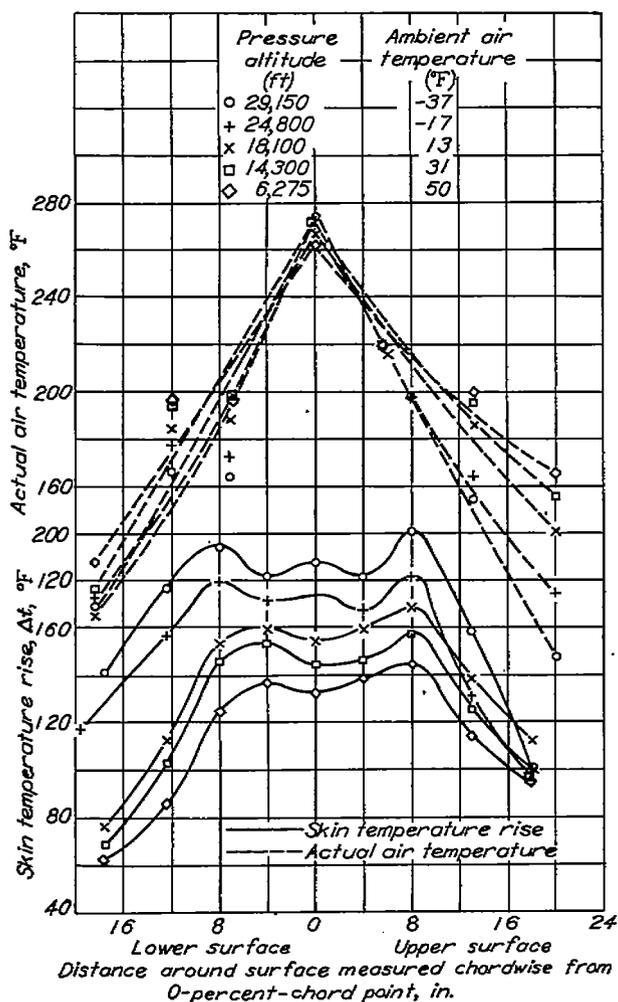
FIGURE 21.—Left wing outer panel station 159 chordwise skin- and air-temperature distributions at various altitudes. Test condition 3: Full throttle; twin engine operation.

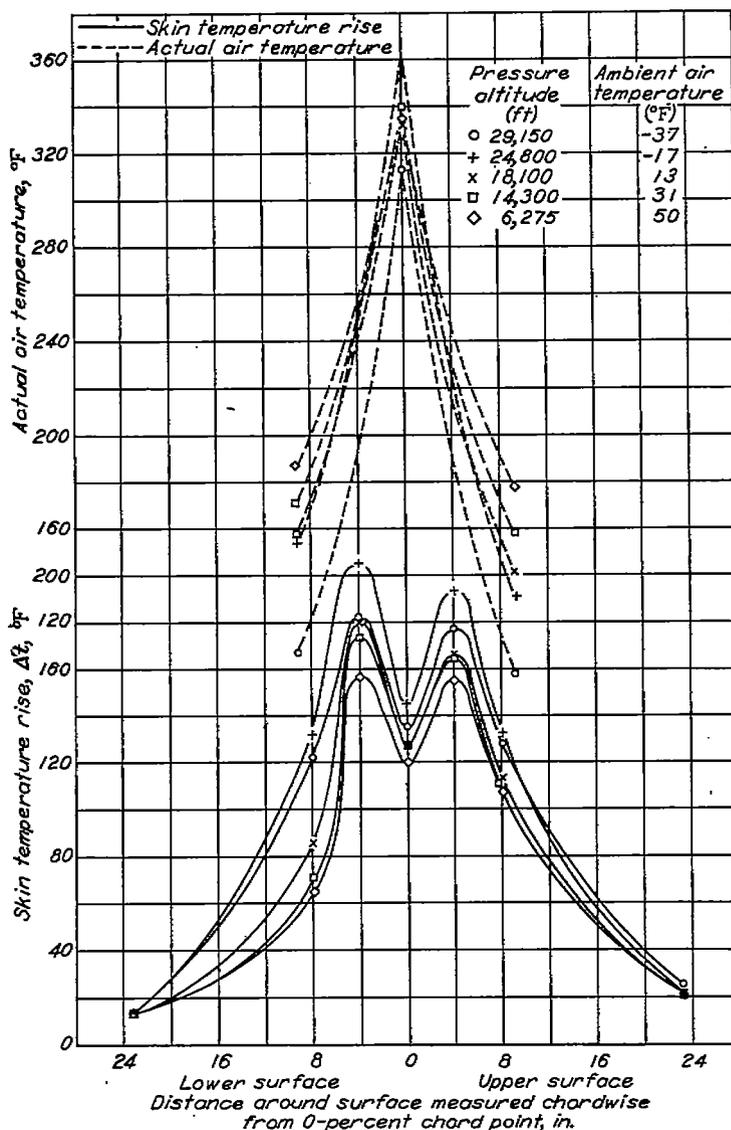
FIGURE 22.—Right stabilizer station 125 chordwise skin- and air-temperature distribution at various altitudes. Test condition 3: Full throttle; twin engine operation.

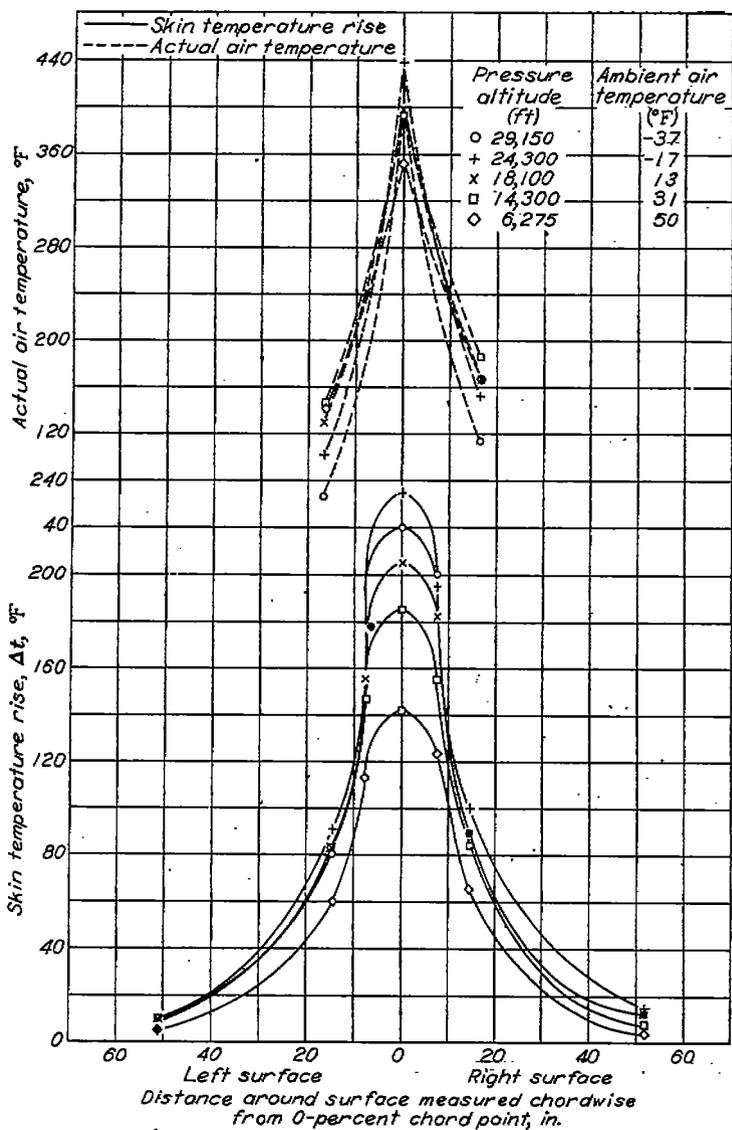
FIGURE 23.—Vertical fin station 124 chordwise skin- and air-temperature distribution at various altitudes. Test condition 3: Full throttle; twin engine operation.

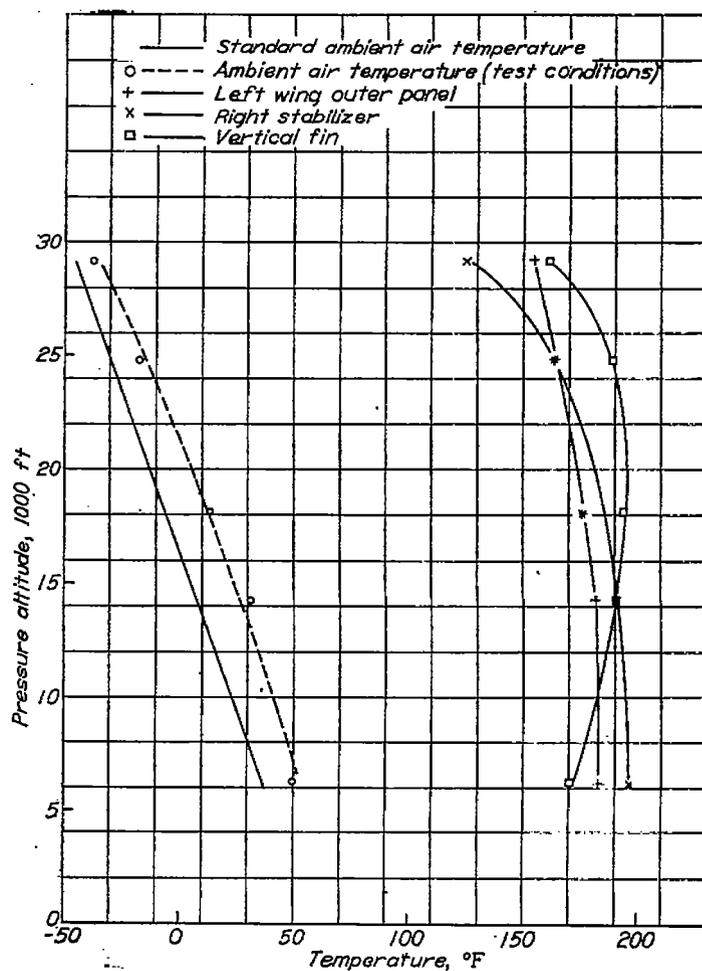
FIGURE 24.—Variation with altitude of average skin temperatures forward of baffle plates for left wing outer panel, right stabilizer and vertical fin. Test condition 3: Full throttle; twin engine operation.

The change with altitude of the average actual skin temperatures of the leading-edge regions of the wing, stabilizer,
