## REPORT No. 862

# AN INVESTIGATION OF A THERMAL ICE-PREVENTION SYSTEM FOR A TWIN-ENGINE TRANSPORT AIRPLANE

### SUMMARY

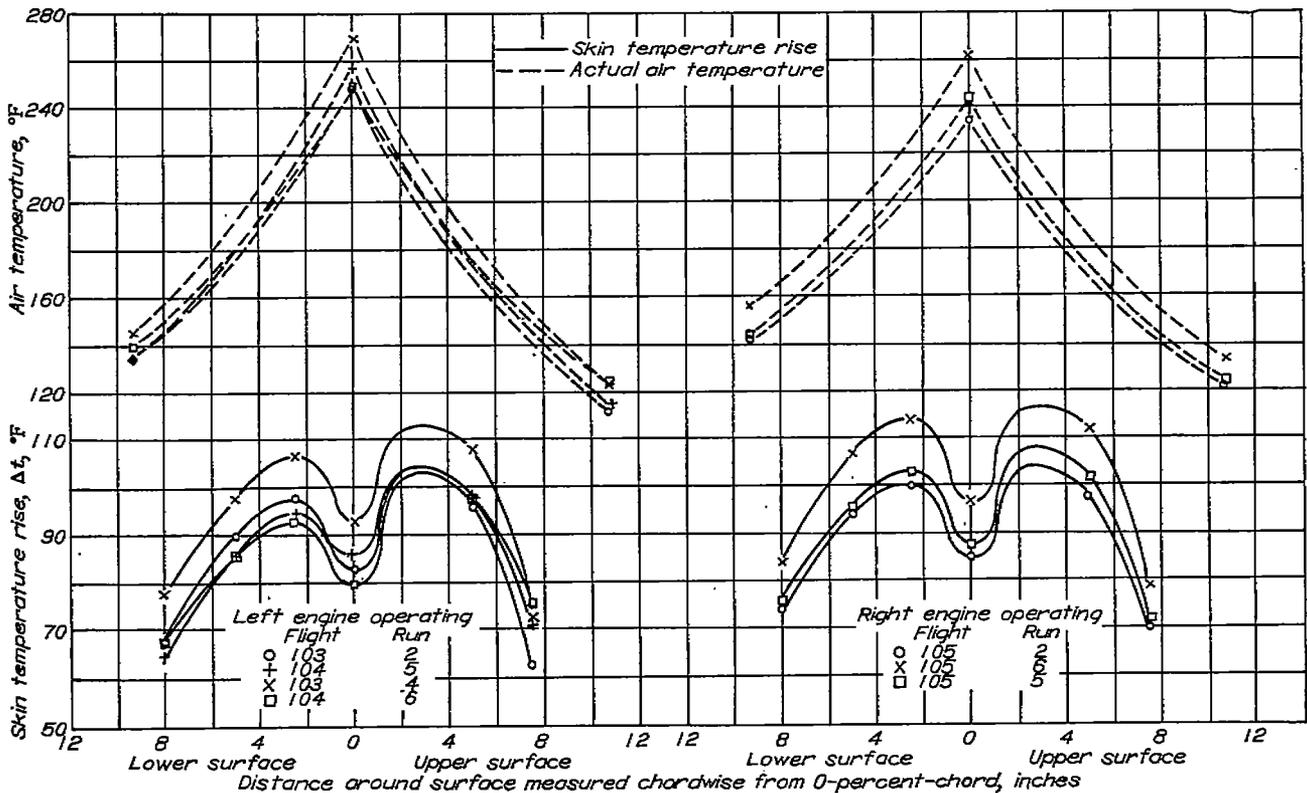
FIGURE 25.—Left wing outer panel station 380 skin- and air-temperature distribution for right and left single engine operation at 10,000 feet pressure altitude.

Considering next the single-engine tests, the chordwise air- and skin-temperature variations at wing station 380 are presented in figure 25 for the flights conducted at 10,000 feet pressure altitude.

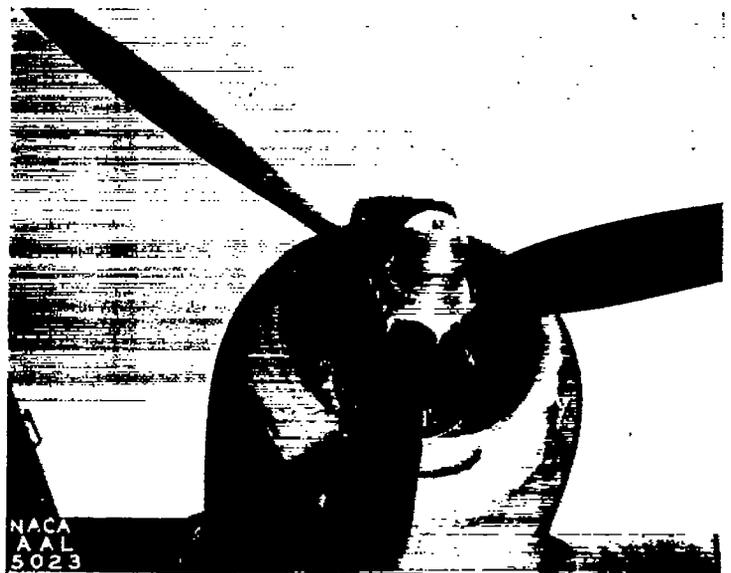
FIGURE 32.—Ice accretion on the left engine cowling after flight 50

icing conditions. Figures 31 and 32 are photographs taken after landing of some of the ice accumulations resulting from this flight. These ice formations were much larger in flight. The temperature of the ambient air before landing in Minneapolis was 38° F and the ice was melting and falling off at the time the pictures were taken. During flight, the ice on the cowling (fig. 32) had extended 2 to 3 feet rearward along the nacelle sides and the ice on the nose of the airplane (fig. 31) had extended rearward over the windshields.

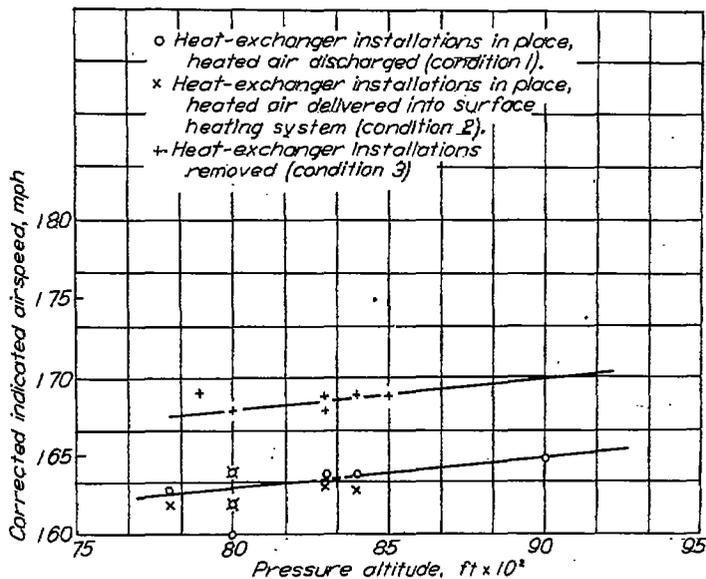
FIGURE 34.—Variation of indicated airspeed with pressure altitude for the test airplane with and without the heat exchanger installations in place. Flight conditions: 10,000-foot density altitude; 30 inches of mercury manifold pressure and 1,900 rpm.

The curves of figure 34 indicate that the performance change resulting from the installation of the thermal system amounted to approximately 6 miles per hour indicated air-

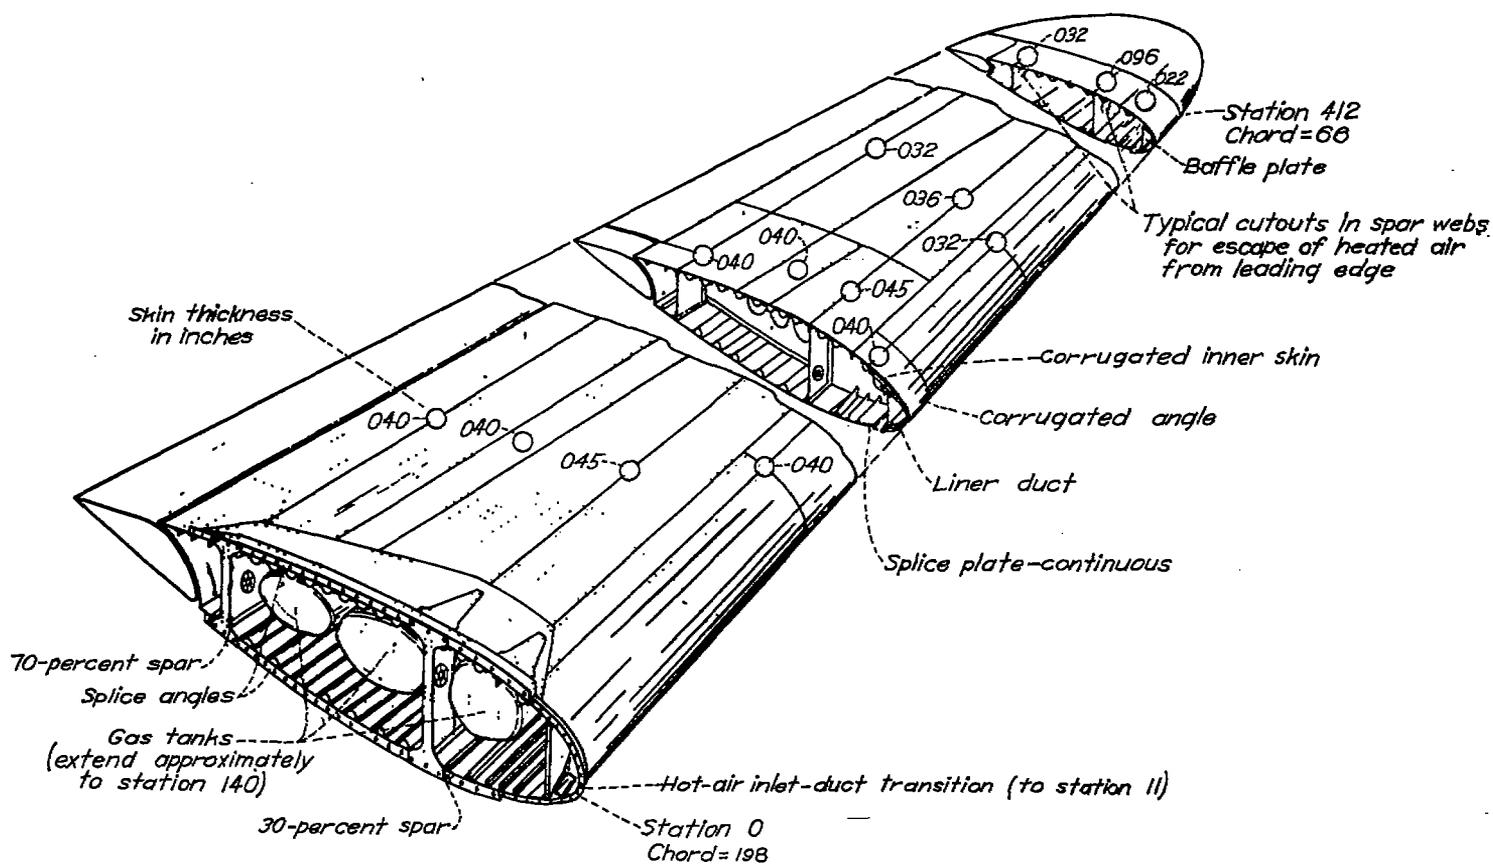
FIGURE 35.—Structural details of the left-wing outer panel of the test airplane with leading-edge revised for thermal ice prevention

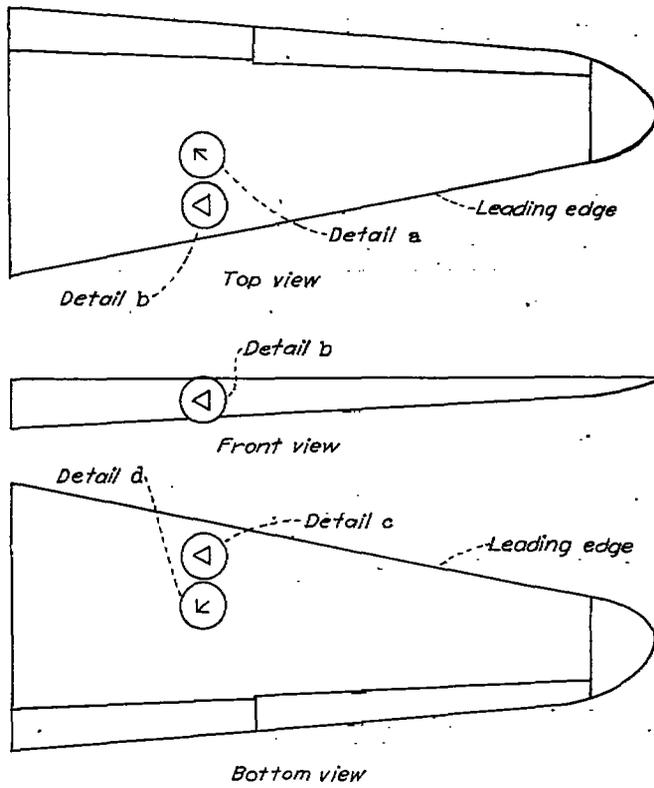
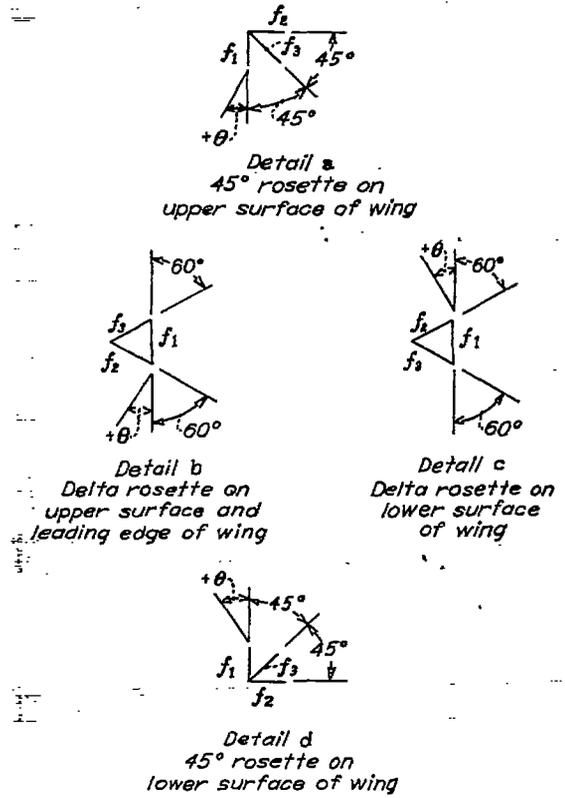
Note: In all cases  $f_1$  was mounted parallel to the chord line and  $\theta$  gives direction of maximum normal stress

FIGURE 38.—Orientation of rosette gages on the left-wing panel of the test airplane.

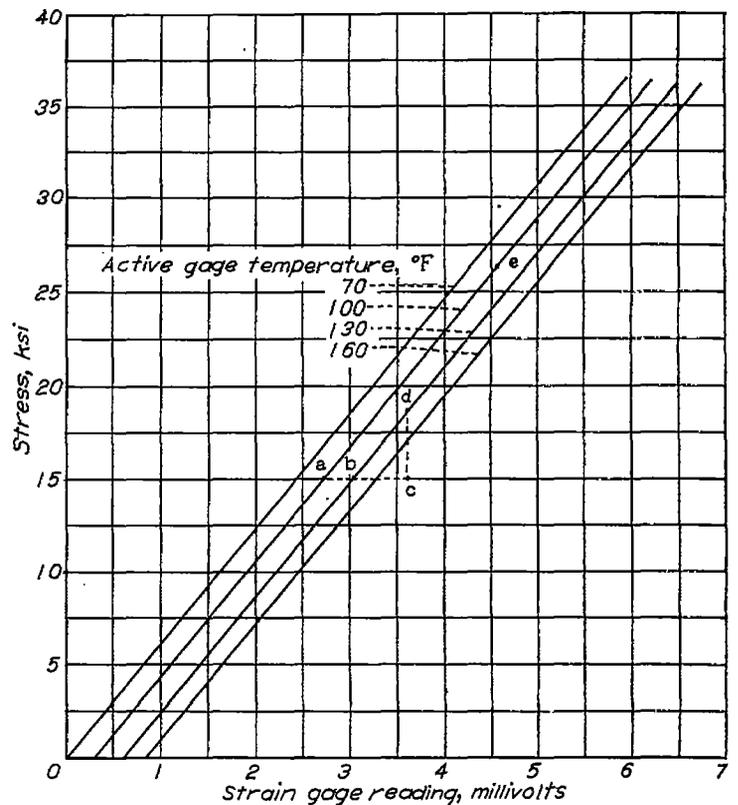
FIGURE 39.—Typical laboratory calibration of strain gage showing effect of temperature on gage reading. Dummy gage temperature constant at 70° F.

ature change had been 30° F and the strain-gage reading agreed with point b, pure expansion and no change in stress would be indicated. If the strain-gage reading corresponded

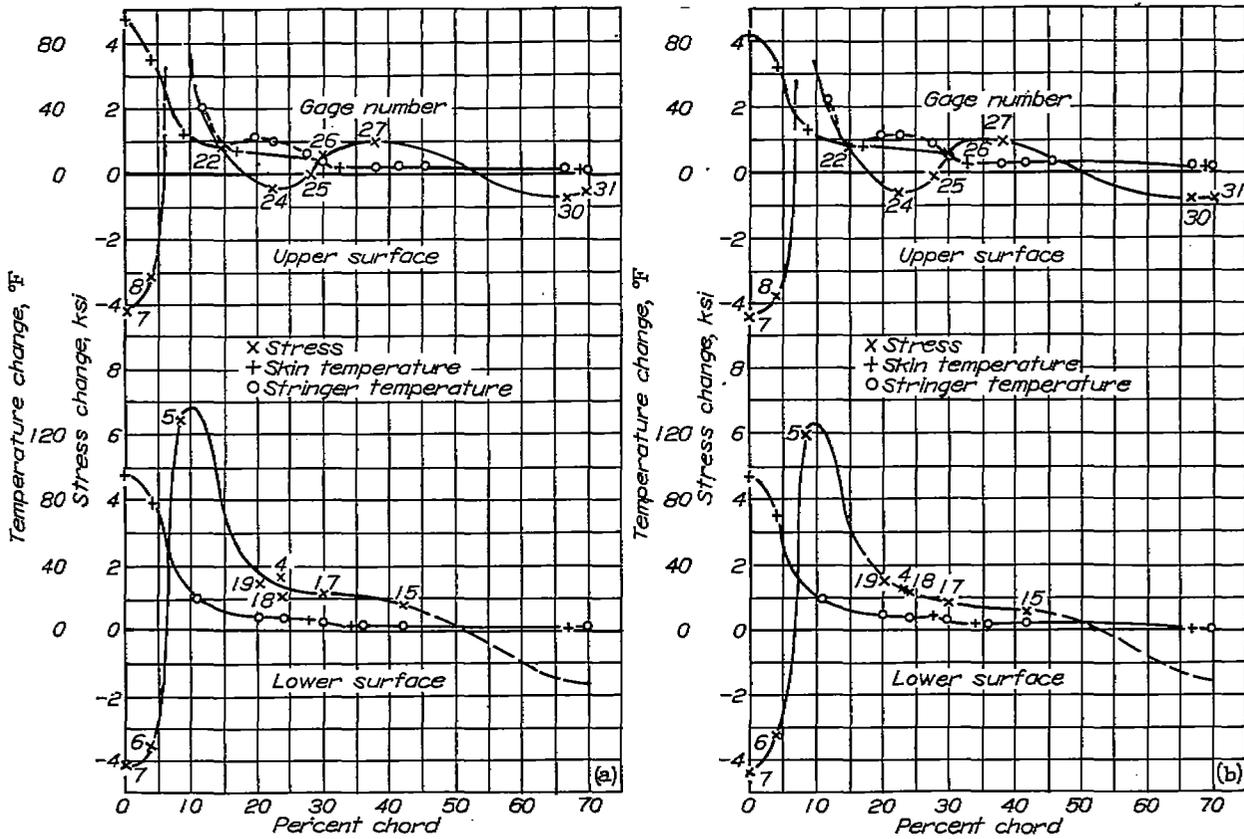
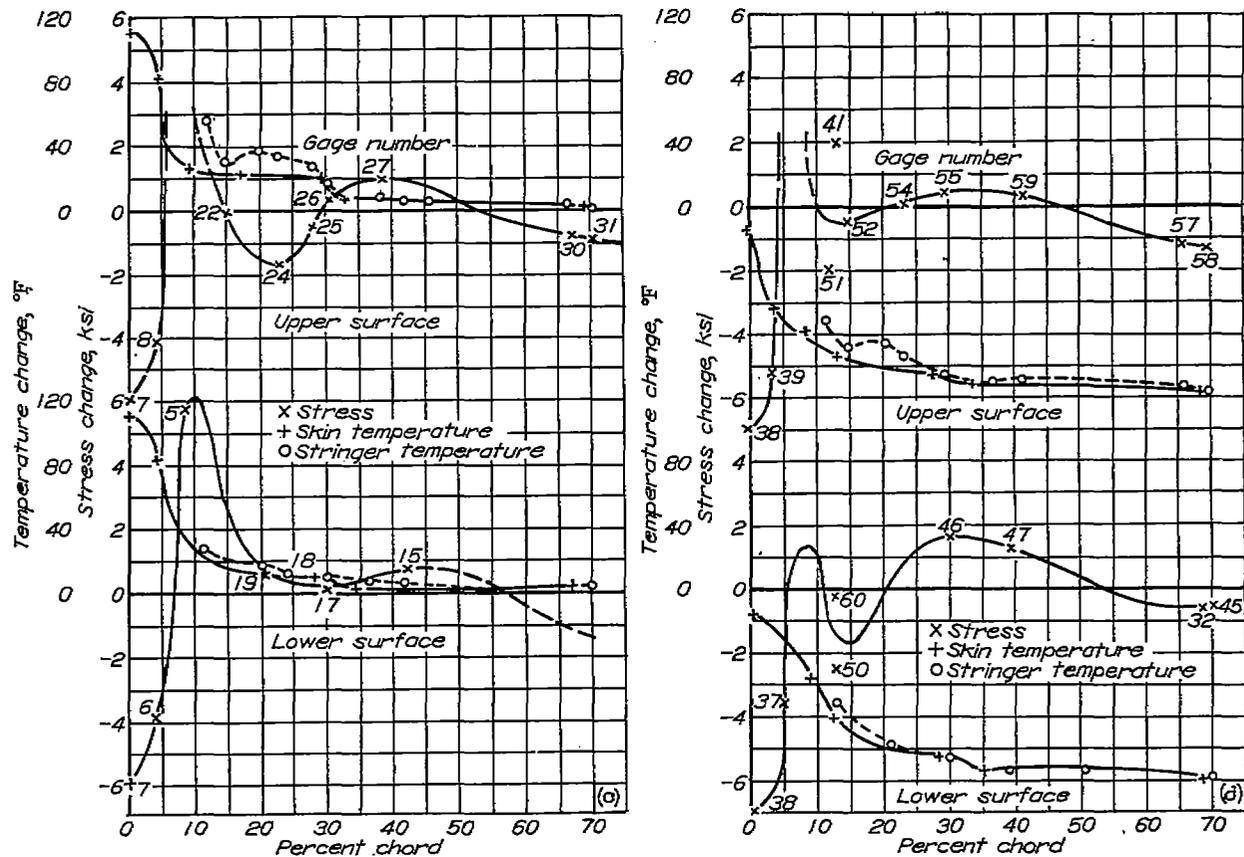
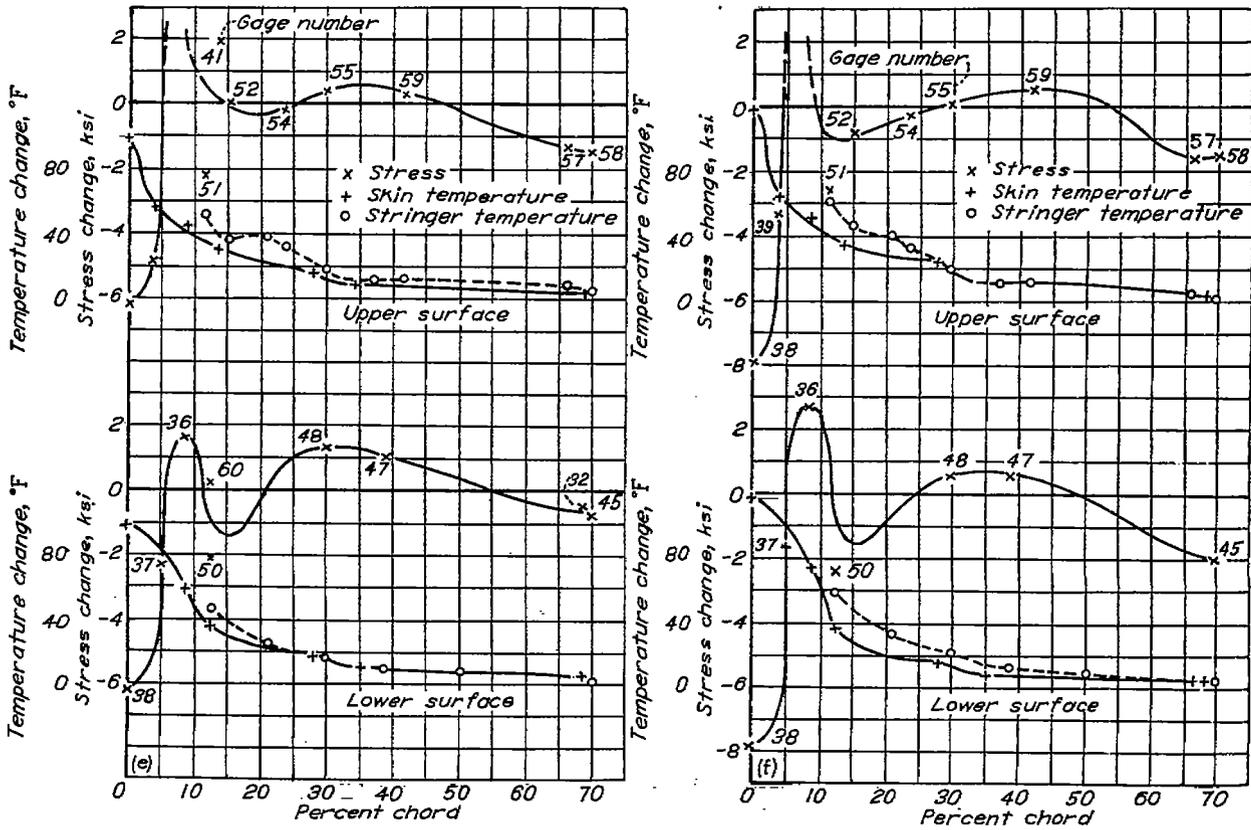
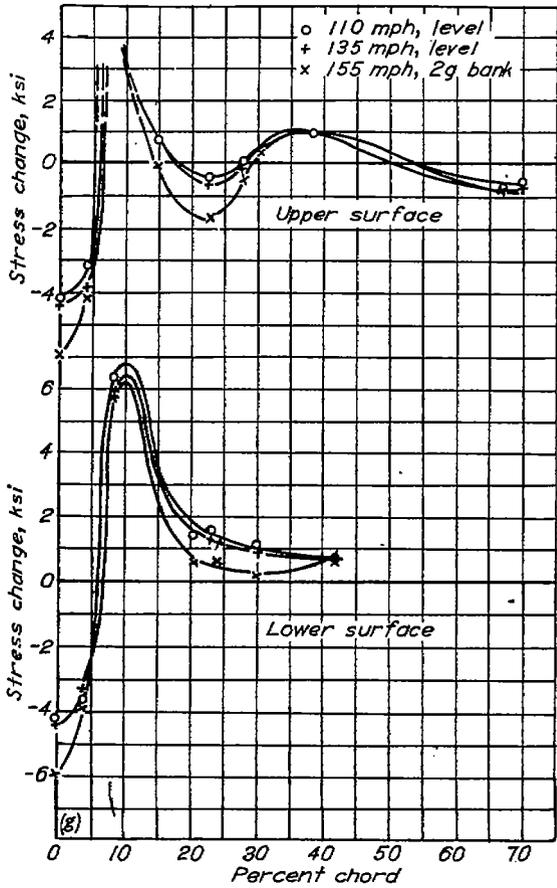
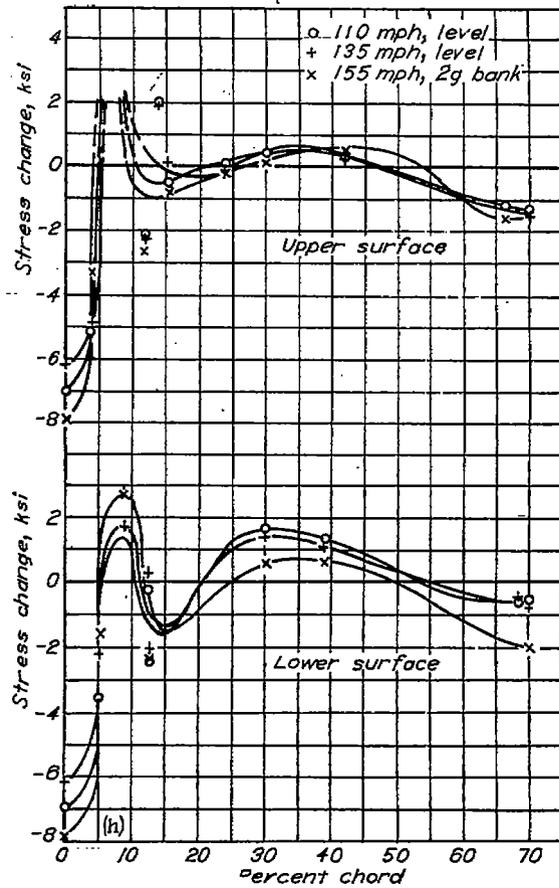
(a) Station 47, level flight, 110 mph.  
 (c) Station 47, 2g bank, 165 to 185 mph.

FIGURE 40.—Chordwise distribution of stress change in the wing resulting from operation of the thermal ice-prevention system.

(e) Station 137, level flight, 135 mph.
