RESEARCH MEMORANDUM

FACTORS THAT AFFECT OPERATIONAL RELIABILITY OF TURBOJET ENGINES

By Lewis Laboratory Staff

WASHINGTON
January 31, 1956

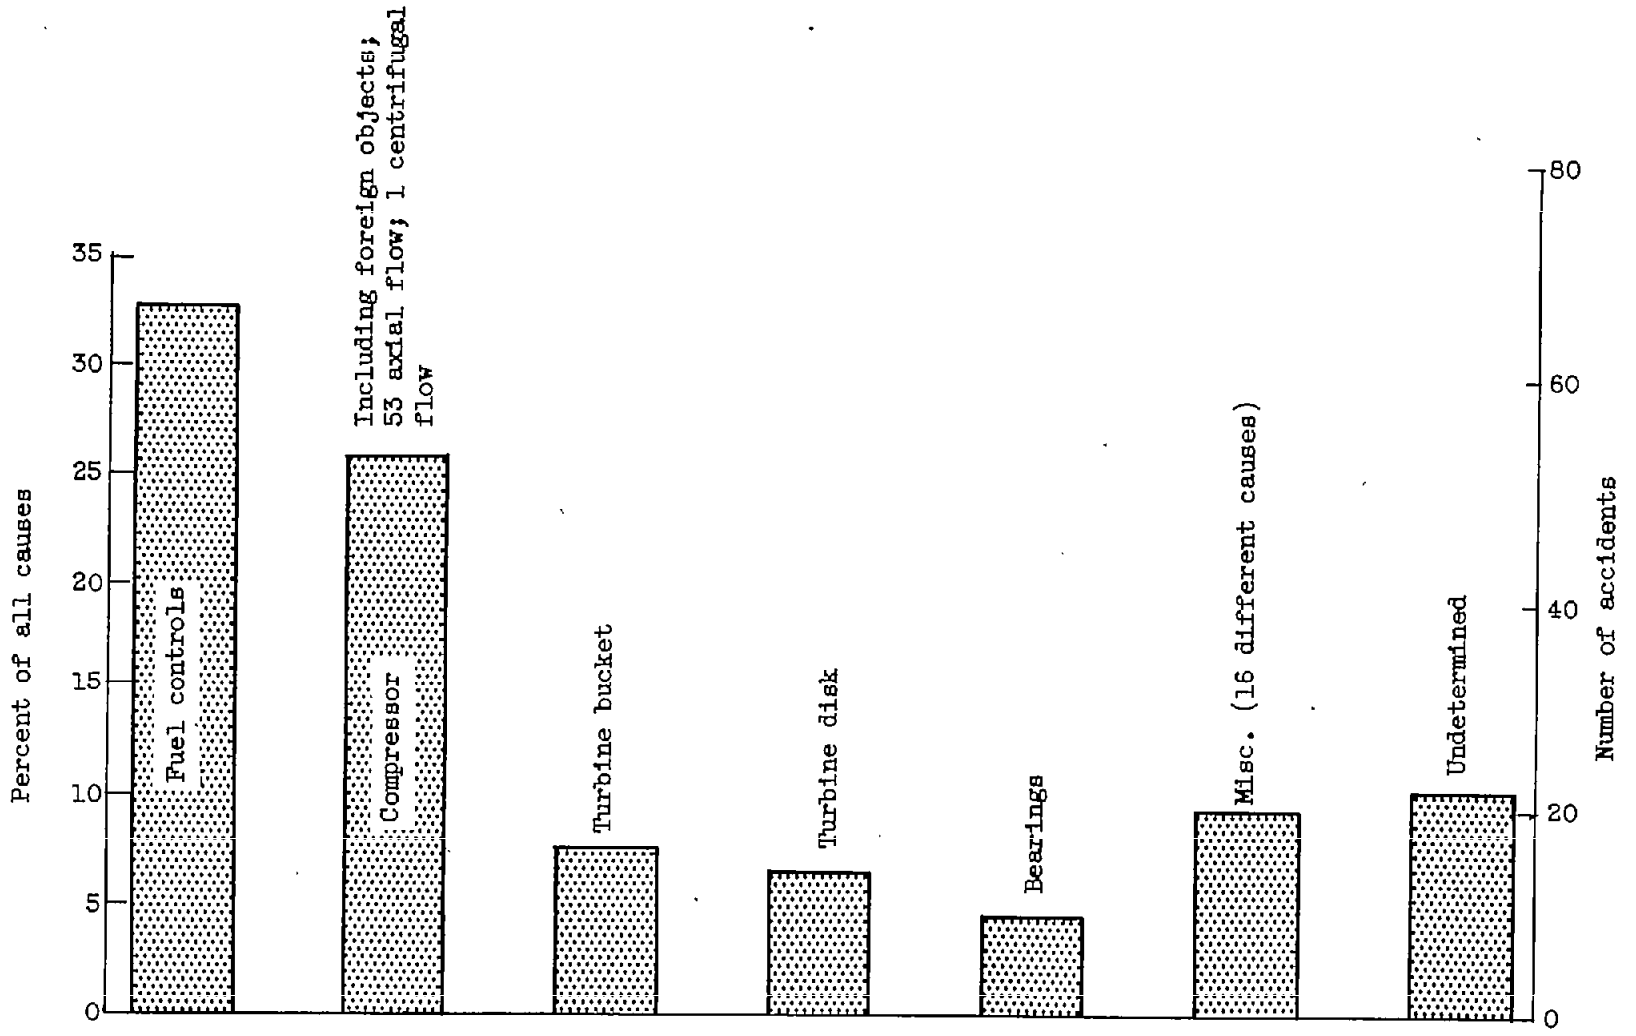
Figure 13. - Distribution of causes of engine failure or malfunction that resulted in 205 Air Force jet aircraft accidents during 1953 (ref. 4). (Aircraft destroyed in about half the accidents resulting from each cause.)

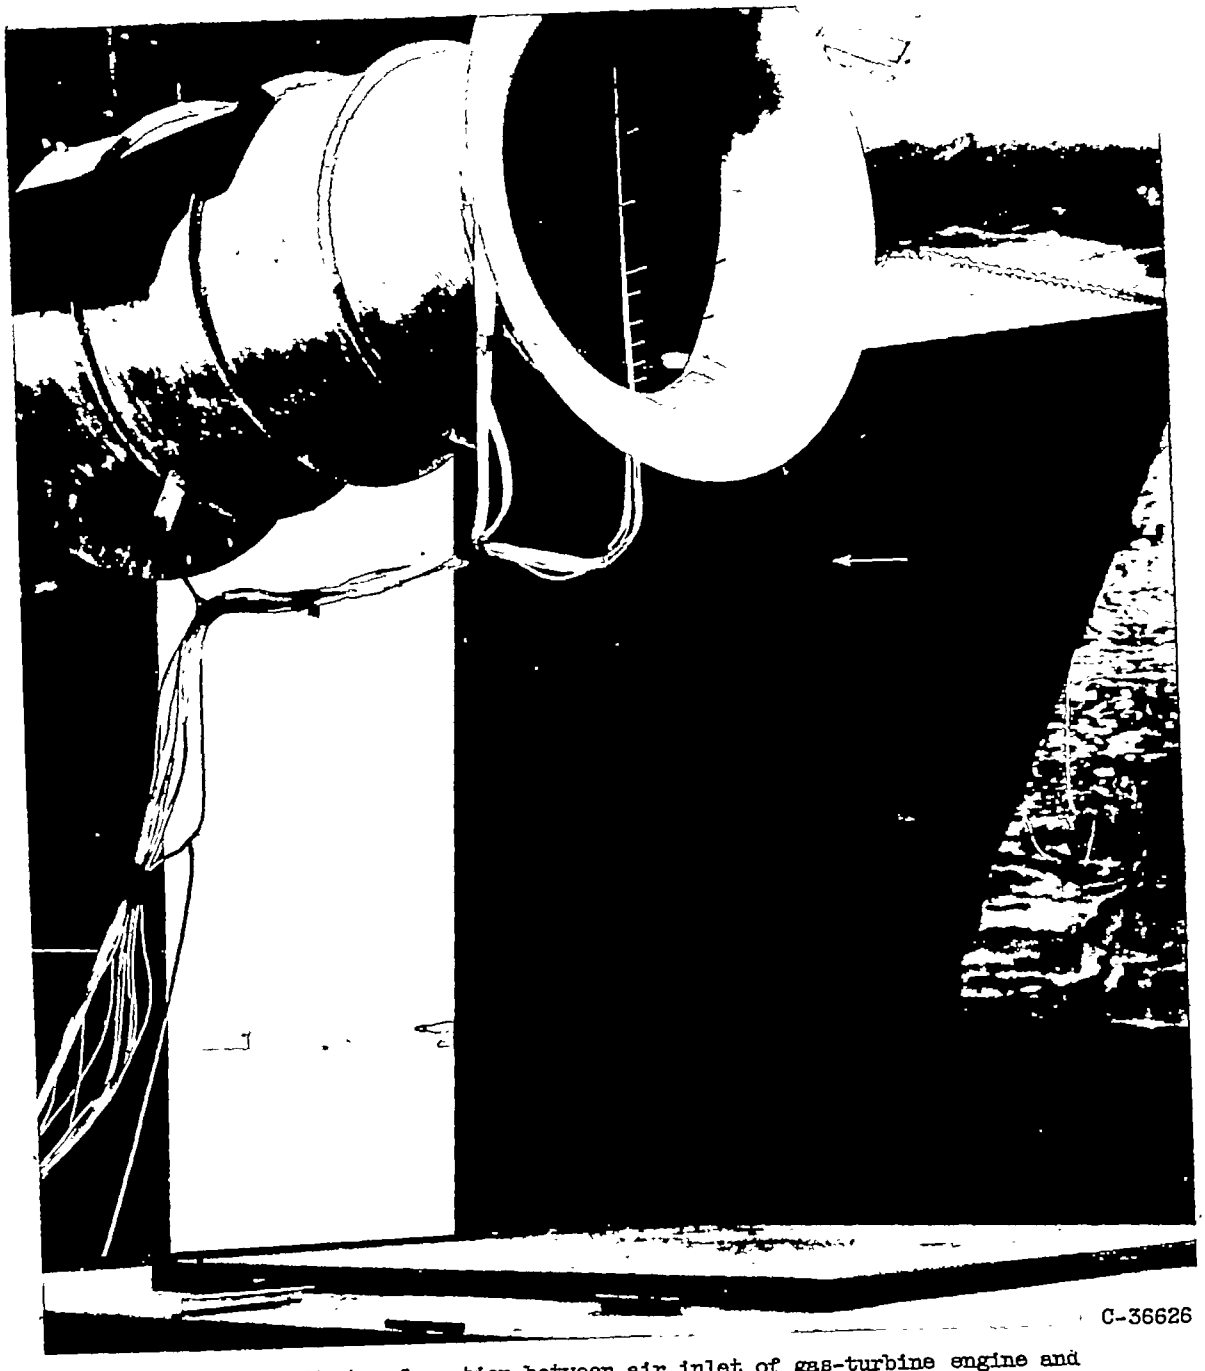
Figure 1. - Vortex formation between air inlet of gas-turbine engine and adjacent plane surface.

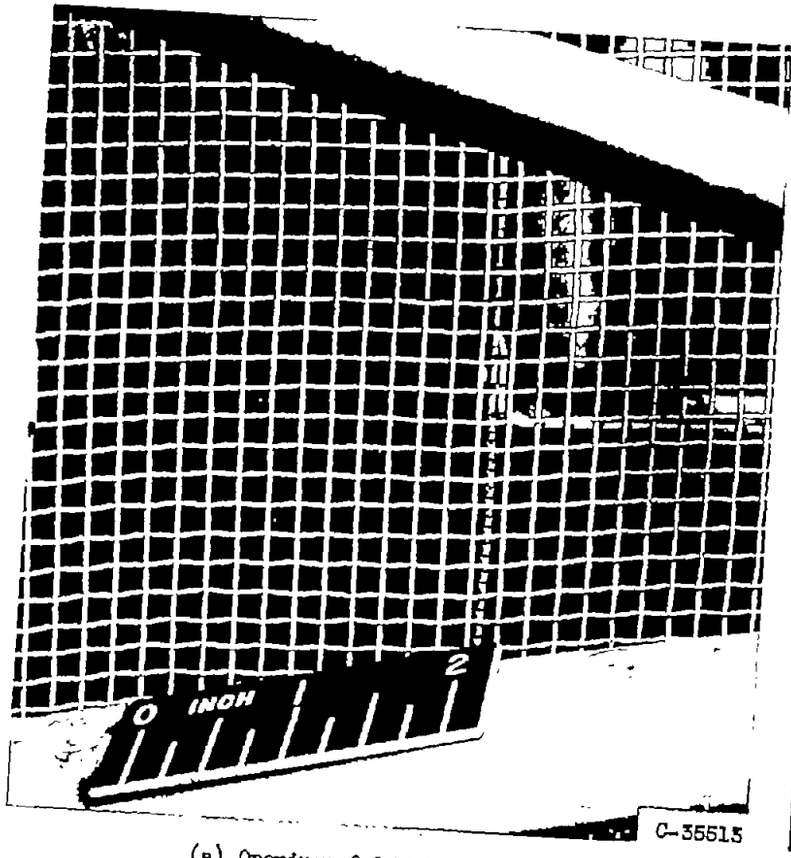
Number of engines	Engine	Screen installation	Percent of engines damaged
239	C-1 to -4	Fixed, 0.034-inch wire diameter spaced 0.166 inch on center giving 0.132-inch-square openings (fig. 3(a))	36
487	C-5 to -7	Fixed, 0.034-inch wire diameter spaced 0.250 inch on centers giving 0.216-inch-square openings (fig. 3(b))	84

(a) Openings 0.132 inch square.

(b) Openings 0.216 inch square.

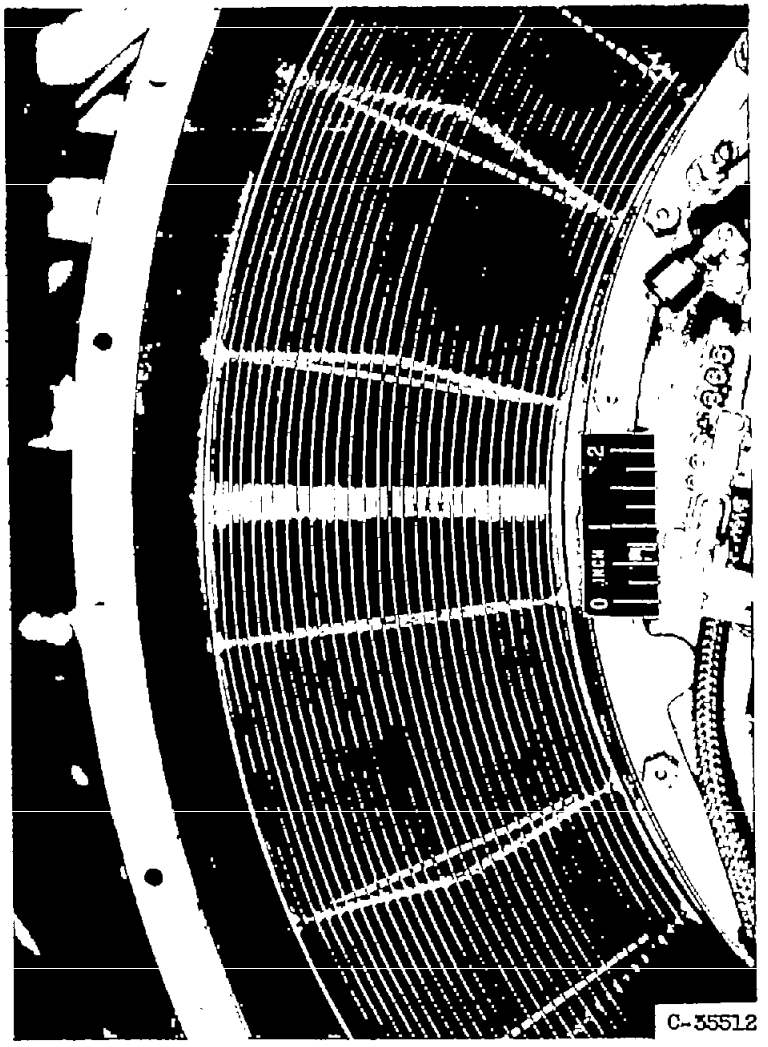
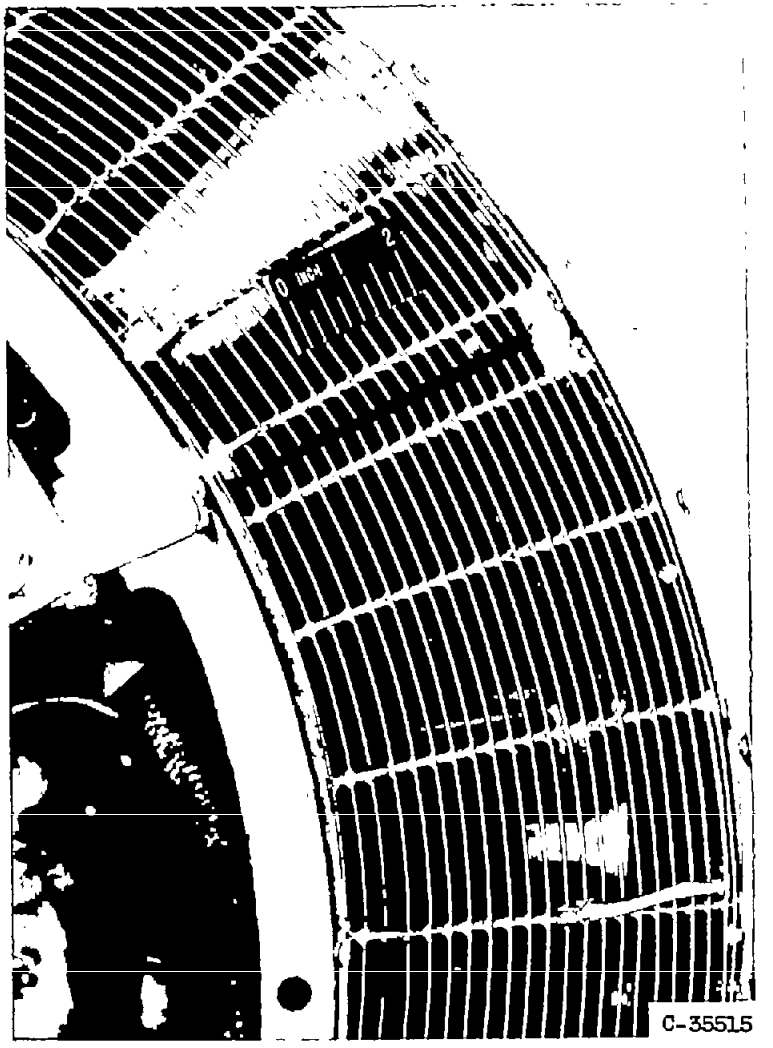
Figure 4. - Fixed inlet screens on early axial-flow engines.

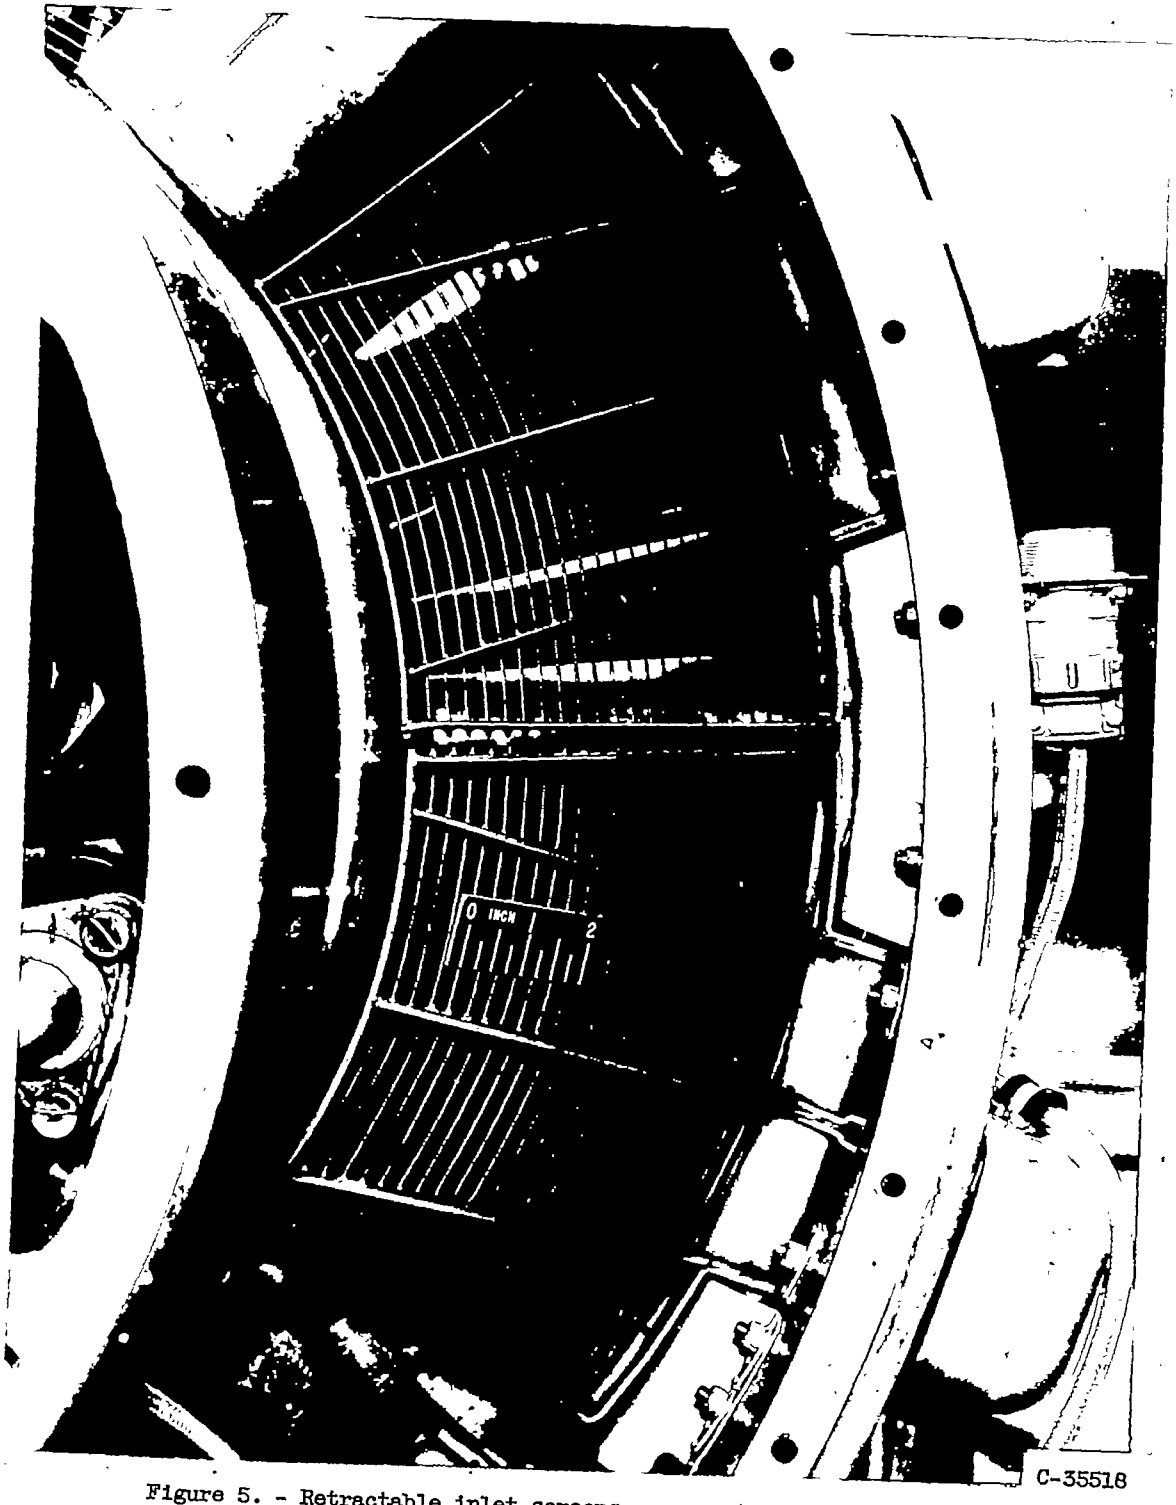
Figure 5. - Retractable inlet screens on recent axial-flow engine.

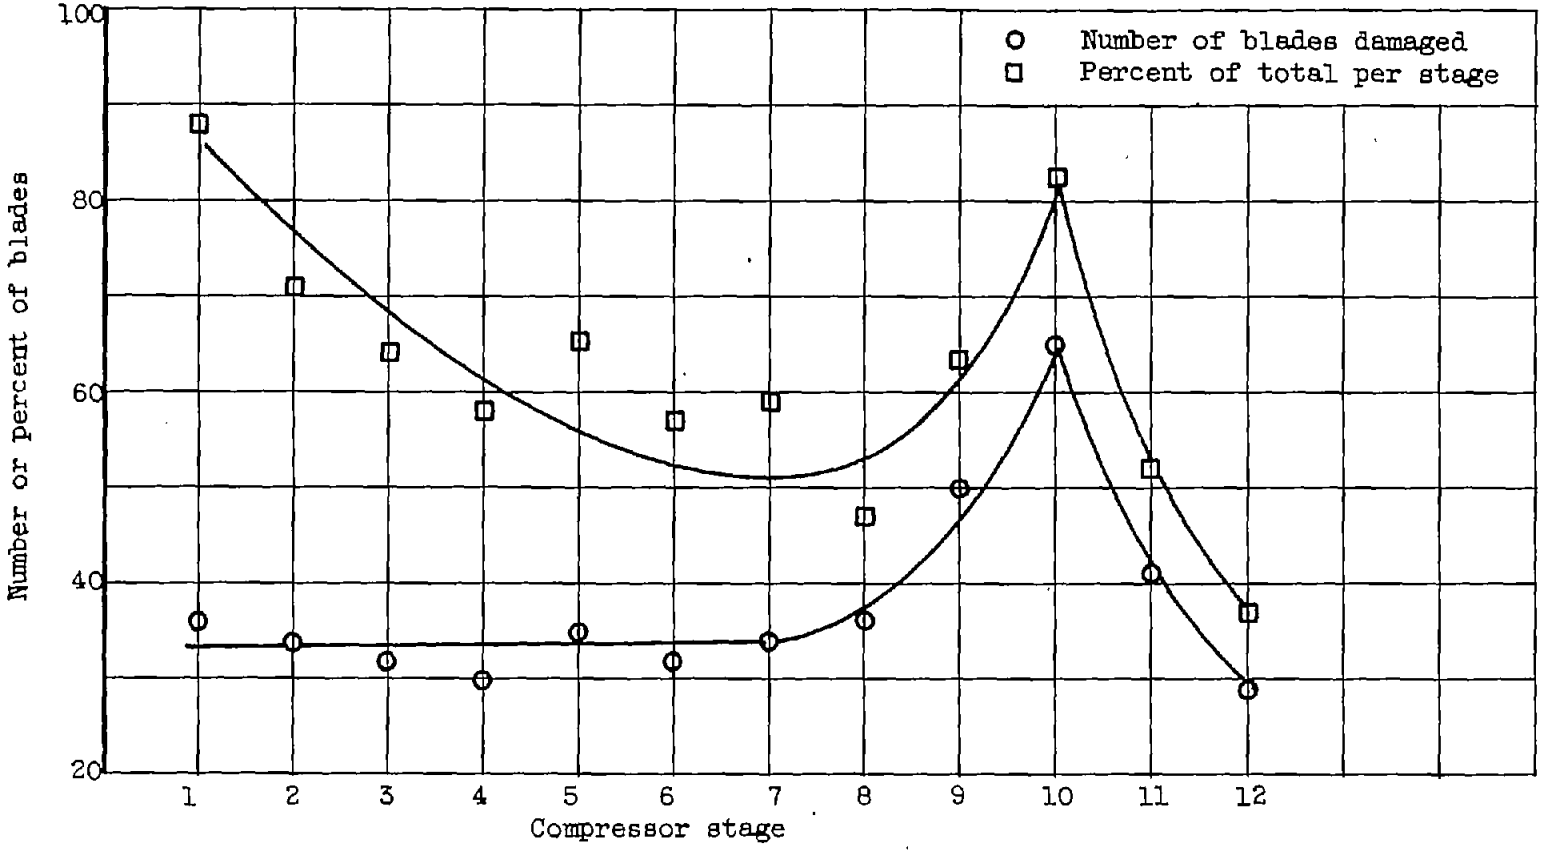
Figure 8. - Number of blades damaged by foreign object in typical axial-flow compressor.

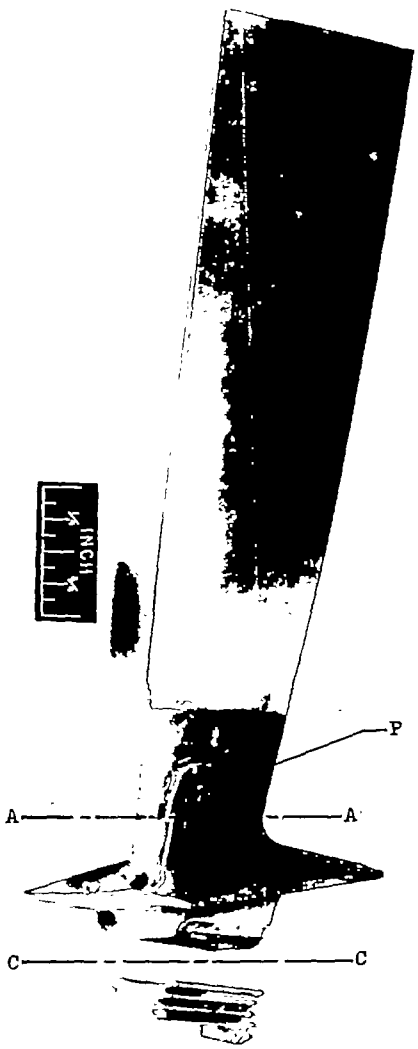
(a) Failed blade.

(b) Cross section AA from (a).

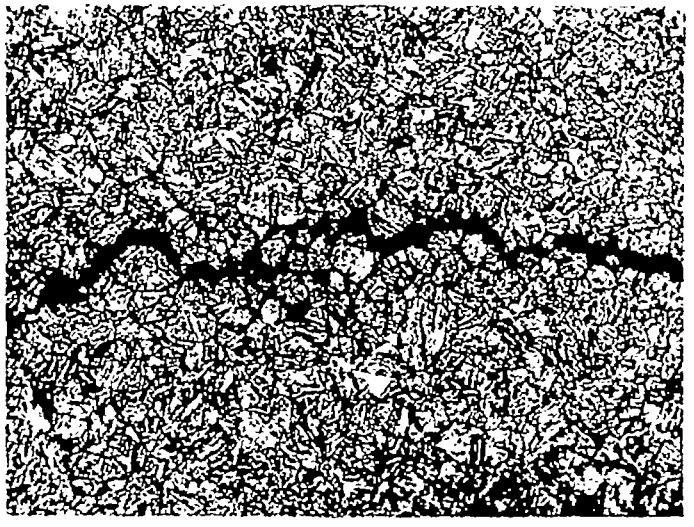
Figure 12. - Typical blade cracked by stress corrosion.

Stress-corrosion cracks

(a) Location of cracks.

(b) Photomicrograph of crack.

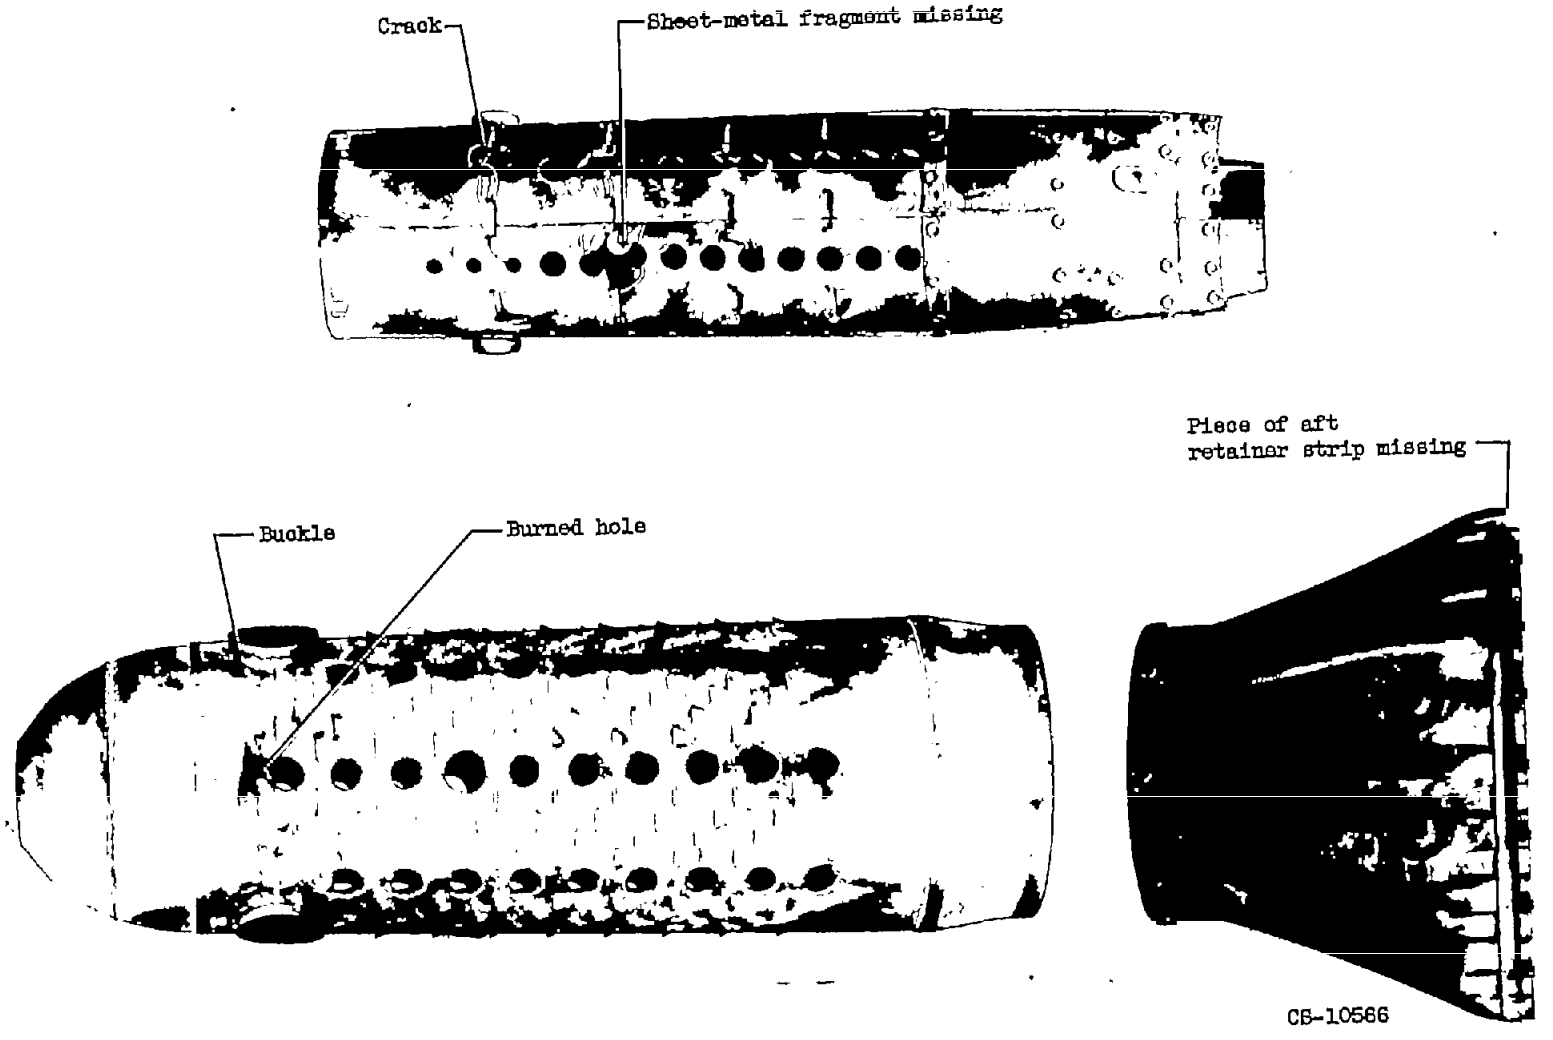
Figure 4. - Typical failures in turbojet liners.

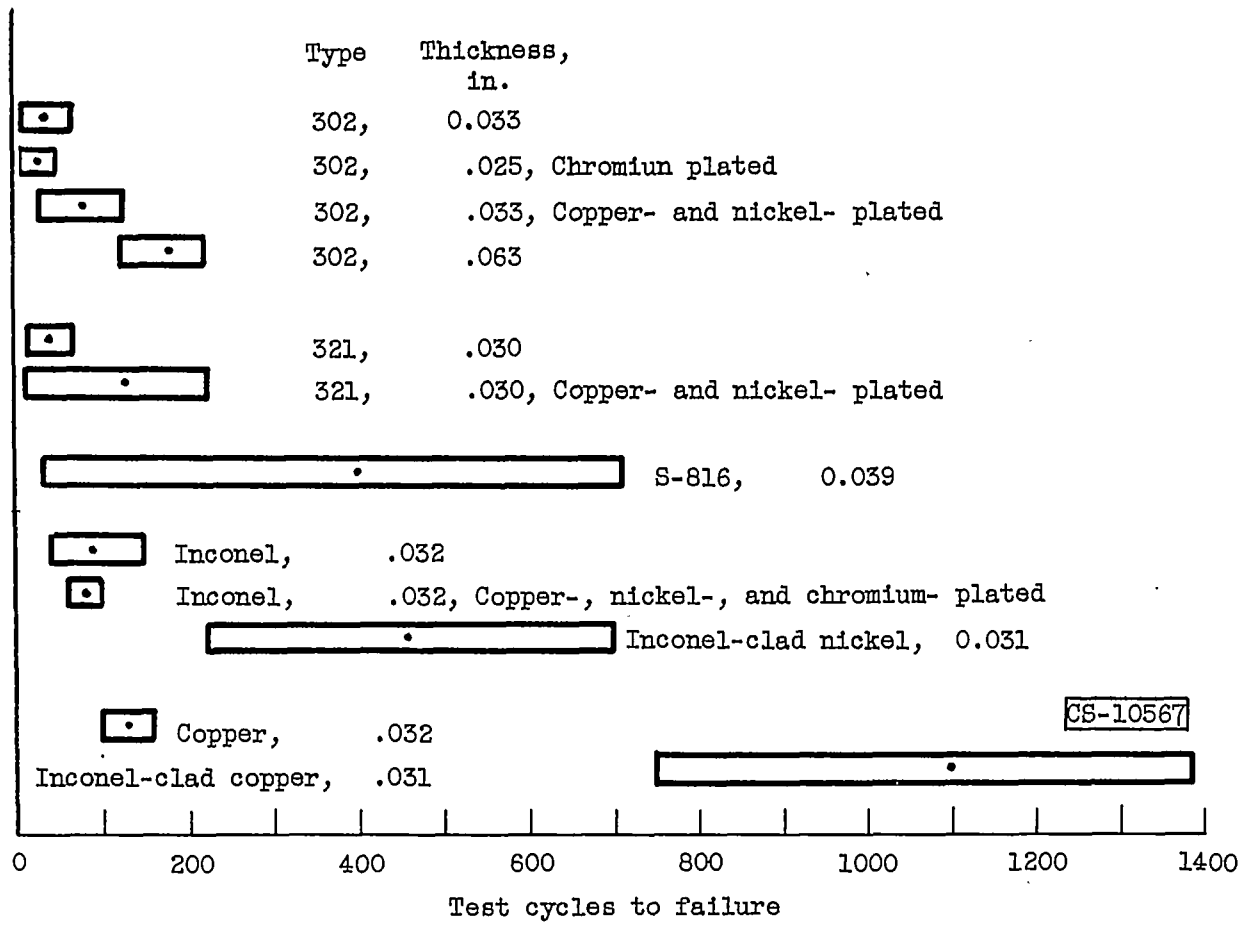
Figure 8. - Fracture due to repeated flame impingement. (Dot indicates average number of cycles for specimens of each material.)

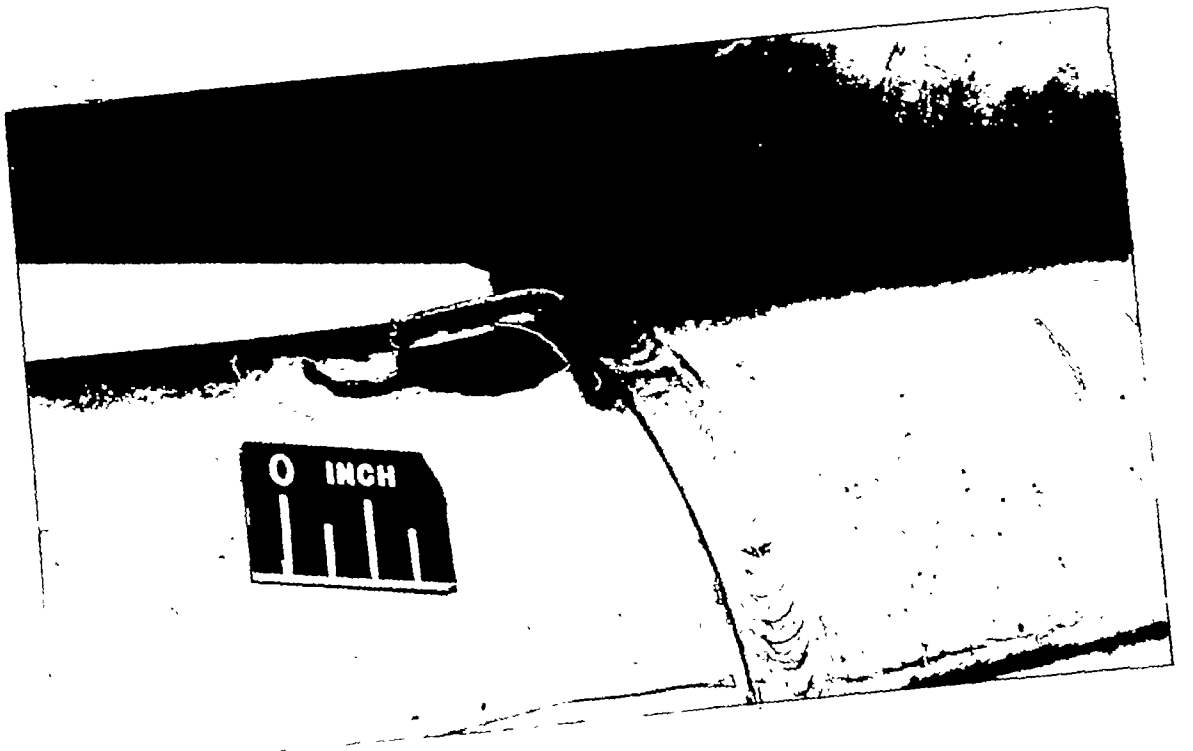
Figure 9. - Failure and patch in outer combustion chamber.

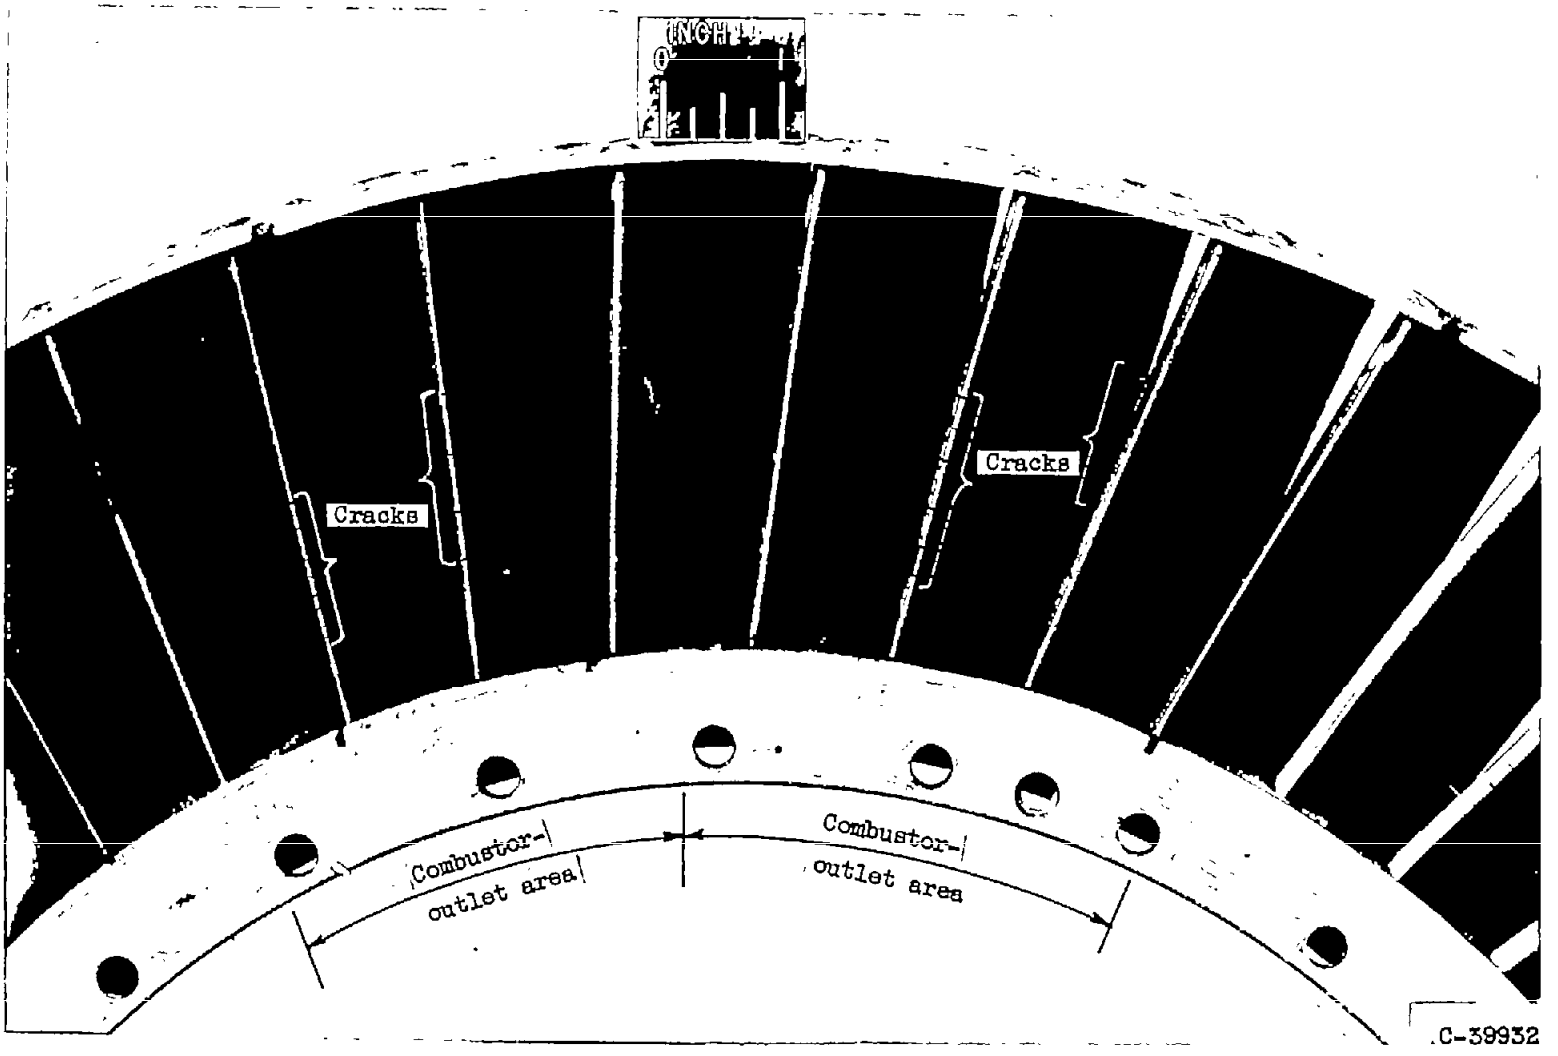
(a) Upstream edges.

Figure 3. - Nozzle diaphragm showing cracks on edges of vanes (ref. 9).

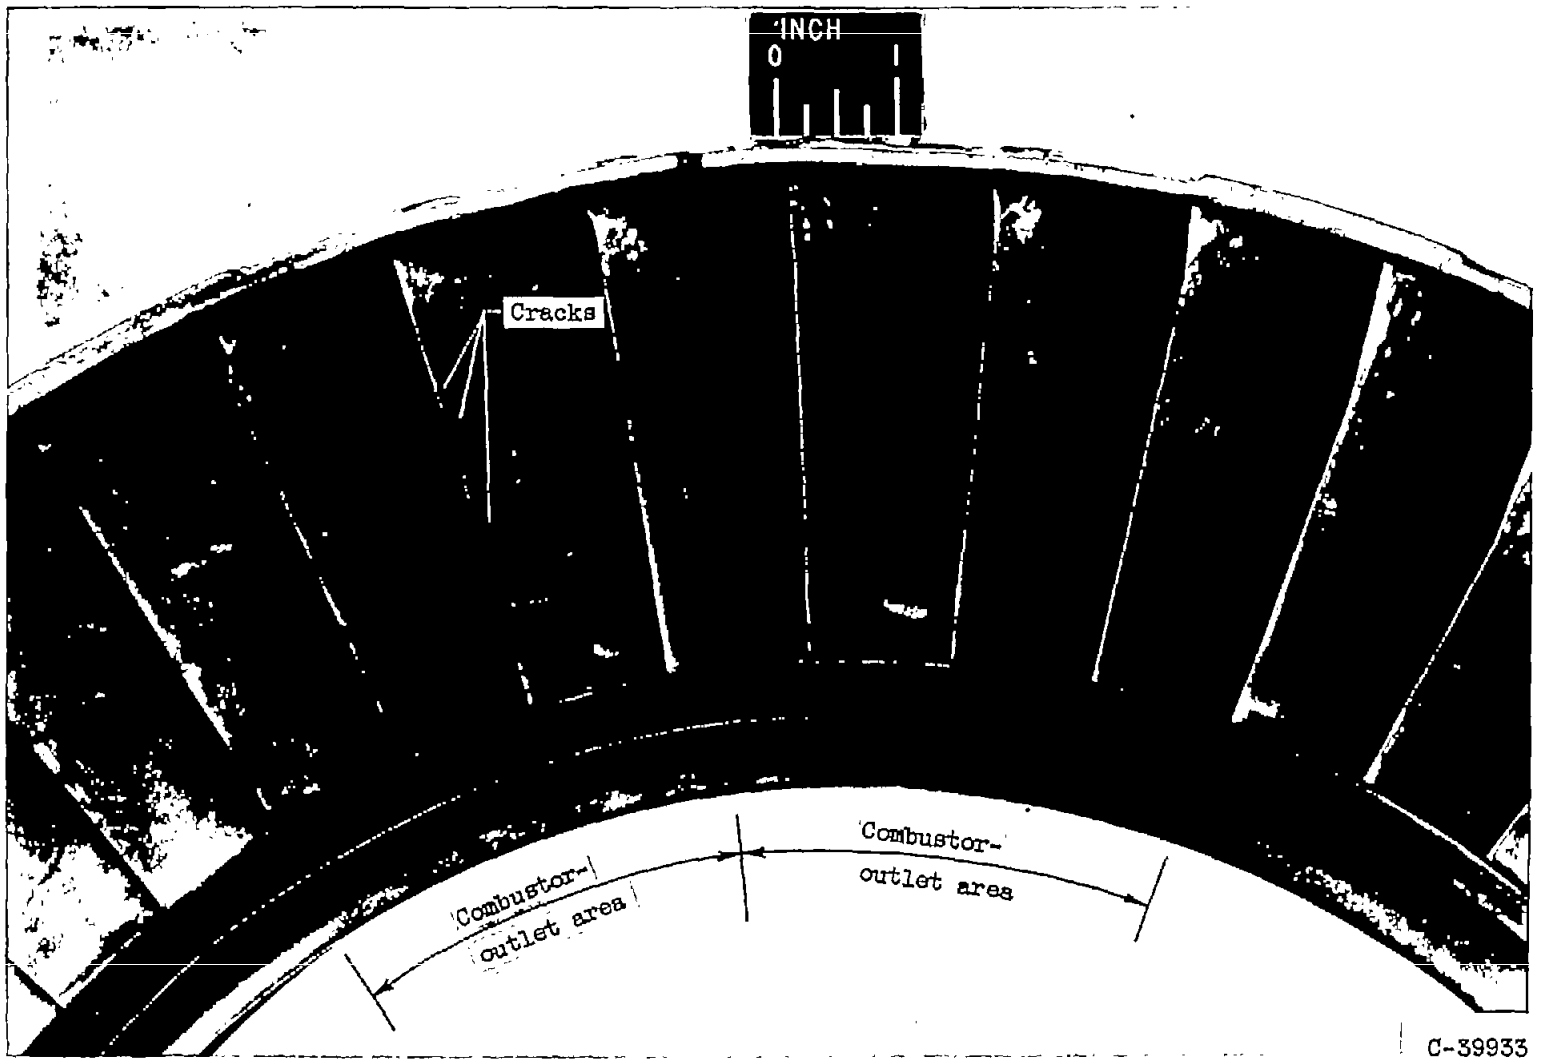
(b) Downstream edges.

Figure 3. - Concluded. Nozzle diaphragm showing cracks on edges of vanes (ref. 9).

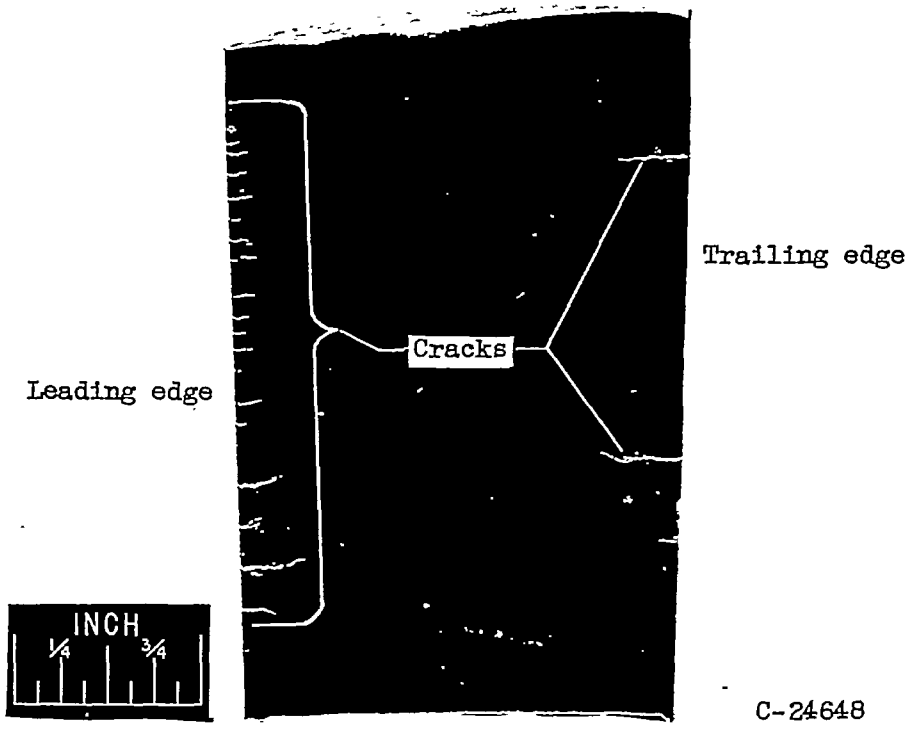
Figure 4. - Typical cracks in nozzle-diaphragm vane after 319 cycles (ref. 9).

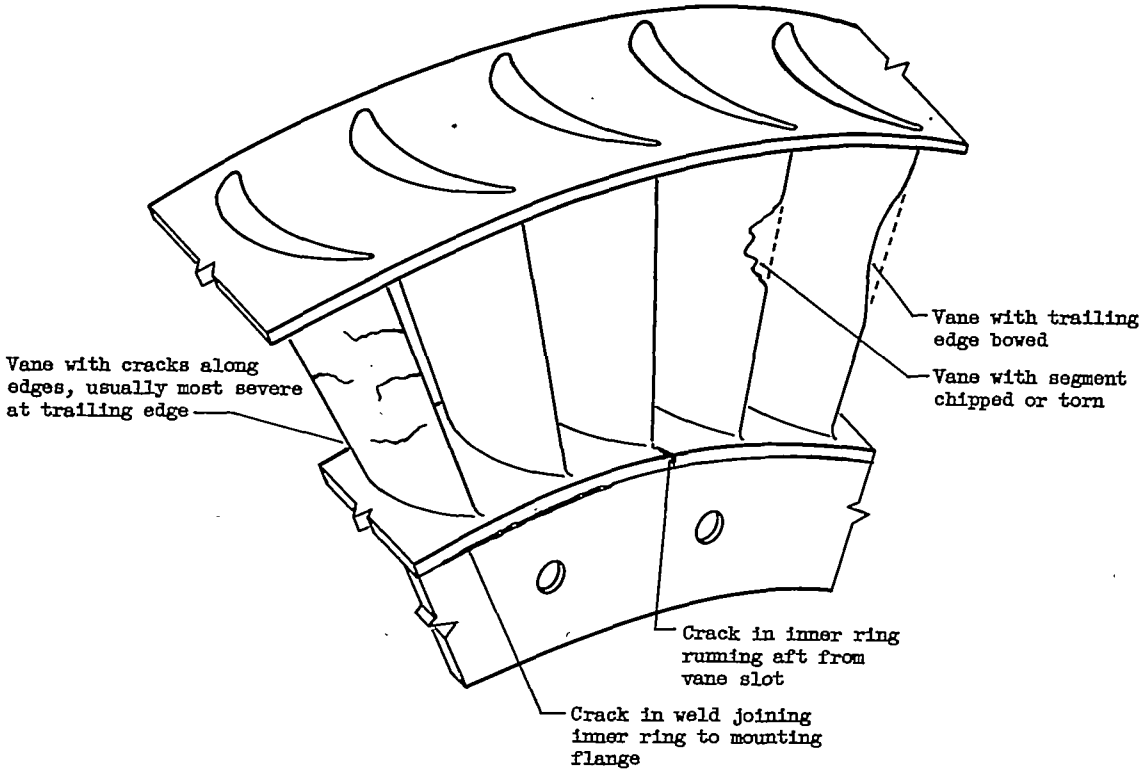
Plan view of hollow vane "ballooned" from original contour

Figure 6. - Types of damage most common to nozzle diaphragms.

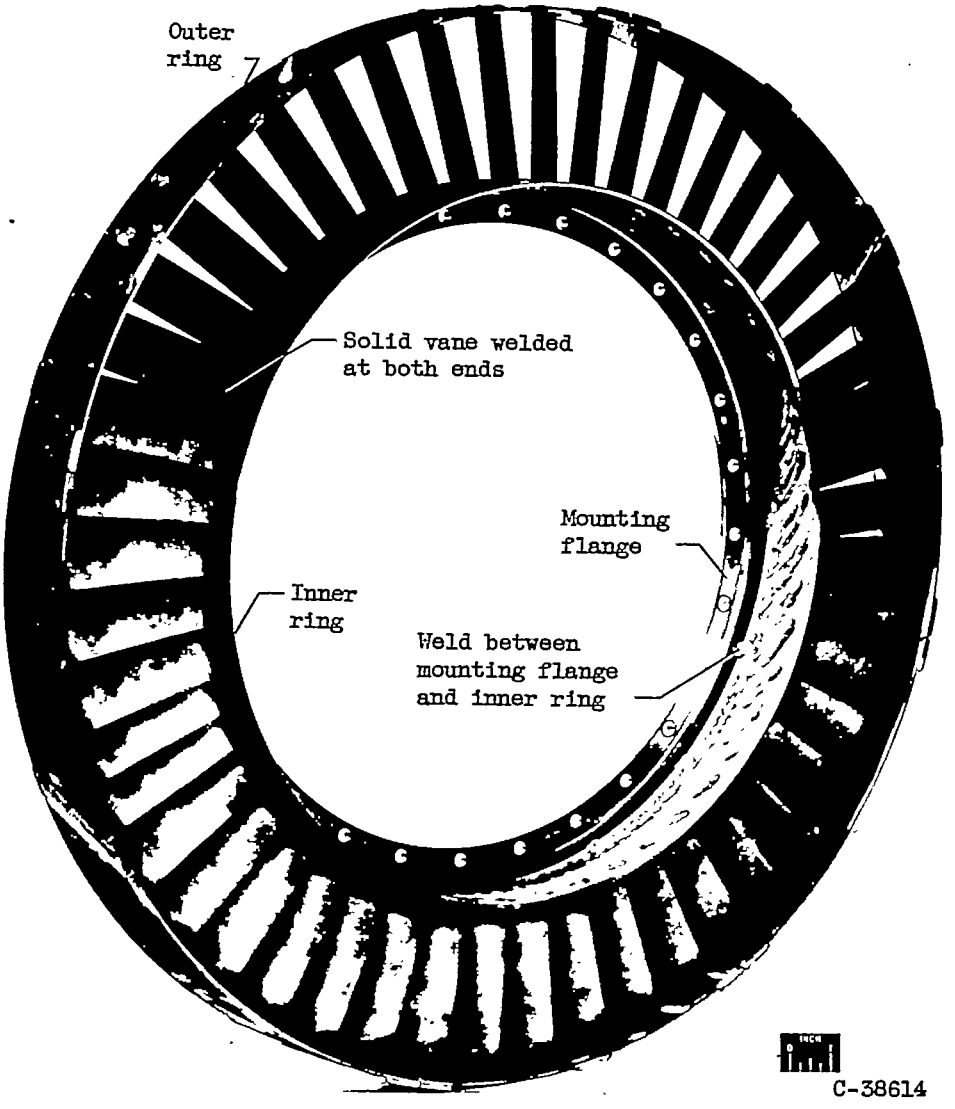
(a) From early engine.

Figure 14. - Nozzle diaphragm.

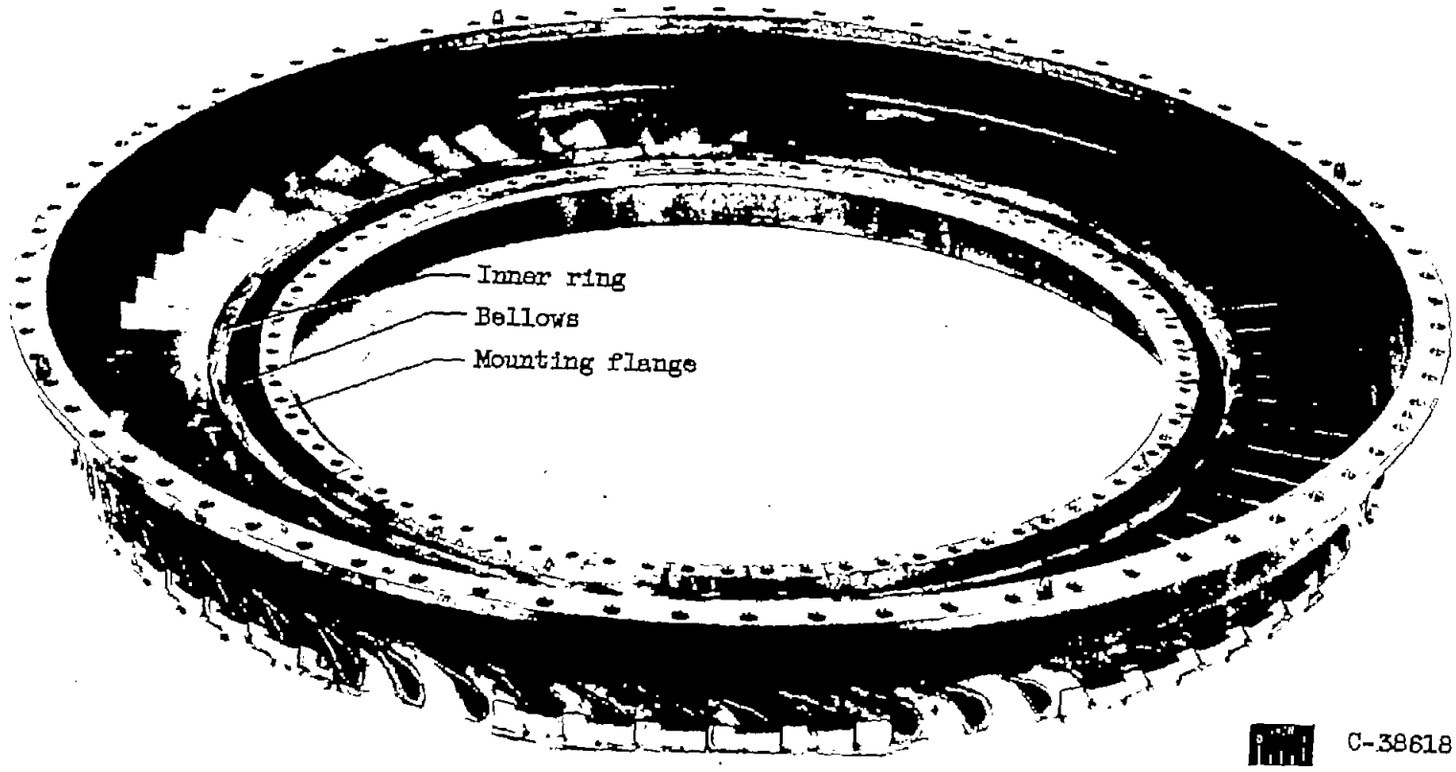
(b) From later engine.

Figure 14. - Concluded. Nozzle diaphragm.

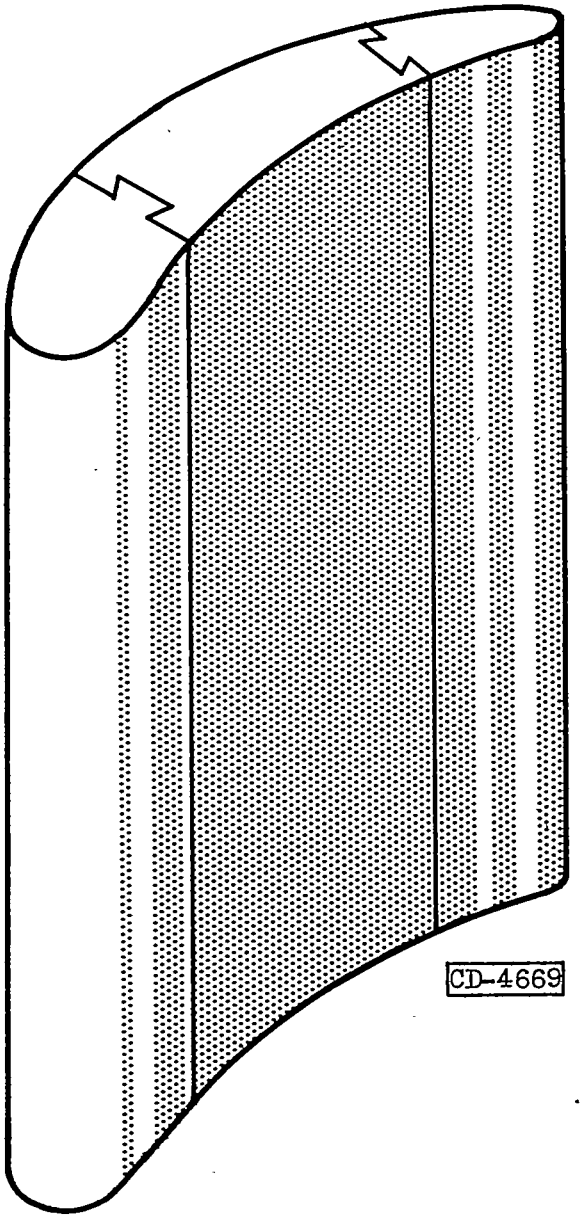
Figure 15. - Example of vane segmentation.

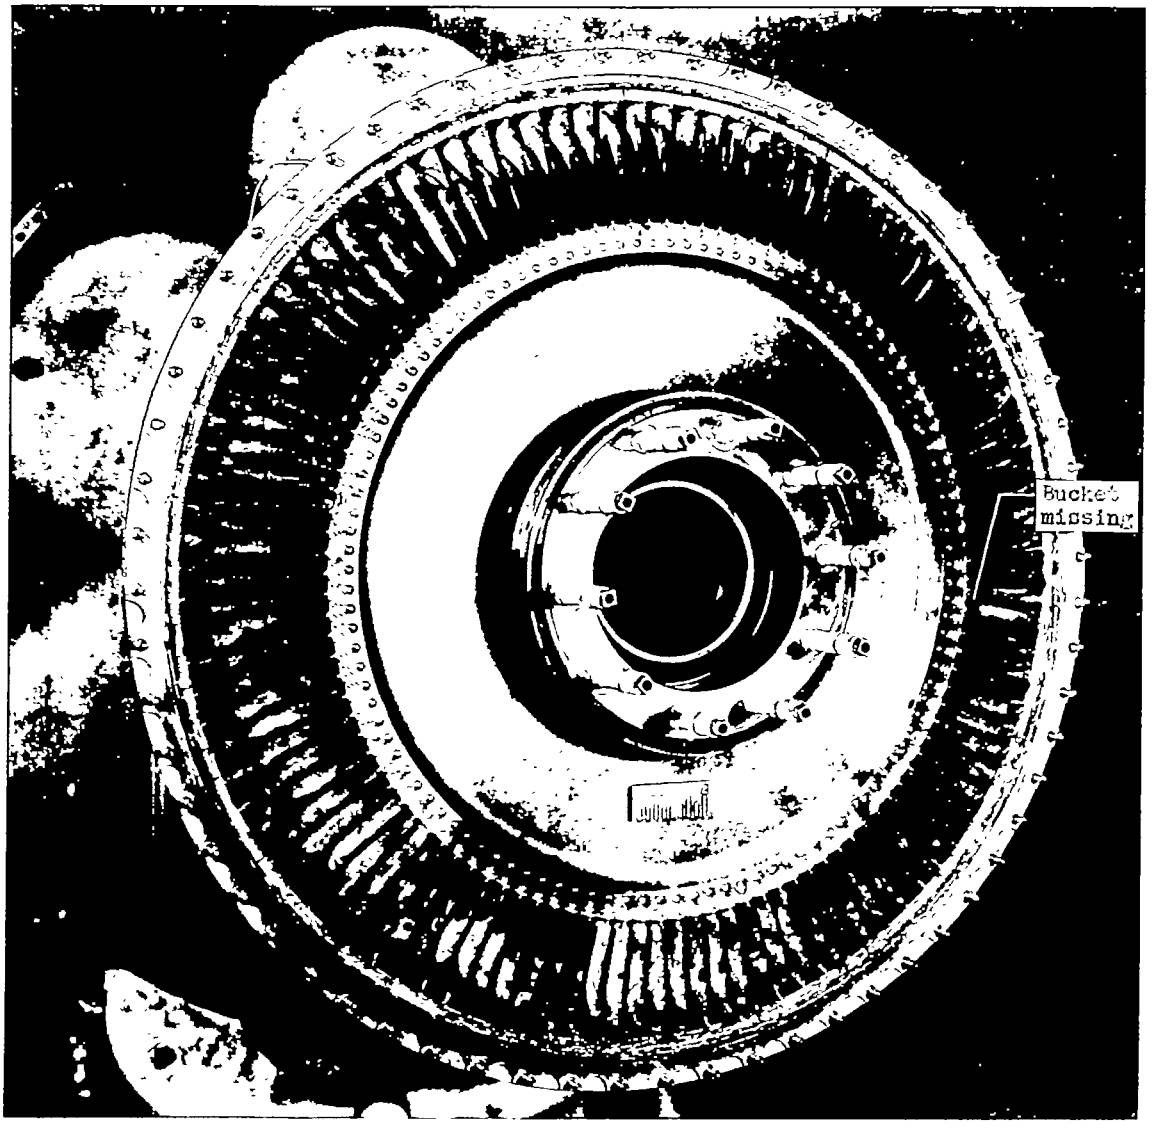
(a) Second stage of turbine; all bucket shrouds gone.
