RESEARCH MEMORANDUM

FACTORS THAT AFFECT OPERATIONAL RELIABILITY OF TURBOJET ENGINES

By Lewis Laboratory Staff

WASHINGTON
January 31, 1956

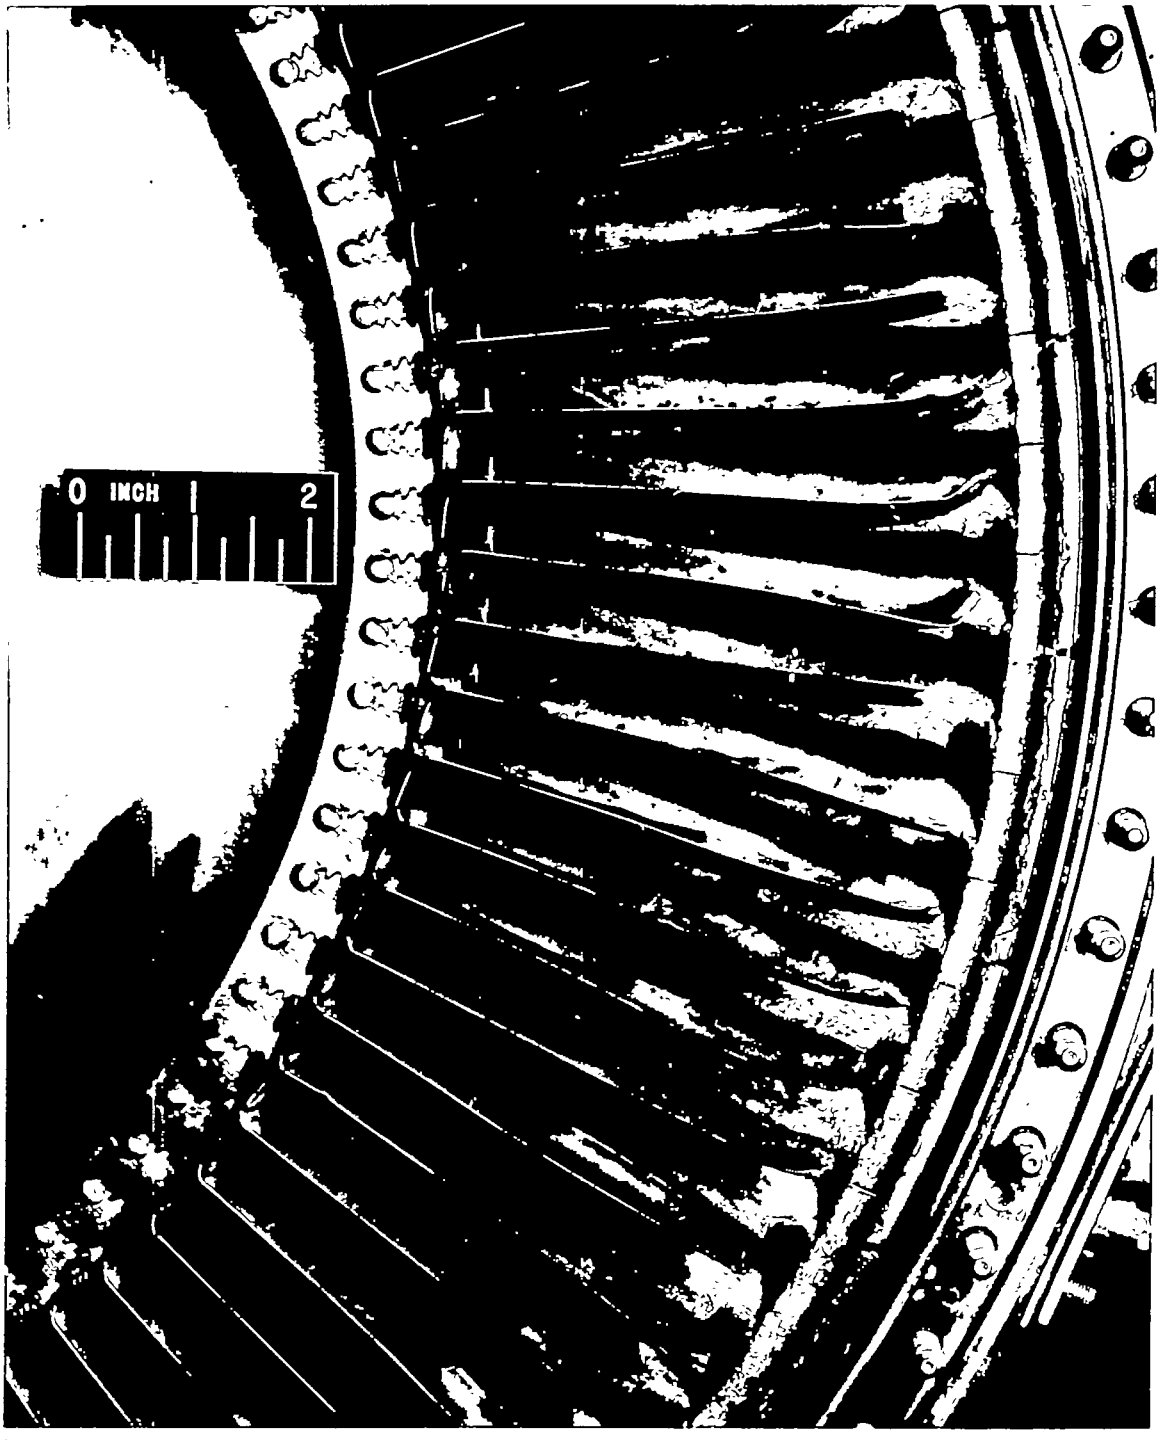
(c) Third stage of turbine; all bucket shrouds gone.

Figure 2. - Concluded. Damage to three-stage turbine resulting from failure of second-stage bucket.

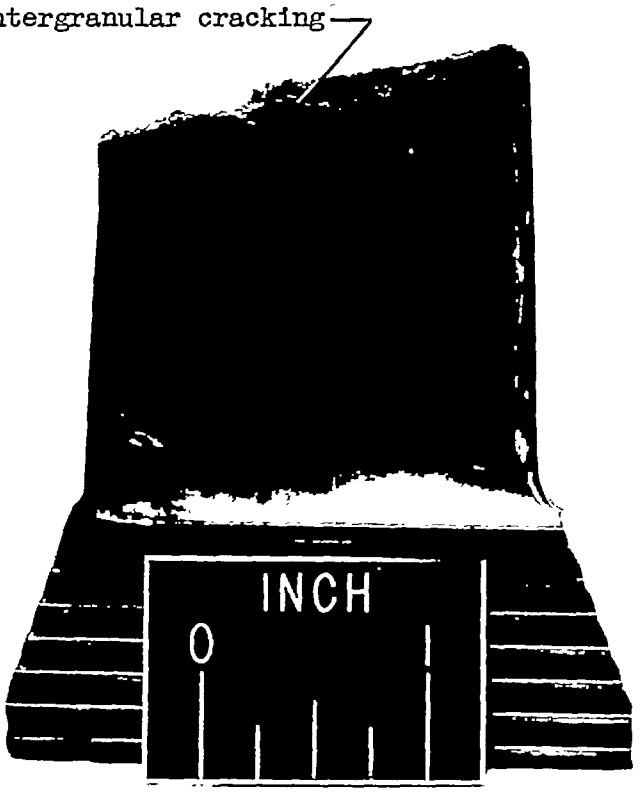
Figure 6. - Typical stress-rupture fracture.

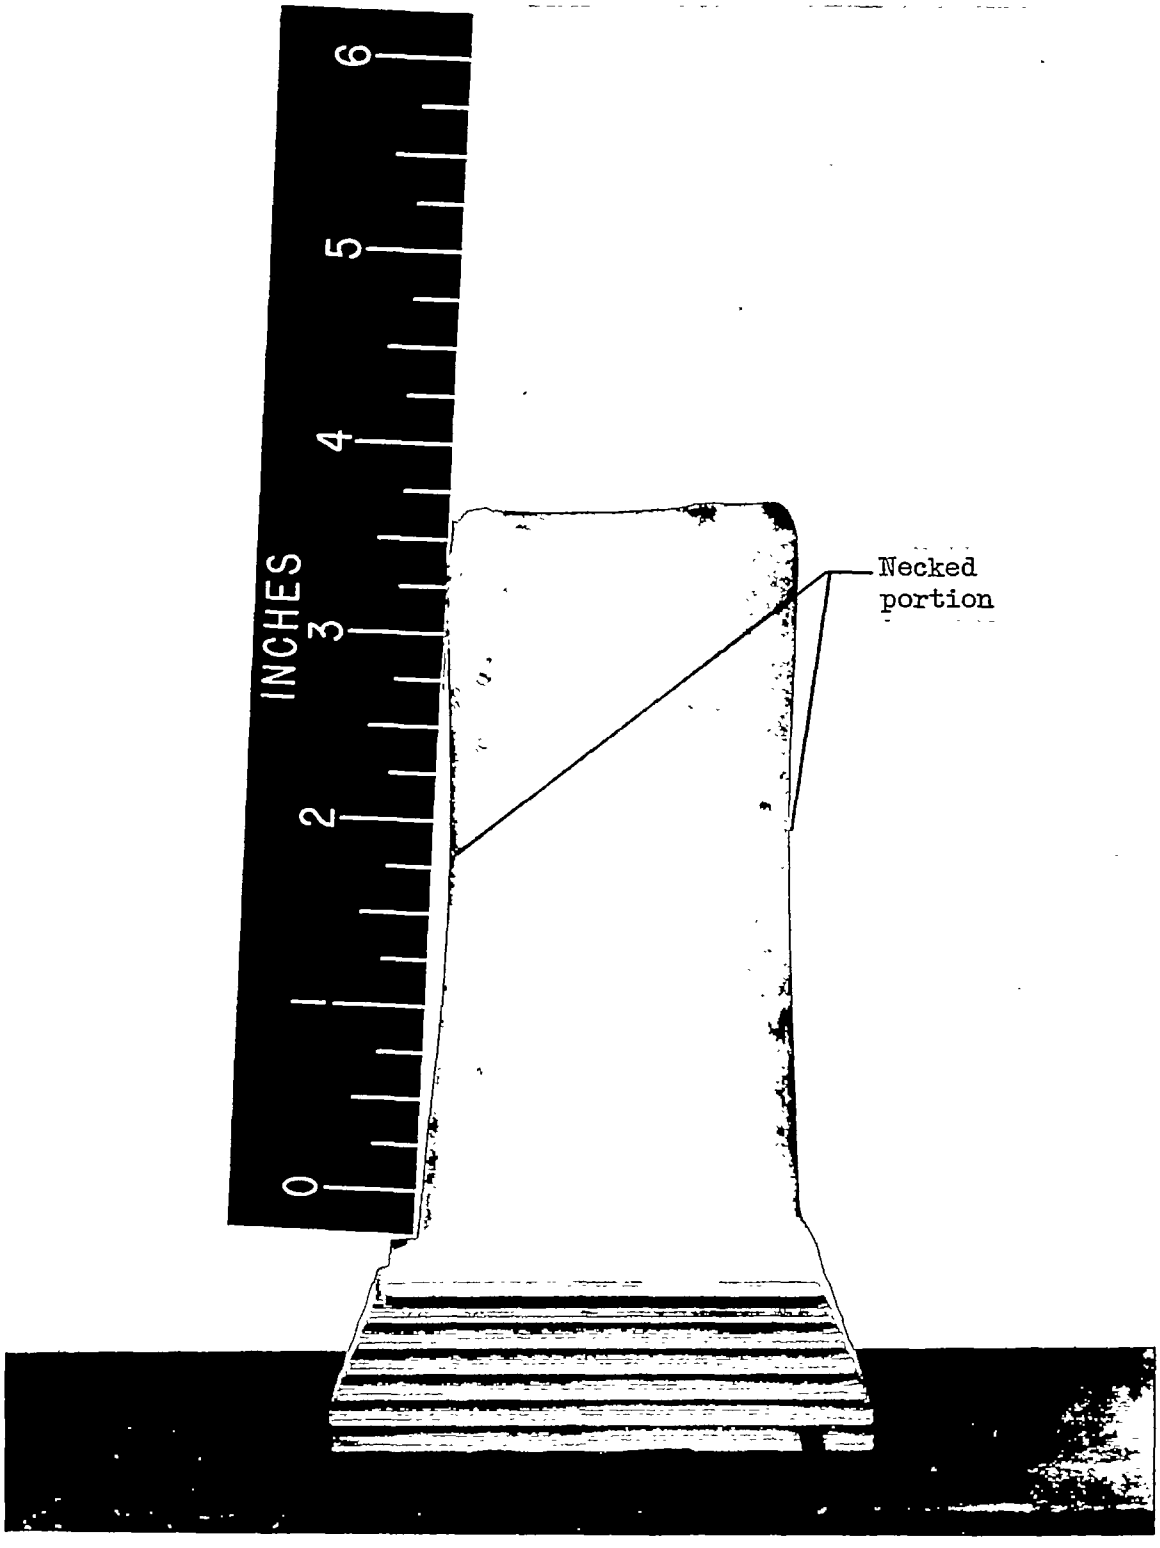
Figure 11. - Necked bucket.

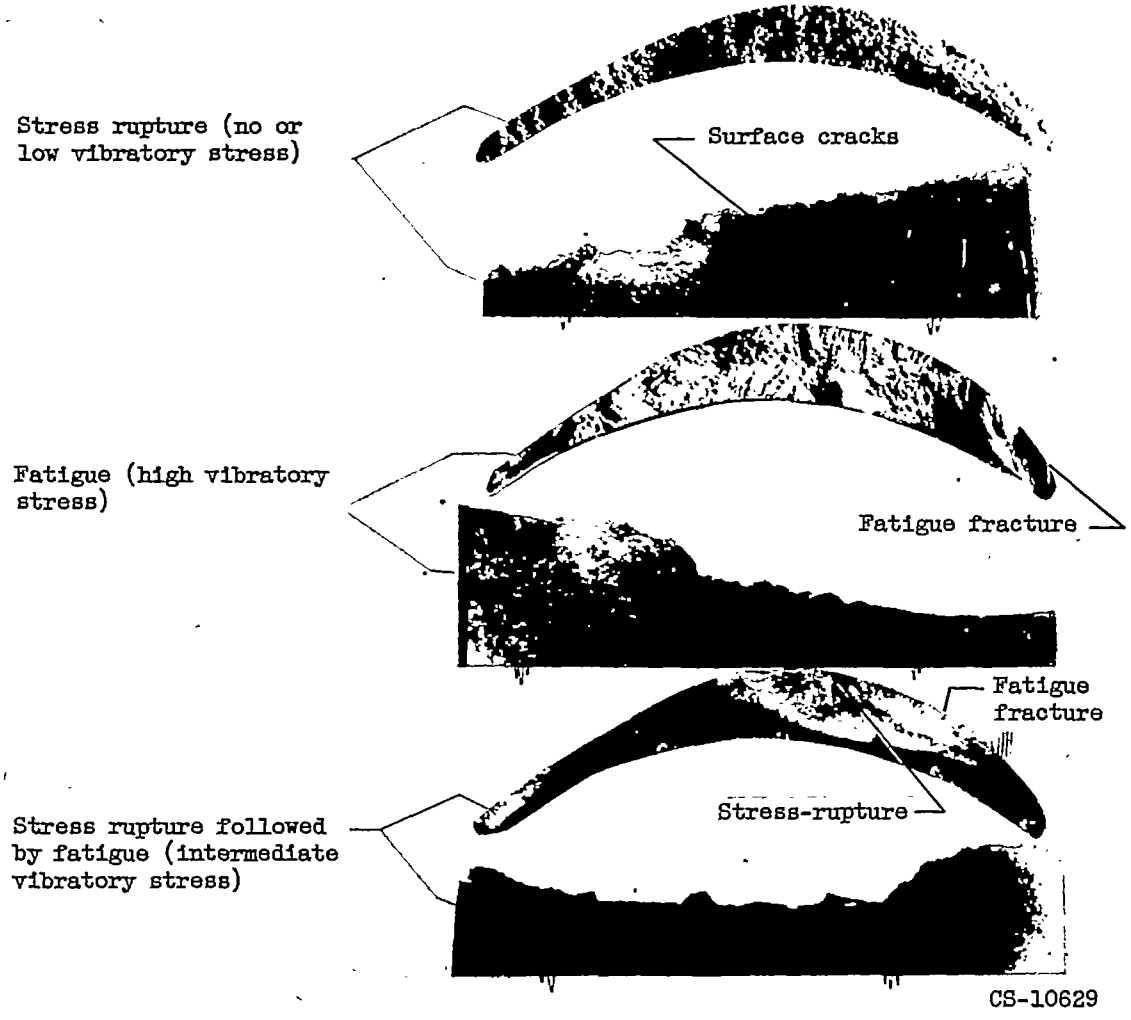
When vibratory stress is superimposed on the centrifugal stress the appearance of the fractures is dependent upon the magnitude of the vibratory stress relative to the mean tensile stress. This dependency is shown in figure 20. If vibratory stress is high relative to mean tensile stress, the fracture shows typical fatigue characteristics, a smooth transgranular area on the fracture surface and no additional cracks on the airfoil surface near the point where the failure started. With no vibratory stress, the specimens, of course, have only stress-rupture failure characteristics. With small amounts of vibratory stress the fracture may have characteristics of only stress-rupture, or only fatigue, or a combination depending on the alloy composition and the temperature (ref. 2). In fact, the vibratory stress can be high enough to cause an appreciable decrease in life over the life predicted on the basis of stress-rupture (mean stress) alone, without introducing any indications

Figure 20. - Typical bucket failures.

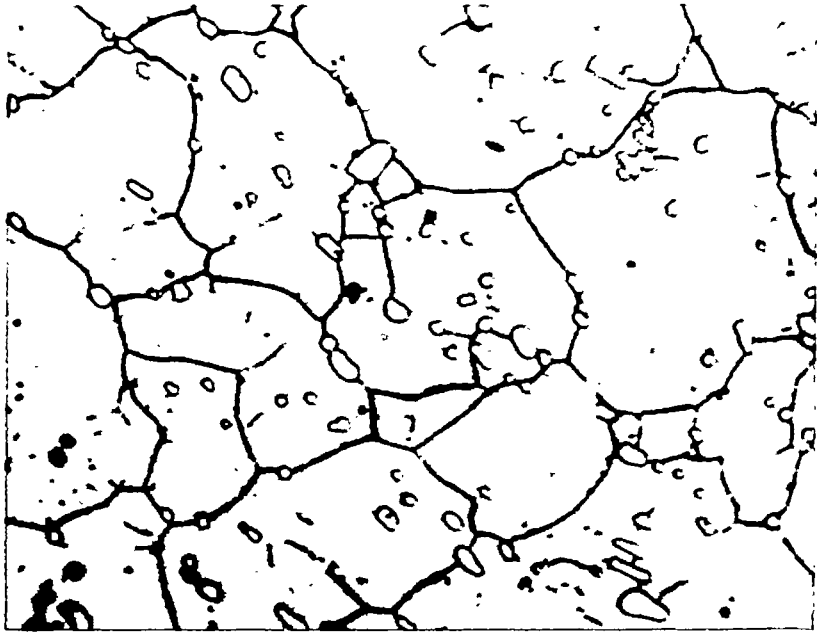
(a) Standard heat treatment: 1 hour at 2150° F, water-quench; 16 hours at 1400° F, air-cool.

Figure 25. - Effect of overtemperature on microstructure of S-816. X1000

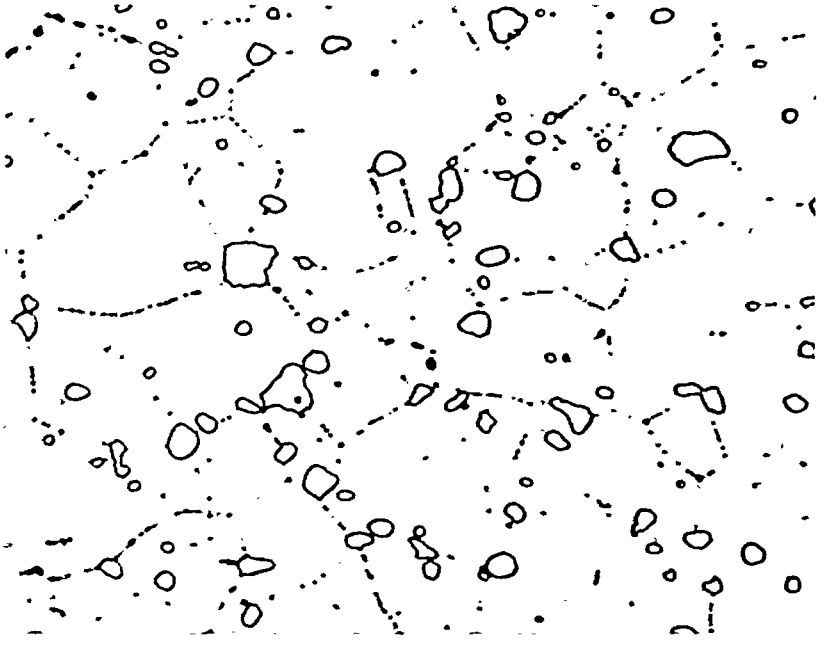
Overtemperature can be so severe as to melt or burn the buckets, or to cause warping, cracking, obvious stretch, or fracture. For some alloys, the occurrence of overtemperature causes changes in the microstructure. This is shown for overtemperatured S-816 in figure 25(b), which shows that grain boundary precipitates have been partially redissolved, compared with an undamaged structure in figure 25(a). Many buckets now being examined during overhaul show these indications. For some alloys, hardness is changed markedly by re-solution, and such a change may indicate damage.

(b) Severely overtemperatured (15 min at 2000° F) following standard heat treatment.

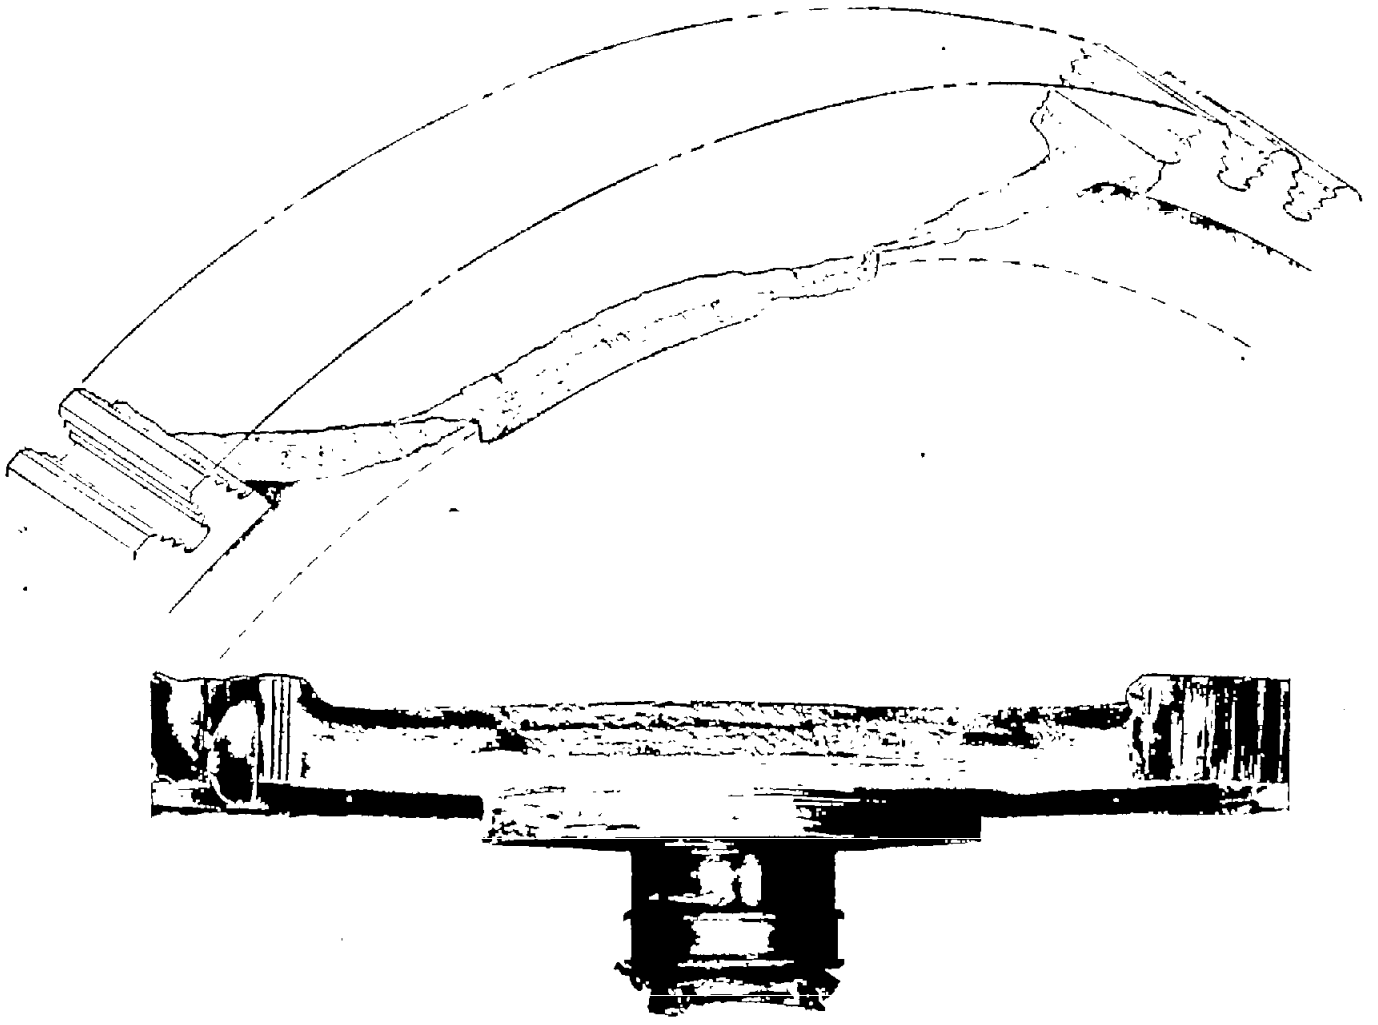
Figure 11. - Weld failure.

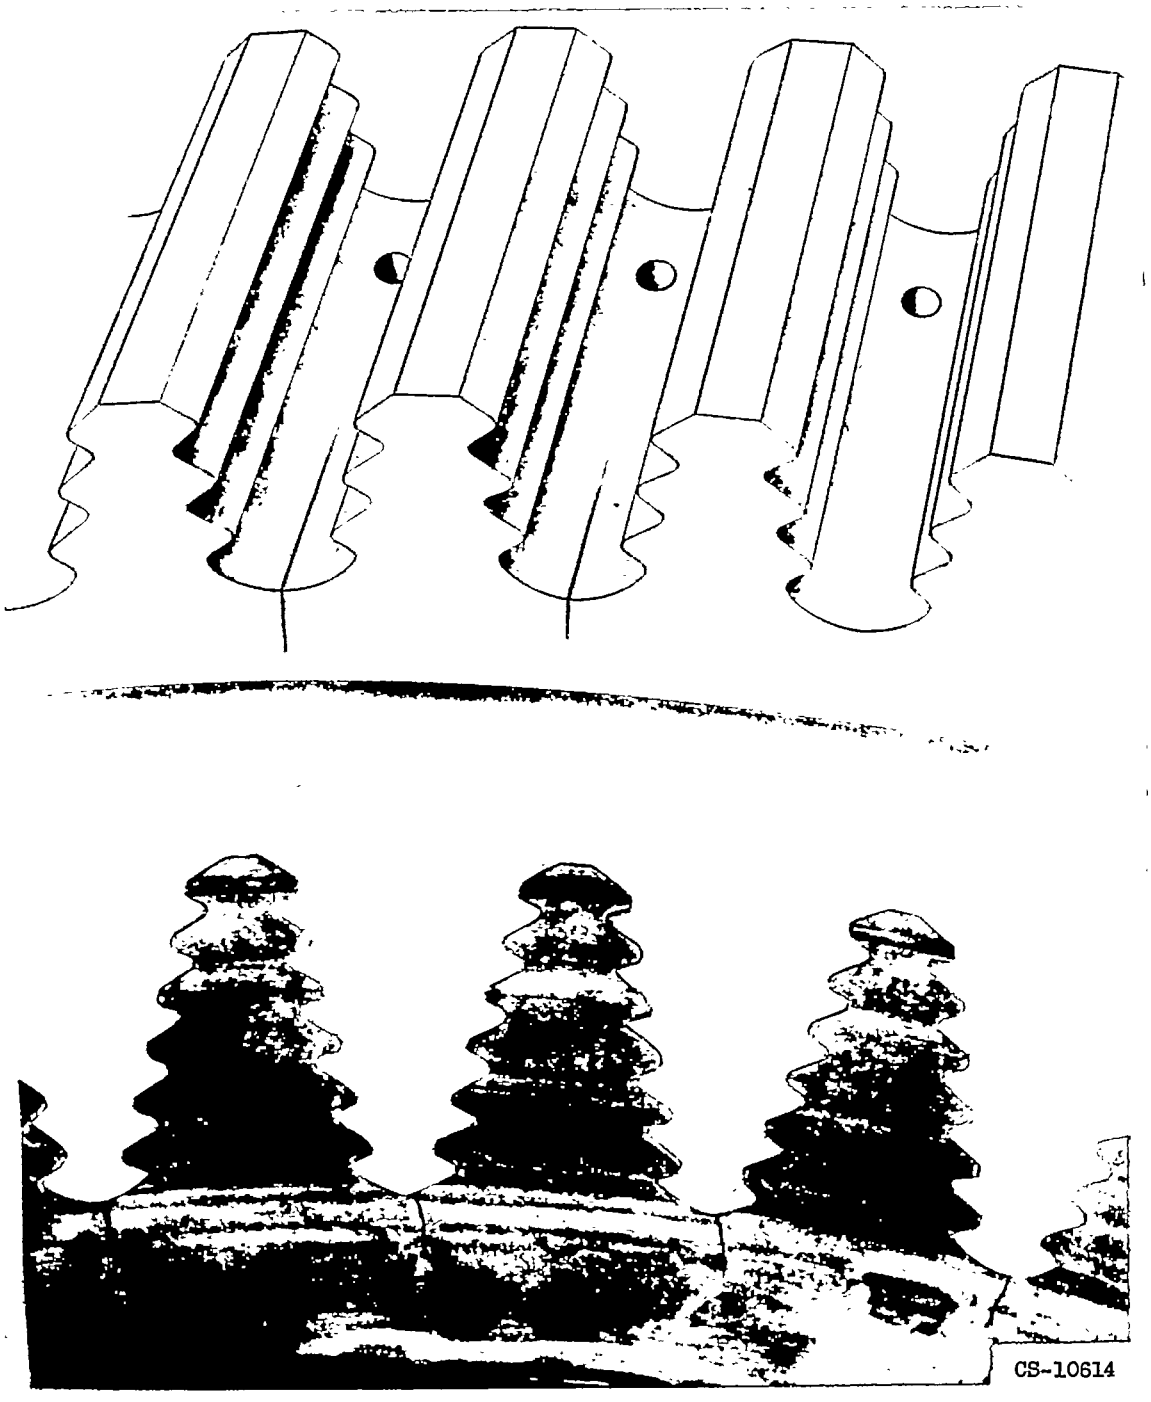
Figure 12. - Thermal-fatigue cracks.

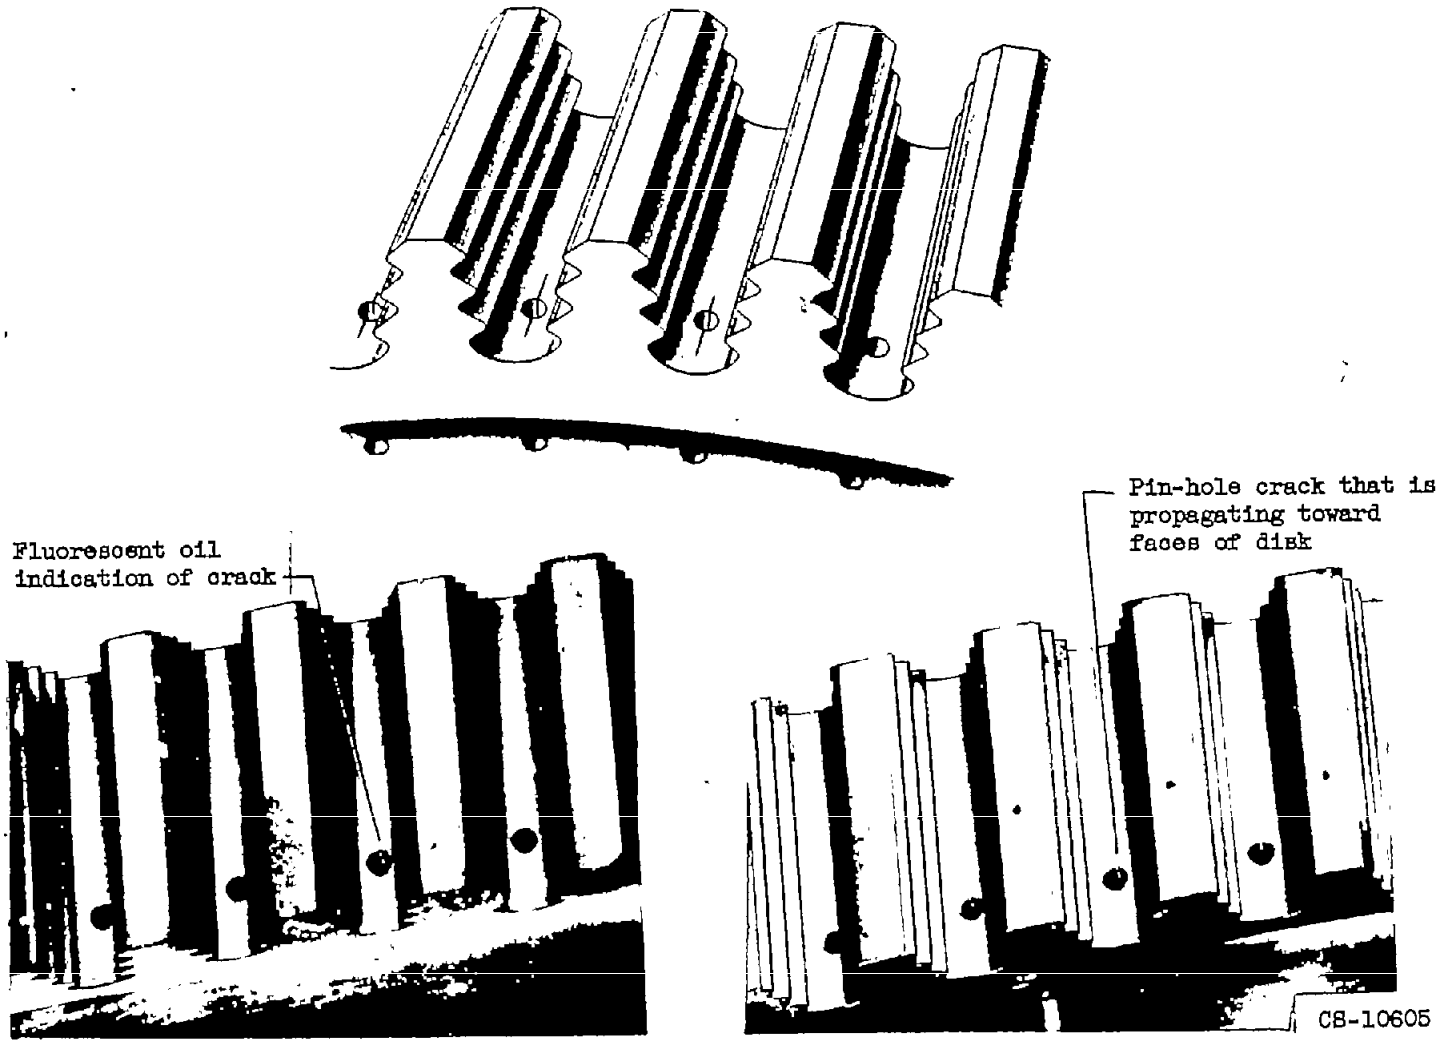
Figure 13. - Pin-hole cracks.

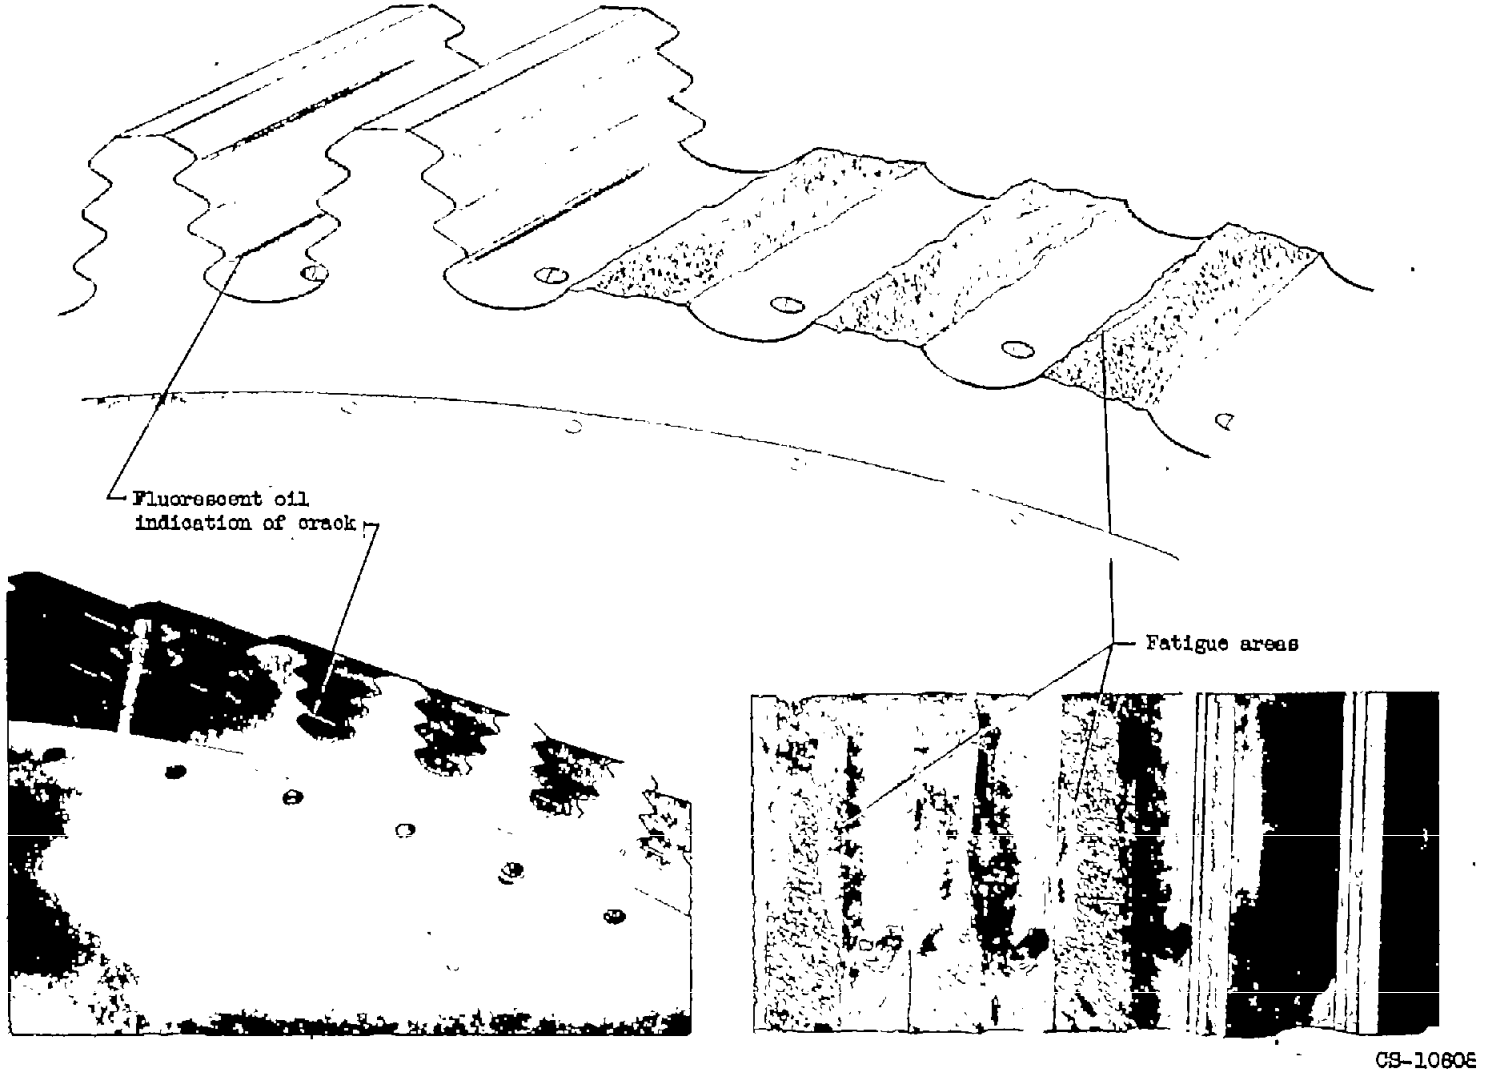
Figure 18. - Serration failure.

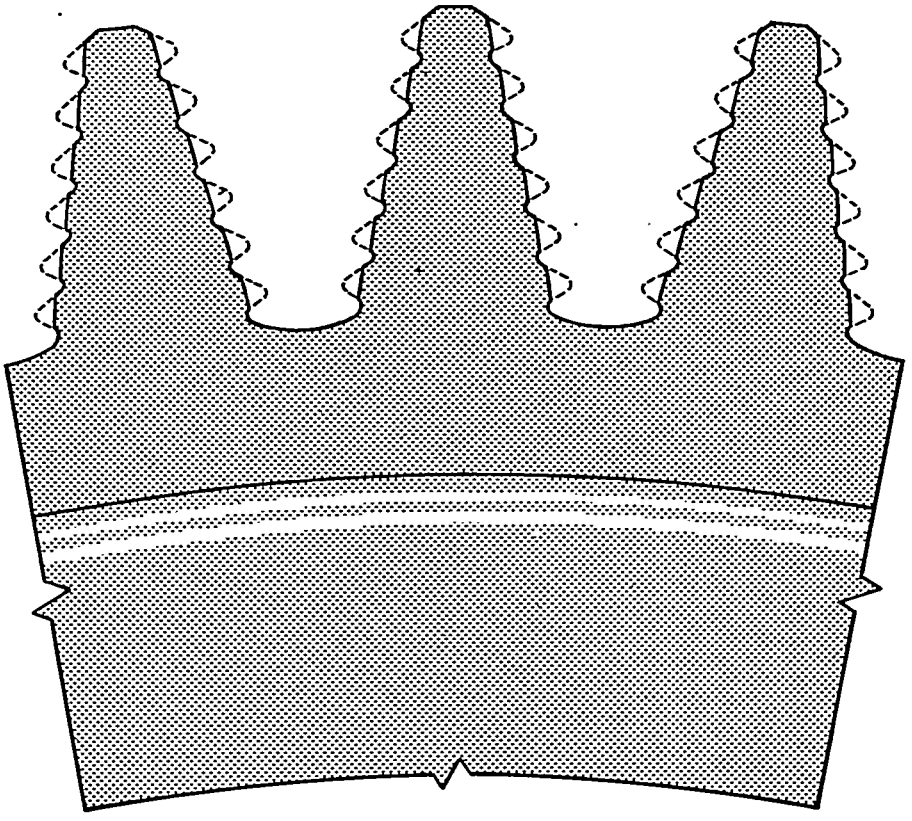
Figure 20. - Serration shear failure.

Figure 20 shows a spin-pit disk that has suffered a shear failure.

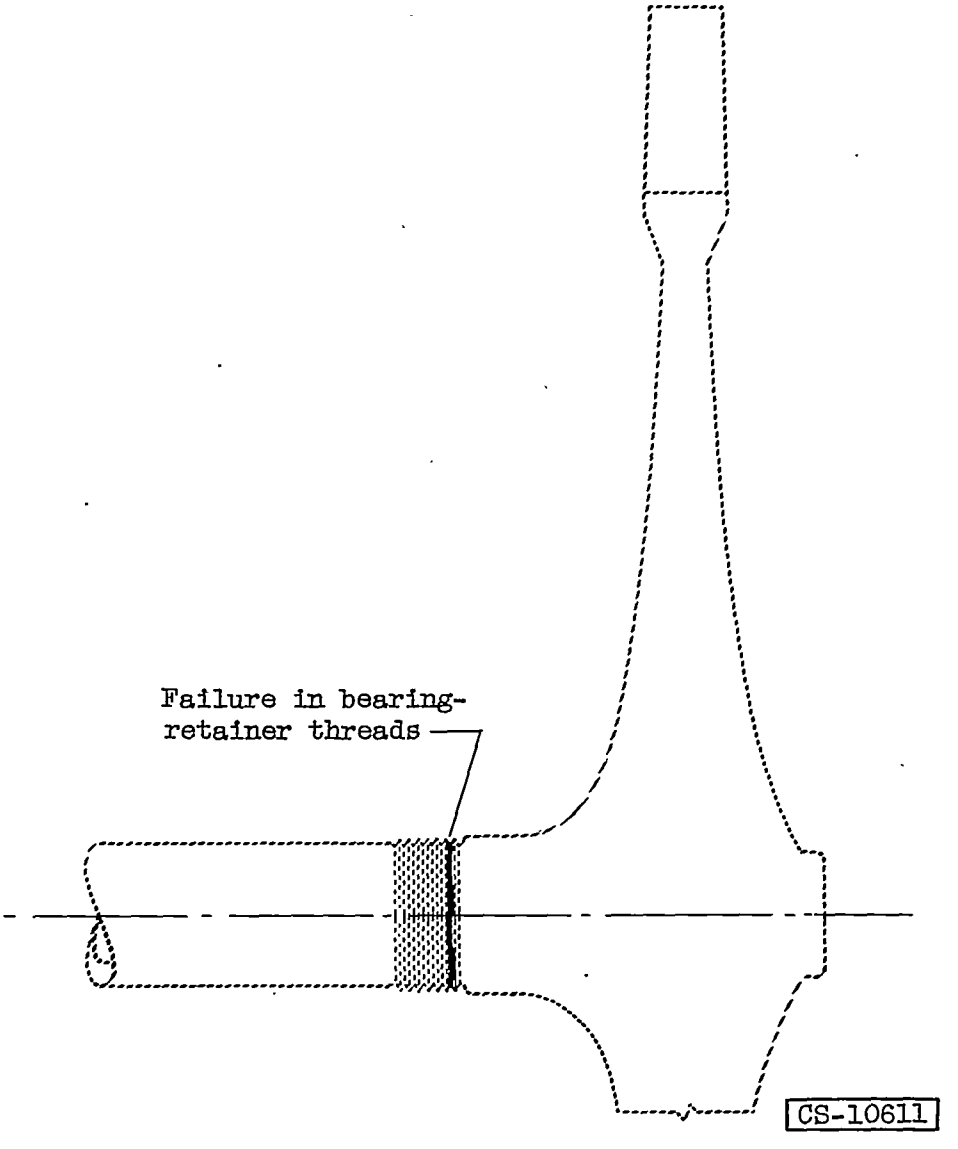
Figure 21. - Turbine-shaft failure.

A typical turbine-shaft failure is represented schematically in figure 21. Failure generally occurs at stress-concentration points such as those at the bearing-retainer threads. Since this region of the disk operates at relatively low stress, the failures are attributed to unusual operating conditions. Several possible causes are (1) torsional vibration of the shaft, (2) overheating of the shaft caused by faulty bearing operation, (3) failure of the cooling-air supply to the bearing, (4) sudden unbalance loads imposed by bucket failures and (5) gyroscopic loads.

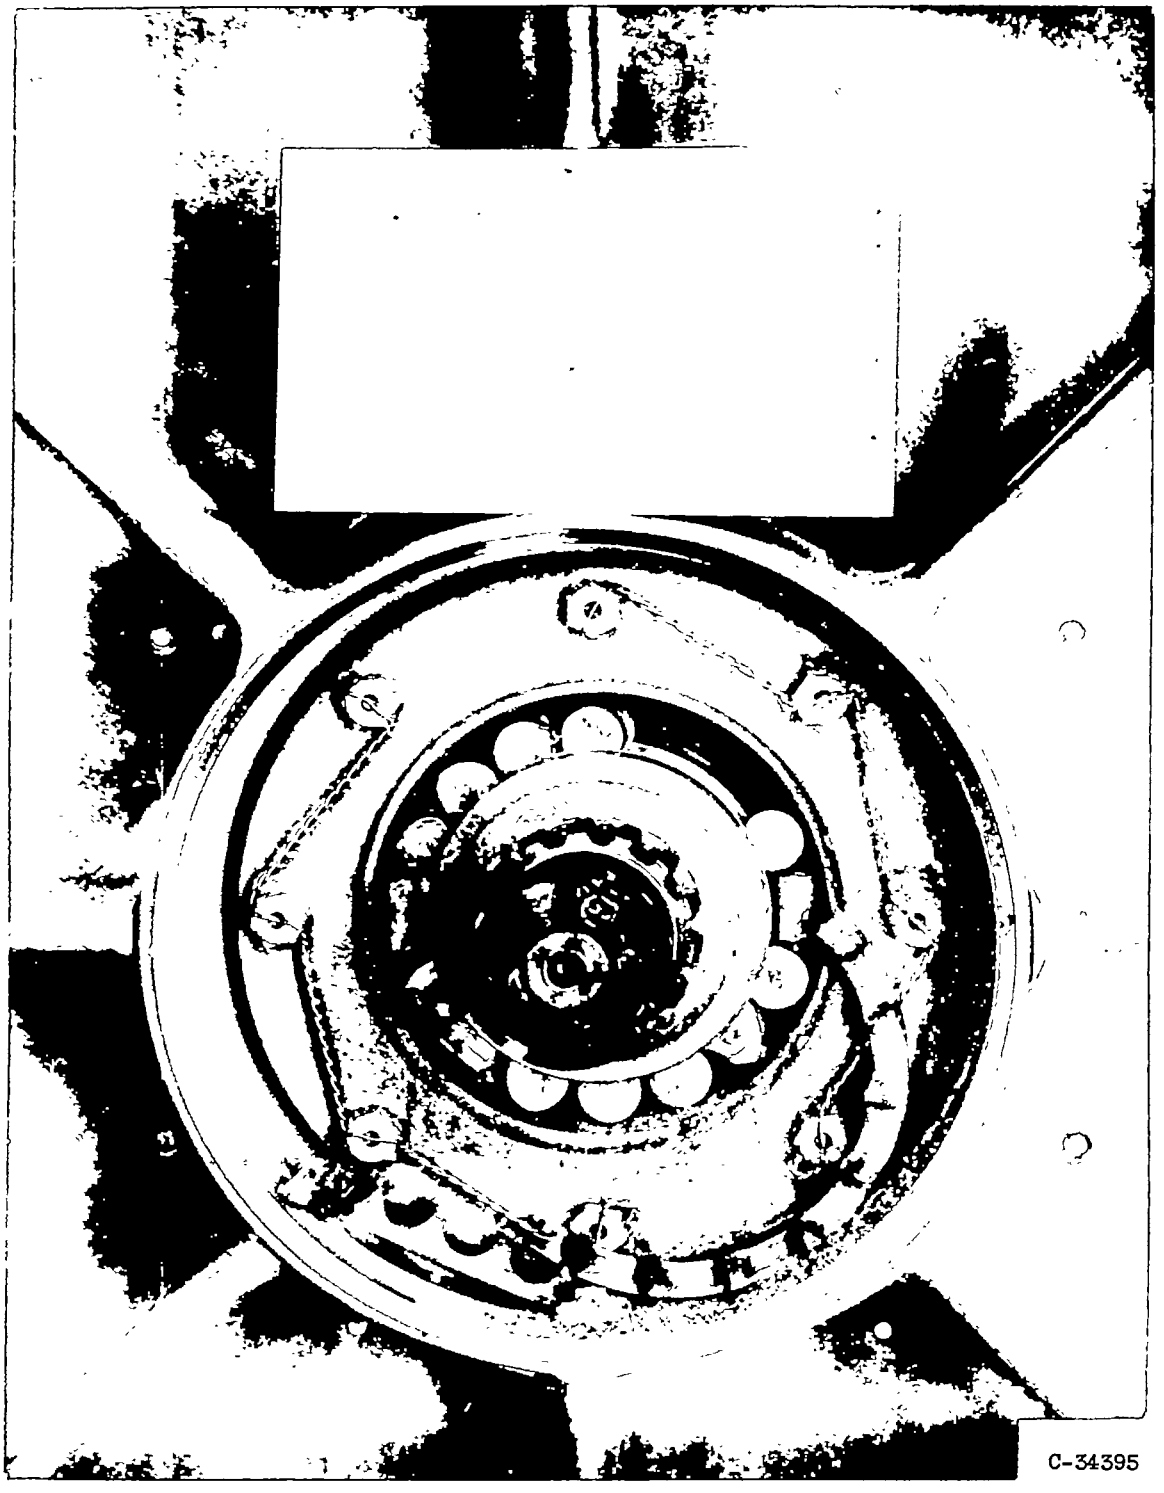
Figure 5. - Bearing failure resulting from oil interruption. Engine with jet lubrication of bearings. Photograph shows cage has failed completely. Failure occurred 17 minutes after the oil interruption. (From appendix B, ref. 1) Other photos of engine in figures 6 and 7.

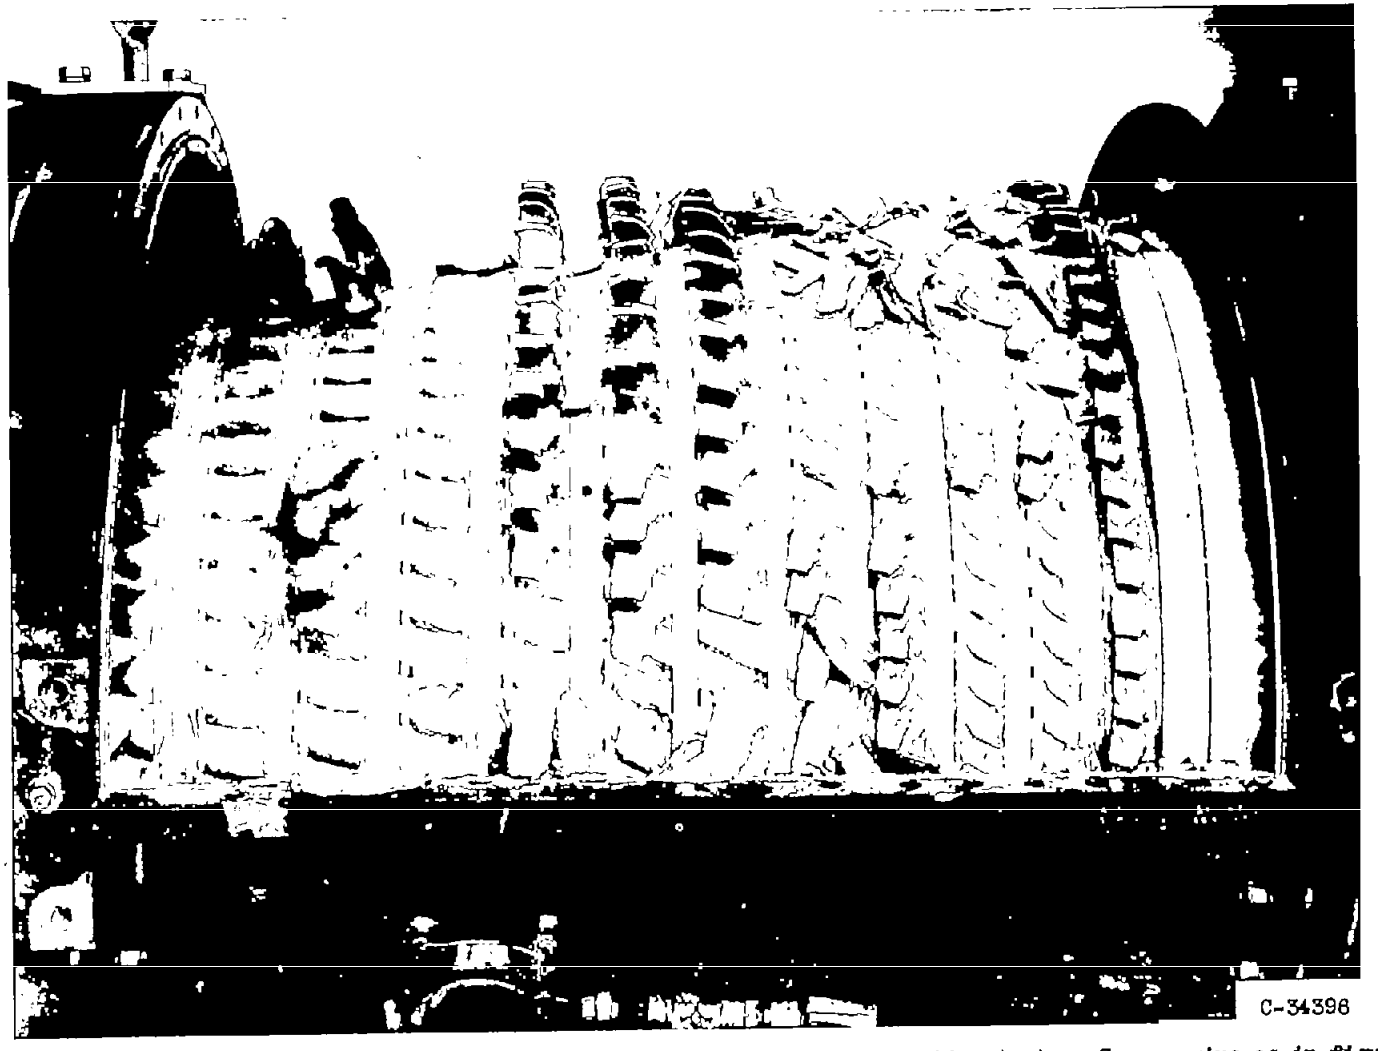
Figure 6. - Compressor damage resulting from bearing failure in oil interruption tests. Same engine as in figures 5 and 7. (From appendix B, ref. 1.)

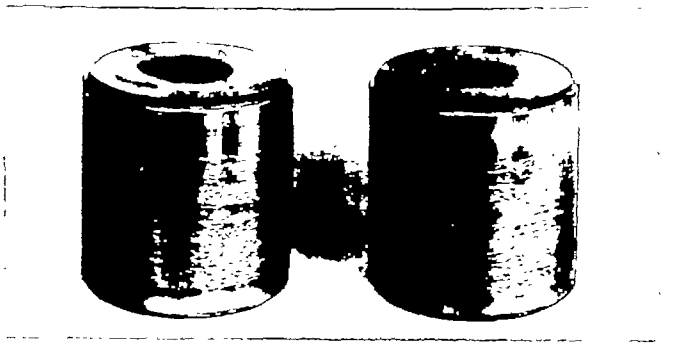
(a) Smearing on cylindrical rollers.

(b) Smearing on cage pockets.

Figure 12. - Typical cylindrical roller bearing failure caused by inadequate lubrication between rollers and cage pockets. (From ref. 15.)

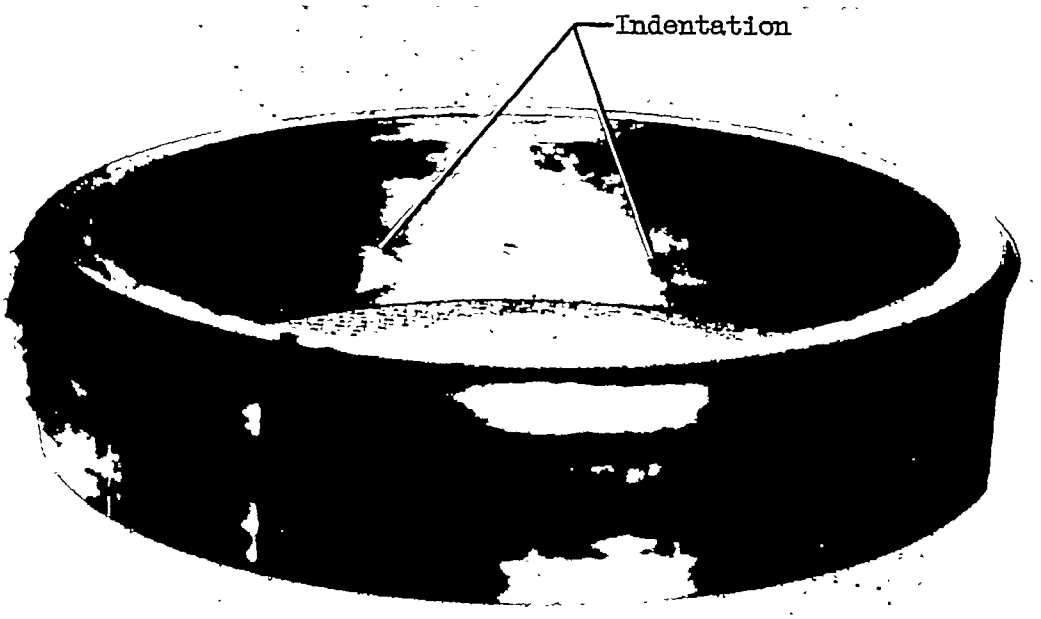
Figure 13. - False brinelling of the outer race of a double-row self-alining ball bearing caused by vibration without bearing rotation. (From ref. 15.)

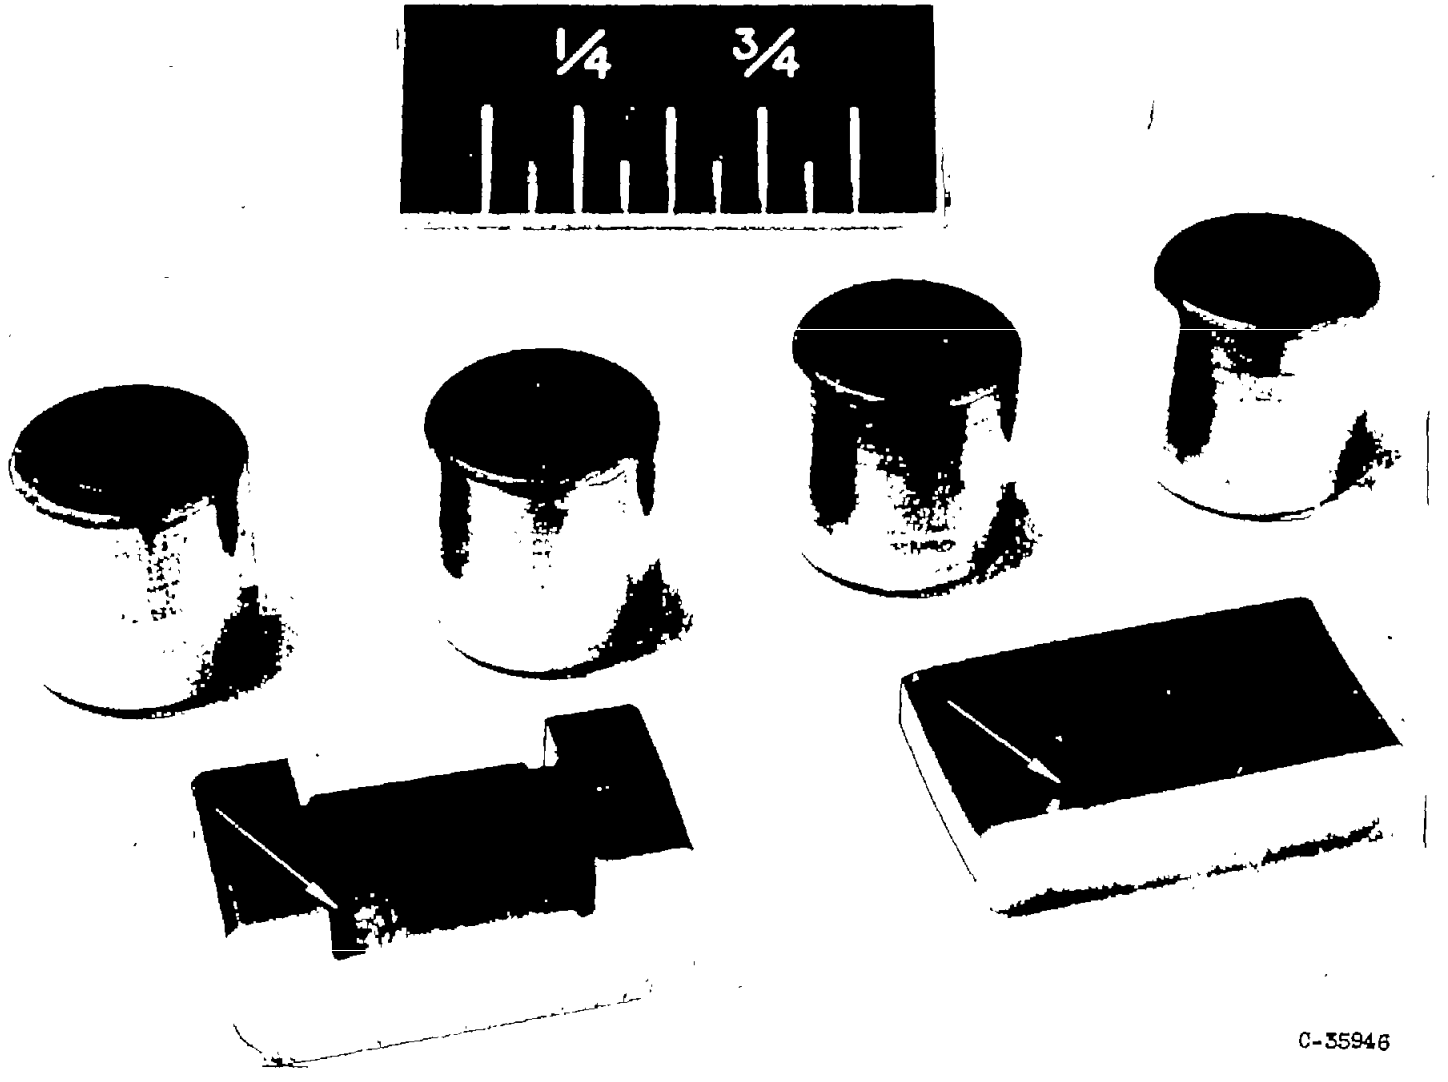
Figure 14. - Cylindrical roller bearing that failed because of misalined load.

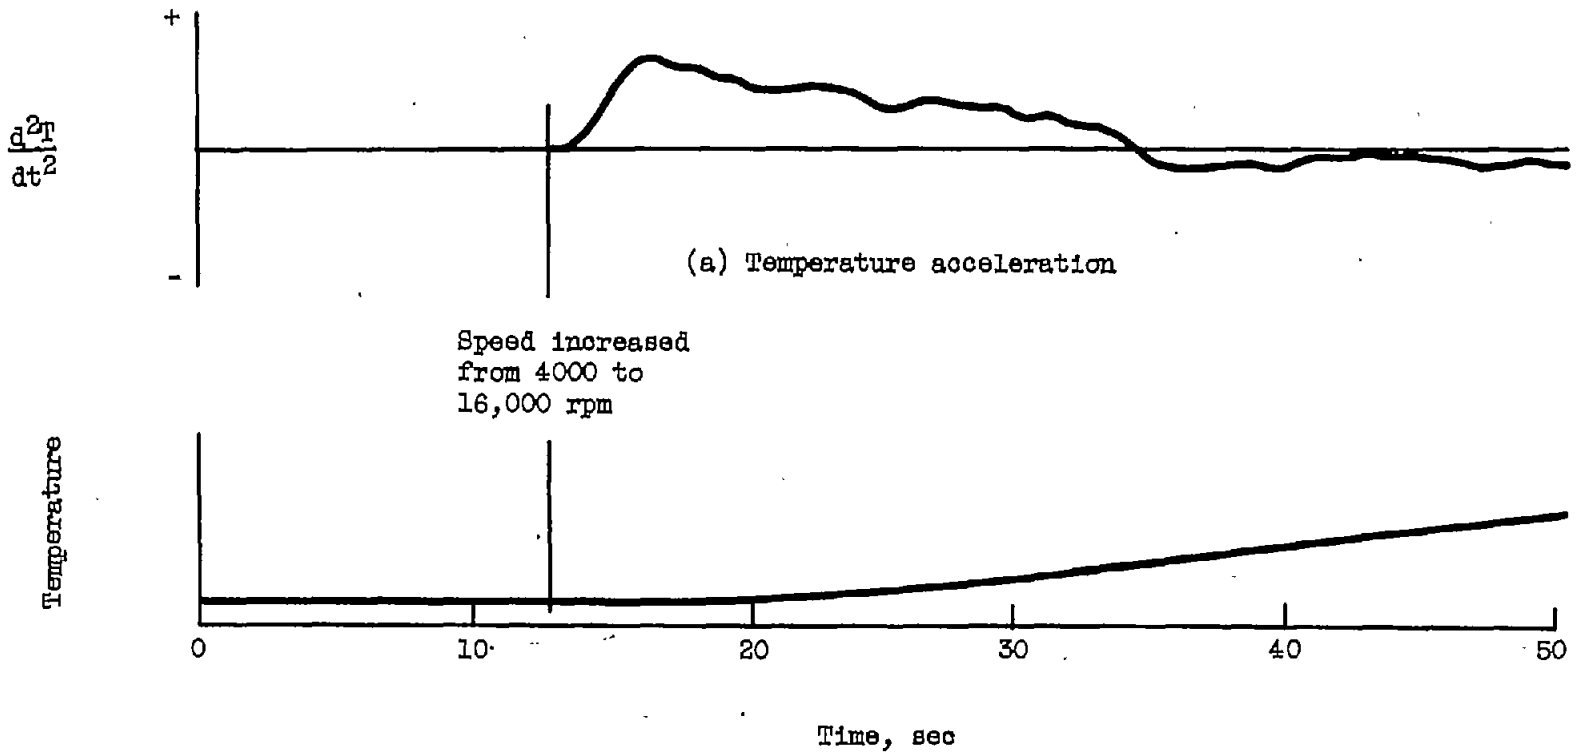
(a) Temperature and temperature acceleration: Thermocouples placed in bearing housings and read in the cockpit have been used extensively with new engines in aircraft. After sufficient engine time has been accumulated to remove design faults, however, it has been general practice to remove these thermocouples. Temperature level may not be sufficiently sensitive, however, to indicate bearing trouble. Preliminary NACA research has shown (ref. 18) that incipient bearing failures can be detected by measuring bearing temperature acceleration. The response of temperature acceleration to changing operating conditions is much more rapid than that of temperature. Figure 19 illustrates typical temperature and temperature-acceleration patterns that occur during an increase in severity of operating conditions. After an increase in severity of operating conditions, temperature acceleration is positive. If an equilibrium condition is being approached, it becomes negative after a time interval. During an incipient failure, however, temperature acceleration remains positive unless the cause of the imminent failure is removed. Figure 20 shows a temperature-acceleration pattern during an incipient failure produced by shutting off the oil flow. Restoration of the oil flow prevented a total failure and caused the temperature acceleration to become negative.

(b) Temperature

Figure 19. - Temperature and temperature acceleration patterns during an increase in severity of operating conditions on a 75 millimeter bore cylindrical roller bearing. (Data from ref. 18)
