RESEARCH MEMORANDUM

FACTORS THAT AFFECT OPERATIONAL RELIABILITY OF TURBOJET ENGINES

By Lewis Laboratory Staff

WASHINGTON
January 31, 1956

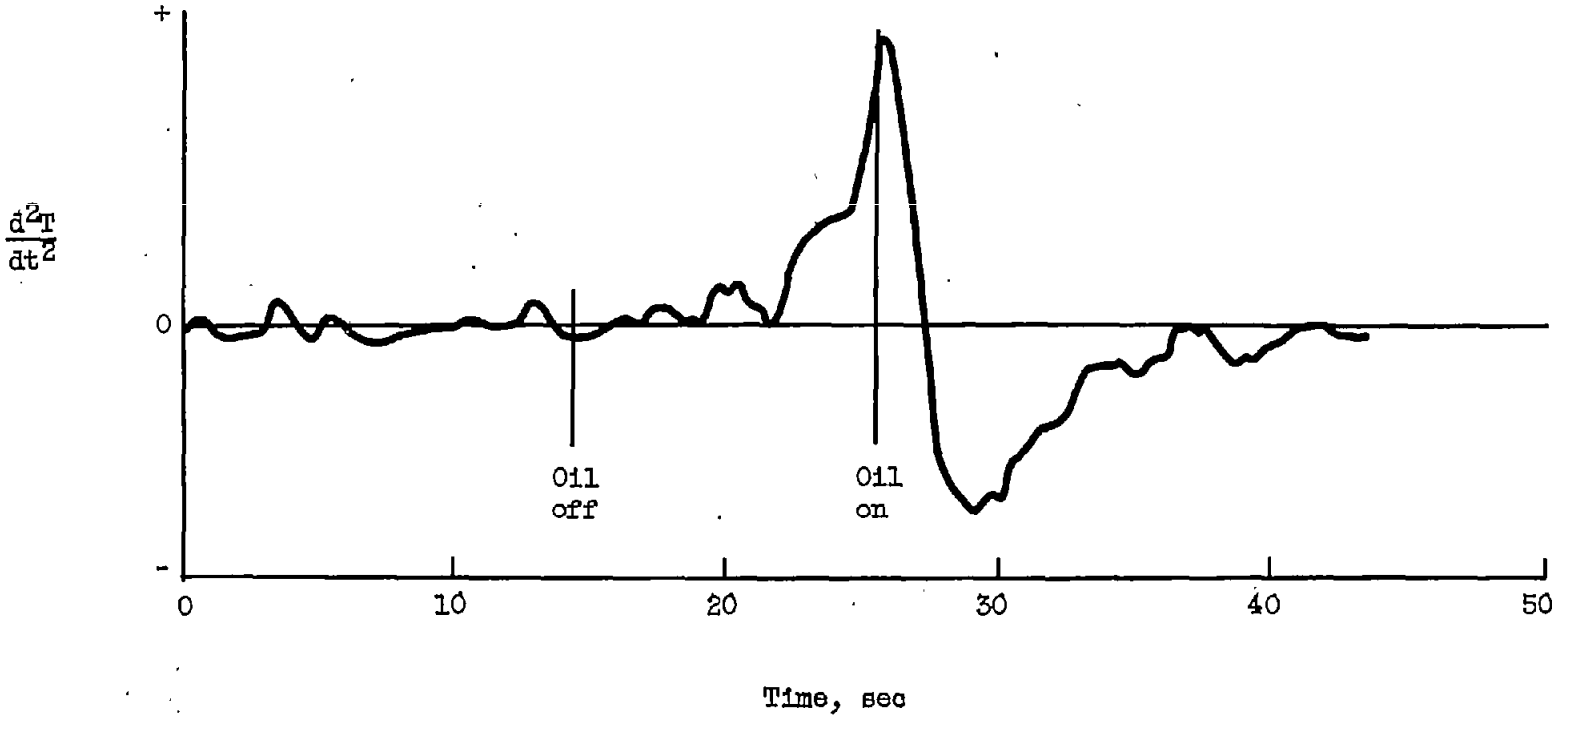
(a) Temperature and temperature acceleration: Thermocouples placed in bearing housings and read in the cockpit have been used extensively with new engines in aircraft. After sufficient engine time has been accumulated to remove design faults, however, it has been general practice to remove these thermocouples. Temperature level may not be sufficiently sensitive, however, to indicate bearing trouble. Preliminary NACA research has shown (ref. 18) that incipient bearing failures can be detected by measuring bearing temperature acceleration. The response of temperature acceleration to changing operating conditions is much more rapid than that of temperature. Figure 19 illustrates typical temperature and temperature-acceleration patterns that occur during an increase in severity of operating conditions. After an increase in severity of operating conditions, temperature acceleration is positive. If an equilibrium condition is being approached, it becomes negative after a time interval. During an incipient failure, however, temperature acceleration remains positive unless the cause of the imminent failure is removed. Figure 20 shows a temperature-acceleration pattern during an incipient failure produced by shutting off the oil flow. Restoration of the oil flow prevented a total failure and caused the temperature acceleration to become negative.

Figure 20. - Temperature acceleration pattern during an incipient failure. (Data from ref. 18).
