NACA RM E56J12

RESEARCH MEMORANDUM

IDENTIFICATION OF FOREIGN OBJECTS DAMAGING COMPRESSOR BLADES IN TURBOJET ENGINES

By A. E. Spakowski and J. Graab

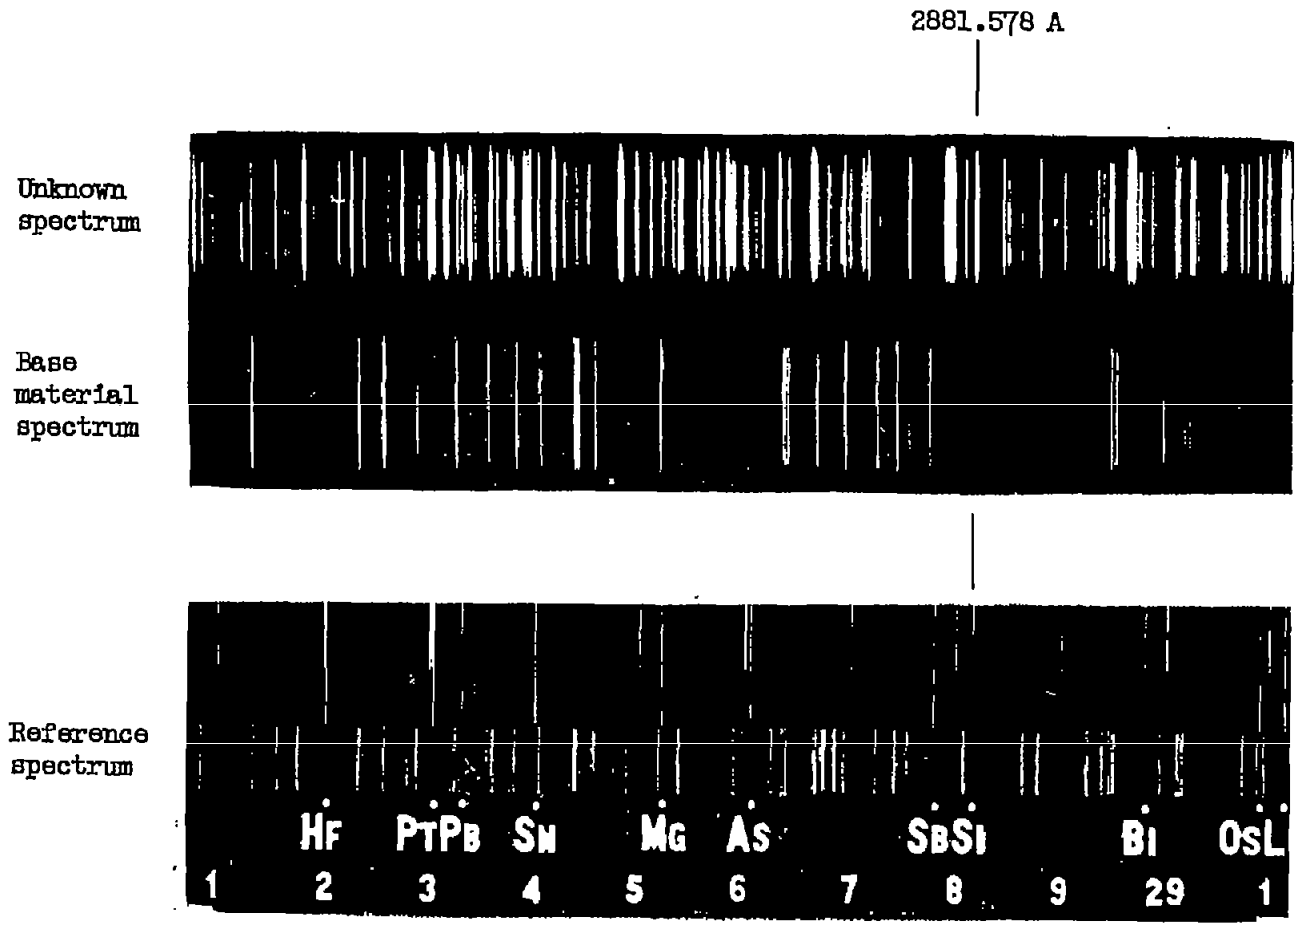
(a) Identification of silicon.

During the course of this study compressor blades became available from two engines that had suffered damage due to the ingestion of foreign objects. These engines were received new and were run entirely in jet, static test stands. The results of the analysis of the damaged compressor blades from these two engines (labeled A and B) are shown in table IV. The compressor of engine A had been severely damaged, and damaged areas where copper and aluminum metal were clearly visible could be easily observed. In testing the spectroscopic method, however, only those areas where minor damage occurred were used. In actual practice every available means would be used to aid in the identification of the foreign material. The compressor of engine A has aluminum blades in the first stages and 403 stainless-steel blades in the remaining stages. A number of damaged areas on each type blade was analyzed; the results in table IV show that the principal element in each foreign material was found. It was known beforehand that engine B was damaged by a titanium carbide cermet with nickel as the binding agent. Upon analysis large quantities of titanium and nickel were found with trace amounts of aluminum and magnesium. The origin of the aluminum and magnesium is unknown.

Figure 1. - Emission spectrum of a foreign-object-damaged compressor blade from engine A.

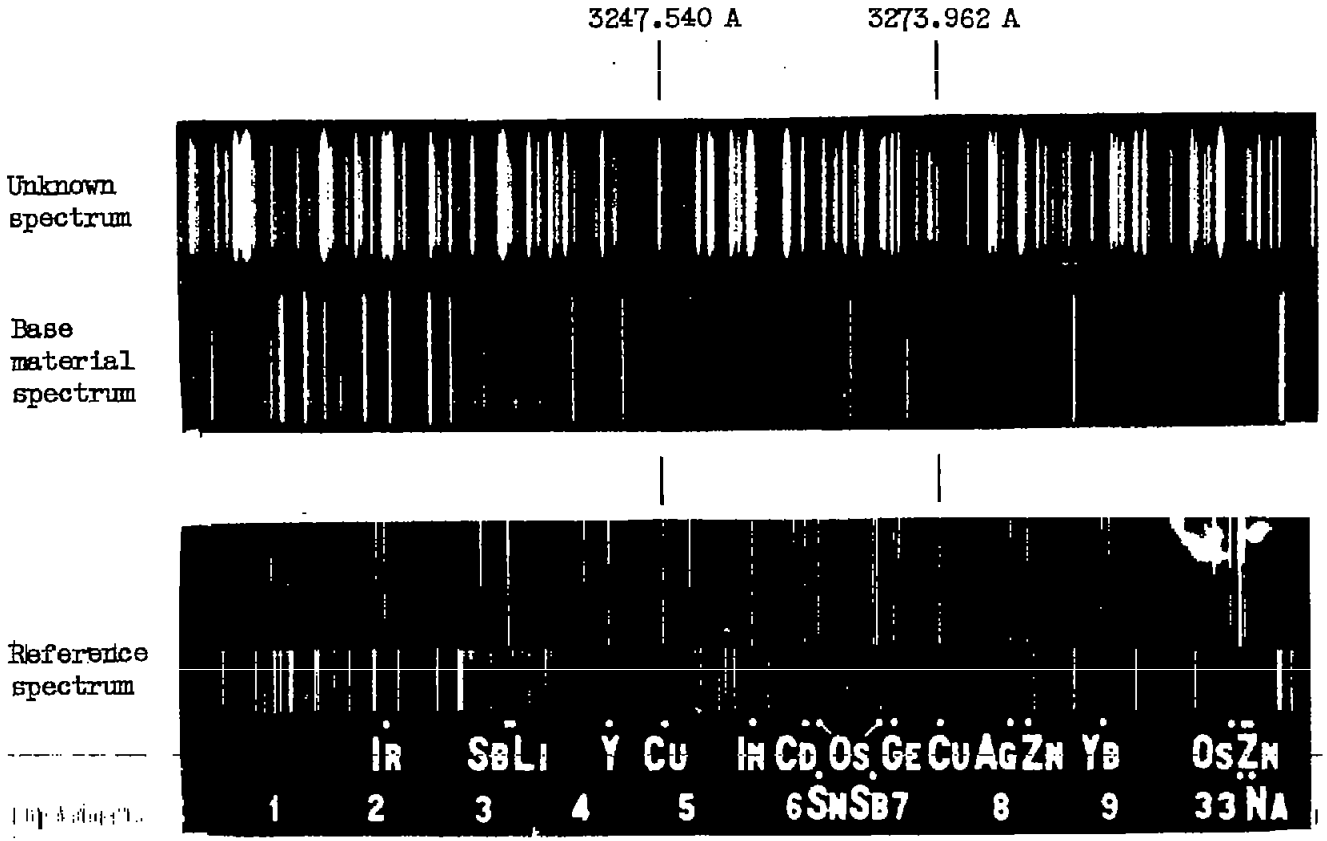
(b) Identification of copper.

Figure 1. - Concluded. Emission spectrum of a foreign-object-damaged compressor blade from engine A.
