TECHNICAL MEMORANDUMS

No. 710

TESTS FOR THE ELIMINATION OF TAIL FLUTTER

By Curt Biechteler

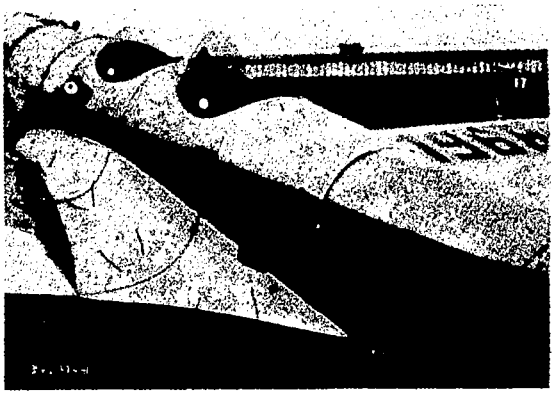
Figure 7.

FIGURE 7.- Wing-fuselage connection without fairing.

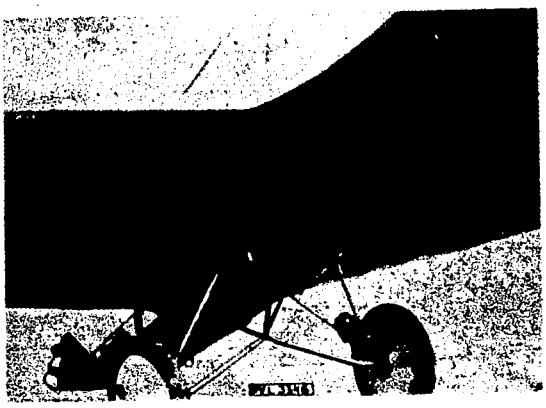
Figure 9.

FIGURE 9.- Lower surface of wing before fairing was added. The highly cambered lower surface of the wing makes a sharp angle with the bottom of the fuselage. The trailing edge at the wing root extends below the bottom of the fuselage.

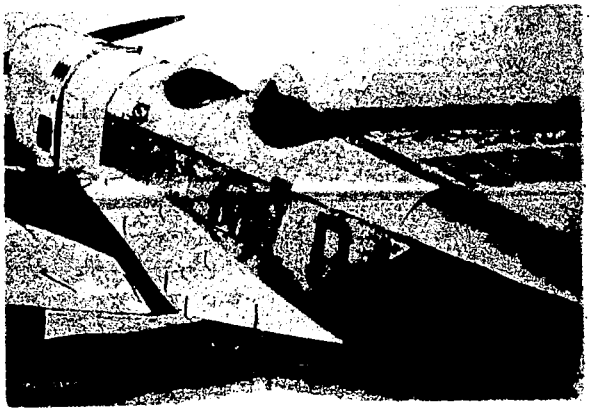
Figure 10.

FIGURE 10.- Lower surface of wing with fairing I. The fairing forms a gradual transition from the lower surface of the wing to the bottom of the fuselage. The trailing edge extending below the bottom of the fuselage is cut off and the lower surface of the wing is raised to the second rib.

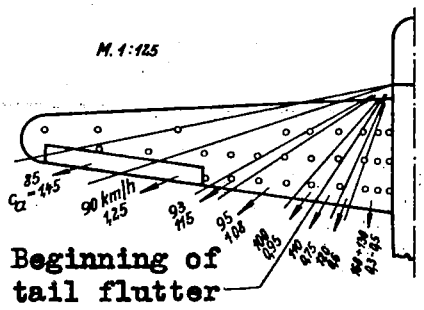
Figure 3.

FIGURE 3.- Boundaries of regions of separation at various indicated speeds in straight flight with idling engine and unfaired wing root. Tail flutter began at about 110 km/h and below.

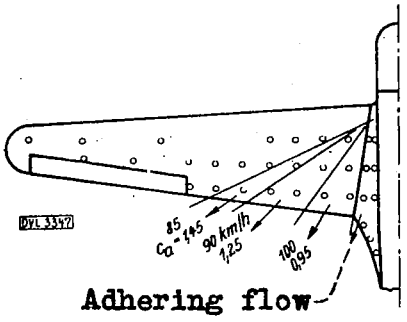
Figure 4.

In straight flight with full throttle, the flow about the wing was only slightly disturbed near the fuselage at speeds down to 110 km/h. Tail flutter began at 90 km/h (56 mi./hr.). The amplitude of vibration of the stabilizer tip at 90 km/h was approximately 2 cm (0.79 in.) and reached 3 cm (1.2 in.) at 85 km/h (53 mi./hr.). As in straight flight with idling engine, the region of disturbed

flow spread out fanlike with decreasing flight speed. The displacement of the boundary of the region of separation with decreasing speed in straight flight with full throttle is shown in figure 4.

FIGURE 4.- Boundaries of the regions of separation at various recorded speeds in straight flight with full throttle and unfaired wing root. Tail flutter began at about 90 km/h (56 mi./hr.) and below.

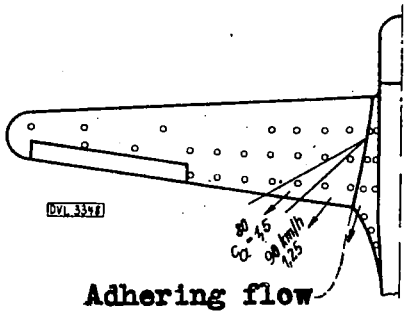
Figure 11.

FIGURE 11.- Boundaries of the regions of separation at various indicated speeds in rectilinear flight with idling engine and fairing I. Tail flutter occurred at no impact pressure. The area of the disturbed regions for equal velocities was reduced by the fairing.

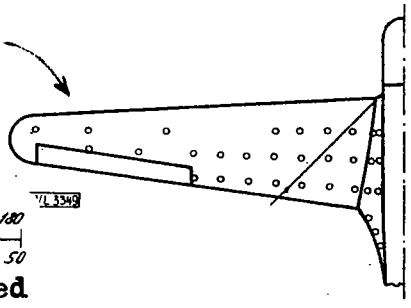
Figure 13.

In right- and left-hand turns and spirals with full throttle or idling engine the tail unit was quiet, regardless of inward or outward slipping. In pronounced sideslips with rudder fully deflected to the left or right and engine running at full throttle, the tail unit was likewise quiet, whereas slight fluttering occurred in slips with idling engine. The double amplitude of the stabilizer tip was about 1 cm (0.4 in.). The boundary between the region of separation and that of conforming flow in sideslips to the right with idling engine is shown in figure 13.

FIGURE 13.- Boundaries of the regions of separation in a sideslip to the right with idling engine and fairing I. Slight tail flutter occurred in this case.

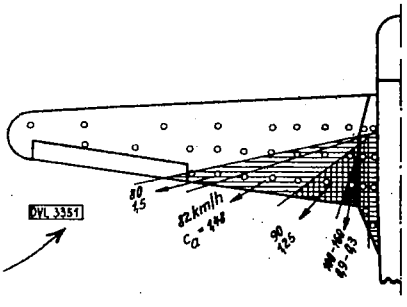
Figure 15.

b) Test results.- The displacements of the boundary of the region of separation at various speeds in straight flight with idling engine are shown in figure 15. Even at very small angles of attack the woolen thread at the observation point 9 was disturbed. With decreasing speed, the region of separation extended triangularly toward the wing tips and the fuselage. At approximately 80 km/h (50 mi./hr.) it reached the inner end of the aileron at the trailing edge. Flutter of the horizontal tail surfaces occurred at no impact pressure.

FIGURE 15.- Boundaries of the regions of separation at various indicated speeds in straight flight with idling engine and fairing II. Tail flutter occurred at no impact pressure. The region of separation spreads triangularly with decreasing speed.

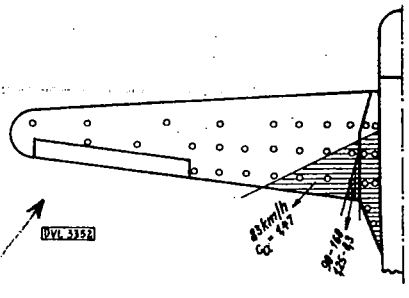
Figure 16.

Similar conditions were found in tests with full throttle at various speeds in straight flight. The flow conformed up to large angles of attack under the influence of the propeller slipstream. At all speeds, a slight separation of the flow occurred at the trailing edge near the fairing. A greater separation was observed only at speeds below 85 km/h. The extension of the region of separation is shown in figure 16. Tail flutter occurred at no speed. Even in right and left turns and spirals and in sideslips with full throttle or idling engine the horizontal tail surfaces remained quiet.

FIGURE 16.- Boundaries of the regions of separation at various indicated speeds in straight flight with full throttle and fairing II. Flutter of the horizontal tail surfaces occurred at no impact pressure.
