RESEARCH MEMORANDUM

TESTS OF AERODYNAMICALLY HEATED MULTIWEB WING

STRUCTURES IN A FREE JET AT MACH NUMBER 2

THREE ALUMINUM-ALLOY MODELS AND ONE STEEL MODEL OF

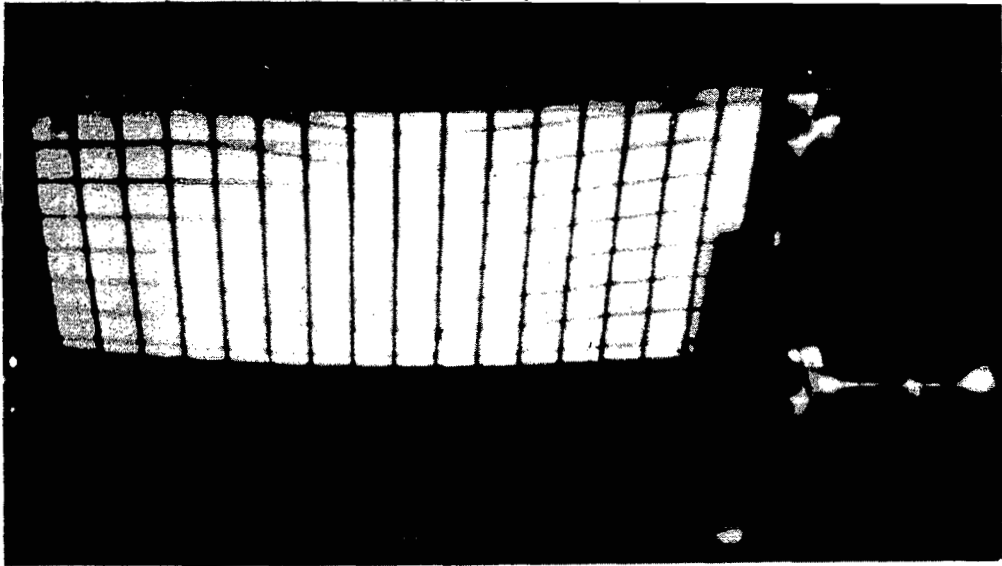
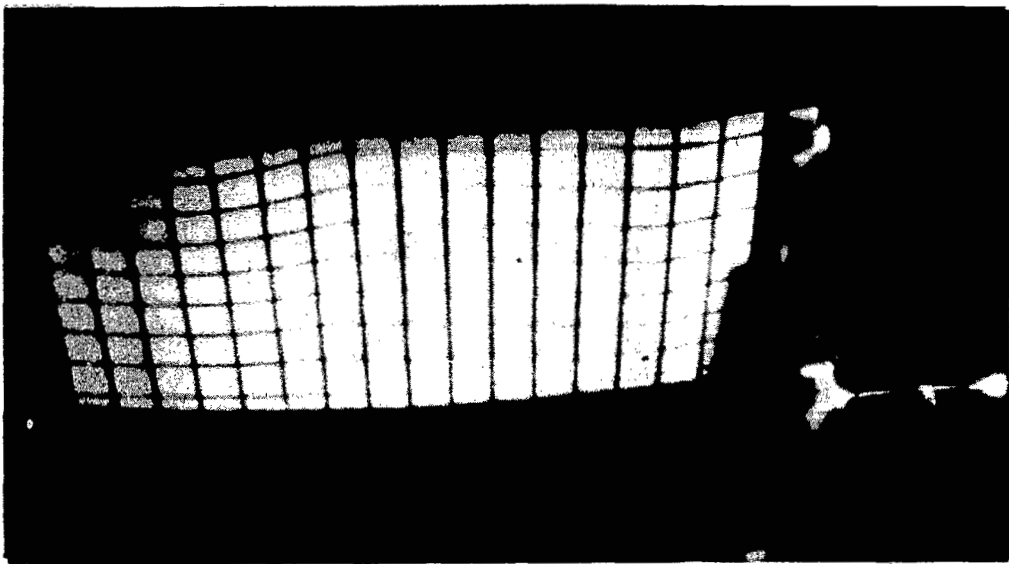
Model MW-4.- By 1.57 seconds after air began to flow, vibrations
had reduced until model MW-4 was virtually stationary. After this, no
motion of any consequence occurred until 5.22 seconds, when flutter of
the whole model, involving about $1\frac{1}{2}$ waves along the chord, started with
a frequency of about 240 cycles per second. During the time from

(a) Small amplitude.

Figure 6.- Flutter of model MW-4.

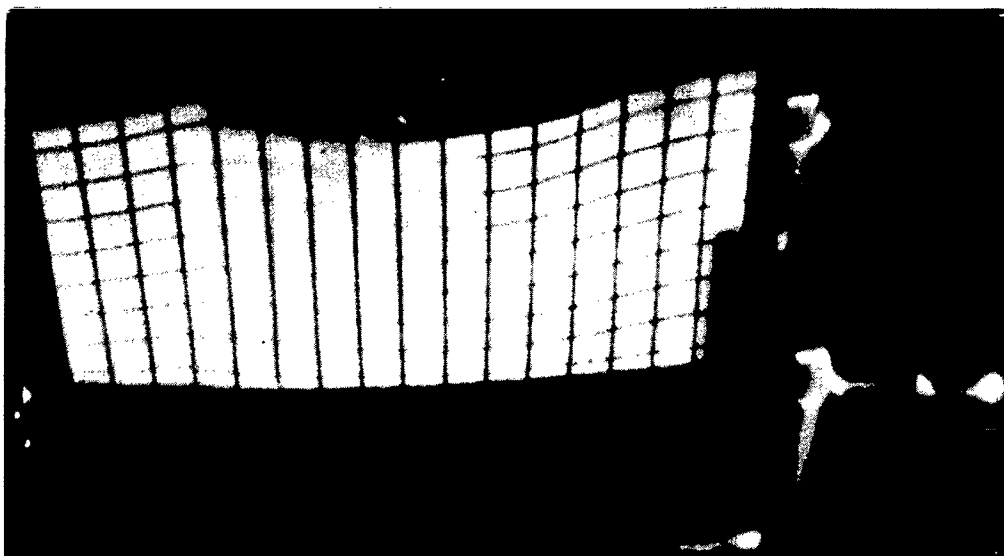
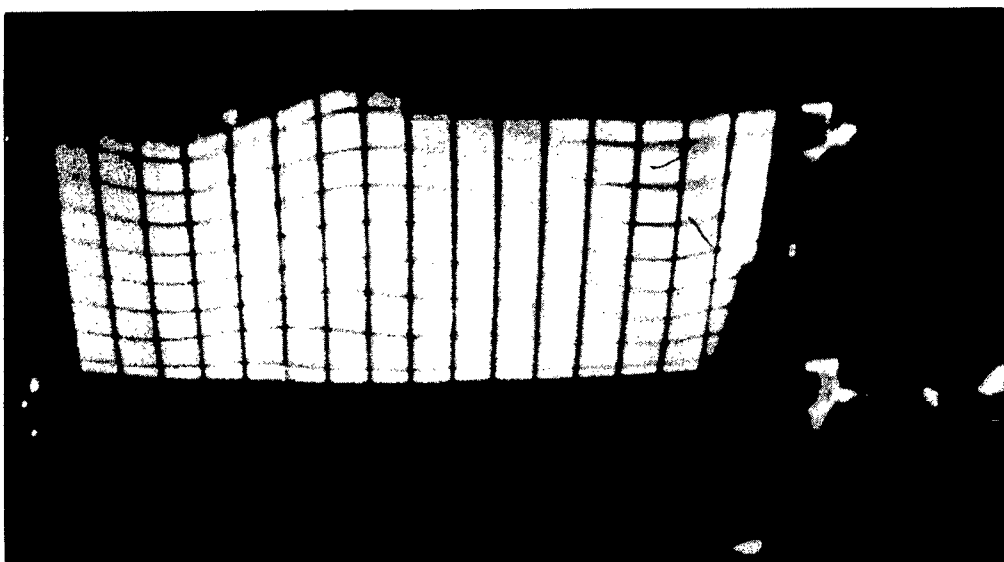
5.22 seconds to 5.25 seconds amplitudes increased and then remained sub-
stantially constant at the same frequency until 5.57 seconds. After
5.57 seconds, there was a rapid and continuing increase in amplitude,
with the chordwise bending distortions near the tip becoming very great.
Figure 6 shows several frames from high speed motion pictures taken
between 5.57 and 5.60 seconds. In these views, taken at 650 frames per
second, the distorted shape of the model is evident. It appears that
the chord was formed into about one and one-half waves, producing a flag-
waving effect. When amplitudes became sufficiently large, at 5.58 seconds,
the wing collapsed (as shown in fig. 6(c)) beginning near the tip at a
point about two-thirds of the chord downstream from the leading edge.
At this time the model tore away from the base, the tear being roughly
at the top of the doubler plate, beginning at the leading edge and pro-

(b) Amplitude near failure.

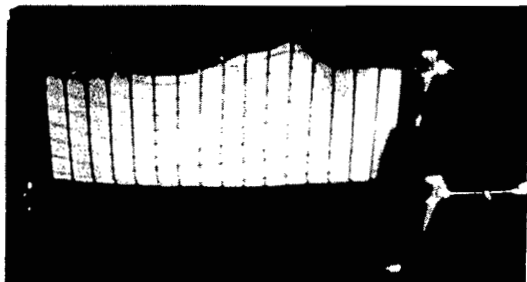
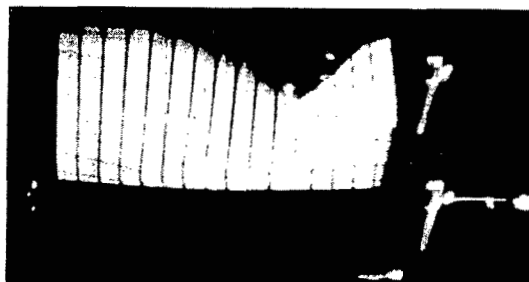
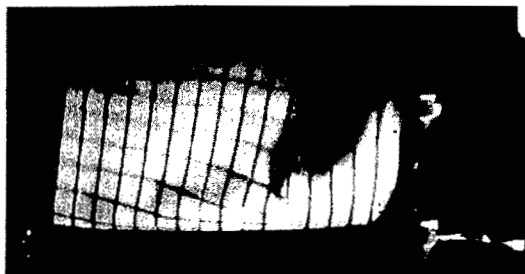
gressing to the trailing edge. Failure was complete at 5.60 seconds.
Figure 7 shows the condition of the wing at the conclusion of the test.
Some of the distortion was due to collision with other objects after the
main portion of the model left the test stand, but much of the damage
resulted from action of the air during the test. Both the tip bulkhead
and the webs were crushed to some degree, and figure 7 shows that many
of the rivets failed.

(c) Failure sequence.   L-57-2723

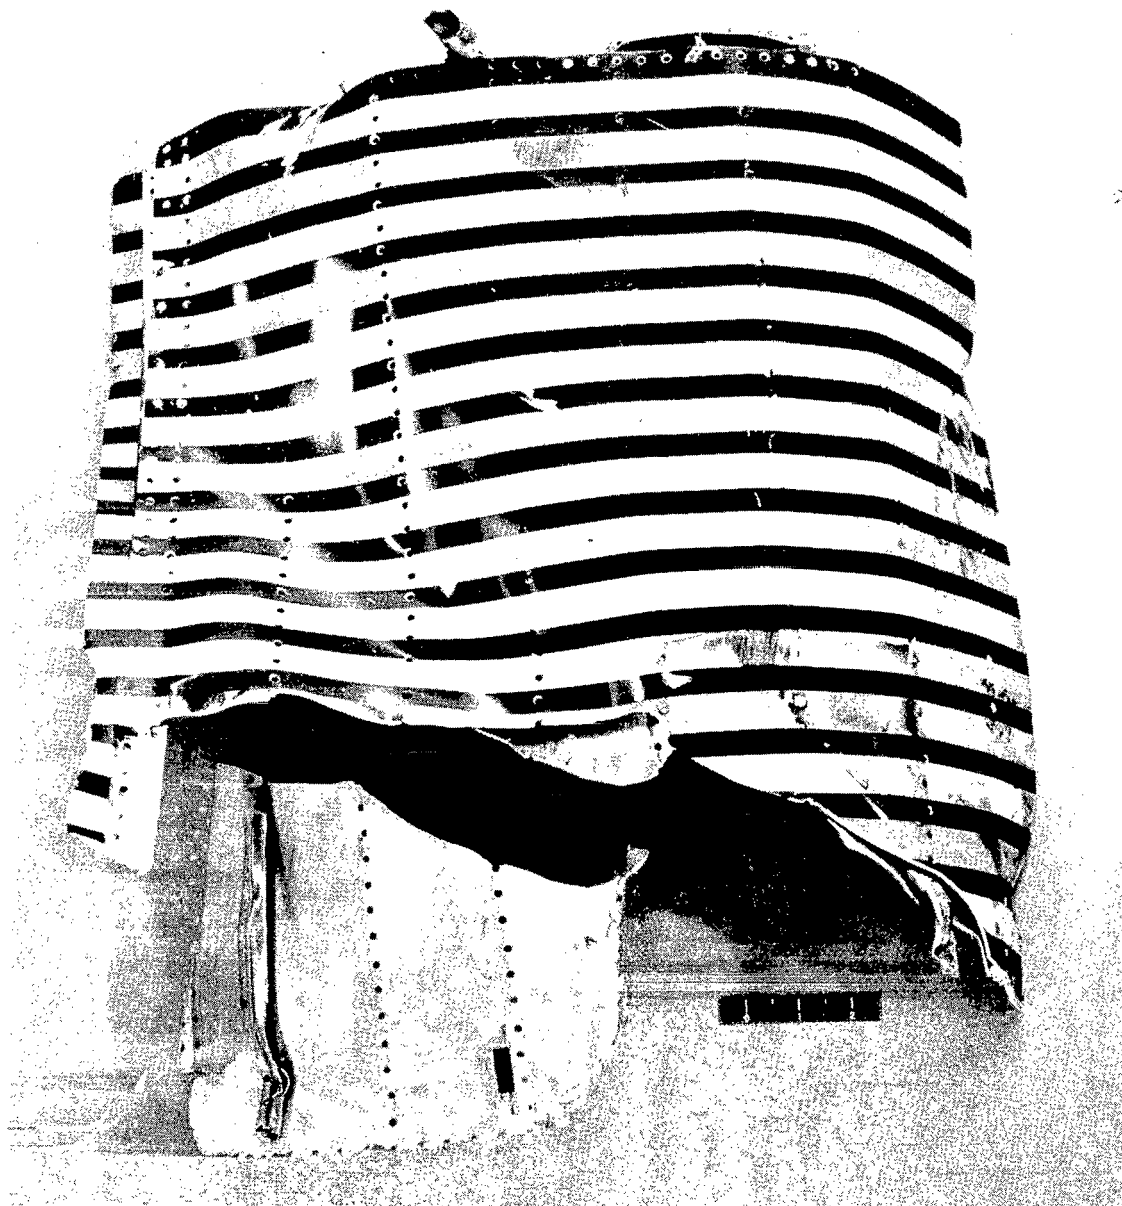
7. The flutter and failure of model MW-4 was due to loss of stiffness caused by thermal stresses and change in material properties resulting from aerodynamic heating.

Figure 7.- Model MW-4 after failure.   L-78913

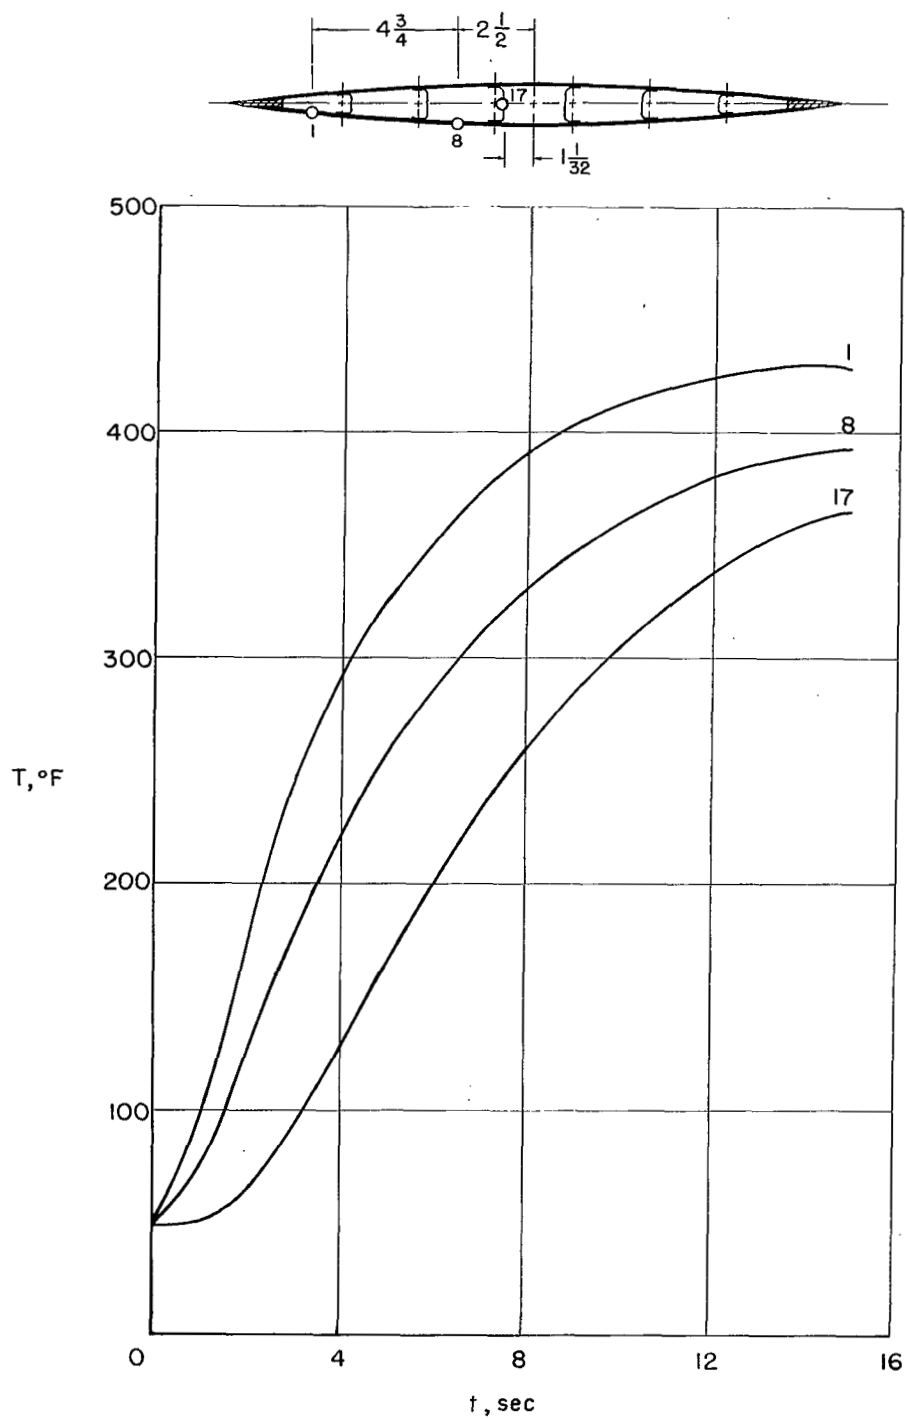
Figure 8.- Typical temperature histories. Model MW-5.

All model temperature data are listed in table 4. In all tests, temperatures were changing throughout, indicating that the entire test was transient in nature and of insufficient length to produce a steady-state temperature condition. Three temperature histories, typical of the test data, are shown in figure 8. Chordwise variation of skin temperature, at points unaffected by heat sinks, for model MW-6 is shown in figure 9; similar results were obtained for the other models. The temperature data show that heating of the model took place most rapidly near the leading edge and diminished steadily toward the trailing edge. Figure 10 shows the spanwise variation of skin temperature for model MW-7. The data indicate that, in the spanwise direction, heating took place more slowly near the root. Arrangement of instrumentation in other models did not permit similar comparisons, but such evidence as they do give indicates that figure 10 represents the usual spanwise temperature condition. Reduced temperatures near the root are due mainly to the lower stagnation temperature of the airstream near the boundary wall of the nozzle where the roots of the models were located, slightly accentuated, perhaps, by

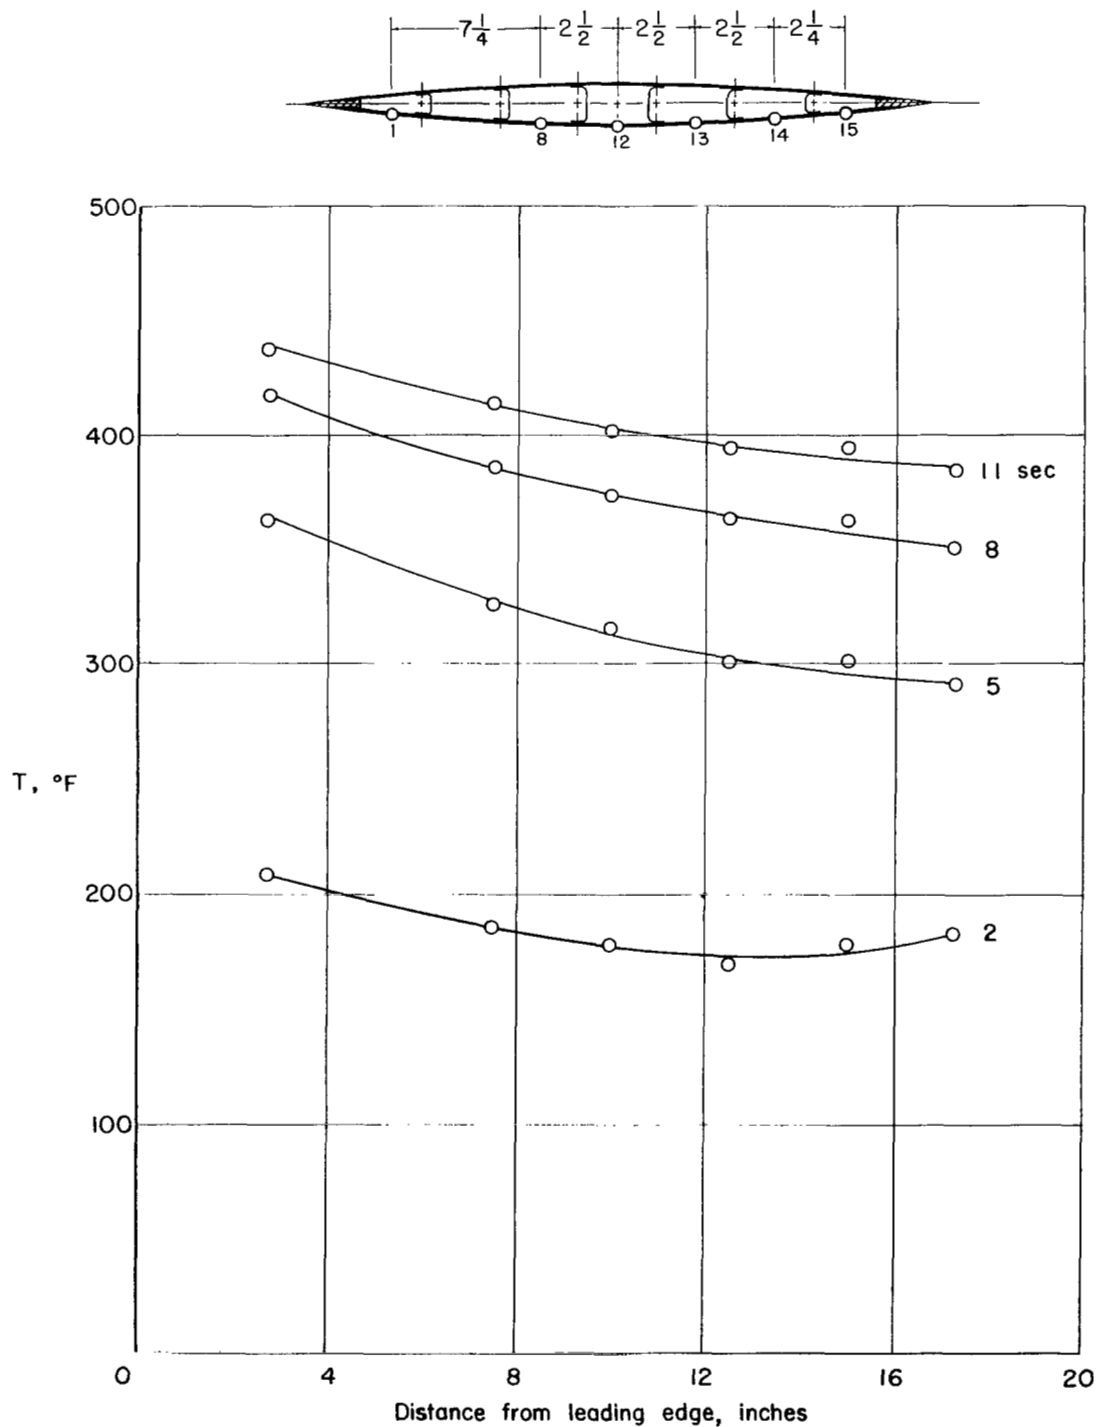
Figure 9.- Chordwise variation of skin temperature.   Model MW-6.

Since the thermal stresses depend, in part, upon unequal temperature
distribution, such as that shown in figure 9, it is pertinent to note the
difference between skin and web temperatures for each of the models. For
all tests, the stagnation temperatures were very nearly the same (see
table 3) thus validating a direct comparison. Figure 12 shows the time
variation of the differences between the maximum skin temperature and the
minimum web temperature for the third skin and web element and indicates
that the greatest difference is only about 130° F for models MW-4 and MW-5
compared with 200° F for model MW-6 and 175° F for model MW-7. It appears
that the heavier skins of models MW-4 and MW-5 result in lower temperature
differences than those experienced by model MW-6 with a thinner skin,
although the temperature distribution may have been affected to some
extent by differences in joint conductivity. (See ref. 8.) The lower

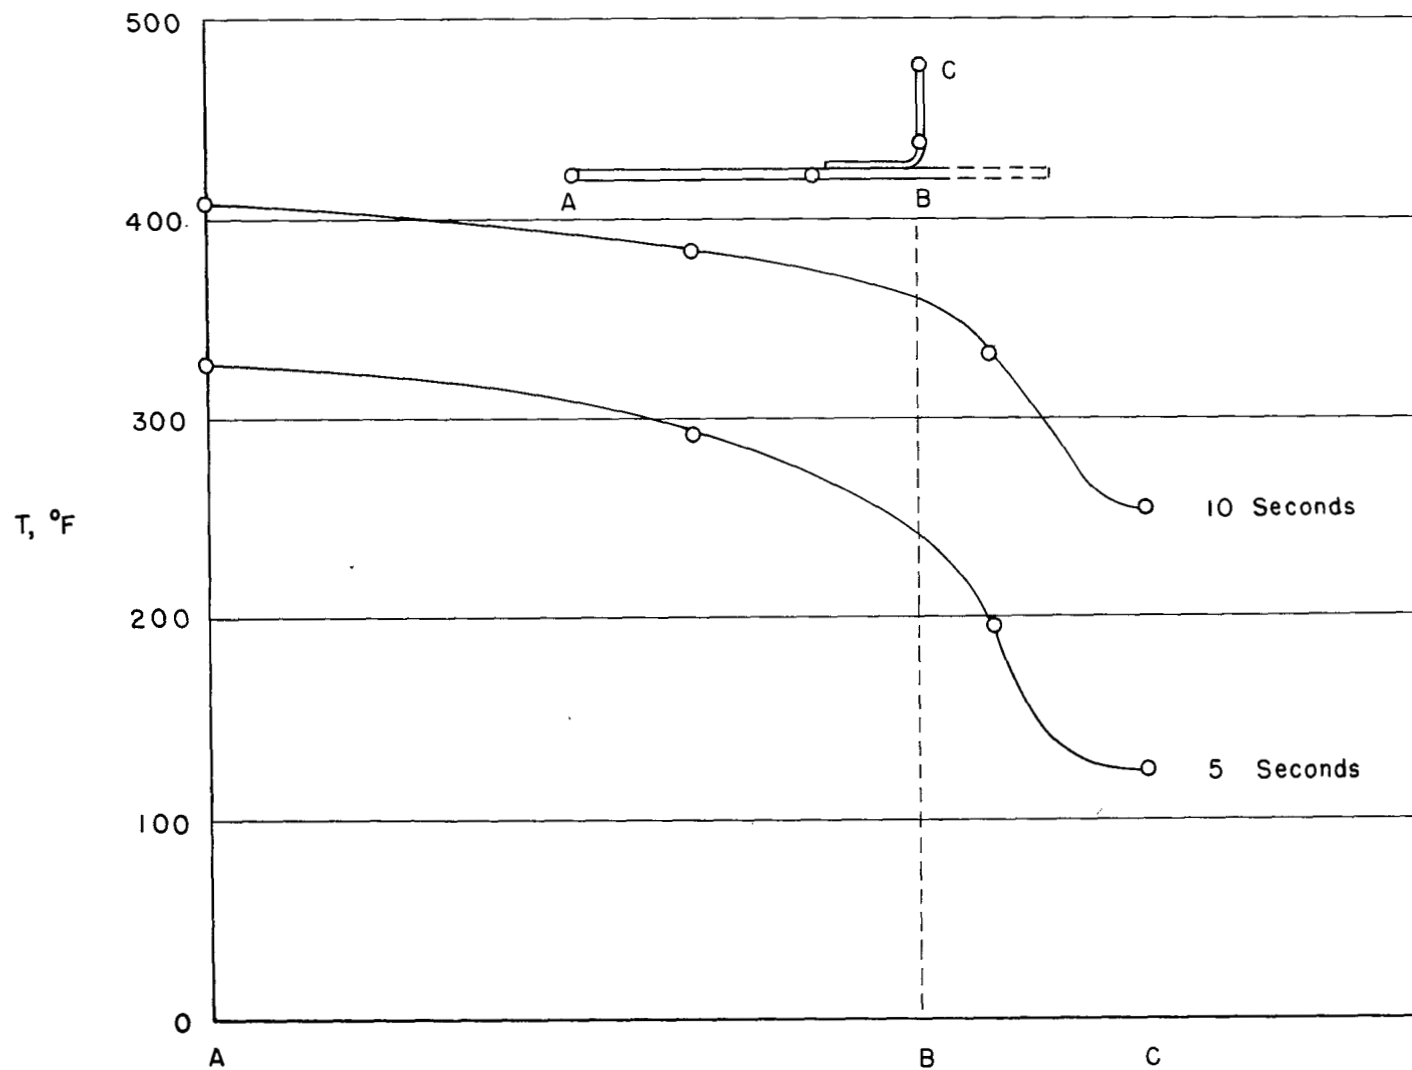
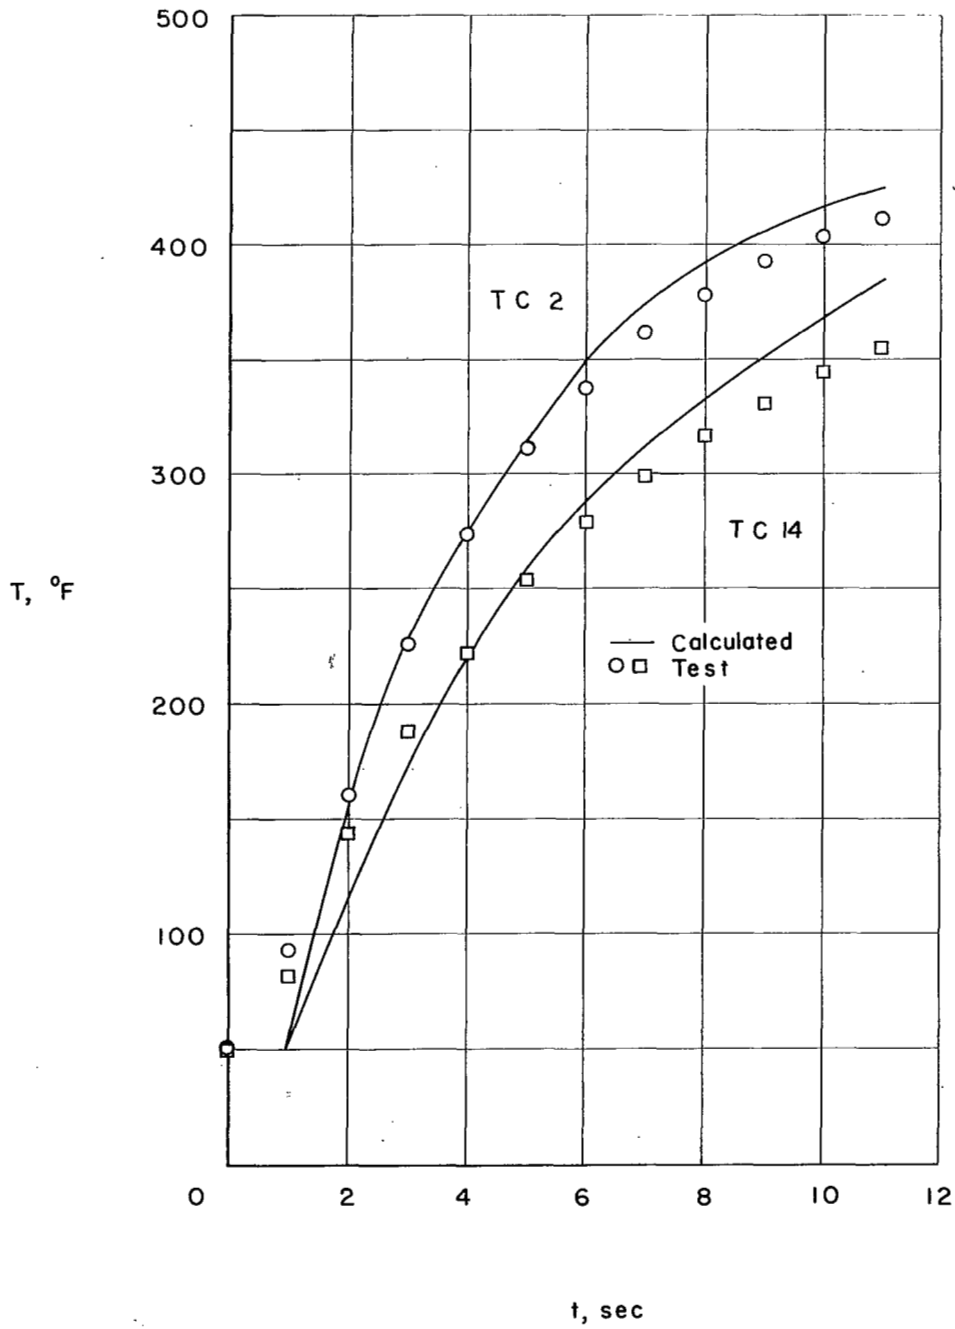
Figure 11.- Temperature distribution in skin and web combination. Model MW-6.

Figure 11 shows the temperature distribution in a skin and web com-
bination in the third bay from the leading edge of model MW-6 at 5 and
10 seconds after air began to flow from the nozzle. The general nature
of the distribution was typical of all of the other skin and web combi-
nations, and conformed to what was expected. Temperatures were highest
in the skin midway between webs. Transfer of heat from the skin increased
the web temperature, particularly in the vicinity of the flange and
decreased the skin temperature near the webs. Lowest temperature was in
the web midway between the skins.

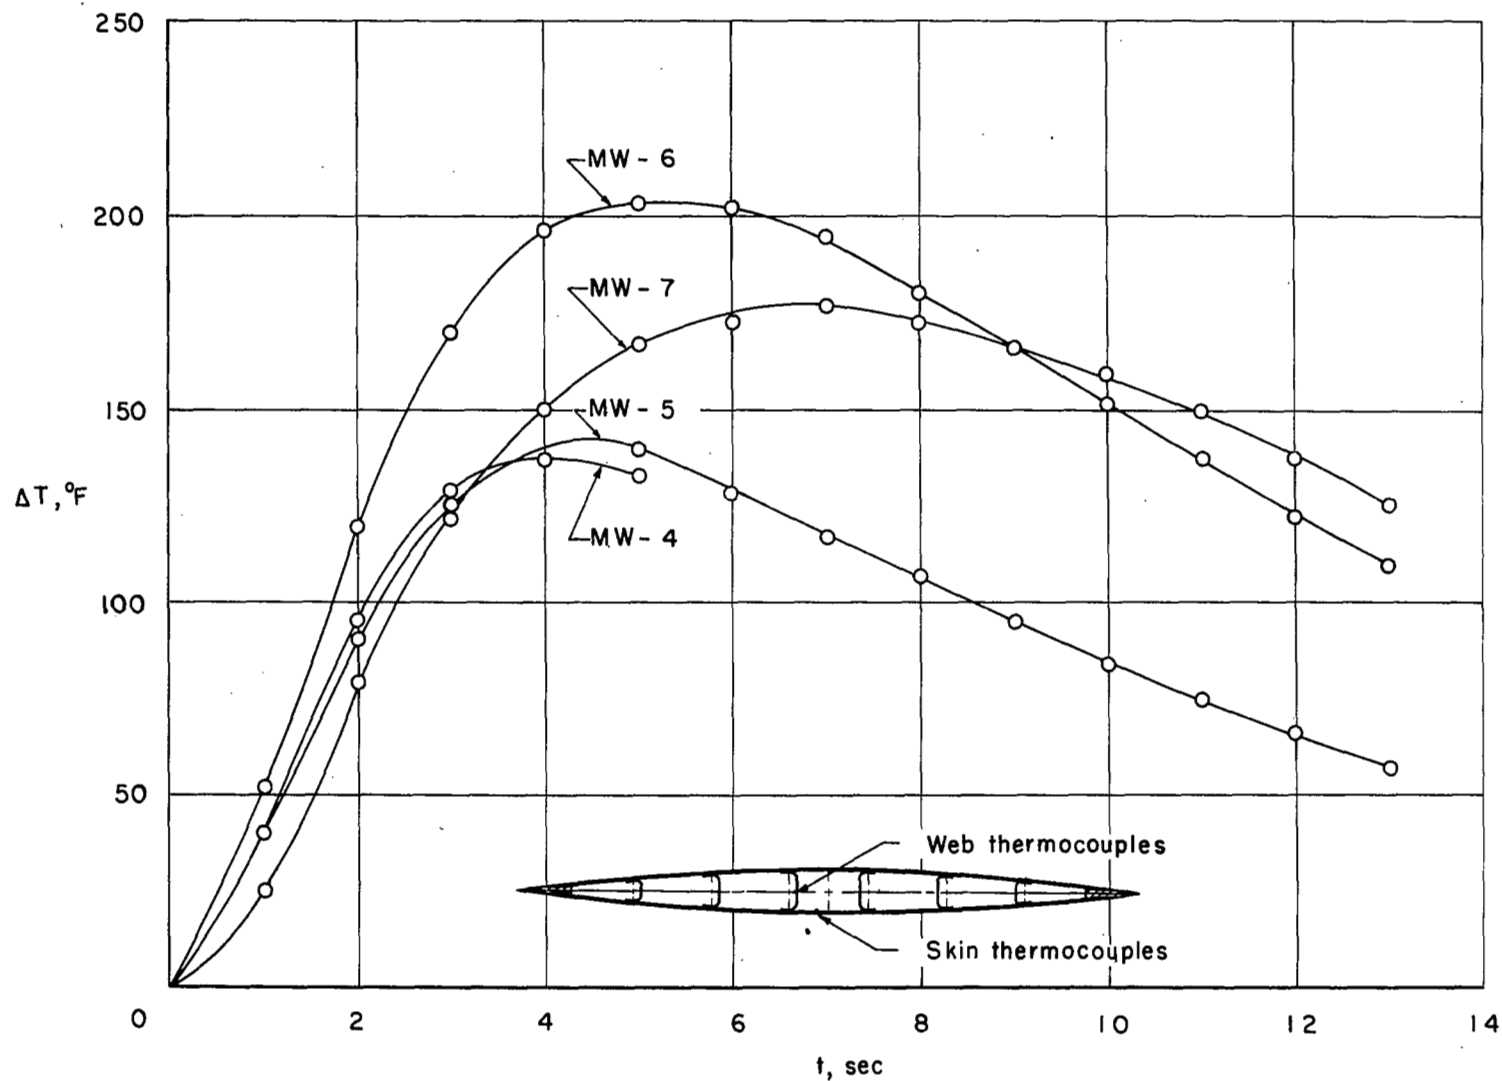
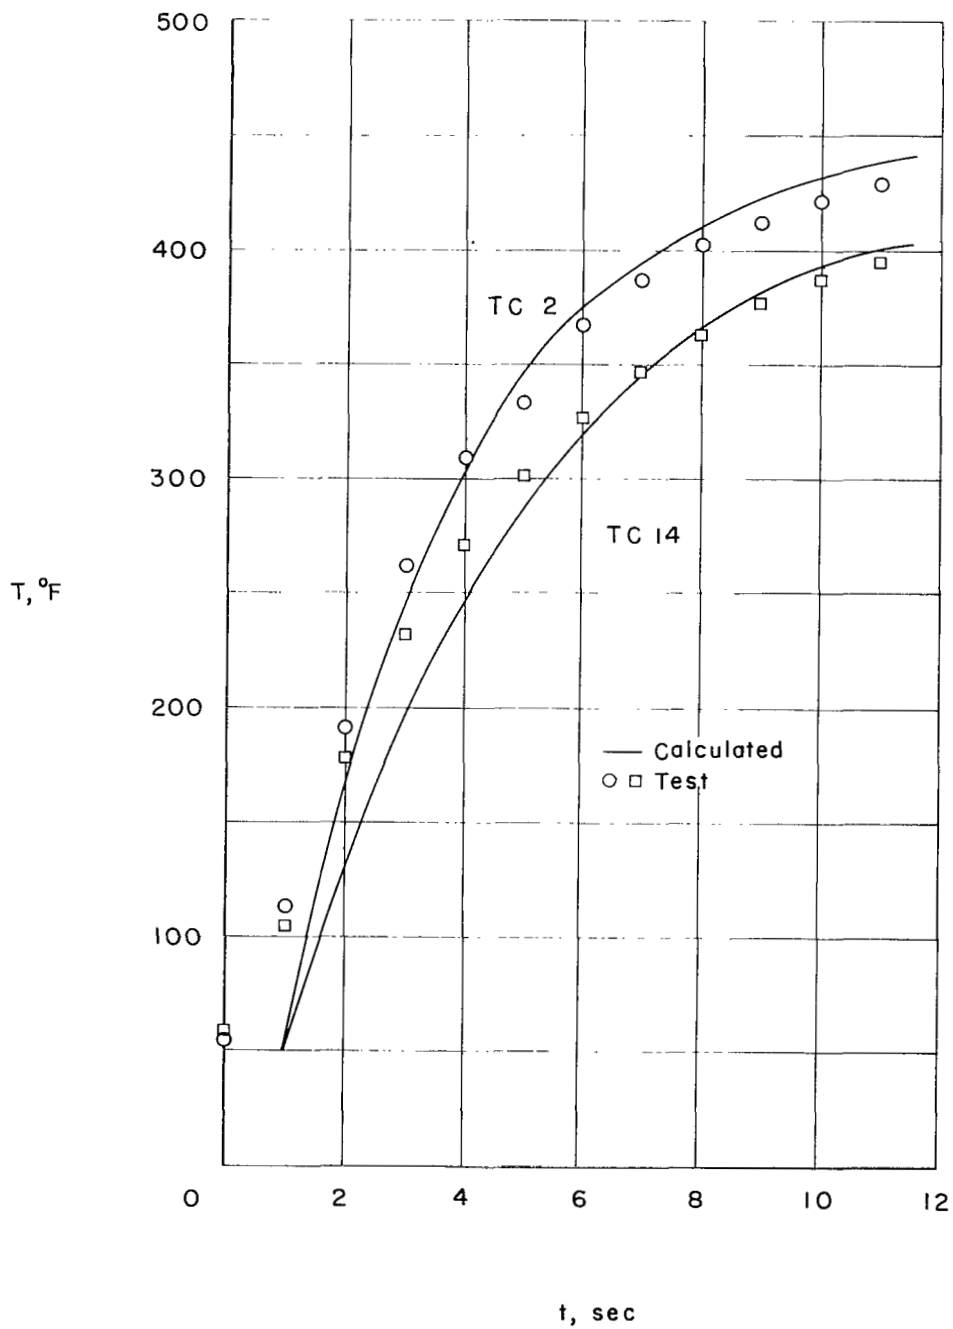
Figure 12.- Difference between skin and web temperatures.

value of thermal conductivity of the steel undoubtedly contributed to
lower interior (web) temperatures and thus to an increase in temperature
differences and to a later time at which the maximum temperature differ-
ence occurred in the test on model MW-7. Figure 12 shows that the alumi-
num models reached the point of maximum temperature difference in about 4
to 5 seconds, whereas the corresponding point for the steel model occurred
at about 7 seconds.
