TECHNICAL NOTE

No. 1432

CHANGES FOUND ON RUN-IN AND SCUFFED SURFACES OF STEEL, CHROME PLATE, AND CAST IRON

By J. N. Good and Douglas Godfrey

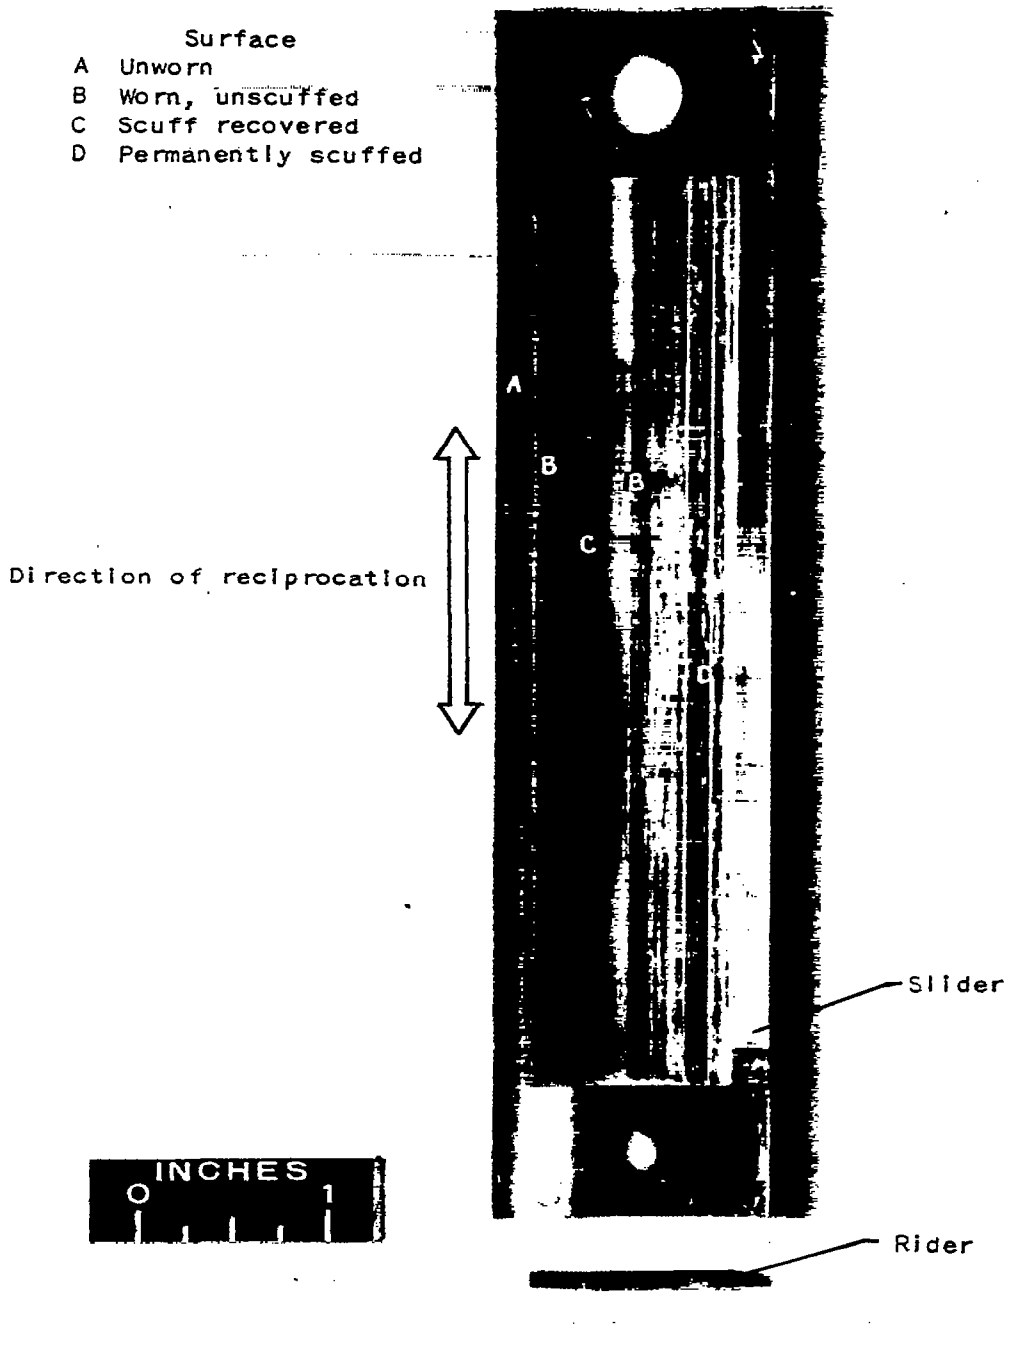
Figure 2. - Run-in and scuffed SAE 4140 steel slider and cast-iron rider showing types of surface on slider.

With the slider-rider combination of SAE 4140 steel and cast iron, several conditions occurred successively in strips, or zones, on the steel slider (fig. 2). The production of more than one surface condition on one specimen was due to slightly imperfect mating of rider and slider. The manner in which surface changes progressed represents various steps in increased loading until failure. Identification of the surface conditions is as follows: A represents the original unworn (unrun) surface; B represents a worn but unscuffed surface; and C represents a surface that appeared to have entered an initial condition of scuff rather early in the experiment but to have almost immediately recovered. Close observation during the run revealed a momentary darkening in color and then a change to dark gray. The permanently scuffed surface that developed in several stages, which succeeded each other within a few seconds, is represented by D. The first stage of formation was indicated by the momentary appearance of a dark-brown or reddish-brown surface color, which changed to black. The change in color was accompanied by the appearance in the recovered oil of a sediment whose major constituent was analyzed as alpha ferric oxide α-Fe_2O_3 by X-ray diffraction methods.

The appearance of bright spots and heavy scuff marks on the surface accompanied by a sharp increase in temperature indicated permanent scuff. It appears that because of the initial imperfect mating a shifting of load took place, which led to variations and irregularities in local load concentrations. Surface B may be considered to have carried a large portion of the load during the mating procedure and therefore to have been able to support the load as it was increased. As the load was increased, surface C suddenly appeared. This appearance occurred as a result, possibly, of slight warping as the temperature rose and because surface C may have been insufficiently mated at the time the load increased. As the load was further increased, strip D appeared, possibly because of a combination of higher load and further warping until the surface scuffed rapidly with so much progressive damage that the scuff became extensive and permanent.

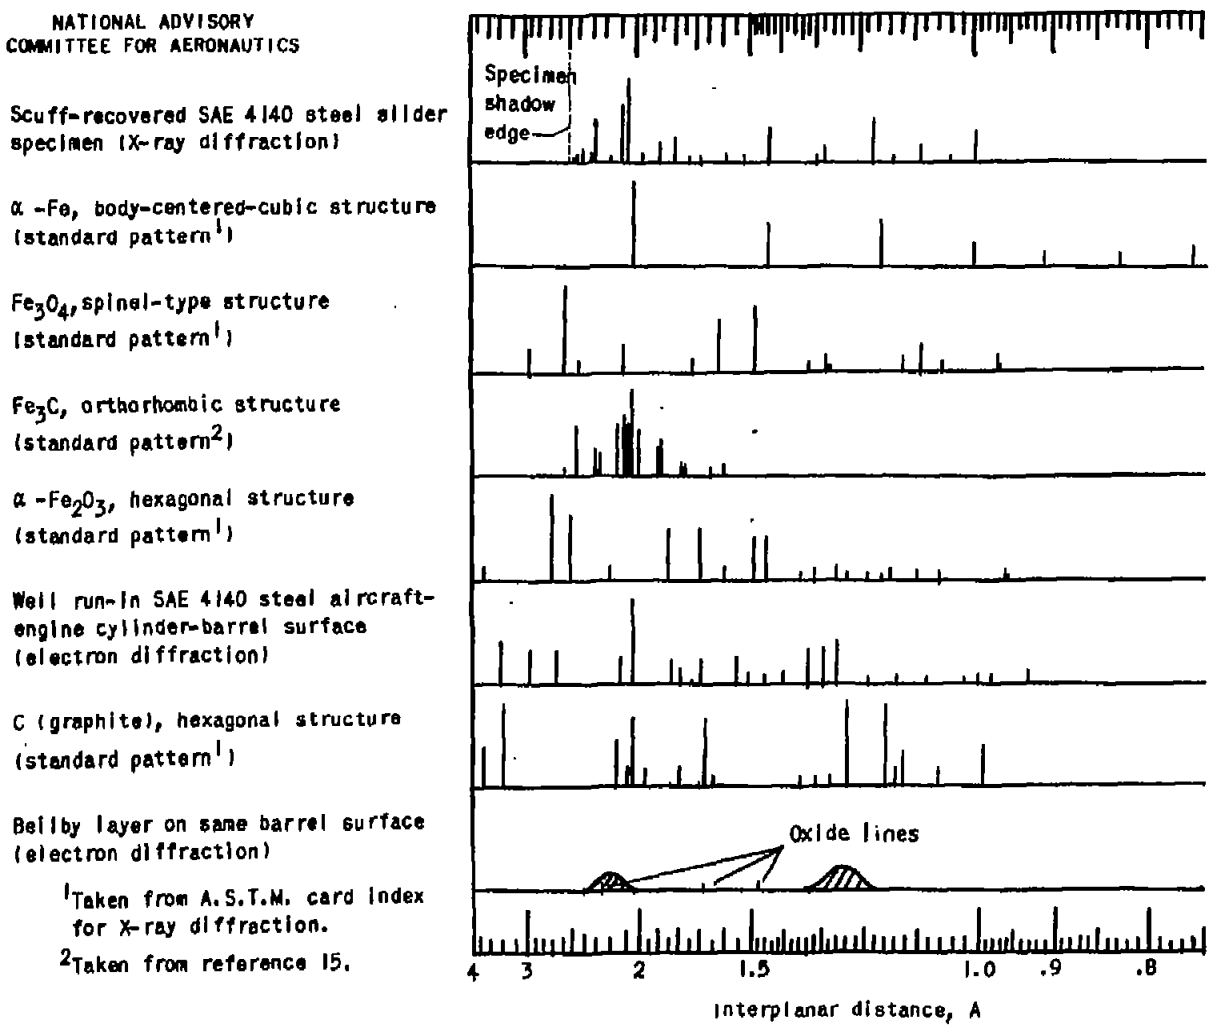
Figure 3. - Typical electron and X-ray diffraction patterns from surfaces of specimens of SAE 4140 steel slider and aircraft-engine cylinder barrel and standard X-ray diffraction patterns of materials identified.

Identification of alpha iron, α-Fe, ferrosoferric (ferrosic) oxide, Fe_3O_4, and iron carbide, Fe_3C, in these surfaces was made by X-ray diffraction. (See fig. 3.) (Whenever Fe_3O_4 is mentioned herein, the possibility that it could also be γ-Fe_2O_3 should be considered, because the two are indistinguishable by usual diffraction methods.) On all four surfaces (A, B, C, and D), Fe_3O_4 was considered present and gave an apparent maximum diffraction intensity for scuff-recovered and a decreased intensity for scuffed conditions as judged from the number of lines and from the changes in visual intensity. The identification of Fe_2O_3 on surfaces B, C, and D was questionable. Iron carbide was identified on the scuffed surface D and questionably identified on scuff-recovered surface C. The intensities were greater for the scuffed than the scuff-recovered surface. No Fe_3C was identified on the unscuffed surfaces.

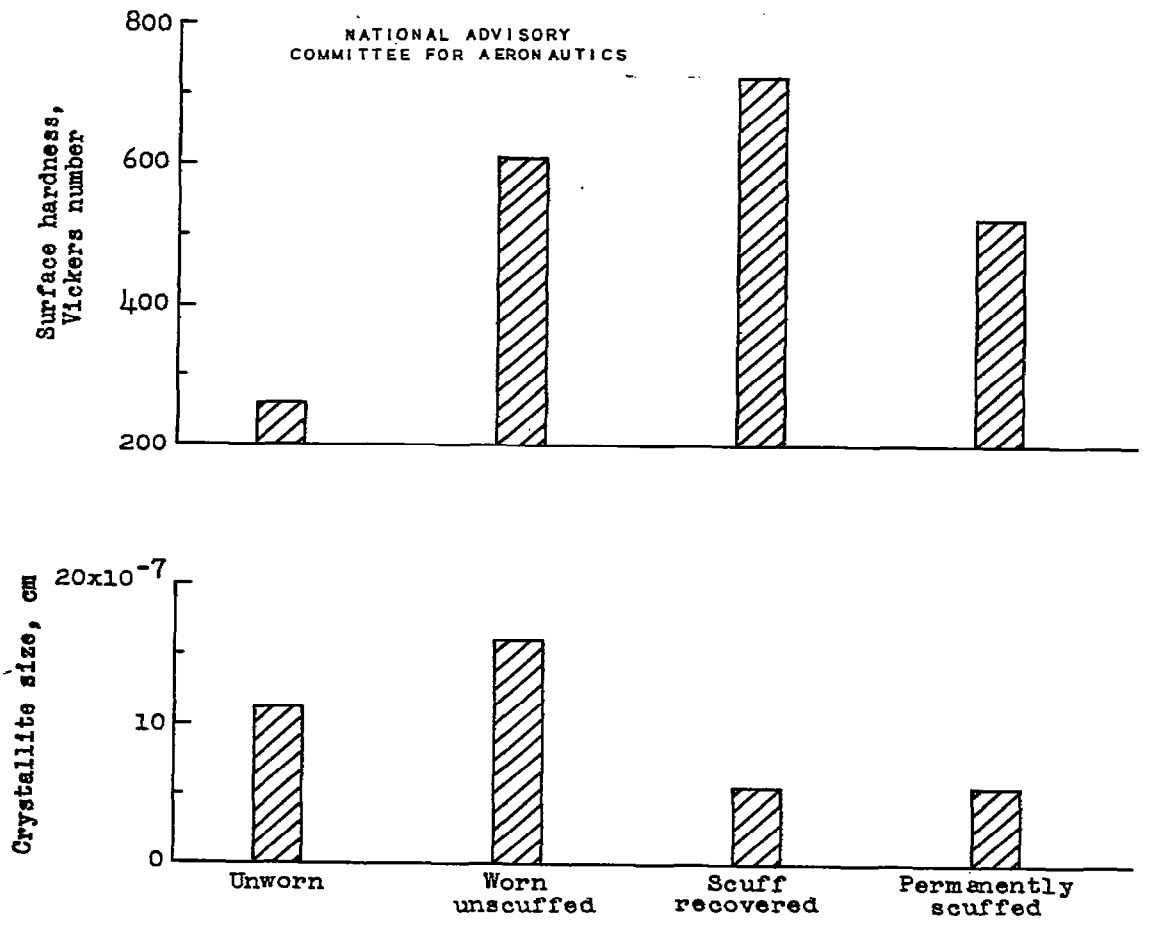
Figure 4. - Relation between surface changes and surface condition of SAE 4140 steel slider specimens.

The results of the determination of crystalite sizes are presented in figure 4 and the X-ray patterns showing the differences are shown in figure 5. The hardness of the four surface conditions is also shown in figure 4; maximum hardness existed on the scuff-recovered surface.

The crystallite size and the hardness of the wearing surfaces are possibly as important as the chemical reactions. The relations between crystallite size and hardness for steel, chrome, and cast iron vary as shown in figures 4 and 9 and are somewhat complex. The average hardness of the SAE 4140 steel for the scuffed and scuff-recovered surfaces was greater than the average hardness of the unscuffed surfaces, and by similar comparison the crystallite size was smaller. In conjunction with these facts, the formation of the iron oxides and carbide on the scuffed surfaces is noted. If the change in hardness is to be attributed

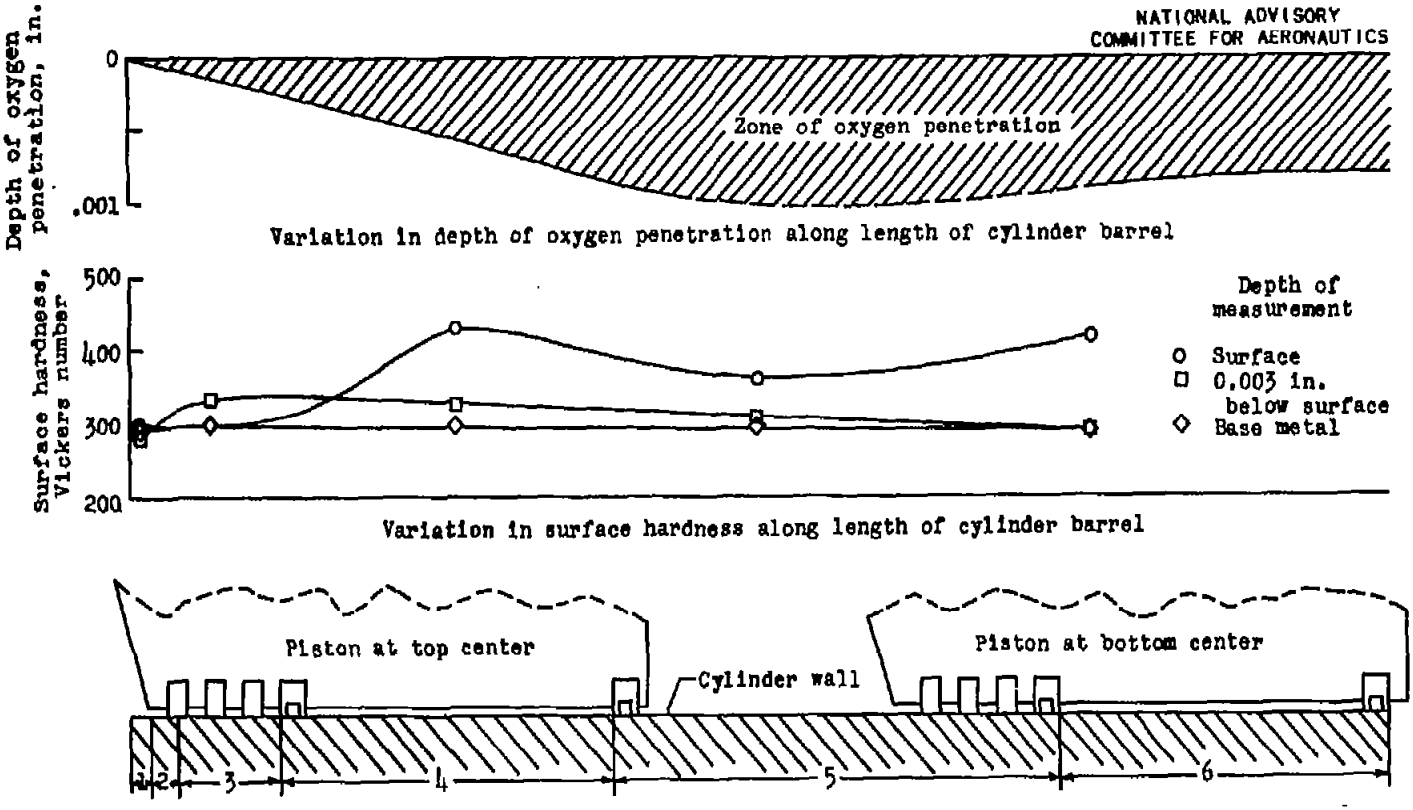
Figure 6. - Relations among surface condition, material hardness, and depth of oxygen penetration found on worn – unscuffed SAE 4140 steel aircraft-engine cylinder barrel.

This oxidation is shown in more detail in figure 6 and is labeled depth of oxygen penetration. Oxides existed beneath the surface of the metal everywhere the cylinder had been rubbed. The top 1/8 inch of the barrel was subjected to conditions within the combustion chamber but to no rubbing during engine operation because it was above the region of piston contact. In that top area the oxide existed only as a tenacious blue surface film under a carbon deposit. Variation in surface hardness is plotted on the same abscissa as the oxygen data in figure 6. These data were taken at five representative points along the barrel length.

The wear profile of engine cylinders showed a depression, or highest wear, at the top of compression-ring travel. In this region of high wear where less oxygen penetration seemed to have occurred, the surface had been worn away almost as fast as the penetration progressed. Farther down the length of the cylinder barrel the rate of oxygen penetration seemed to exceed the rate of wear. As a result, oxides formed within a relatively pliable matrix of steel and possibly gave rise to a desirable surface, combining pliability with decreased abrasion, which was continually renewed under the slow abrasion of operating wear.

Area number	Location of area on cylinder wall with reference to piston	Piston position	Surface condition
1	Above piston travel	----------	Thin oxide film, no wear
2	Opposite top land	Top center	Light pitting
3	Opposite compression rings	Top center	Heavier pitting and wear
4	Opposite skirt (high sliding speeds)	Top center	Light pitting
5	Opposite compression rings	Bottom center	Low wear
6	Opposite skirt	Bottom center	Very low wear

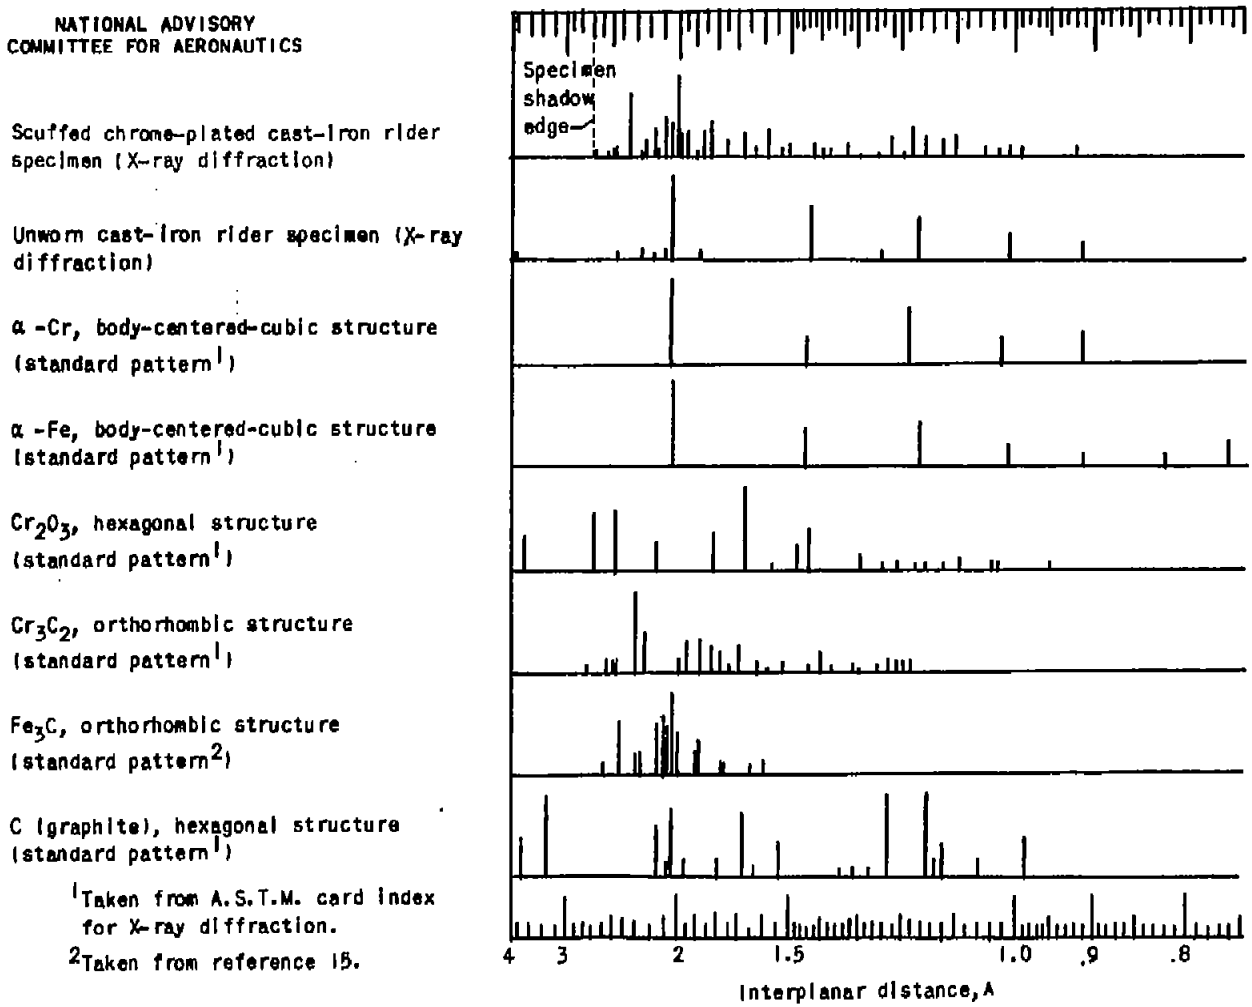
Figure 7. - Typical electron and X-ray diffraction patterns from specimens of chrome-plated cast-iron and cast-iron riders and standard X-ray diffraction patterns of materials identified.

The chrome pattern predominates in all the surface X-ray diffraction patterns. Diffraction examination showed no presence of any chromic oxide, Cr_2O_3, on the unscuffed surface although this surface was expected to contain at least a small amount of this oxide, possibly in the amorphous condition. The compounds Cr_2O_3 and chromium carbide, Cr_3C_2, were easily identified on the burnished and scuffed surfaces. An X-ray diffraction pattern containing evidence for these compounds on the scuffed surface is shown in figure 7. A number of diffraction lines that stand alone and belong to none of the previously mentioned compounds may be parts of the diffraction patterns of Fe_2O_3, Fe_3O_4, the chromium nitrides, Cr_2N and CrN, the chromium carbides, $Cr_{23}C_6$, Cr_7C_3, and also Fe_3C (on the scuffed surfaces). No completely reliable quantitative trends could be found because of some difficulty in rating diffraction intensities, but the intensities of Cr_2O_3 and Cr_3C_2 appear to be greater on the scuffed than on the burnished portion. Under the microscope, patches of loose-appearing material with the color and texture of red and black iron oxides and giving dissolution reactions for iron were observed in the surface depressions, apparently as left after pickup from the mating steel slider.

Two cast-iron slider specimens were examined that had been subjected respectively to a normal and to a prolonged run-in procedure. The prolonged run-in increased load-carrying capacity. Figure 7 lists an X-ray diffraction pattern from an unrun surface showing the presence of α-Fe and one weak ring (interplanar spacing, 4.5 A) that coincides with the strongest line of the graphite pattern. A number of weak lines and one strong line coincide with all the strong lines of Fe_3C, and several unidentified lines also show. On all the surfaces, α-Fe was observed. The presence of graphite was more completely indicated on the worn and scuffed surfaces. Hardness values showed decrease as scuff condition was approached (fig. 9) and crystallite sizes increased.

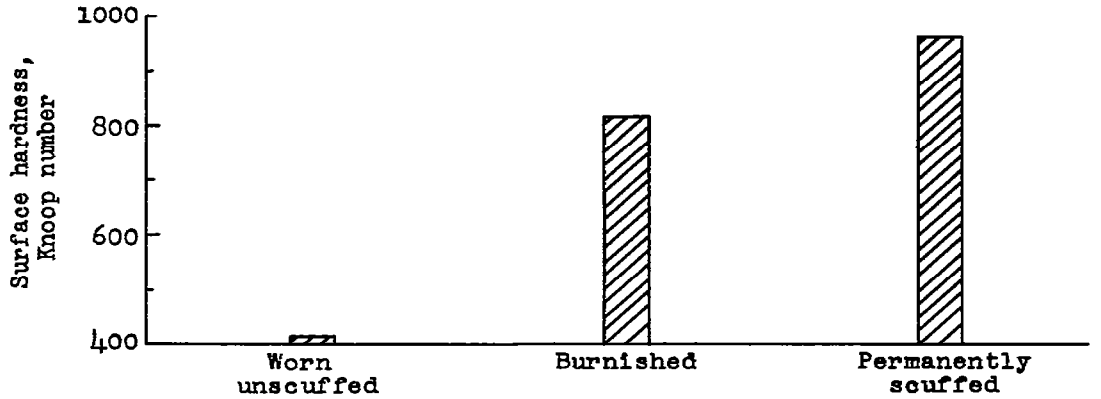
Figure 8. - Relation between hardness and surface condition of chrome-plated cast-iron rider specimen.

The variations in hardness among the different surface conditions are graphically illustrated in figure 8. Crystallite-size determination showed no large differences. A decrease in crystallite size was expected approaching scuff and such a trend was indicated, but the differences were within experimental error. The sizes were of the order of 14×10^{-7} centimeters.

The hardness of the chrome surface increased markedly for the burnished surface condition and corresponded with the formation of Cr_2O_3 and Cr_3C_2. The cast iron softened throughout the runs and the crystallite size increased. The end result at scuff was approximately the same for normal and for prolonged run-in. The prolonged-run-in surface, having the higher load at failure, showed slightly less softening than the normal-run-in surface. The more pronounced crystallite-size increase for the worn-unscuffed surface under prolonged run-in seems incompatible with increased resistance to failure. Chemical changes may account for the reversed trend for this material with respect to the over-all trend associated with the other materials, although such changes were undetectable in this case. Relatively, an opposite trend is indicated for any one of these materials when the change in hardness is compared with change in crystallite size between unscuffed and scuffed surface conditions.
