TECHNICAL NOTE 3775

CRASH INJURY

By Gerard J. Pesman and A. Martin Eiband

Lewis Flight Propulsion Laboratory
Cleveland, Ohio

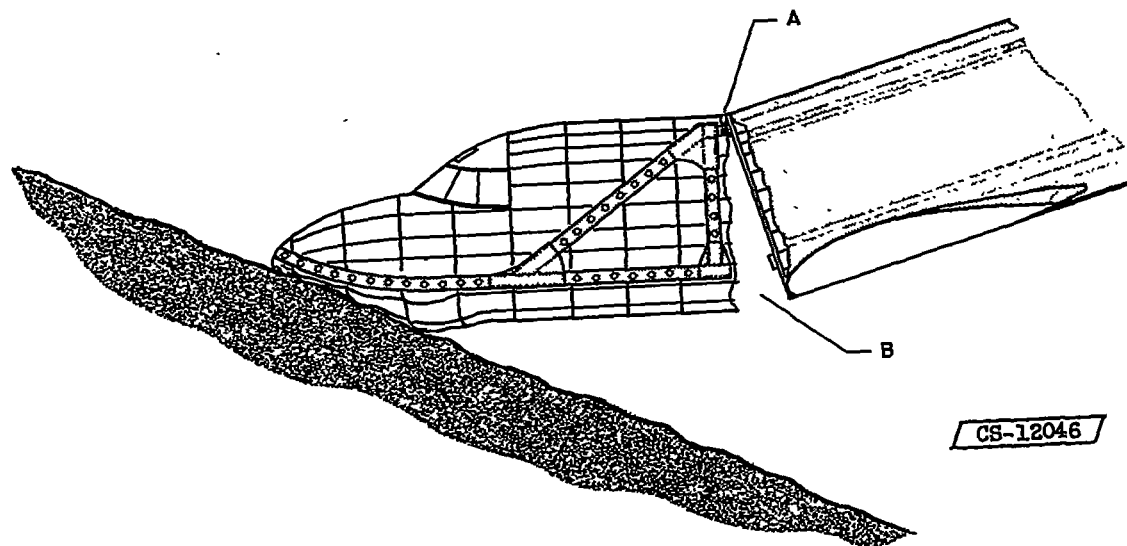
The hinging action apparent in the crash just described might be deliberately emphasized in designing the airplane structure. The general principle is indicated by figure 3. It is not implied, however, that the structure should be constructed as shown. If the forward compartment is so constructed that it is essentially a cantilever structure with a strong floor, then it can support and lift the occupants (fig. 3). If the compartment is also designed so that it can hinge at a point above the leading edge of the wing (point A), then the compartment can hinge and lift. The bottom members (at point B) should be connected to carry the front-landing-gear loads but should be weak enough to break when a crash impact occurs. Deliberately applying this principle in the design of an airplane would be difficult because of conflicting structural requirements. Any compromise, however, that would favor this hinging-lifting principle would be one step that would help to reduce the crushing hazard.

Figure 3. - Crush-resistant cabin lifting at impact.

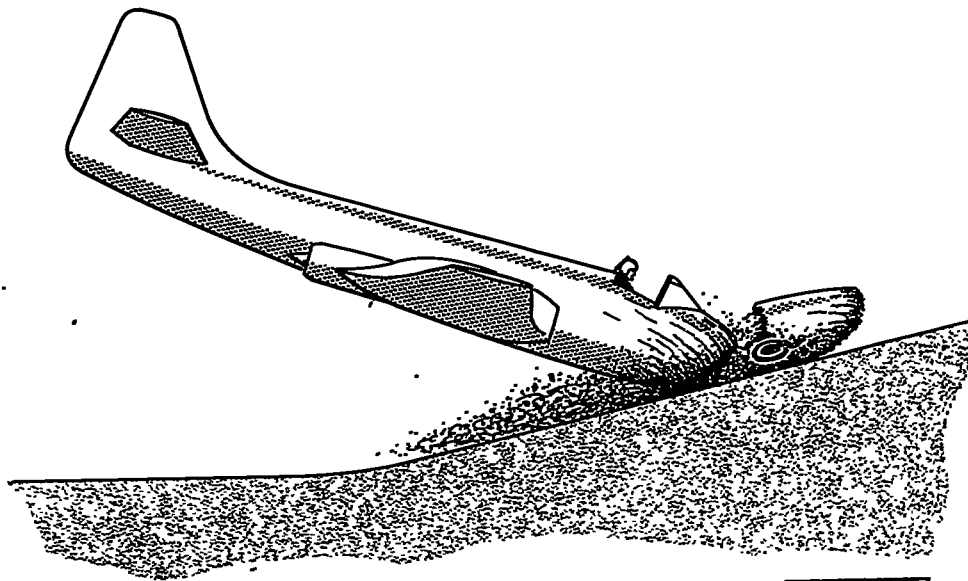
CS-12147

When the understructure does not tear along the floor line, then the occupied compartment can be pulled under the sliding airplane. This action is shown by figure 5. Immediately after the initial impact, the nose section of the airplane back to the front cockpit bulkhead crushed, lifted, and then broke free. The lower edge of the cockpit then dug into the ground and the cockpit began to pull down and under the airplane.

Figure 5. - Destruction of pilot's compartment.

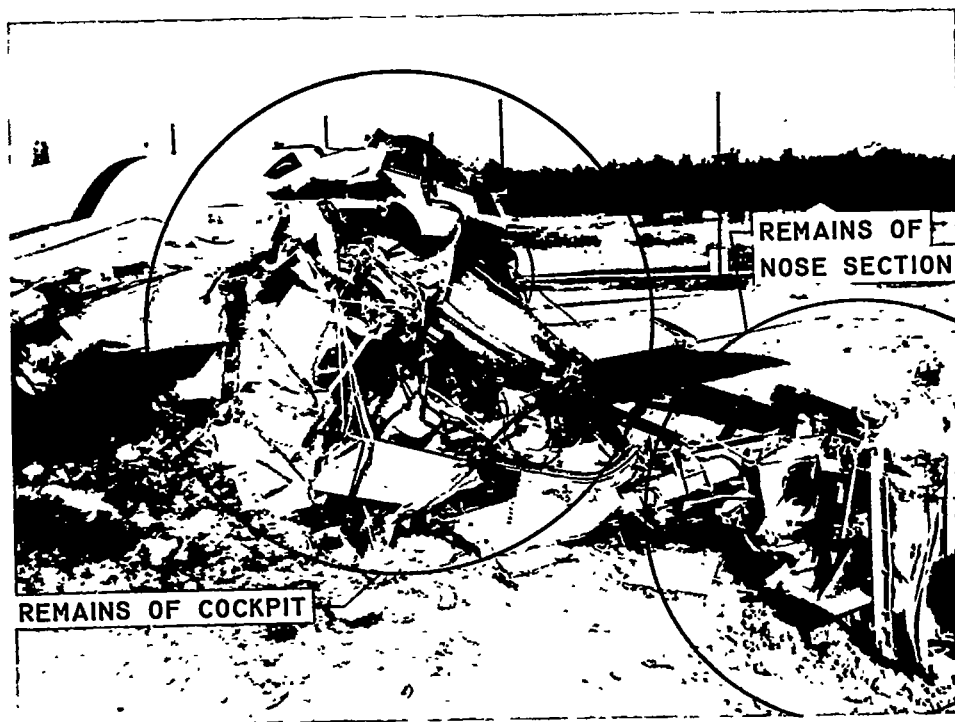
CS-12036

When the airplane had stopped, the cockpit appeared as in figure 6. The remains of the detached nose wreckage are shown at the right, the cockpit wreckage, wings, and part of the fuselage on the left. Figure 7 is a closer view of the cockpit zone. Part of the cockpit structure had been pulled under the airplane. The dummy's head, one shoulder, body, and one thigh can be seen. From the dummy's position, it can be seen that it would also have been pulled under if the airplane had continued to slide. Comparison of the crushing action in this crash with that in the cargo airplane crash shows that if the forward fuselage structure is designed to tear free below the floor line, as well as hinging and lifting, the crushing hazard is further reduced. This principle is shown by figure 8. Again, the figure portrays the principle, not a suggested structure.

Figure 6. - Front fuselage structure nearly pulled under sliding airplane.

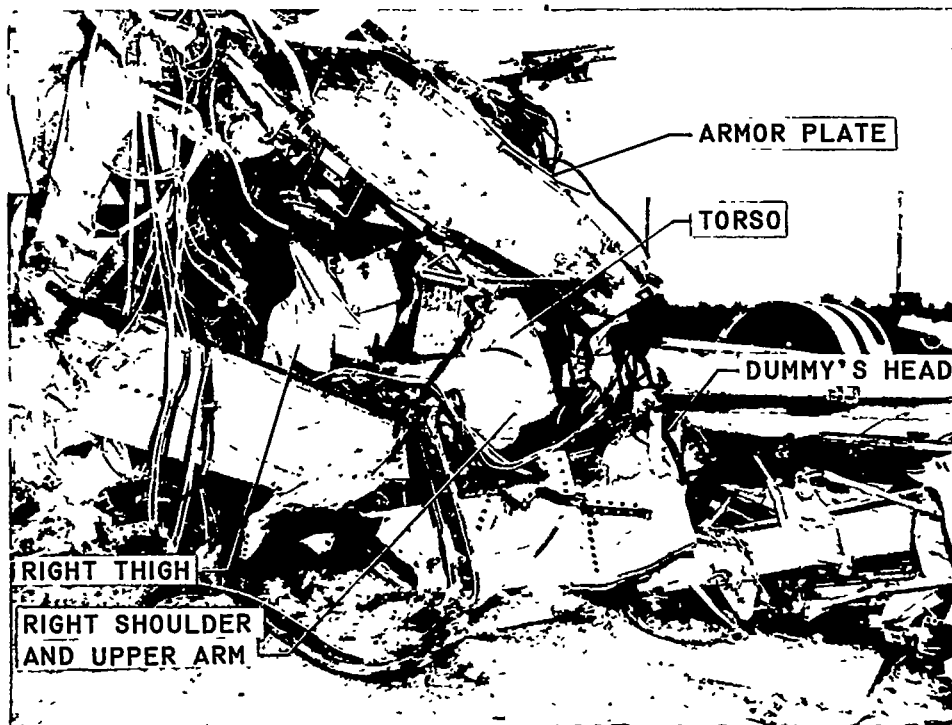
Figure 7. - Close-up of front fuselage structure nearly pulled
under sliding airplane.

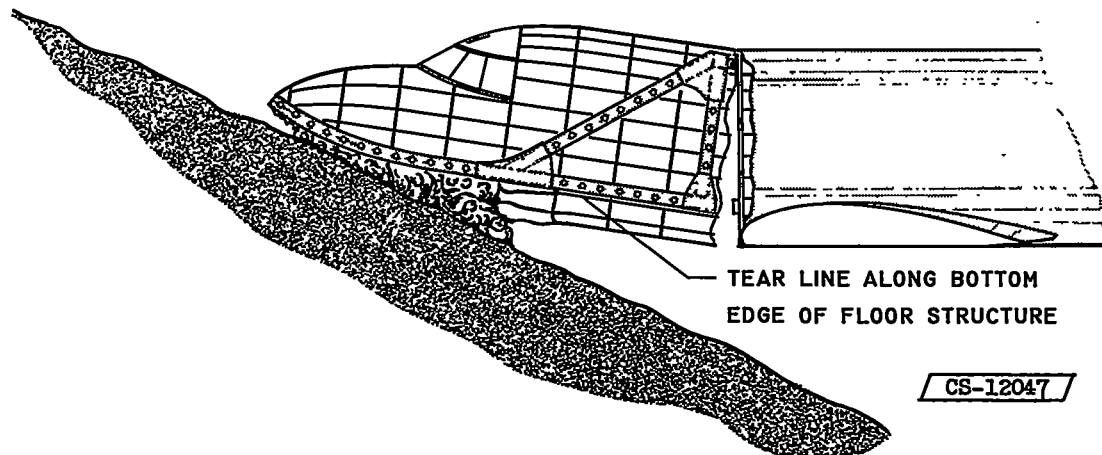
Figure 8. - Crush resistant cabin with understructure tearing away.

Deliberately incorporating the lifting-hinging and the tear-line principles may not be practical. If any choice is possible, however, the design that permits the fuselage to hinge up during the initial impact and that permits the structure to tear free at the floor line should be favored.

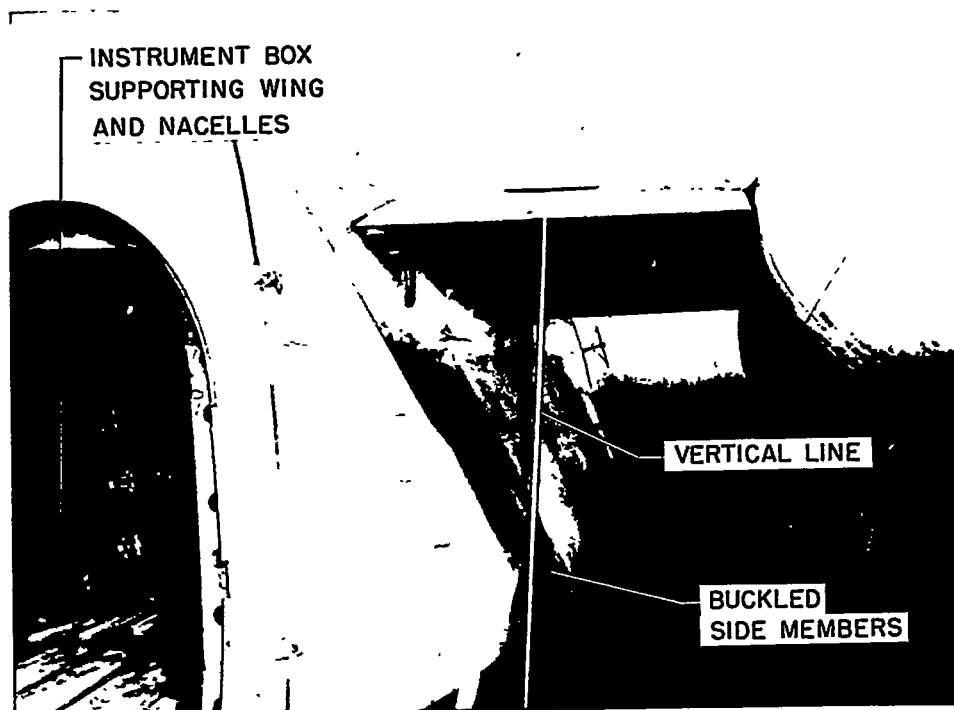
The crushing just discussed is caused by the forward motion of the airplane. If the airplane slides sideways, or ground loops, then large side loads are applied to the fuselage structure. Most transport airplanes have a circular or oval cross section that can resist these side loads rather well. Airplanes that must use a rectangular cross section usually cannot carry heavy side loads. The fuselage framing collapses sideways and crushes the occupants. An example of such collapse is shown by figure 9. The airplane ground looped during the experimental crash. The heavy steel instrument box seen through the rear door kept the fuselage from collapsing completely.

Figure 9. - Airplane with rectangular cross section after ground-
loop crash.

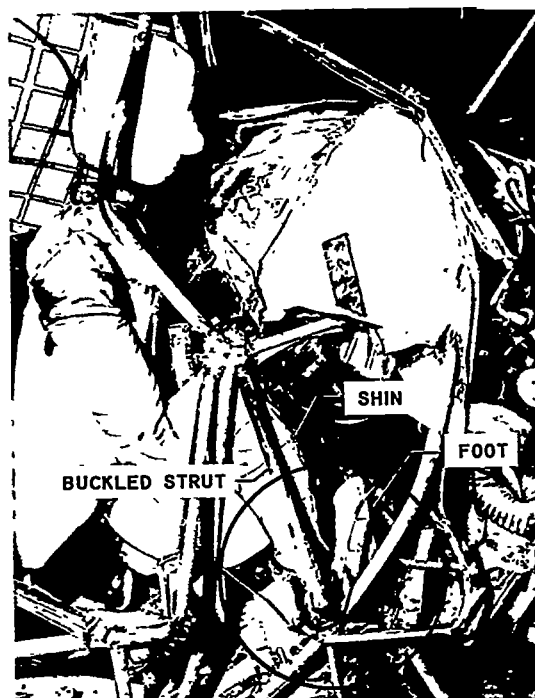
The collapse of secondary structures such as seats, or the partial collapse of the cabin structure, can also threaten survival. Occupants can be trapped or pinned in the wreckage although they may not be severely injured. An example is shown by figure 10, which shows a side view of a light-plane fuselage after an experimental crash. The dummy's foot was pinned in the wreckage by the buckled strut. Its foot was bent up nearly parallel to its shin. A person in similar circumstances would not have been severely injured, but escape would have been impossible, and rescue would have been difficult. If such trapping occurs during a ditching or crash fire, the results might be fatal.

Figure 10. - Foot trapped by bent structural brace.

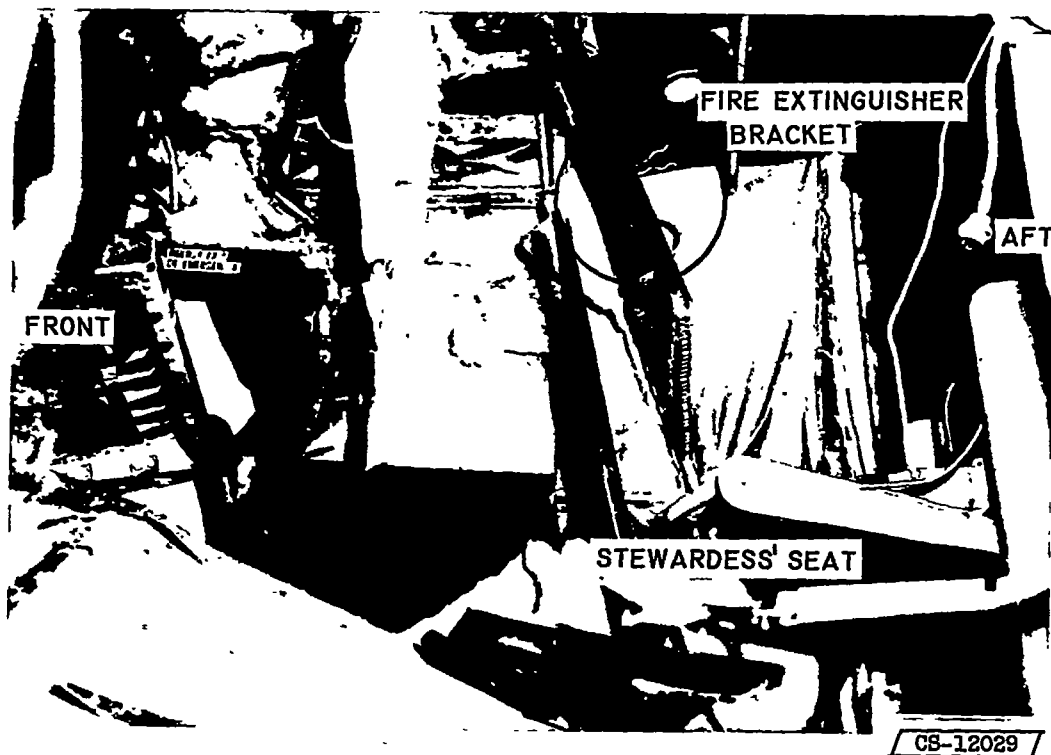
Similar incidents occur in actual accidents. During one crash, the fire extinguisher held by brackets on the bulkhead hit the stewardess seated at her normal place and knocked her unconscious (fig. 12). This hazard can be readily eliminated by designing the brackets for such equipment to withstand the crash impact loads.

Figure 12. - Empty bracket for fire extinguisher which broke away and struck stewardess.

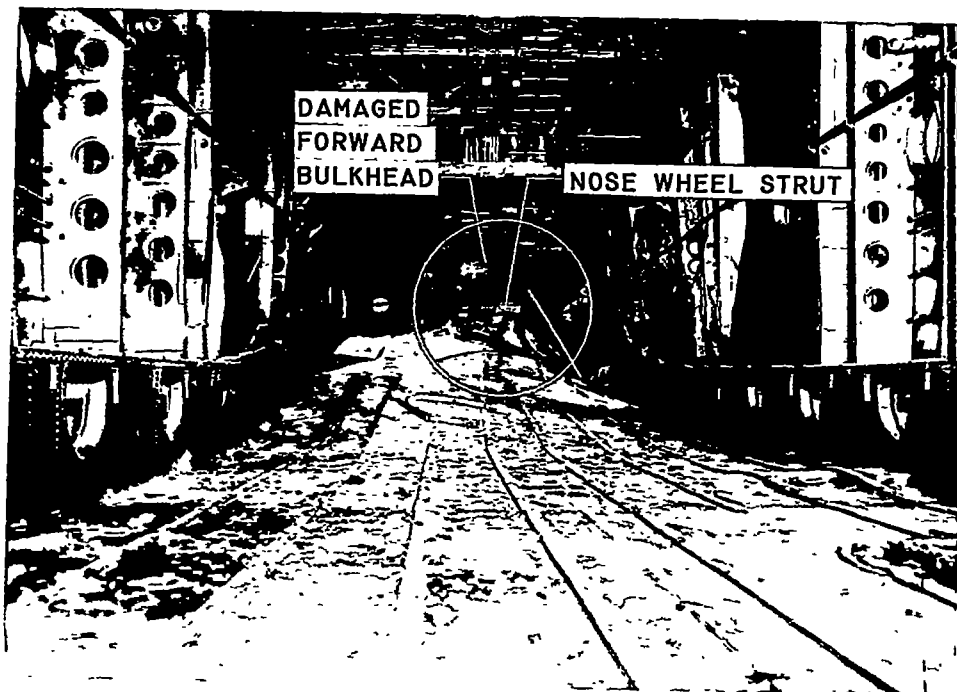
The front landing wheel assembly and the propellers can also produce missiles that may enter occupied zones. If a nose wheel is torn off by an obstacle, it can be driven back into the airplane, or it may be tangled with the debris under the belly and work its way through the floor. The results of such an incident can be seen in figure 13. This view was taken looking forward in the fuselage. The nose gear entered the fuselage a few feet behind the main forward bulkhead. The nose wheel strut can be seen protruding from the floor.

Figure 13. - Nose gear driven into cabin.

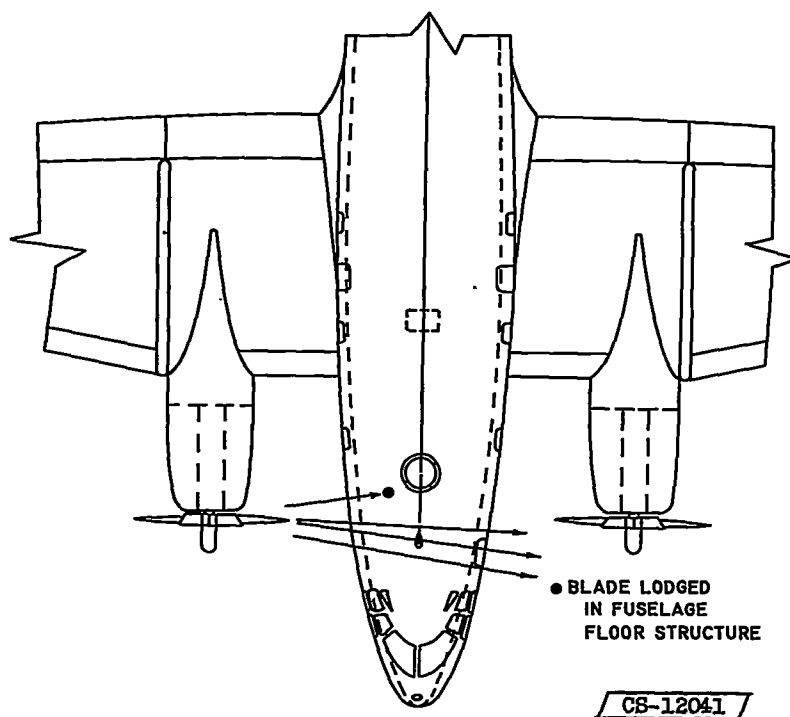
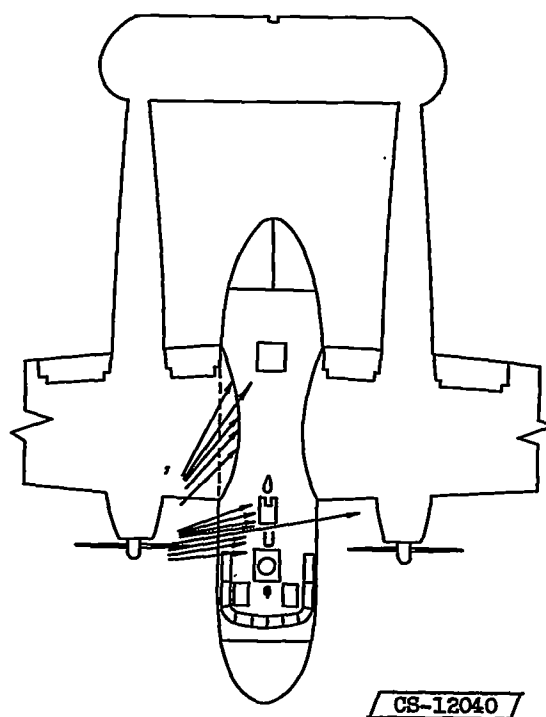
Although these missiles are obviously dangerous, fortunately the penetrations usually lie within an angle of about 30° of either side of the propeller disk. Figure 17(a) shows the paths of the detached propeller blades for four experimental crashes. The results from figure 16 agree with those shown by figure 17.

Forged aluminum propeller blades break off at the tips instead of twisting out of the hubs. Each blade can produce one, two, or even three missiles. These fragments scatter over a wider angle because they are of smaller mass and are thus more easily deflected when the blade strikes the ground. The paths of these fragments during 14 crashes are shown by figure 17(b). Few of the fragments have enough kinetic energy to go through both fuselage walls. Fragments deflected through a large angle when striking the ground would be more likely to glance off the fuselage walls instead of cutting through.

Figure 17. - Propeller blade penetration of fuselage.

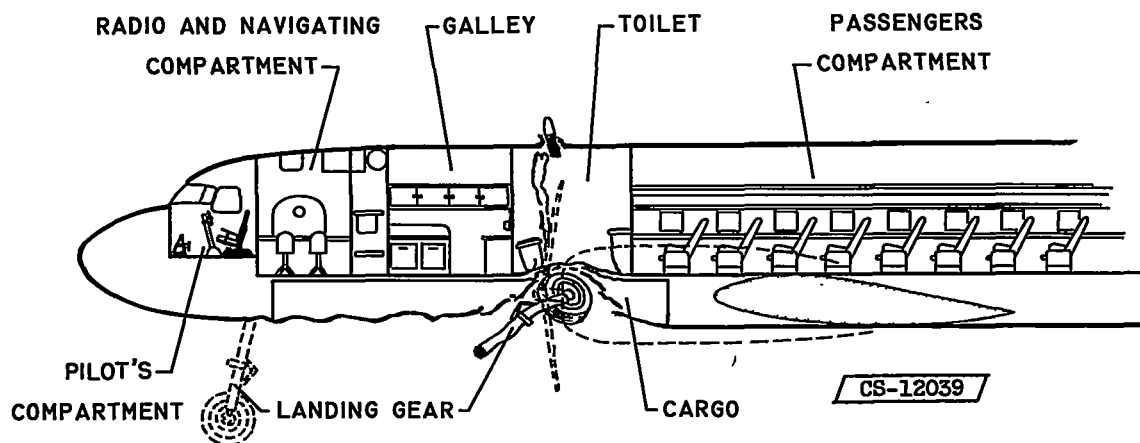
Figure 18. - Cargo and unoccupied zones placed in path of
front landing gear and propeller fragments.

The hazards of both landing gear and propeller parts as missiles can be reduced by locating the baggage holds, the galley, and coat-rack and toilet compartments in the usual paths of these missiles (fig. 18). Some aircraft manufacturers have adopted this idea to a limited extent. The propeller blade hazard can also be reduced by reversing the direction in which the right-side propellers turn. This remedy is discussed in reference 1.

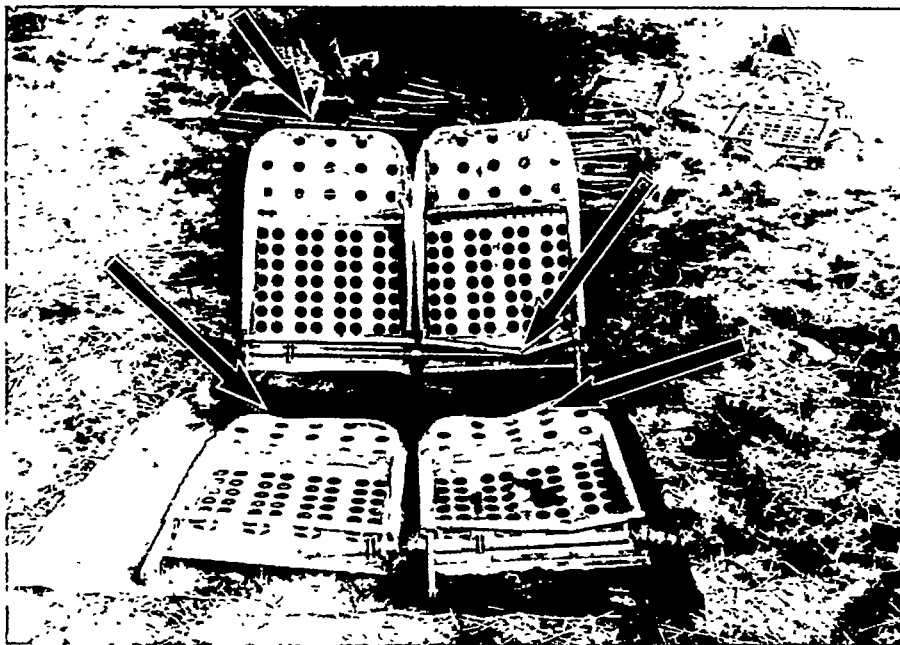
Figure 20. - Seat backs made of easily deformed metal which protect
passengers from impact injury. (Photograph supplied by Aviation
Crash Injury group of Cornell University.)

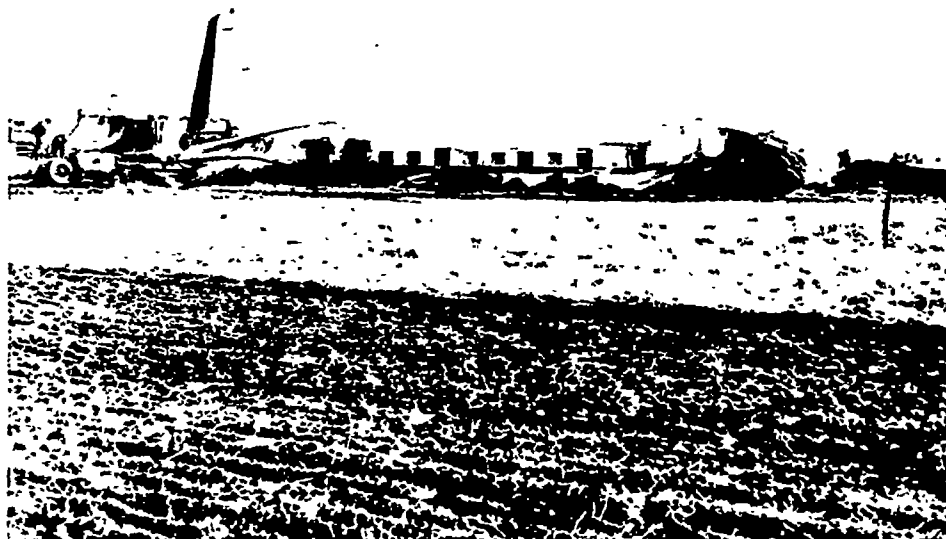
Wreckage from another accident in which many seats pulled loose is shown in figure 22. Broken seats could have been expected in front of the break in the fuselage (fig. 22(a)) because the fuselage structure was severely damaged. Aft of the break, however, the fuselage structure did not appear severely damaged, and little seat damage would have been expected. After the debris had been removed, the cabin appeared as shown in figure 22(b). The floor was badly deformed, and all the passengers' seats except the aft four had come loose (fig. 22(c)).

Figure 22. - Crash in which impact forces destroyed seat attachment
    fittings. (Photographs supplied by Aviation Crash Injury group
    of Cornell University.)

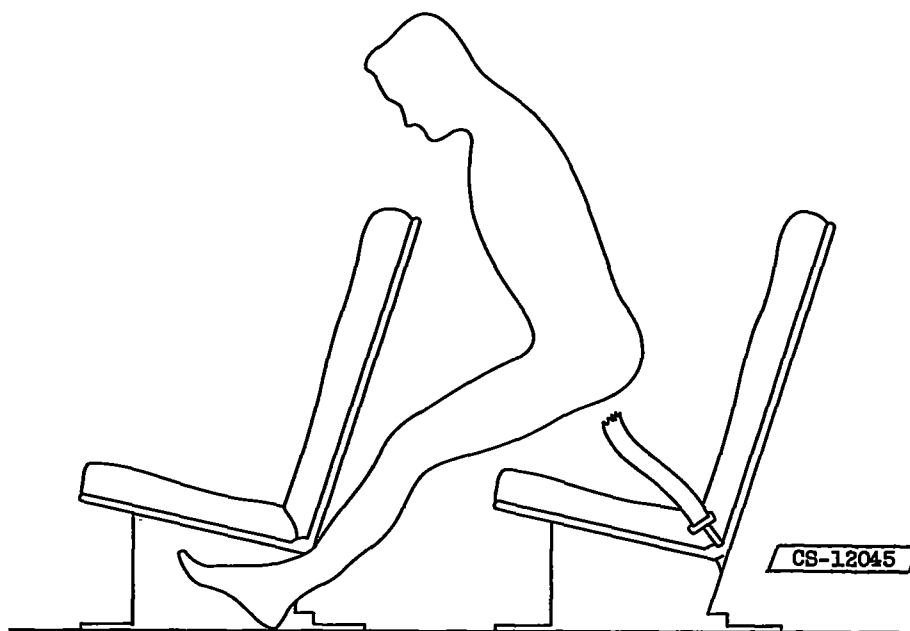
If the seats remain fixed, but a belt fails, then a person's feet can slide under the seat ahead as shown in figure 24. The inertia of a person's body is applied to his shins with the seat structure as a fulcrum. A lower leg fracture is almost certain. Such injuries have occurred and can be avoided if the seat belts are made as strong as the seats.

Figure 24. - Shanks broken by lever action.

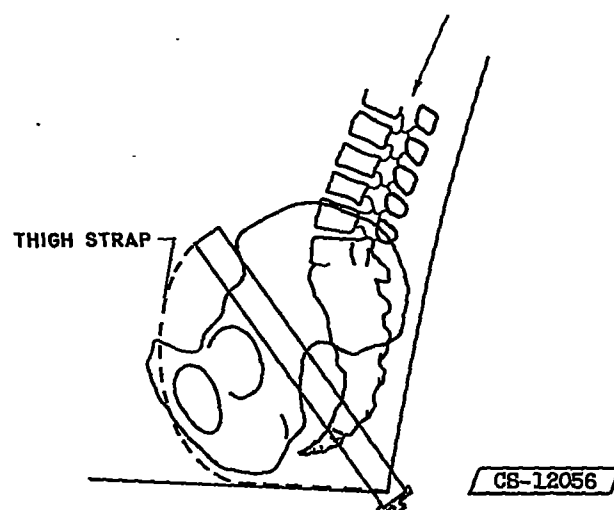
Figure 30. - Vertical reaction of shoulder harness on spine.

There is also a third load transmitted to the spine. The horizontal
load on the shoulder harness introduces a vertical load over the occu-
pant's shoulder (fig. 30).

Considering the manner in which these loads are applied to the spine, it appears that changing the military lap-belt - shoulder-harness combination might reduce the unit vertical load on the vertebrae. The addition of thigh straps (fig. 31) would keep the pelvis from tipping. This would keep the spinal column and pelvis vertical, keep the unit compressive loads on the vertebrae smaller, and increase the load the spine could carry. The animal data (fig. 26) show that this addition would increase the tolerance. Experimental human data are not available to prove this point, however. It seems that a chest strap could also remove some of the load on the spine. The chest strap would take some of the horizontal load off the shoulder harness. This would reduce the vertical component of the shoulder-harness load. If the strap were well up under the arm pits, it could also help support the vertical reaction of the arms and shoulders. Both of these remedies have been used by Lt. Col. Stapp to increase the tolerance to loads perpendicular to the spine. They may also be useful for loads parallel to the spine.
