NATIONAL ADVISORY COMMITTEE FOR AERONAUTICS

November 1943 as
Advance Restricted Report 3K10

FLIGHT TESTS OF THERMAL ICE-PREVENTION EQUIPMENT ON A LOCKHEED 12A AIRPLANE

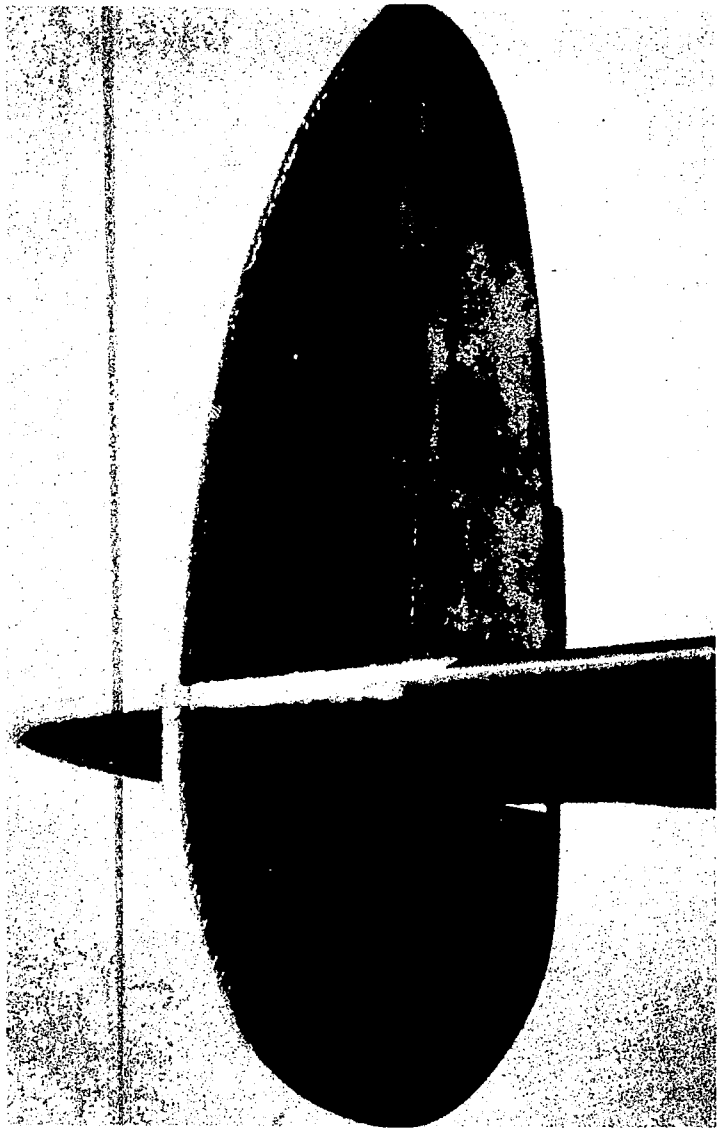
Figures 14 and 15 show ice accretions which formed at the ends of the leading edge of the horizontal stabilizer when the air-outlet gap between the inner and outer skins was 1/16 inch. These formations occurred at the same location on both the right and left stabilizer leading edges. The air-outlet gap then was increased to 1/8 inch at the ends so as to increase the air flow through the gaps in the region where the ice had formed. This increased air flow prevented ice formations on the leading edge in succeeding flights.

Figure 14.- Ice accretion on the outboard leading edge of the horizontal stabilizer of the Lockheed 12A airplane before adjustment of air-outlet gap.

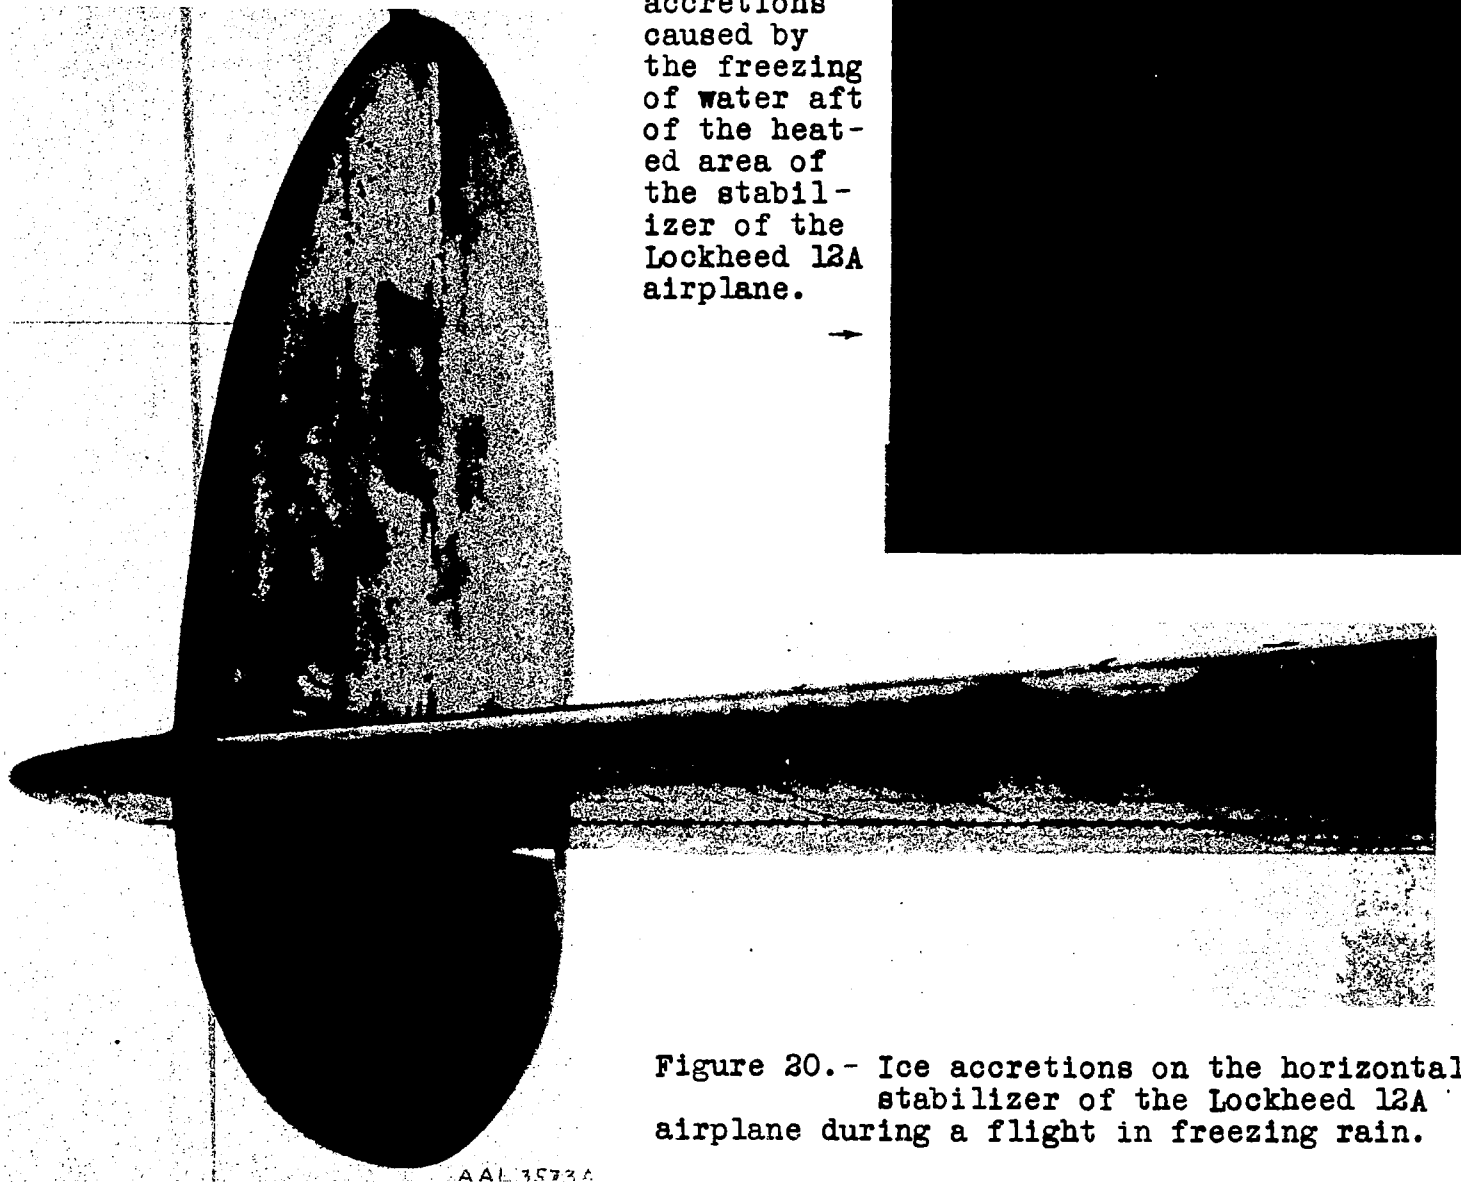
Figures 19 and 20 show the results of flying in a

freezing rain with a free-air temperature of 19° F. Ice formed on the pilot's windshield, as shown in figure 19, after which the heated air to the cabin was shut off, directing all the heat to the windshield. With this condition, the ice was removed. The removal process was quite gradual, indicating that a critical condition for the windshield ice-prevention system had been approached. The stabilizer collected ice just aft of the leading edge, as shown in figure 20, during the same flight. The ice formed in small sheets up to 1/4 inch thick and intermittently blew away. Ice did not form on the leading edge of the horizontal stabilizer. The combination of the relatively large supercooled water drops required for rain and the ambient-air temperature (19° F) indicates that the icing condition during this flight was quite severe.

Figure 20.- Ice accretions on the horizontal stabilizer of the Lockheed 12A airplane during a flight in freezing rain.
