No. 595

BENDING TESTS OF CIRCULAR CYLINDERS OF

CORRUGATED ALUMINUM-ALLOY SHEET

By Alfred S. Niles, John C. Buckwalter, and Warren D. Reed
Stanford University

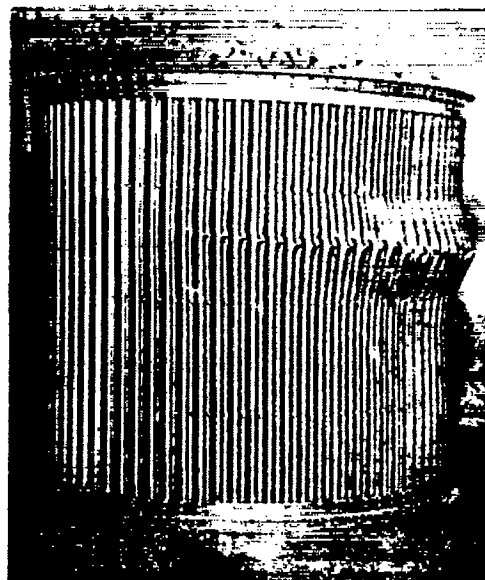
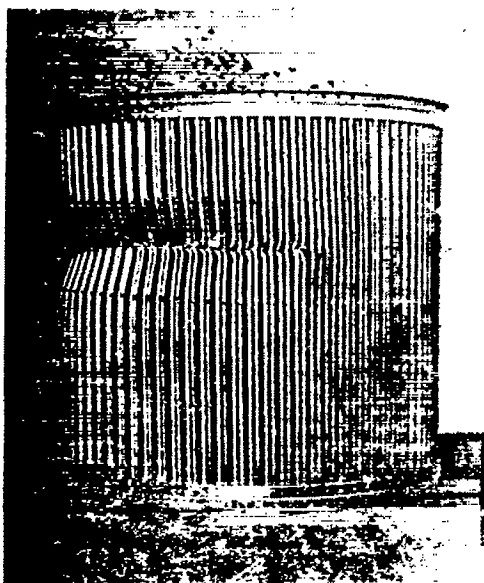
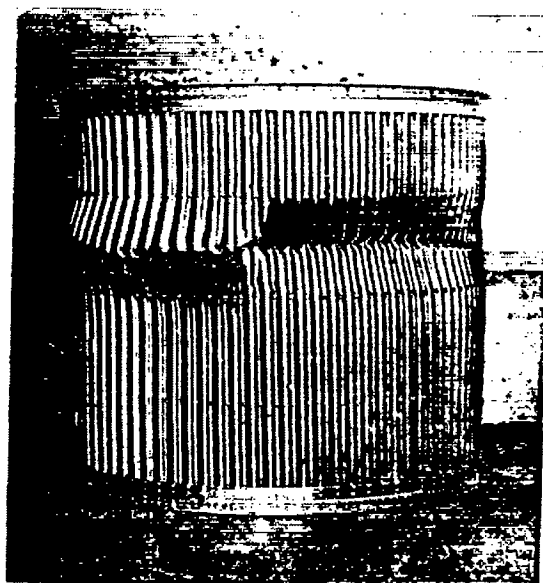
Cylinders 1 and 3, after failure, are shown in figures 1 to 4. It is evident from these pictures that the corrugated sheet in the critical bays behaved in the manner of a column. Final failure occurred in the vicinity of the first bulges to form, the bulges gradually increasing with load until the sheet buckled. In both specimens this buckling at the middle of the panel was accompanied by buckling or cracking of the sheet over the bulkheads at each end of the critical bay. As shown in figure 4, cylinder 3 failed by buckling inward on one side of the vertical axis of the specimen, and outward on the other, while the corrugation at the axis remained practically straight. As noted in the log sheet, before any load was applied,

very slight initial bulges in the specimen, corresponding
in location and direction to the final ones, were observed,
and the peculiar pattern of failure evidently resulted from
the gradual growth of these initial bulges. They were no
more pronounced, however, than bulges which might be ex-
pected to appear in any practical structure of the corru-
gated monocoque type.

Figure 1.- Cylinder 1 after failure.

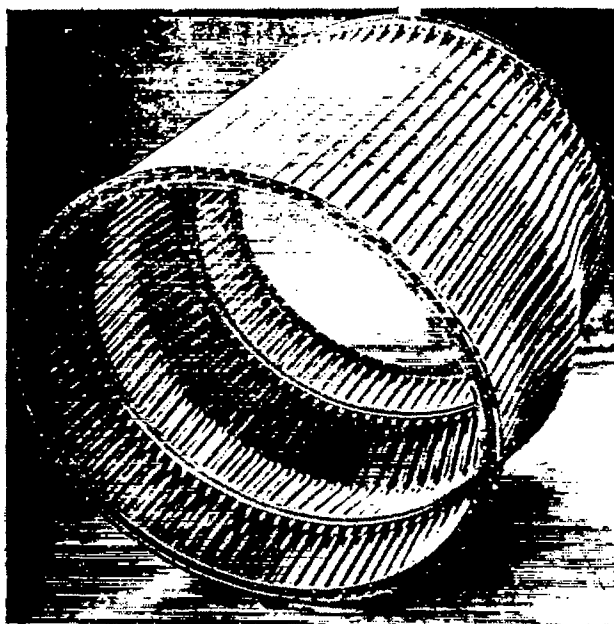
Figure 2.- Cylinder 3 after failure.

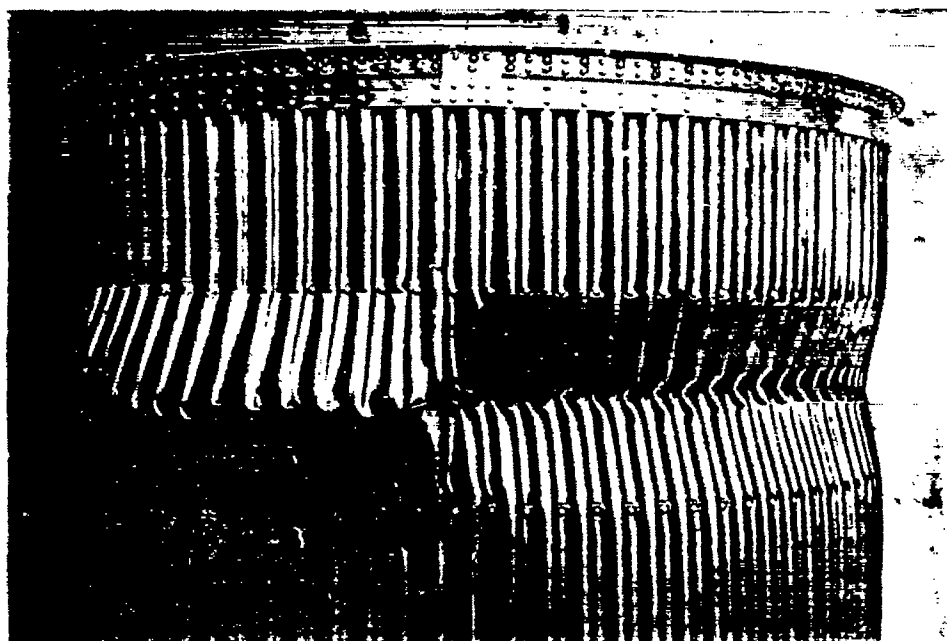
A corrugated sheet under compression will fail either
by bending normal to the plane of the sheet or by local
buckling of the corrugations, depending upon which gives
the lower strength. In the panel tests mentioned in the
preceding paragraph it was found that the strength for lo-
cal failure was in excess of 34,000 pounds per square inch.
As the cylinders failed at computed stresses of 28,400
pounds per square inch and less (table III), it is conclud-
ed that failure in the cylinders occurred by bending of
the corrugations normal to the skin. This conclusion is
also verified by the observed types of failure. (See figs.
1 to 4.)

Figure 3.- Failure of cylinder 1.   Figure 8.- Backplate of testing jig.

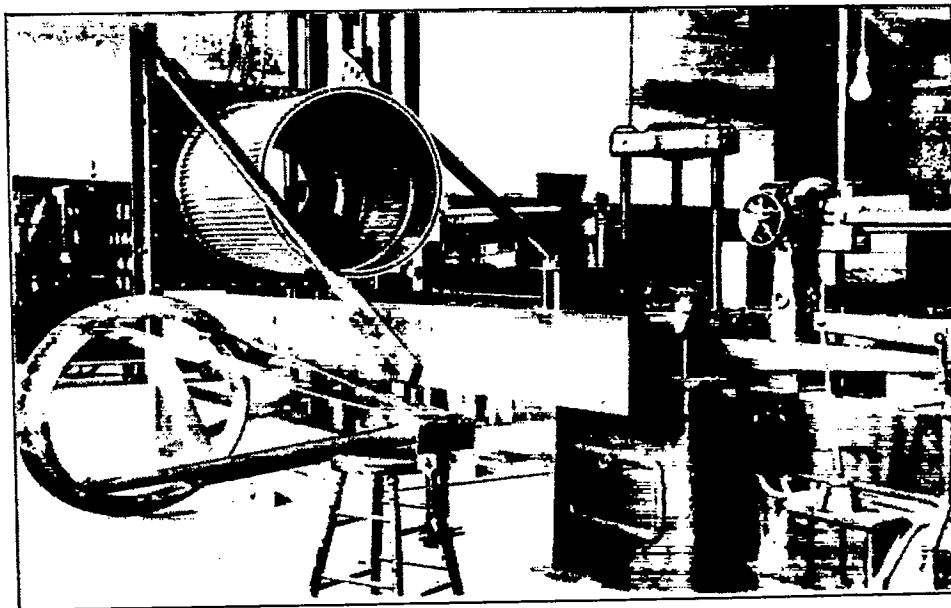
Figure 6.- Testing jig partly assembled.

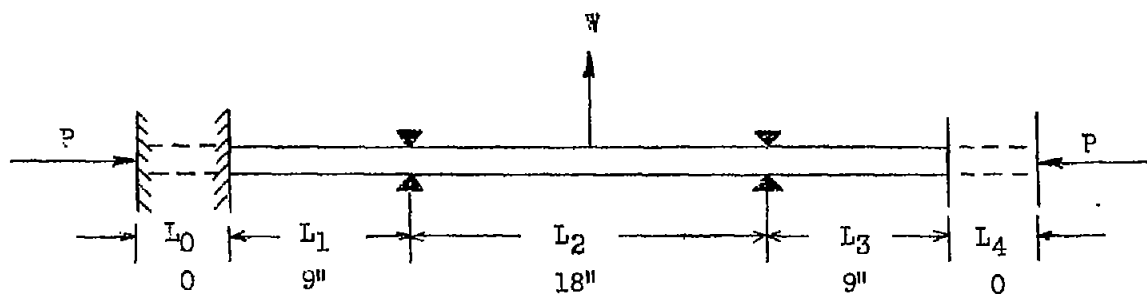
Fig. 10

After the foregoing assumptions were made, the beam-column representative of the most stressed corrugation of cylinder 1 could be represented diagrammatically as in figure 10. When writing the three-moment equations for this and other cases with fixed ends, the effect of the end conditions was allowed for by assuming extra end bays of zero length and including terms with appropriate subscripts for those bays. The generalized three-moment equations for the beam-column of figure 10 can be written (reference 3, ch. XI) as follows:

The determination of the critical value of L/j for the beam-column of figure 10 may be carried out by trial. In this case $L_2 = 2L_1$, $L_2/j_2 = 2L_1/j_1$, and equation (9) becomes

Figure 10.- Loading of assumed beam-column.
