TESTS OF CAST ALUMINUM-ALLOY MIXED-FLOW IMPELLERS

By John E. Douglas and Irving R. Schwartz

MEMORANDUM REPORT

Bureau of Aeronautics, Navy Department

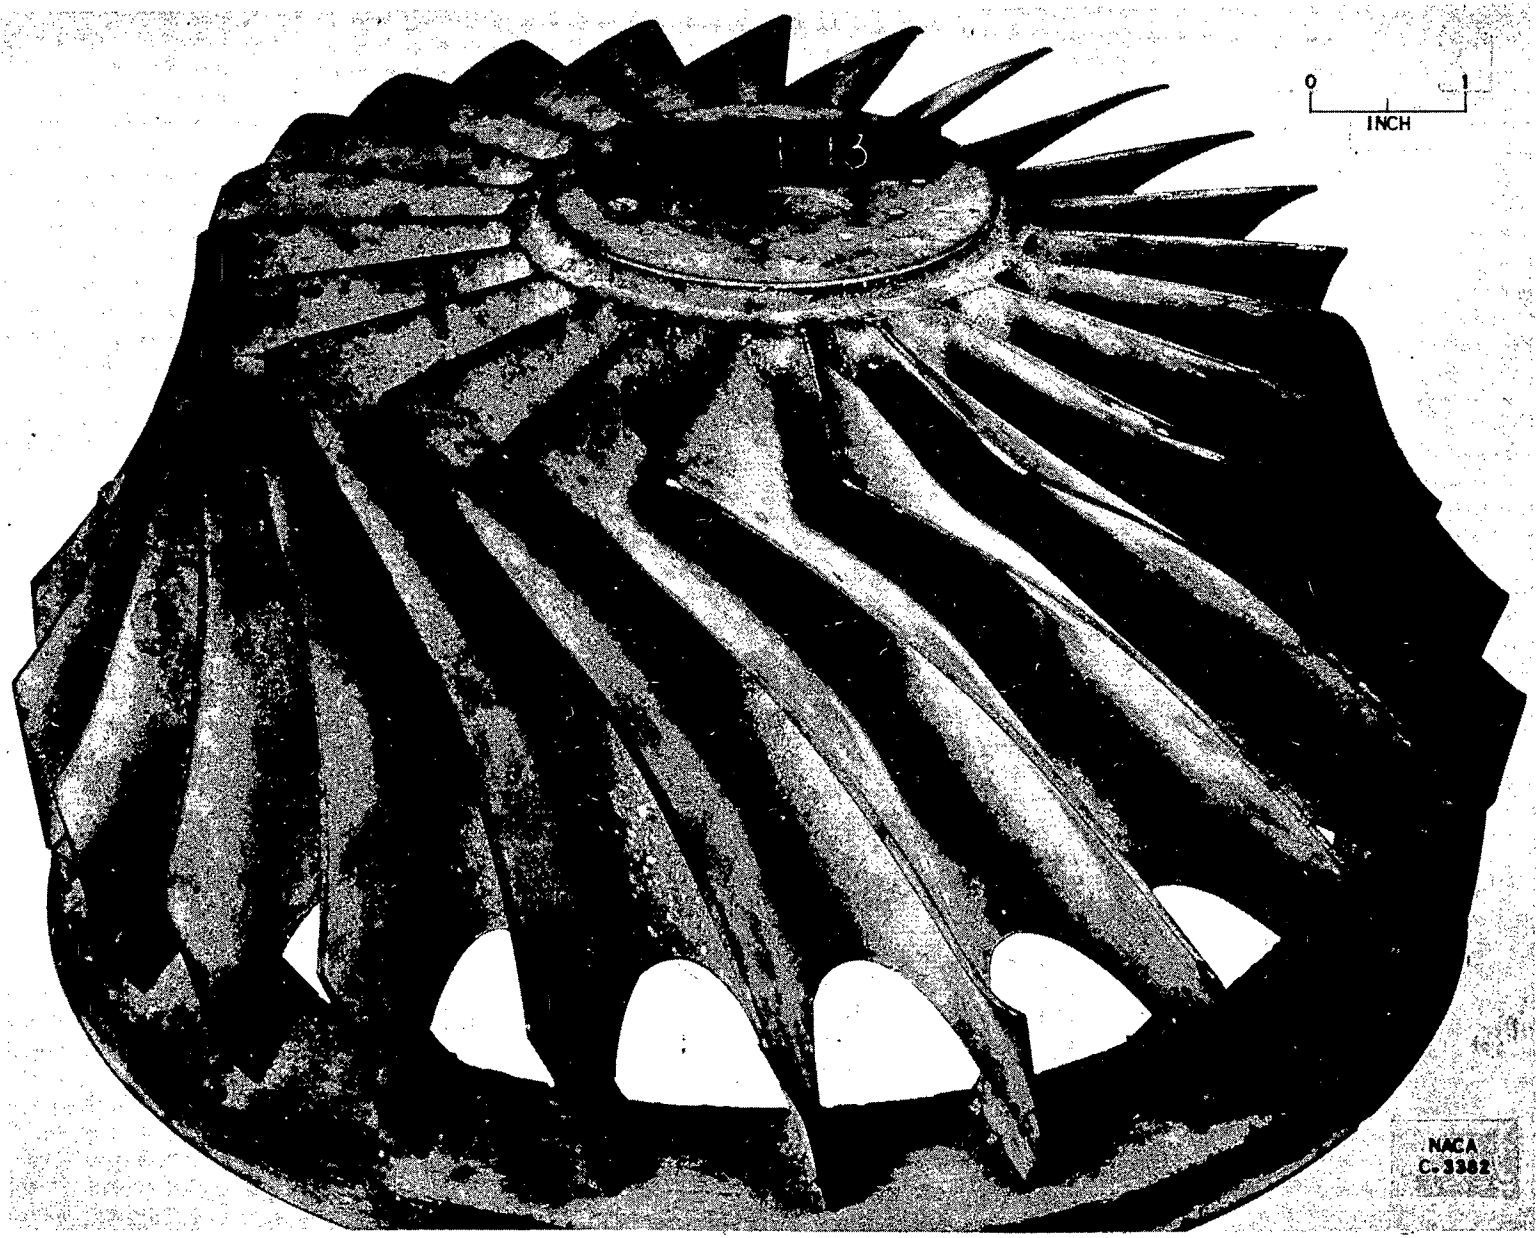
Figure 1. - Cast mixed-flow impeller received from the U.S. Naval Engineering Experiment station, Annapolis, Md.

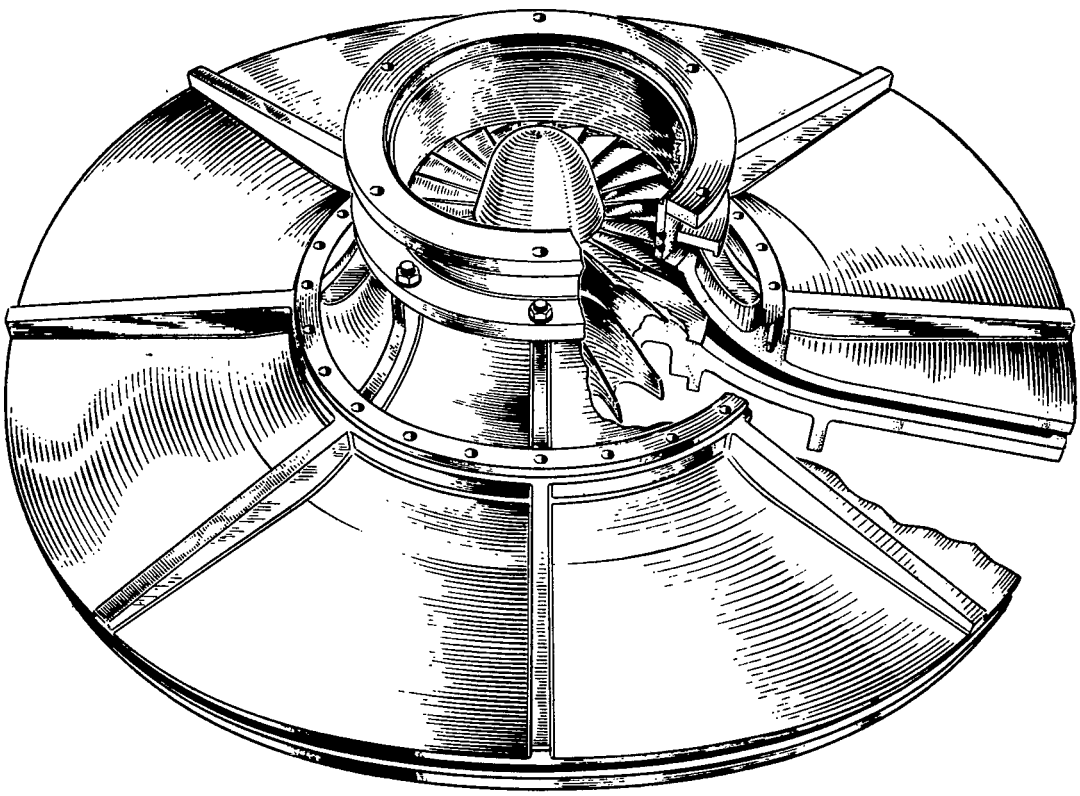
performance from the cast impeller with a vaneless diffuser on the basis of test results from the NACA Langley Field laboratory of a similar mixed-flow impeller with diffusers of various throat ratios. Figure 2 is a drawing of the cast impeller with the vaneless diffuser.

Figure 2. - Sketch of cast mixed-flow impeller with vaneless diffuser.

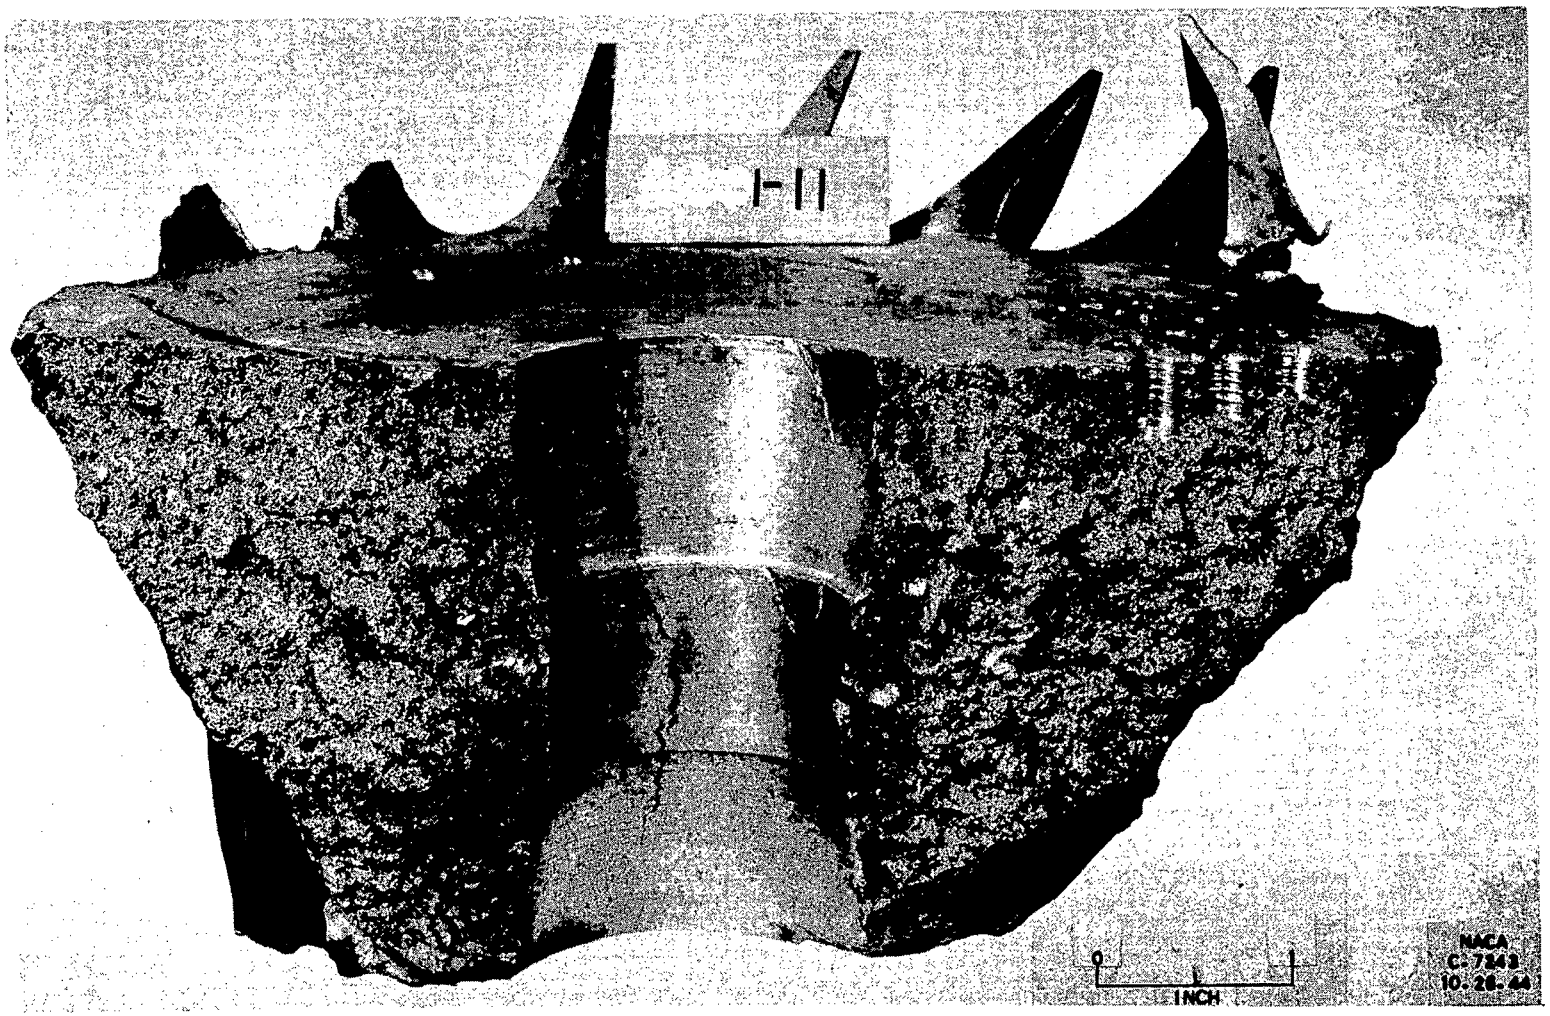
All of the impellers except 1-15, which was not spun to destruction, failed through the hub. Usually the impellers burst into three parts, by splitting into halves with one of the halves further dividing into two parts. Figure 4 shows a typical fragment of cast impeller 1-11 after being spun to destruction. The roughness of the fracture indicates the porosity.

Figure 4. - Typical fragment of cast mixed-flow impeller I-II after being spun to destruction.

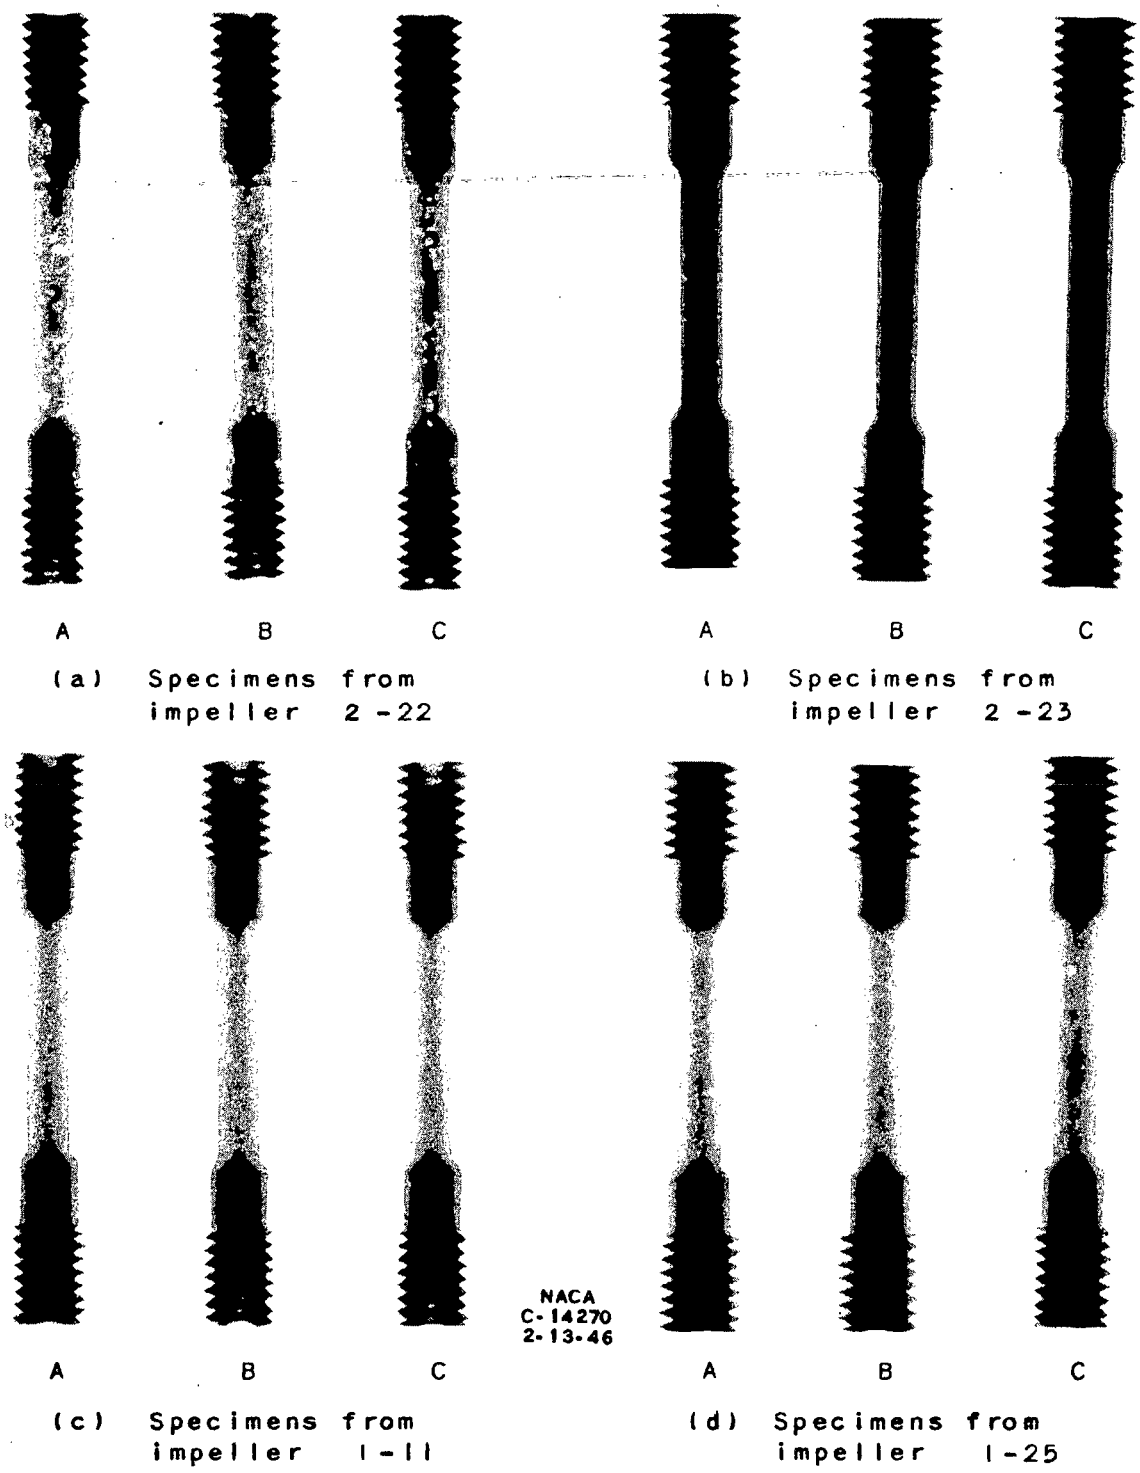
Figure 5. - X-ray photographs of tensile-test specimens cut from fragments of cast mixed-flow impellers.

Tensile-strength tests and X-ray examination of bar specimens. - A comparison of X-ray photographs of tensile-test specimens cut from fragments of impellers 2-22 and 2-23 (figs. 5(a) and 5(b)) with the results of the tensile tests shown in table III demonstrates that the tensile strength varies indirectly with the amount of porosity indicated by X-ray examination. The strength of the tensile-test specimens from impellers of alloy 2 varied from a maximum of approximately 110 percent to about 30 percent of the tensile strength recommended in Navy specifications. The tensile-test results of alloy 2 were erratic because of variations in the extent of porosity and other faults among the test specimens as shown in the X-ray of figures 5(a) and 5(b). The average tensile strength of all tested specimens of this alloy was 20,900 pounds per square inch.

X-ray photographs of tensile-test specimens cut from fragments of impellers 1-11 and 1-25 are shown in figures 5(c) and 5(d). These representative X-rays show that a fine porosity exists in the specimens of alloy 1, which results in tensile strengths varying from a maximum of approximately 70 percent to 26 percent of the tensile strengths recommended in Navy specifications, except for one specimen that broke under the initial load of the testing machine. The tensile strengths of these specimens of alloy 1 are given in table III. The average tensile strength of all specimens of alloy 1 was 23,260 pounds per square inch. The results of the tensile tests of specimens taken from the impellers of both alloys indicated that the material was brittle.

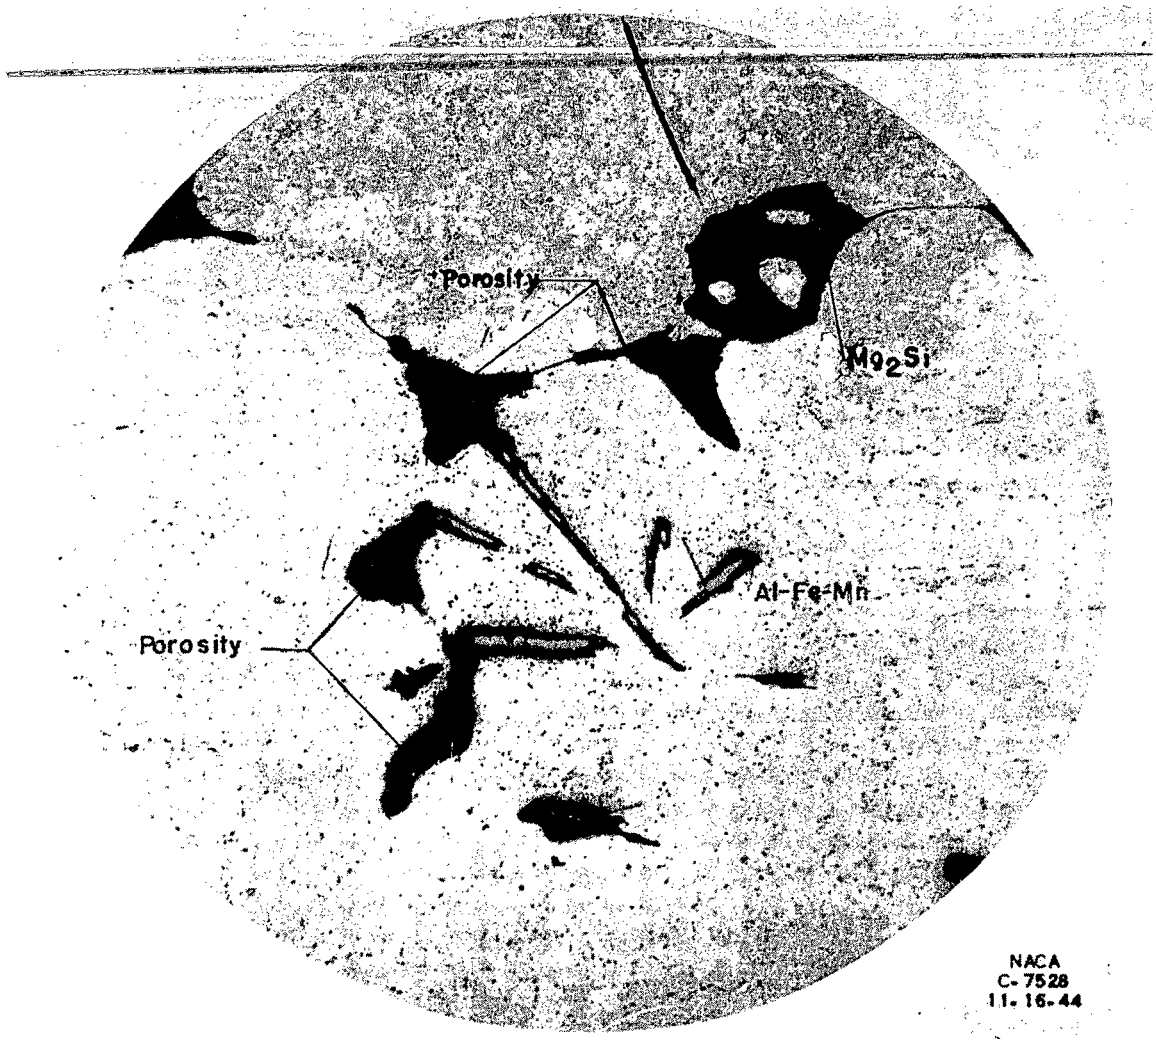
The structure of the alloys was further examined from photomicrographs of specimens cut from various portions of the cast impellers. A typical photomicrograph of a specimen of alloy 2 is shown in figure 7(a). The photomicrograph of the specimen showed that aluminum combined with impurities to form Al-Mn and complex compounds of Al-Fe-Si. The free silicon that came out of solution on cooling appears to be fairly uniformly distributed. The photomicrograph in figure 7(b) is of a specimen taken from the top of impeller 1-11 and shows complex compounds of Al-Fe-Mn-Co-Si and Mg_2Si and Al_2O_3. The fine porosity characteristic of this alloy is shown for impeller 1-11 at a magnification of 500 diameters in figure 7(b) and for impeller 1-15 at a magnification of 100 diameters in figure 8. The solid black areas indicate porosity. In general, the photomicrographs show that the impellers are of the normal structure with the maximum permissible amount of impurities.

(b) From top of impeller I-II. Etched in mixed acid.

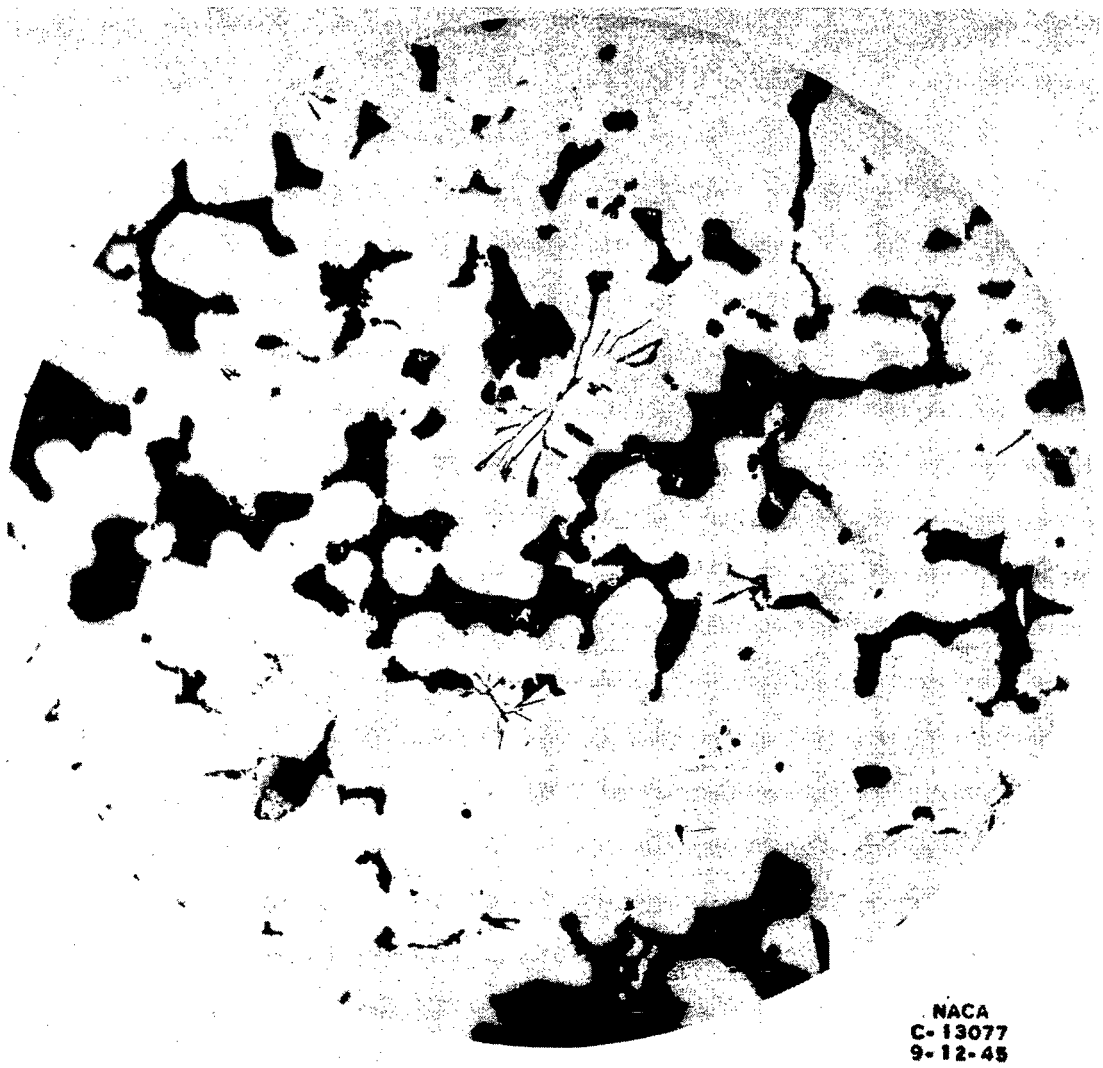
Figure 8. - Etched specimen from bottom of impeller I-15 showing characteristic porosity of the alloy. Etched in mixed acid. X100.

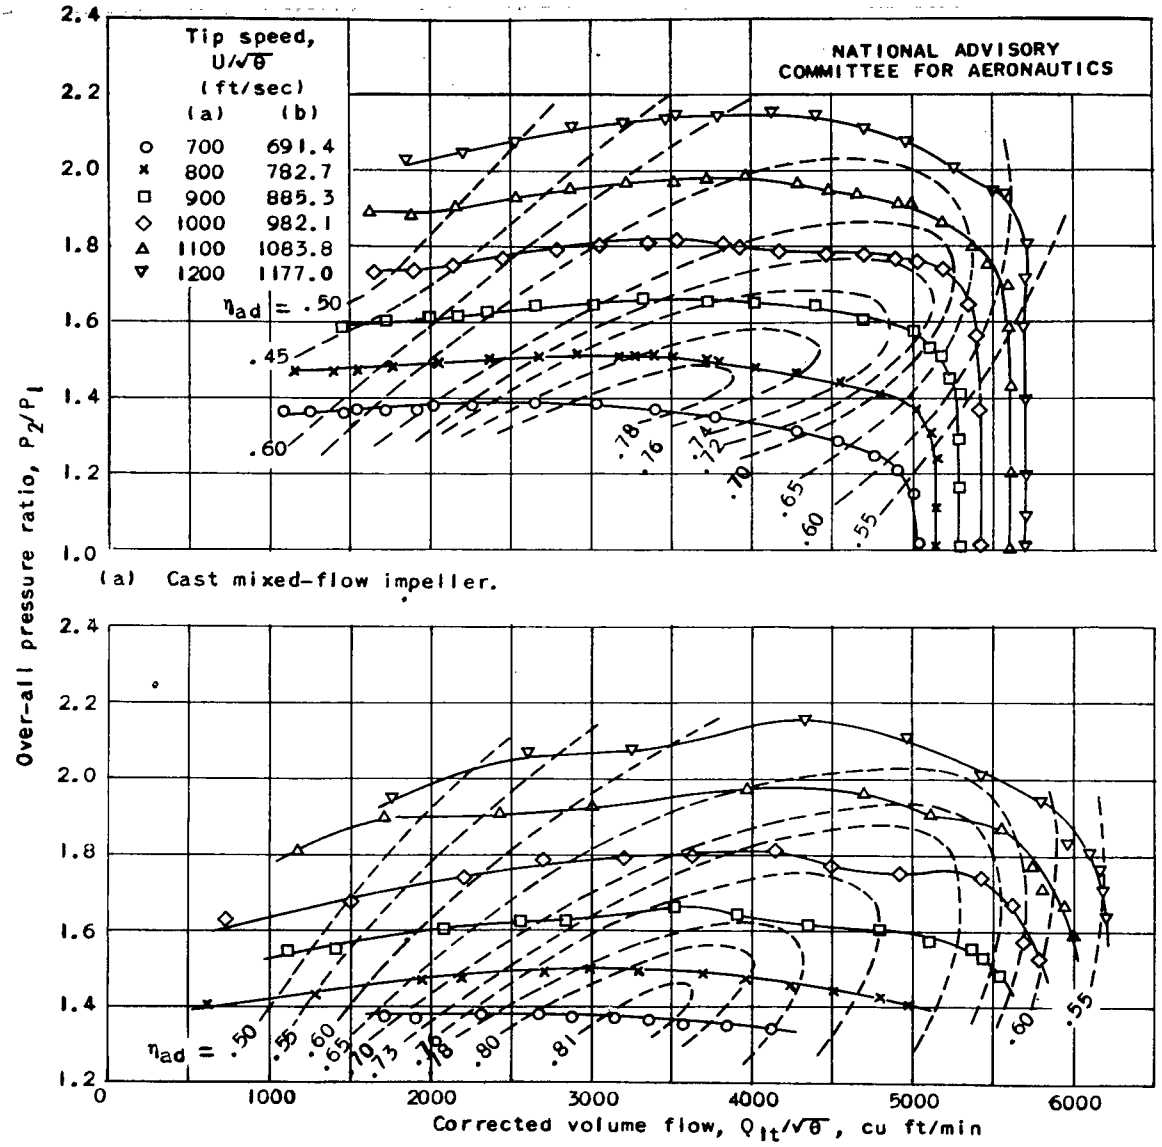
Although the diffuser used with the cast impeller was designed to improve the performance of this combination, results of these tests (figs. 9 and 10) showed a decrease in over-all performance compared with that of the machined-impeller combination. Most of this decrease in performance can be attributed to the differences in the impellers and is probably due to the effects of the rough casting surface and distortion of the impeller passages during casting and heat-treating.

(a) Cast mixed-flow impeller.

(b) Machined impeller.

Figure 9. - Over-all pressure ratio and corrected volume flow with over-all adiabatic efficiency of impellers with NACA vaneless diffuser.

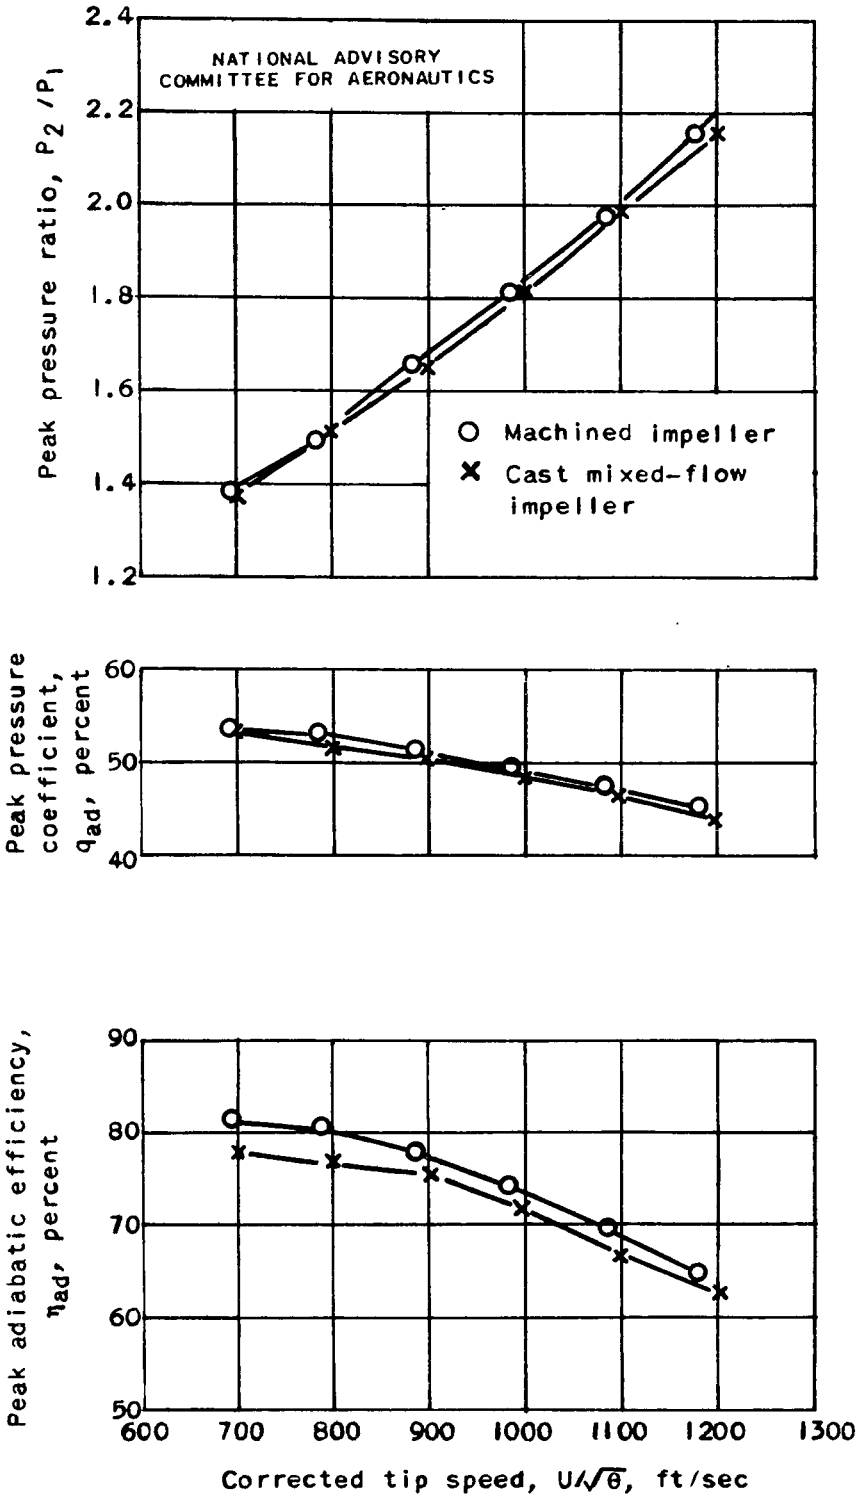
The over-all peak adiabatic efficiency η_{ad}, pressure coefficient q_{ad}, and pressure ratio P_2/P_1 of the two impeller-diffuser combinations are shown in figure 10. The peak adiabatic efficiency of the cast impeller with the diffuser was approximately 78 and 62 percent at corrected tip speeds of 700 and 1200 feet per second, respectively; these efficiencies were approximately 3 points lower than the corresponding peak efficiency of the machined impeller with the diffuser at low speeds and 2 points lower at high speeds. The peak pressure coefficient was approximately 63 percent for both impeller-diffuser combinations at a corrected tip speed of 700 feet per second. The peak pressure coefficient of the cast-impeller combination was slightly lower than that of the machined-impeller combination at all tip speeds above 700 feet per second; at 1200 feet per second, it was 53 percent. The peak pressure ratio of the cast impeller with the vaneless diffuser was slightly lower than that of the machined impeller with the vaneless diffuser at all corrected tip speeds. A maximum pressure ratio of 2.16 was obtained with the cast-impeller combination at a corrected tip speed of 1200 feet per second.

Figure 10. - Over-all peak performance of impellers with NACA vaneless diffuser.
