RESEARCH MEMORANDUM

Air Materiel Command, Army Air Forces

AERODYNAMIC CHARACTERISTICS OF A PORTION OF THE HORIZONTAL TAIL FROM A DOUGLAS C-74 AIRPLANE WITH FABRIC-COVERED ELEVATORS

By Angelo Perone and Cecil L. Berthold

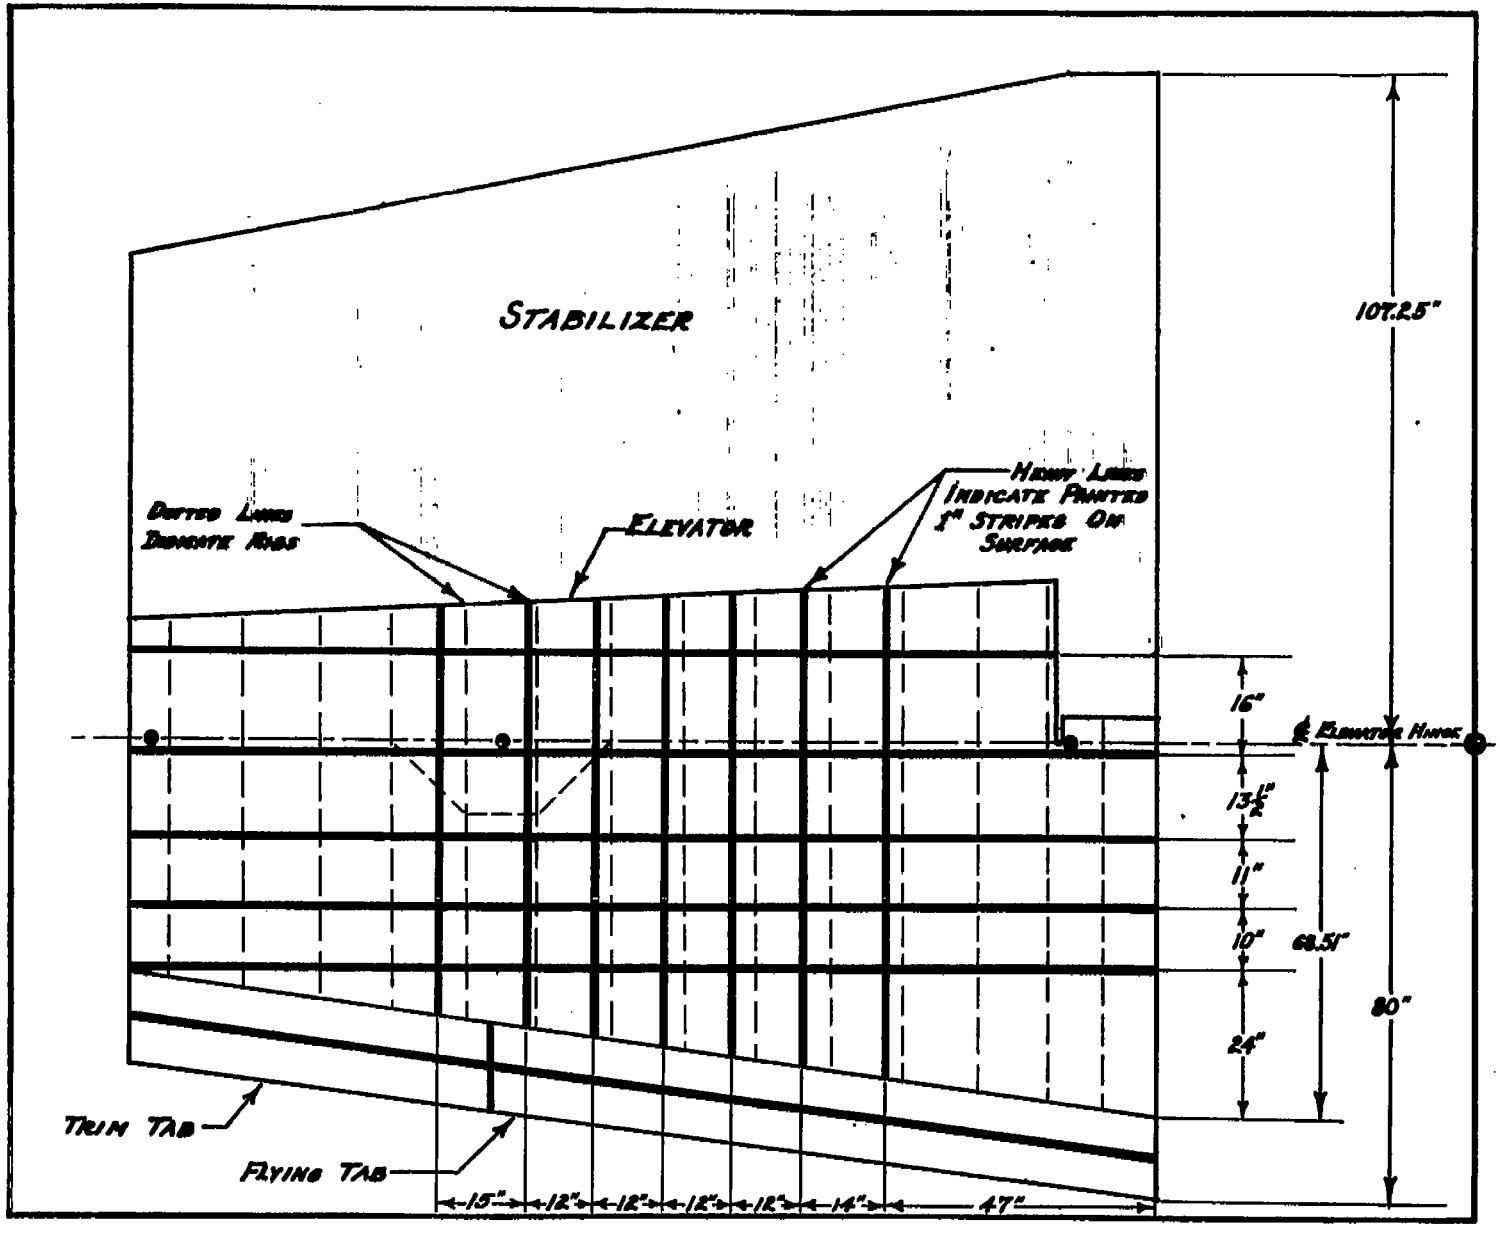
FIGURE 3.- LOCATION OF LINES TO SHOW DEFORMATION OF FABRIC ON C-74 ELEVATOR. [redacted]

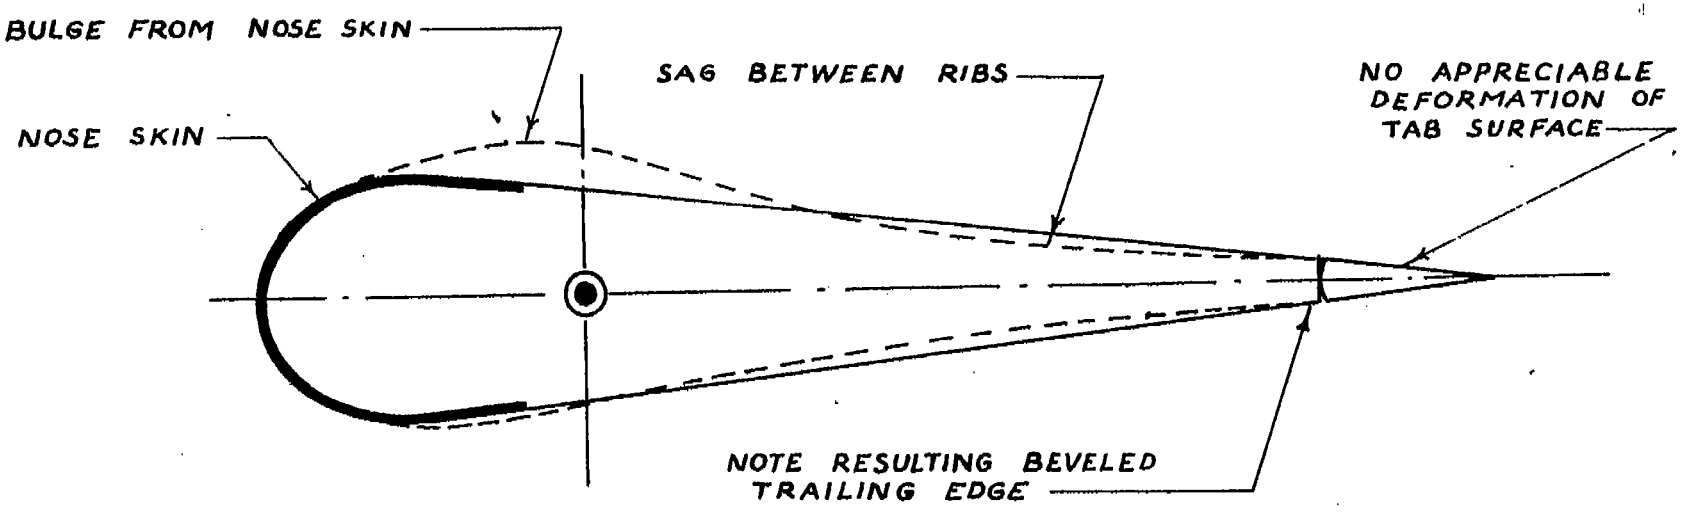
The first of these was one in which the elevator fabric, at the start of the testing, was attached to the ribs by small screws and drawn over the metal nose skin but attached to it only by doping. Early in the course of the tests the fabric pulled loose from the nose skin and a bulge developed which, upon increasing in size, began tearing the fabric from its fastenings to the fore parts of the ribs. The bulging and detachment from the ribs rapidly extended from about 5 to 40 percent of the elevator chord and, in extreme cases, bulging up to an estimated 4 inches in height occurred over about one-half of the test span. Fabric sag varying in

magnitude up to an estimated 1.5 inches in depth occurred between the ribs at the aft portion of the elevator over the complete test span. Typical bulging and sag of the elevator fabric for this condition is shown in figure 4. This first elevator condition will henceforth be referred to as the "original condition, fabric detached."

FIGURE 4.- TYPE OF SURFACE DEFORMATION FOR THE DOUGLAS C-74 ELEVATOR DURING TESTS IN THE AMES 16-FOOT HIGH-SPEED WIND TUNNEL FABRIC DETACHED CONDITION. $\alpha = 0°$ $\delta_e = +2°$ $M = 0.55$

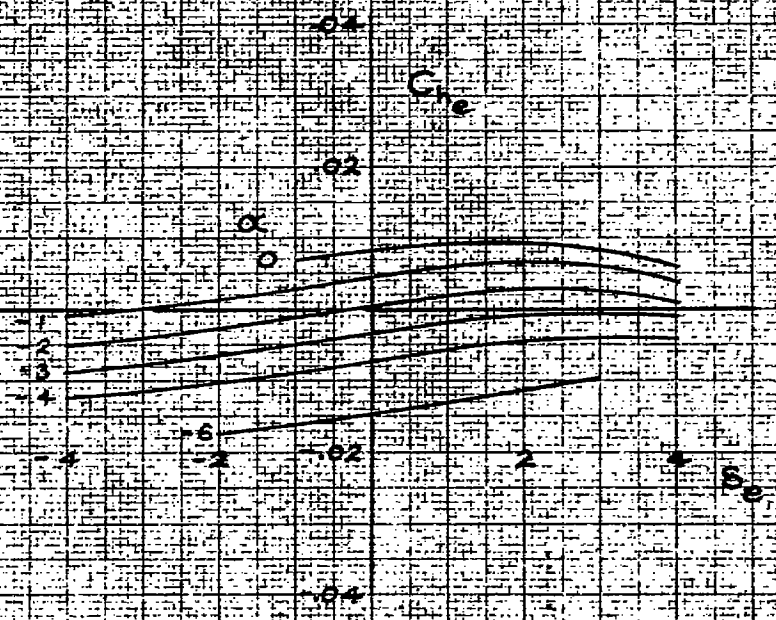
The variation of hinge-moment coefficient with elevator angle is presented in figures 6 to 9 for all the conditions tested. The positive variation for the fabric-detached (fig. 6) and the fabric-fastened conditions (fig. 7) is apparent. A negative slope is shown when the fabric was fastened with decreased rib spacing (fig. 8) and for the original condition (fig. 9), the predominant feature being a less negative slope with increase of Mach number. In some cases the tunnel-wall corrections were of such magnitude as to convert a negative slope into a positive one. Therefore, the absolute values of the coefficients, in each case, are subject to question.

FIGURE 6.– VARIATION OF ELEVATOR HINGE-MOMENT COEFFICIENT WITH ELEVATOR ANGLE FOR A SECTION OF THE HORIZONTAL TAIL FROM A DOUGLAS C-74 AIRPLANE. ORIGINAL CONDITION – FABRIC DETACHED. M=0.2

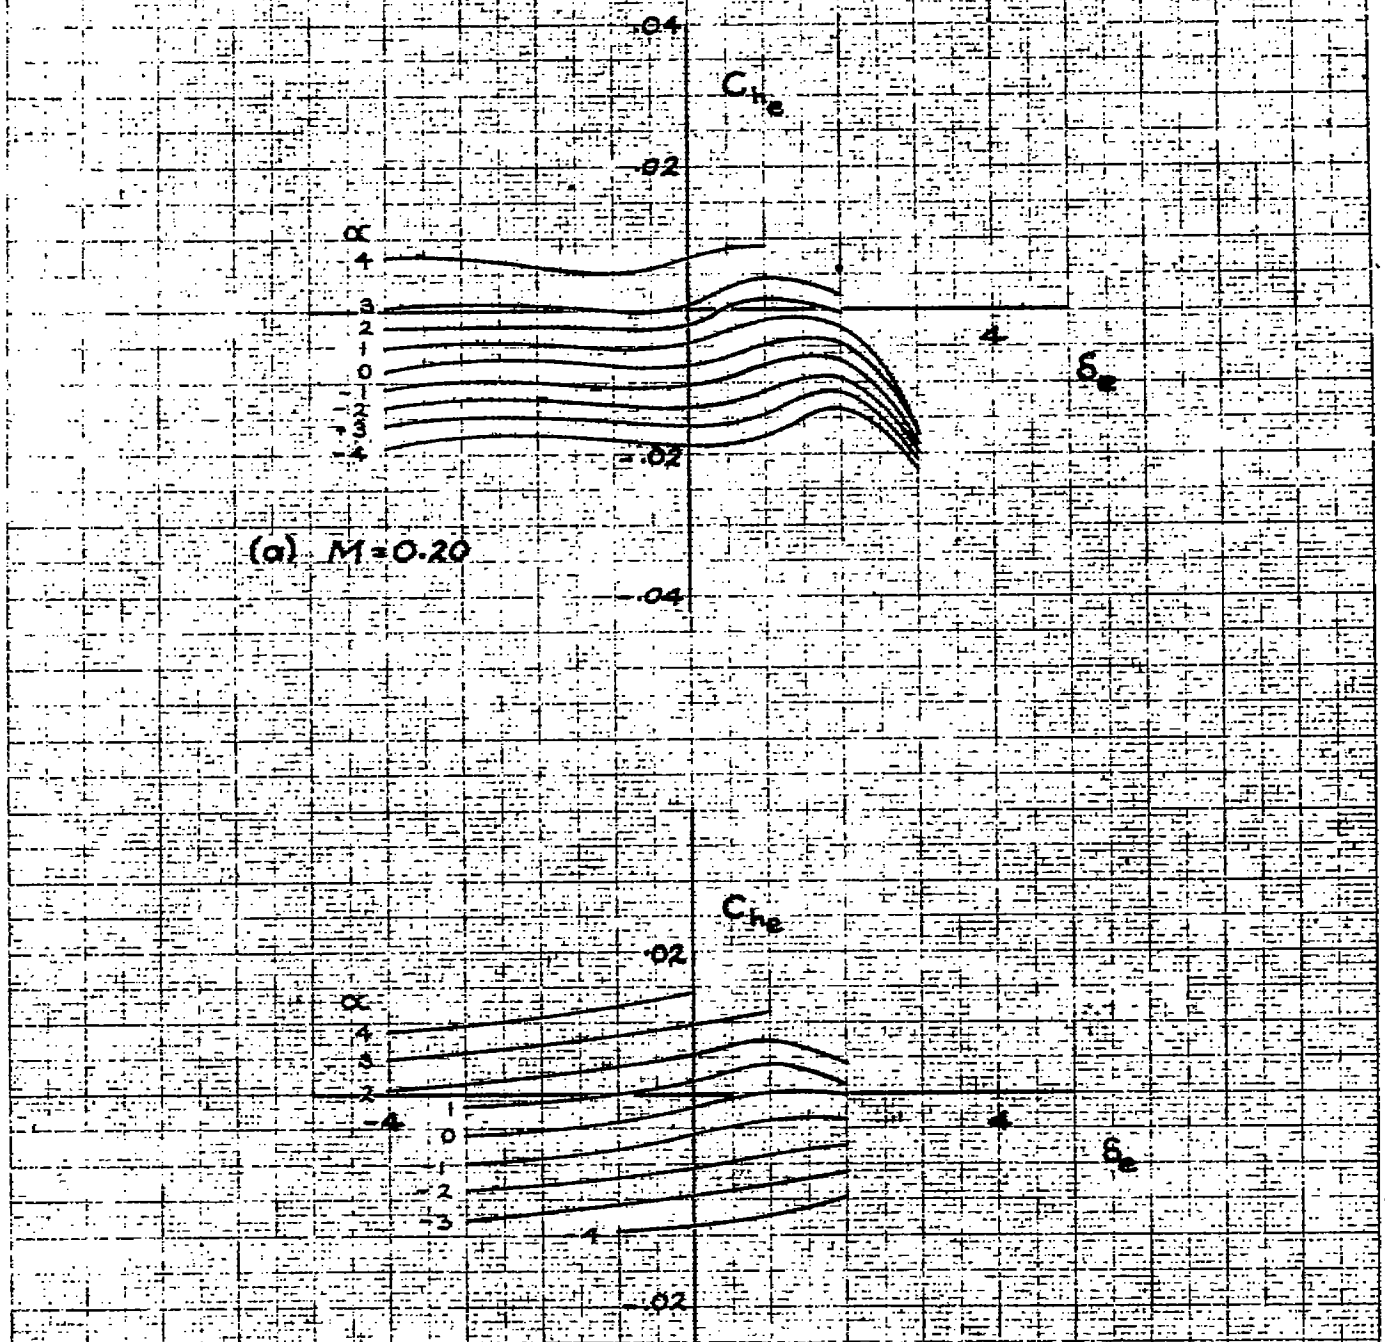
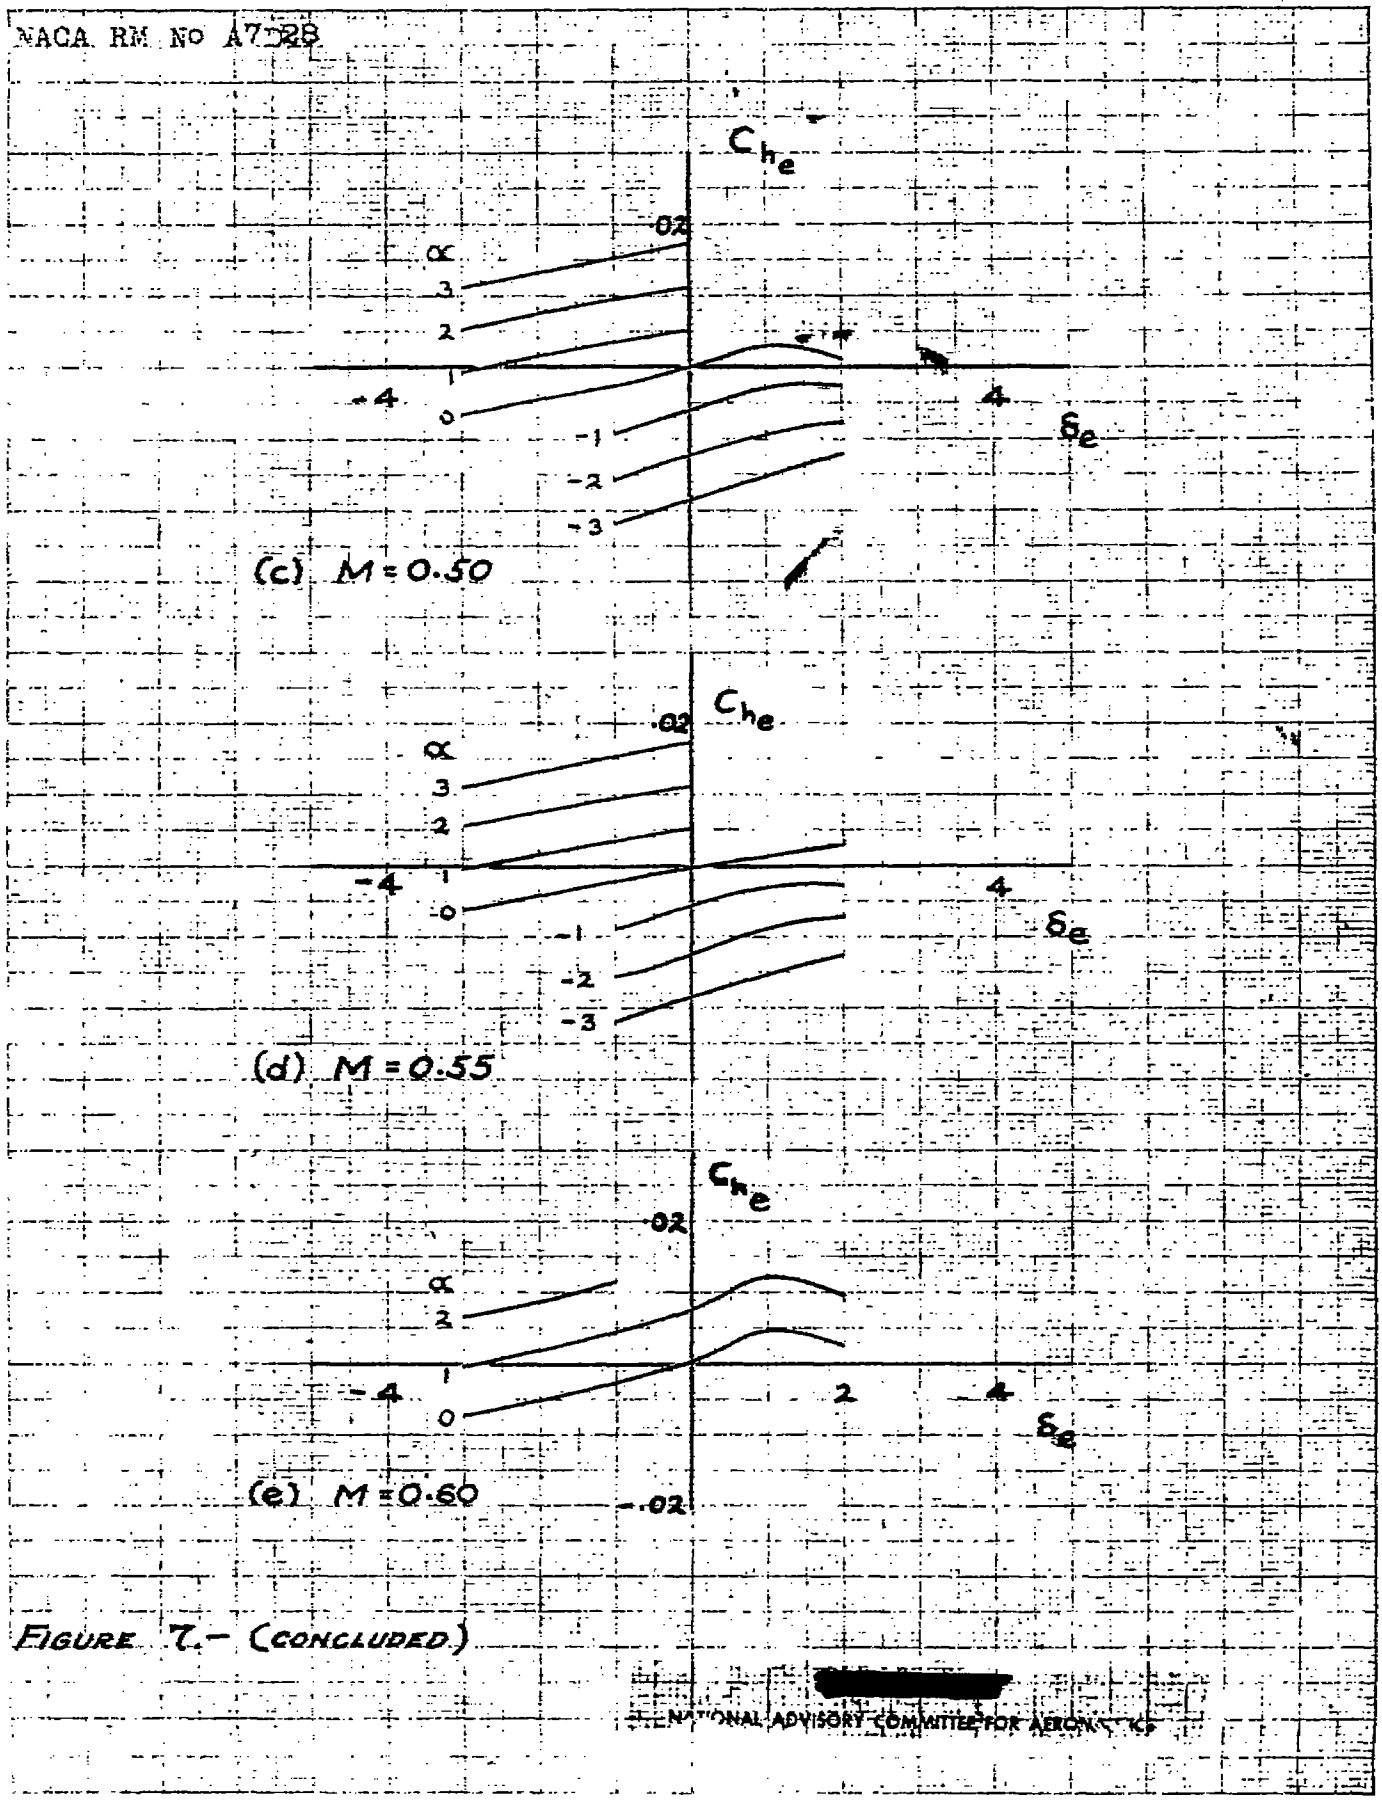
FIGURE 7.- VARIATION OF ELEVATOR HINGE-MOMENT COEFFICIENT WITH ELEVATOR ANGLE FOR A SECTION OF THE HORIZONTAL TAIL FROM A DOUGLAS C-74 AIRPLANE. ORIGINAL CONDITION - FABRIC FASTENED.

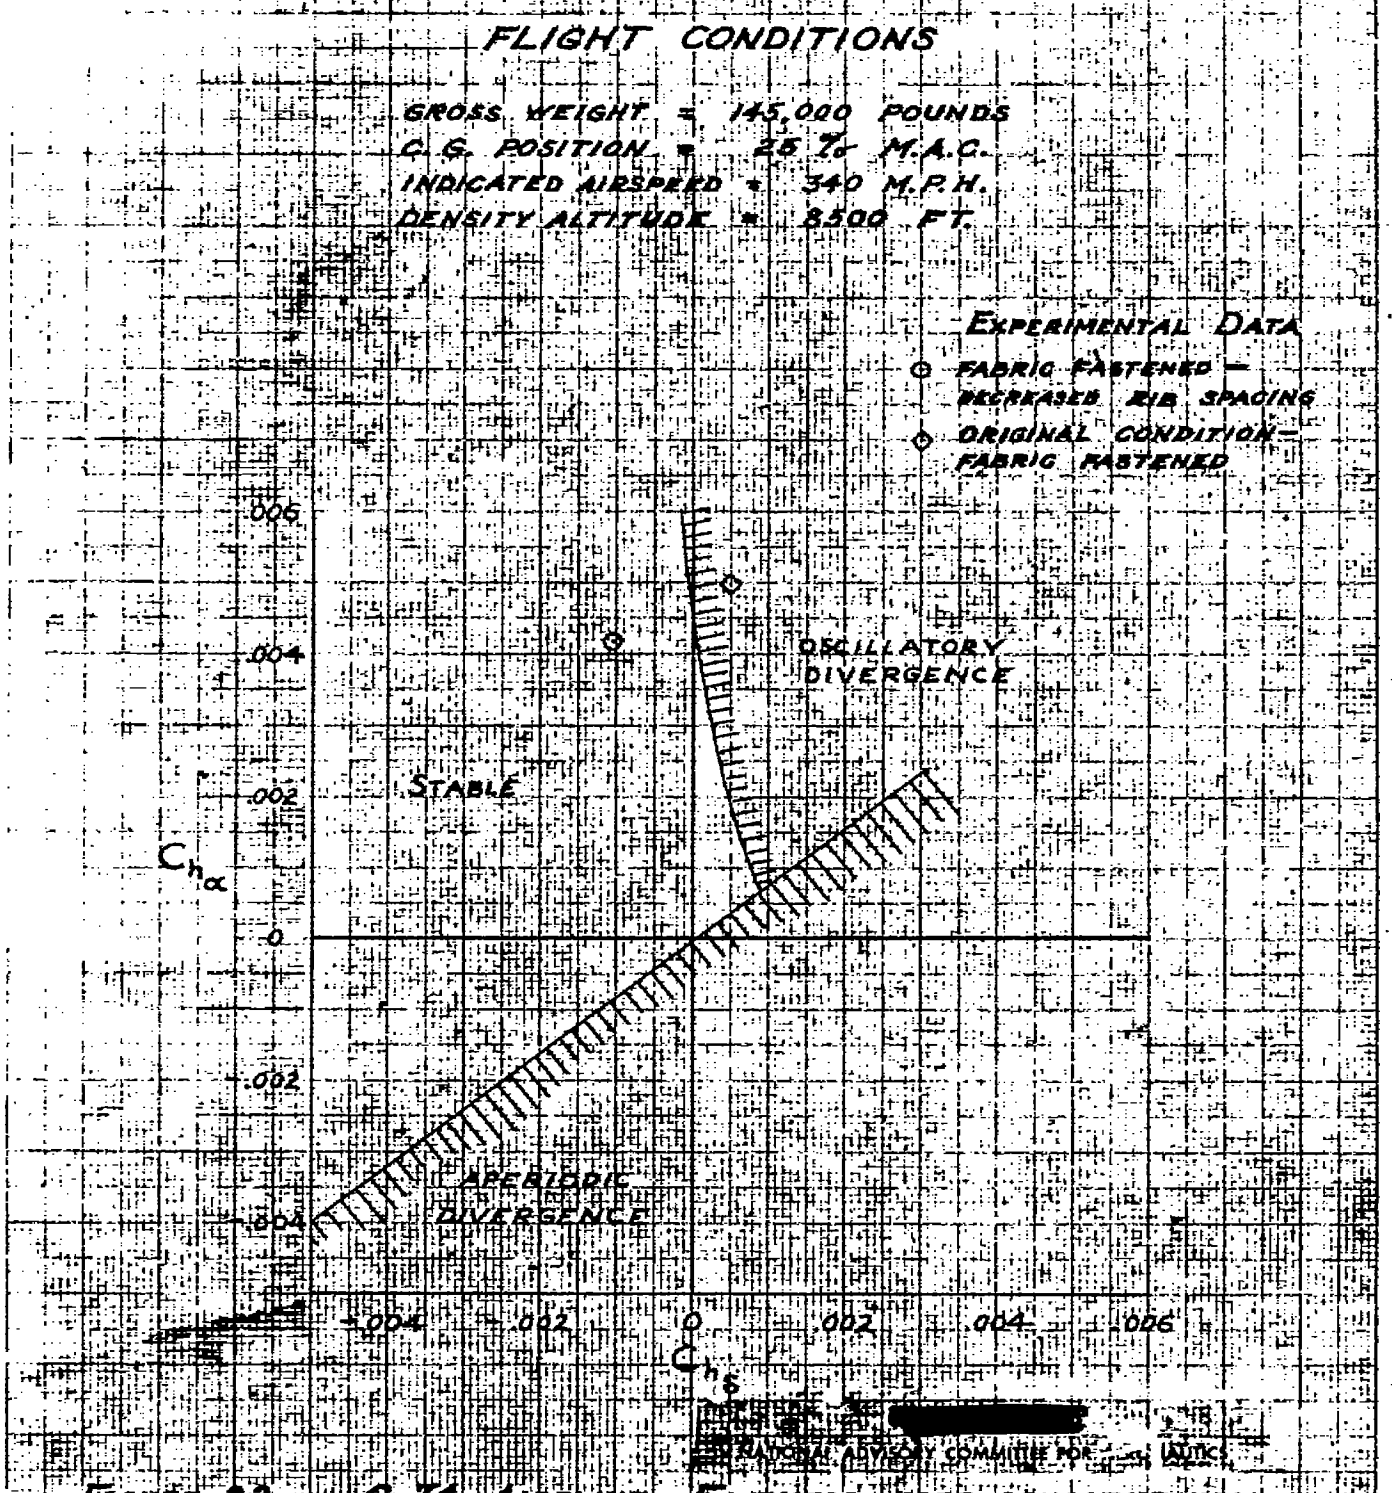
Figure 22 presents the results of an analysis of the dynamic pitching stability of the C-74 airplane made by the Douglas Aircraft Corporation according to the method of reference 3. The flight conditions for which the critical boundaries have been calculated are approximately those under which the accident occurred to the airplane. The experimental data included in the figure are for the fabric-fastened - decreased rib spacing and fabric-fastened conditions. Due to load limits, not enough data were available for the conditions without the fabric fastened to present more test results on the pitching-stability plot. The uncertainty of the tunnel-wall corrections is especially critical in applying this curve as only a slight error in their magnitudes could cause a shift of the experimental points, thereby either denoting stability or instability.

It is shown on figure 22 that either stable or unstable dynamic pitching-moment conditions of the airplane are possible, dependent on the extent to which elevator surface deformation occurs. Unfortunately, it is impossible to reach any definite conclusion from this curve due to the uncertainty of the absolute values of the data. It is evident, however, that for greater dynamic longitudinal stability more negative values of C_{h_δ} are required. The effect of bulge and sag, in general, was to cause more positive C_{h_δ} values. The bulging of the fabric over the nose of the elevator changed the nose balance shape to one of greater bluntness. A more blunt nose shape can produce more positive C_{h_δ} values (reference 1), which would be especially detrimental with a closely balanced elevator of this type. Adverse effects are also attributed, in part, to the beveled trailing-edge section resulting from sag of the fabric between ribs at the aft portion of the elevator. The beveled edge in this case was composed of the trim and control tabs whose surfaces did not deform appreciably under load. Results of flight tests of elevator sections have shown more positive C_{h_δ} values resulting from beveled trailing edges (reference 4). Wind-tunnel data for beveled trailing-edge elevators having overhanging balance and a blunt nose have shown overbalance at high Mach numbers (reference 5). Elimination of the overbalance, in that case, resulted upon changing to straight-sided elevators. The results obtained from tests of the C-74 elevator show that the only fabric condition in which C_{h_δ} remained negative with increase in Mach number was that where the surface deformation was held to a minimum by fabric fastening and decreased rib spacing. Fabric fastening and decreased rib spacing may not be the safest solution, however, as upon aging and deterioration of the fabric, it is possible that bulging and sagging may recur with accompanying

FIGURE 22. C-74 AIRPLANE ELEVATOR-FREE LONGITUDINAL STABILITY BOUNDARIES AT CONSTANT SPEED.

adverse effects. This consideration suggests the use of metal-covered elevators.

After fabric bulge and sag have been reduced to a minimum, still greater longitudinal dynamic stability of the airplane may be obtained by using a sharper nose section or by decreasing the area of the overhanging balance (reference 6). Similar results may also be obtained by extension of the trailing edge, a change which in effect amounts to a decrease in balance. It is recommended that should further tests be conducted for investigation of the effect of these modifications, a smaller model be used so that the absolute values of the aerodynamic coefficients can be obtained more accurately.
