NATIONAL ADVISORY COMMITTEE FOR AERONAUTICS

No. 1603

APPLICATION OF STATISTICAL METHODS TO STUDY OF GAS-TURBINE BLADE FAILURES

Washington
June 1948

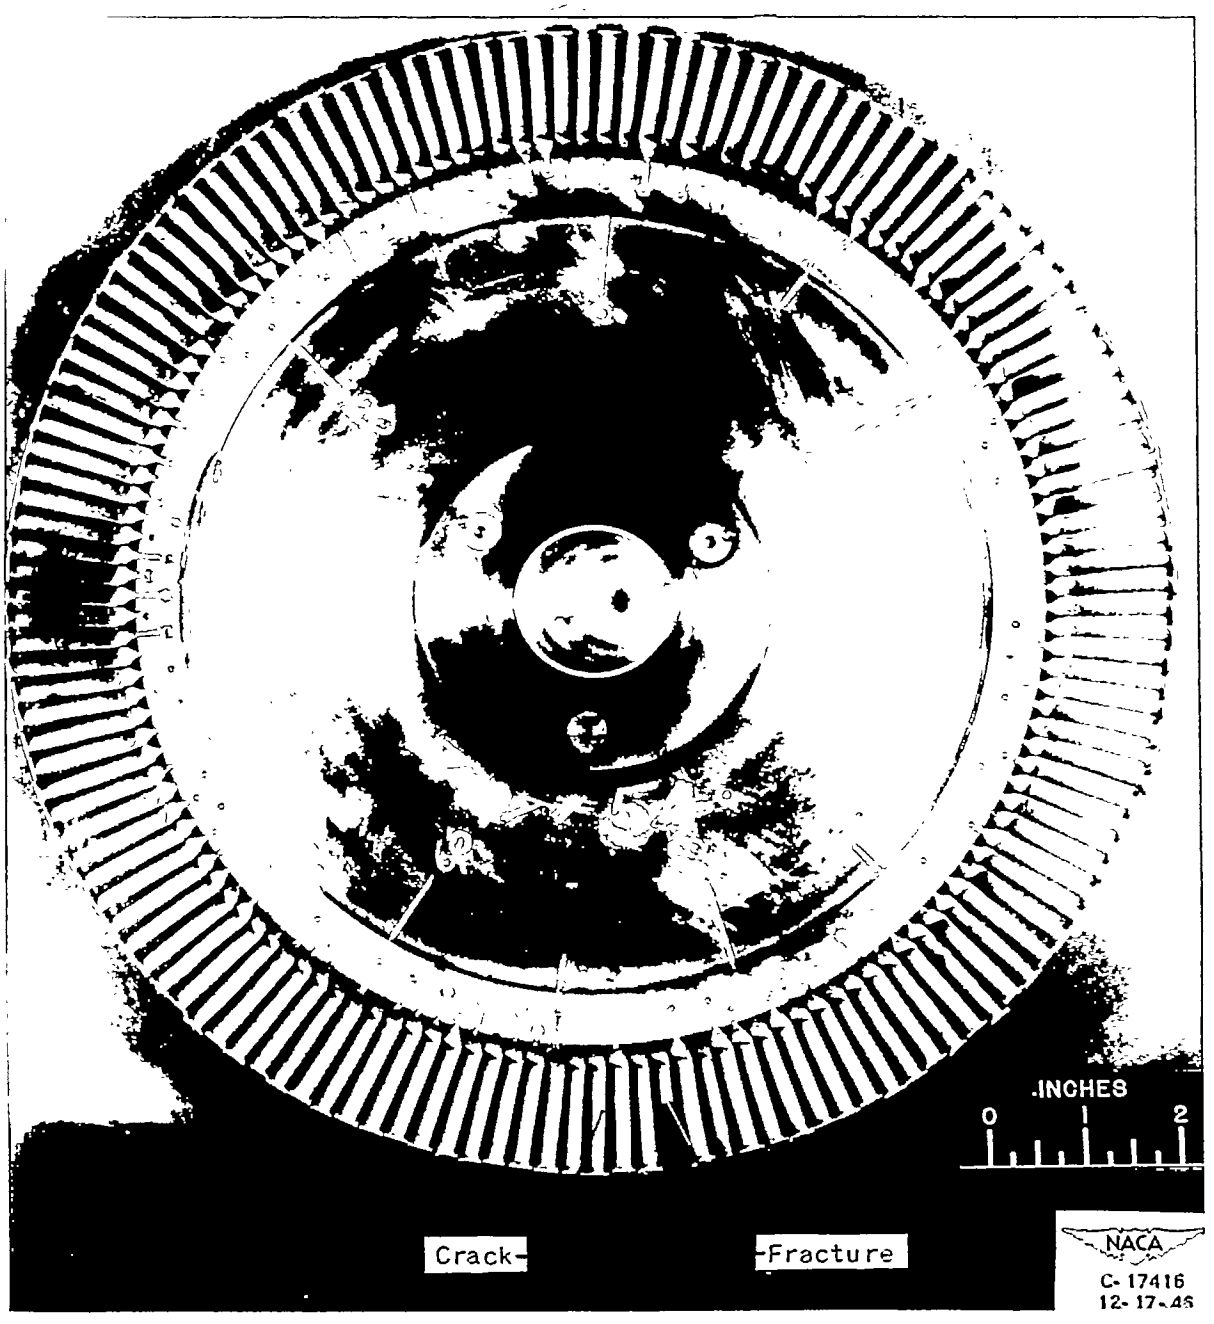
The appearance of wheel 1 after a total of $28\frac{1}{2}$ hours of power and condition time is shown in figure 3(a). The blade-root portion and fragments from wheel 1 after a total of $28\frac{1}{2}$ hours of power and condition time are shown in figure 3(b). These photographs are

of the wheel during initial runs revealed that a few blades were badly cracked (figure 3(a)). The assumption was therefore made that these cracked blades would fail very soon and removal of blades which had cracks longer than half the blade width would speed the program by lengthening the interval between wheel removals. The criterion of failure of the material was therefore considered to be fracture or severe cracking. The number of failures recorded during a given time period was the total of all replaced. Operation in this manner was found to allow periods of operation as long as 5.4 hours without shutdown for overhaul. At shutdown as many as nine fractured blades and as many as 13 cracked blades were replaced. The use of these data in the plotting of distribution curves was found to be difficult. The time interval chosen for plotting the frequency-distribution curve was necessarily large because the length of time between shutdowns was very large. The use of time intervals less than the length of time between shutdowns occasionally resulted in time intervals with a frequency of zero. An unsuccessful attempt was made to adjust the data of the cracked blades to approach more closely their actual fracture times. The data of the completely fractures blades were studied to determine the average time elapsed between a severe crack and a complete fracture, but these elapsed times had a very wide range and a reliable correction factor could not be determined. In addition, the exact time when a given amount of cracking occurred was impossible to determine.

(a) Turbine wheel showing cracked and fractured blades.

Figure 3. - Damage to blades of wheel 1 after $28\frac{1}{2}$ hours of power and condition time.

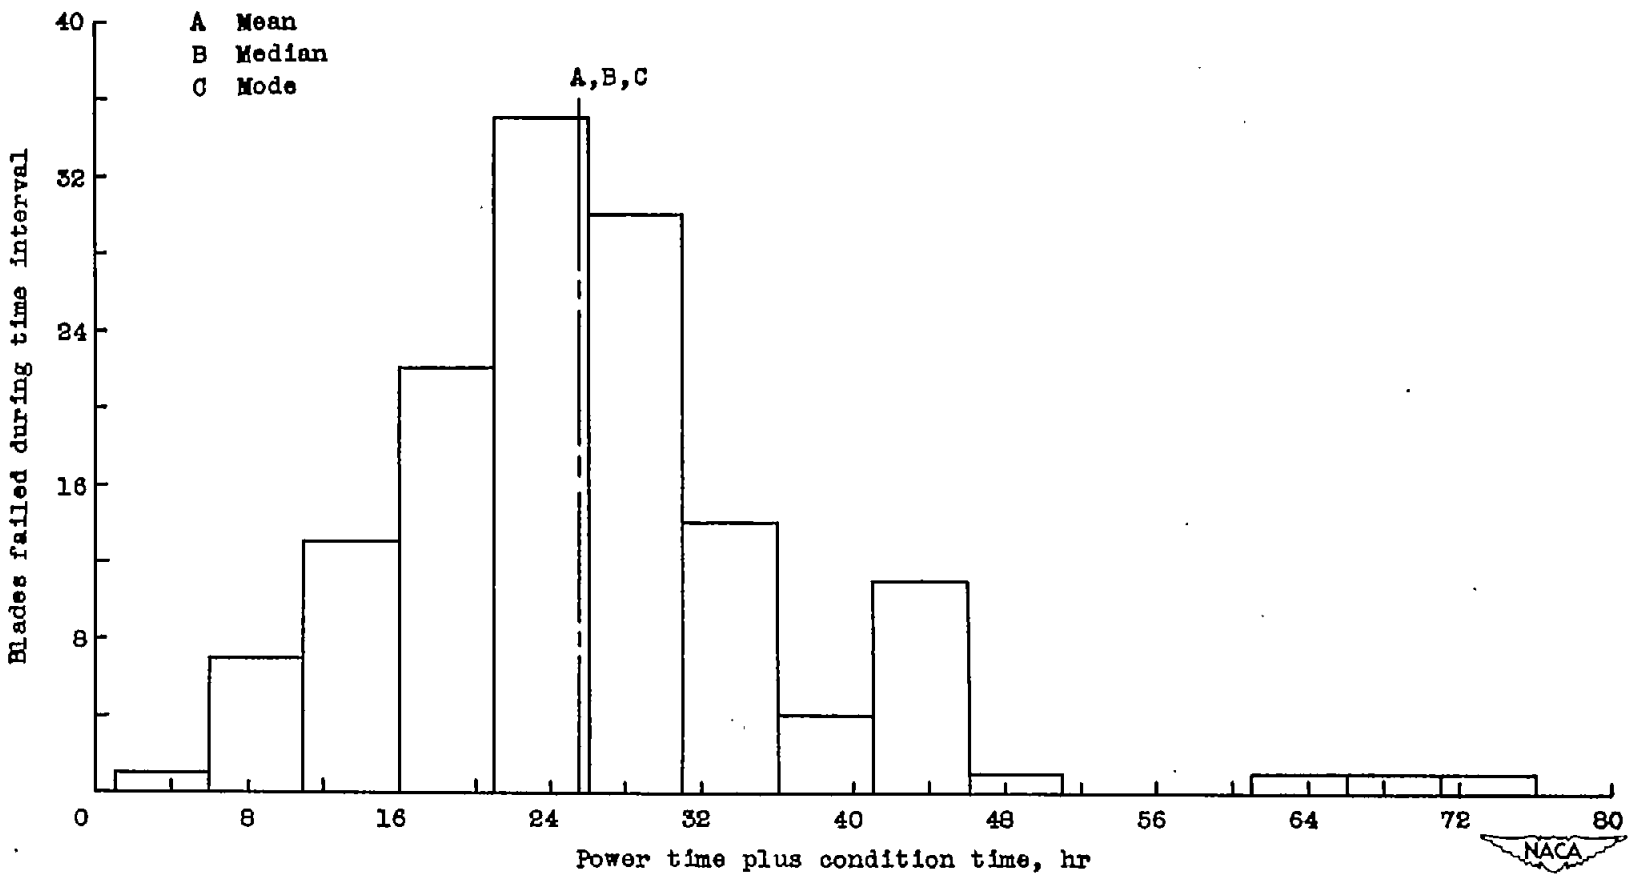
Wheel 1. - The failures for wheels 1 and 2 are summarized in tables I and II, respectively. The blade failures experienced appeared to be of the stress-rupture type, in combination with other effects. The distribution of blade failures for wheel 1 are shown in figure 5. The abscissa is the total of power and condition times

The median is the life of the middle most blade of the 142 investigated, that is, the life of the 71st or 72nd blade failed. The median was 25.53 hours. By substitution into the equation, the mode for wheel 1 was found to be about 25.55 hours. The insignificance of the difference (0.03 hr) between the mean and the mode indicates that the distribution is effectively a normal one.

The deviation is great, which indicates considerable differences in the performance of the individual blades. These differences apparently may result from dimensional differences among the blades that cause a wide variation in stress. An exploration of the possible dimensional differences in the blades of this wheel yielded no data that could be significantly correlated to explain the large range in blade life, which indicates that this effect was of secondary importance. Possibly the large deviation may be explained by the presence of minute faults in the blade material — faults too small to be resolved by the usual inspection methods. Although a radiographic inspection method is used for detection of internal flaws and a fluorescent-oil method for external cracks, the size of the flaws detected is limited by the resolving power of the inspection equipment. Considerable improvement in blade performance could probably be made by reducing the dispersion of failure times by the use of better inspection techniques and improved processing. The existence of blades with a life of 70 hours, as shown at the upper end of the distribution curve, suggests this life as a goal for the blades of wheel 1 that may be reached by preliminary elimination and improvement of the blades that fail early.

Figure 5. - Distribution of time to blade failure for wheel 1.

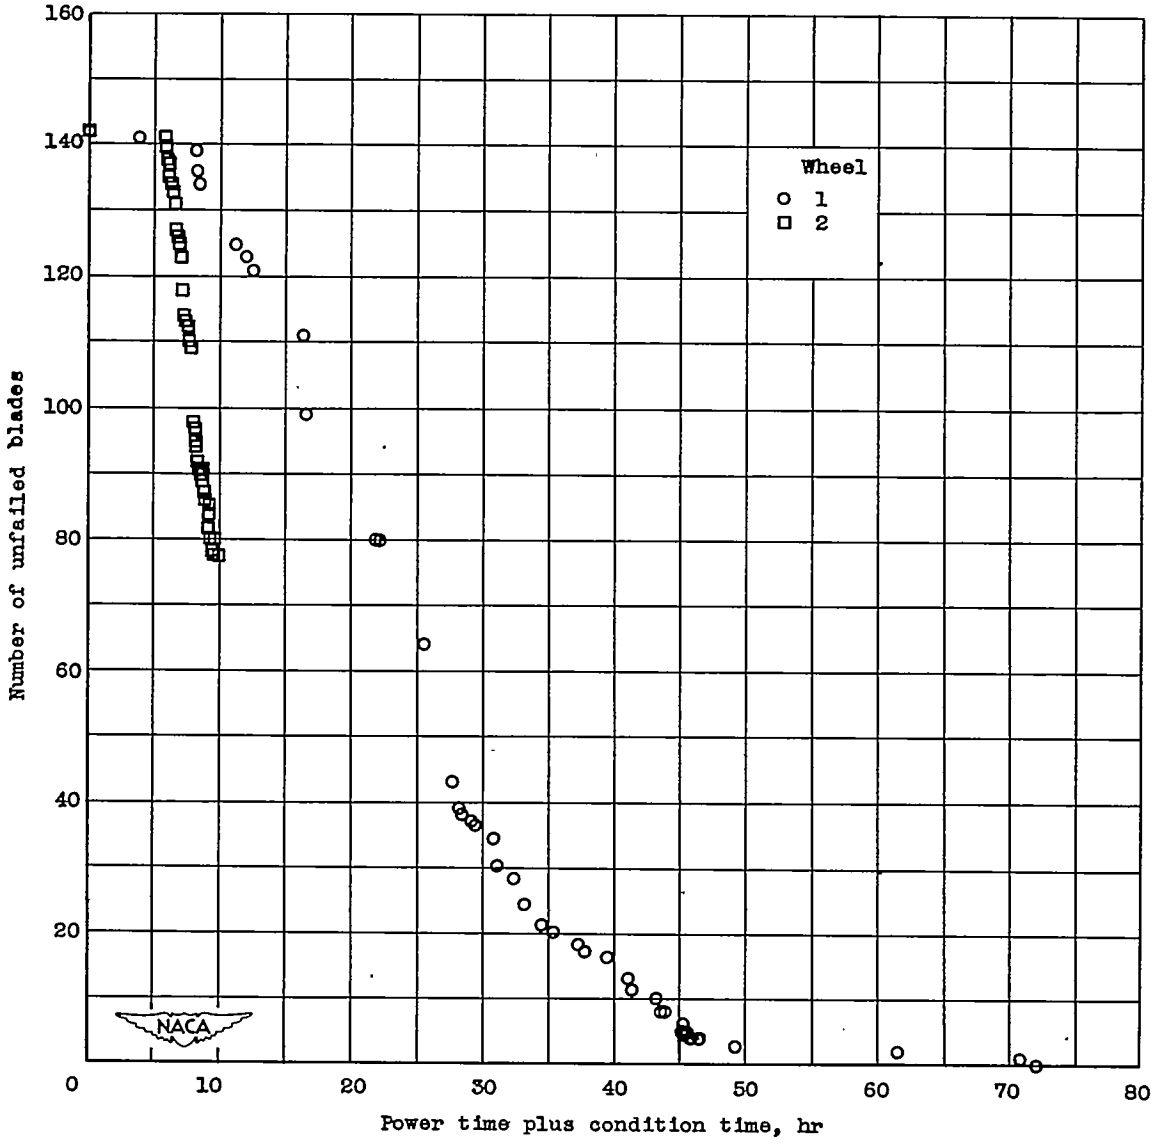
Figure 6. - Cumulative-frequency curves of time for blade failures.

wheel 1 occurred after 3.92 hours and the first of wheel 2 after 5.59 hours. If the wheels are compared on this basis, the probable life of wheel 2 is indicated as being 43 percent greater than that of wheel 1. The error in this conclusion may be seen by comparing the materials by means of a cumulative-frequency curve (fig. 6), which is a plot of total blades surviving against running time. The life of the average blade of wheel 2 is suggested as less than that of wheel 1, contrary to the analysis suggested by consideration only of initial failures. Although the blades in wheel 2 had heavier shrouds and consequently were more highly stressed, the time of initial failure of the wheel was greater than that of wheel 1, and the possible error resulting from the use of initial failure is thereby emphasized.
