NATIONAL ADVISORY COMMITTEE FOR AERONAUTICS

TECHNICAL NOTE

No. 1626

A STUDY OF CERAMIC COATINGS FOR HIGH-TEMPERATURE PROTECTION OF MOLYBDENUM

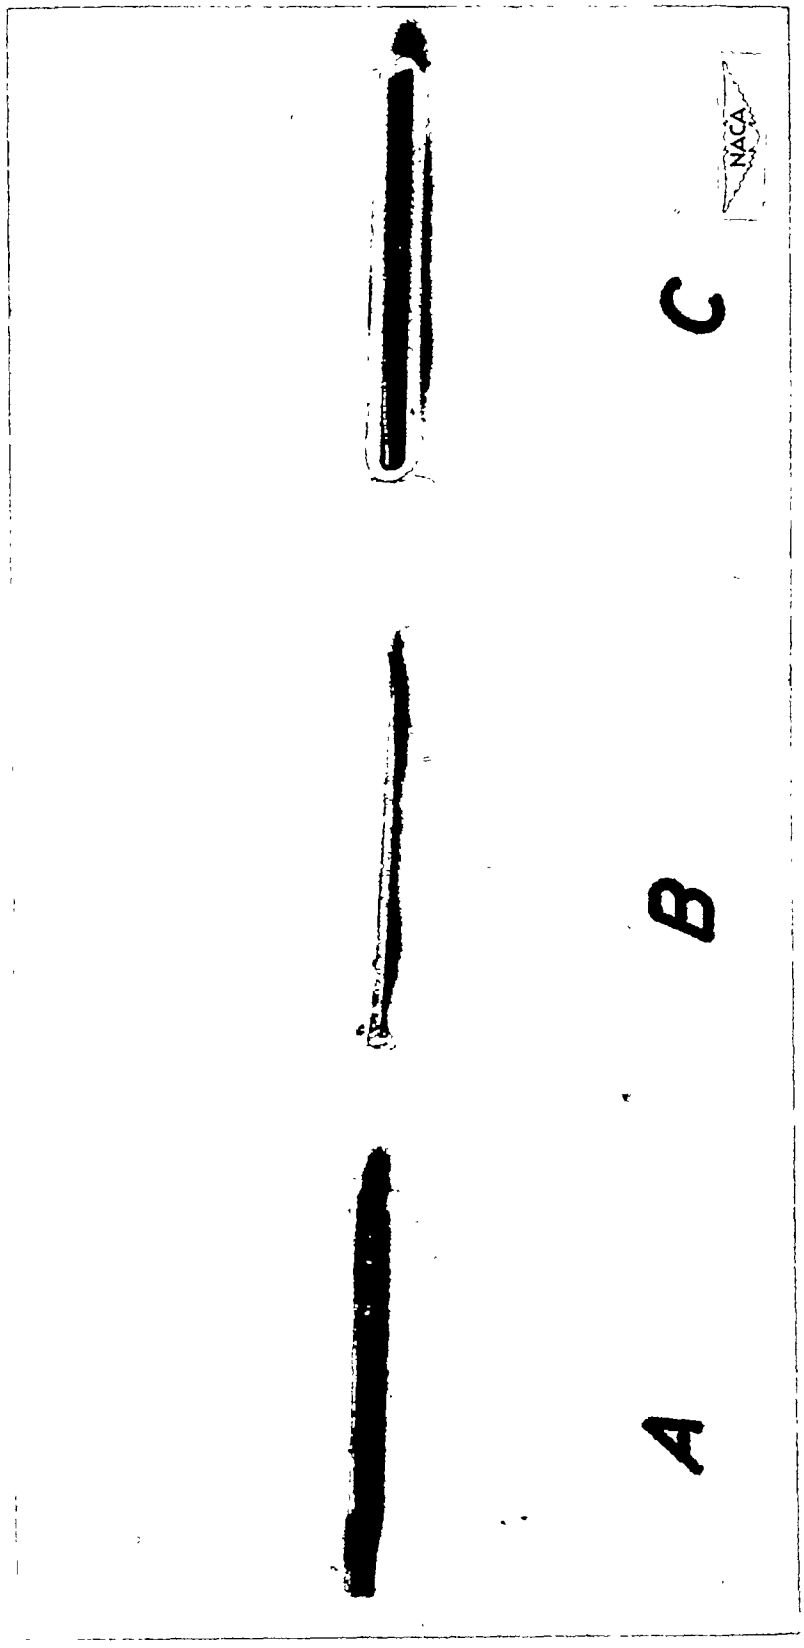
Specimen A, in figure 2, illustrates the uncoated molybdenum metal while specimen B shows a section of the same metal after 30 minutes of heating at 1650° F. It will be noted that specimen B, with no coating, has been reduced to one-half of its original thickness in only 30 minutes of heating while specimen C has maintained its full thickness throughout 70 hours of heating.

Figure 2.- Enlarged photograph (2.3X) of sections cut through coated and uncoated sheet molybdenum. Specimen A is the original uncoated molybdenum 0.040 inch thick. Specimen B is similar to A except that it has been heated for 1/2 hour in air at 1650° F, losing approximately half its thickness. Specimen C which has had a ceramic coating applied at a thickness of 0.028 inch has undergone 70 hours of heating in air at 1650° F with no evidence of oxidation of the metal.

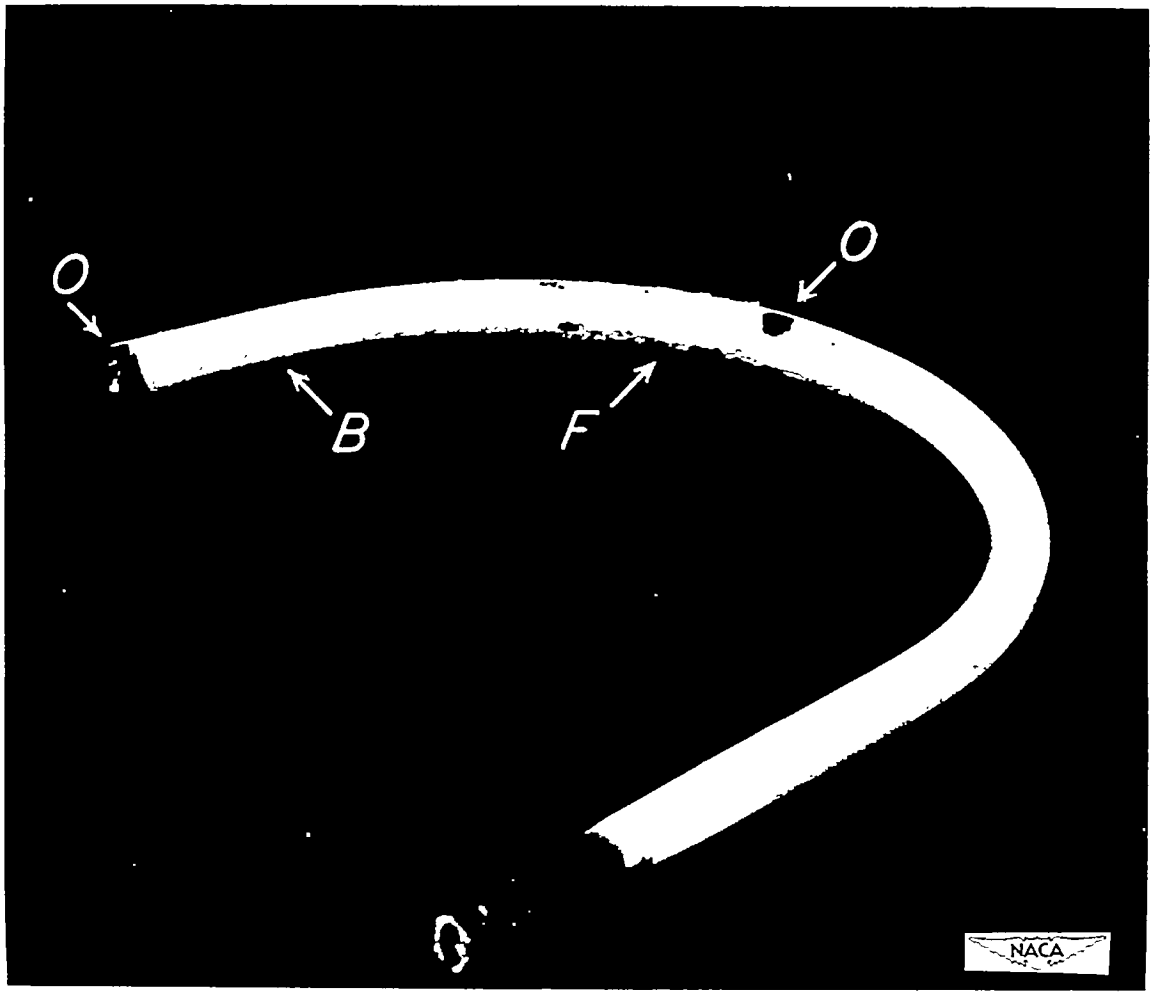
The M-13-35 tube (coating thickness, 0.008 in.) had undergone 45 minutes of service without any considerable oxidation of the metal except at two spots. One of these spots, shown as O at the upper end of the tube in figure 7, was originally not so well protected as on the M-3-8 tube inasmuch as it had not been reinforced with extra coating at the tip. As a result, the protection at this point terminated during the test and considerable oxidation occurred. The dark area indicated as O at the central section of the tube was believed to have resulted from damage to the coating during installation. Oxidation had progressed sufficiently at this area to halve the thickness of the tube wall. No serious damage had occurred elsewhere, although several small spots appeared to have lost the coating, possibly near the end of the 45-minute test period.

The speckled appearance of the coating on the tube at B in figure 7 is caused by healed blisters in the coating. There is evidence also of flow of the coating, which is apparent at F in the photograph as ripples in the surface. This flow was believed to have occurred at the moment the blisters formed. The blisters caused added obstruction to the smooth flow of the high-velocity gases. The flow of the coating reduced this obstruction.

Figure 7.- Coated pitot tube of the type shown in figure 6 after 45 minutes of service operation in blast of ram jet at computed gas temperature of 3000° F. Although deterioration of the coating has occurred, the tubes have performed satisfactorily under conditions which would have caused serious oxidation of uncoated parts.
