RESEARCH MEMORANDUM

VIBRATION SURVEY OF BLADES IN 10-STAGE

AXIAL-FLOW COMPRESSOR

I - STATIC INVESTIGATION

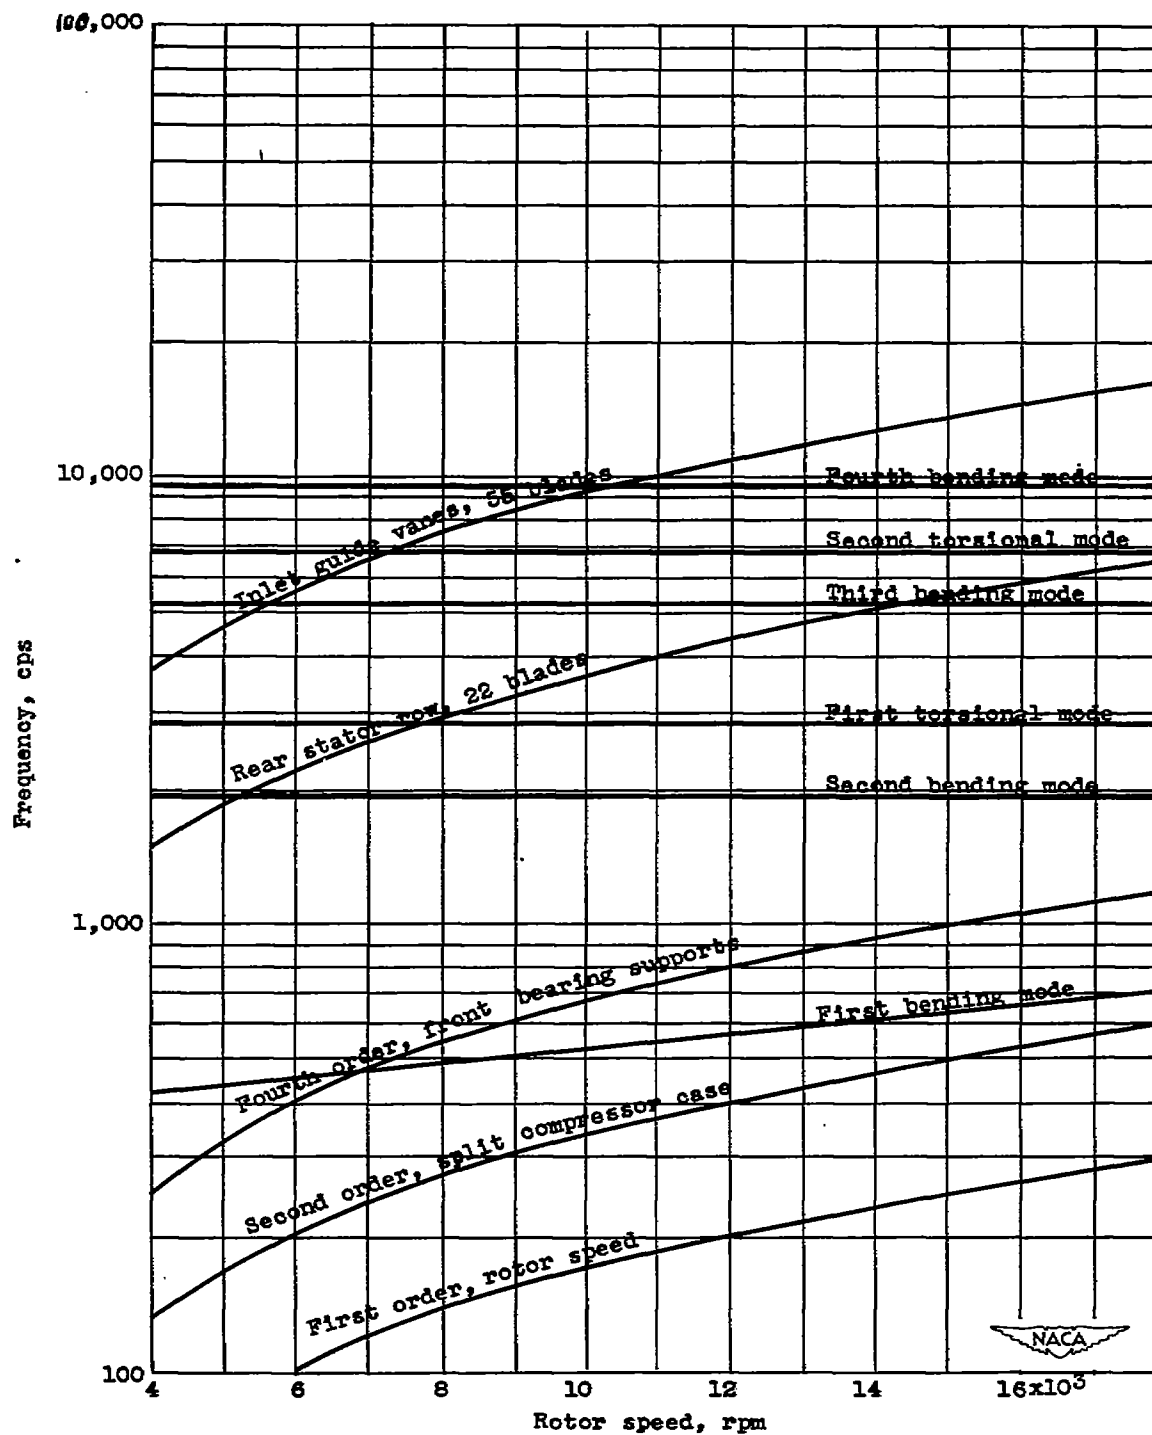
(a) First stage.

A critical speed of 14,400 rpm is indicated on figure 9(a) at a
third bending-mode vibration excited in the first-stage rotor blades
by the 22 stator blades immediately following. High modes of vibration
such as the third bending mode are difficult to excite and are there-
fore probably not serious. This critical speed is the only one readily
apparent in the compressor.

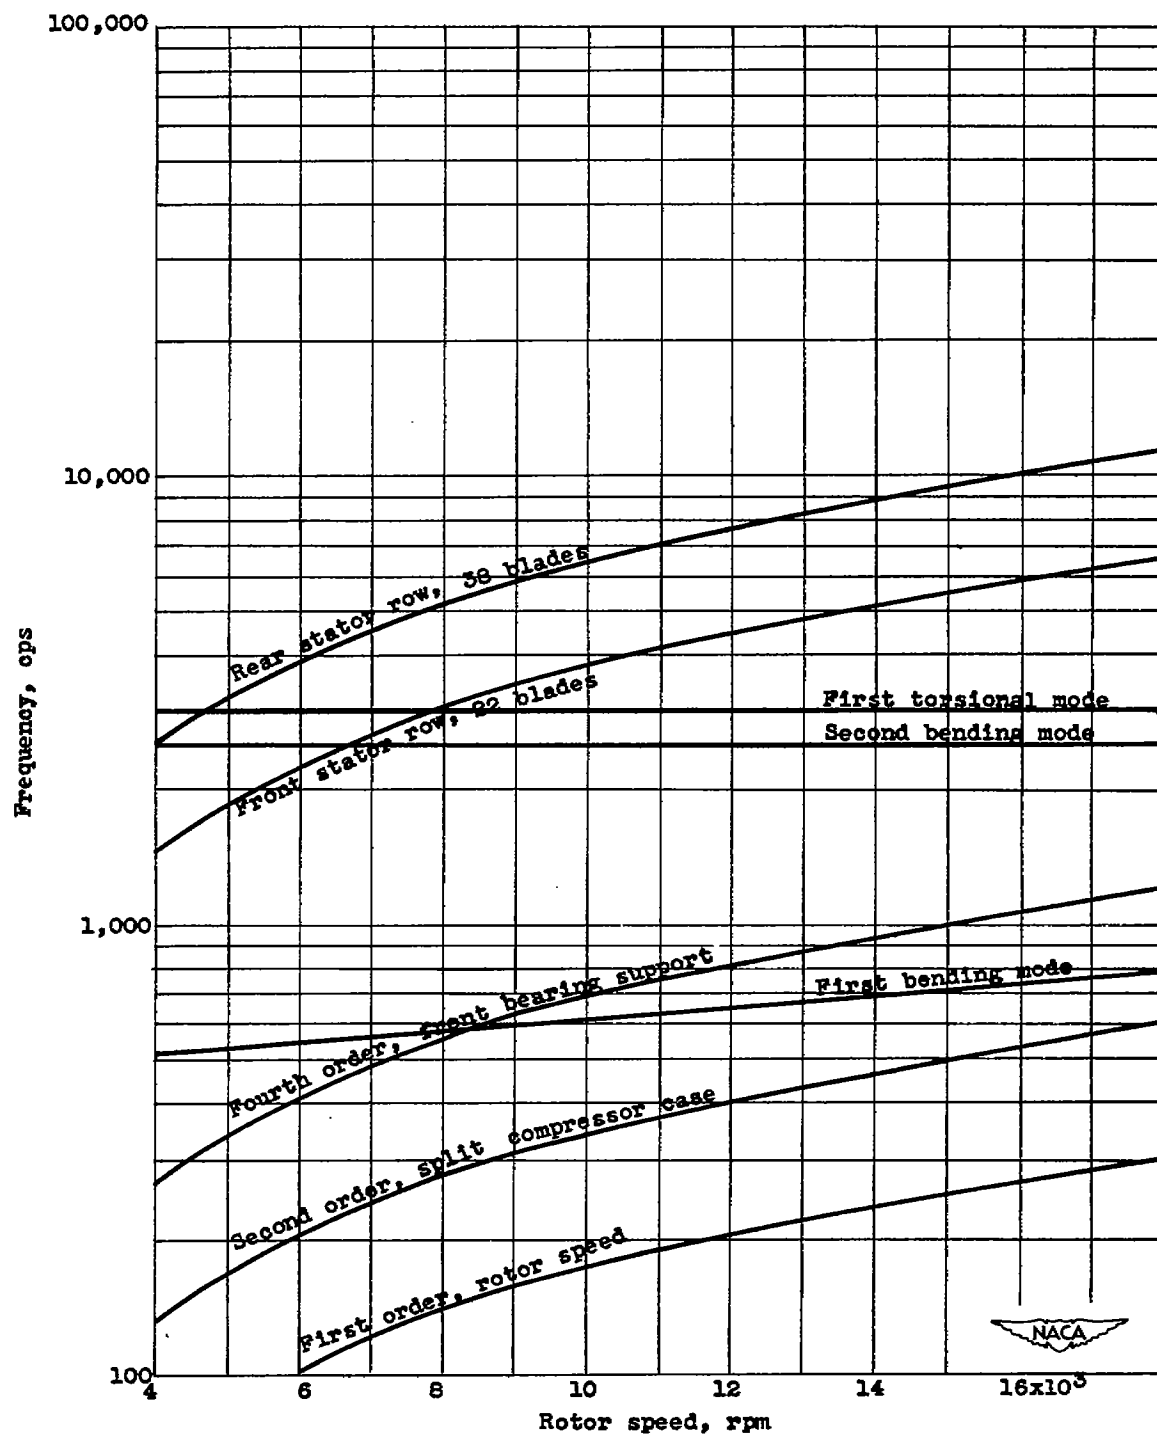
(b) Second stage.

Figure 9. - Continued.   Critical-speed diagrams for 10 stages of
                          compressor rotor.

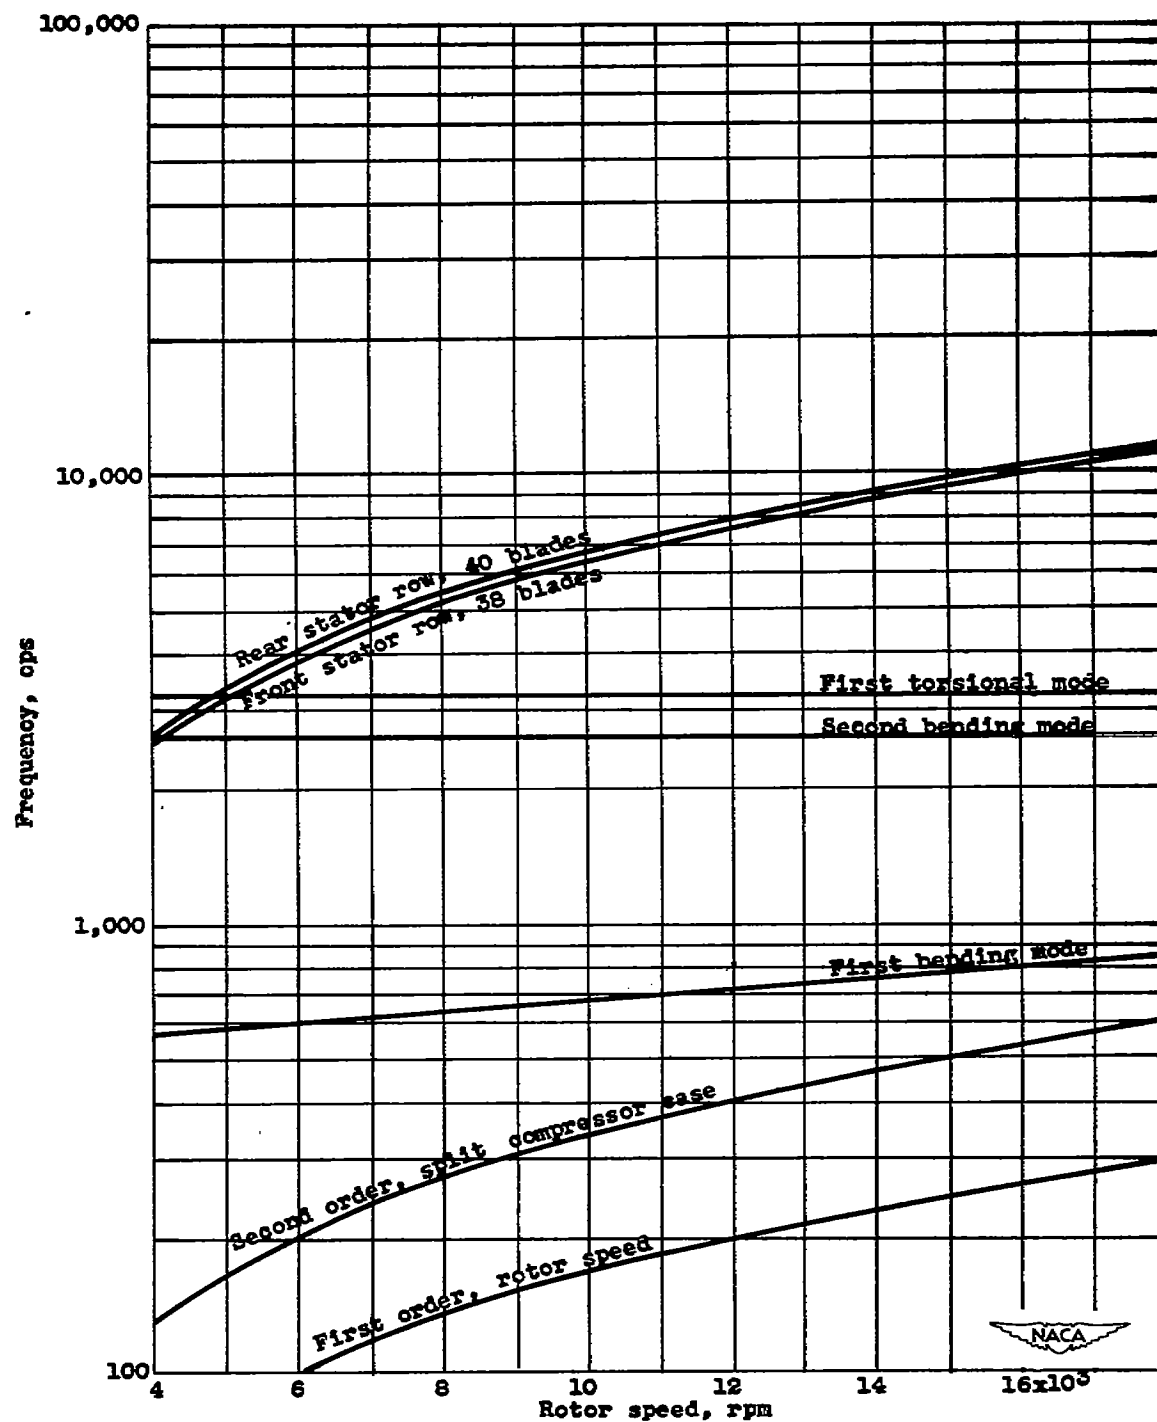
(c) Third stage.
Figure 9. - Continued.   Critical-speed diagrams for 10 stages of

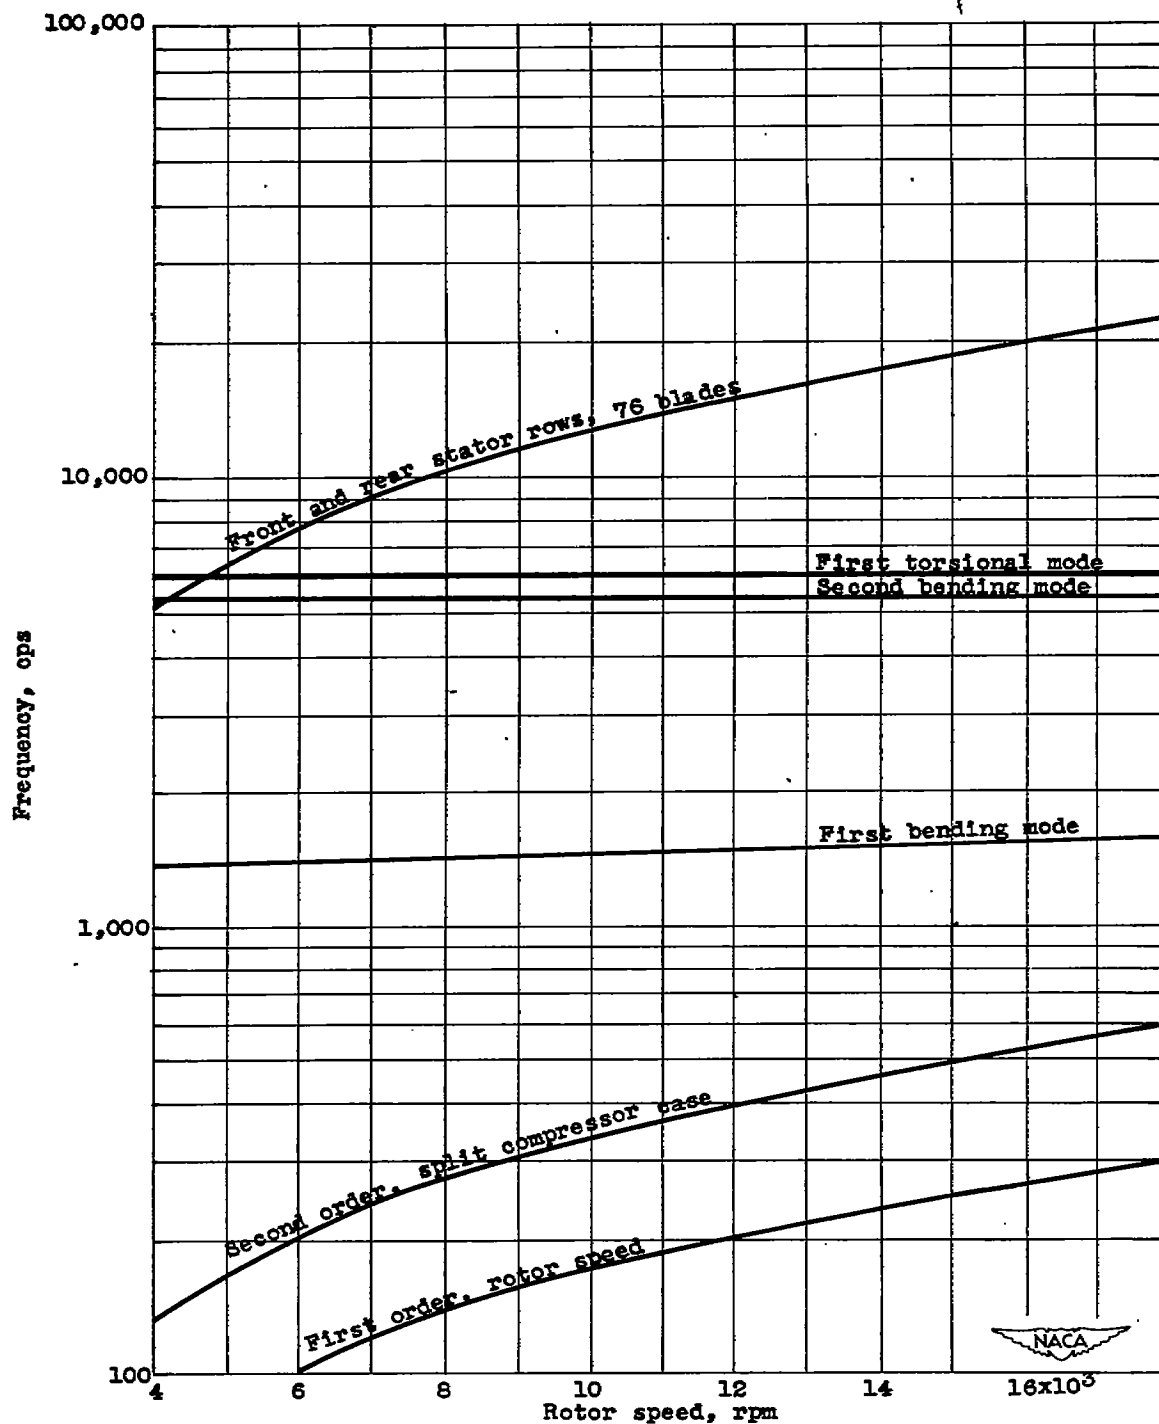
(g)   Seventh stage.

Within the operating range of the engine, the exciting force required to cause a resonant vibration in the seventh-stage blades in the first bending mode is approximately the fourth order of the rotor speed (fig. 9(g)). The only fourth-order exciting force obviously present in the compressor is caused by the four arms supporting the front main bearing but it is doubtful that the effect of the arms would carry through as far as the seventh stage. In the tenth stage, the resonant point of first bending-mode vibrations at 16,600 rpm coincides exactly with a sixth-order excitation (fig. 9(j)). The blades are possibly being mechanically or aero-dynamically excited but no exciting force of these orders could be determined. All the failures reported occurred in complete engines and, although a compressor has been operated at various speeds up to 17,000 rpm in an NACA test cell for more than 450 hours, no failures have occurred. Some coupling effect might possibly take place between the turbine or the accessories and the compressor during complete engine operation. Operation at high pressure ratios may also produce the air-flow velocities and pressure conditions necessary to excite blade flutter.

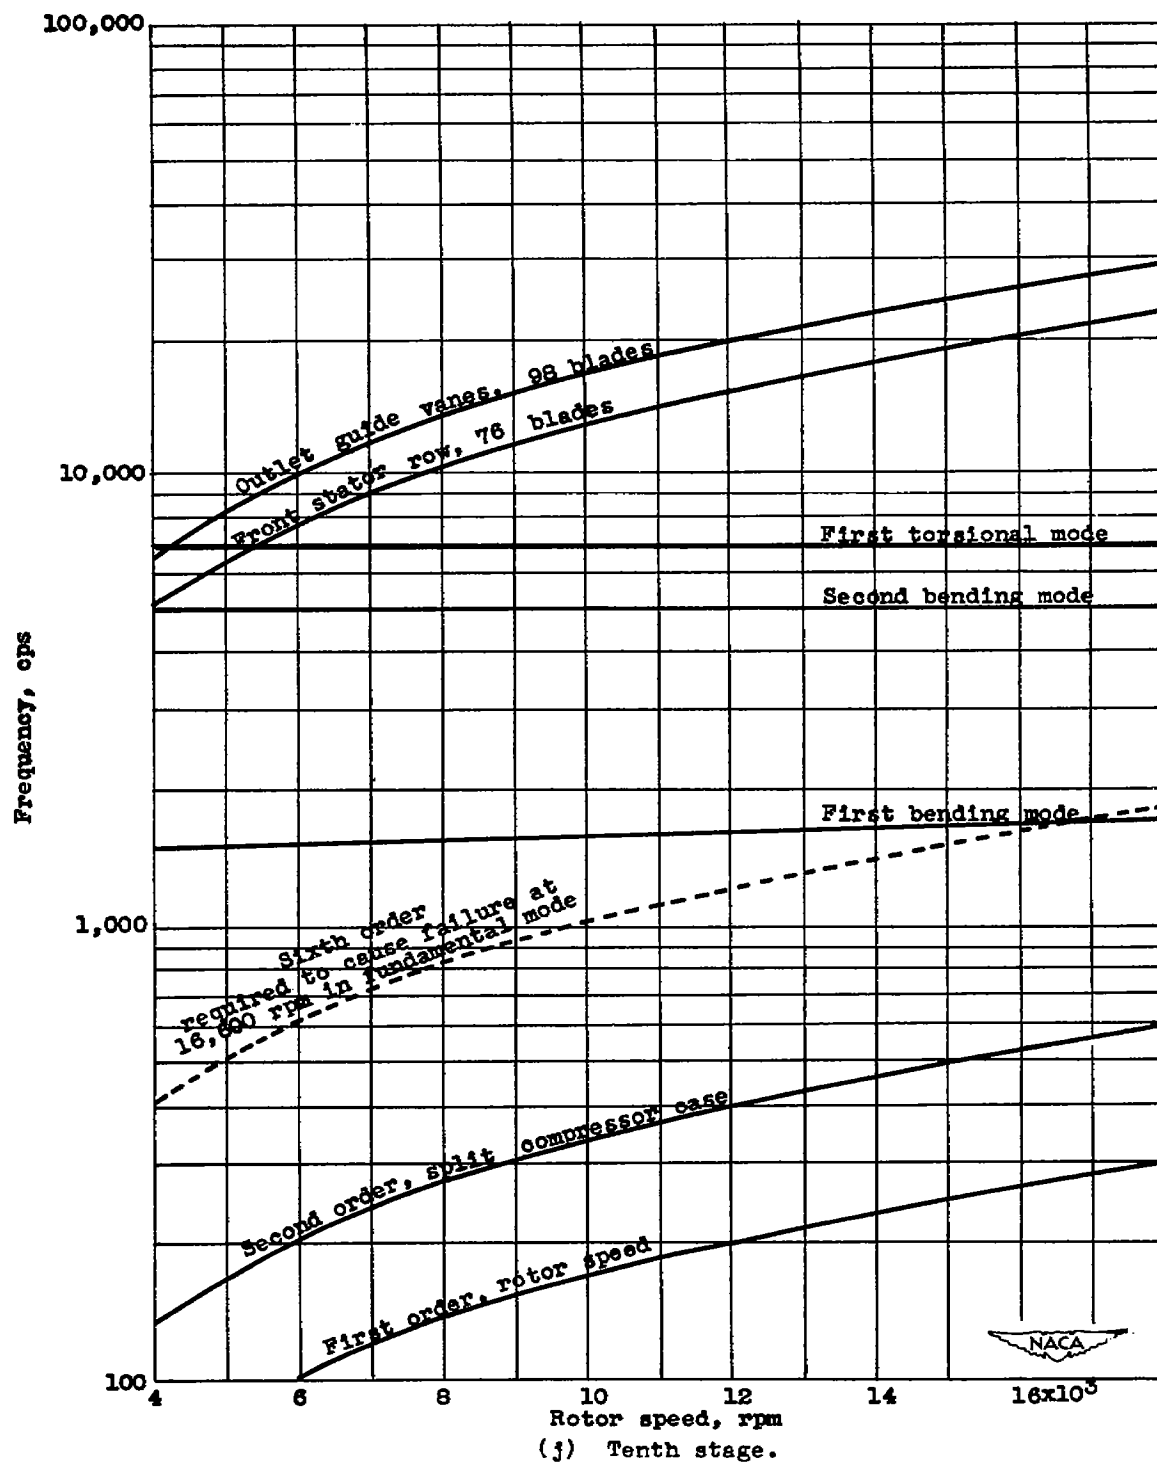
(j) Tenth stage.

Results of an investigation to determine the reason for failure of blades of the seventh and tenth compressor stages in the 10-stage axial-flow compressor at a speed of 16,600 rpm indicated a possibility of exciting first bending-mode vibrations in the seventh-stage blades by a fourth-order excitation of the rotative speed. The tenth-stage blades were possibly excited in the first bending mode by a sixth-order excitation.
