TECHNICAL NOTE 2052

EFFECTS OF AN AGING TREATMENT ON LIFE OF SMALL CAST VITALLIUM GAS-TURBINE BLADES

By Charles A. Hoffman and Charles Yaker

Lewis Flight Propulsion Laboratory
Cleveland, Ohio

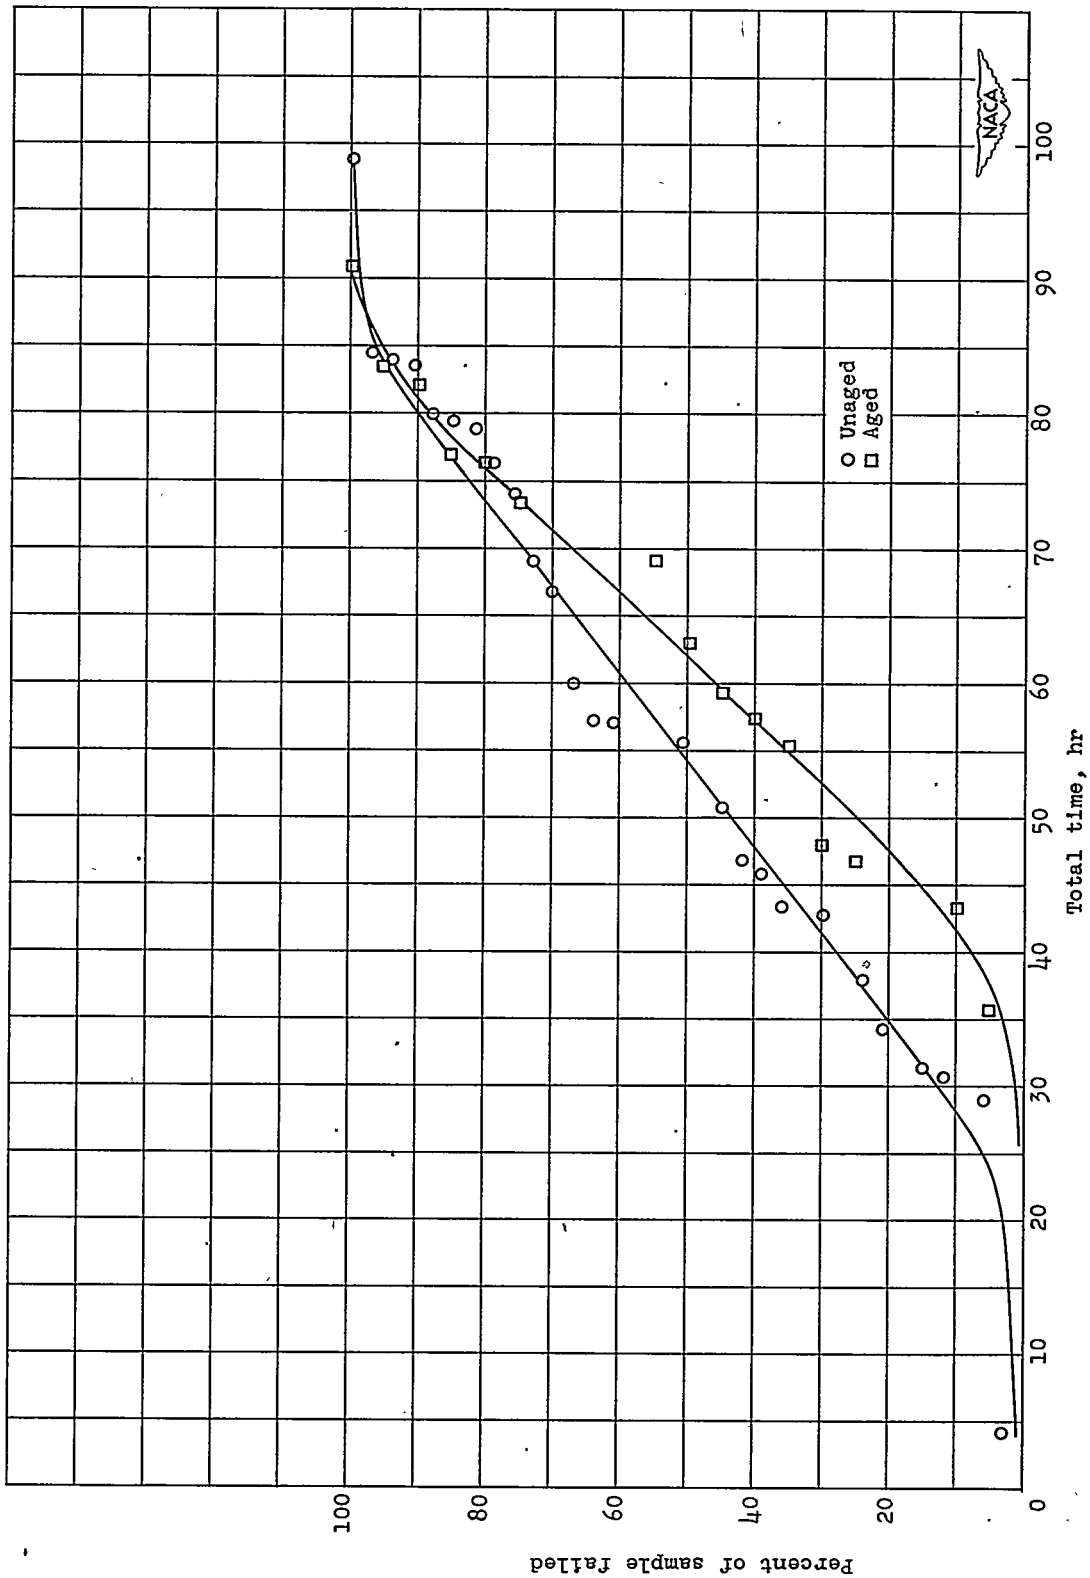
The times for failure for turbine blades of the unaged and aged materials are listed in table I. The failure times for both types of blade are presented in figure 3 as cumulative-frequency (ogive) plots. The data show that aging prior to operation apparently increases the mean life, the uniformity of life, and the time for initial failure of Vitallium turbine blades. These results indicate that aging, which improves stress-rupture strength, increases blade life. The cumulative-frequency data points (fig. 3) also show that after about 73 hours of operation there is little difference in the performance of the two samples, which indicates that aging has not significantly affected the lives of the last blades to fail.

Figure 3. - Cumulative frequency of failures for 33 unaged Vitallium blades and 20 aged Vitallium blades. Temperature, 1500° F; centrifugal stress, 20,000 pounds per square inch in failure-zone cross section.

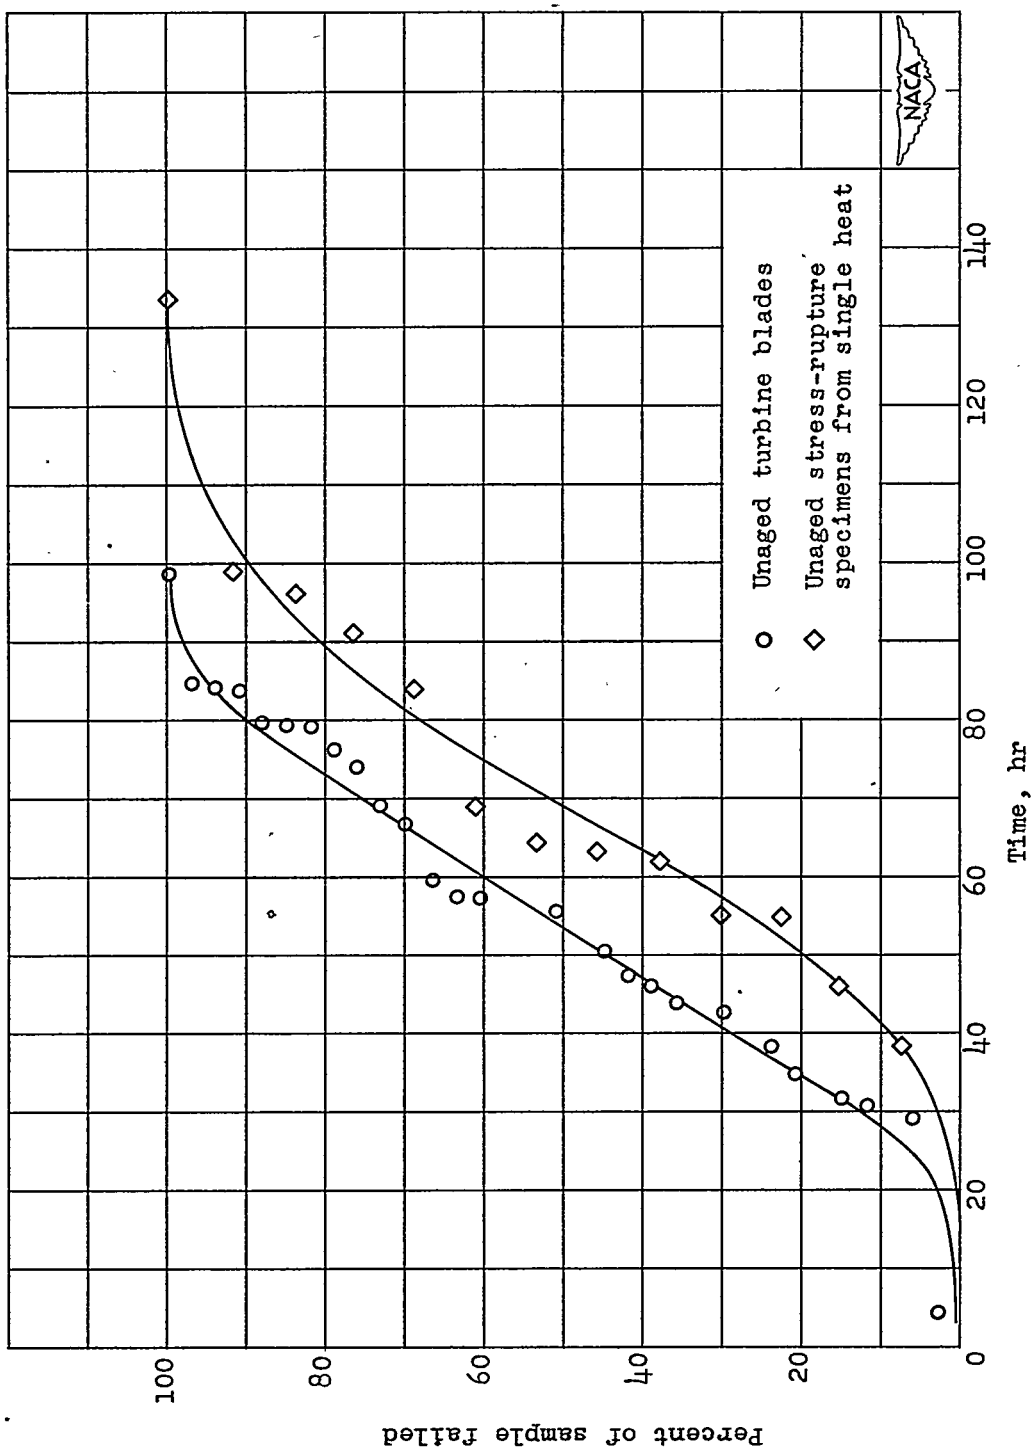
It is of interest to examine the specific manner in which stress-rupture properties of unaged Vitallium, cast in the shape of standard stress-rupture specimens, compare with the behavior of the unaged blades. A tabulation of cumulative failures of unaged Vitallium specimens that failed in stress-rupture evaluations at 1500° F and 20,000 pounds per square inch (plane stress in failure zone of blades) is given in table III; the stress-rupture data were obtained from reference 5. The data of table III are for specimens cast in a single heat; they therefore may be of the same chemical composition. The mean life for the stress-rupture specimen sample is 73.5 hours and the standard deviation is 25.2 hours. The cumulative-frequency curves for these data and for the unaged blades are compared in figure 4. The stress-rupture specimens had a longer mean life than the unaged blades (73.5 hr as compared to 55.2 hr). The standard deviation is slightly greater for the stress-rupture specimens (25.2 hr as compared to 20.7 hr). Calculations indicate that there is a 95-percent probability that the stress-rupture-specimen population mean is greater than 63.9 hours and that the unaged-blade population mean is less than 61.1 hours. It can therefore be concluded that there is a significant difference in population means. Also, computations indicate that there is a 95-percent probability that the actual standard deviation for the unaged-blade population will be no greater than 27.6 hours; hence, it is seen that the deviation for the stress-rupture specimen could be the same or approximately the same as that for the unaged-blade-sample standard deviation. Inasmuch as both samples may have about the same dispersion, there is a possibility that the same systematic causes of failure operate in both instances, but about different levels. An accurate comparison, however, can be made only with a larger number of items in both samples. Figure 4 can support this theory inasmuch as the two ogive curves are similar in shape and dispersion, but are displaced. Thus, there is an indication that stress-rupture data may be a primary criterion in determining blade life in a small gas turbine of the type used in this investigation.

Figure 4. - Comparison of cumulative-frequency distributions of 33 unaged blades and 13 stress-rupture specimens of cast Vitallium. Temperature, 1500° F; stress, 20,000 pounds per square inch.

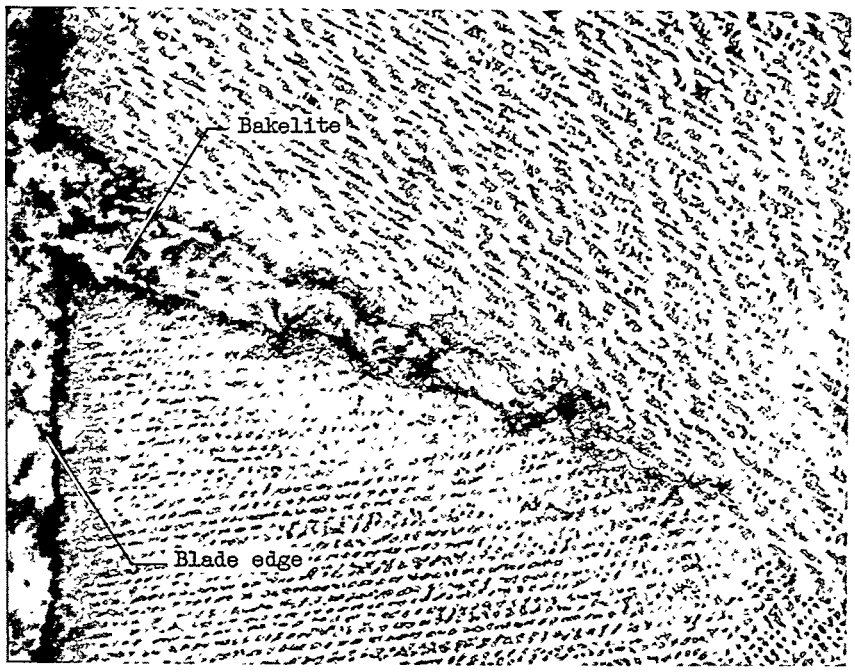
Examination of the failures of both samples indicated that cracks started in the grain boundaries and became transcrystalline as they progressed. A typical intergranular edge crack is shown in figure 6. Intergranular surface cracks also occurred at the center of the blades. This microstructural evidence indicates that under the temperature and stress conditions of this investigation, the failure progresses in its early stages along the grain boundaries. It is not known whether transcrystallinity is characteristic only of the later stages of rupture, or is present at an earlier stage. Thermal stresses apparently were not severe, because no blade warping was noted.

Figure 6. - Typical intergranular crack at edge of blade. Electrolytically etched in 10-percent nitric acid and 10-percent ethylene glycol in ethyl alcohol. Vertical illumination. X50.

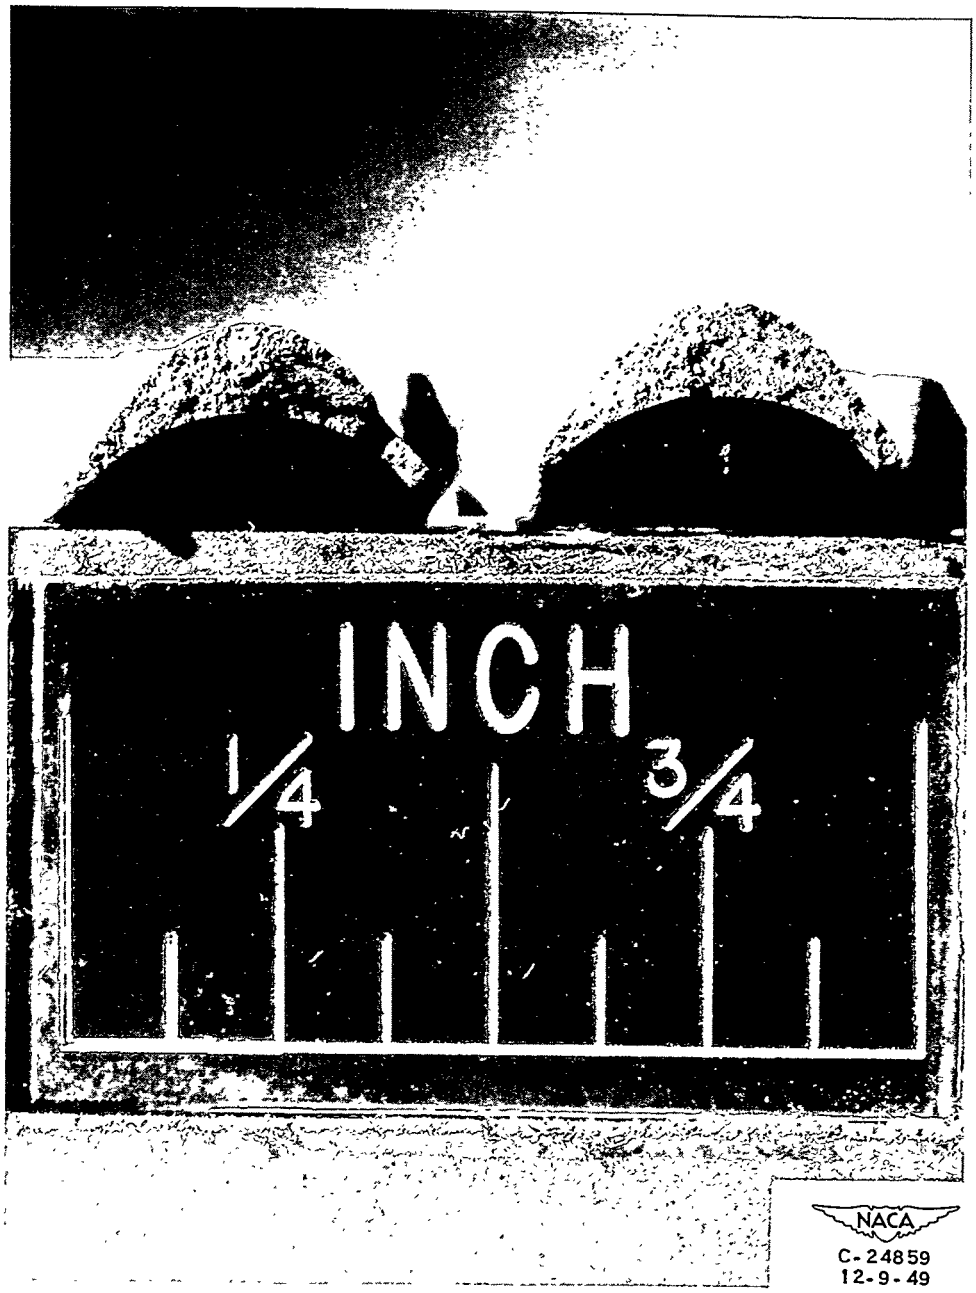
The textures of failure surfaces are exemplified by those shown in figure 7. The coarse crystalline surface was observed in all failures. The surface was divided into two distinct zones manifesting different oxide colors, one a dark gray and the other ranging in color from light straw to deep blue. The gray zone was present in the area where cracking first occurred; whereas the other colors were observed only on freshly fractured surfaces. There was no evidence of a fatigue type of failure in any of the fractures and, from the nature of the fractures, stress rupture is probably the major cause of failure. It is impossible from the results of this investigation to determine the extent of other factors, such as thermal shock or vibration, and whether or not they are contributing causes of failure.

Figure 7. - Blade-fracture surfaces showing coarse crystalline texture.

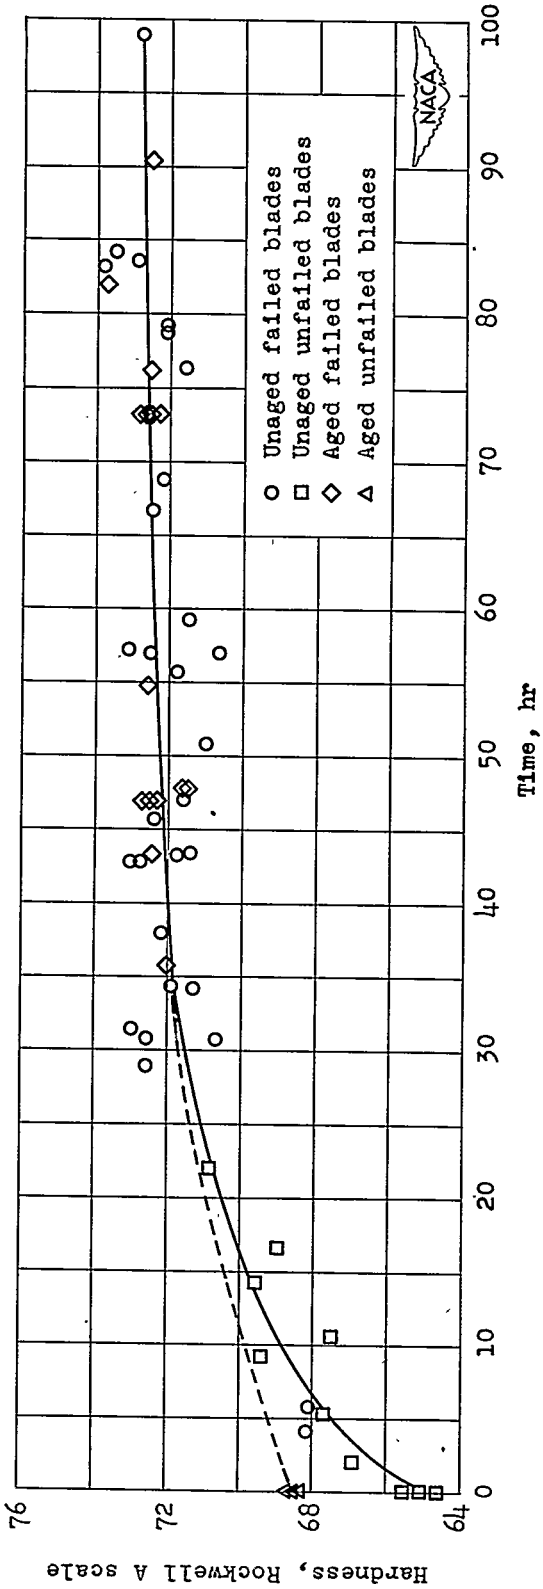
The results of hardness determinations on both types of blade after turbine operation, as well as blades that had not failed, are presented in figure 8. Each point on the graph represents an average value of five readings distributed over the blade cross section. It should be noted that the unaged blades hardened rapidly and reached the same hardness as the aged blades that had not failed in about 9 hours. The presence of high stresses possibly contributed to the rapid aging. The presence of stress is known to accelerate aging in light alloys (reference 6), but it is not conclusively known whether high-temperature alloys of the Vitallium type are so affected. Both sets of used blades attained the same hardness after about 35 hours of operation, and the hardness increased slightly at approximately equal rates thereafter. These results show that failure of some unaged blades occurs before the blades reach the point where the hardness increase levels off (35 hr). No aged blades, however, failed before 35 hours, which indicates that preoperation aging resulted in the blades becoming almost fully hardened before failure. The aging period of 48 hours at 1500° F was selected to yield good stress-rupture properties (reference 1). It is apparent from the hardness data, however, that aging before operation was only partly complete. The attainment of a higher preoperation hardness might further improve performance.

Figure 8. - Variation of hardness of turbine blades with time of operation.

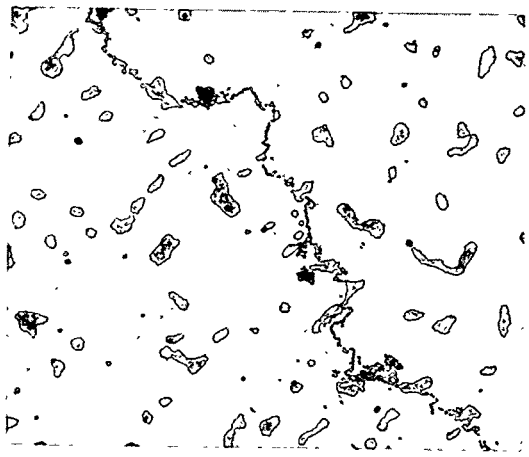
Photomicrographs of unaged blades before turbine evaluation and after failure, at times ranging from 4.3 to 84.2 hours, are presented in figure 9. Figure 10 shows the structures of aged blades before evaluation and after failure at times ranging from 35.8 to 90.8 hours. The unaged material shows no precipitate before engine operation (fig. 9(a)); a precipitate is clustered about the original microconstituents after 4.3 hours of operation (fig. 9(b)); further operation shows a greater tendency for the precipitate to penetrate the matrix. By comparison, the aged sample before operation shows a precipitate close to the microconstituents (fig. 10(a)) and all aged blades that were examined after failure had a precipitate extending into the matrix. The evidence of the precipitate serves to corroborate the hardness data.

Figure 9. - Microstructure of unaged blades before turbine evaluation and at various failure times, showing stages of precipitation. Electrolytically etched in 10-percent nitric acid and 10-percent ethylene glycol in ethyl alcohol. X250.
