NATIONAL ADVISORY COMMITTEE FOR AERONAUTICS

TECHNICAL NOTE 2452

FLEXURAL FATIGUE STRENGTHS OF RIVETED BOX

BEAMS - ALCLAD 14S-T6, ALCLAD 75S-T6,

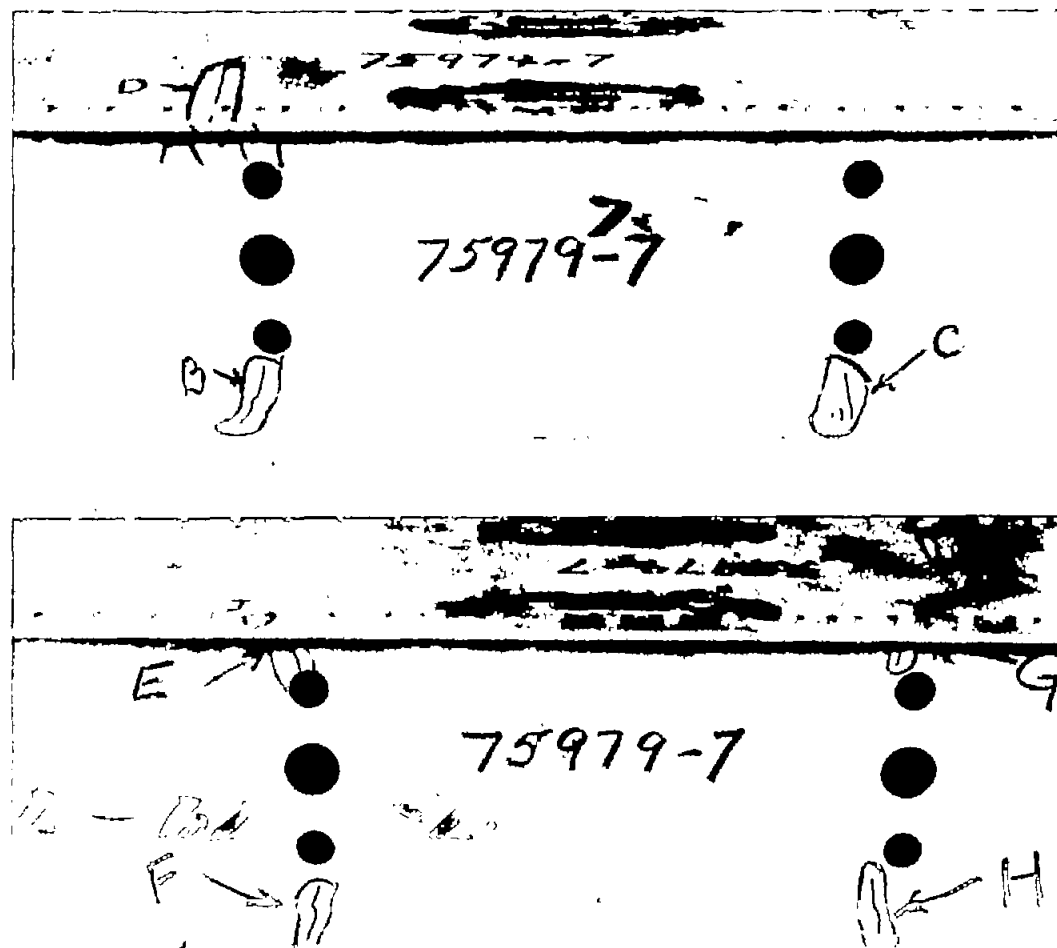
Typical failures are illustrated in figures 6(a) through 6(e). The general location of the failures can be seen in figure 6(a) through 6(c). Figures 6(d) and 6(e) are close-ups of the individual fractures in the beams illustrated in figures 6(a) and 6(b), respectively. Although the fixtures were designed to reduce the effects of stress concentration at the load points, it can be seen that some failures involved one or more of these holes. Of the 64 channel failures observed, 29 involved the loading holes; however, many of the 35 remaining channel failures had not reached a loading hole at the completion of the test.

(a) Specimen 75979-7. For close-ups of individual
failures see figure 6(d).

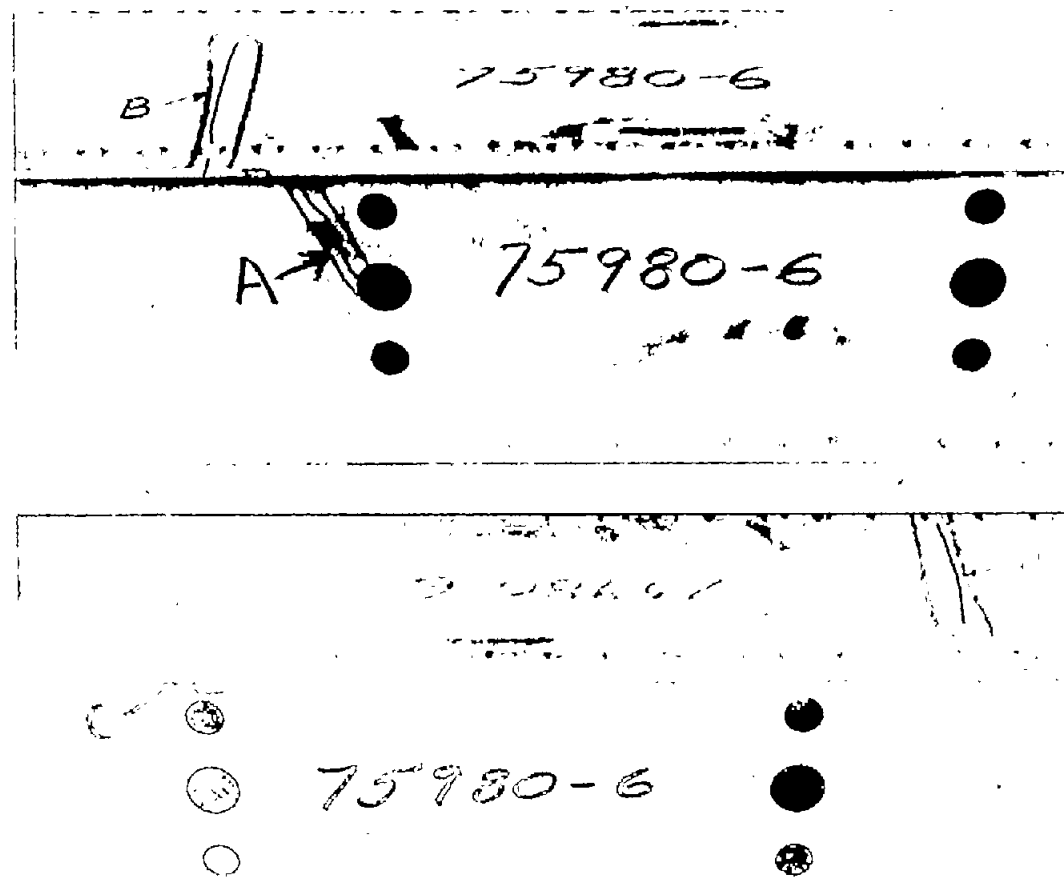
(b) Specimen 75980-6. For close-ups of individual

fractures see figure 6(e).

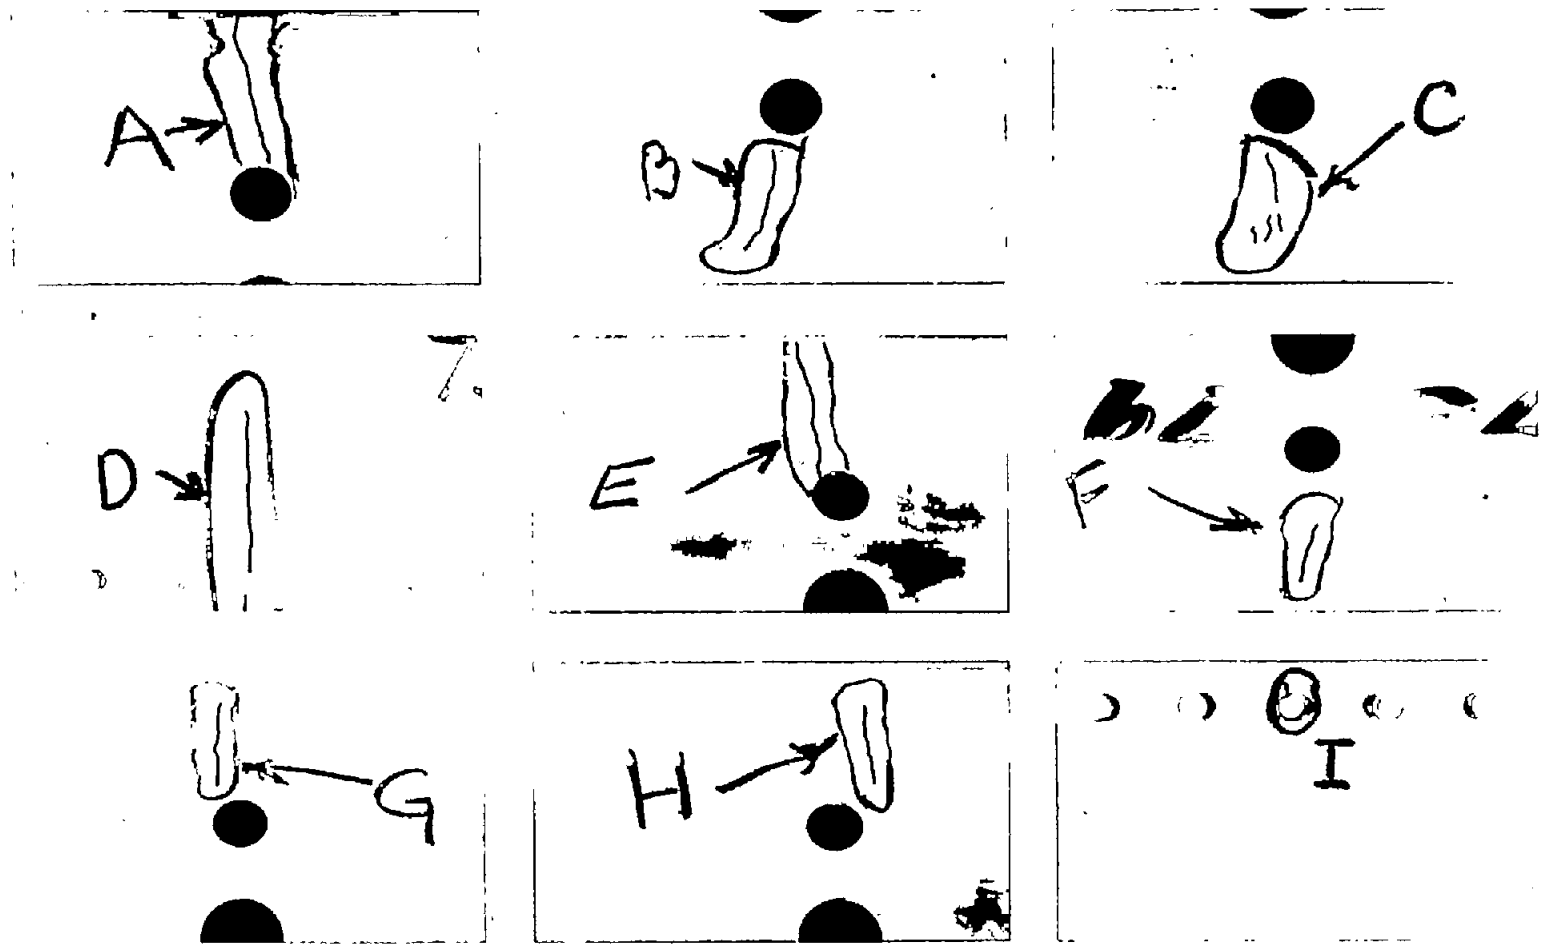
75981-4

(c) Specimen 75981-4.

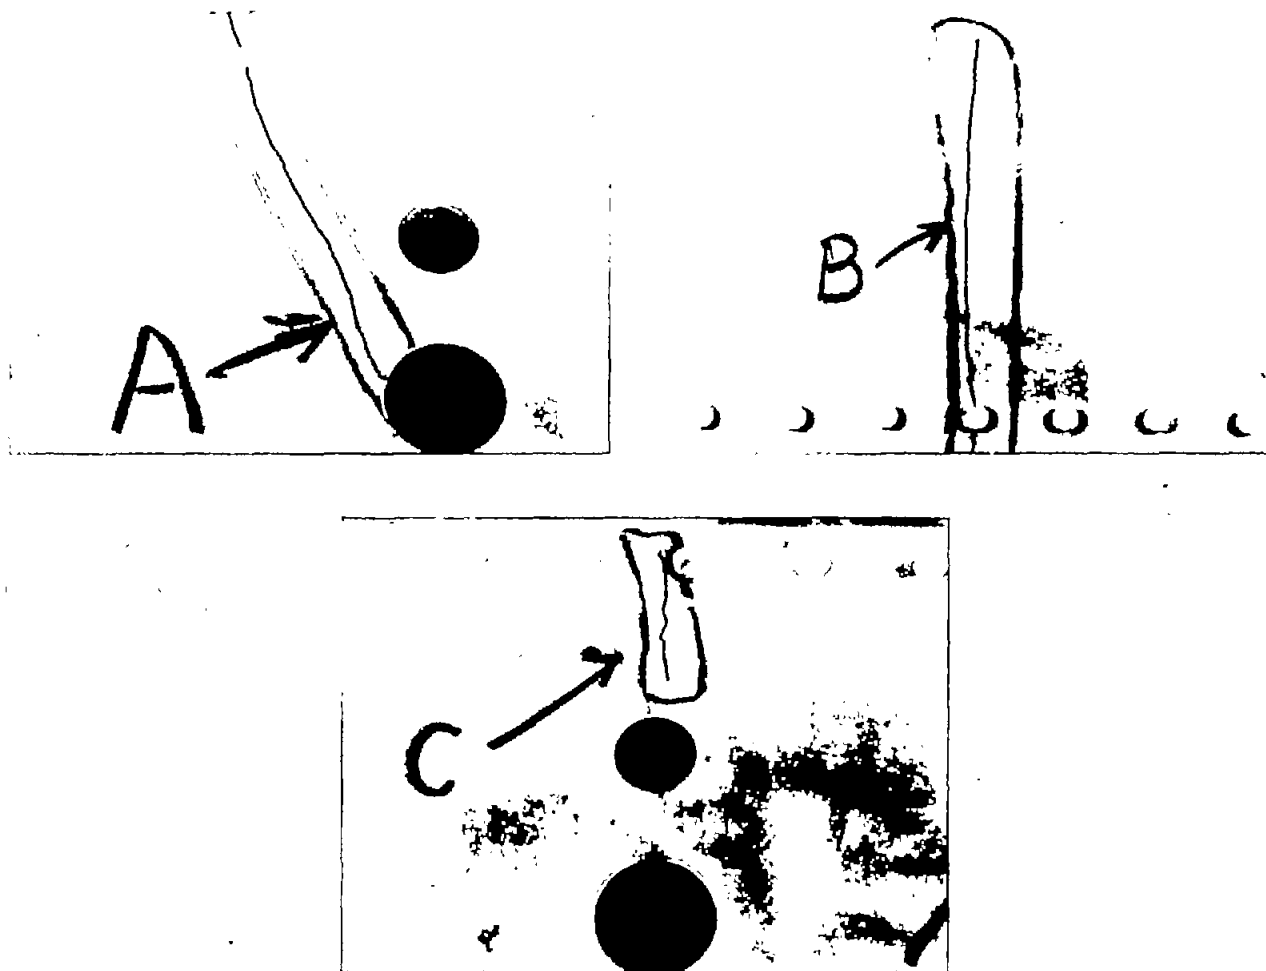
(d) Close-ups of fractures in specimen 75979-7.
For general location see figure 6(a).
