TECHNICAL NOTE 2513

EFFECTS OF SOME SOLUTION TREATMENTS FOLLOWED BY AN AGING TREATMENT ON THE LIFE OF SMALL CAST GAS-TURBINE BLADES OF A COBALT-CHROMIUM-BASE ALLOY

II - EFFECT OF SELECTED COMBINATIONS OF SOAKING TIME, TEMPERATURE, AND COOLING RATE

By C. A. Hoffman and C. F. Robards

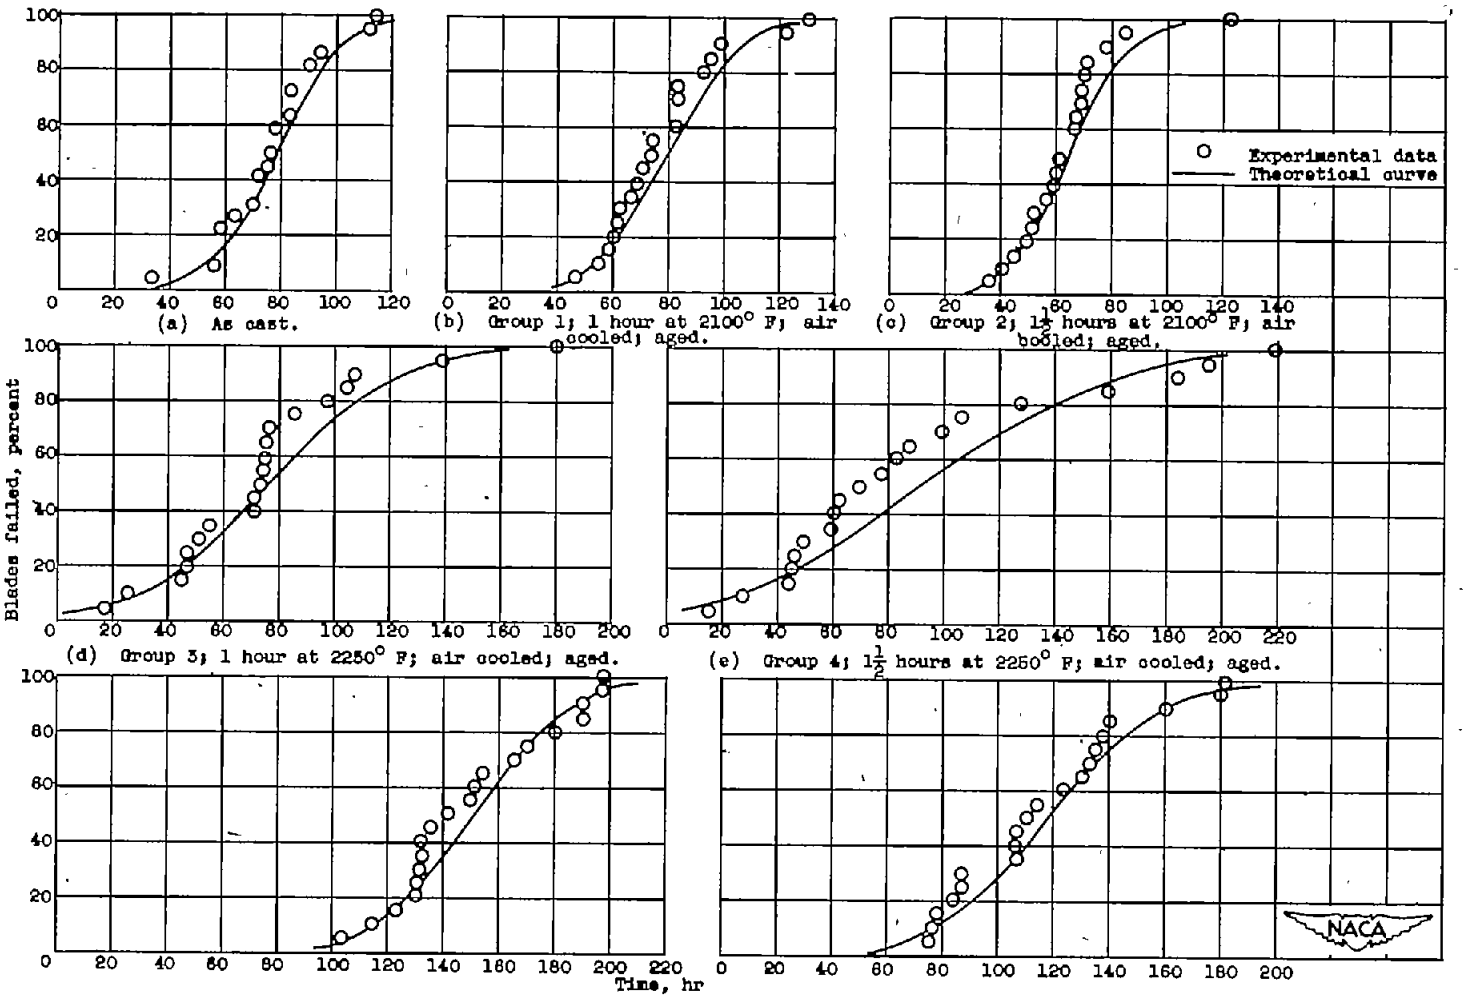
Figure 2. - Cumulative-frequency-distribution curves for as-cast and heat-treated blade groups.

The time of failure for the individual blades in each of the different groups is presented in table II. The mean life and standard deviation are also given in this table. The failure time for the individual blades of each group and the corresponding theoretical cumulative-frequency distribution (assuming normal distributions of blade failures) are presented in figure 2. The theoretical cumulative-frequency-distribution curves are presented for comparison in figure 3.

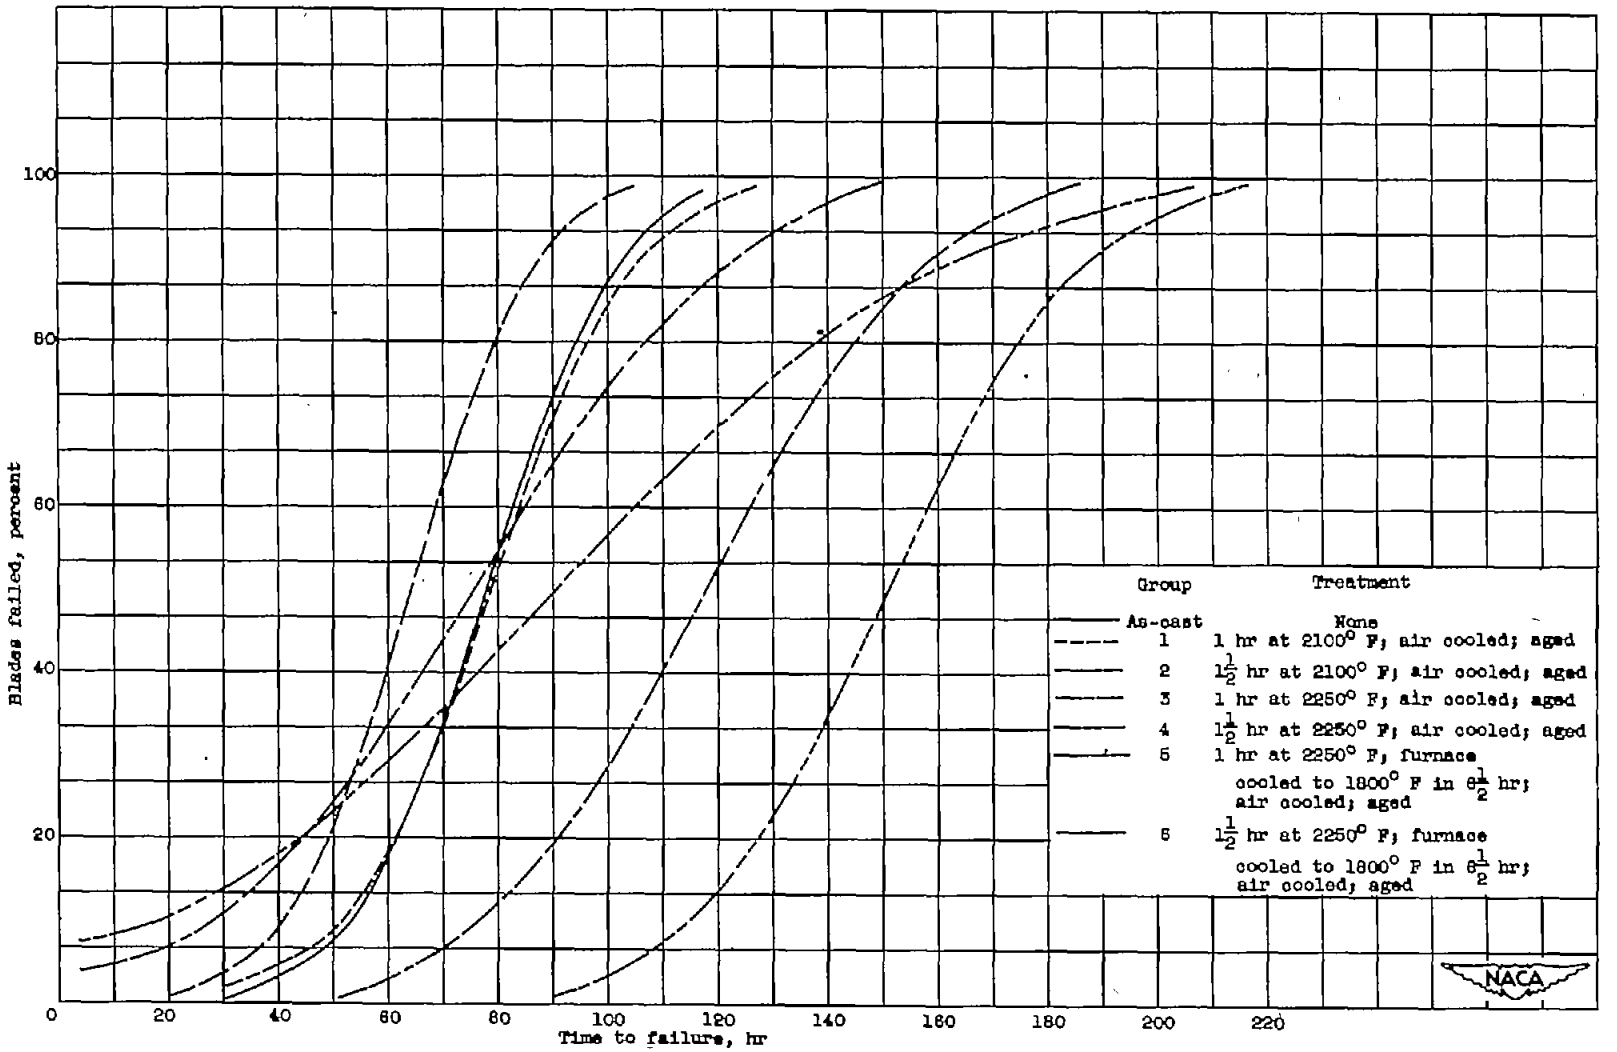
Figure 3. - Theoretical cumulative-frequency-distribution curves for as-cast and heat-treated blade groups.

The heat treatment applied to group 5 produced the greatest increase in life over that of the as-cast blade group as shown in table II and figure 3. The nature of this improvement is apparent from the following comparison taken from table II:

The theoretical indices (see appendix) of initial (first) failure are 18.3 hours for the as-cast blades and 14.2, 8.3, -38.7, -77.9, 65.6, and 20.5 hours for groups 1 to 6, respectively, (table II). A negative index, for practical purposes, is interpreted as possible failure immediately on commencement of operation. This analysis indicates that the treatments of groups 5 and 6 have improved the time to initial failure.

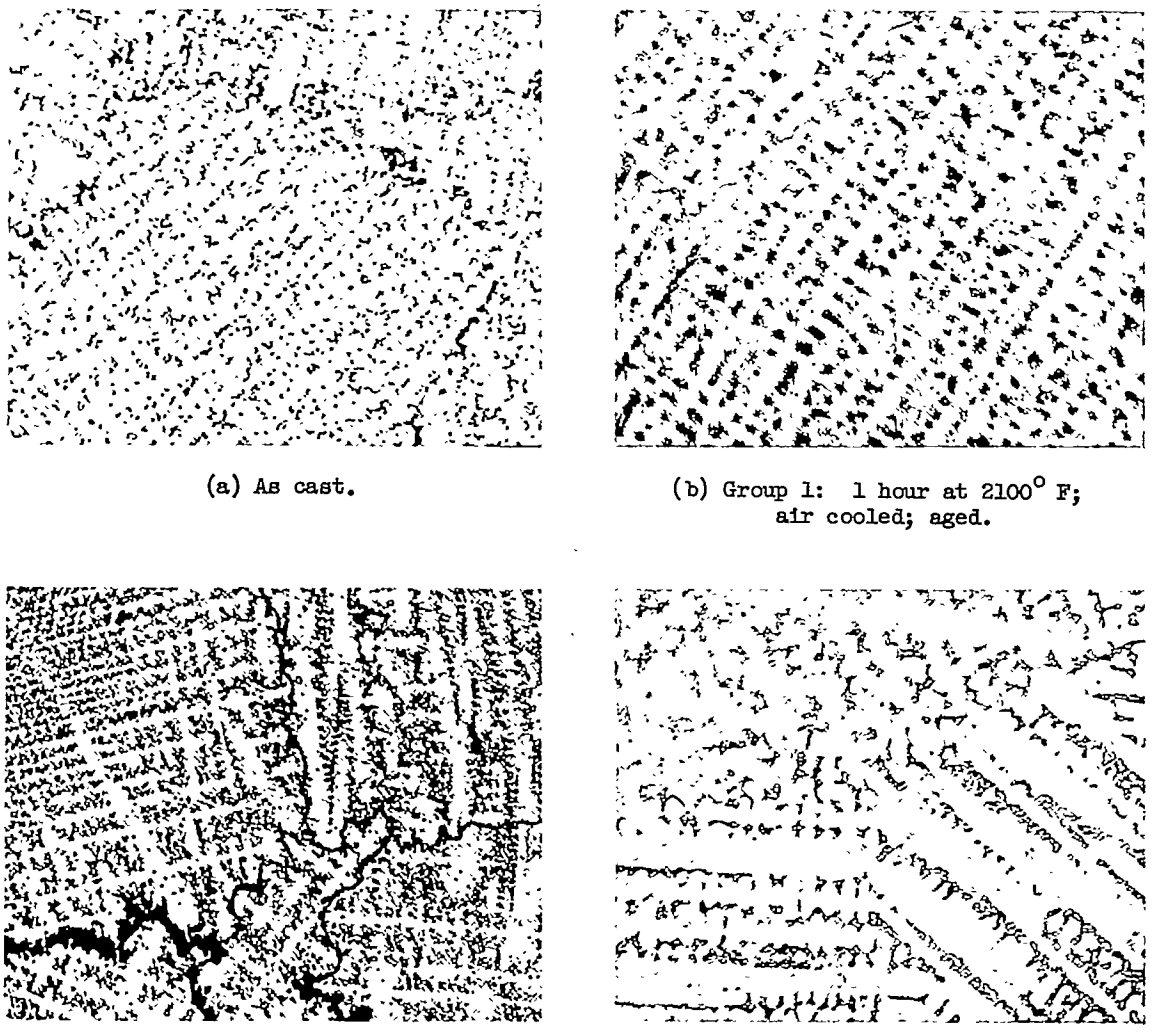
Figure 4. - As-cast and solution-treated and aged blade structures before operation. Etchant, 10-percent nitric acid and 10-percent ethylene glycol in ethyl alcohol. (Photographs at X75 unless otherwise noted.)

Photomicrographs of the structure of a blade from each group before operation are shown in figure 4. A typical as-cast blade structure is shown in figure 4(a). A small amount of lamellar structure adjacent to the grain boundaries was observed. Structures of blades that were soaked at 2100° F for 1 and $1\frac{1}{2}$ hours, respectively, air cooled, and then aged at 1500° F for 72 hours are shown in figures 4(b) and 4(c). These structures show evidence of considerable aging and contain numerous precipitates. Structures of blades soaked at 2250° F for 1 and $1\frac{1}{2}$ hours, respectively, air-cooled, and aged at 1500° F for 72 hours are shown in figures 4(d) and 4(e). The as-cast dendritic structure is reduced in size and extent by the $1\frac{1}{2}$-hour treatment compared with the 1-hour treatment. Microstructures of blades soaked at 2250° F for 1 hour and for $1\frac{1}{2}$ hours followed by furnace cooling for $6\frac{1}{2}$ hours to 1800° F, air cooling and aging at 1500° F for 72 hours are shown in figure 4(f) and 4(g), respectively. An unusually large amount of lamellar structure is present in these blades (fig. 4(h)). There was no evidence of aging precipitate in the matrix of these specimens. There was no conclusive metallographic evidence that explained the variation in blade life within any of the groups.

The outstanding performance of the blades of groups 5 and 6 may be associated with the presence of the lamellar structure. The atmosphere used in heat-treating these blades was found to be decarburizing rather than neutral; this may be noted from table IV, which presents the relation between depth and carbon content for specimens given the same treatment (including atmosphere) that was applied to blades of group 6. Because blade failure is apparently initiated by surface cracking, anything affecting the surface may affect blade life. The stress-to-rupture life of this alloy at 1500° F and 30,000 pounds per square inch increases as the carbon content increases (reference 5). Hence, the atmosphere effects alone probably could not be expected to improve blade life and the lamellar structure may therefore be considered a contributing factor in increasing blade life.

3. Large quantities of lamellar structure were formed in the blades of the two best performing groups.

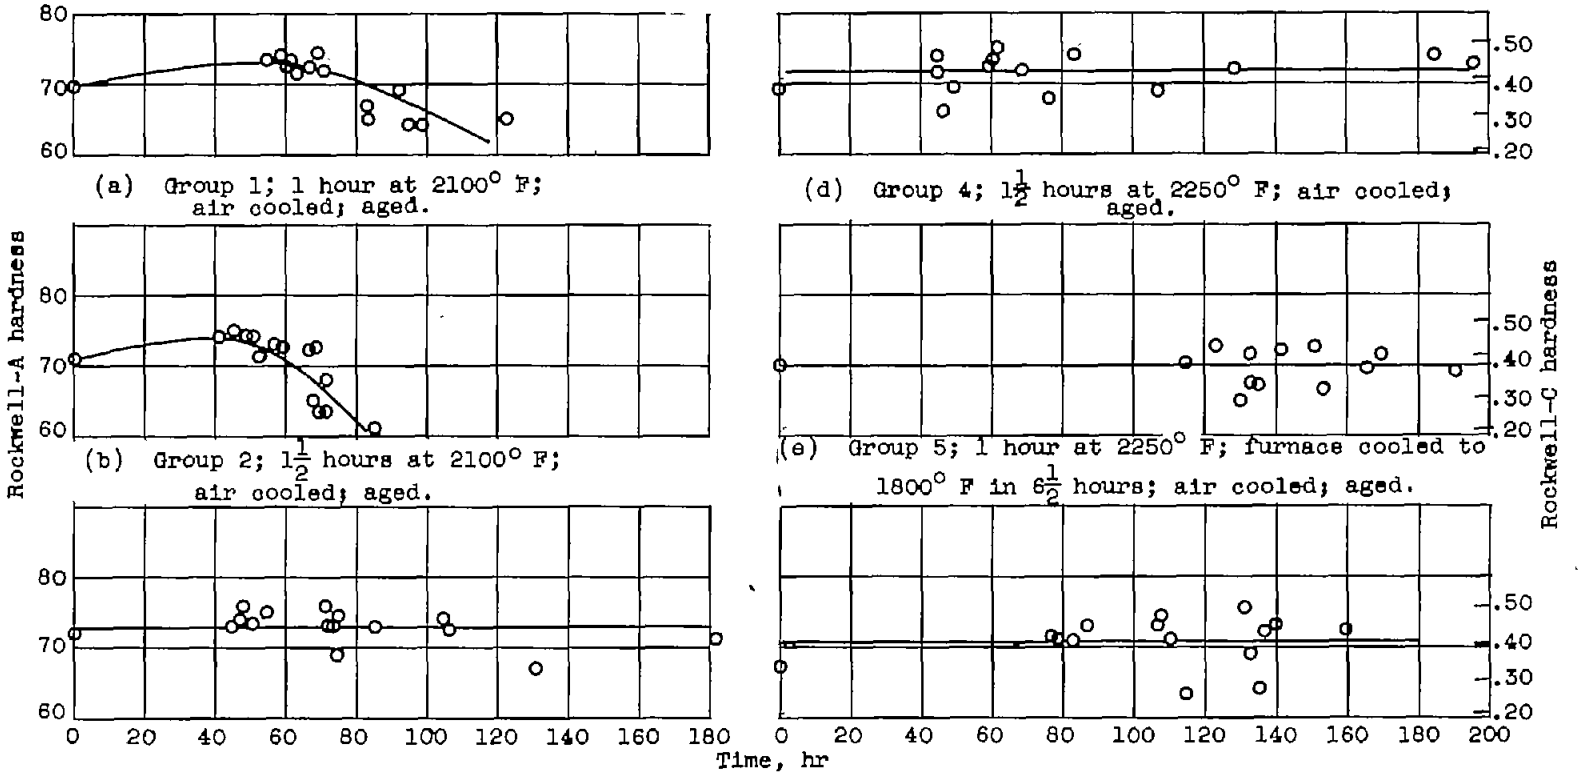
Figure 5. - Variation of blade hardness with turbine operating time. Each point represents average of five measurements.

A plot showing the variation of blade hardness with turbine operating time for blades of each group is presented in figure 5. The blades of groups 1 and 2 first hardened during operation and then decreased in hardness. Blades of groups 3, 4, 5, and 6 exhibited no change in hardness with turbine operating time.

The blades of groups 1 and 2 overaged during operation (fig. 5). Hence, overaging may be a factor contributing to the comparatively poor performance of blades of these groups. A shorter aging time at 1500° F may be required with this soaking temperature.

5. Blades soaked at 2100° F for either 1 or $1\frac{1}{2}$ hours, air-cooled, and aged at 1500° F for 72 hours overaged during operation. Blades of the remaining groups showed no change of hardness with operating time.
