TECHNICAL NOTE 2632

CORROSION OF MAGNESIUM ALLOY ZK60A IN MARINE ATMOSPHERE AND TIDEWATER

By Fred M. Reinhart

National Bureau of Standards

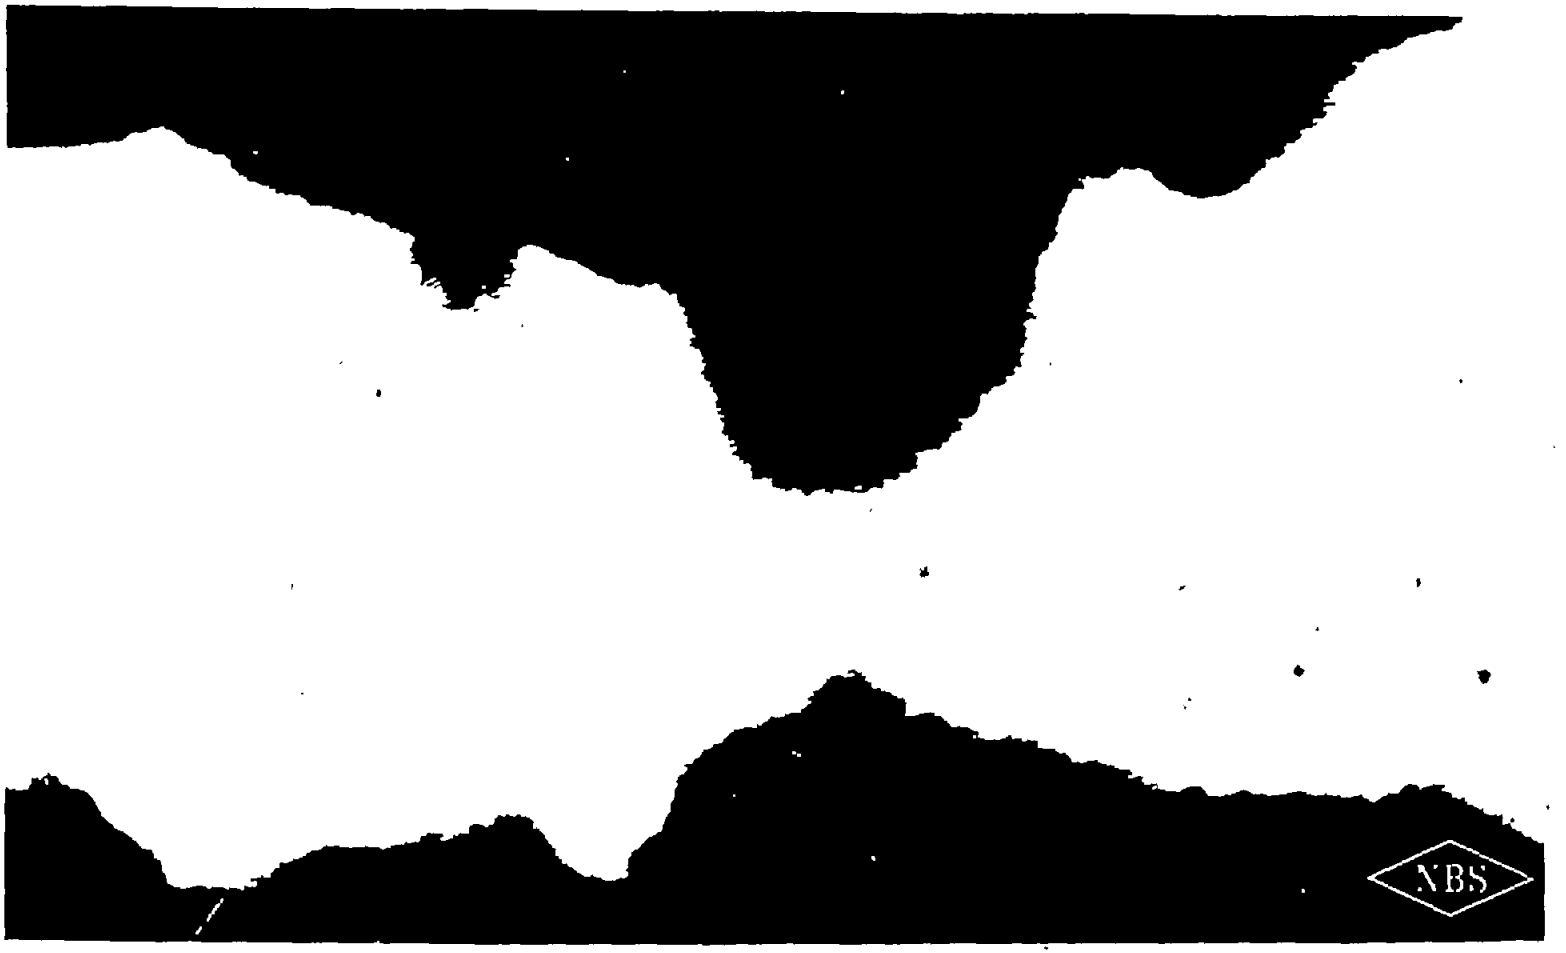
After 6 months of exposure in the tidewater the surfaces of the ZK60A alloy were deeply pitted as shown in figure 1. These surfaces were so irregular and uneven that it was impossible to measure the depths of the pits on the transverse sections by the usual technique. Therefore, to determine the extent of attack it was necessary to measure the thicknesses of sound metal remaining between the bottoms of pits on opposite sides of the specimens. Average values of these measurements are given in table 2. Similar values for AZ31A-H are included to give a comparison of the behavior of the two materials.

In the marine atmosphere both alloys turned dark gray in color and later became speckled with light-gray corrosion products. The products on the ZK60A specimens after 6 months' exposure are shown in figure 1. The depths and widths of the corrosion pits on polished transverse sections of both alloys after exposure to the marine atmosphere are given in table 3.

Figure 1.- Appearance of ZK60A specimens after 6 months of exposure in tidewater (top four) and in marine atmosphere (bottom two, earthward surfaces). X5/8.

The corrosion resistance of the unprotected ZK60A alloy was not so good as that of the unprotected AZ31A-H alloy in either environment. To obtain an adequate service life for any application involving the use of ZK60A in the marine atmosphere for any extended period of time the structure should be well-protected by the application of a good chemical surface treatment and a good paint system.

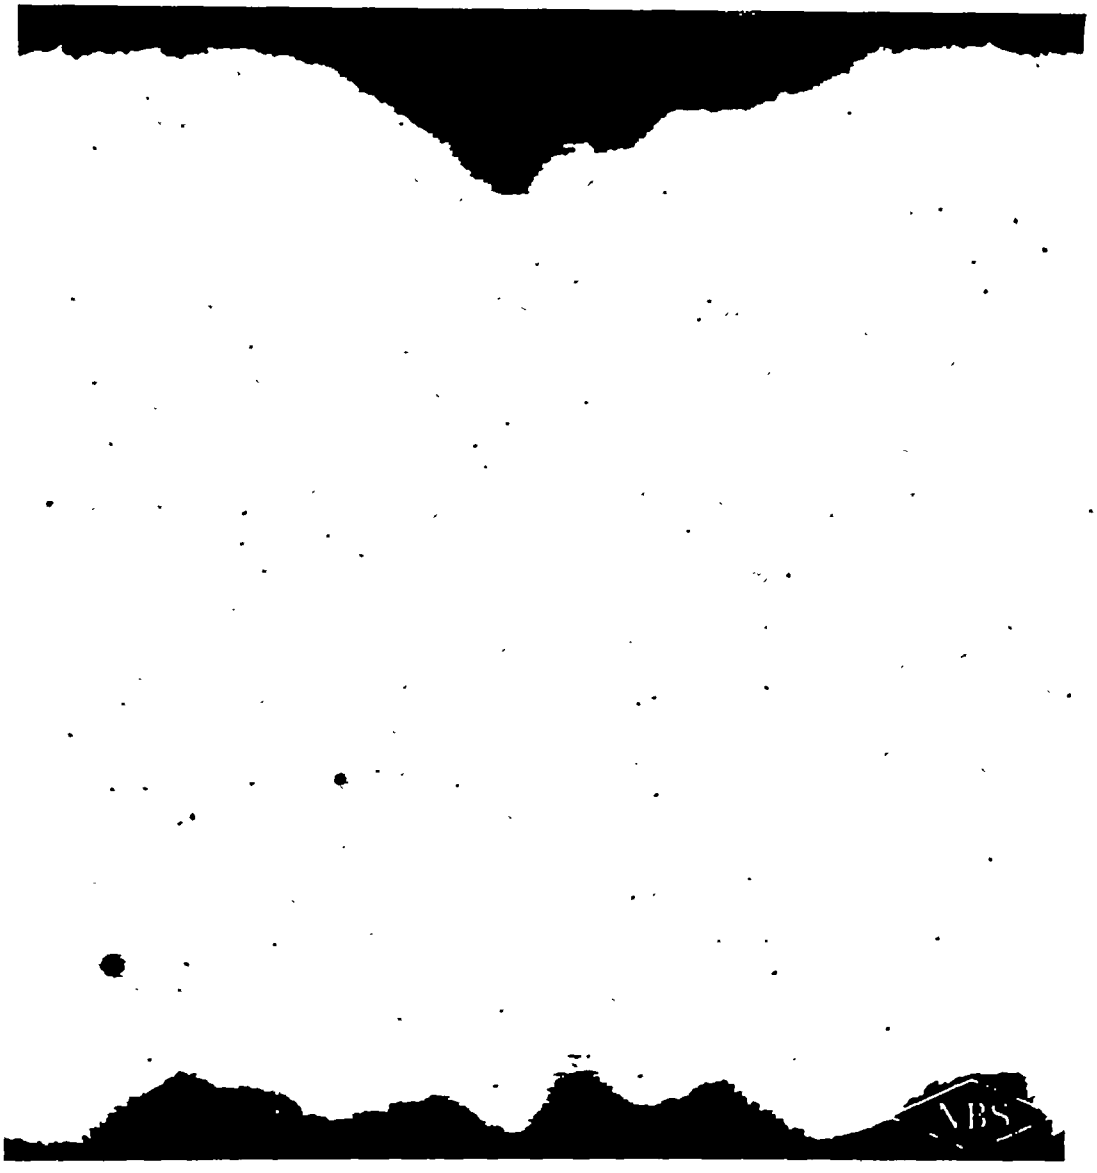
These results indicate that after 6 months of exposure the corrosion pits in the ZK60A alloy were deeper and wider than those in the AZ31A-H alloy. Typical corrosion pits in the ZK60A alloy after 6 months of exposure are shown in figure 3. An idea of the difference in the rapidity of attack between exposure in tidewater and in marine atmosphere can be obtained by comparing the thickness of the remaining metal in figure 2 with that in figure 3.

more prevalent. Typical pits in this alloy after 18 months of exposure are shown in figure 4. No comparison could be made with the AZ31A-H alloy because no specimens of the latter alloy were removed at that time.

Figure 3.- Typical pits in ZK60A material after 6 months of exposure in marine atmosphere. Compare thickness of this sheet with that of one in figure 2. X100.

Figure 4.- Typical pits in ZK60A material after 18 months of exposure in marine atmosphere. Compare thickness of this sheet with that of one in figure 2. X100.
