TECHNICAL NOTE 2709

FATIGUE AND STATIC TESTS OF FLUSH-RIVETED JOINTS

By Darnley M. Howard and Frank C. Smith

National Bureau of Standards

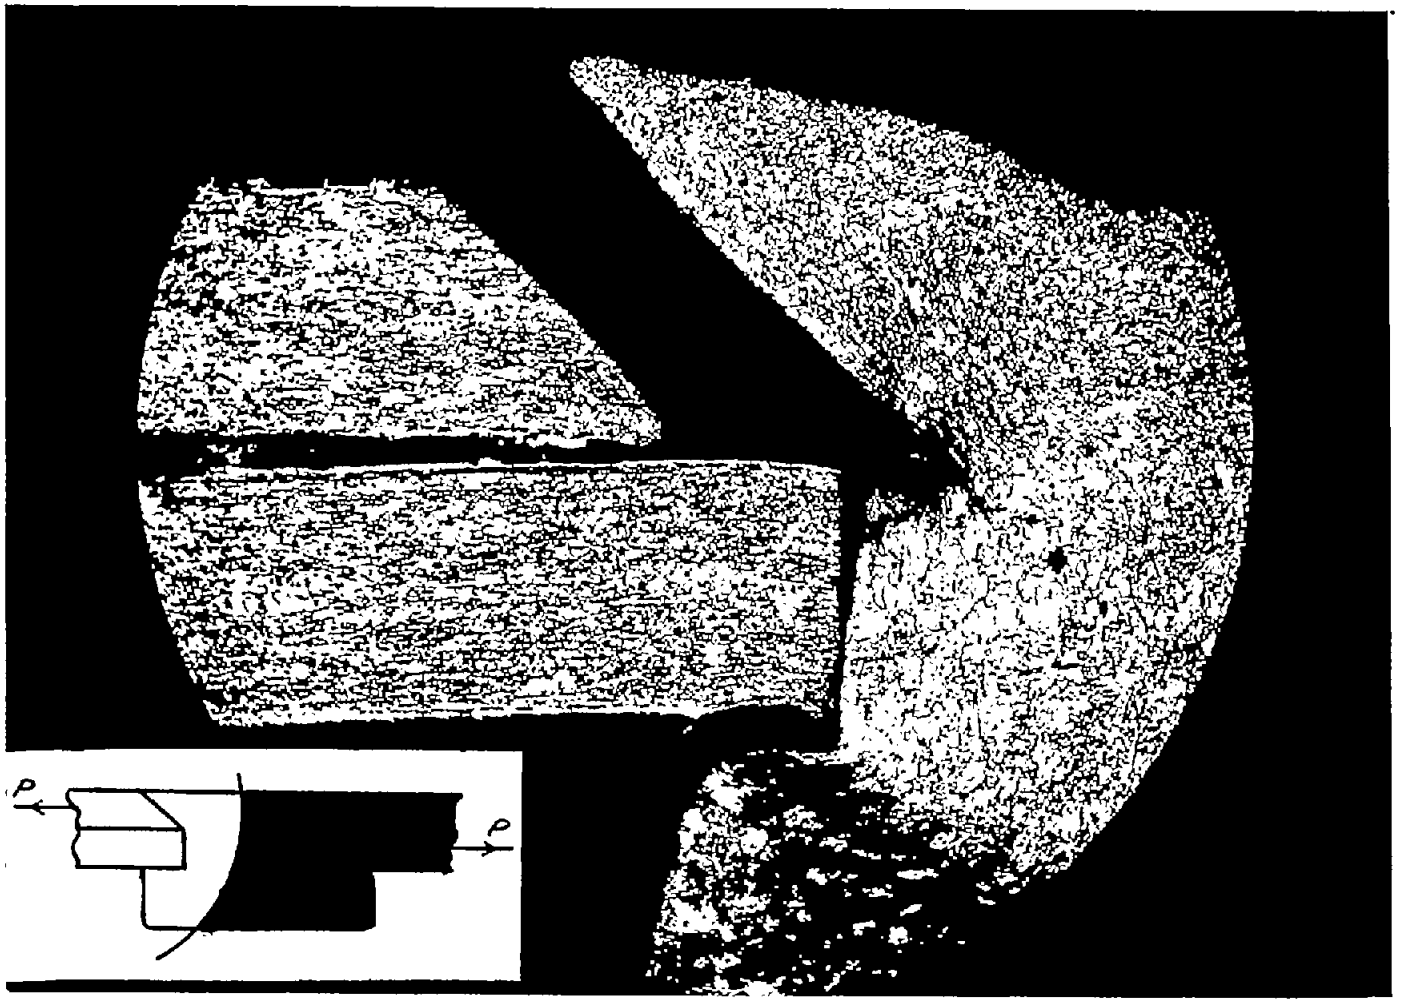
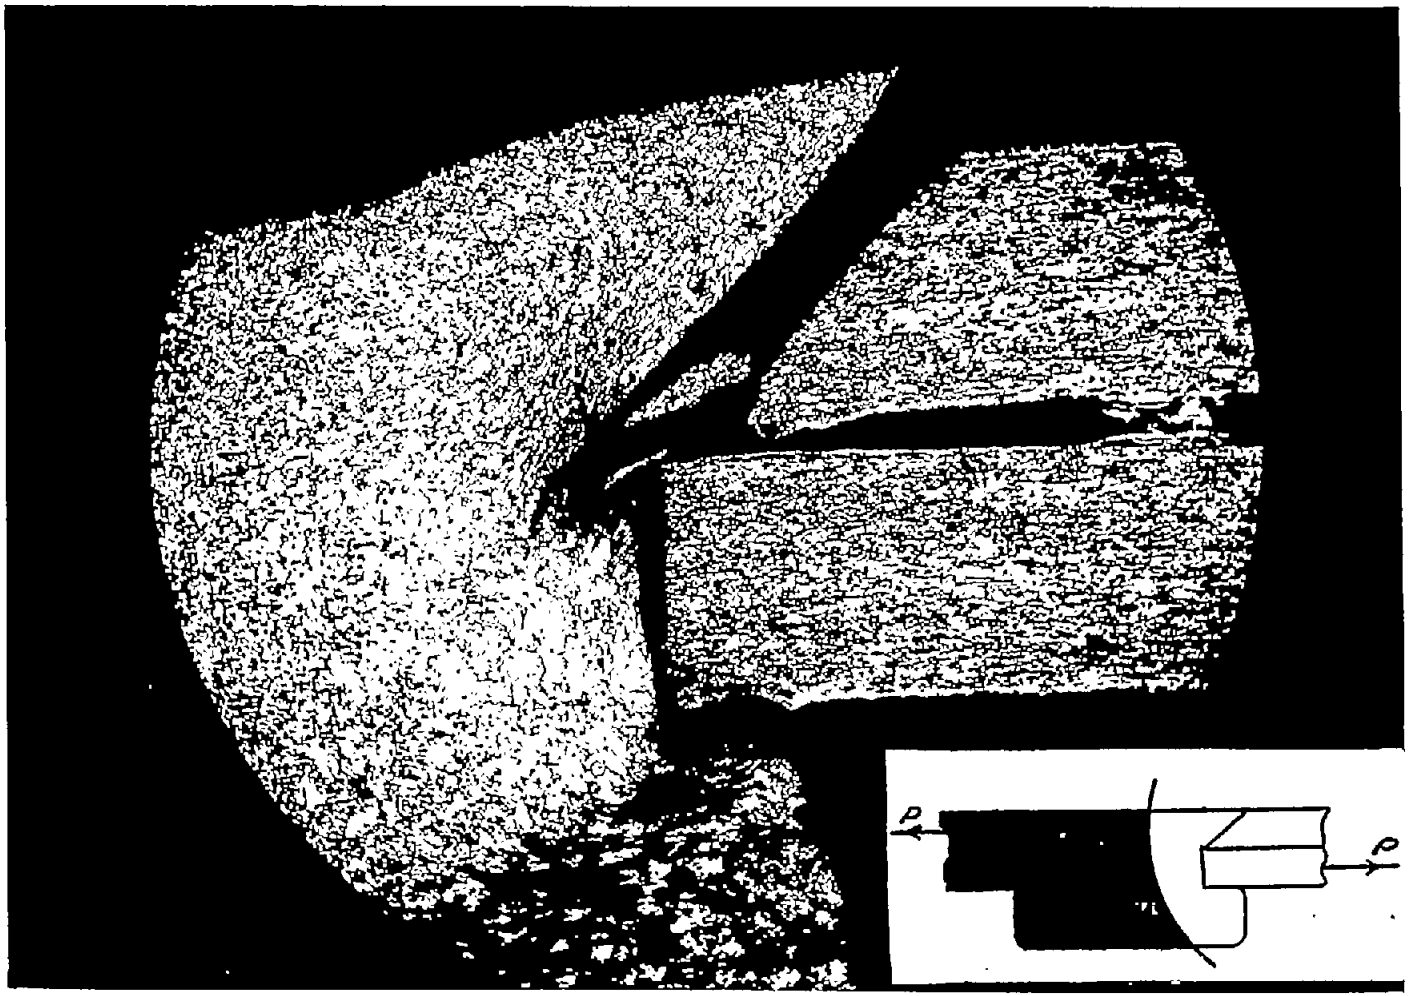
Figures 13(a) and 13(b) are photomicrographs of the left and right sides of a rivet in an 0.032-inch-thick alclad 24S-T3 aluminum-alloy lap joint with machine-countersunk holes. Photomicrographs of a similar joint after it had been subjected to 200 cycles of completely reversed load slightly above the 4-percent static-slip value are shown in figures 14(a) and 14(b). The fatigue loading caused gouging of the rivet, tipping of the rivet head, and deformation of the sharp edge of the upper plate.

Figure 14.- Rivet after test. Lap joint in alclad 24S-T3 with machine-countersunk holes.

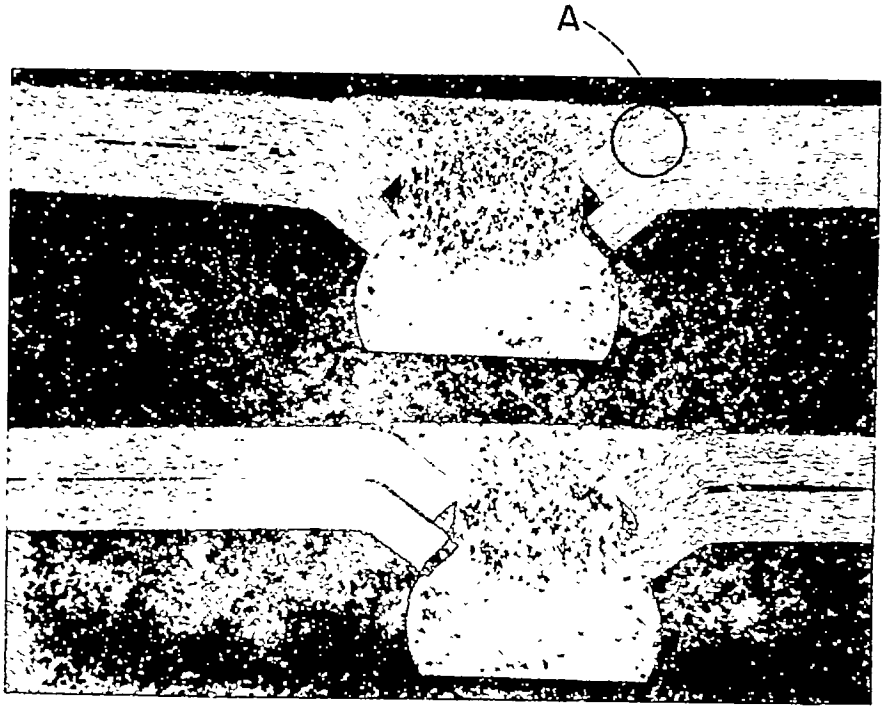
Figure 15 is a photomicrograph of typical 75S-T6 aluminum-alloy dimpled joints after fatigue failure. The deformation of the sheets and rivets due to cold-working during fabrication is clearly shown. It is interesting to note that the rivets do not appear to fill the holes

completely in these joints. The damaged area at A (fig. 15) is shown much enlarged in figure 16. The crack began apparently at the point of highest cold-work B (fig. 16) and initially propagated in the direction of the slip lines. A secondary crack on the convex side of the sheet may have affected the direction of propagation as the failure progressed. A similar crack in another joint is shown in figure 17.

Figure 15.- Section of dimpled joints in 0.032-inch 75S-T6 aluminum-alloy sheet after fatigue failure. Cracks shown at A. X8.

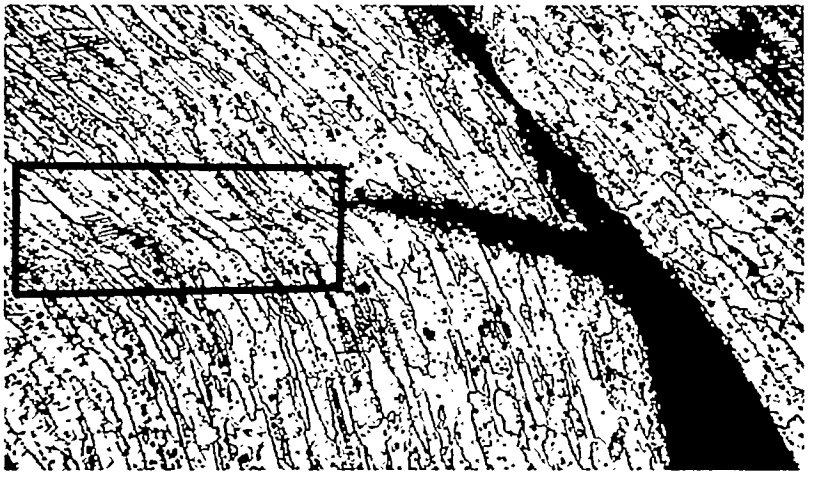
Figure 17.- Secondary crack on convex side of dimple in 75S-T6 alloy. Crack propagation through area of heavily cold-worked material (rectangular box). X100.
