NACA RM E58D11

RESEARCH MEMORANDUM

COMPATIBILITY OF METALS WITH LIQUID FLUORINE AT HIGH PRESSURES AND FLOW VELOCITIES

By Harold W. Schmidt

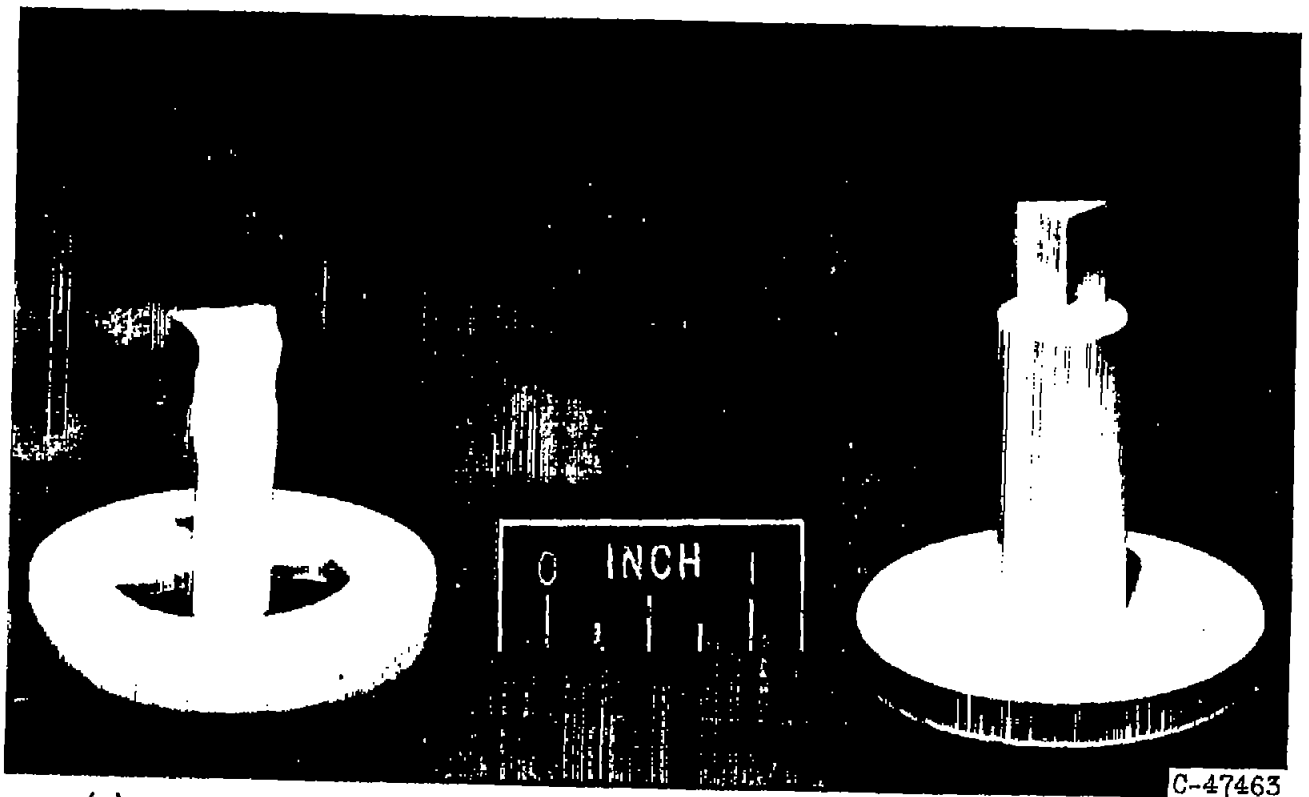
Figure 4. - Teflon turbulence specimen exposed to fluorine flow.

Under the flow conditions of this present run, failure was spontaneous and violent at 50 pounds per square inch. Reaction began immediately after the fluorine flow valve was opened, and a small piece of Teflon was blown clear of the reaction area. The remaining part was unchanged; chemical reaction had occurred evenly over its entire surface area and had resulted simply in diminishing the size of the original piece. A photograph of the reacted test specimen, together with the original configuration, is shown in figure 4. The backup flange used to clamp the specimen in the housing had a 3/4-inch hole through its center, so that the Teflon base acted as its own blowout disk. This feature, together with the inhibiting effect of the liquid-nitrogen bath, prevented damage to the rest of the system.

The fact that Teflon withstood the static exposure to liquid fluorine and yet failed in the dynamic test is of particular interest. Metals form a protective fluoride surface film when exposed to fluorine; Teflon, on the other hand, tends to react with fluorine to break down the polymer and forms saturated low-molecular-weight fluorocarbons, such as CF_4 (refs. 3 and 4). These fluorocarbons would not adhere to the Teflon surface in a dynamic system and, therefore, would be of no value as a protective film.

6. Teflon did not resist attack when exposed to liquid-fluorine flow.
