TECHNICAL NOTE 4100

VIBRATION SURVEY OF FOUR REPRESENTATIVE TYPES OF AIR-COOLED TURBINE BLADES

By Howard F. Calvert and Gordon T. Smith

July 1958

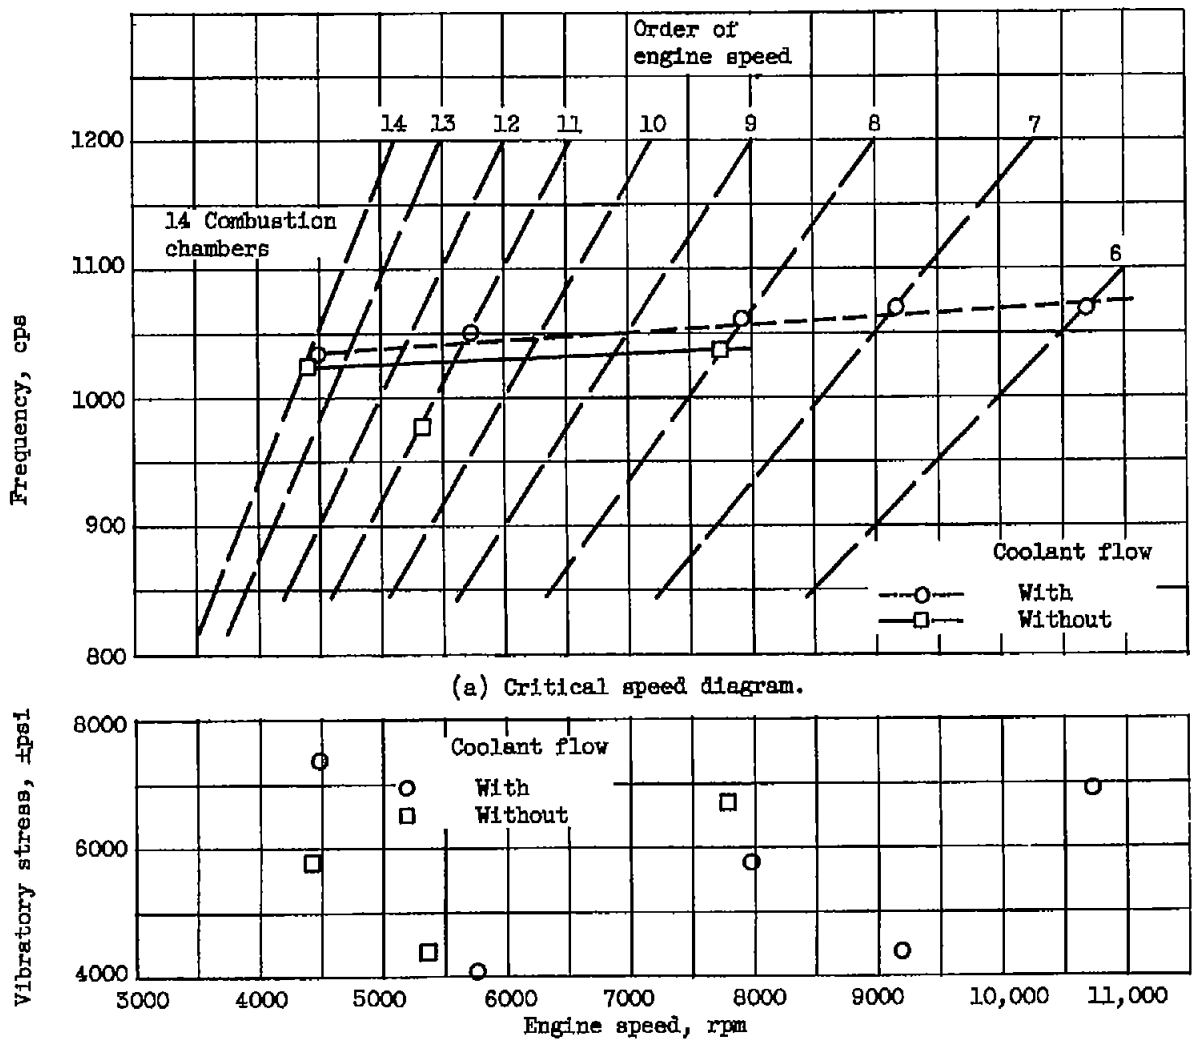
Tube-filled shell-supported blade. - Figure 4 presents vibratory frequency and stress data. These data include the number of peaks or critical vibrations, the change in vibration frequency with coolant flow, and the vibratory stress at each critical speed. It can be noted in figure 4(a) that the sixth- and seventh-order vibrations were observed only with coolant flow. Hence, this blade type was more susceptible to vibration with coolant flow than without; that is, more vibrations were observed with coolant flow. Also, with a coolant flow rate of about 8 percent the vibrational frequency was increased approximately $2\frac{1}{2}$ percent. For example, with the eighth-order vibration the frequency was increased from approximately 1035 to 1060 cycles per second. Calculations based on temperature measurements from previous heat-transfer investigations indicated that the frequency increase was due to the increase in the blade-material modulus of elasticity with a decrease in blade-material temperature. The fourteenth-order vibration was probably excited by the presence of 14 combustor cans.

The peak vibratory stresses reported in figure 4(b) varied between ±4000 to ±7500 psi; however, the peak stress measured either with or without coolant flow was approximately the same, indicating that coolant flow had little effect on peak vibratory stress. These peak vibrations occurred over a narrow speed range and the resonant peaks were sharp and often difficult to obtain. Figure 5(a) presents a typical oscillogram showing the resonant-type vibration signal obtained with the tube-filled-type, air-cooled turbine blade.

Figure 4. - Measured blade frequencies and vibratory stress of standard-span tube-filled shell-supported blades.

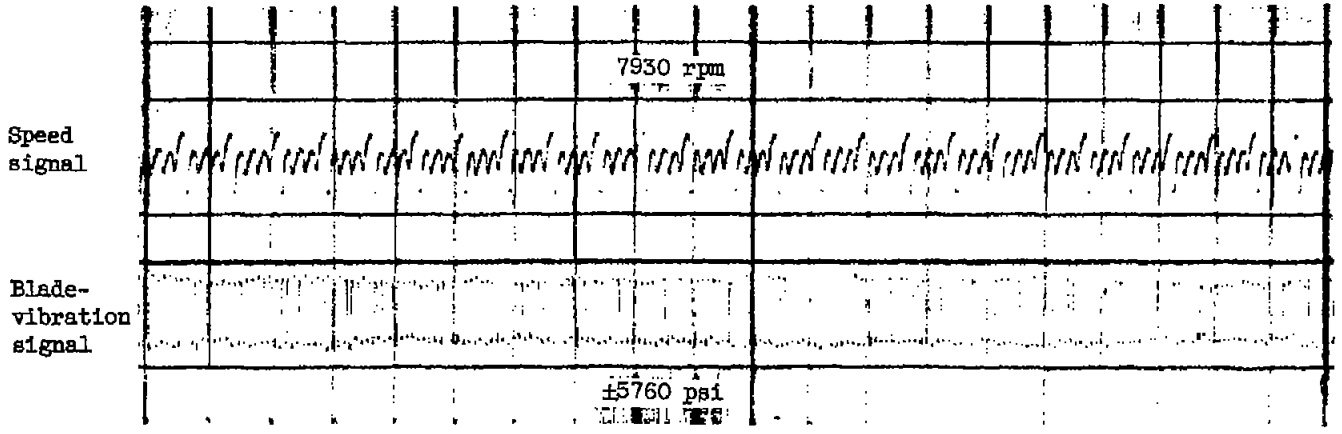
(a) Resonant-type vibration characteristic of standard-span tube-filled shell-supported blade.

signals for the corrugated-insert, shell-supported and solid blades were the same as for the tube-filled blade shown in figure 5.

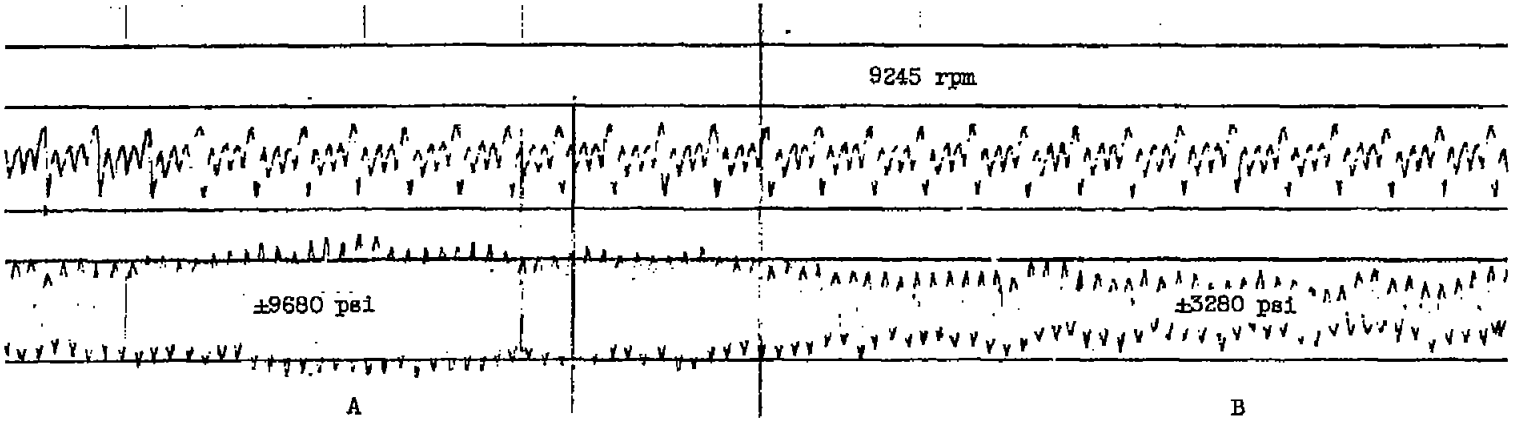
(b) Characteristic vibration signal for long-span, strut-supported blade.

In figure 7(b) the maximum vibratory stress was approximately ±9680 psi at 9250 rpm without coolant flow. At speeds below 8700 rpm, the maximum stresses were measured with coolant flow. Figure 5(b) presents a typical oscillogram showing the characteristic vibration for a long-span strut-supported blade. Close examination of figure 5 shows that the amplitude of the long-span blade vibration is constantly changing. With the standard-span blade the amplitude was relatively constant. In figure 5(b) the stresses vary from approximately ±3280 to ±9680 psi, and the stresses varied in a like manner at all speeds. The excitation of these blades may have been associated with or influenced by the testing environment described in APPARATUS AND INSTRUMENTATION and shown in figure 3. The varying-amplitude-type vibration signal is considered to be associated with a stalling condition in axial-flow compressors. Since the tips of

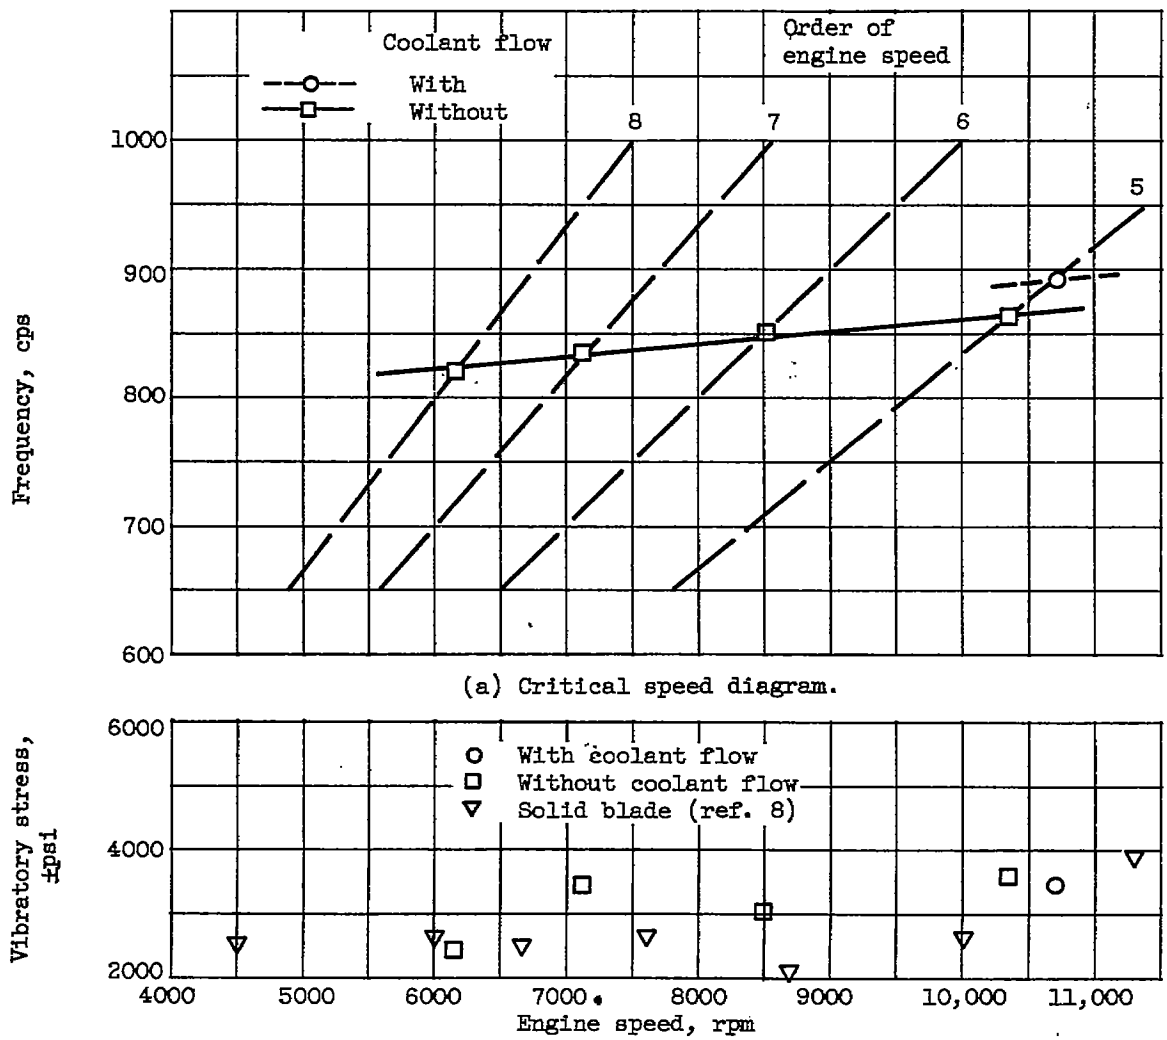
Corrugated-insert shell-supported blade. - The frequency and stress data are plotted in figure 6. The only vibration that was observed when the corrugated-insert shell-supported blade was operated with coolant flow was the fifth-order vibration. The fifth, sixth, seventh, and eighth orders of vibration were observed when the blade was operated without coolant flow. Therefore, this blade type was more susceptible to vibration when operated without coolant flow, or just the opposite result of that obtained with the tube-filled blade. The vibrational frequency was raised about 3 percent when the blade was operated with coolant flow.

The peak vibratory stresses measured were approximately ±3500 psi (fig. 6(b)) or approximately one-half as high as for the tube-filled blades. These peak vibrations also occurred over a narrow speed range. Also plotted in figure 6(b) are the vibratory stresses measured in another investigation and reported in figure 4 of reference 8. These data were obtained with high-temperature strain gages mounted on solid blades used in the same type engine as this investigation. The vibratory stresses were of approximately the same magnitude as those reported herein for the corrugated-insert shell-supported blade. The characteristic vibration

Figure 6. - Measured blade frequencies and vibratory stresses in standard-span corrugated-insert shell-supported blade.

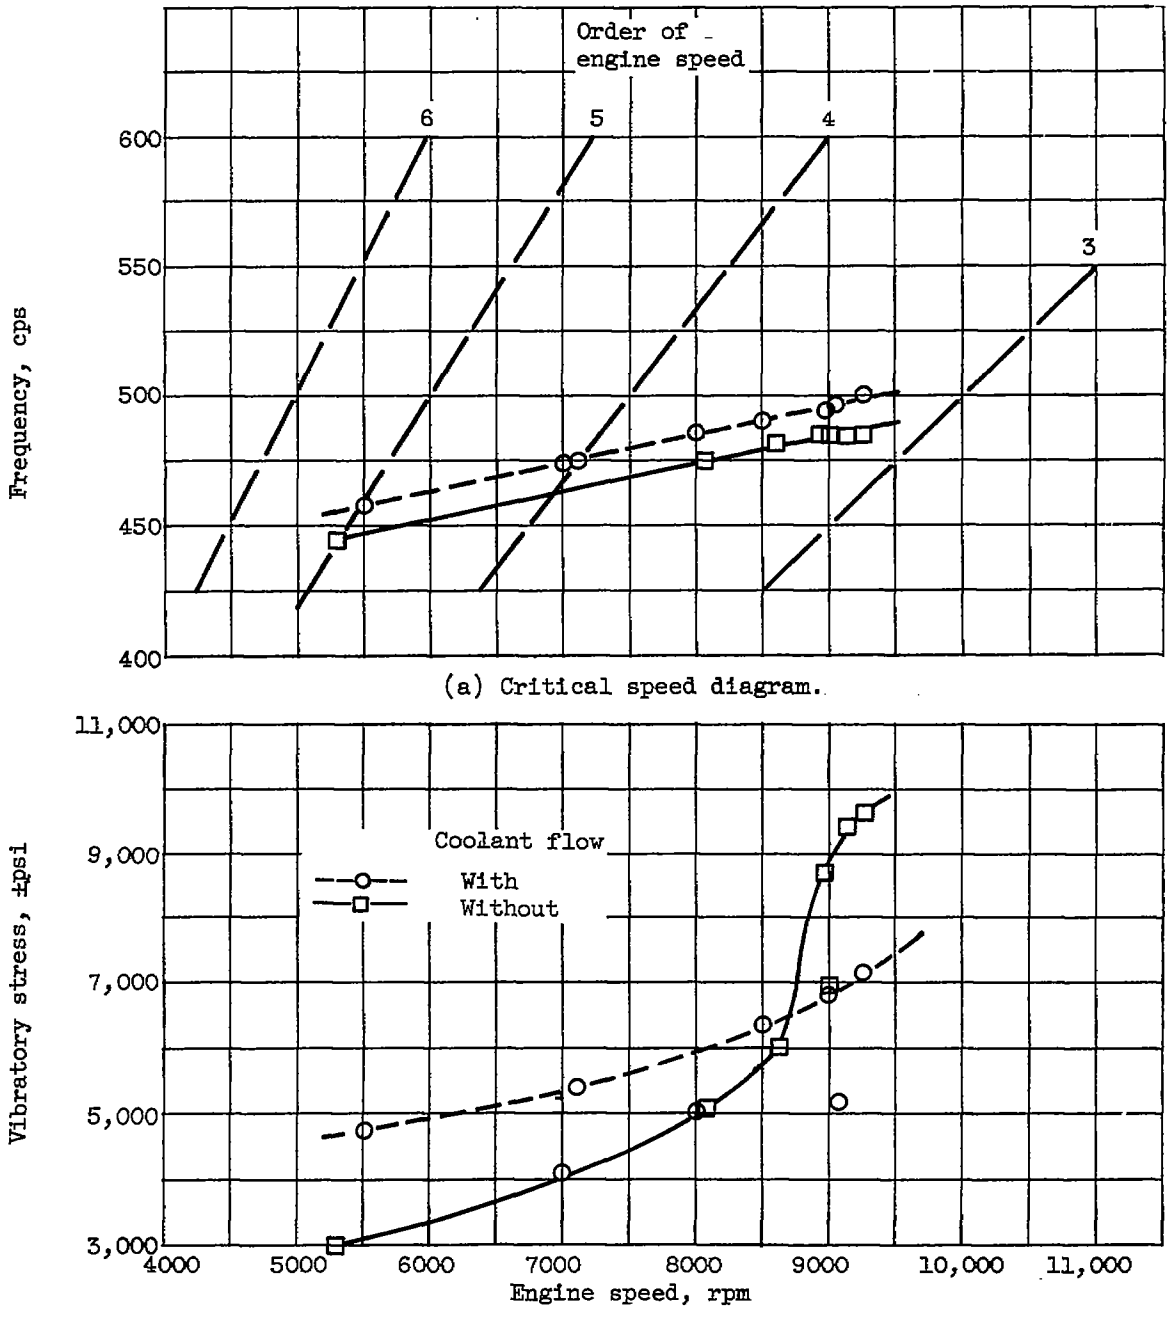
Strut-supported blade. - The vibration data are presented in figure 7. The blade vibration frequency data in the critical speed diagram (fig. 7(a)) do not all correlate with the order of engine speed lines as did the data for the standard-span blades (figs. 4 and 6). The long-span blades were different from the short-span blades in that they vibrated at all speeds investigated, and not just at critical speeds or the intersection of the measured blade frequency and engine speed order lines. In fact, data could have been obtained at any speed between idle and rated, and for this reason a continuous curve was drawn through the peak stress points. At speeds between the third and fourth engine speed orders, many data points were obtained in order to define the shape of the stress curve. Blade coolant flow increased the blade vibrational frequency approximately 3 percent.

Figure 7. - Measured blade frequencies and vibratory stresses in long-span strut-supported blades.

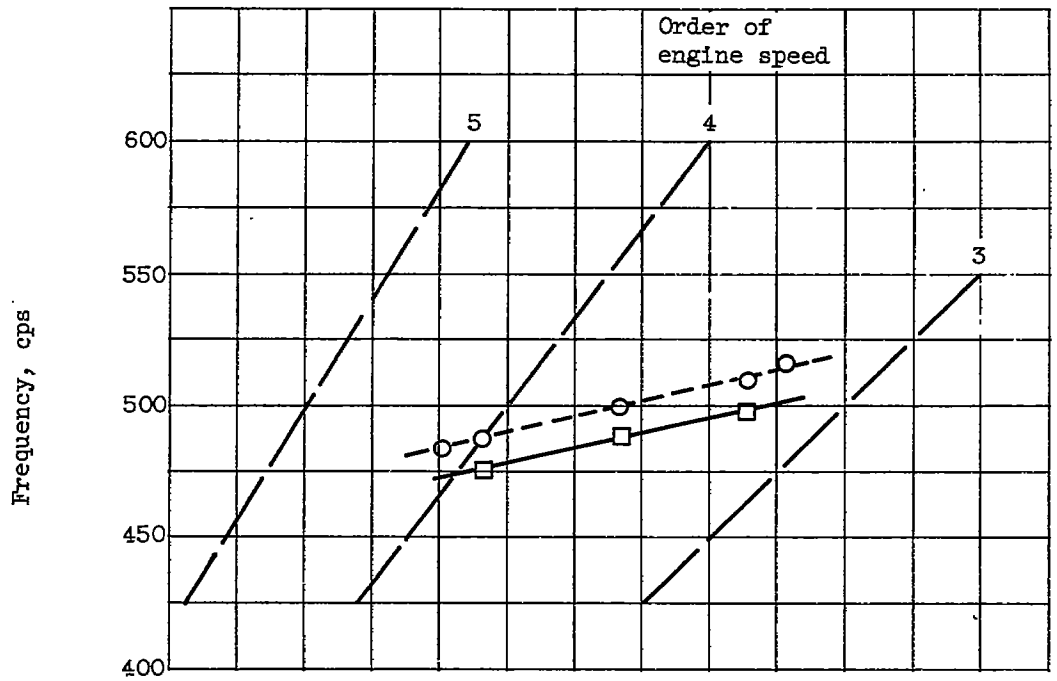
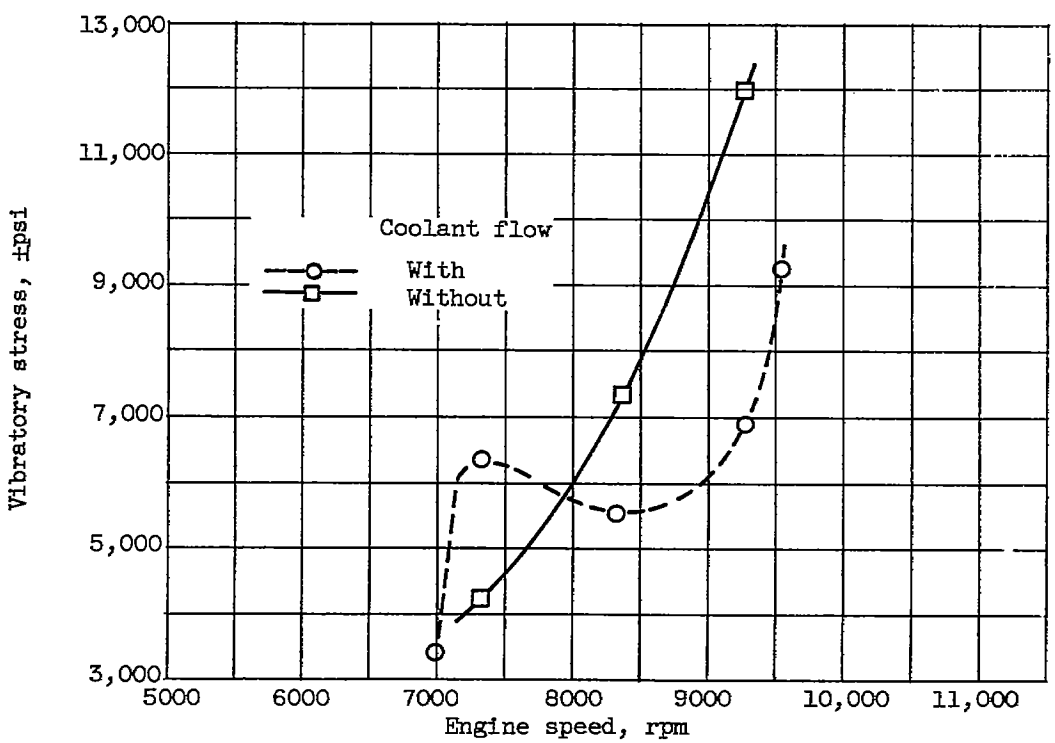
Corrugated-insert shell-supported blades. The vibration data for the corrugated-insert shell-supported blades are reported in figure 8. The vibration frequency and character of the strain-gage signals were the same for both the strut-supported and corrugated-insert, shell-supported long-span blades. That is, the blades were vibrating at all speeds with an irregular amplitude. With the corrugated-insert, shell-supported blades, the vibration frequency was increased approximately 3 percent with coolant flow.

The maximum vibratory stress of ±12,000 psi (fig. 8(b)) was measured at 9250 rpm without coolant flow. Above 8000 rpm the stresses increased very rapidly with increased engine speed either with or without coolant flow.

Figure 8. - Measured blade frequencies and vibratory stresses in long-span corrugated-shell-supported blade.

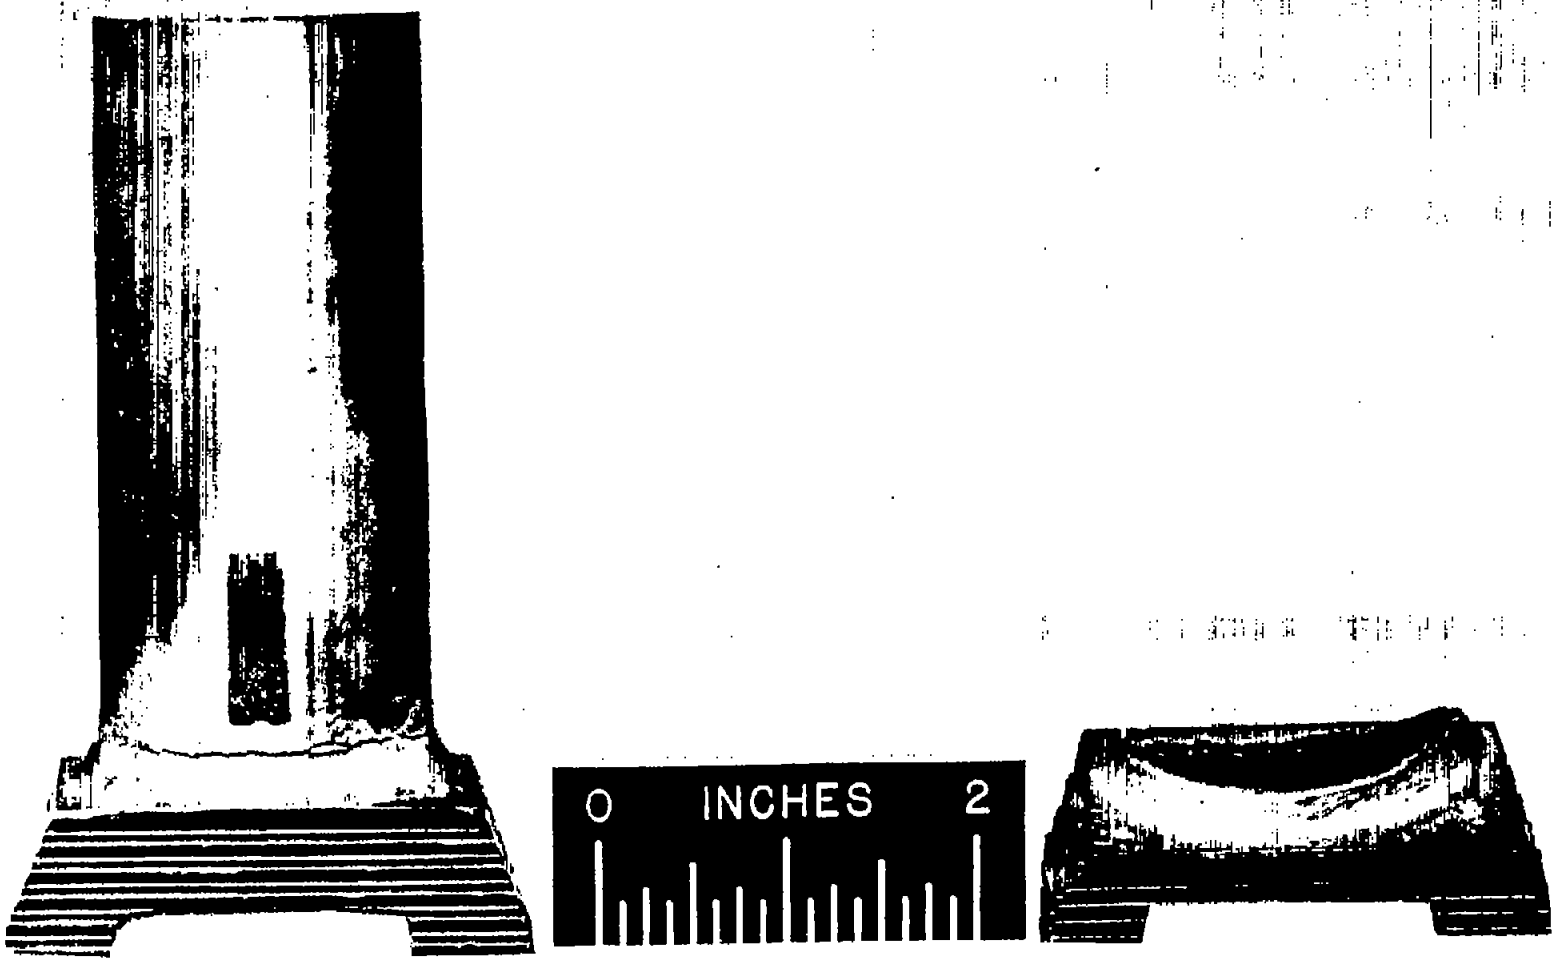
Tube-filled shell-supported blade. - Figure 9 shows a typical tube-blade failure obtained during engine operation and reported in reference 1. Blades 1 and 2 of static investigation reported herein (table II) also exhibited fatigue failures at the same location. With a vibratory stress of ±10,000 psi, blade 2 failed in only $7\frac{1}{2}$ hours. Figure 4 shows that vibratory stresses as high as approximately ±7500 psi were measured during engine operation. A vibratory stress of ±7500 psi may appear to be too low to cause blade failure; however, because of stress concentrations at the fillet, the stress at the point of failure would be many times higher or high enough to cause blade failure.

The results summarized in table II of reference 1 are for the endurance testing of 69 tube-filled blades with various blade heat treatments

and types of fillet at the base of the airfoil. A total of 23 of the failures were at the base of the airfoil and were of the fatigue type reported herein with the two static fatigue-tested blades. Of the failures, 15 occurred in less than 10 hours. It was concluded in reference 1 that the vibrational characteristics of the blades were not principal causes of the failures. However, the measurement of the vibratory stresses during engine operation reported herein indicates that the blade vibration could have been the principal cause of failure for two reasons: (1) the type of blade failure was reproduced in the laboratory with a static fatigue test; (2) even when the effects of centrifugal force, gas loading, and temperature were neglected the vibratory stress that would cause failures in $7\frac{1}{2}$ hours was close to that measured in the engine at a critical speed.

Figure 9. - Typical failures of short-span tube-filled shell-supported blades.
