RESEARCH MEMORANDUM

ALTITUDE-WIND-TUNNEL INVESTIGATION OF A 4000-POUND-THRUST
AXIAL-FLOW TURBOJET ENGINE

II - OPERATIONAL CHARACTERISTICS

By William A. Fleming

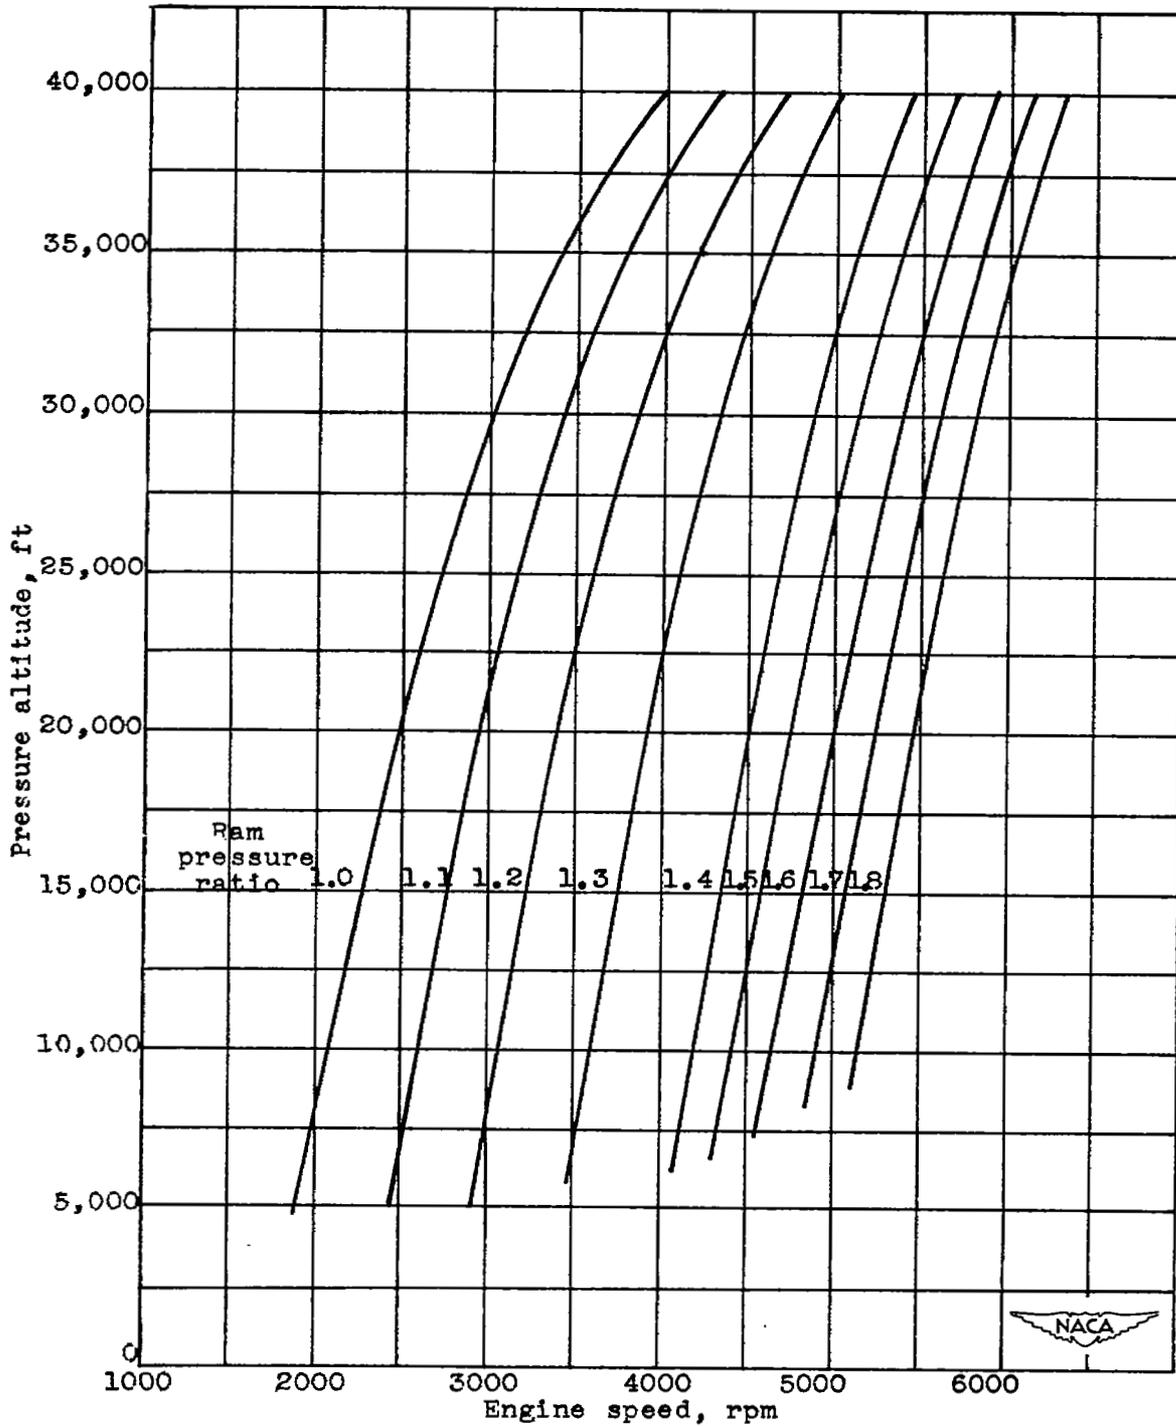
Increasing the ram pressure ratio at the engine inlet resulted in a higher minimum operating speed at all altitudes. (See fig. 6.) At high altitudes with ram, temperatures as low as 275° to 350° F were measured in the tail pipe at the minimum speed just before combustion failure.

Figure 6.- Variation of minimum operating speeds with pressure altitude and ram pressure ratio with low-flow compressor, configurations 1 to 5.

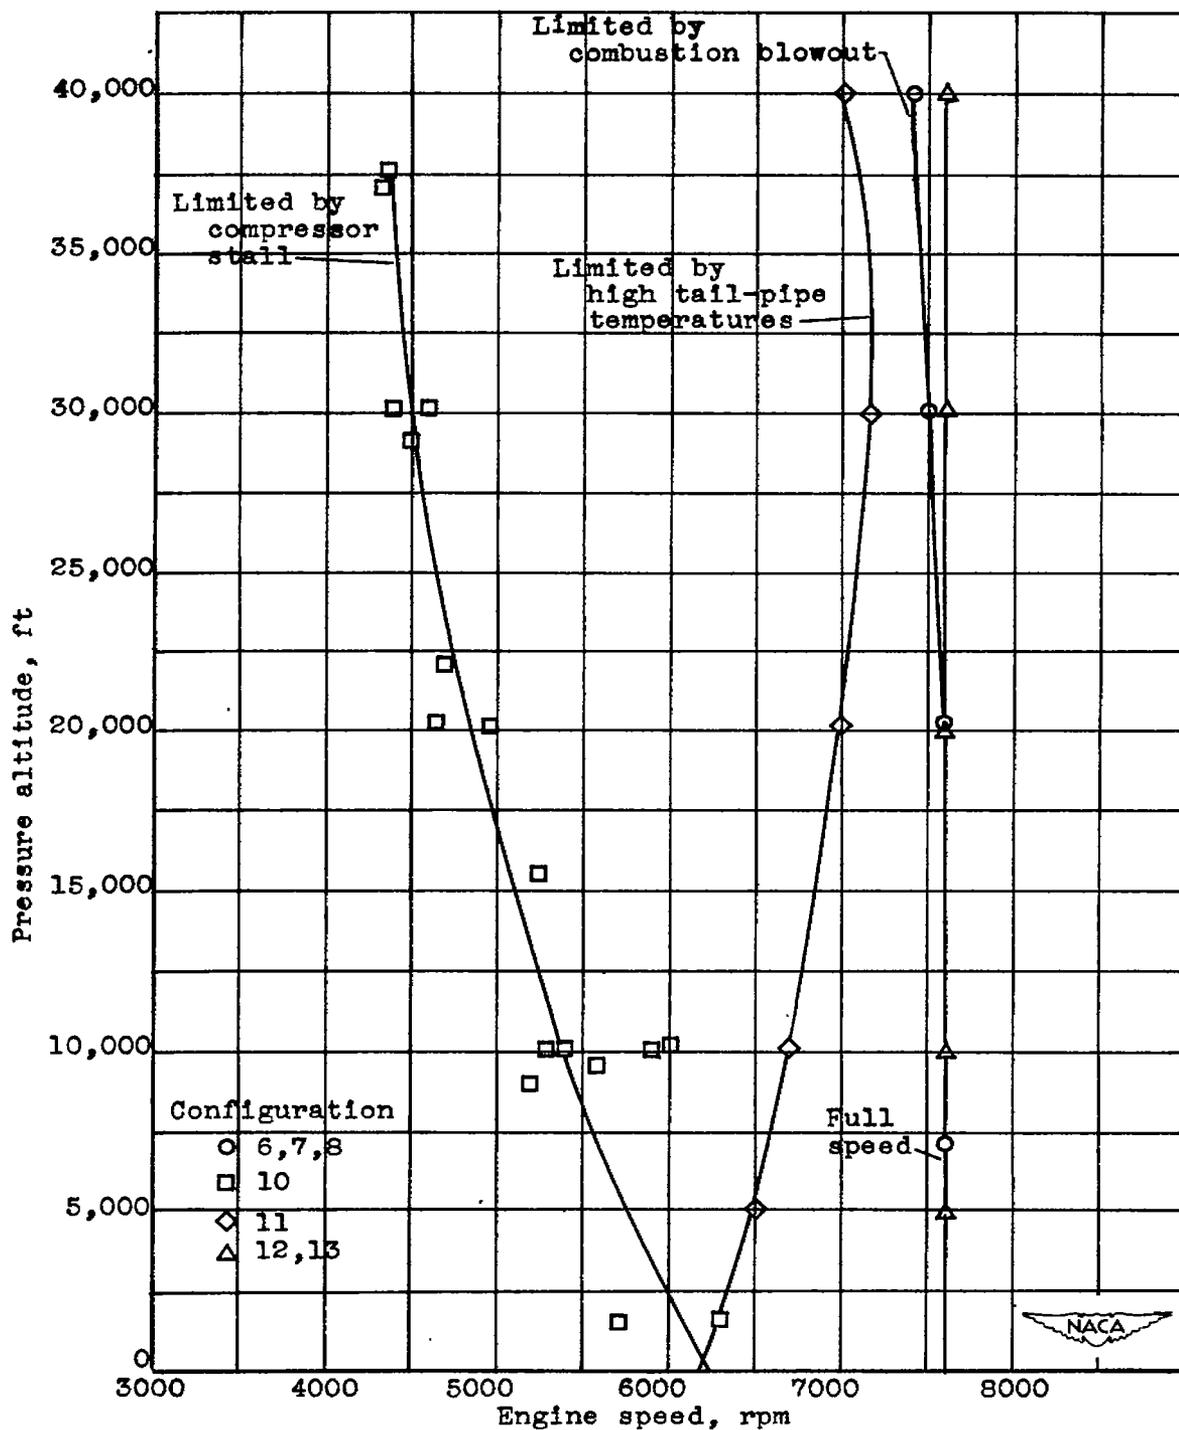
Replacement of the small turbine nozzles with the large nozzles (configuration 11) made possible operation of the engine at higher speeds. (See fig. 7.) Static tests were made with this configuration at pressure altitudes from 5000 to 40,000 feet. The maximum speed of the engine with this configuration was limited by high tail-pipe temperatures resulting from excessive fuel flow. The maximum engine speed at 5000 feet was 6500 rpm, with tail-pipe temperatures between 1150° and 1300° F. A maximum engine speed of 7000 rpm was reached at 40,000 feet with a tail-pipe temperature of 1300° F. Slow acceleration to the maximum engine speed was required in order to avoid blow-out of the combustion chambers. Combustion blow-out was encountered at 5400 rpm with a pressure altitude of 30,000 feet and at 6400 rpm with a pressure altitude of 40,000 feet during rapid accelerations.

Replacing the 18-inch-diameter jet nozzle with a 19 $\frac{1}{2}$ -inch-diameter nozzle and replacing the turbine wheel having excessive radial clearance with one having proper radial clearance (configurations 12 and 13) made possible operation of the engine at full speed. (See fig. 7.) Configuration 12 was investigated at indicated airspeeds from 250 to 300 miles per hour and configuration 13 was investigated at static conditions. Both configurations were investigated over a range of pressure altitudes from 5000 to 40,000 feet. With these configurations, the tail-pipe temperature at full speed was between 1000° and 1100° F at all altitudes.

Figure 7.- Effect of pressure altitude on maximum engine speed with high-flow compressor installed on configurations 6, 7, 8, 10, 11, 12, and 13.

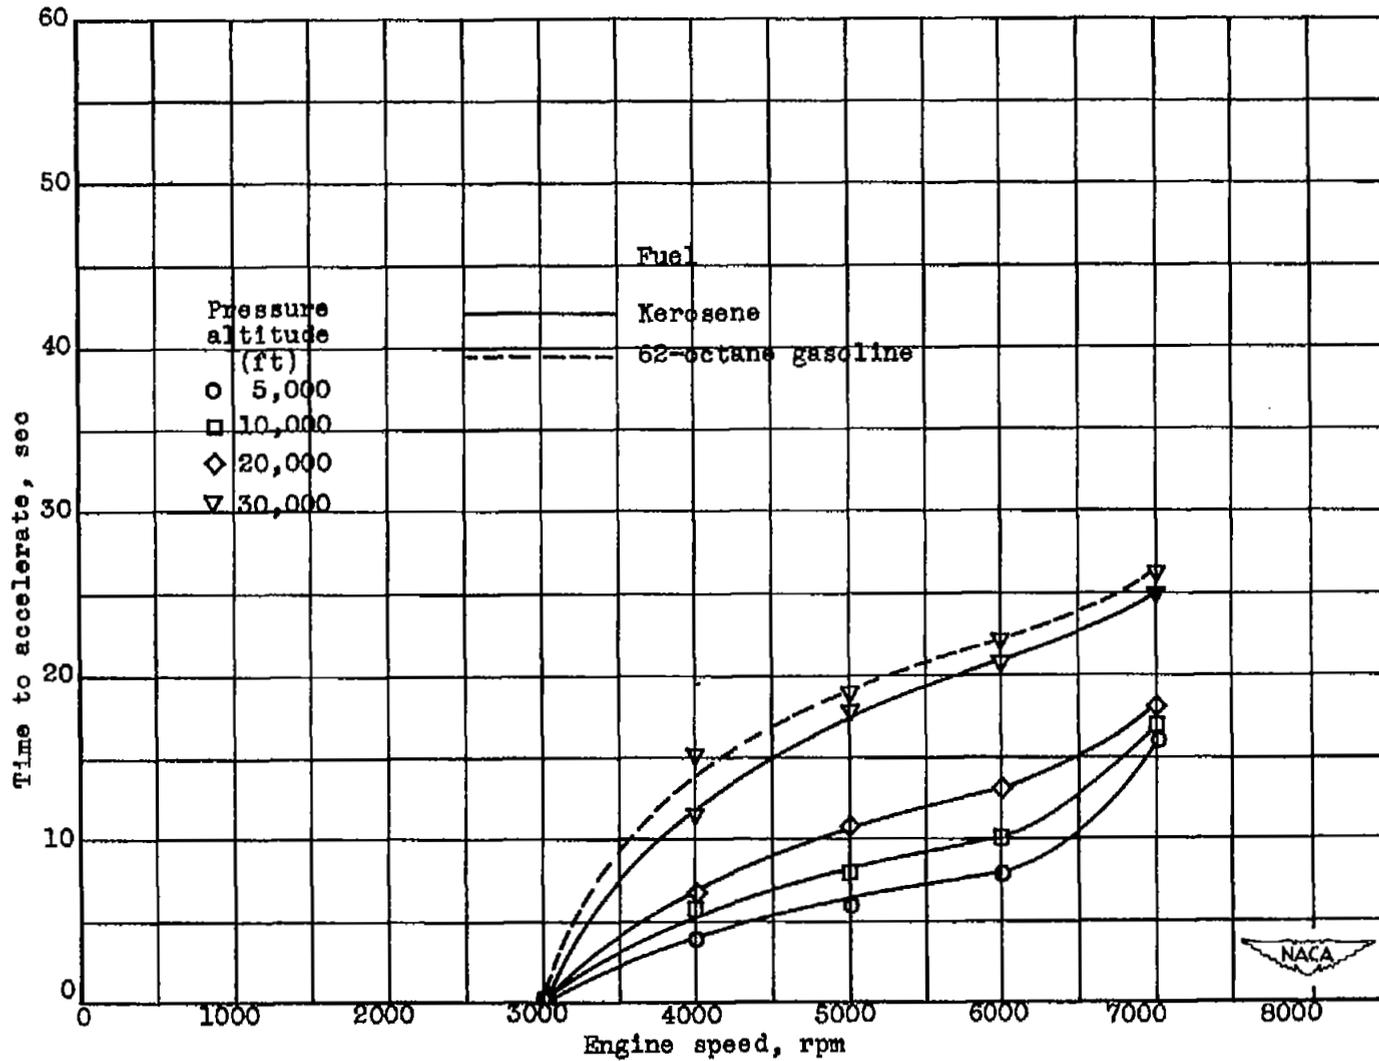
Modified fuel regulator. - The modified fuel regulator, which replaced the original fuel regulator when the high-flow compressor was installed in the engine, so restricted the fuel flow during acceleration that above 6000 rpm acceleration was very slow (figs. 12 and 13). The original fuel regulator controlled the fuel flow up to an engine speed of approximately 6800 rpm where the variable-speed governor began to control the fuel flow. The modified regulator, however, controlled the fuel flow up to an engine speed of about 7000 rpm at a pressure altitude of 5000 feet. With the modified fuel regulator an increase in altitude resulted in an increase in the engine speed at which the governor took control of the fuel flow. At pressure altitudes above 20,000 feet the revised fuel regulator controlled the fuel flow up to 7600 rpm. The maximum small-slot fuel pressure obtainable when starting was 90 pounds per square inch with the modified fuel regulator as compared with 120 pounds per square inch with the original fuel regulator.

Figure 13.- Effect of pressure altitude on the time required to accelerate from an idling speed of 3000 rpm with high-flow compressor, configuration 13.

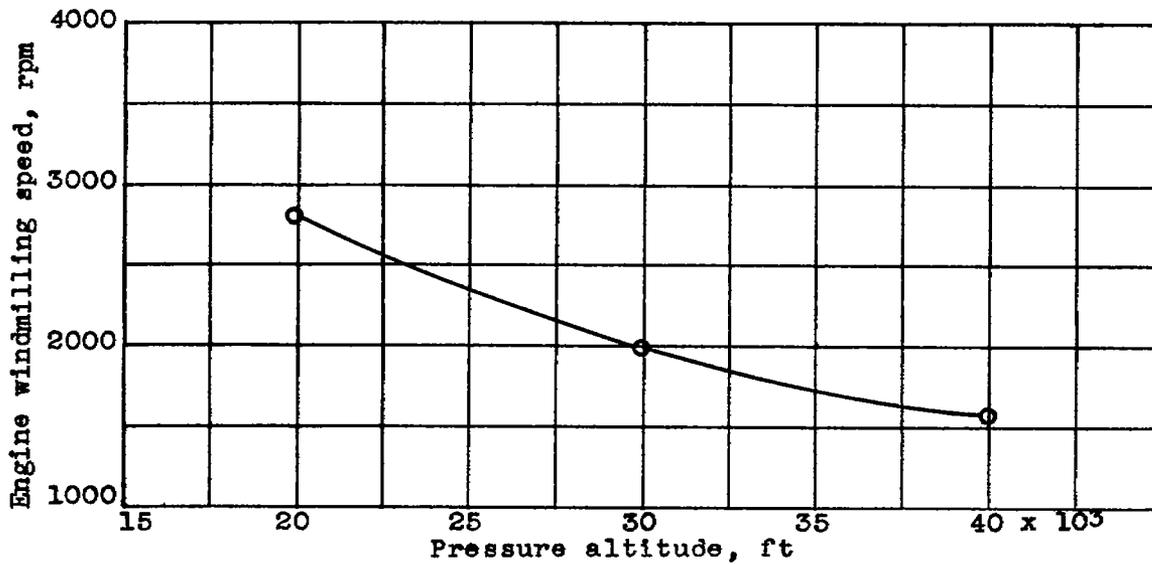
A summary of the conditions at which windmilling starts were attempted is given in table III and the maximum windmilling speeds and true airspeeds at which the engine could be started at each altitude are shown in figures 14 and 15. Acceleration of the engine was more rapid in starts at high airspeeds.

Figure 14. - Variation with altitude of maximum engine windmilling speed at which engine could be started.

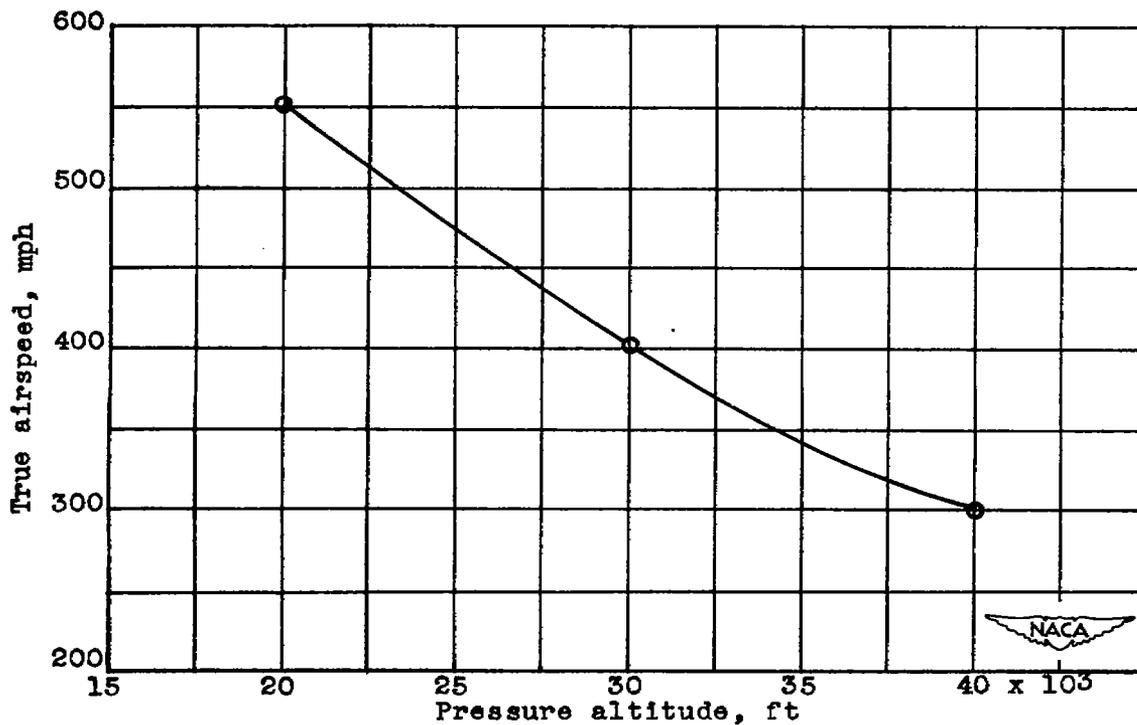
Figure 15. - Variation with altitude of maximum true airspeed at which engine could be started.

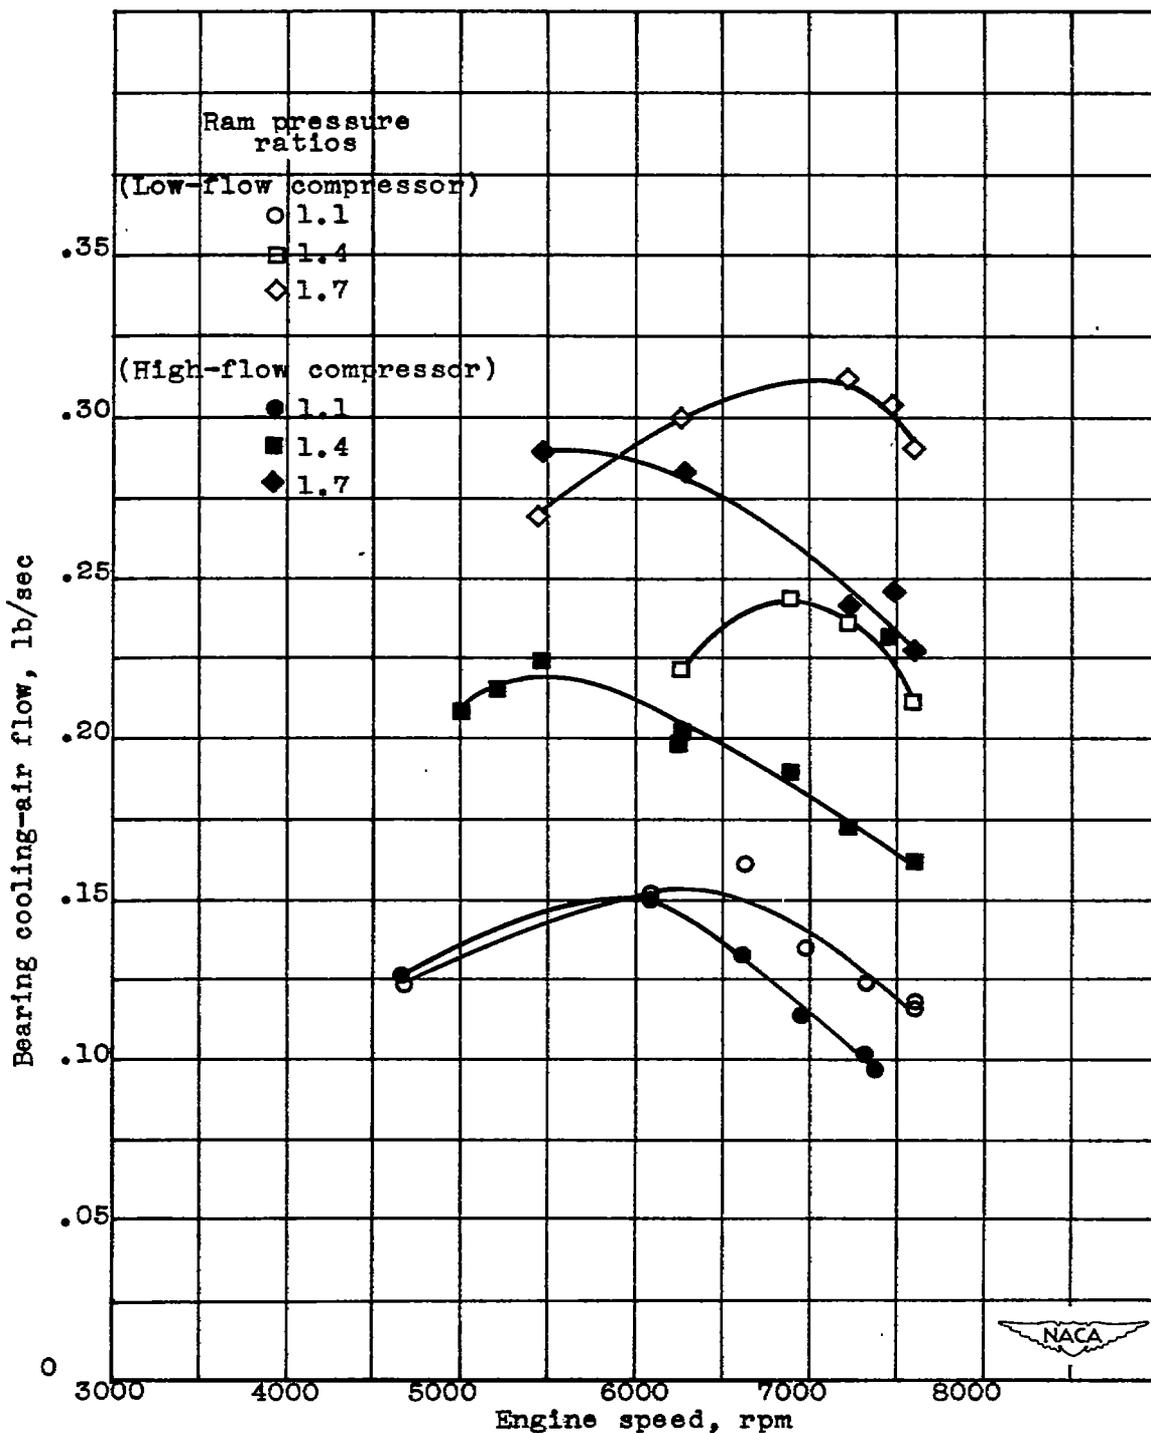
Failure of the bearings to cool properly at high pressure altitudes and high engine speeds was attributed not only to the reduced density of the air at high altitude but also to the fact that at high engine speeds the bearing cooling-air flow decreased with increasing engine speed. Representative data showing the comparison of bearing cooling-air flow with the low-flow and high-flow compressors at a pressure altitude of 30,000 feet are presented in figure 16. The decrease in bearing cooling-air flow at high engine speeds was more rapid with the high-flow compressor than with the low-flow compressor. At maximum engine speed the high-flow compressor delivered from 15 to 25 percent less cooling air to the bearings at all altitudes than the low-flow compressor.

Figure 16.- Comparison of bearing cooling-air flow with low-flow and high-flow compressors at a pressure altitude of 30,000 feet.

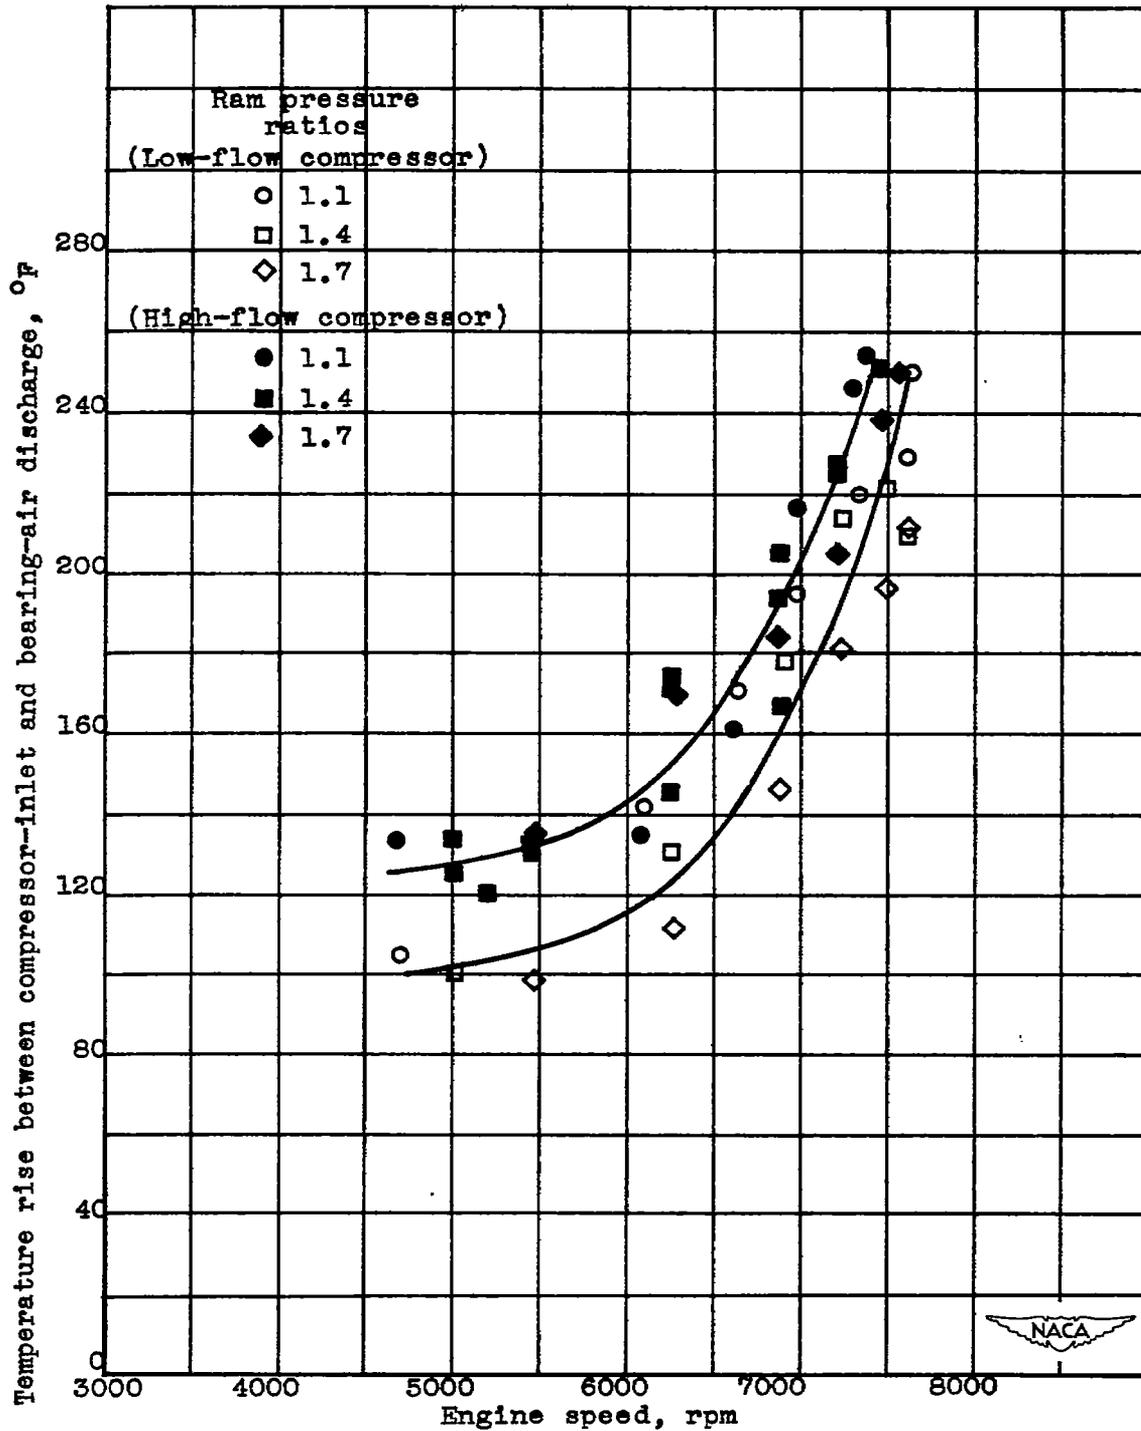
The temperature rise between the compressor inlet and the bearing cooling-air discharge at all altitudes was from 10 to 20 percent greater with the high-flow compressor than with the low-flow compressor. A comparison of this temperature rise for the low-flow and high-flow compressors at a pressure altitude of 30,000 feet is shown in figure 18.

Figure 18.- Comparison of temperature rise between the compressor inlet and bearing-air discharge with low-flow and high-flow compressors at a pressure altitude of 30,000 feet.
