# RESEARCH MEMORANDUM

EFFECT OF FORGING TEMPERATURE AND HEAT TREATMENT  
ON THE PERFORMANCE OF INCONEL 700 BUCKETS AT  
1625° F IN A J33-9 TURBOJET ENGINE

By C. A. Gyorgak, D. F. Springsteen, and J. R. Johnston

Lewis Flight Propulsion Laboratory  
Cleveland, Ohio

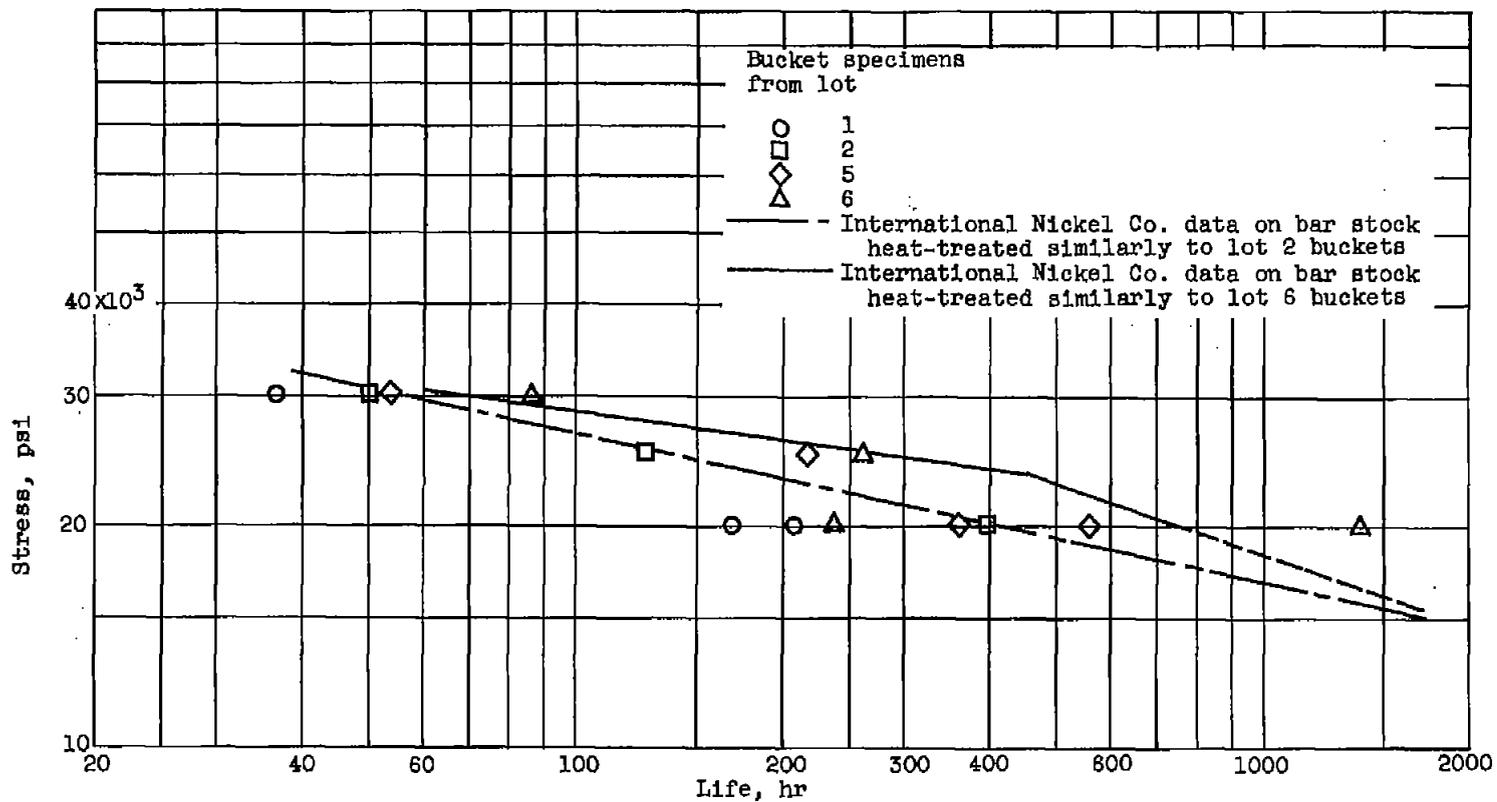
Figure 7. - 1600° F Stress-rupture life of Inconel 700 specimens taken from airfoils of buckets.

Although some of the stress-rupture data obtained from airfoil specimens were questionable, the remaining data compare favorably with the manufacturer's data, as shown in figure 7. It is interesting to note that one specimen from the lot-6 buckets had a stress-rupture life of nearly 1400 hours when stressed at 20,000 psi at 1600° F. This stress is comparable to that encountered in the critical zone of the buckets during rated-speed operation, and the temperature is within 25° F of the temperature in the critical zone of the bucket.

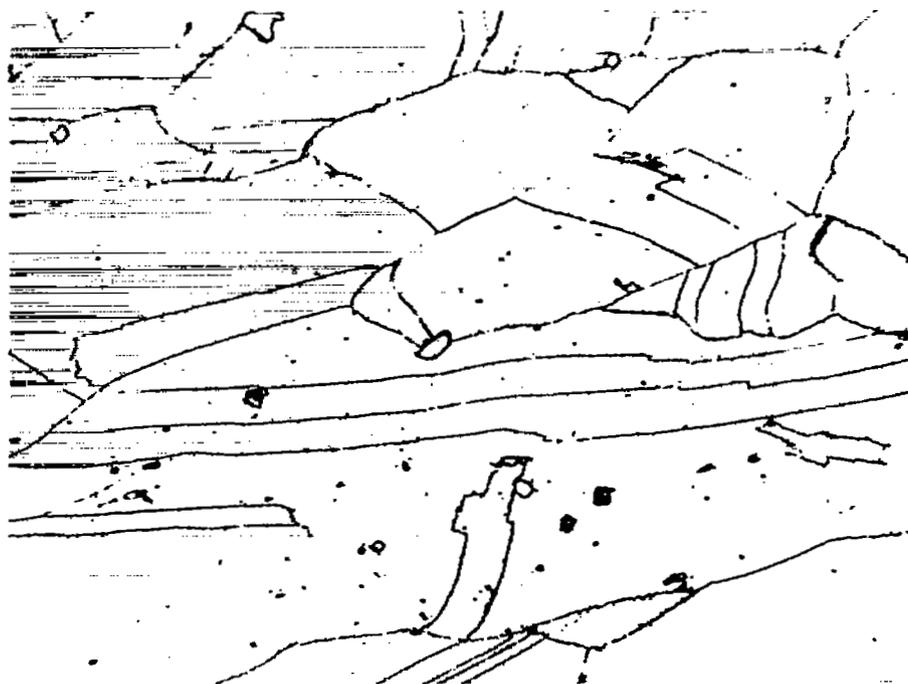
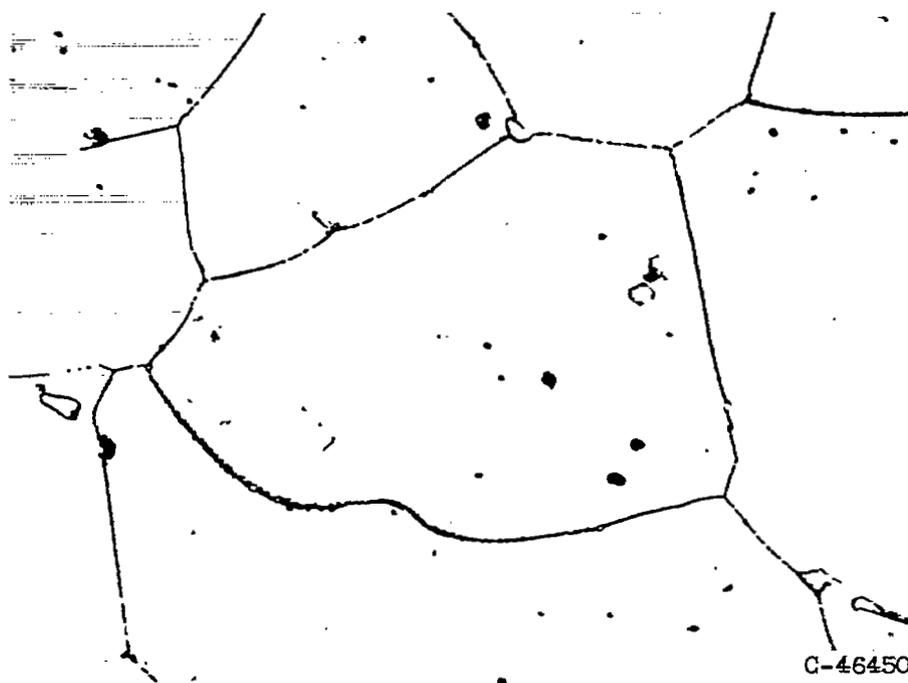
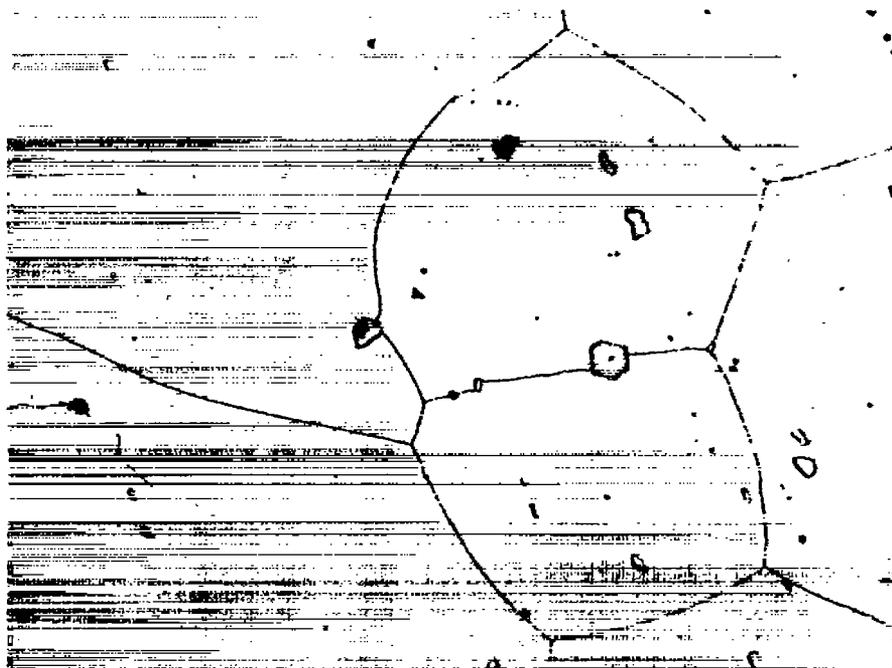
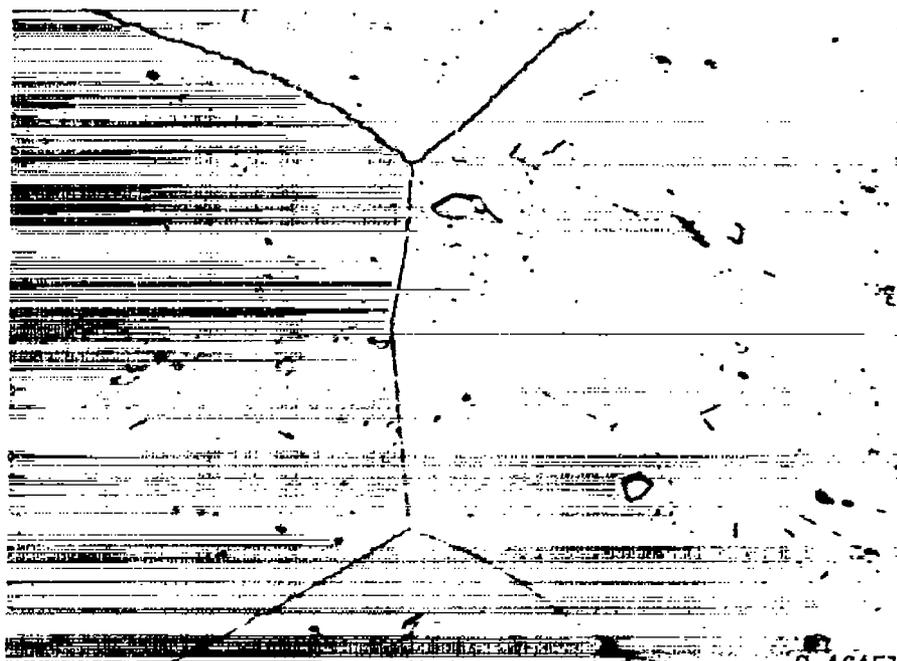
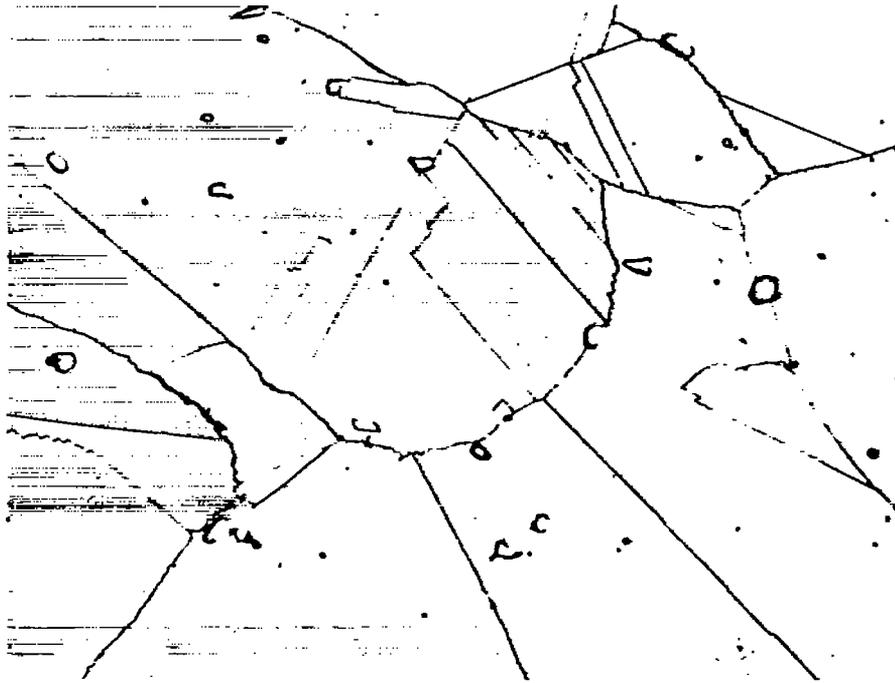
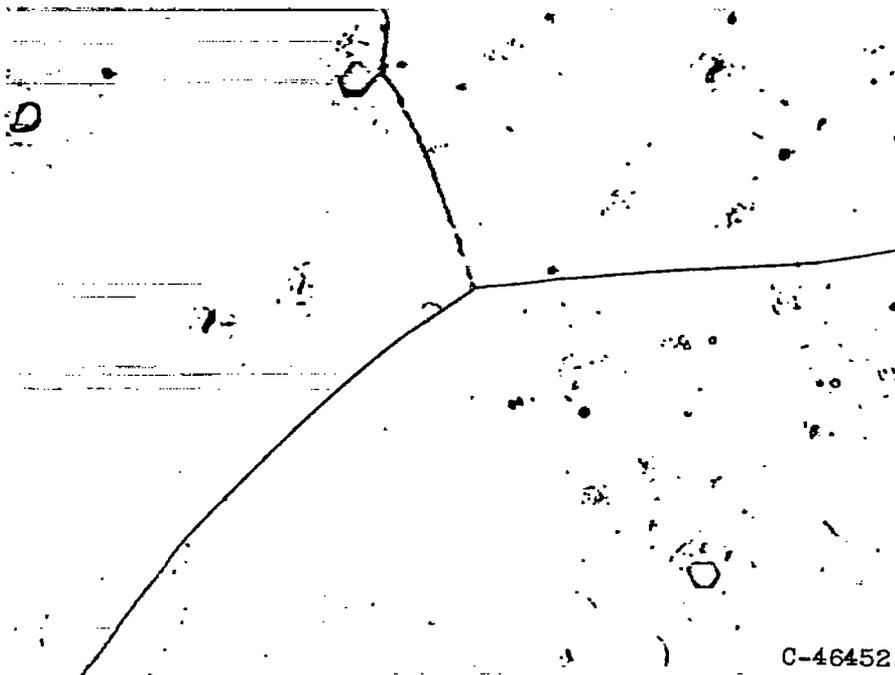
Figure 10. - Typical as-heat-treated microstructures.  
Original magnification, X750.

The typical microstructures of the six lots of buckets are shown in figure 10. The photomicrographs do not show the matrix precipitates that are often visible in an age-hardenable alloy. In all probability the precipitates are too fine (or coherent) to be resolved optically. (Long-time aging in a furnace or operating the buckets in an engine will cause the precipitates to grow and become readily visible, as will be shown later.) The larger minor-phase particles present in these microstructures have been identified as titanium carbonitride  $Ti(C,N)$  (ref. 3).

Metallographic studies of the buckets offer some assistance in understanding the effects of the different forging temperatures and solution treatments on the bucket performance. The microstructures of as-forged buckets, even those forged from a temperature of 2225° F, showed evidence of cold-working in the form of elongated grains (figs. 9(a) and (e)). More severe grain elongation was present in the buckets forged from a temperature of 2100° F, indicating that these buckets received a greater degree of cold-working.
